Confidential Inspection Report

LOCATED AT:
337 S. Rodeo Dr
Beverly Hills, California

INSPECTED ON:
Wednesday, January 15, 2025

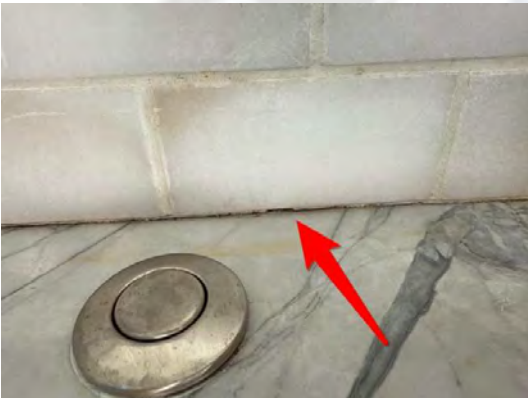
COUNTERS

NDSA The seal at the backsplash is deteriorated and should be sealed to limit moisture intrusion into the cabinets below.

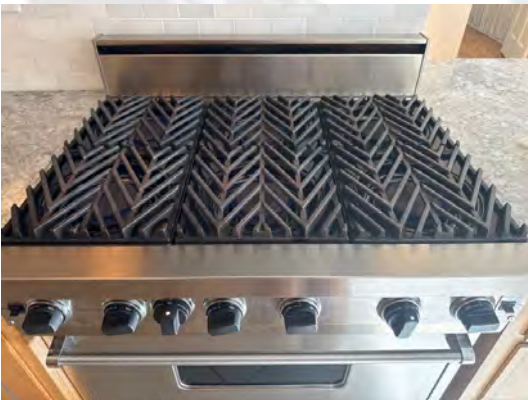
COOKTOP

NDSA Needs Attention the right rear burners ignition did not work when tested

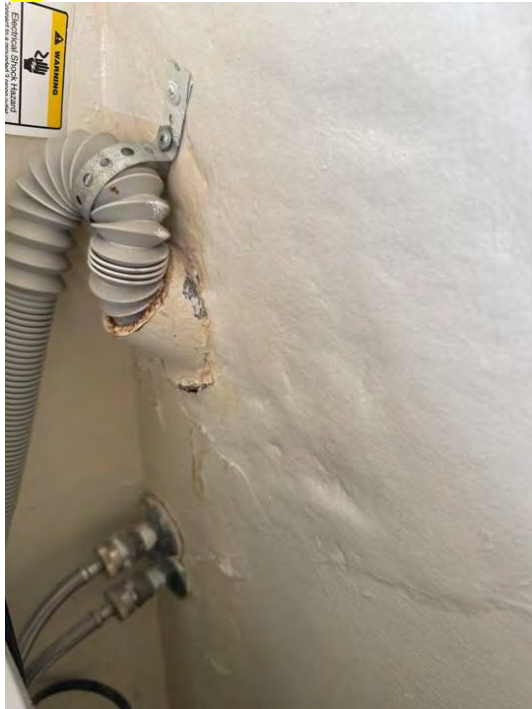
LAUNDRY AREA

NDSA The washing machine drain may have leaked in the past as the wall has been patched.

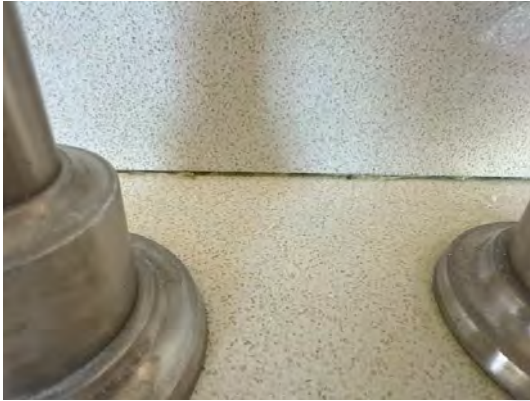
COUNTERS

NDSA The seal at the backsplash is deteriorated and should be sealed to limit moisture intrusion into the cabinets below.

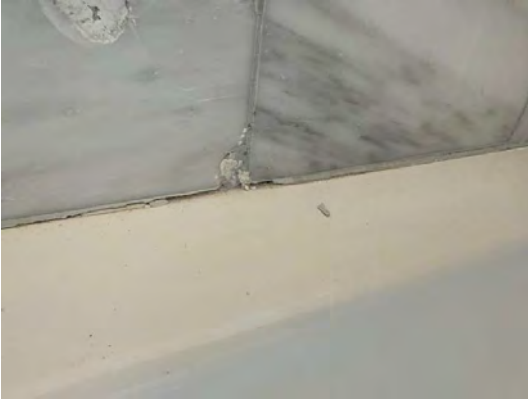
TUB FIXTURES

NDSA The seal at the tub/tile connection is deteriorated.

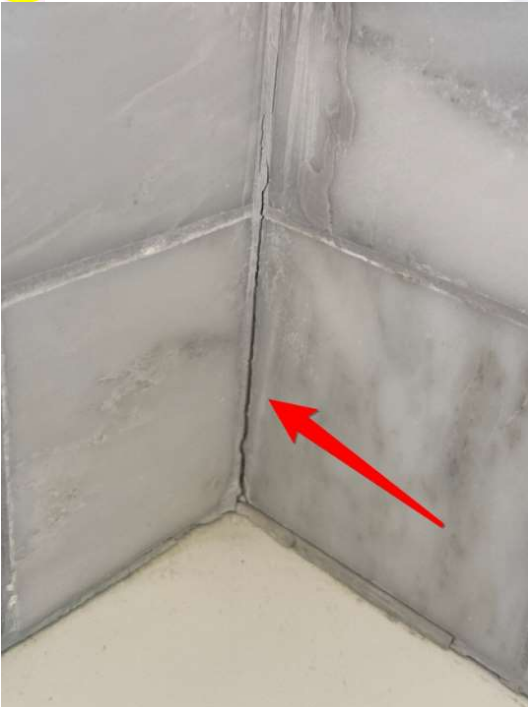
SHOWER WALLS

NDSA The shower has areas of deteriorated grout.

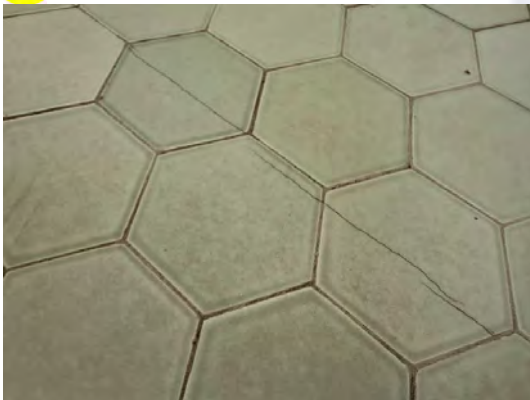
FLOORING

NDSA The bathroom floor tile is cracked in areas.

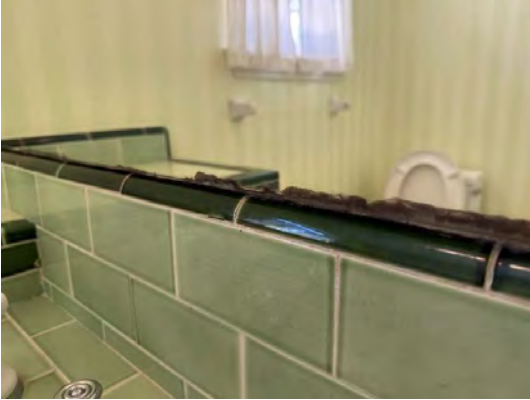
MIRRORS

NDSA The mirror surfaces are deteriorated in areas.

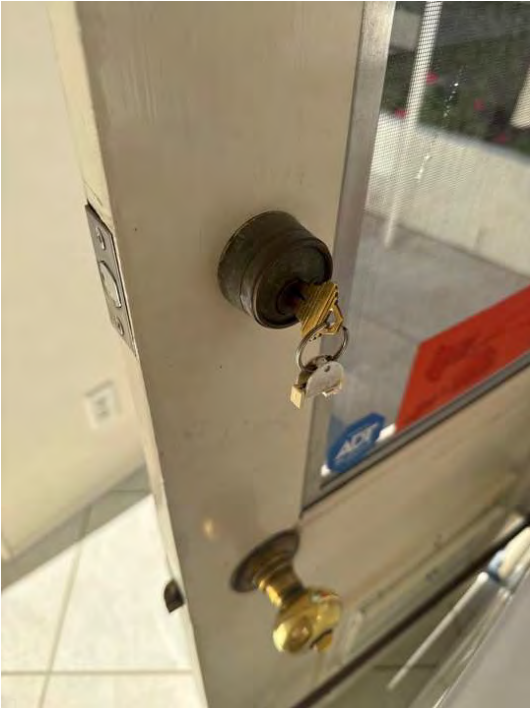
DOOR COMMENTS

NOTA The inside of the dead bolt on the exterior doors is operated with a key instead of a thumb turn. This is a potential safety issue for an emergency exit as it requires a key to get out of the building.

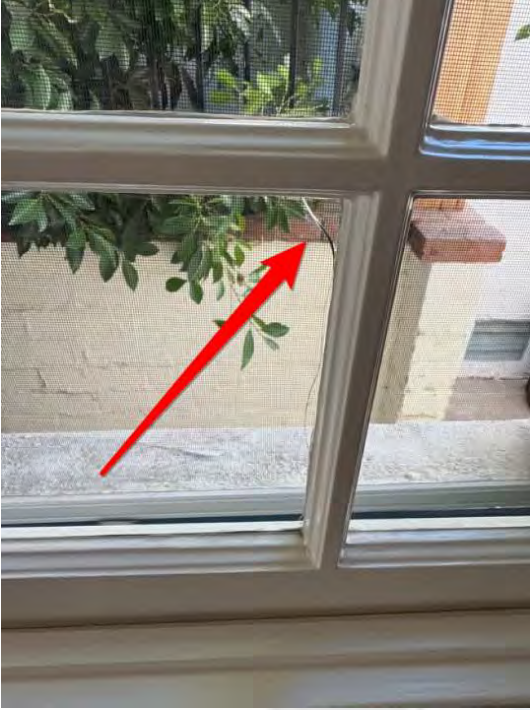
WINDOW CONDITION

NDSA There are cracked window panes such as in the living room on the north wall

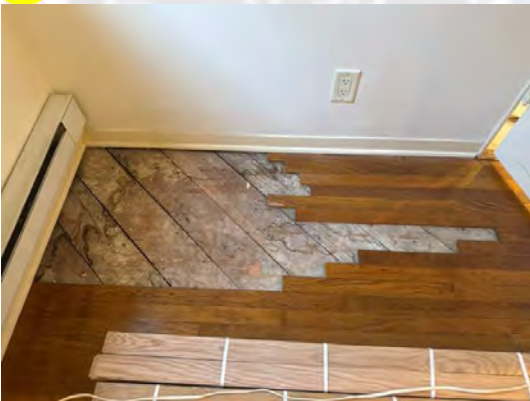
HARDWOOD CONDITION

NDSA There are areas of missing flooring, such as in the third bedroom.

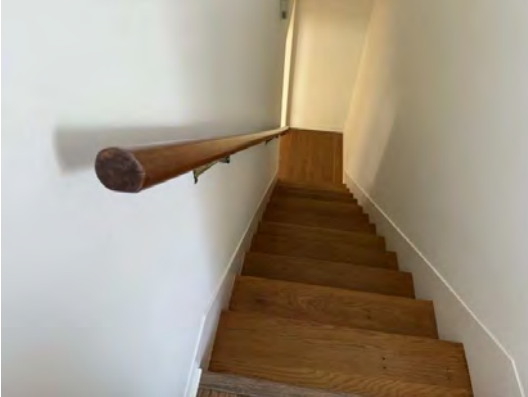
RAILING CONDITION

NDSA The handrail does not return to the wall and could catch clothing and cause a fall.

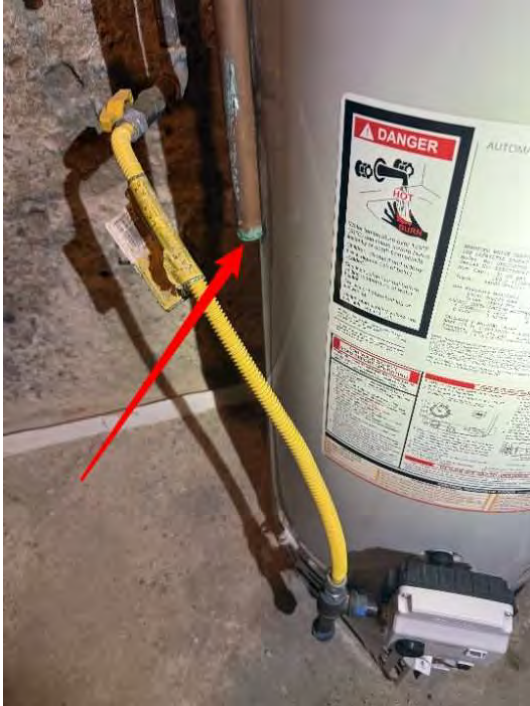
TEMPERATURE/PRESSURE RELIEF VALVE

NOTA The temperature/pressure relief valve has a partial drain line installed but it does not go far enough down to take the water away to a safe location. We recommend this drain line be installed in case this valve ever releases.

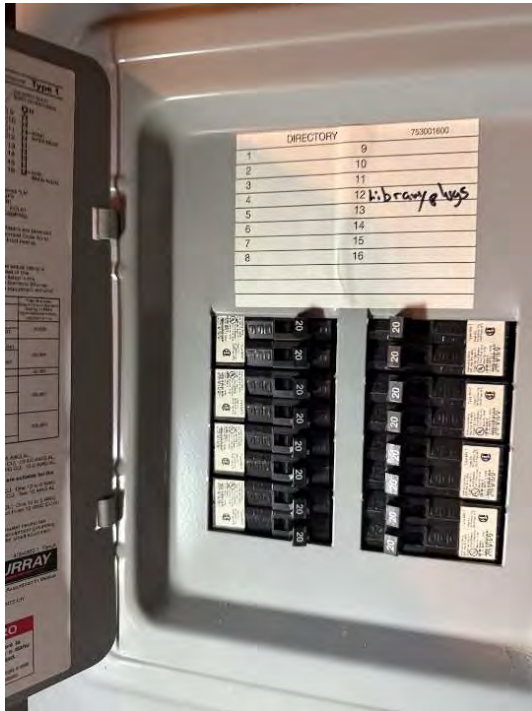
SUBPANEL CONDITION

NDSA The basement panels breakers are not completely labeled and it is unknown what each circuit controls.

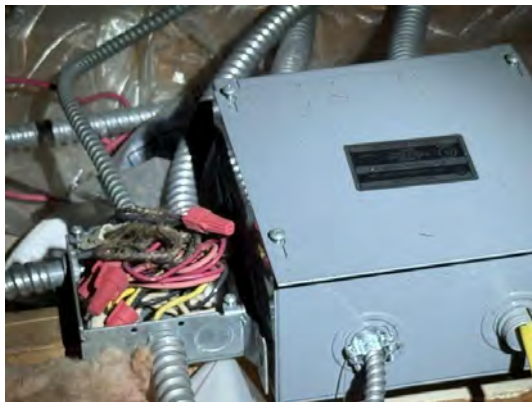
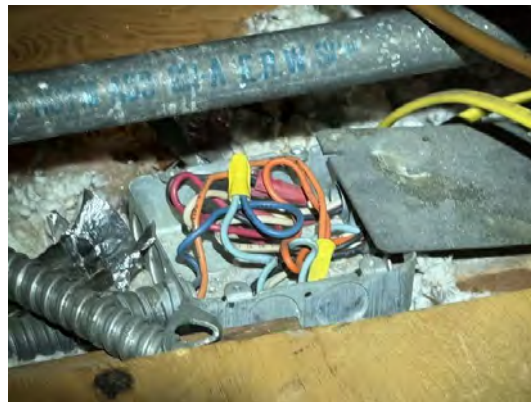
ELECTRICAL WIRING COMMENTS

NOTA There are open junction boxes with wires exposed. These need to have covers installed over them. Such as in the first floor attic.

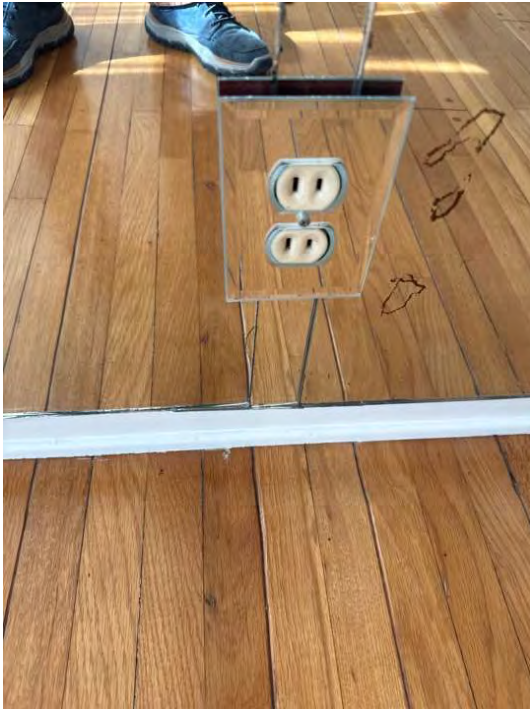
CONDITION

UPG The outlets are a combination of 2 prong and 3 prong outlets. The 2 prong are the older ungrounded type. In many cases they could be upgraded to the 3 prong type with a ground installed in them but it is not a requirement.

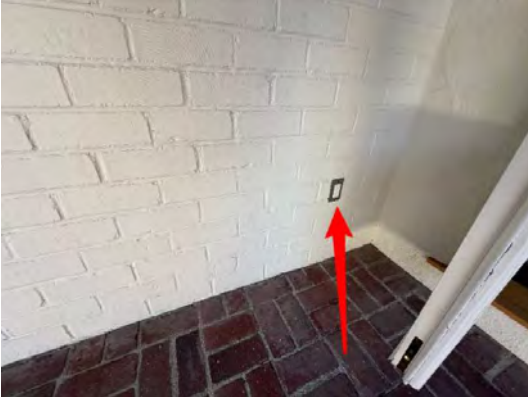
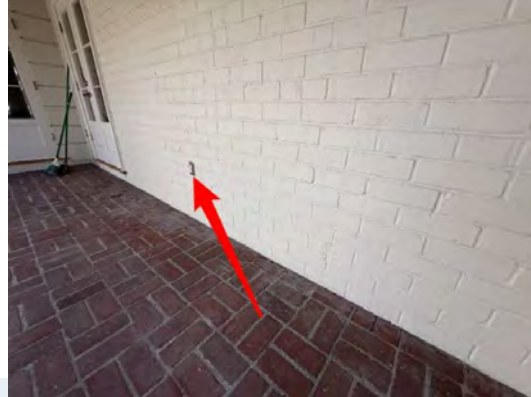
CONDITION

NOTA There are some exterior electrical outlets that do not have waterproof covers.

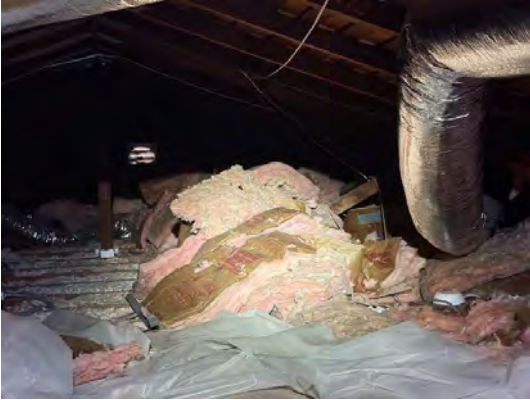
INSULATION CONDITION

NOTA The insulating material is not installed per the manufacturers recommendations. It has the wrong side facing upward in areas. This is printed in the backing of the insulation as a potential fire hazard.

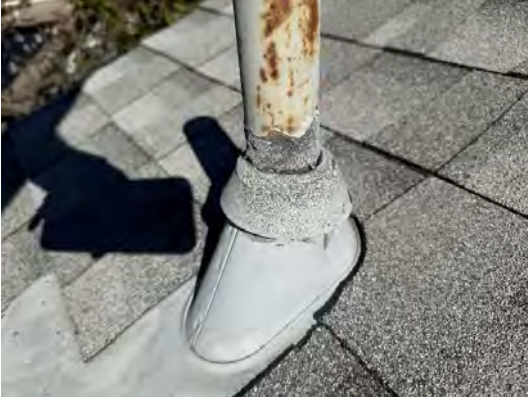
CONDITION

NDSA The mastic is cracked in areas and is not reliable to ensure a watertight seal. This was noted at the right rear of the roof

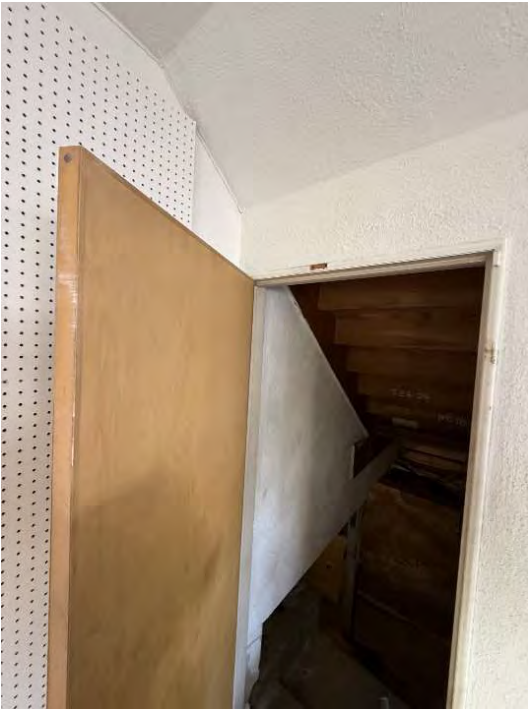
CONDITION

NOTA The door between the garage and the closet space is not self closing for fire safety. It needs a spring hinge or a closer on it.

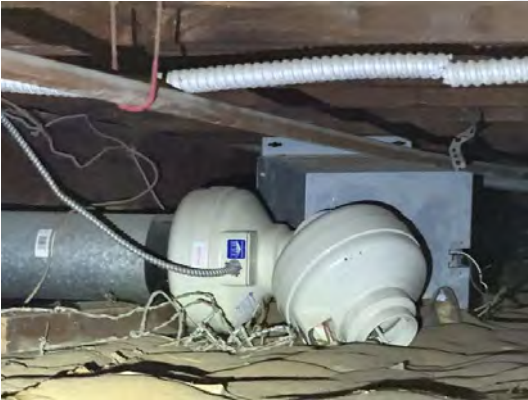
CRAWL SPACE

NDSA There appears to be a moisture issue in the crawl space. There are signs of damage from moisture as well as a powered exhaust fan to circulate under the house.

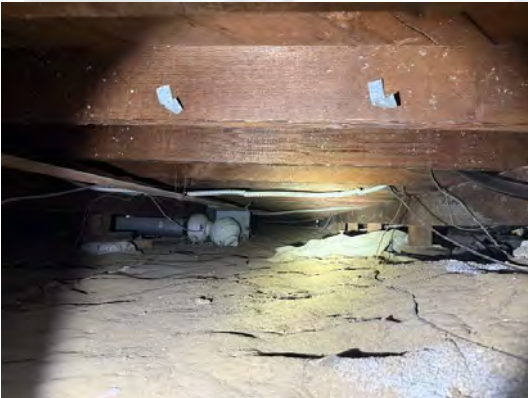
NDSA The crawl space has debris in it, it is advisable to have it removed and the area cleaned up. Wood especially should be removed to help prevent future infestations.

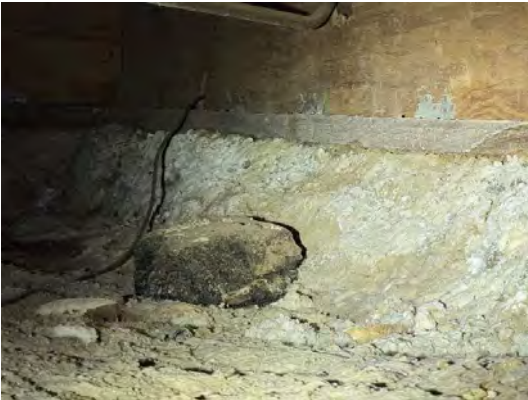
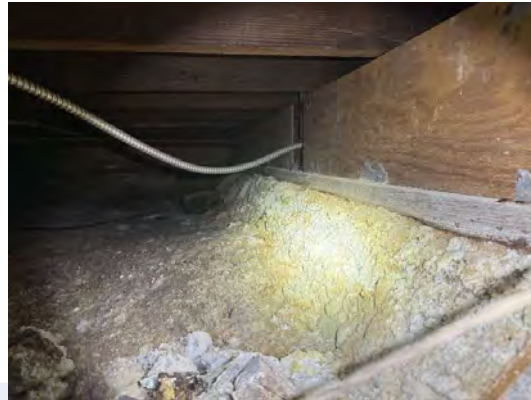
RAISED FOUNDATION

NDSA There are chalky areas on the concrete. These are an indication that water has entered the concrete and crawl space during wet weather and brought salts out of the concrete when it came to the surface.

NDSA The concrete is deteriorated in areas. This appears to be from excessive moisture, age, or a combination of the two. It does not appear to be a major concern but if more information is desired, a foundation expert would need to be called

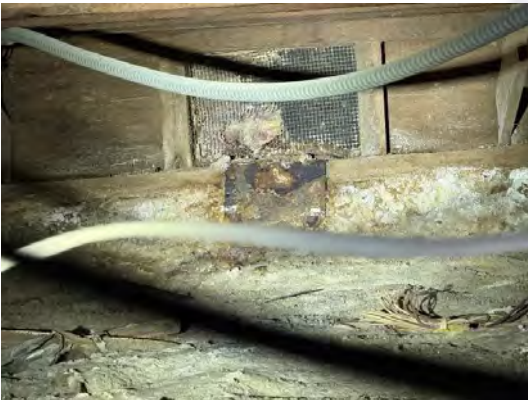
FOUNDATION BOLTING

ACPT **NDSA** The foundation has been seismically retrofitted with anchor bolts at a later date than the original construction. This is an upgrade. It is noted though that some of the retrofit plates are heavily rusted and may need replacement

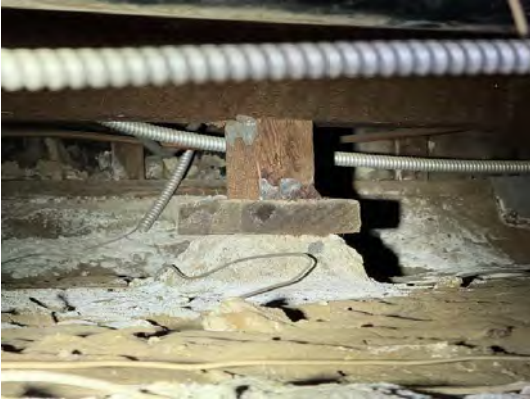
POSTS AND PIERS

NDSA Needs attention, the concrete piers are deteriorated in areas.

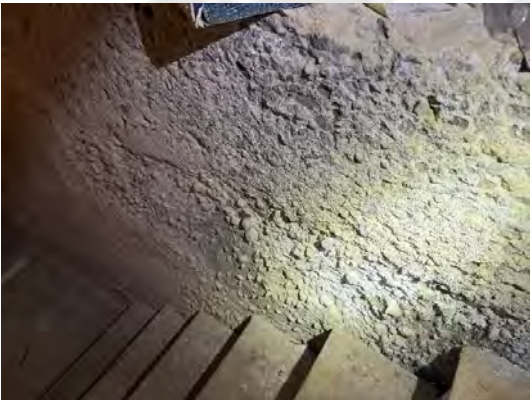
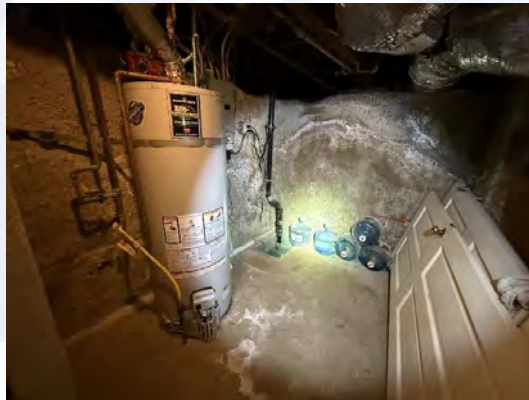
BASEMENT CONDITION

NDSA There is efflorescence on the basement walls. This is an indication that moisture has entered the basement in the past.
