**INSPECTRITE** LLC  
PREMIER INSPECTION SERVICES

**SUBJECT PROPERTY:**  
**1511 Promontory Ridge Way, Vista, CA 92081**

**INSPECTION DATE:**  
**07/28/2026**

## SUMMARY REPORT

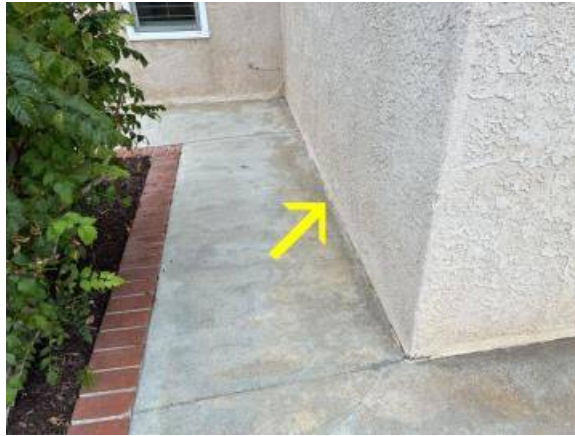
### **3.4 Exterior Grade at Foundation:**

**Marginal** - The finished grade level of exterior flatwork was too high against the building. Flatwork was in contact with siding material. Ideally, the exterior flatwork should be held at least 2" below the bottom edge of the siding to help protect the siding and structure against moisture damage and termite infestation. Condition was observed at: right rear.

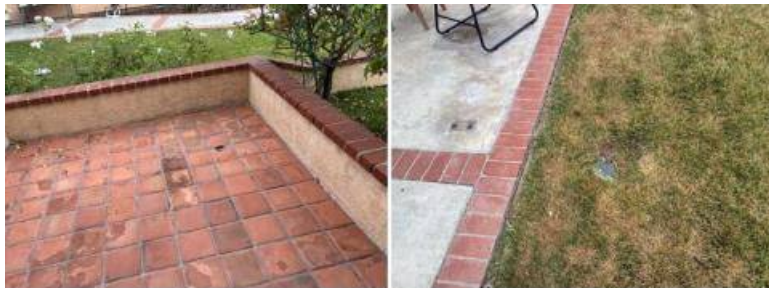
### **3.7 Trapped Areas:**

**Advisory** - Surface drainage was trapped or blocked at one or more areas. Surface runoff was directed into drain inlets of the subsurface drainage system. Consequently, adequate site drainage was dependent on subsurface drains. It is essential that the subsurface drainage system is functional for adequate site drainage. Recommend verifying that the underground drainage system is functional, and recommend flushing drains annually. Condition was observed at: front and rear.

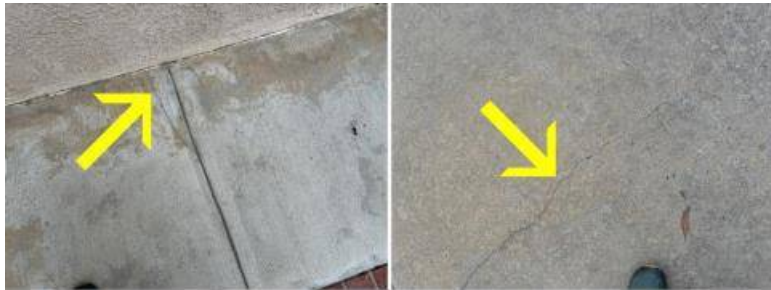
### 3.11 Maintenance:

**Maintenance** - Cracks and gaps in paving should be sealed/repaired to stop water infiltration, which can help prevent further damage.

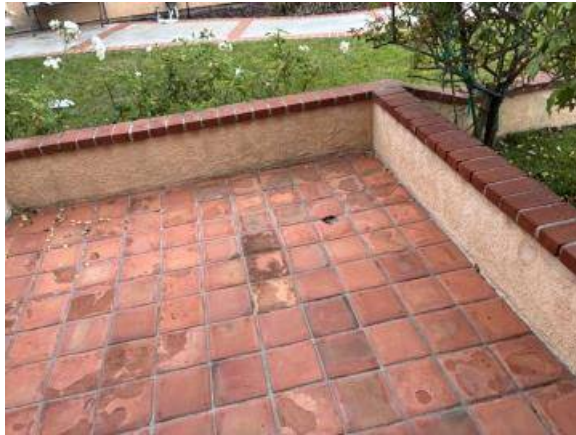
### 3.12 Trip Hazards:

**Advisory** - Smooth tiled surfaces were present. Be aware that exterior tiled surfaces can become slippery when wet.

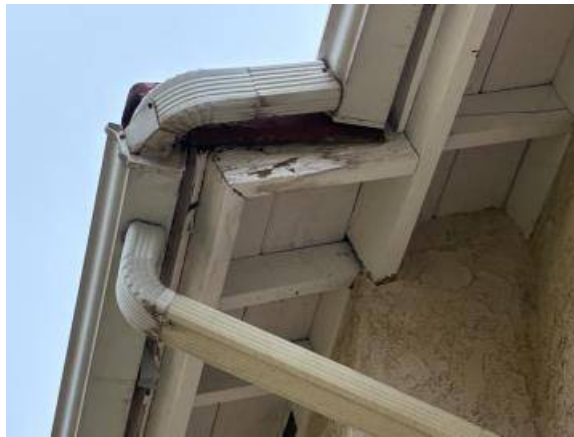
**4.7 Damaged Wood:**

**Further Evaluation** - Damage/Deterioration was noted. We recommend further evaluation from a licensed pest inspection company. If a pest inspection has already been performed than refer to that report for additional information regarding damage to wood members. Condition was observed at: Eaves on right side.

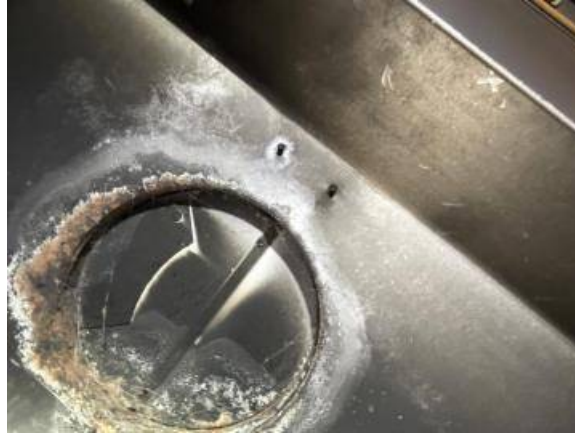
### 5.6 Fireplace Maintenance:

**Upgrade** - A clamp was not installed to hold the damper(s) in the open position. A damper clamp is required when gas plumbing is installed in the fireplace.

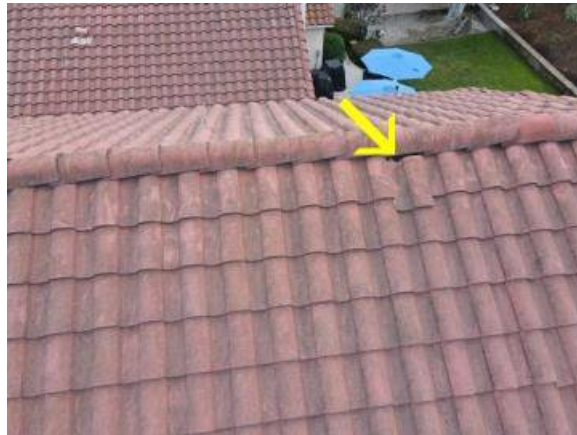
### 7.5 Tile Roof Damage:

**Repair** - Slipped or displaced tiles were observed. This condition allows rain water and/or UV light to infiltrate under the roof covering, which over time can prematurely erode/damage the roof underlayment. Any opening in the roof covering is considered an active leak. Corrections are needed to ensure adequate weather protection.

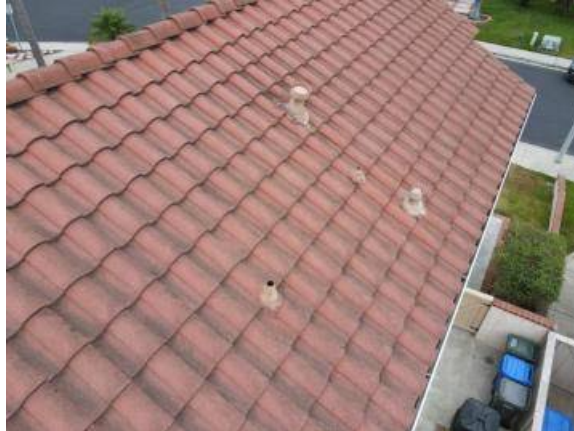
**7.8 Improper Flashing:**

**Marginal** - Secondary metal flashings around vent penetrations were not installed. Instead, mortar was packed around penetrations. Though this method of flashing was a common practice among roofing contractors until the late 1980's, it is not recommended because it lacks durability, obstructs drainage, and is prone to leaking.

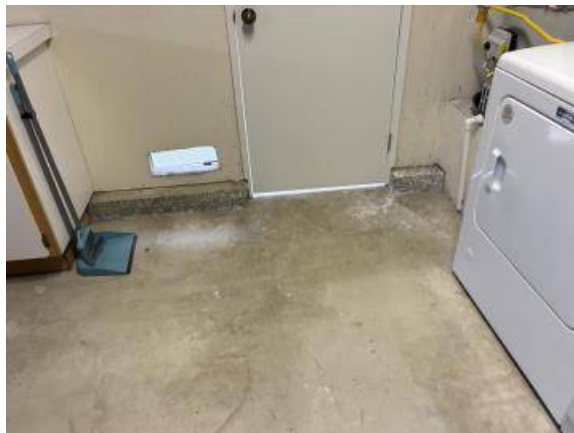
### **9.5 Exterior Door(s):**

**Maintenance** - Weather-stripping was damaged, missing or not effective.

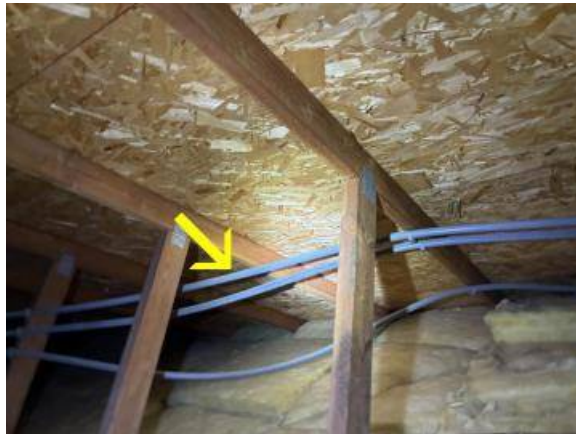
**10.5 Plastic Water Pipes:**

**Further Evaluation** - PB plastic pipes were identified. Polybutylene (PB) plastic plumbing was installed in many buildings in So. California during the mid to late 1980's. It is known to be less reliable than copper plumbing. We recommend further evaluation and correction as needed at this time by a licensed plumbing contractor.

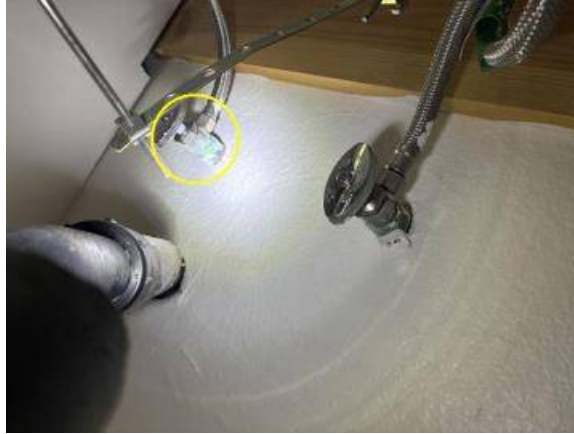
**10.6 Local Water Shutoffs & Connectors:**

**Marginal** - Corrosion was noted at local shutoff valves and/or plumbing connections serving sinks and/or toilets. Although there were no leaks at the time of inspection, replacement is recommended as preventative maintenance. Noted in master bath.

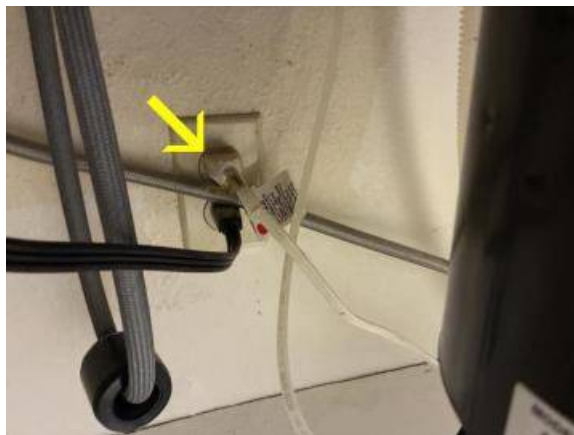
**13.10 Interior:**

**Marginal** - An extension cord is being used for permanent wiring. Extension cords are designed for temporary use only. Cords should not be used to replace wiring or installed through a wall or floor, and should never be concealed behind construction materials. Noted in kitchen under sink.

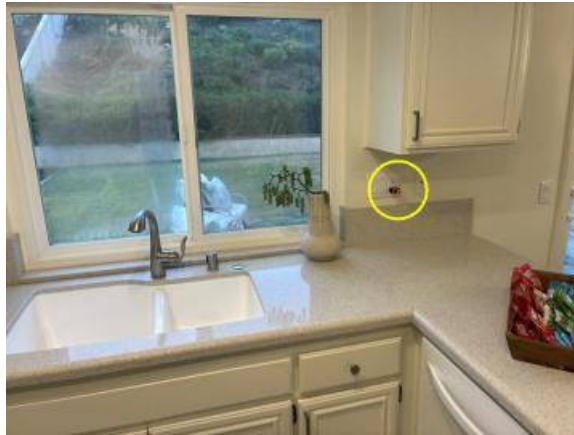
**Safety** - GFCI safety device(s) were not installed at required locations at the time the structure was built/renovated. These included the following locations: kitchen.

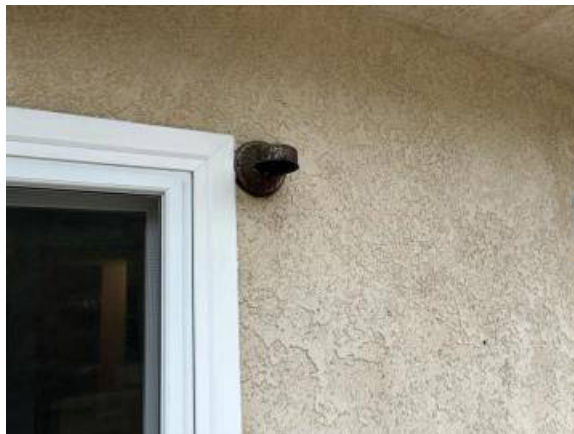
**Maintenance** - Light(s) were not working or missing bulb(s). Recommend installing new light bulb(s) to test if the light fixture(s) are working. Noted at exterior and garage.

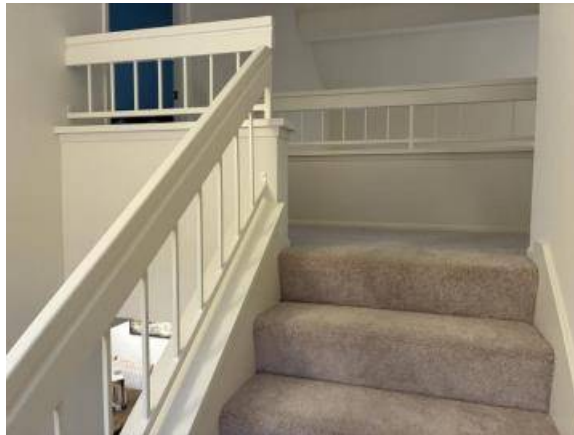
**14.12 Condition:**

**Safety** - Openings in railings were wider than 4". The current requirement is for openings to be no wider than 4". Wide openings are a safety issue for young children and pets.

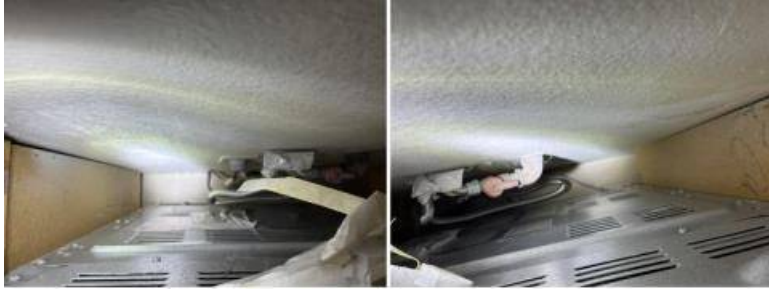
**15.7 Range:**

**Maintenance** - Anti-tip safety brackets are not present. Installation is recommended for improved safety.

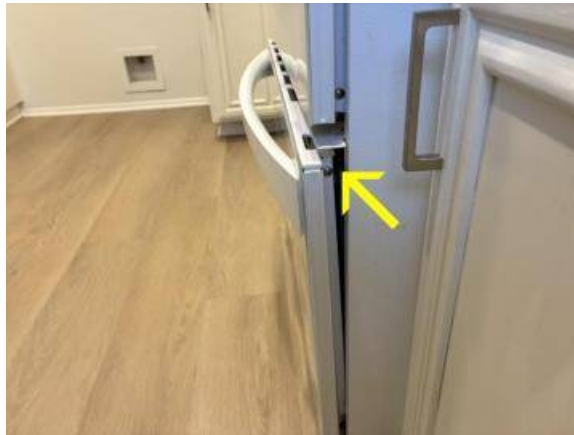
**15.8 Oven(s):**

**Repair** - Lower oven door doesn't fully close. Recommend repair.

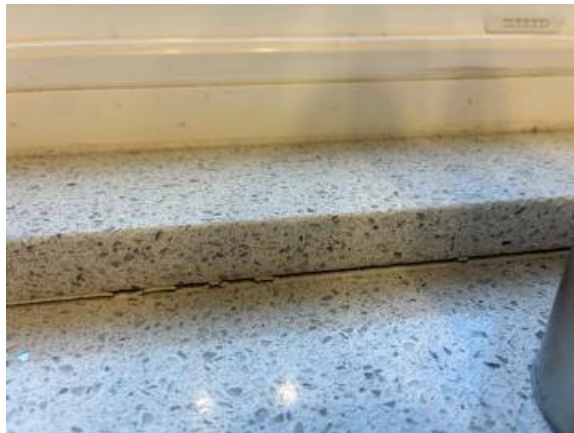
**15.9 Countertops:**

**Maintenance** - Caulking is needed to prevent water infiltration.

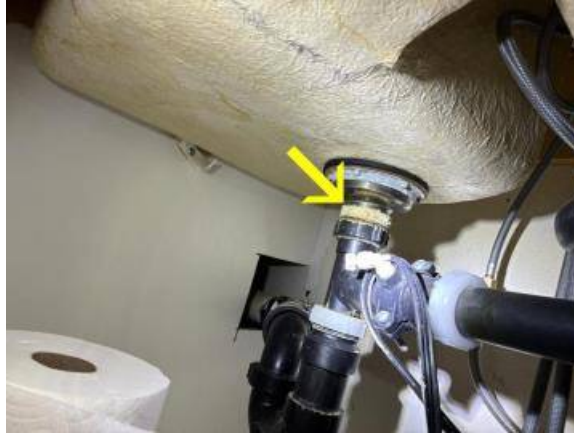
### 15.11 Sink Drain Plumbing:

**Repair** - Deterioration/Corrosion noted to the drain line and/or wet trap under the sink. Replacement recommended.

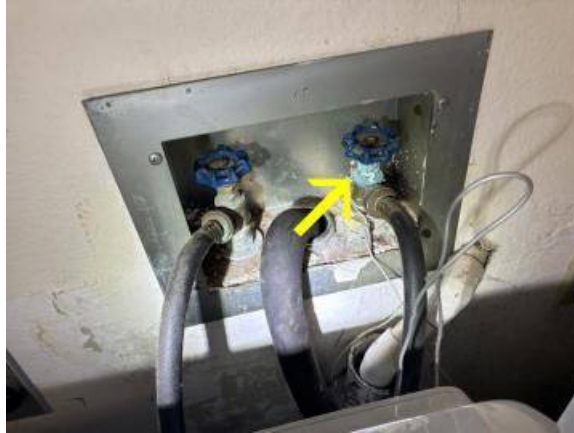
**16.4 Water Supply:**

**Repair** - Rust/Corrosion noted on water shutoff valves for the washer. Be aware that old corroded components are at a higher risk of leaking and valves may fail when turned closed, either leaking or not shutting off the flow of water. Recommend replacement.

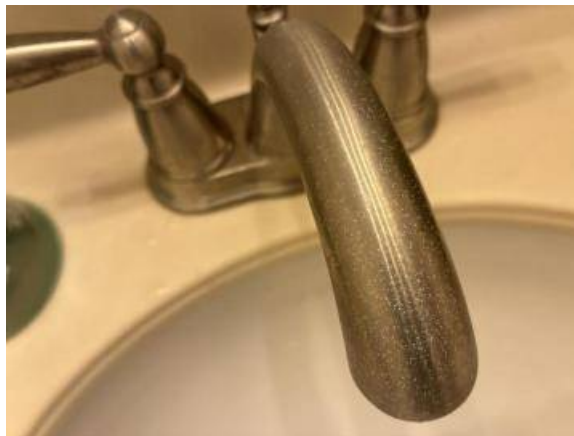
**17.6 Sink Plumbing Fixture:**

**Maintenance** - Paint over spray noted on faucet. This can be easily removed with a scotch pad and soapy warm water.

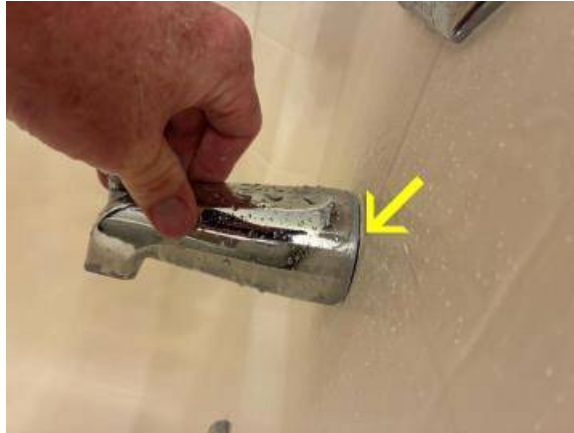
**17.10 Tub/Shower Plumbing:**

**Maintenance** - Missing or deteriorated caulking around the fixtures. Caulking as needed to prevent water infiltration.

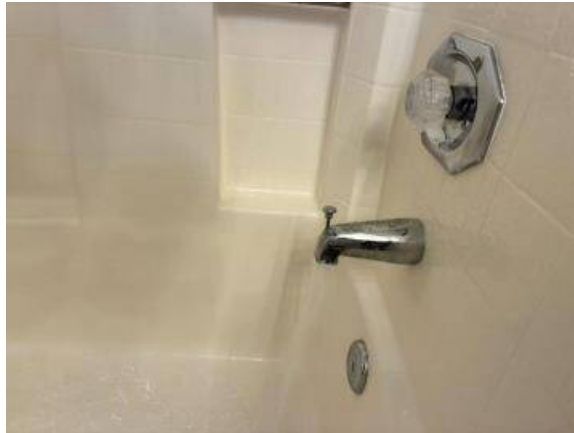
**Maintenance** - The tub/shower diverter did not operate properly. Mechanism didn't fully divert water.

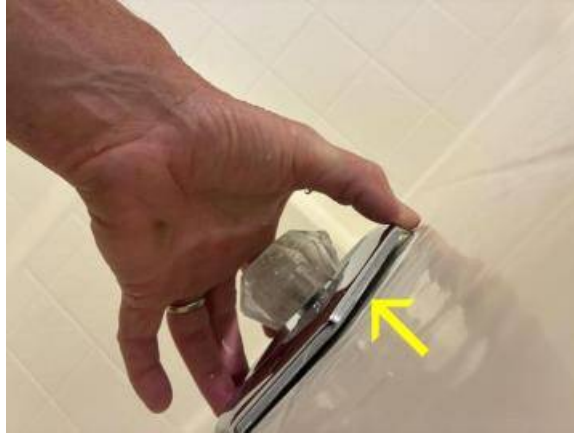
#### 17.14 Shower Plumbing:

**Maintenance** - Missing or deteriorated caulking around the fixtures. Caulking as needed to prevent water infiltration.
