# Inspection Report

J Bixler Inspections

23732 Parrotts Ferry Rd Spc 1  
Columbia, CA 95310

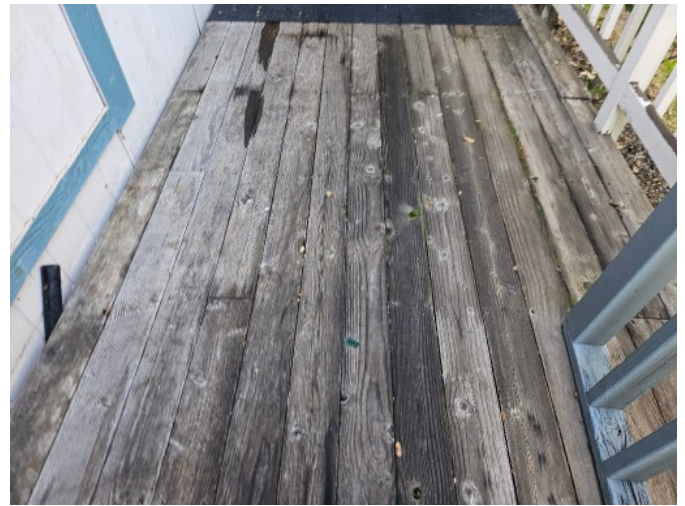
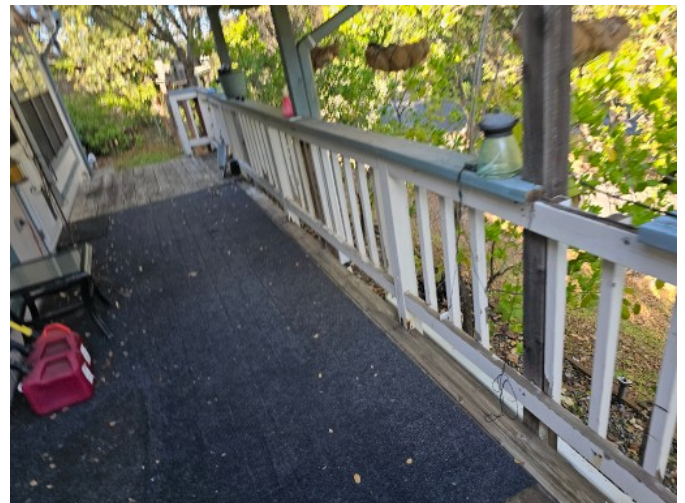
The deck showed signs of rot. See termite report for further break down and cost estimates.

The surface appeared weathered. Recommend cleaning and maintenance as needed.

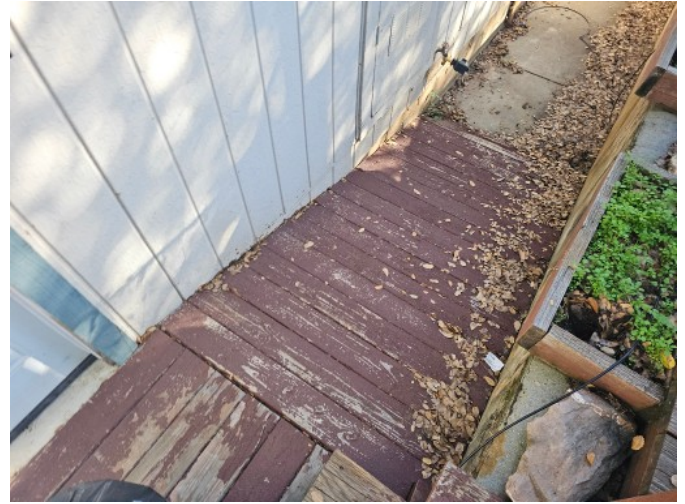
The stairs along back were broken. Recommend repair and/or replacement.

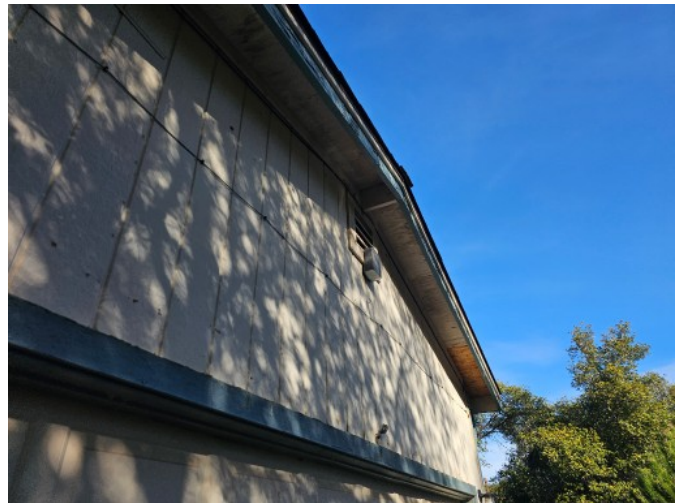
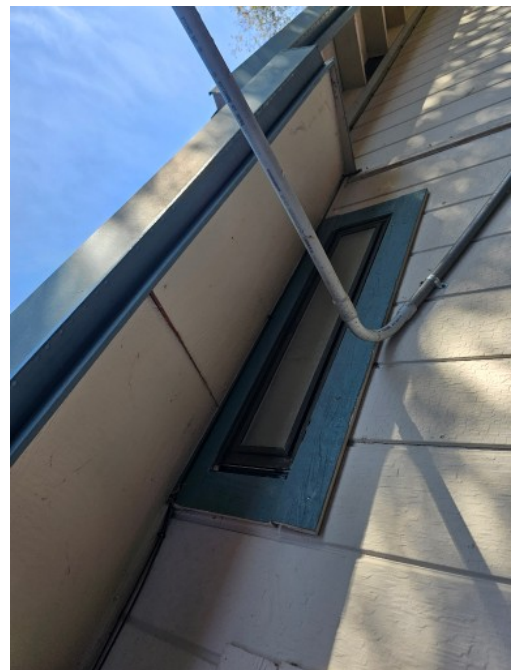
Woodpecker damage was noted. Recommend sealing and/or repair.

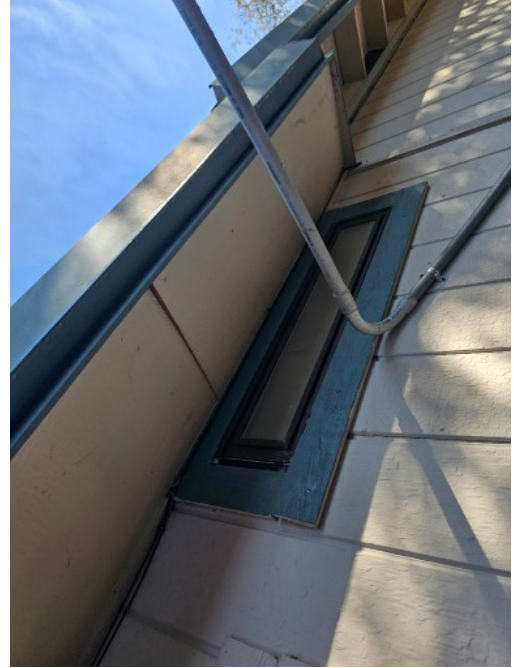
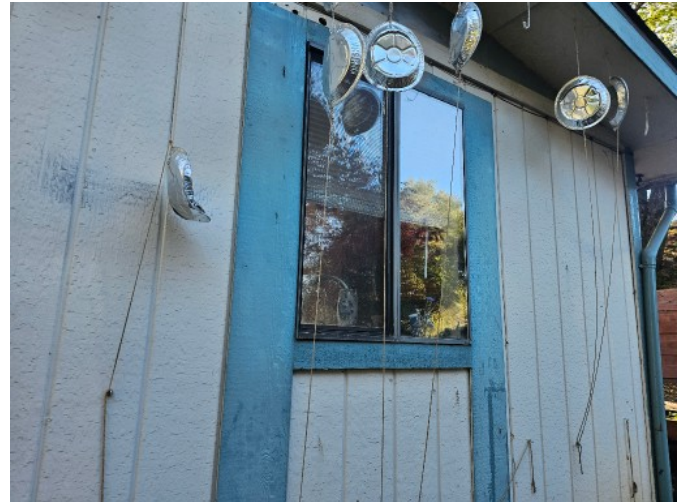
Some single-pane windows were observed. Although these appeared to be functional, updating windows is recommended in the future for energy purposes.

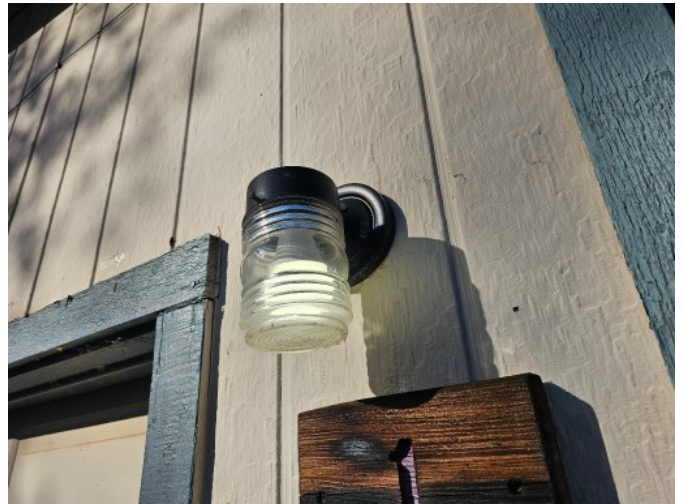
Some of the exterior lights appear to need new bulbs.

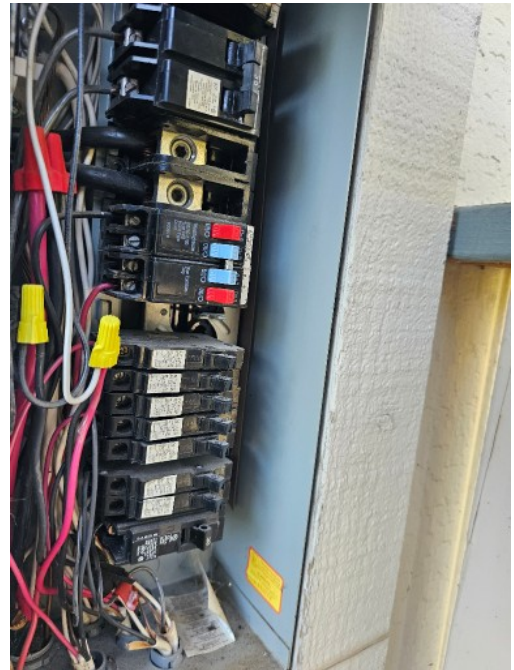
Some unprofessional electrical work was noted throughout home and some of the breakers were tripping when everything was in use. It's recommended that an electrician be called for full evaluation of the electrical system prior to closing.

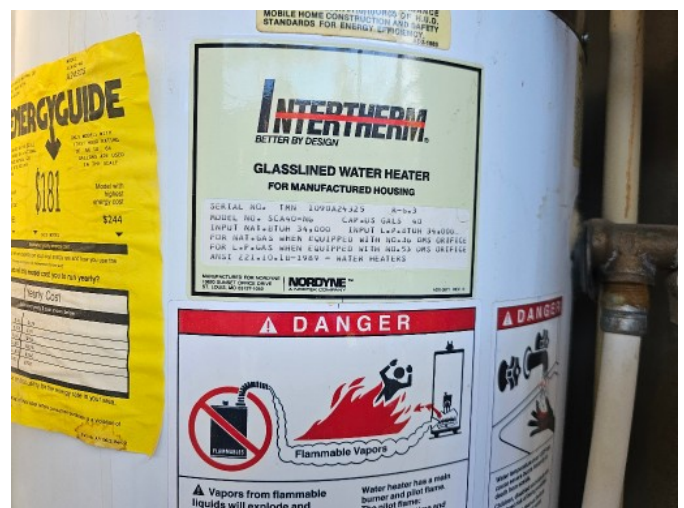
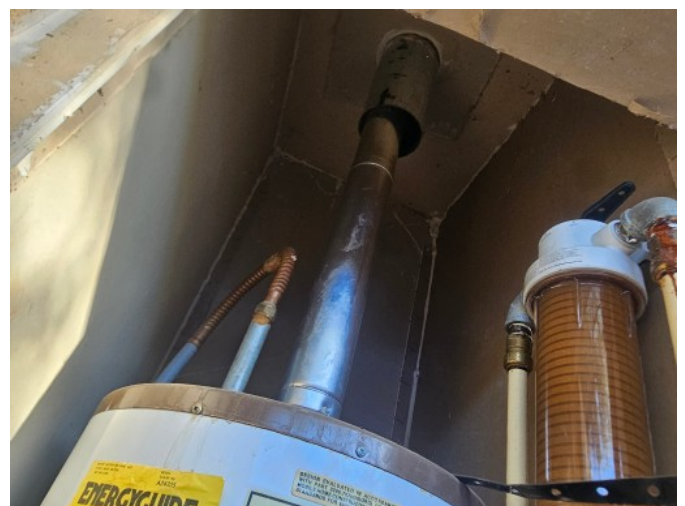
The water heater did not have a pan. Recommend having a pan installed underneath the water heater to catch any overflow/drips.

Due to the age and/or conditions observed, the water heater is past or approaching the end of its useful life. **Replacement is recommended.**

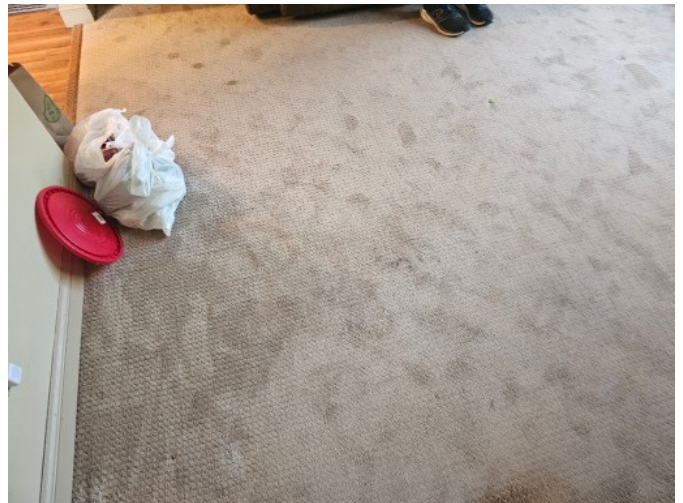
Minor stains and wear were noted at the carpet.

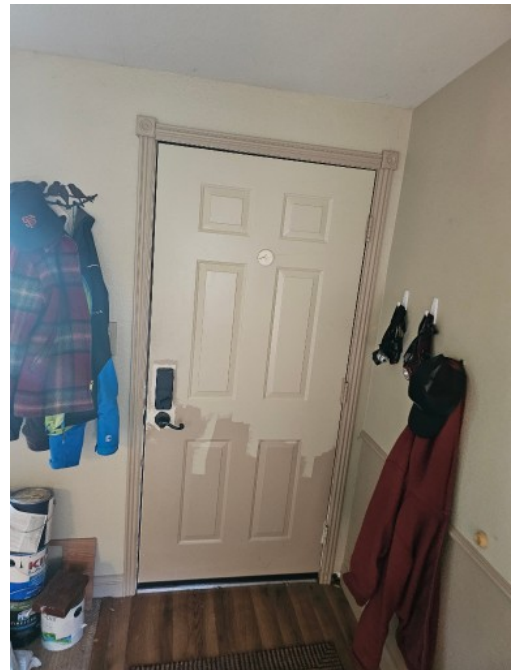
A minor amount of moisture damage was noted on the inside right base of entry door. Recommend repair or replacement.

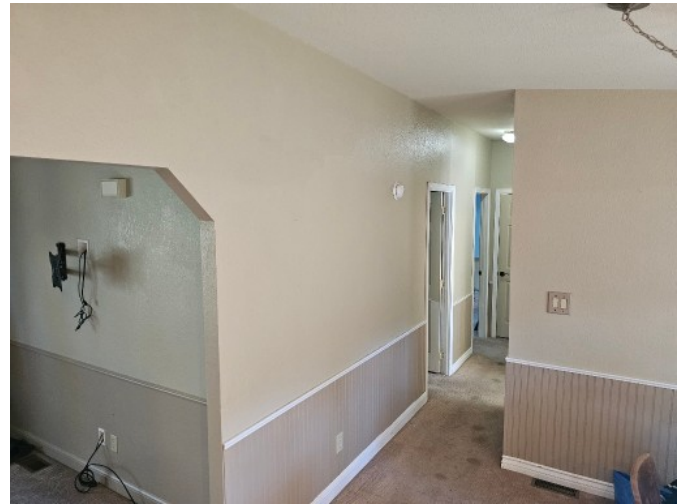
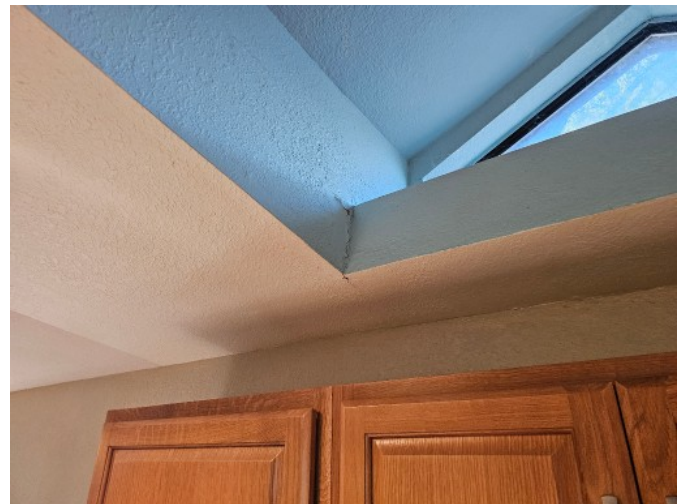
Some flaking was noted at the texture around skylight.

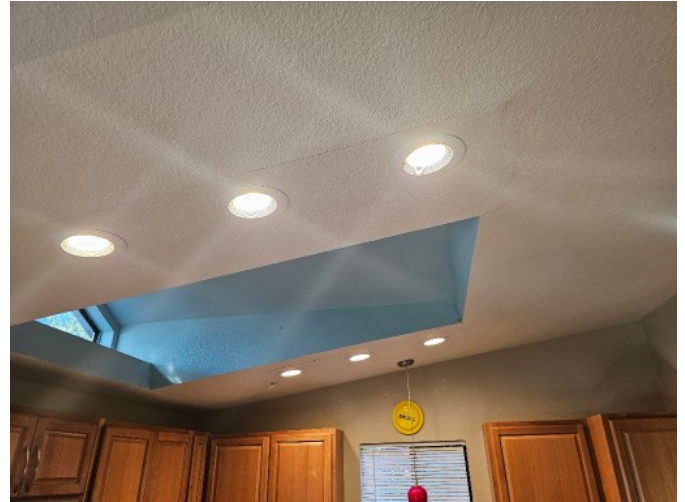
Patching/spackling was observed at the ceiling. The client should obtain disclosure information from the seller.

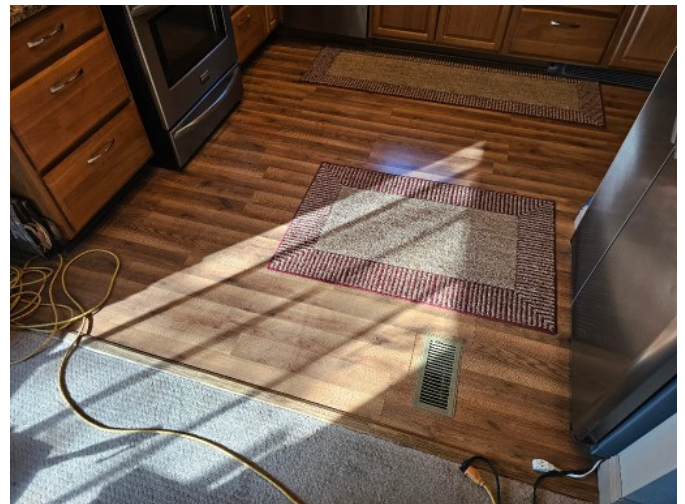
Stains at the carpeting/floor covers were observed at the time of inspection. In most cases, the stains can be removed by a professional cleaning service but may need to be replaced in some cases. Recommend evaluation by a flooring professional prior to close.

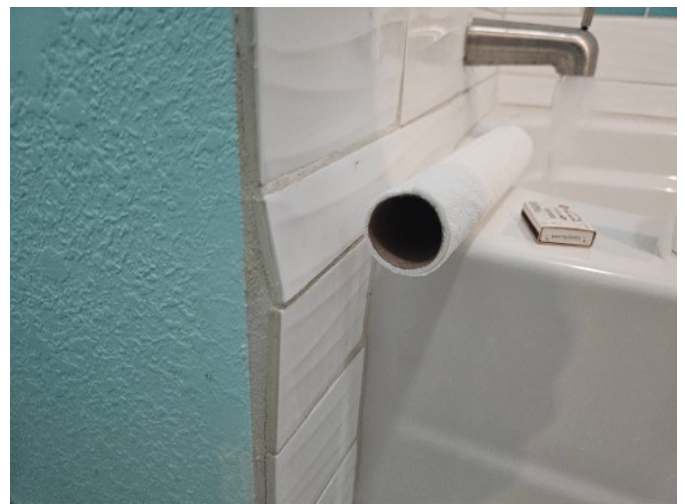
Unprofessional tile work was noted around the tub and enclosure, which has lead to bottom row buckling away from wall. Recommend further evaluation and repair or replacement.

The bathtub faucet was leaking. Recommend repair.

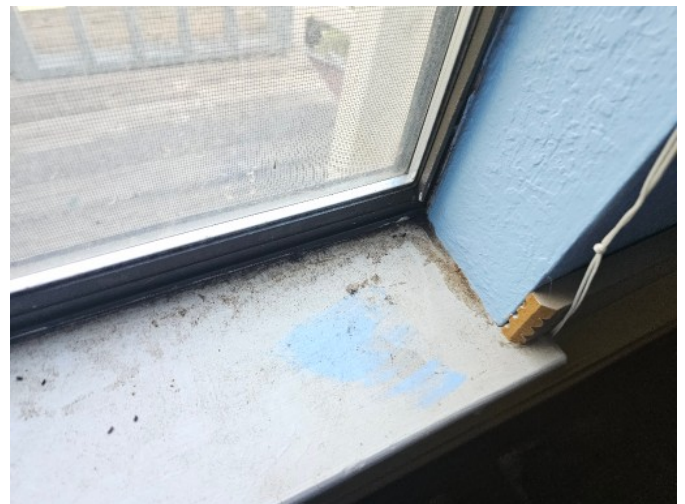
Moisture stains were noted at the windowsill(s). This is common with aluminum windows due to the condensation. Recommend wiping down and/or maintenance as needed.

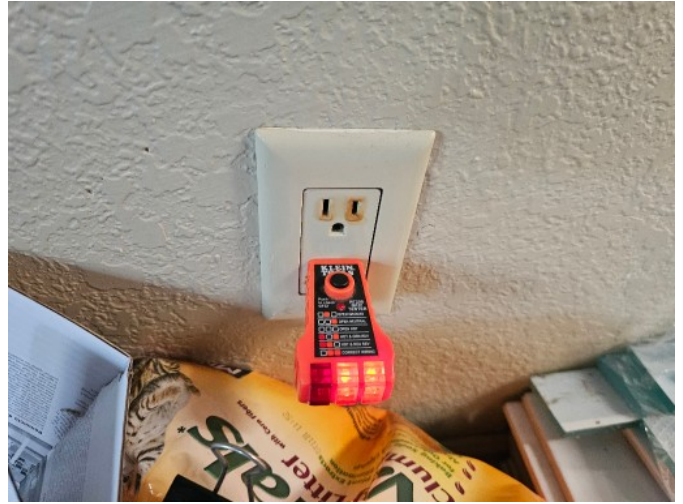
Missing receptacle or switch covers were observed at the time of inspection. Recommend covers be installed for safety.

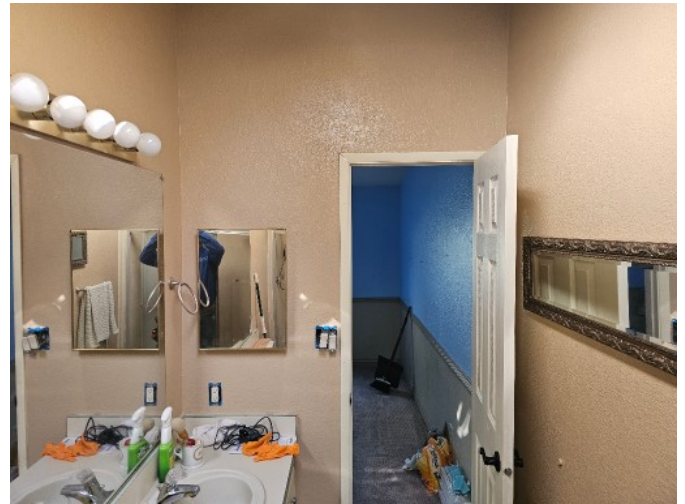
There were common/typical settlement-type cracks observed at the interior walls.

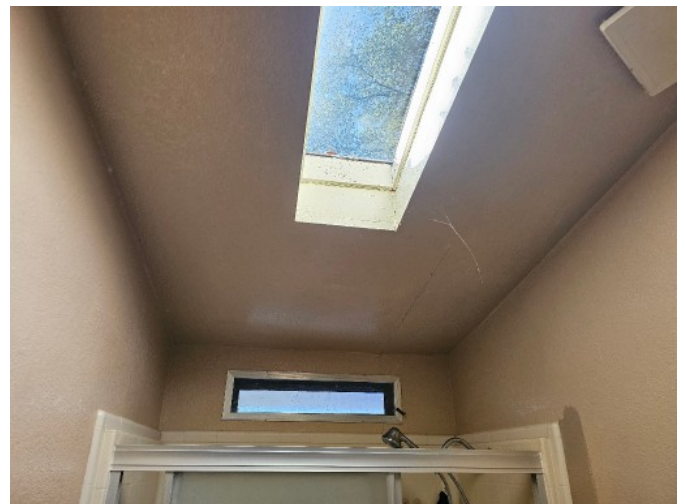
Some moisture damage was noted around the skylight. Recommend removing any damaged materials for further investigations and repairs or replacement.

Common cracks were observed at the ceiling.

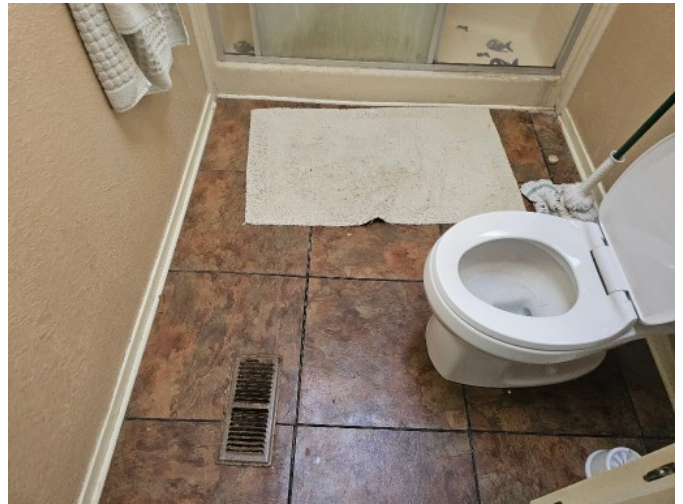
Soft and buckled flooring with sloping was noted. This area may need to be opened up for further investigations and repairs or replacement.

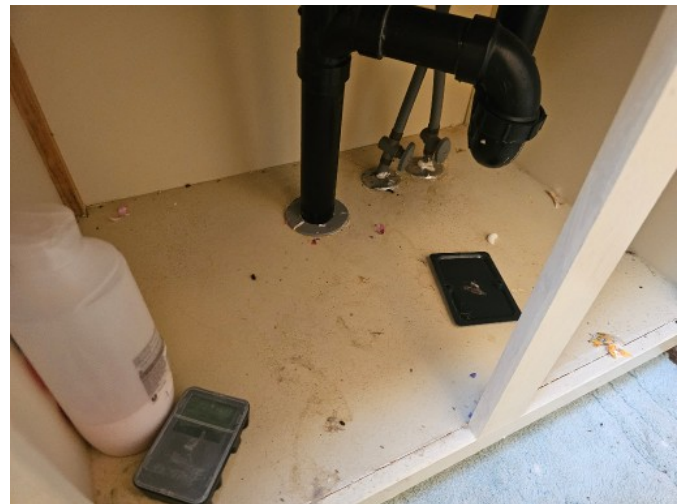
Minor wear was observed at the counter/cabinets.

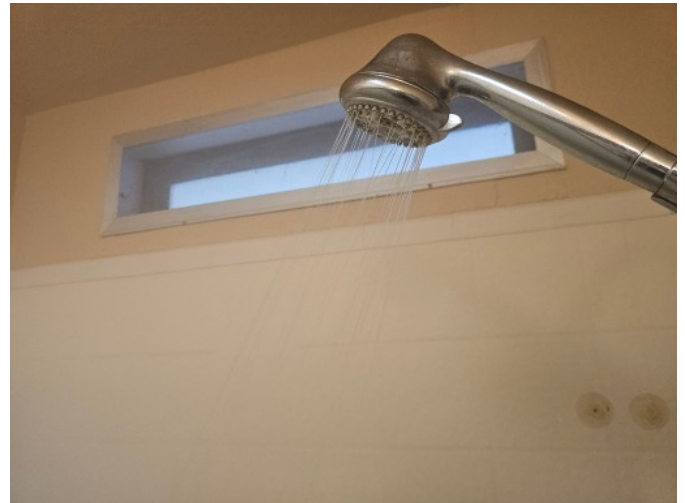
Deteriorated or old caulking was noted around the pan and shower enclosure. Recommend removing the comprised caulking and resealing as needed.

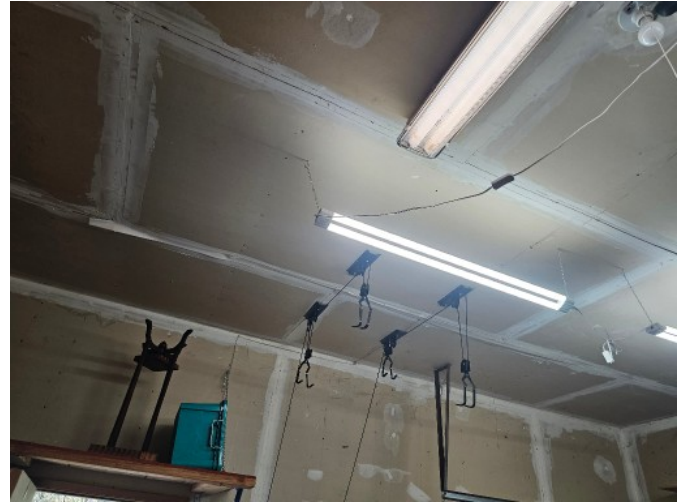
Some staining and moisture damage were noted to the ceiling at the garage to home connection. Hidden damage may exist in areas not readily visible or accessible. It's recommended that any damaged sheetrock and material be removed for further investigations and repairs or replacement.

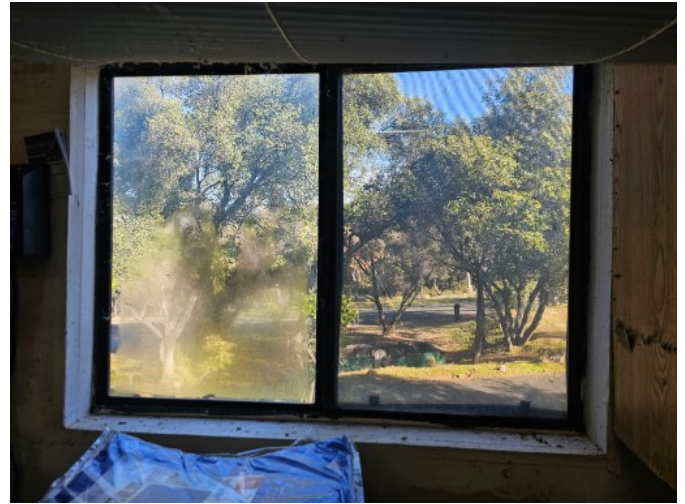
Some windows were difficult to operate. Recommend oiling, adjustment, and/or repairs as needed.

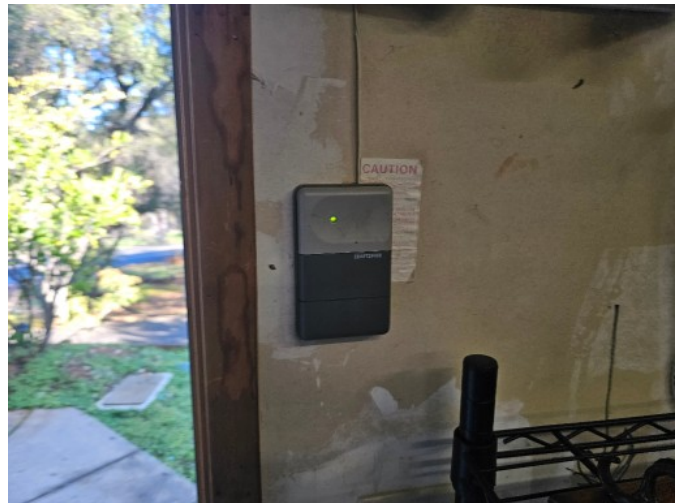
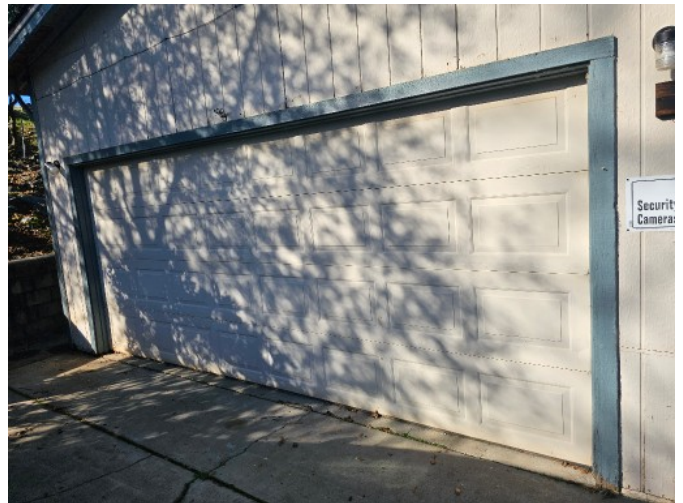
The two lower garage door panels had dents and some minor damage.

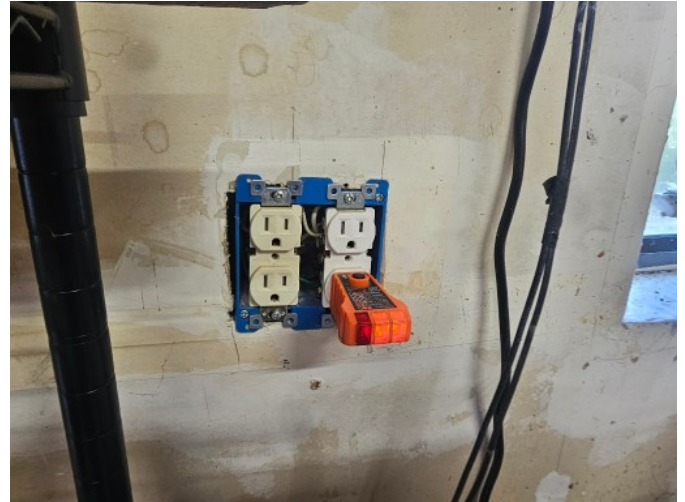
Missing receptacle or switch covers were observed at the time of inspection. Recommend covers be installed for safety.

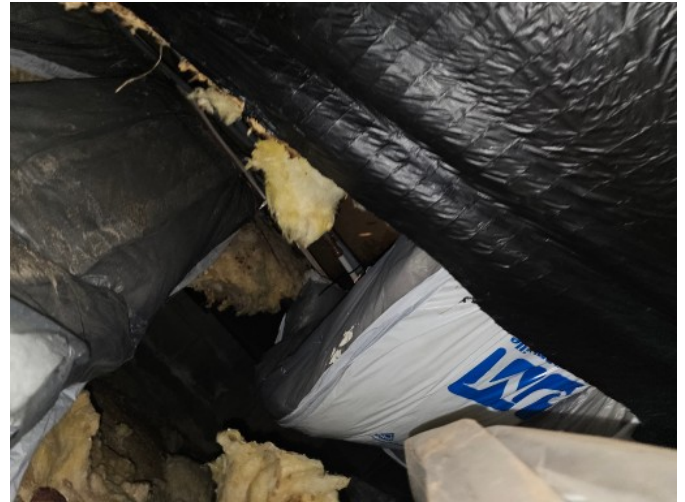
Some of the covering was torn and cut. Recommend patching and/or repair.

This was a prefabricated home. These homes have a thick covering stapled to the underside, which prevents an inspection of the flooring structure and components within. There are areas that may need to be opened up for further investigation due to conditions found within home.
