Summary Report, prepared exclusively for:

204 S.Steckel Dr. Santa Paula - Delia Ramires 03 24 2023 By Leo

Inspected by: **BEST HOME** Inspection

RE: 204 S. Steckel Dr.
Santa Paula, CA

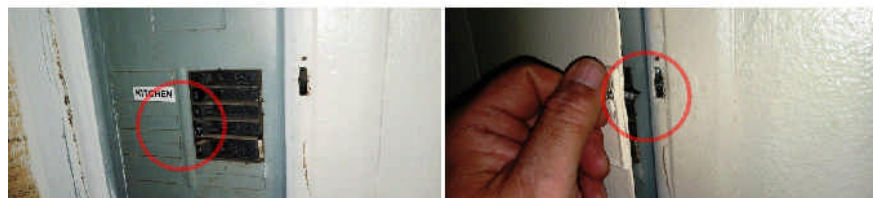
Circuit and wire sizing correct so far as visible. Grounding system is present. SUB PANEL breakers and wiring were tested or observed by the inspector and found they are wearing well, durable and capable of being used. EXCEPT: Some breaker labels are missing. Panel door lock is damaged. Recommend proper repairs by a qualified tradesperson. (see photo, detailed report page -6)

Missing labels/panel lock damaged

Circuit and wire sizing correct so far as visible. Grounding system is present. SUB PANEL breakers and wiring were tested or observed by the inspector and found they are wearing well, durable and capable of being used. EXCEPT: Some breaker labels are missing. Panel door lock is damaged. Recommend proper repairs by a qualified tradesperson. (see photo, detailed report page -)

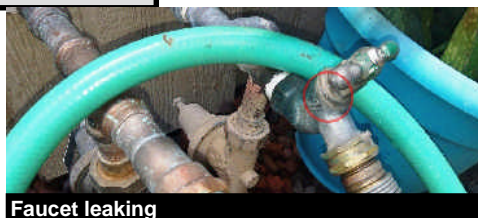
Leak(s) noted at exterior faucet. Repairs or replacement to faucet is needed. Recommend proper repairs by a qualified tradesperson. (see photo, detailed report page -8)

Faucet leaking

Leak(s) noted at exterior faucet. Repairs or replacement to faucet is needed. Recommend proper repairs by a qualified tradesperson. (see photo, detailed report page -)

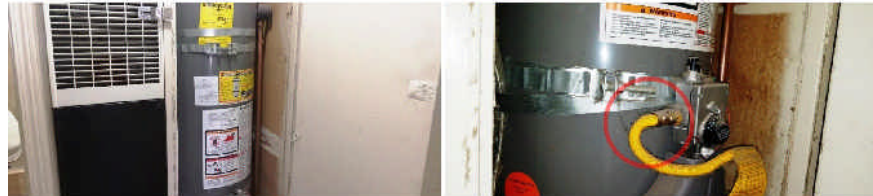
Tank and heating system was tested or observed by the inspector and found it is functional. Pressure relief valve noted, not tested. Pressure relief drain line is installed. Approved earthquake strapping is properly installed. EXCEPT: No sediment trap is noted on gas line. Water heater is older model, expect to replace in the not too distant future. Recommend proper repairs by a licensed plumber. (see photo, detailed report page -9)

Sediment gas trap not provided

Tank and heating system was tested or observed by the inspector and found it is functional. Pressure relief valve noted, not tested. Pressure relief drain line is installed. Approved earthquake strapping is properly installed. EXCEPT: No sediment trap is noted on gas line. Water heater is older model, expect to replace in the not too distant future. Recommend proper repairs by a licensed plumber. (see photo, detailed report page -)

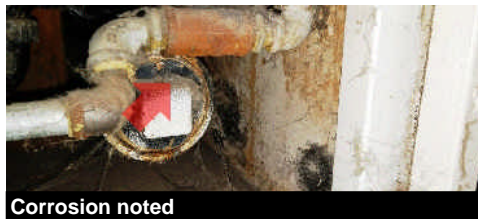
Gas line piping is rusted / corroded. Piping will need to be replaced to prevent a hazardous safety situation. Recommend proper repairs by a licensed plumber. (see photo, detailed report page -9)

Corrosion noted

Gas line piping is rusted / corroded. Piping will need to be replaced to prevent a hazardous safety situation. Recommend proper repairs by a licensed plumber. (see photo, detailed report page -)

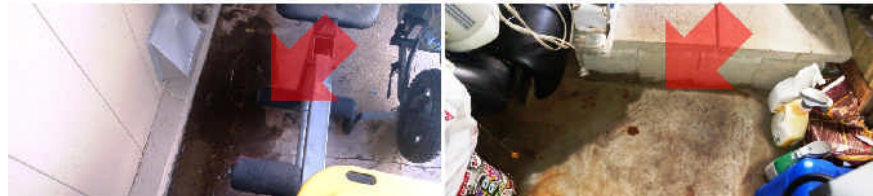
Property is a hillside stair step site. NOTE: Evidence of poor grading and drainage is noted. Recommend improvements / proper repairs. Recommend proper repairs by a qualified tradesperson. Grading is maintained by the Homeowners Association. (see photo, detailed report page -11)

Poor grading / moisture intrusion

Property is a hillside stair step site. NOTE: Evidence of poor grading and drainage is noted. Recommend improvements / proper repairs. Recommend proper repairs by a qualified tradesperson. Grading is maintained by the Homeowners Association. (see photo, detailed report page -)

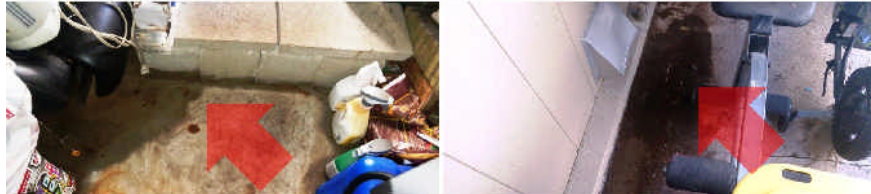
Garage floor was observed by the inspector and found it is wearing well, is durable and capable of being used. Carport floor was observed by the inspector and found it is wearing well, is durable and capable of being used. EXCEPT: Water intrusion from the exterior is present in the garage. Damage can result. Consult a licensed contractor for further inspection and repairs. (see photo, detailed report page -12)

Water intrusion

Garage floor was observed by the inspector and found it is wearing well, is durable and capable of being used. Carport floor was observed by the inspector and found it is wearing well, is durable and capable of being used. EXCEPT: Water intrusion from the exterior is present in the garage. Damage can result. Consult a licensed contractor for further inspection and repairs. (see photo, detailed report page -)

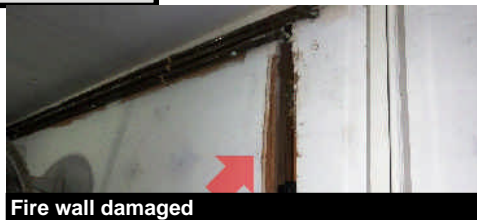
EXCEPT: ***Hole(s) noted in garage fire wall. This is a potential fire safety hazard, which violates fire code regulations.*** Repair any openings with approved materials to restore its fire rating. Recommend proper repairs by a qualified tradesperson. (see photo, detailed report page -12)

Fire wall damaged

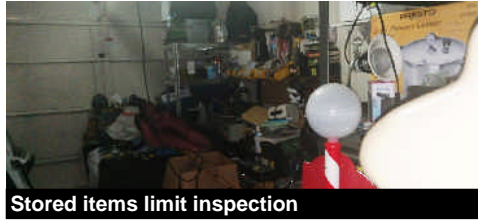
A representative sampling of switches and outlets was tested. As a whole, interior outlets and switches in the garage are in serviceable condition. EXCEPT: Stored items prevent access and testing at some outlets and switches. Inspector could not ensure proper / safe operation. Further inspection is recommended. (see photo, detailed report page -13)

Stored items limit inspection

A representative sampling of switches and outlets was tested. As a whole, interior outlets and switches in the garage are in serviceable condition. EXCEPT: Stored items prevent access and testing at some outlets and switches. Inspector could not ensure proper / safe operation. Further inspection is recommended.

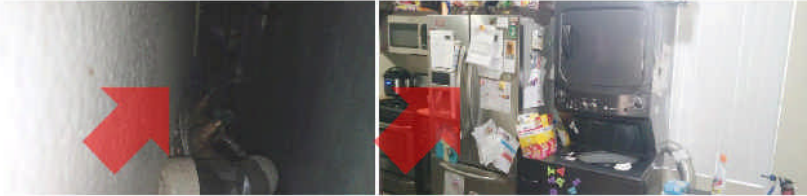
machines and / or stored items at the location. Further evaluation is recommended. The laundry is a substandard installation. Recommend repairs / removal / relocation of laundry by a licensed contractor. Check local codes for all repairs and improvement work done on the property. Recommend proper repairs by a qualified tradesperson. (see photo, detailed report page -14)

Substandard laundry installation

The laundry area wall(s) and laundry connections were not fully visible for inspection, due to machines and / or stored items at the location. Further evaluation is recommended. The laundry is a substandard installation. Recommend repairs / removal / relocation of laundry by a licensed contractor. Check local codes for all repairs and improvement work done on the property. Recommend proper repairs by a qualified tradesperson. (see photo, detailed report page -)

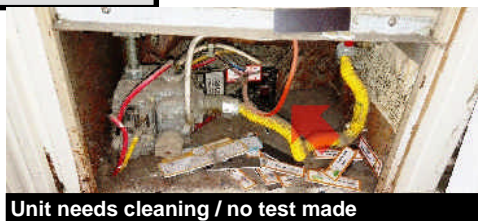
Heating unit was not tested, due to heavy lint. Highly combustible material is a fire safety hazard. Recommend cleaning unit. Heating unit appears to be the original, and may be nearing the end of its serviceability as a functioning unit. Recommend monitoring on a regular basis. (see photo, detailed report page -15)

Unit needs cleaning / no test made

Heating unit was not tested, due to heavy lint. Highly combustible material is a fire safety hazard.

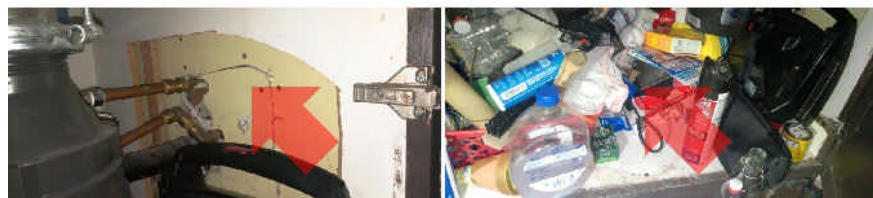
Minor type wear noted. Sink appears serviceable. Sink faucet appears serviceable. EXCEPT: Wall damage / opening in wall is noted in the lower cabinet under the sink. Wall / cabinet water damage is noted under the kitchen sink. Recommend proper repairs / replacement of deteriorated materials by a qualified licensed tradesperson. Area under the sink is not fully visible, due to stored items, full condition is unknown. (see photo, detailed report page -16)

Wall damaged / moisture damaged

Minor type wear noted. Sink appears serviceable. Sink faucet appears serviceable. EXCEPT: Wall damage / opening in wall is noted in the lower cabinet under the sink. Wall / cabinet water damage is noted under the kitchen sink. Recommend proper repairs / replacement of deteriorated materials by a qualified licensed tradesperson. Area under the sink is not fully visible, due to stored items, full condition is unknown. (see photo, detailed report page -)

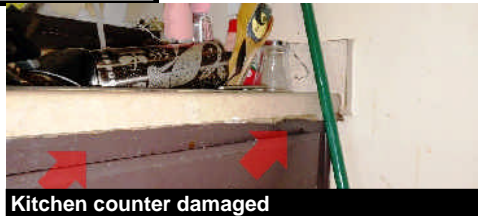
Counter damage is noted. Repair is needed. Recommend proper repairs by a qualified tradesperson. (see photo, detailed report page -17)

Kitchen counter damaged

Counter damage is noted. Repair is needed. Recommend proper repairs by a qualified tradesperson. (see photo, detailed report page -)

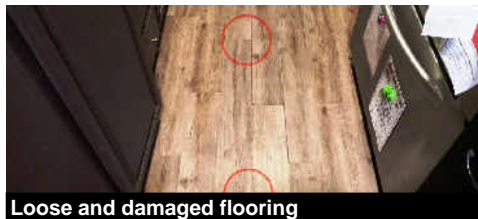
Walls and ceilings were observed by the inspector and found they are wearing well, durable and capable of being used. Minor, normal wear is noted. EXCEPT: Improper flooring installation is noted. Loose and damaged flooring. Recommend proper repairs by a qualified tradesperson. (see photo, detailed report page -17) .

Loose and damaged flooring

Walls and ceilings were observed by the inspector and found they are wearing well, durable and capable of being used. Minor, normal wear is noted. EXCEPT: Improper flooring installation is noted. Loose and damaged flooring. Recommend proper repairs by a qualified tradesperson. (see photo, detailed

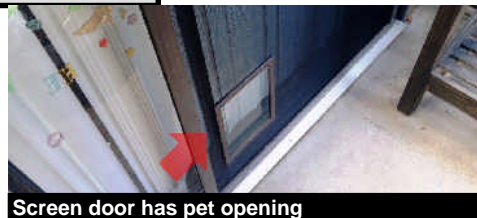
Sliding door(s), with sliding screen(s) present. Exterior doors were tested or observed by the inspector and found they are wearing well, durable and capable of being used. **EXCEPT:** Sliding screen door(s) should be re-screened or replaced. Recommend proper repairs by a qualified tradesperson. (see photo, detailed report page -18)

Sliding door(s), with sliding screen(s) present. Exterior doors were tested or observed by the inspector and found they are wearing well, durable and capable of being used. EXCEPT: Sliding screen door(s) should be re-screened or replaced. Recommend proper repairs by a qualified tradesperson. (see photo, detailed

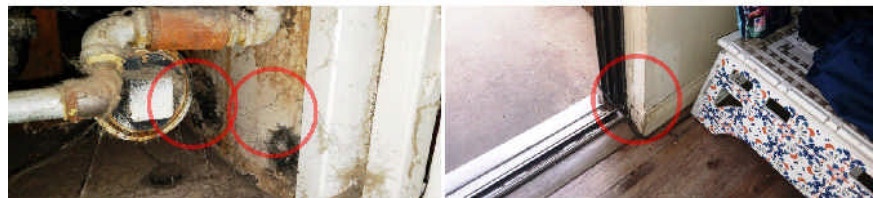
Drywall. NOTE: Heavy moisture damaged was noted in several locations. **The dark stains at the location from wet conditions is a probable health issue.** Please see the current Termite report, in regards to these kinds of issues. Mold and materials testing are beyond the scope of this inspection. Underlying conditions are unknown. Destructive inspection needed. Recommend proper repairs / replacement of deteriorated materials by a qualified licensed contractor. (see photo, detailed report page -19)

Several areas need repairs

Drywall. **NOTE: Heavy moisture damaged was noted in several locations. The dark stains at the location from wet conditions is a probable health issue.** Please see the current Termite report, in regards to these kinds of issues. Mold and materials testing are beyond the scope of this inspection. Underlying conditions are unknown. Destructive inspection needed. Recommend proper repairs / replacement of deteriorated materials by a qualified licensed contractor. (see photo, detailed report page -)

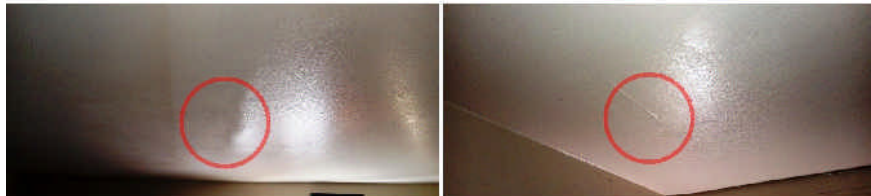
Drywall. Typical cracks noted at construction stress / joint areas, none appear structurally damaging. General condition appears serviceable. EXCEPT: Past ceiling repairs are noted. Recommend inquiring with seller. (see photo, detailed report page -20)

Past ceiling repairs / Inquire with seller

Drywall. Typical cracks noted at construction stress / joint areas, none appear structurally damaging. General condition appears serviceable. EXCEPT: Past ceiling repairs are noted. Recommend inquiring with seller. (see photo, detailed report page -)

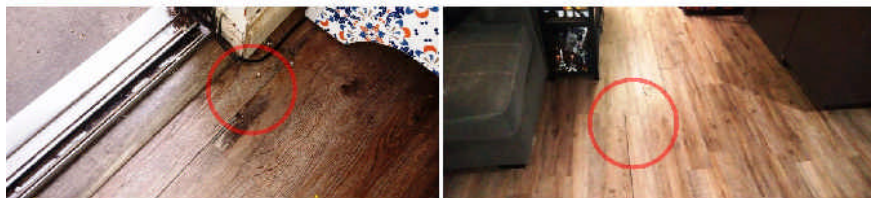
Vinyl. Tile. NOTE: Improper flooring installation is noted. Loose and damaged flooring. Recommend consulting a licensed flooring contractor for further evaluation and for repairs / replacements, as needed. (see photo, detailed report page -20)

Several areas have loose flooring

Vinyl. Tile. NOTE: Improper flooring installation is noted. Loose and damaged flooring. Recommend consulting a licensed flooring contractor for further evaluation and for repairs / replacements, as needed. (see photo, detailed report page -)

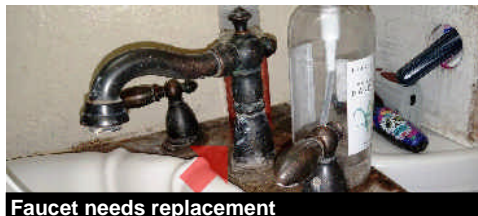
Sink(s) appear serviceable. Sink drain(s) appear serviceable. EXCEPT: Sink faucet(s) is corroded. Faucet(s) will eventually need to be replaced. Recommend proper repairs by a qualified tradesperson. (see photo, detailed report page - 21)

Sink(s) appear serviceable. Sink drain(s) appear serviceable. EXCEPT: Sink faucet(s) is corroded. Faucet(s) will eventually need to be replaced. Recommend proper repairs by a qualified tradesperson. (see photo, detailed report page -)

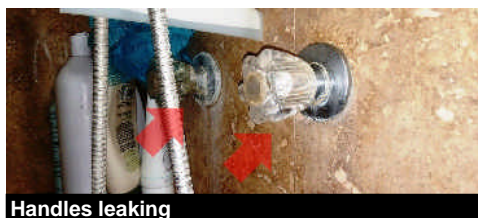
Drain appears serviceable. Shower head appears serviceable. EXCEPT: Faucet leaks around the valve handles are noted when turned-on. Water could enter the wall. Faucet needs new valve or replacement of faucet. Recommend proper repairs by a qualified tradesperson. (see photo, detailed report page - 21)

Drain appears serviceable. Shower head appears serviceable. EXCEPT: Faucet leaks around the valve handles are noted when turned-on. Water could enter the wall. Faucet needs new valve or replacement of faucet. Recommend proper repairs by a qualified tradesperson. (see photo, detailed report page -)

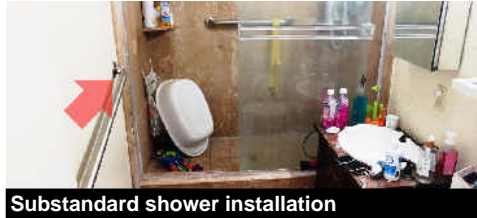
Substandard shower installation is noted. Recommend proper repairs by a qualified tradesperson. Check local codes for all repairs and improvement work done on the property. (see photo, detailed report page - 22)

Substandard shower installation is noted. Recommend proper repairs by a qualified tradesperson. Check local codes for all repairs and improvement work done on the property. (see photo, detailed report page -)
