Building No. / Street	City	Zip		Date	of Inspection	Number of Pages
11033 Meadow Glen Way East	Escondido	92026		06/1	17/2024	1 of 6
LLOYD PEST CONTROL		1331 Morena Blvd San Diego, CA 92110 1.800.570.2847 Registration #436	OPERAT HIS/HEF RELATIV	OR IS A FIELD. E TO TI BE RE	ST CONTF AN EXPER QUESTIO HIS REPOR	T IN NS RT
Ordored by	Dronort (Ou	was and/or Dark, of Interest	Departs	ant to		(epoit #. 00032
Ordered by:		vner and/or Party of Interest	Report s		ltl	
Karen & Tong Untalan		ong Untalan	1	Karen & Tong Untalan		
11033 Meadow Glen Way East		adow Glen Way East		11033 Meadow Glen Way East		East
Escondido, CA 92026	Escondido	o, CA 92026	Escono	Escondido, CA 92026		
		г				
Complete Report Limited Report Supplemental Report				Reinspe	ection Repo	ort 📙
General Description:			Inspection Tag	Posted:		
Occupied Single Family Two Story			Interior			
Attached Garage			Other Tags Posted:			
Slab Foundation with Concrete Roof			None

Building No. / Street	City	Zip	Date of Inspection	Number of Pages
11033 Meadow Glen Way East	Escondido	92026	06/17/2024	2 of 6

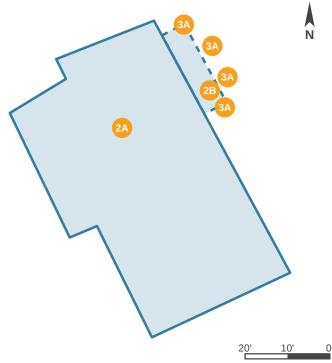
Evidence of drywood termites found in attic. See diagram.

Evidence of drywood termites found in areas marked on Diagram. Trim

Fungus damaged wood at areas marked on diagram. 2x2 trim x0 trim

Eliminate infestation with thermal pest eradication treatment. Lloyd Termite Control Company assumes no responsibility for damage to any plant life or roofing caused by this operation.

Locally treat areas marked on diagram with a registered termiticide for the control of drywood termites. Cover or remove accessible termite pellets as needed. Local treatment is not intended to be an entire structure treatment method. If infestations of wood-destroying pests extend or exist beyond the area(s) of local treatment, they may not be exterminated.

Remove and replace fungus damaged wood as needed. Painting is included in this estimate. If damaged wood extends into concealed or inaccessible areas, cost of repair will be in addition to estimate given.
