Subject: Visual On-Site Evaluation (OSE) Report for the Subject Property Located at 1177 Muirlands Vista Way, La Jolla, CA 92037

A professional engineer from our firm inspected this residence on October 28, 2025 and noted the following:

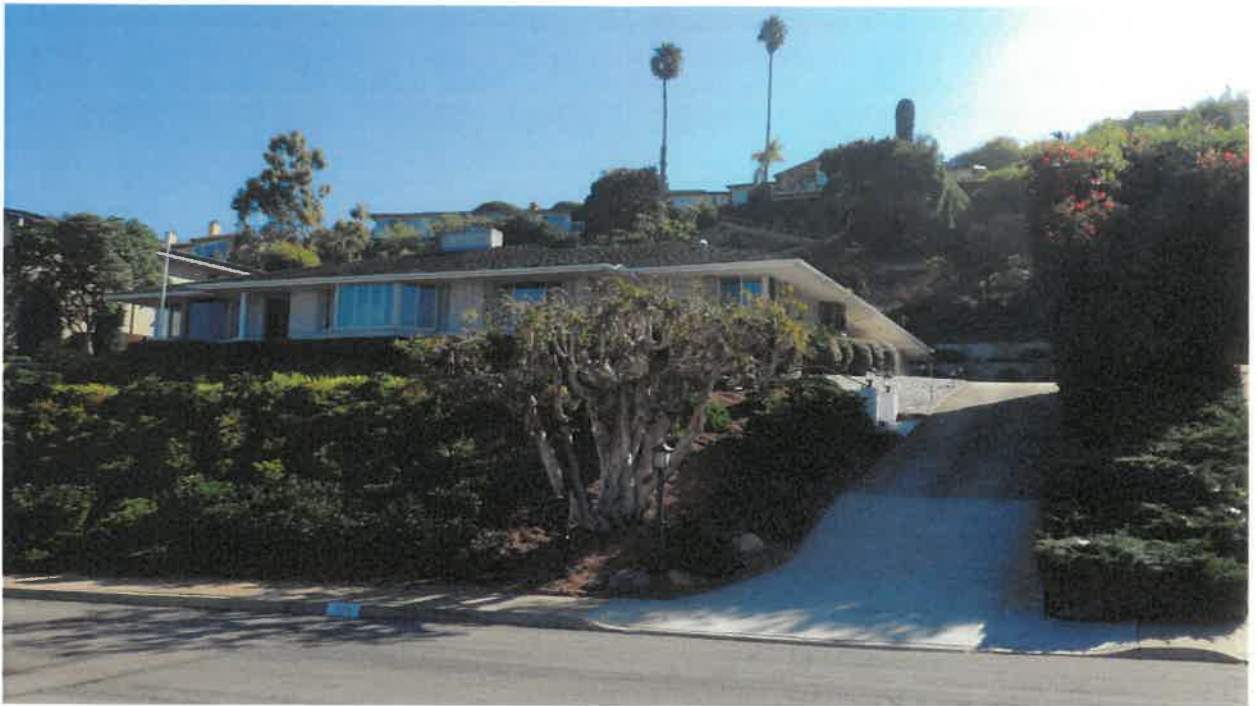
Subject property. Descending slope located to front of residence

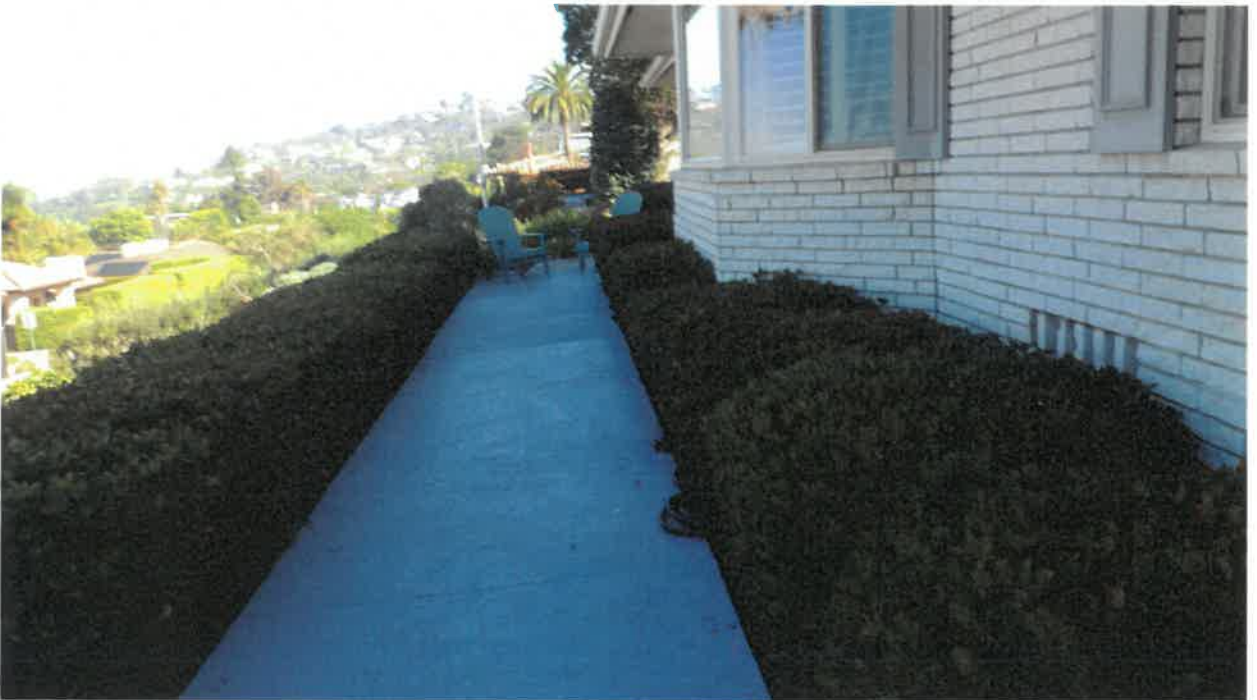
Confined planter with vegetation and irrigation adjacent to south foundation wall

3. The vegetation and confined planter around the residence shall be removed. No vegetation shall be placed within five feet of the structure. We recommend a concrete apron around the entirety of the residence.

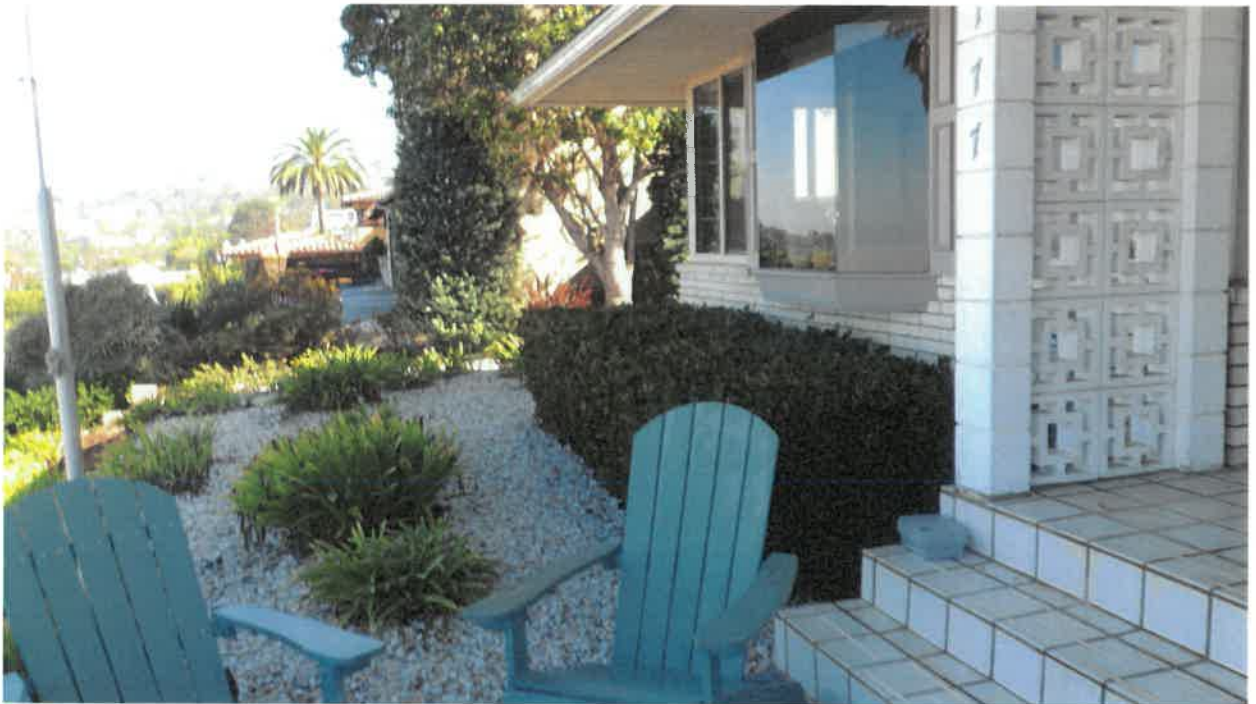
Confined planter with vegetation and irrigation adjacent to south foundation wall

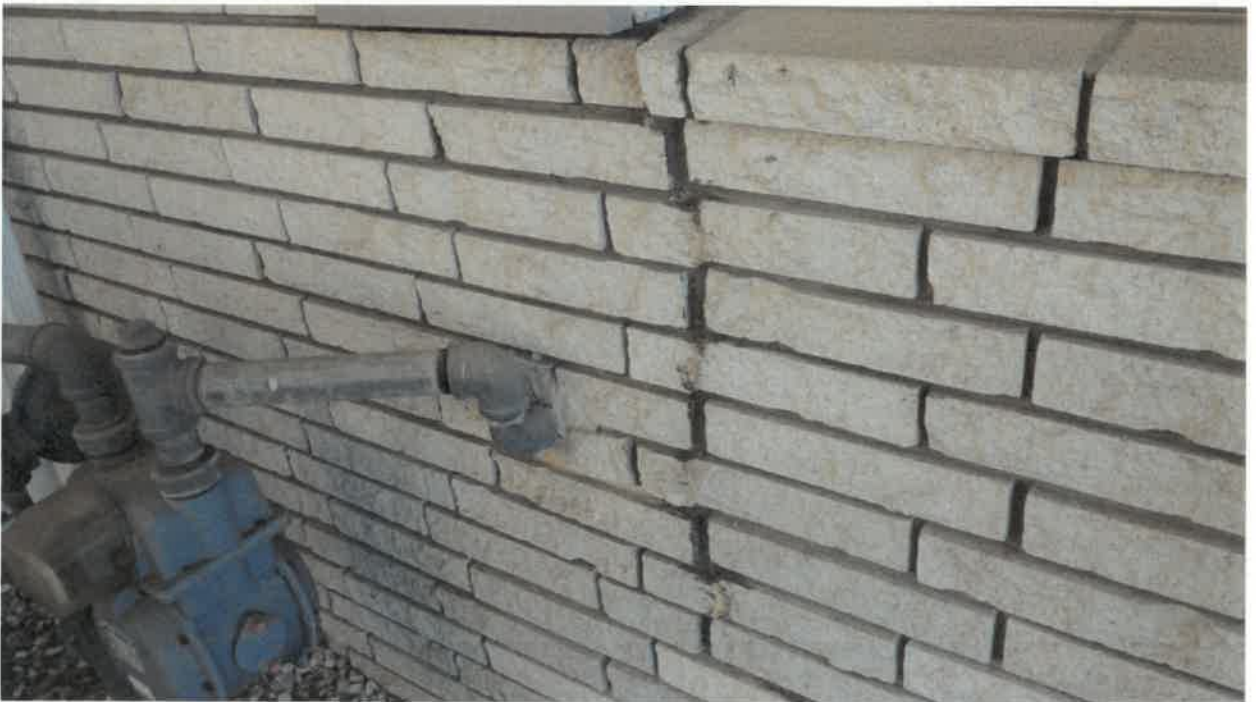
Grout damage and cracked brick fascia

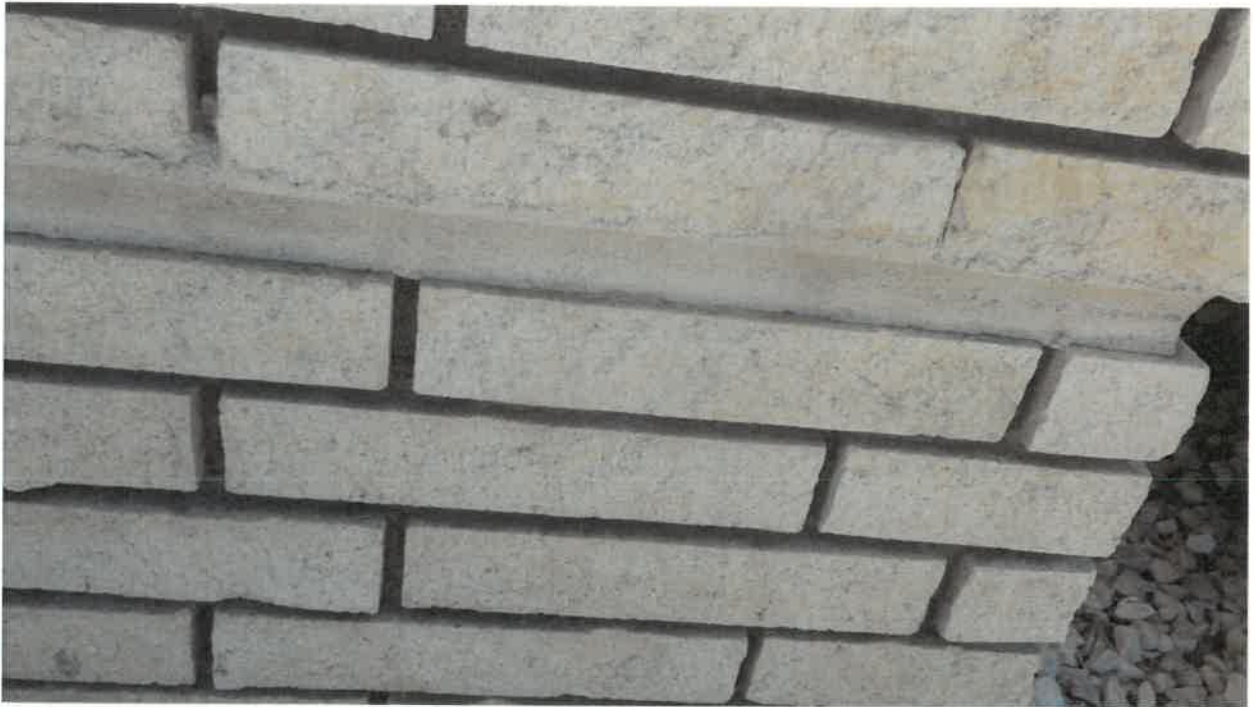
Large grout along south brick fascia

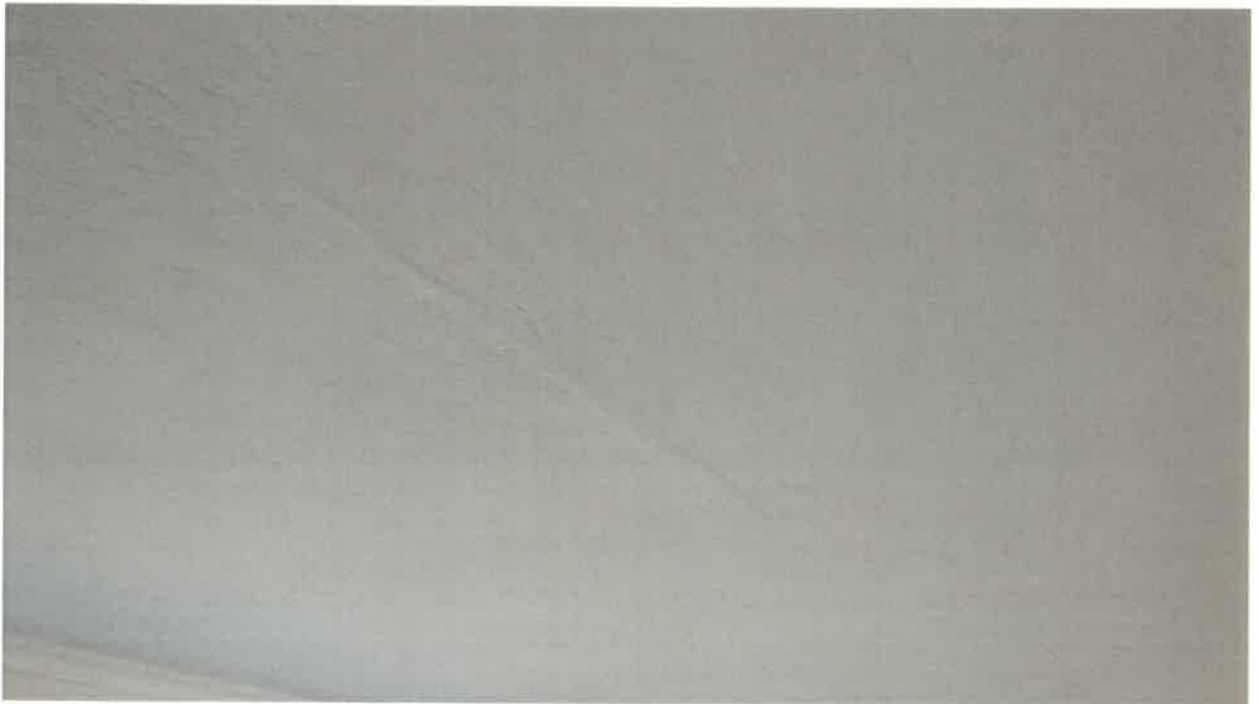
Plaster cracks

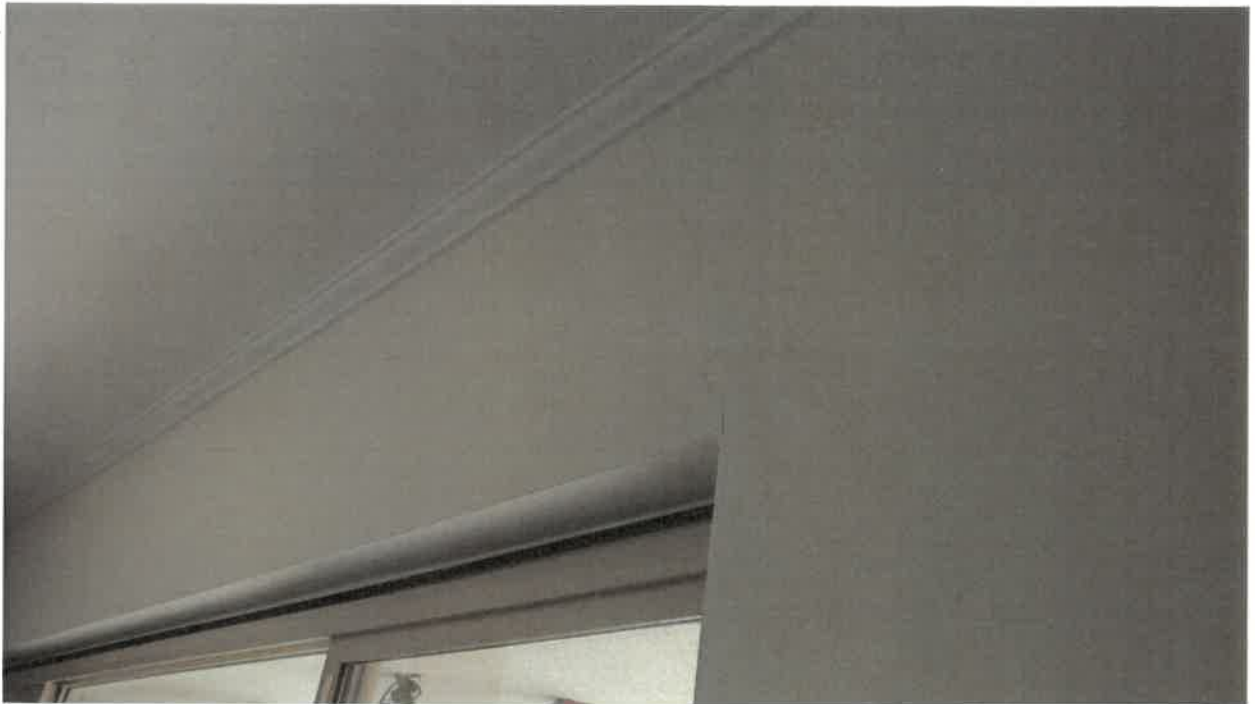
Plaster cracks

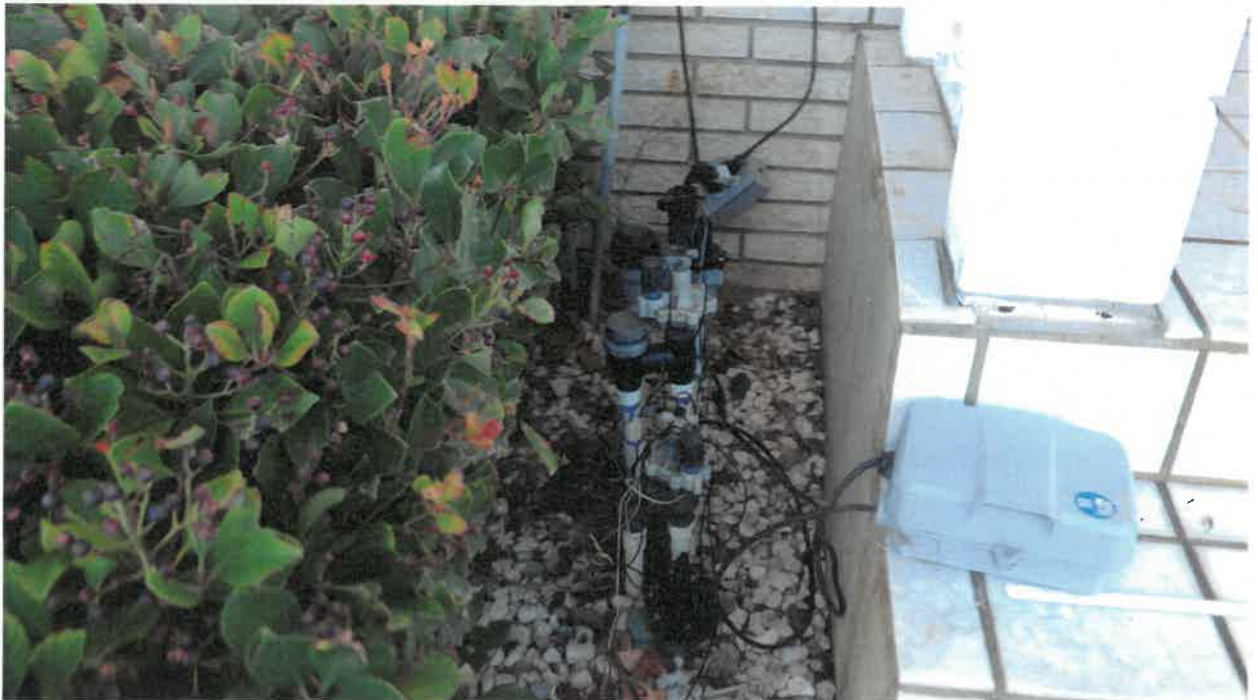
Irrigation manifold adjacent to residence

10. Maintenance of the rain gutters shall be performed.
11. Irrigation around the subject building shall be minimized.
12. All wet utility lines (sewer, water, irrigation) shall be checked for leaks and repaired as necessary. The irrigation manifold shall be periodically checked for leaks.
13. Crawlspace ventilation shall be improved to conform to the California Building Code Requirements.
14. In general, site drainage shall be improved such that the grounds surrounding the residence slope a minimum of 5% positively away from the residence. Runoff shall be directed toward a public storm water collection system. Flatwork may be used in lieu of grading. Confined planters shall be remove and replaced with a sloping soils surface, or a sidewalk.

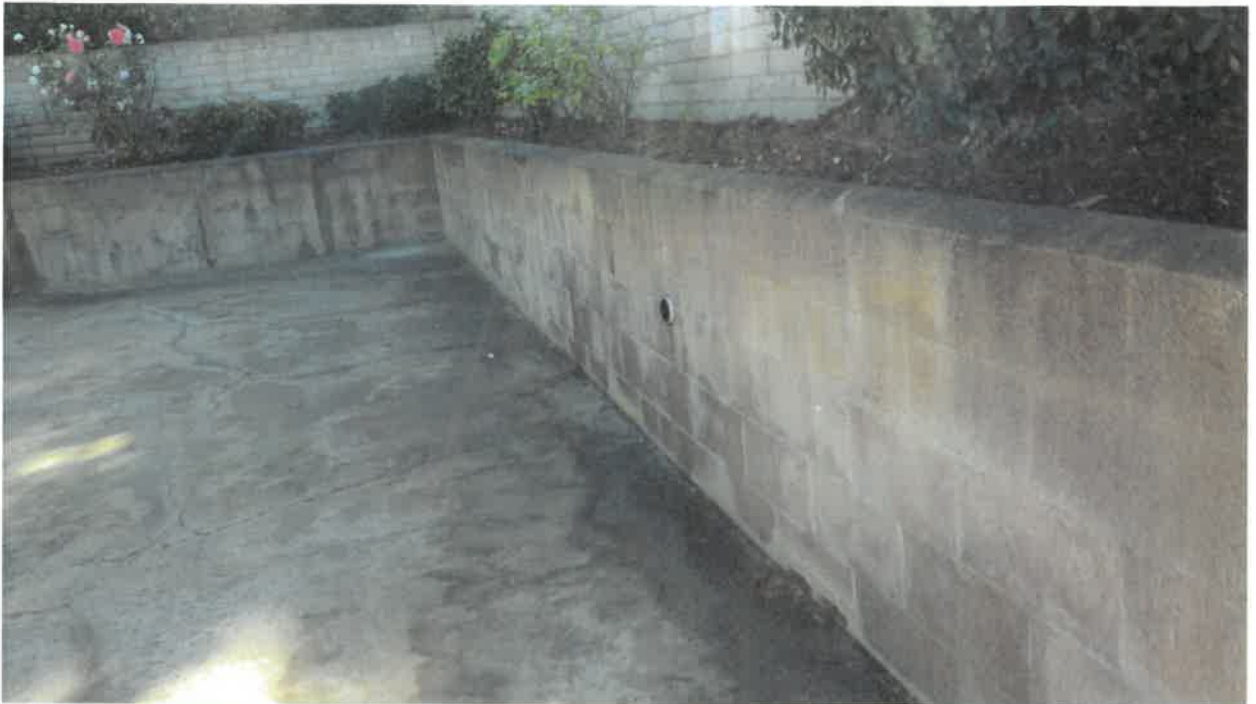
Water damaged site retaining walls

1. The foundation system and retaining walls shall be periodically evaluated.
2. Access to the entirety of the crawlspace shall be established. Additional points of entry may be required. The entirety of the crawlspace shall be reevaluated when proper access is established.

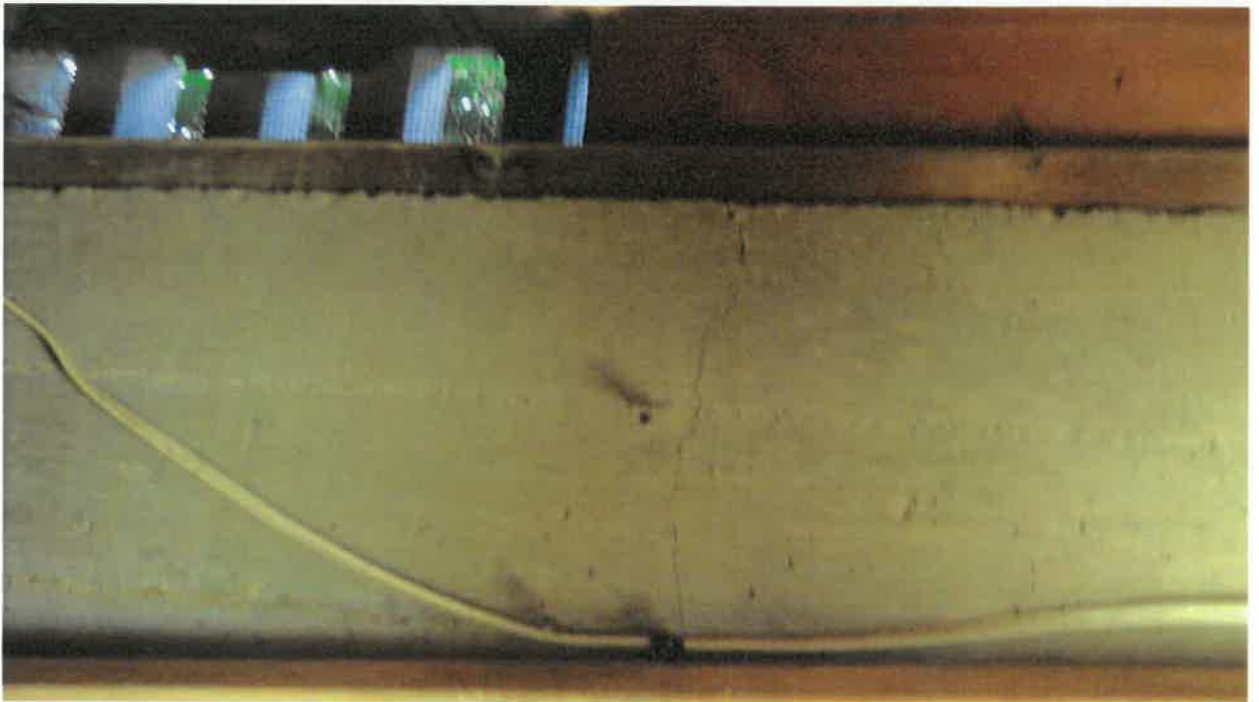
Foundation wall cracks

4. All foundation wall cracks less than ¼" shall be repaired in conformance with Appendix B: General Recommendations for Concrete Repair.
5. The foundation system shall be repaired or retrofitted to conform with Appendix C – General Recommendations for Raised Wooden Floor Foundation Systems.

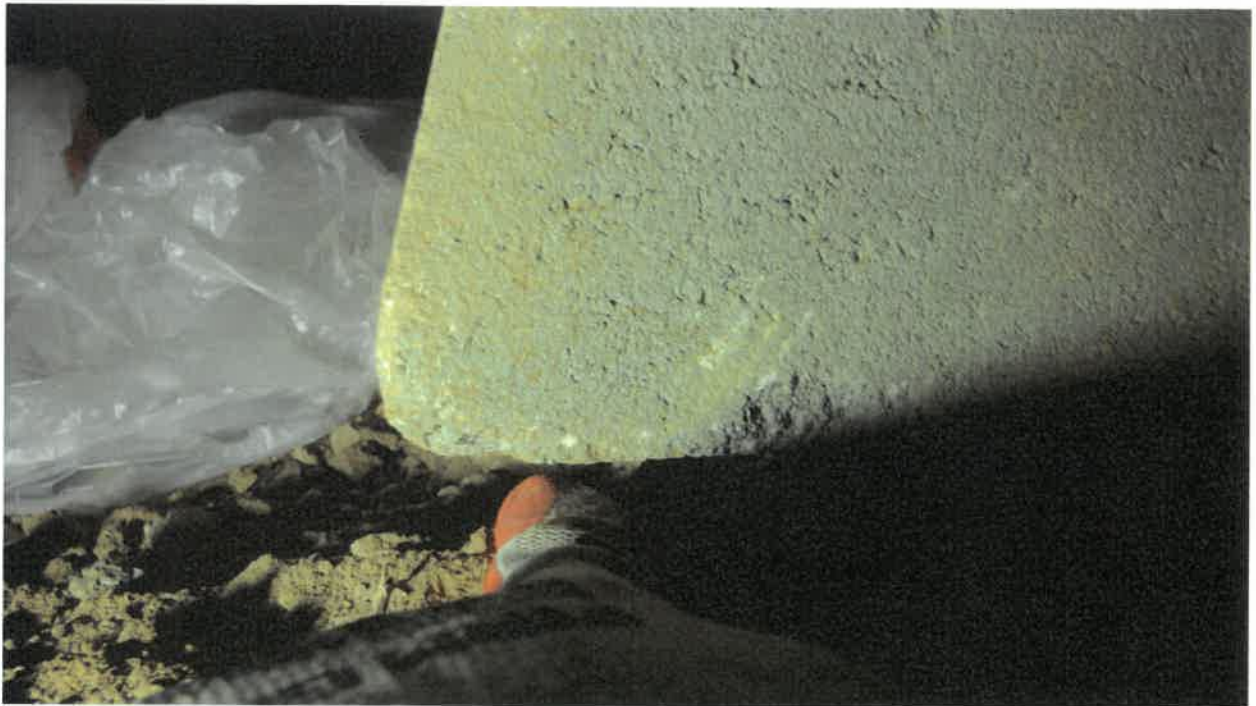
Modern precast footing with no embedment

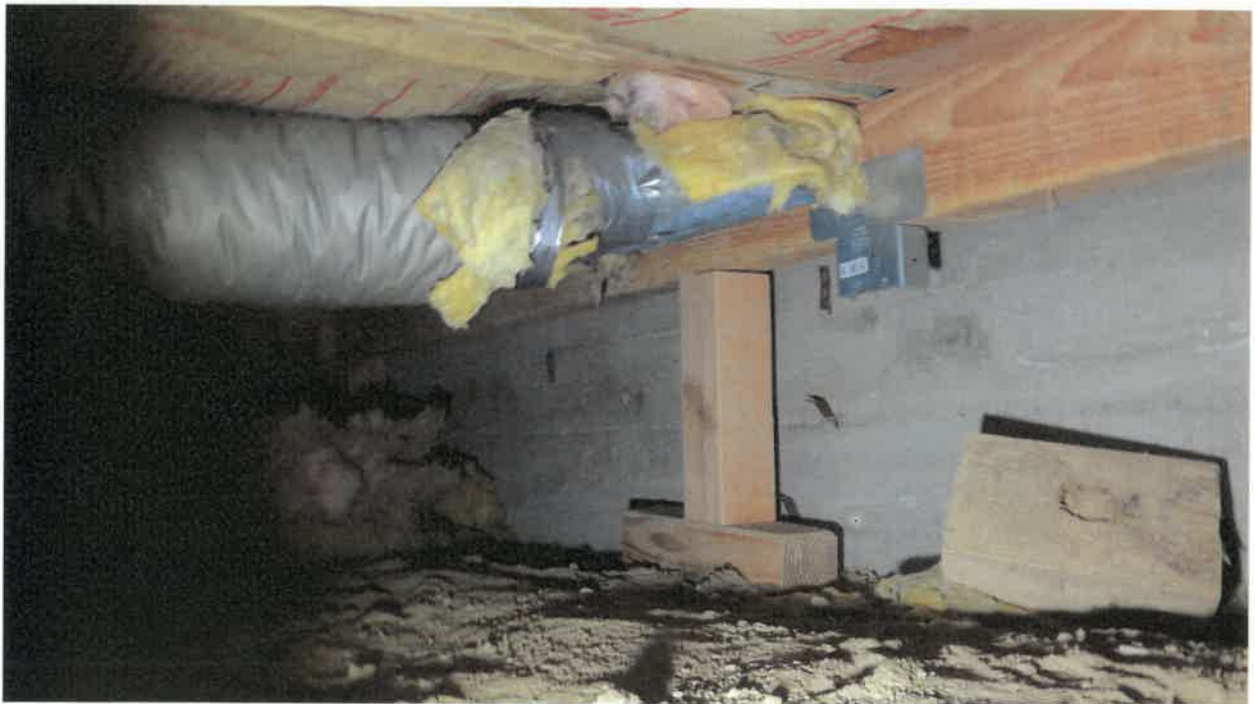
Wood post and beam supported by wood block along south foundation wall

The most probable assumption is that the soils underlying the southern foundation wall have settled. The unconventional posts and beams and wood shims were installed to accommodate floor deformation. The most probable cause of the differential soil settlement is surface drainage or a wet utility line induced soil settlement.

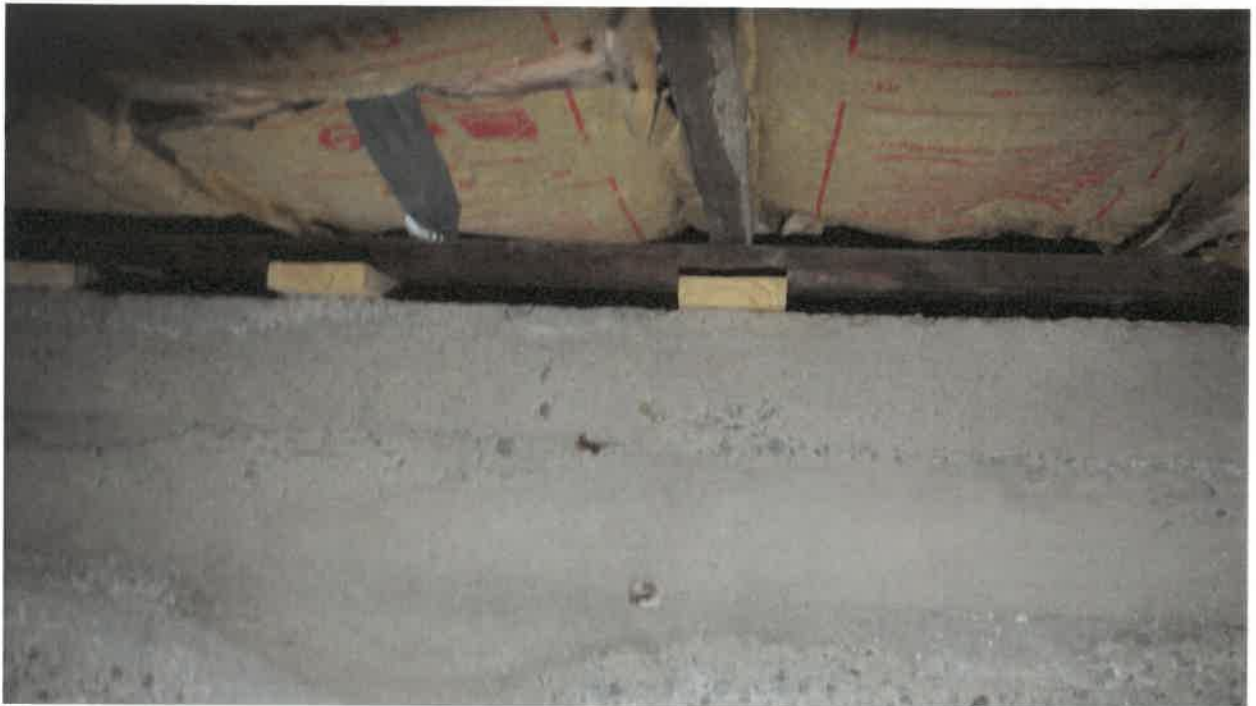
Wood shims at sill plate to foundation wall connection

6. All dryrotted wood members shall be removed and replaced.
7. The separation between the sill plate and foundation wall shall be filled with dry pack mortar.

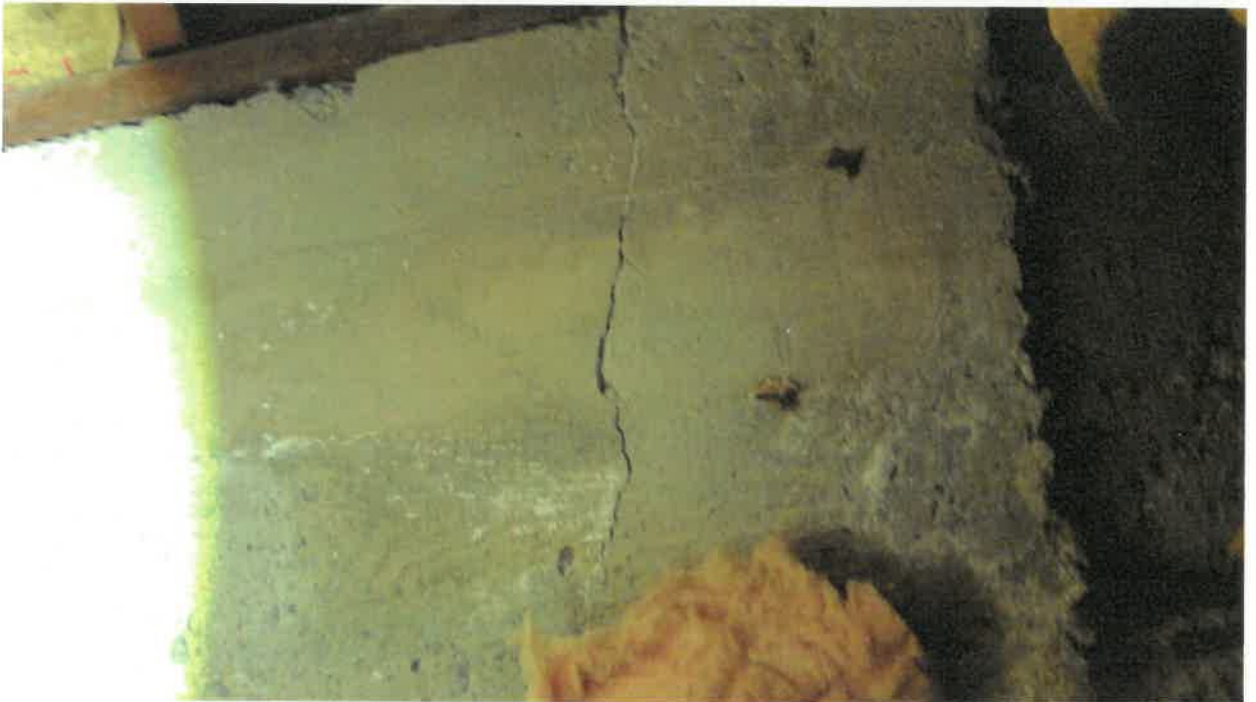
Foundation wall cracks

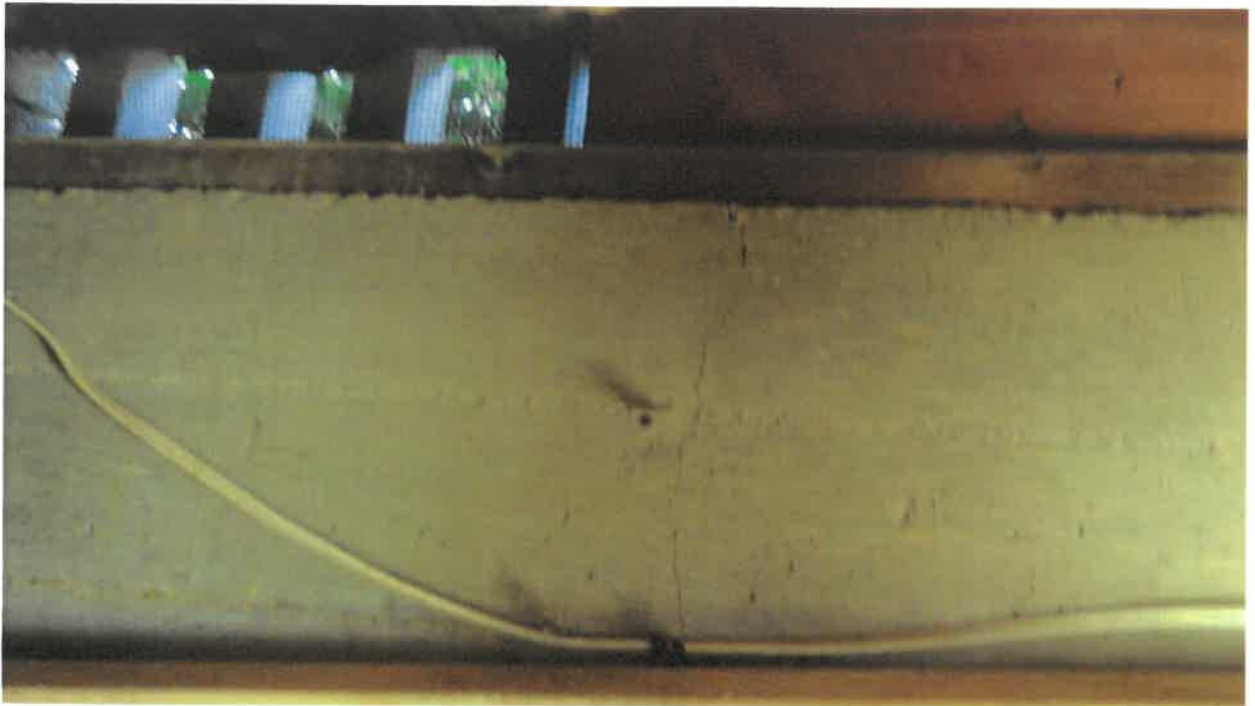
Foundation wall cracks
