# Drainology

## Sewer Inspection Report

1505 Wendy Way  
Manhattan Beach, California 90266

Monday, July 28, 2025 6:13 PM

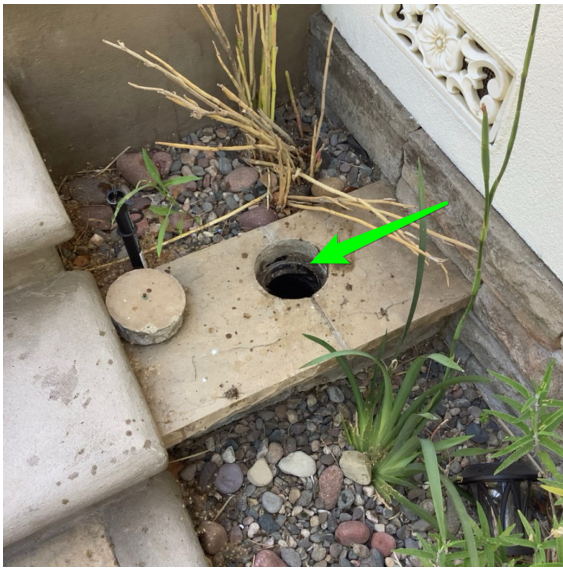
4" ABS clean out

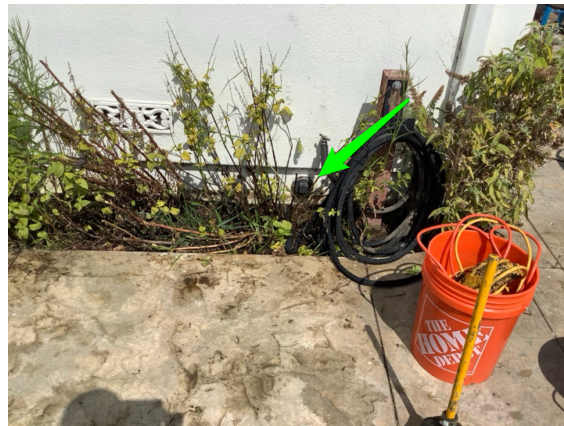
4" abs clean out

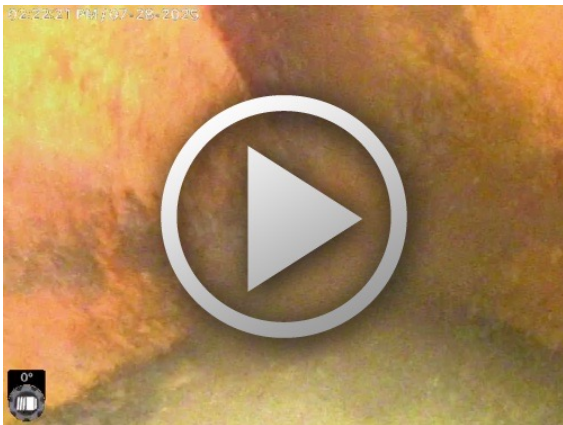
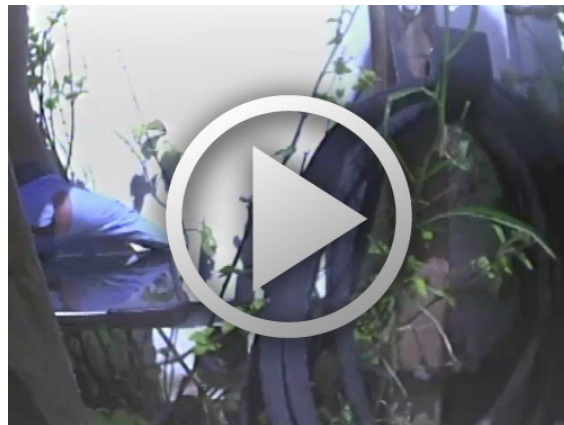
3" abs clean out at the rear of the property

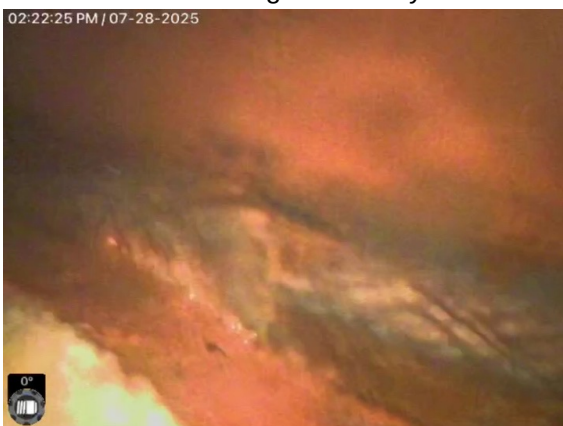
City sewer connection

The city sewer is located near the center of the street out front. The home owner is responsible for any repairs or maintenance through to the city sewer connection even if it runs off of the property.

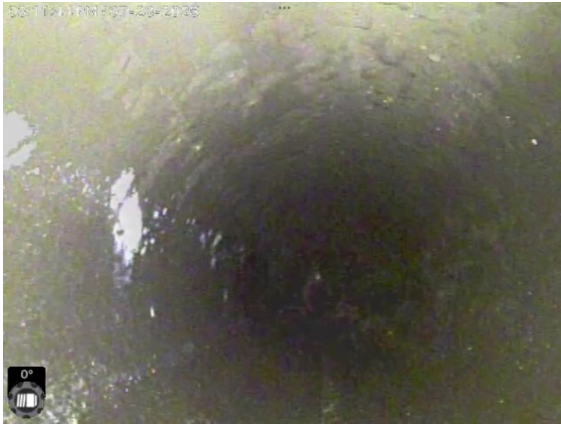
Abs

The inspected 4" ABS pipe is in good condition. There is no standing water, visible cracks or root intrusions.

We recommend that the sewer line be cleaned every 12 months on preventive maintenance using a hydro jet. This will help prevent root intrusions from over growing and blocking or damaging the sewer line.

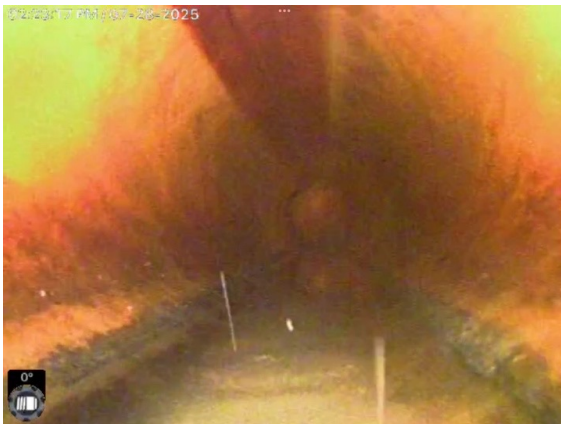
Relined pipe

The re-lined pipe is in good condition, there are no root intrusions or visible cracks. When cleaning the sewer line we recommend not using cable and blades for this section of pipe as they can puncture or damage the liner.
