**Prepared For:**  
Nyla Quintana Sturgis

**Property Address:**  
4801 Boone Dr  
Fremont CA 94538

HouseMaster Home Inspections of Northern California

**Inspection Date:** 9/17/2024

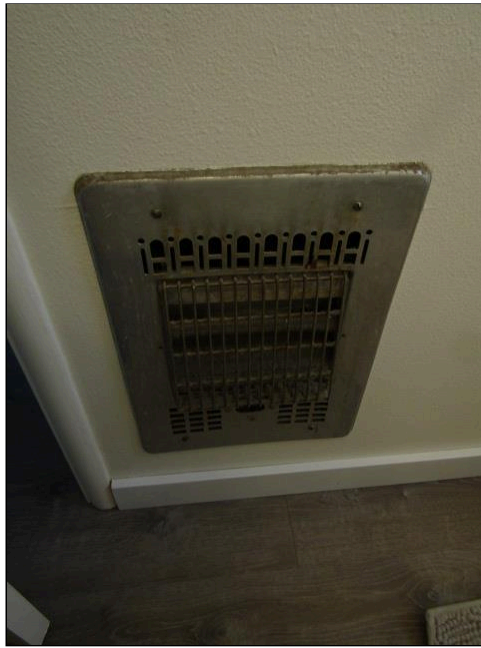
6.8.A HEATER UNIT Item 1(Picture)

| | | ● | | | <b>6.8.A HEATER UNIT</b><br>Wall heater not operated, dusty conditions noted. Heater appears to be over 60 years old. |
