PROPROPERTY INSPECTION AND SERVICES INC.

PROPERTY INSPECTION REPORT

9180 Tokaj Ln
Spring Valley, CA 91977

06/02/2025

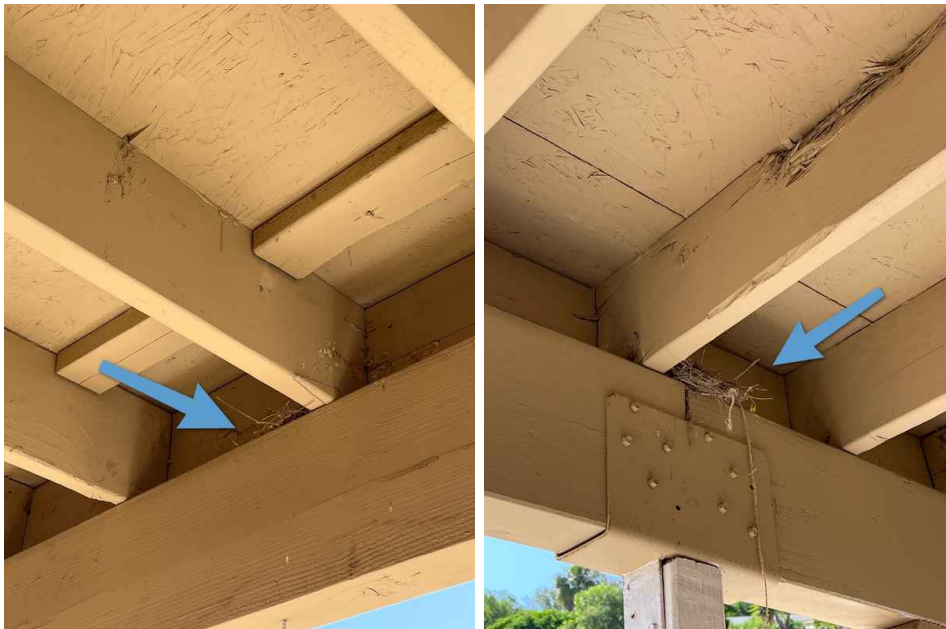
Evidence of birds nesting at one or more locations. Recommend a qualified person remove nests and clean area as necessary.

Contact a qualified pest control specialist.

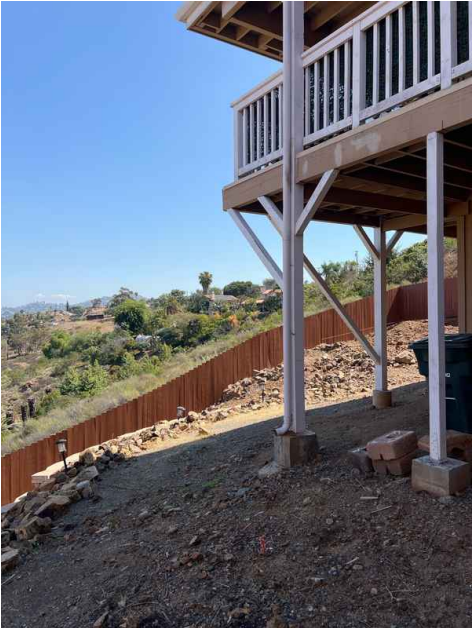
5.1.2 Grading

HILLSIDE SETTING

Contact a qualified structural engineer.

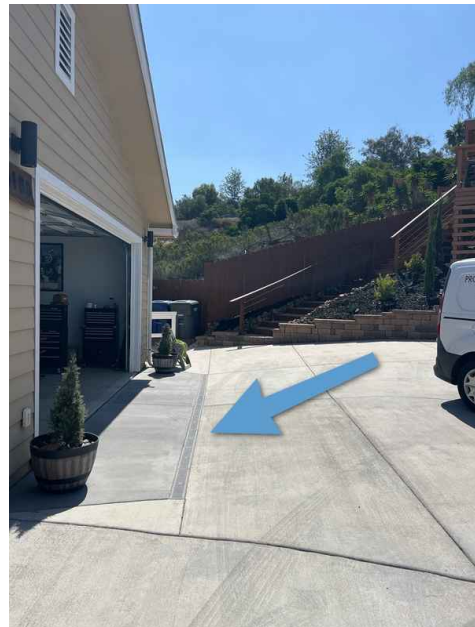
5.1.3 Grading

GROUND DRAINS - DRIVEWAY

The concrete surface has a negative slope and drains towards the structure. The drain will need to be kept clean and in good repair to prevent water entry into the garage.

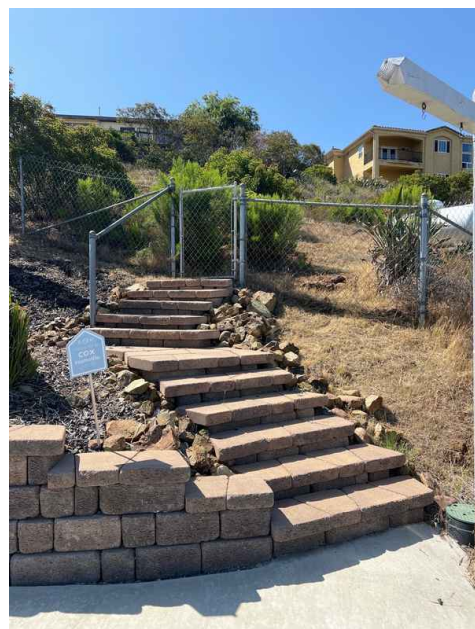
5.4.1 Porches / Steps / Stoops

HANDRAILS MISSING MORE THAN 3 STEPS

Contact a qualified professional.

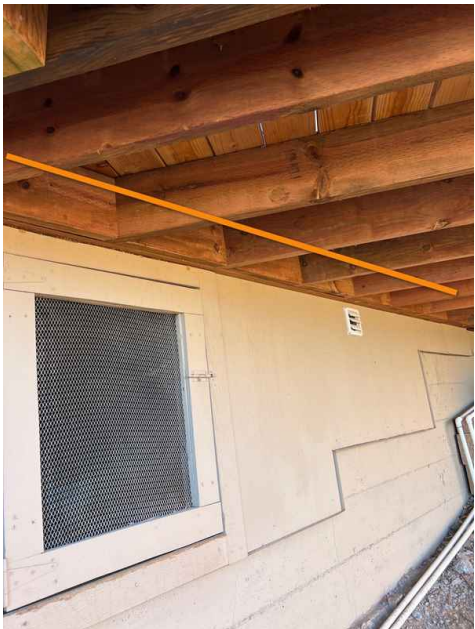
5.6.1 Decks/Stairs

LEDGER BOARD MISSING FLASHING

Contact a qualified professional.

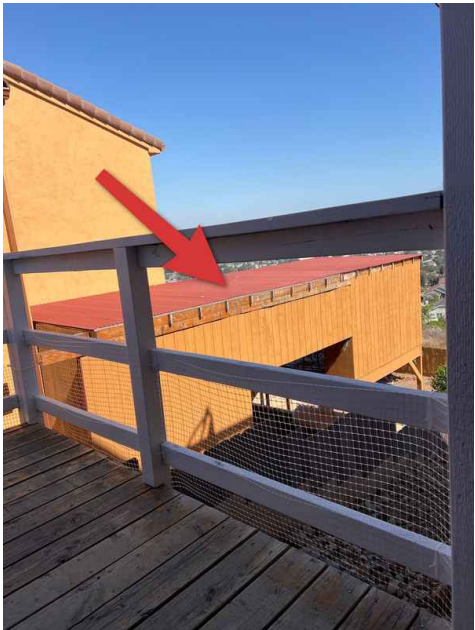
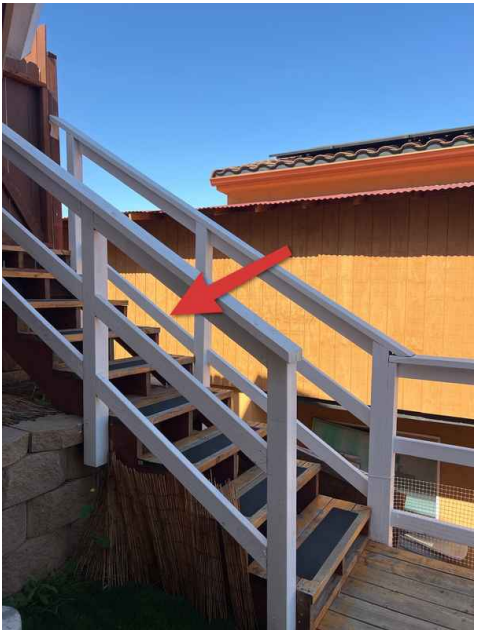
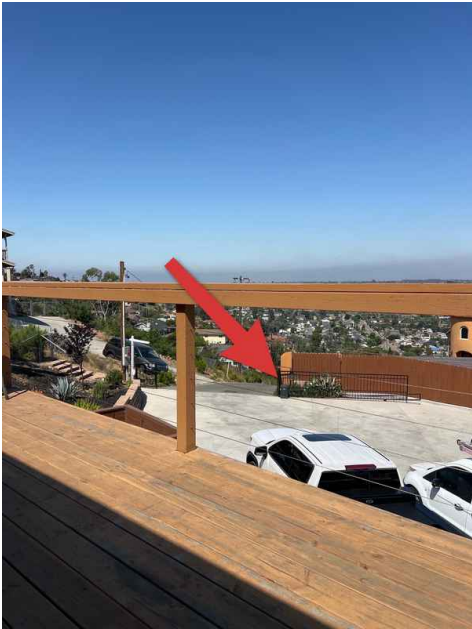
5.6.2 Decks/Stairs

GUARDRAILS GAPS OVER 4" WIDE

Guardrails at one or more locations with drop-offs higher than 30 inches had gaps that were too large. Although an allowed building practice in older structures, this poses a safety hazard for children (e.g. falling, getting stuck in railing). Guardrails should not have gaps or voids that allow passage of a sphere equal to or greater than 4 inches in diameter, or 6 inches in diameter at triangular spaces between stair edges and guardrails and should not be climbable. Recommend that a qualified contractor repair or replace guardrails per standard building practices.

Recommendation
Contact a qualified professional.

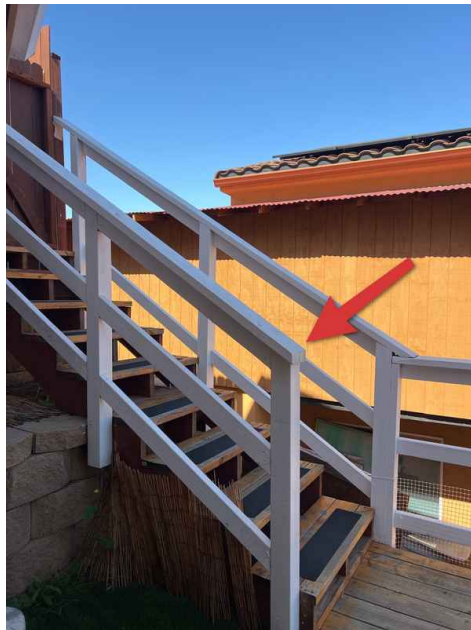
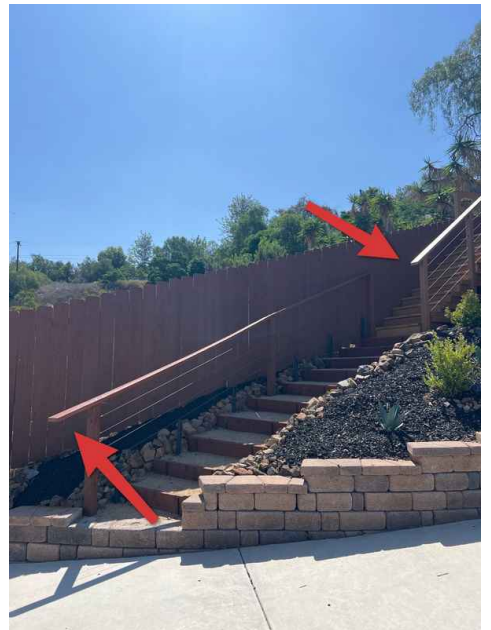
5.6.5 Decks/Stairs

NO RETURNS

Contact a qualified professional.

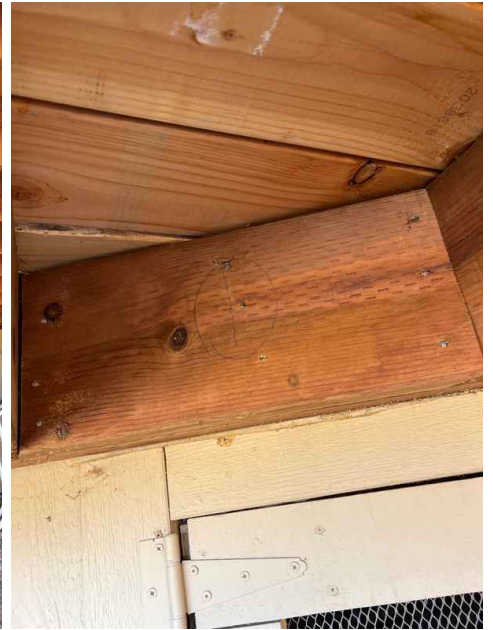
5.6.6 Decks/Stairs

DECK LEDGER ATTACHMENT

Contact a qualified professional.

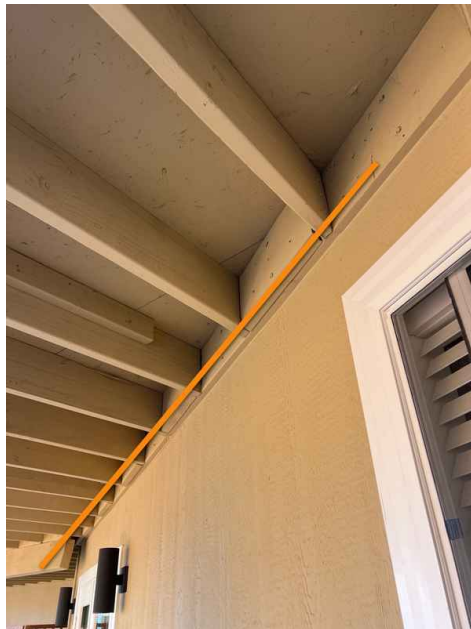
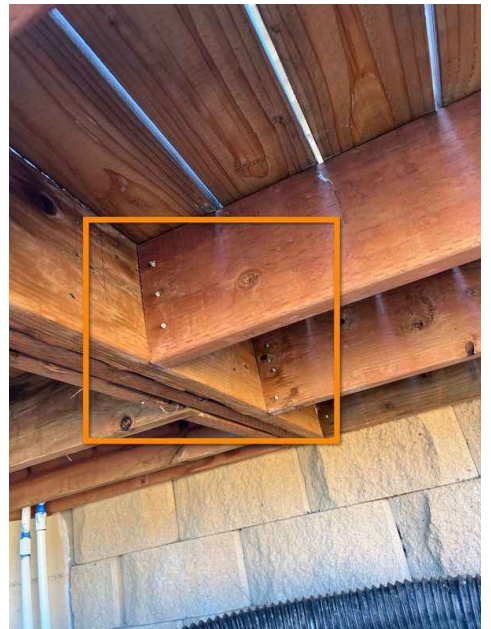
5.6.7 Decks/Stairs

JOIST HANGERS - MISSING

Contact a qualified professional.

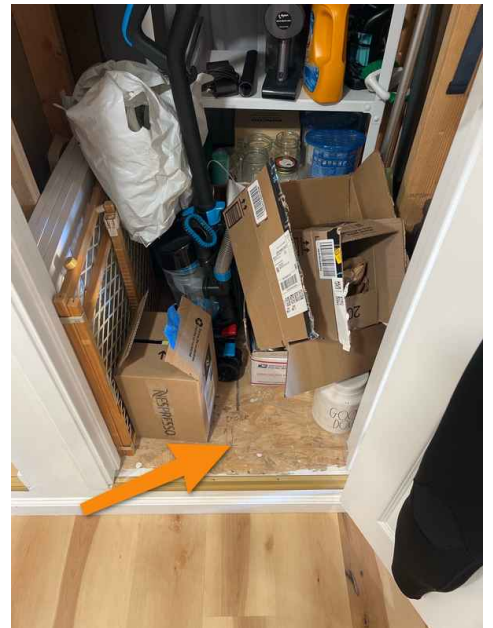
8.6.1 Floors

FLOOR COVERING MISSING / REMOVED

Contact a qualified flooring contractor

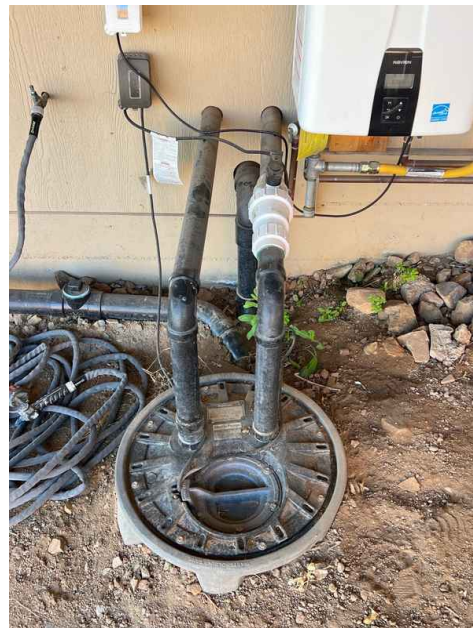
11.1.3 Excluded Items

DRAIN LINE SCOPE RECOMMENDED

Contact a qualified professional.

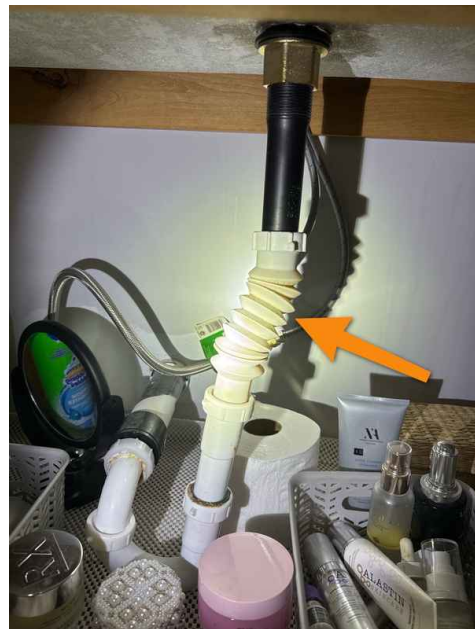
11.4.1 Drain, Waste, & Vent Systems

PVC/ABS - IMPROPER HANGERS

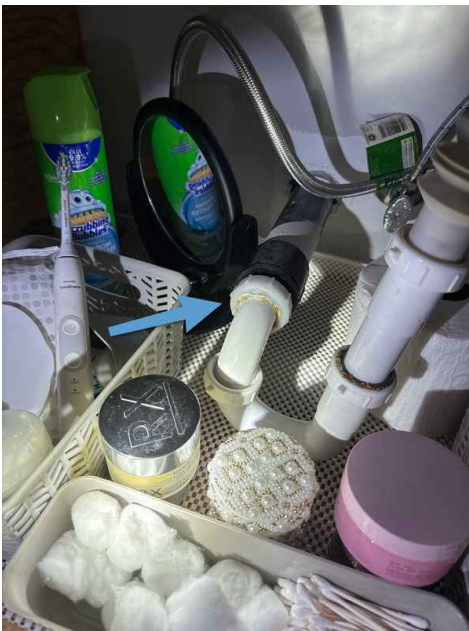
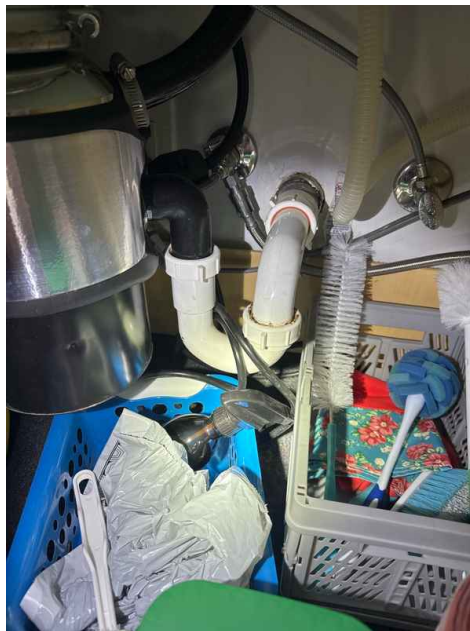
11.6.2 Sinks / Fixtures

SHUT-OFF VALVES / SUPPLY LINE CORRODED

Contact a qualified professional.

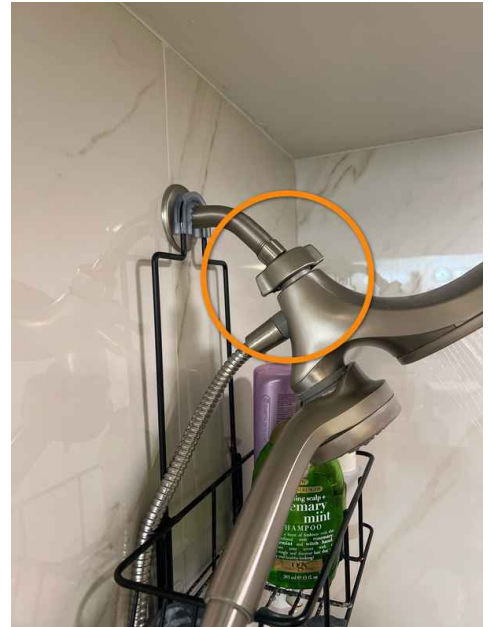
11.8.1 Bathtub / Shower

LEAKS AT SPRAY NOZZLE

Contact a qualified plumbing contractor.

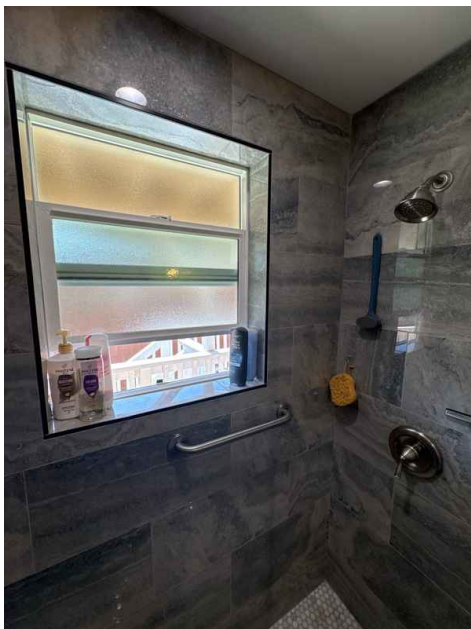
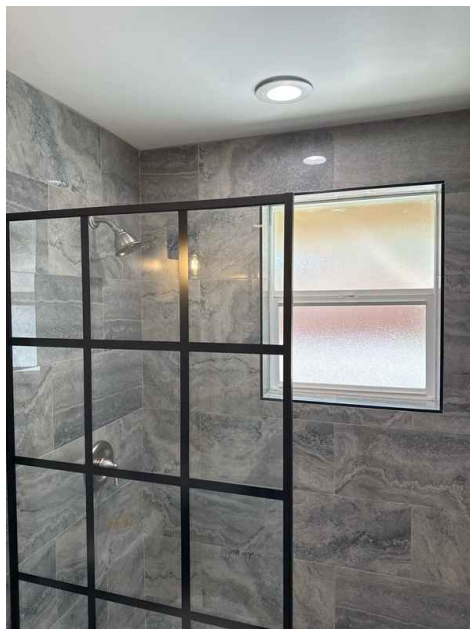
11.8.2 Bathtub / Shower

WINDOW BELOW SHOWERHEAD

Contact a qualified professional.

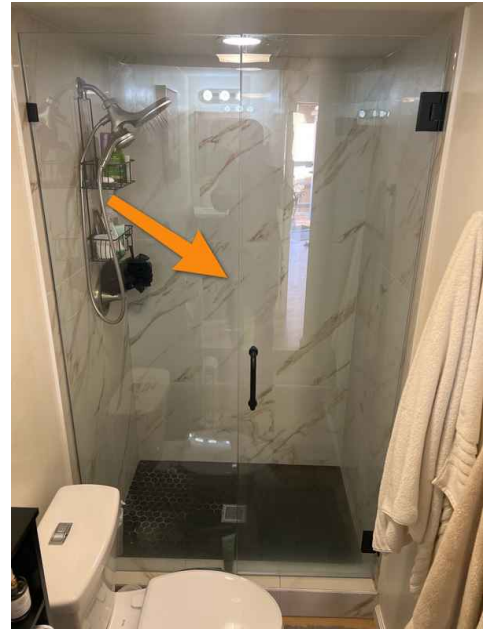
11.8.3 Bathtub / Shower

SHOWER DOOR VINYL MISSING

Contact a qualified professional.

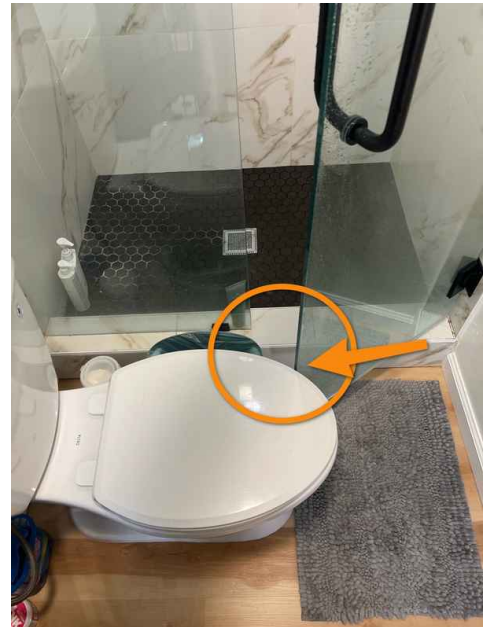
11.8.4 Bathtub / Shower

DOOR/GLASS CONTACT

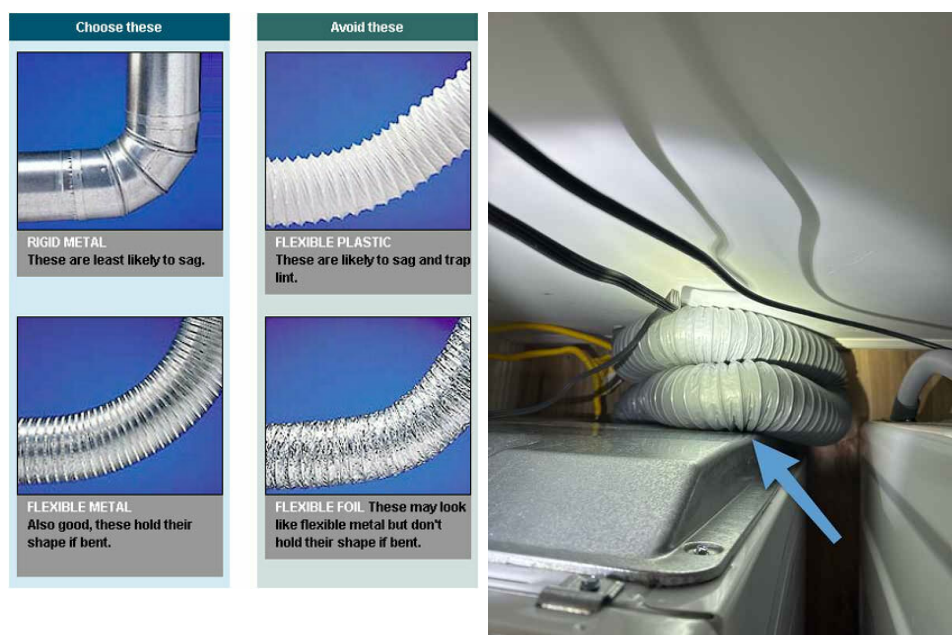
11.9.1 Laundry

NO, LIMITED ACCESS TO BACK OF WASHER, DRYER

Contact a handyman or DIY project

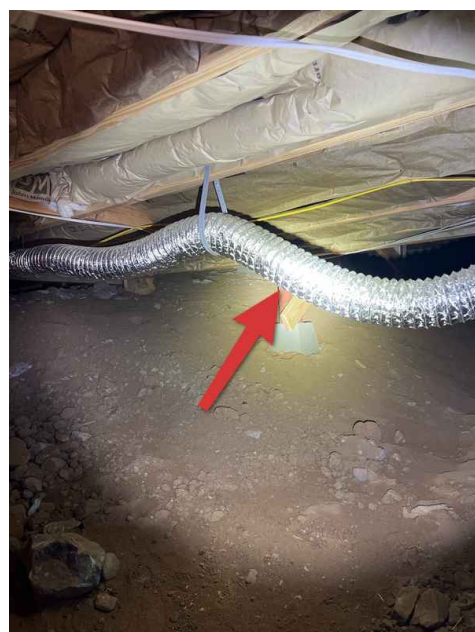
11.9.3 Laundry

FLEXIBLE DRYER DUCT THROUGH CRAWL SPACE

Contact a qualified professional.

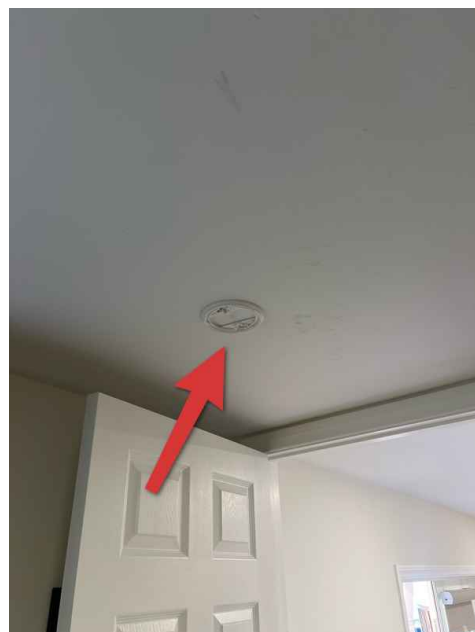
12.9.1 Smoke Detectors / CO Alarms / Door Bell

SMOKE DETECTOR MISSING

Contact a handyman or DIY project

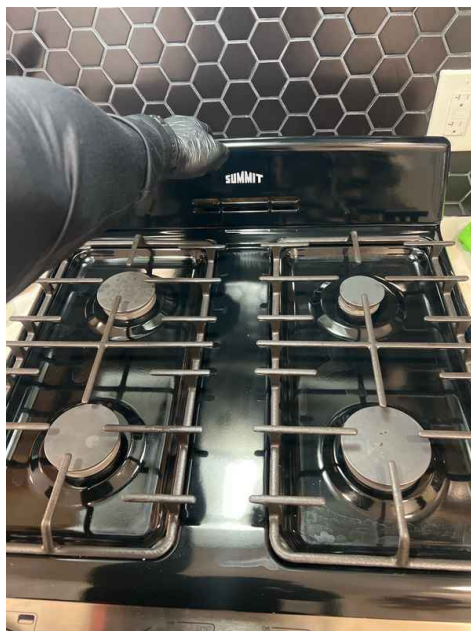
13.3.2 Range/Oven/Cooktop

RANGE / OVEN ANTI-TIP BRACKET NOT INSTALLED / INEFFECTIVE

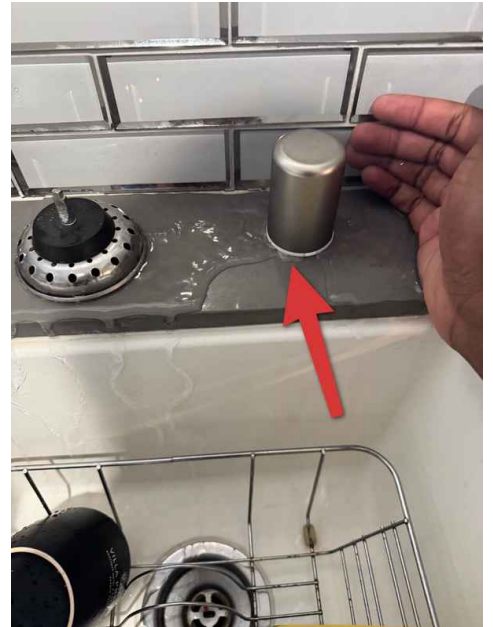
13.5.1 Dishwasher

AIR GAP LOOSE / LEAKS AT COUNTER

Contact a qualified professional.
