REAL ESTATE INSPECTION REPORT

Property Address:
686 S Camino Real
Palm Springs, CA 92264

Report # 10777

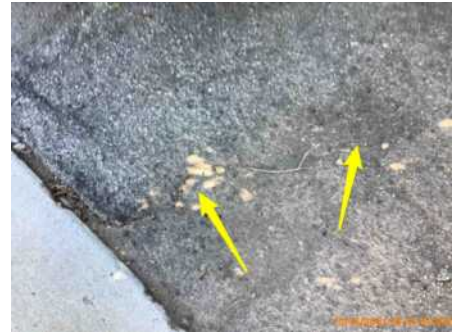
SC Tripping hazards noted at driveway. We recommend further review and repairs by a qualified specialist in the appropriate trade.

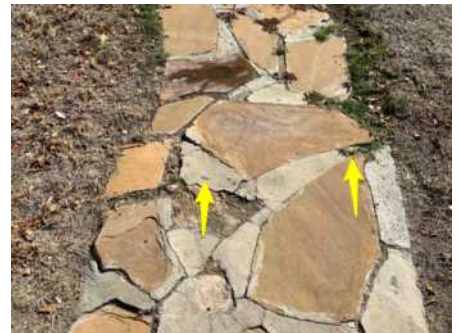
SC Walkway surface is raised/settled, this has created a TRIP - HAZARD at front. We recommend further review and repairs by a qualified specialist in the appropriate trade.

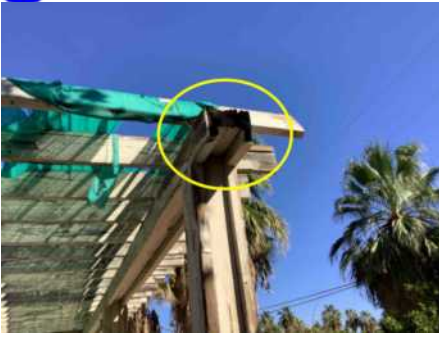
NR Damage noted to wood. Recommend further evaluation by a qualified Termite Company

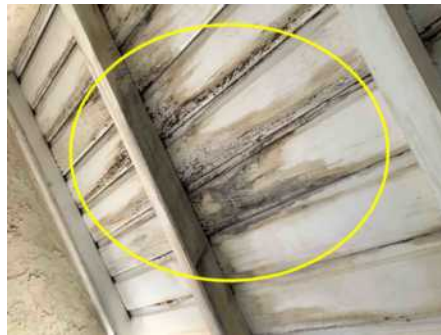
NR Moisture damage noted to front porch roof sheathing, Recommend further evaluation by a qualified Termite Company

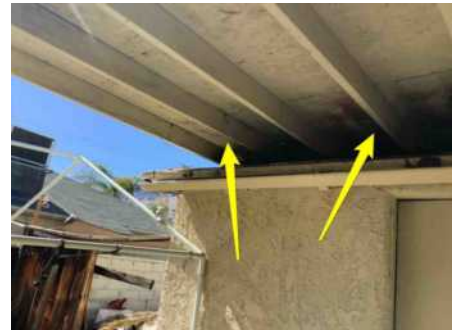
NR Improper installation at patio roof.

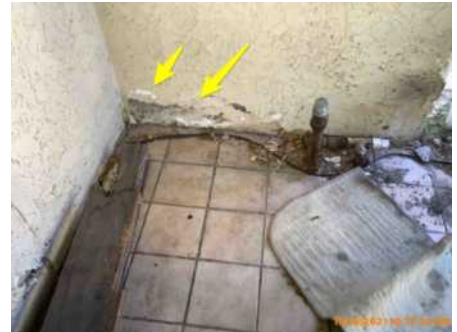
RM Damaged stucco noted at front

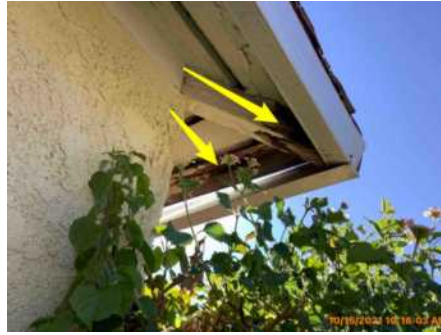
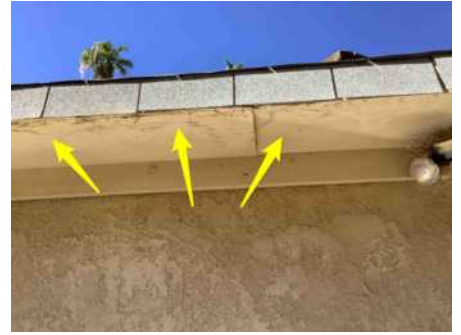
Staining noted at eaves, We recommend further review and repairs by a qualified specialist in the appropriate trade.

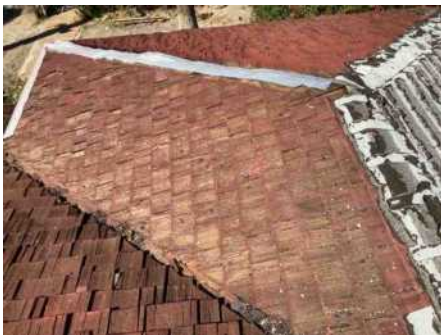
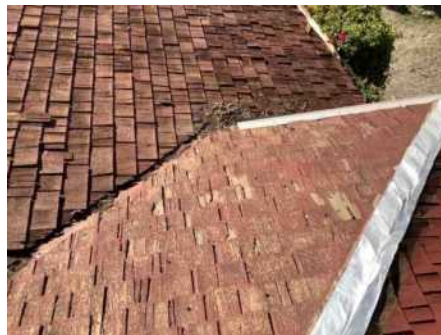
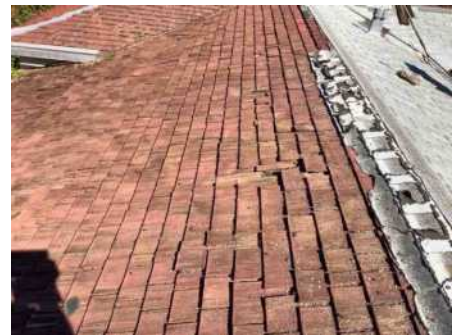
RM The only way to determine whether a roof is absolutely water tight is to observe it during a prolonged rainfall. Many times, this situation is not present during the inspection. Recommend asking the seller for further information on the roof and if they have had any leaks or modifications. Recommend roof be evaluated and certified by a qualified Roofing Contractor.

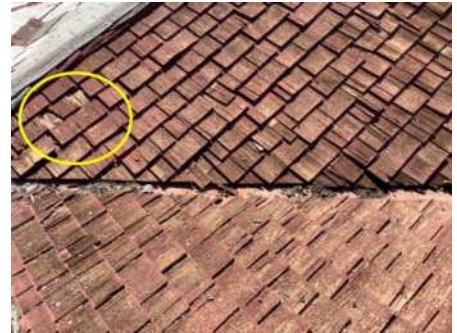
NR Damaged or missing Shingles noted. Repair/Replacement needed.

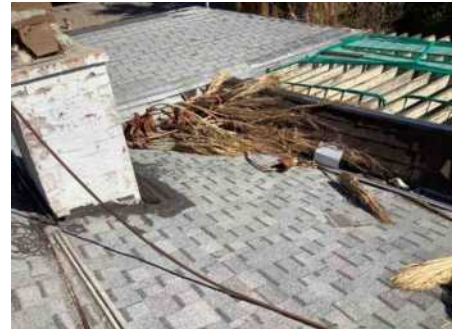
NR The only way to determine whether a roof is absolutely water tight is to observe it during a prolonged rainfall. Many times, this situation is not present during the inspection. Recommend roof be evaluated and certified by a qualified Roofing Contractor due to its age.

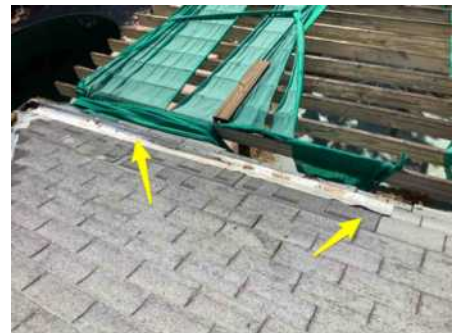
NR Improper installation is found, Recommend the entire roof be evaluated and repaired by a qualified Roofing Contractor

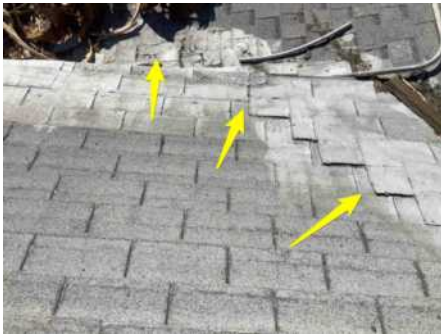
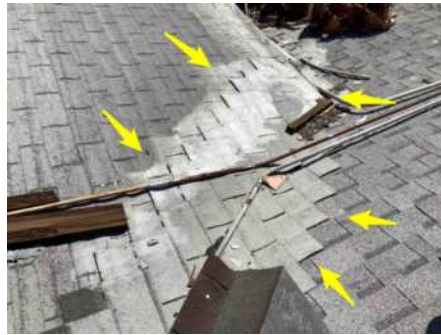
NR Repairs appear to be substandard. Recommend the entire roof be evaluated and repaired by a qualified Roofing Contractor

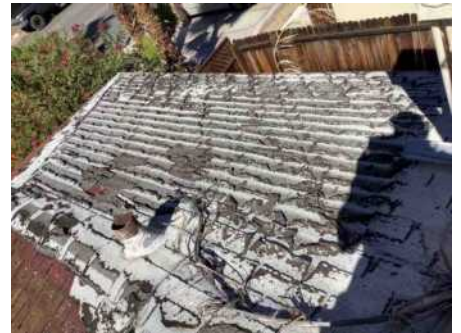
NR Heavy Wear noted to composition roof, composition roof appears to be at its end of its service life. Recommend the entire roof be evaluated and repaired by a qualified Roofing Contractor.

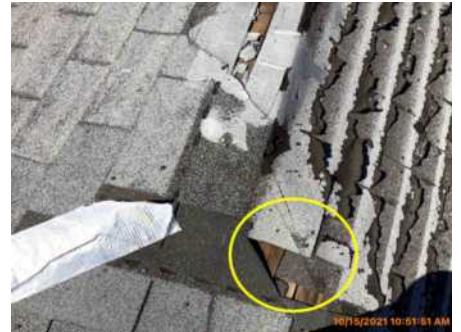
NR Missing composition shingles in several areas

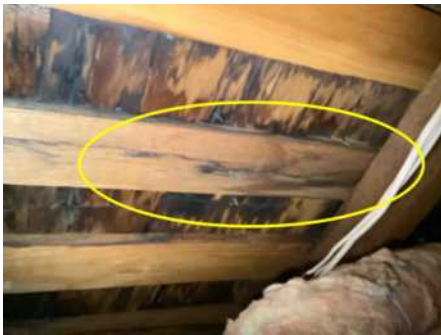
NR Stains seen in attic, unable to determine the status of the stains. Active leakage may be present. We recommend the advice and services of a qualified Roofing Contractor

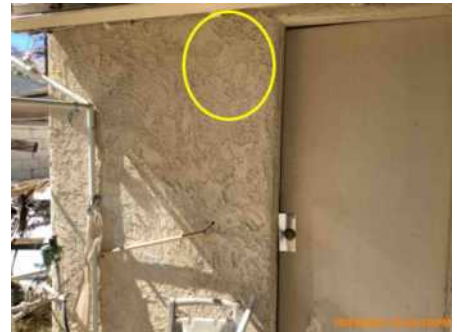
NR Light fixture missing, light fixture required at all grade level doors

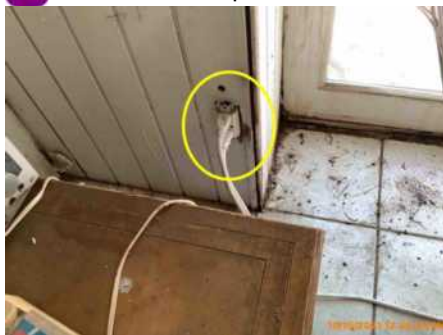
RM There is a receptacle with a missing cover plate at rear room

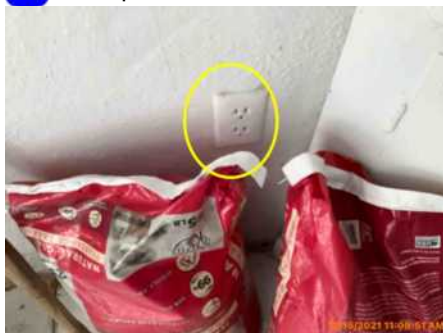
NR Receptacle did not work at rear room

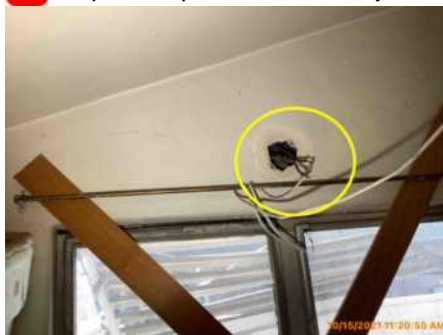
SC Exposed splices are noted, junction box should be installed

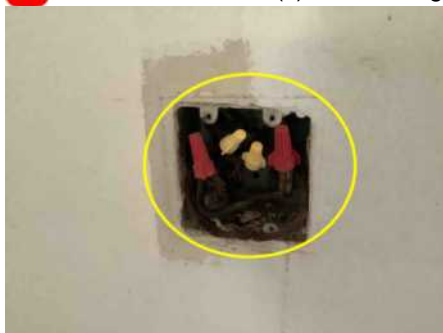
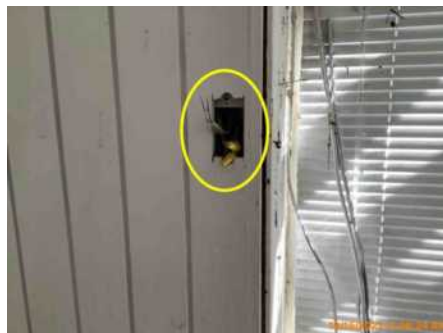
SC Junction box cover(s) are missing

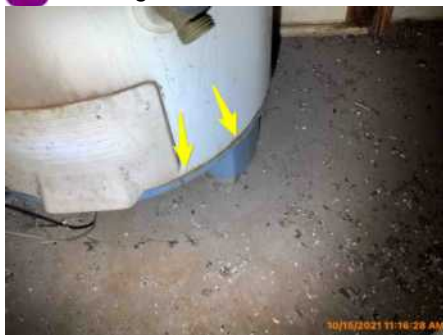
RM Rusting is seen at exterior of tank.

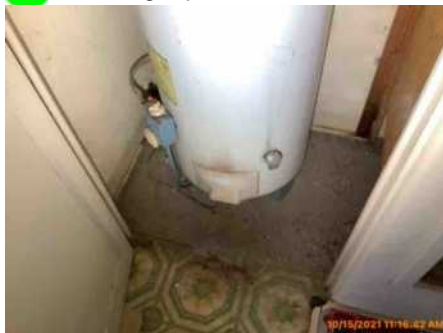
UG Watertight pan recommended for this installation.

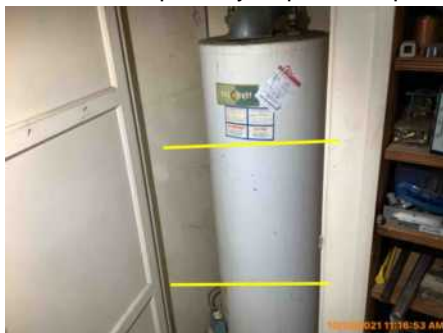
SC Seismic straps missing, Seismic straps need to be installed per manufactures instructions, We recommend further review and repairs by a qualified specialist in the appropriate trade.

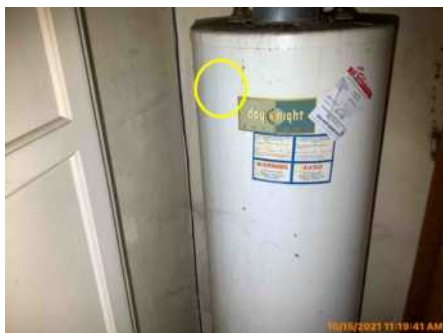
SC No temperature pressure relief valve is installed at water heater, This is a Safety Hazard-Correction is needed. We recommend the advice and services of a qualified Plumbing Contractor

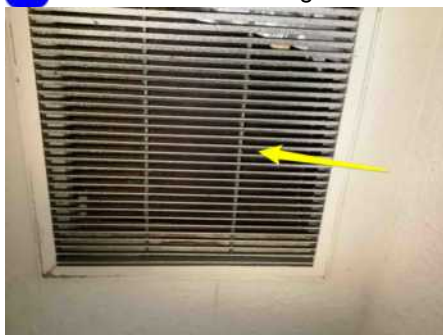
NR Heater filter is missing

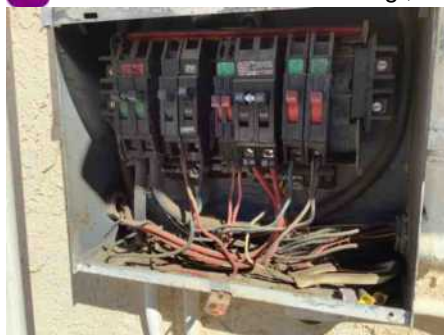
RM Dead front cover was missing , could not verify, recommend verifying breaker size is correct

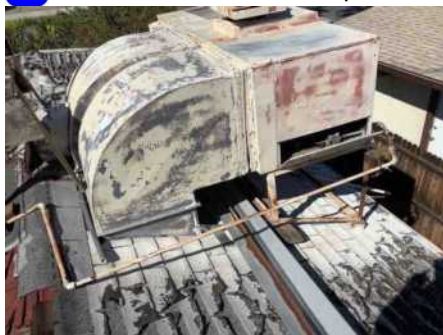
Air conditioner failed to operate, We recommend the advice and services of a qualified HVAC Contractor

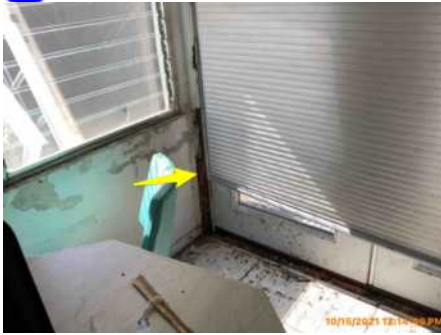
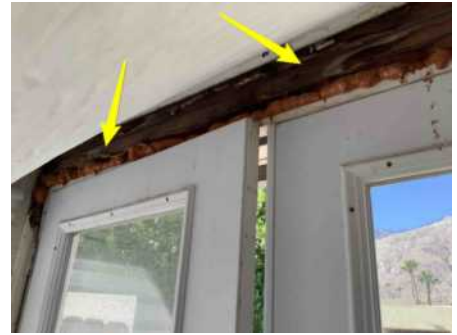
NR Damage and missing wall covering to dining area

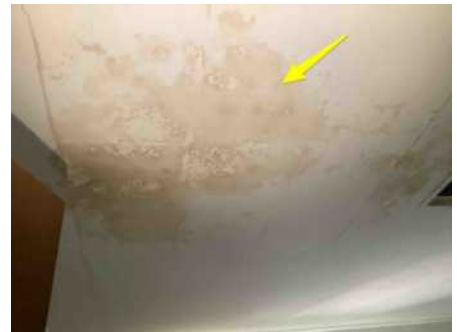
NR Stains noted at throughout home ceilings and walls, possible roof leak . We recommend further review and repairs by a qualified specialist in the appropriate trade.

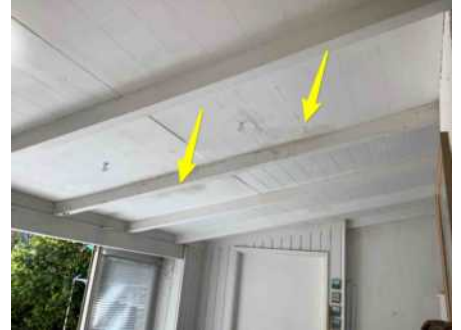
NR Stains noted to ceiling in rear room, roof appears to be leaking. We recommend further review and repairs by a qualified specialist in the appropriate trade.

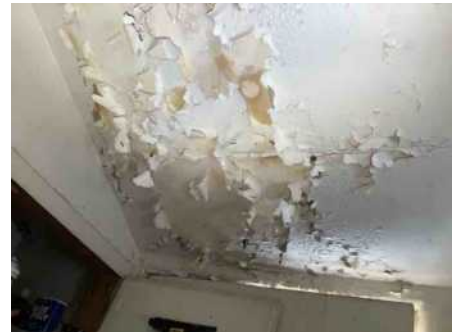
SC Possible lead base paint in walls and ceilings, paint is peeling in several areas throughout home. We recommend further review and repairs by a qualified specialist in the appropriate trade.

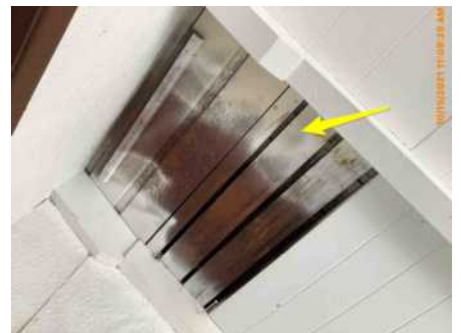
NR Ceiling panels separating, damaged and missing in rear room. We recommend further review and repairs by a qualified specialist in the appropriate trade.

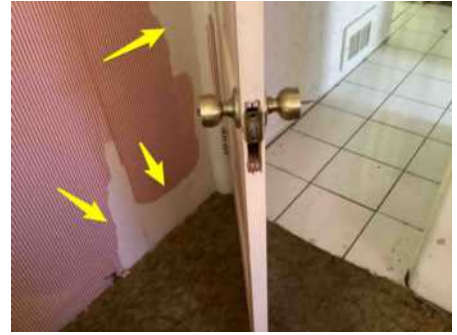
NR Wallpaper peeling/ missing in several areas

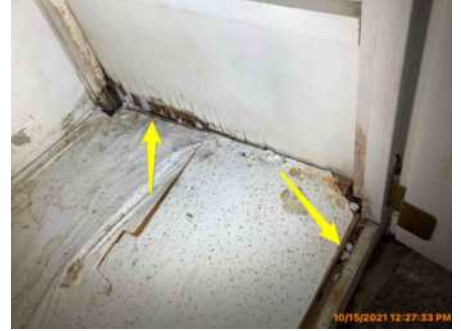
NR I observed evidence of rodents in the hallway and hallway throughout the interior .Ask the Sellers about the rodent history and/or contact a qualified Pest Control Operator to further evaluate.

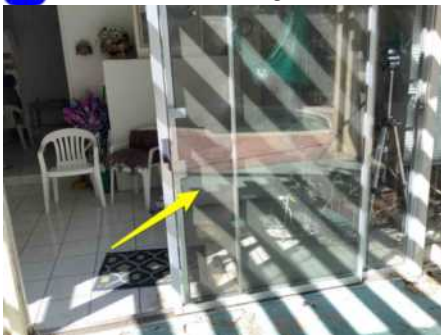
NR Screen door damaged at rear room

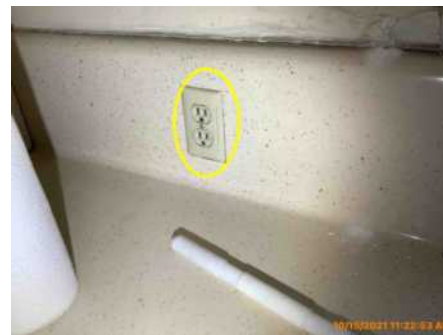
UG All Kitchen receptacles should be GFCI Protected, GFCI protected receptacles were only required by water, the new standard is every receptacles in the Kitchen should be GFCI protected for your safety, installation recommended to all unprotected receptacles, Recommend further review and repair by qualified Electrical Contractor.

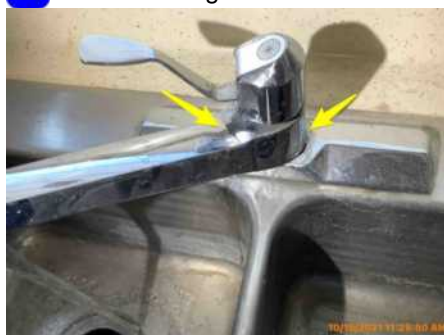
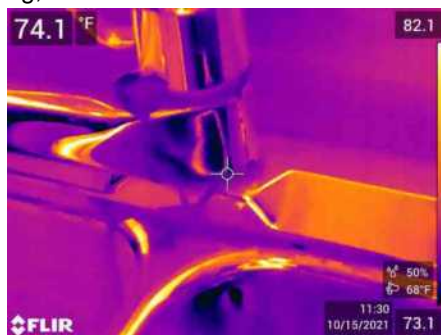
NR Thermal Image shows leak is present under kitchen sink, We recommend the advice and services of a qualified Plumbing Contractor

NR Thermal image shows faucet is leaking, We recommend the advice and services of a qualified Plumbing Contractor.

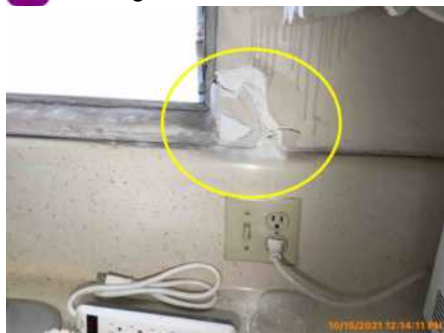
RM Damage noted to wall at near window

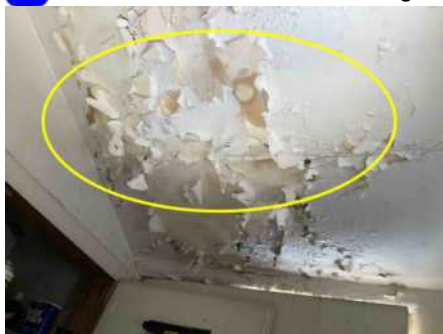
NR Moisture stains noted to ceiling at laundry room, roof appears to be leaking

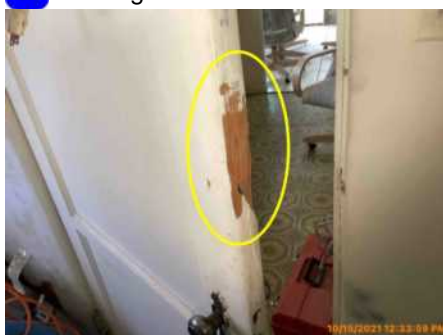
NR Damage noted to door.

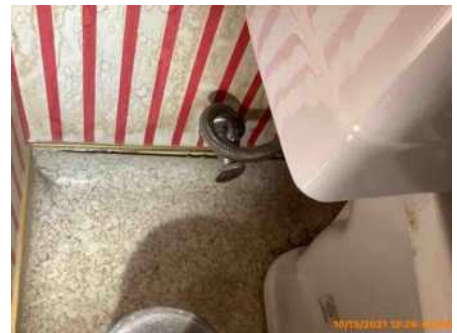
NR Damage noted to floor

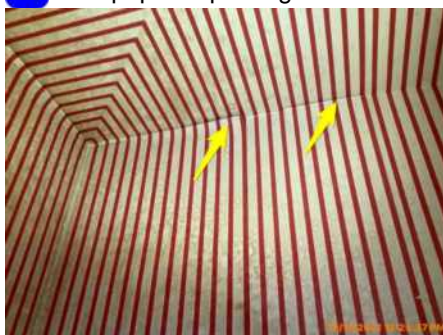
NR Wallpaper is peeling

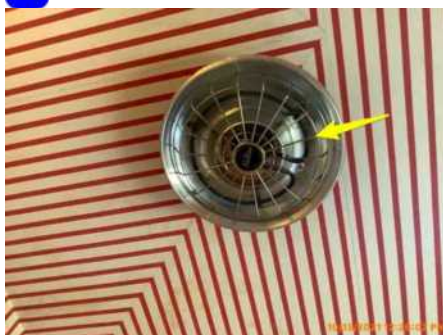
NR Heater fan did not work.

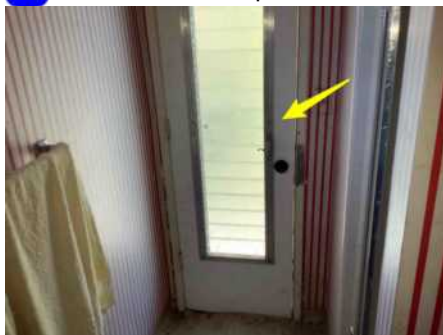
NR Door would not open

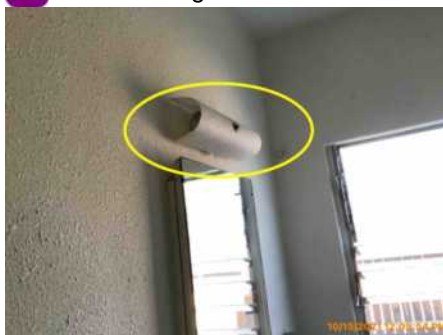
RM Bathroom light did not work

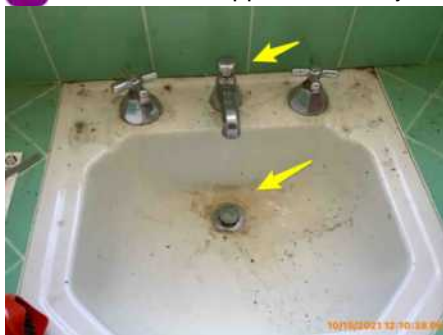
RM Mechanical stopper needs adjustment at sink

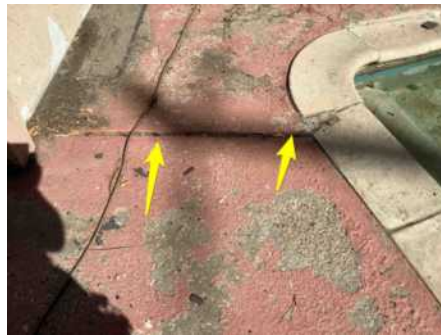
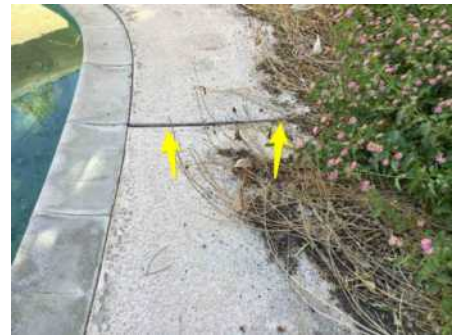
SC The deck has cracked and lifted causing a trip hazard, We recommend further review and repairs by a qualified specialist in the appropriate trade.

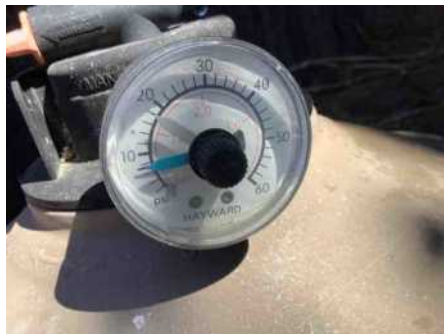
Pressure is low, filter appears to be clean.

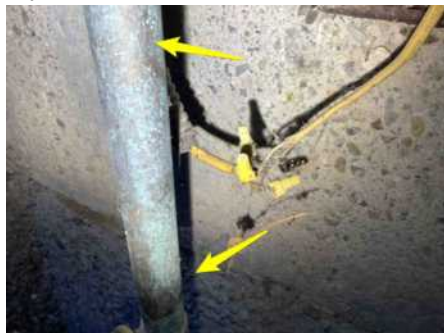
RM Older type original copper piping noted for pool, Copper piping can be a major repair if it is corroded and needs to be replaced. We recommend the advice and services of a qualified Pool Contractor

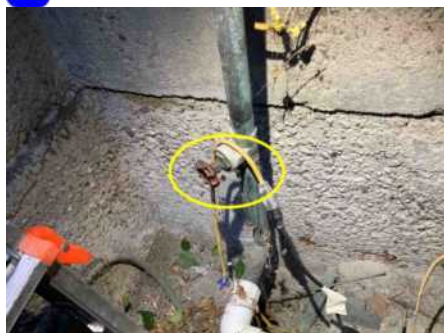
NR Valve seized

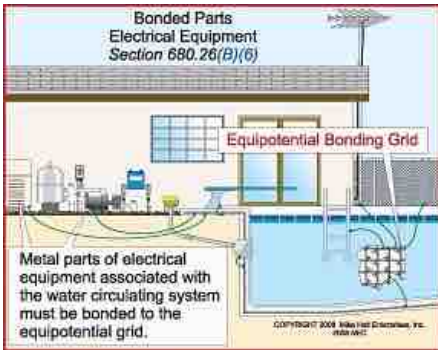
SC External bonding of equipment frames is lacking at the pool pump(s) and the pool heater, All metal pool equipment needs to be bonded to a pool structure. Pool/Spa should not be used until full bonding of the pool system is completed due to the possibility of electrocution. We recommend the advice and services of a qualified Pool Contractor

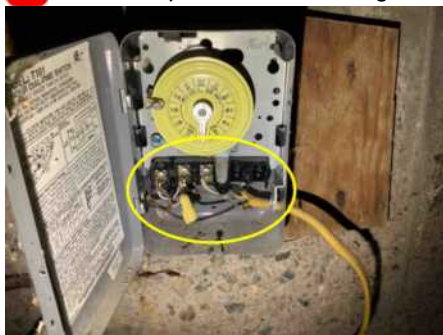
SC Terminal protector is missing from within timer. this is a safety hazard, recommend installing a clock timer insulator.

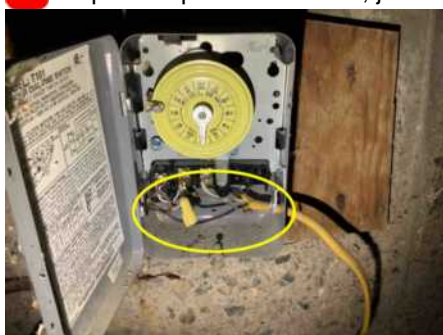
SC Exposed splices are noted, junction box should be installed
