Home Inspection Report

19560 River Birch Ct

Sonora, CA 95370

Inspected on Tue, Apr 7 2026 at 3:00PM

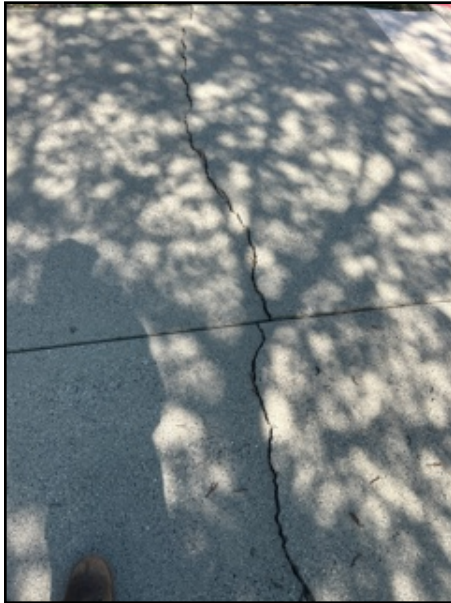
Figure 1-1

Cracks were noted at the concrete driveway. These cracks are most likely due to no reinforcement being installed at the time of the installation as it was not required. These cracks are not considered structural to the house.

1) Comment 1: Cracks were noted at the concrete driveway. These cracks are most likely due to no reinforcement being installed at the time of the installation as it was not required. These cracks are not considered structural to the house.

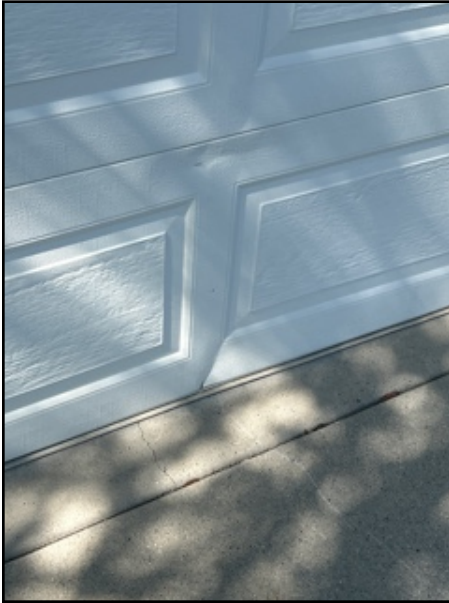
Figure 2-1

Comment 2:
Cosmetic damage was noted to the garage door.

2) Comment 2: Cosmetic damage was noted to the garage door.

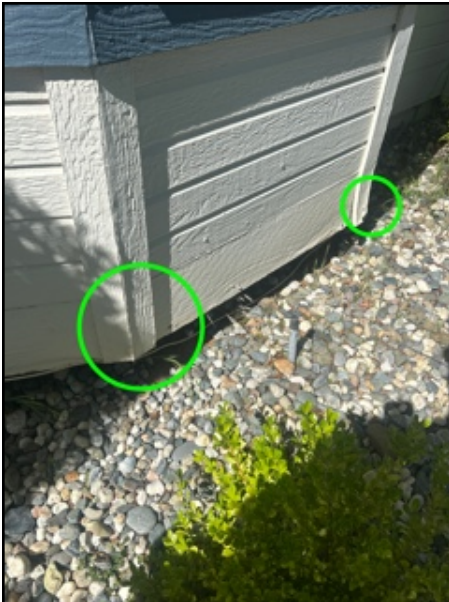
Figure 3-1

Comment 3:
Wood deterioration was noted at the siding trim at the front of the front bedroom.
Recommend repairing or replacing all affected materials as needed.

3) Comment 3: Wood deterioration was noted at the siding trim at the front of the front bedroom. Recommend repairing or replacing all affected materials as needed.

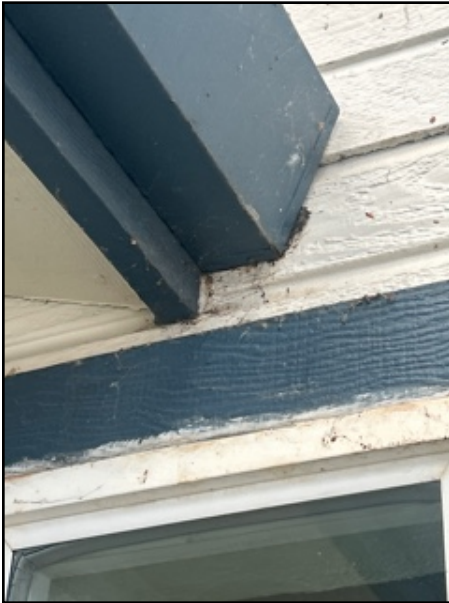
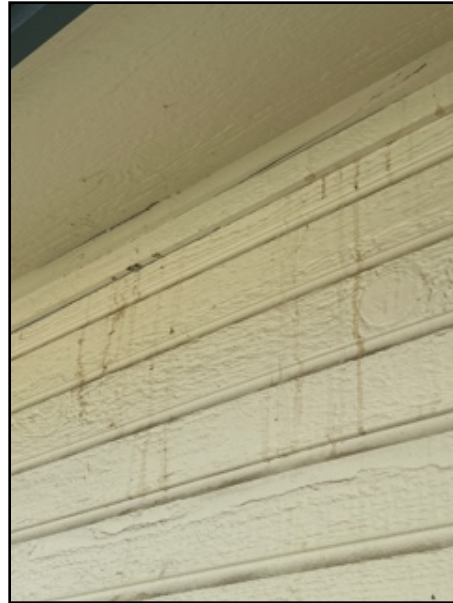
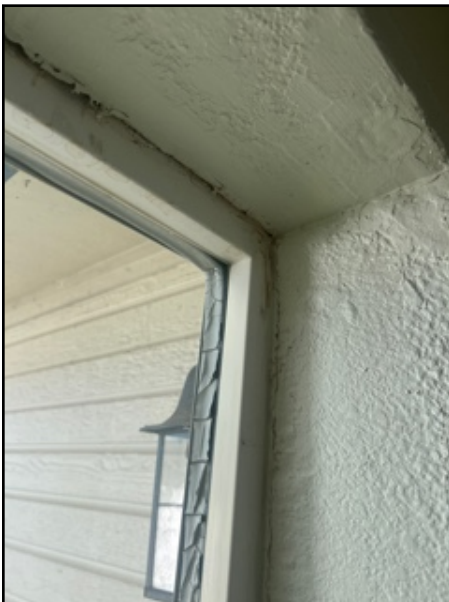
Moisture staining was noted at areas of the eaves and siding at the left side of the front entry. This may be due to leaking gutters. Staining was also noted at the entry window casing. Recommend further review by proper trades

4) Comment 4: Moisture staining was noted at areas of the eaves and siding at the left side of the front entry. This may be due to leaking gutters. Staining was also noted at the entry window casing. Recommend further review by proper trades

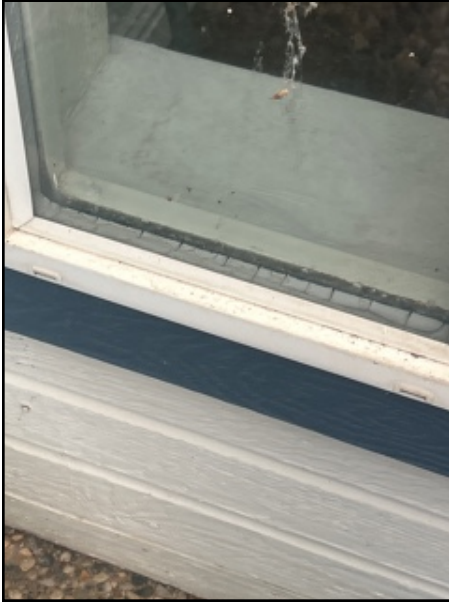
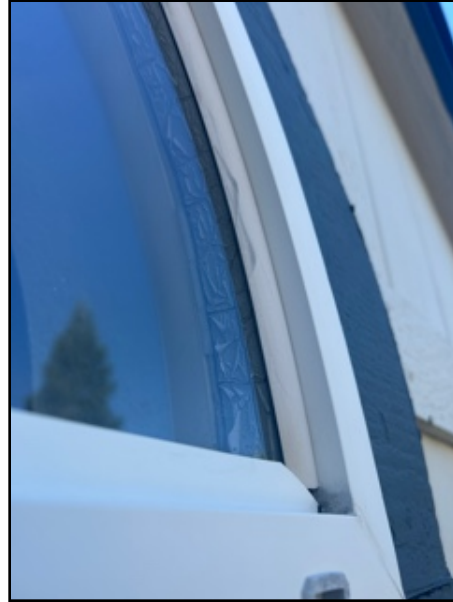
Deteriorated gaskets were noted at multiple windows around the home. This did not appear to have compromise the seals, however.

5) Comment 5: Deteriorated gaskets were noted at multiple windows around the home. This did not appear to have compromise the seals, however.

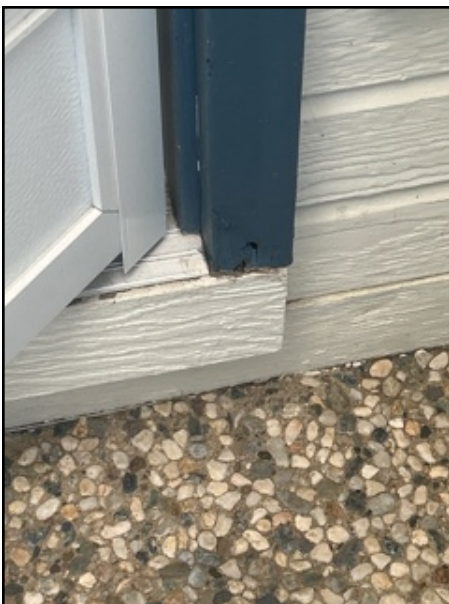
Figure 6-1

Wood deterioration was noted at the trim at the front door. Recommend repairing or replacing all affected materials as needed.

6) Comment 6: Wood deterioration was noted at the trim at the front door. Recommend repairing or replacing all affected materials as needed.

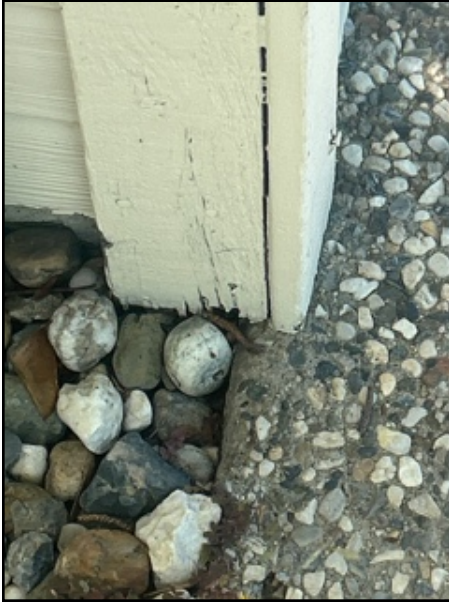
Figure 7-1

- ⚠ Comment 7:
Wood deterioration was noted at the siding trim at the left side of the garage.
Recommend repairing or replacing all affected materials as needed.

7) Comment 7: Wood deterioration was noted at the siding trim at the left side of the garage. Recommend repairing or replacing all affected materials as needed.

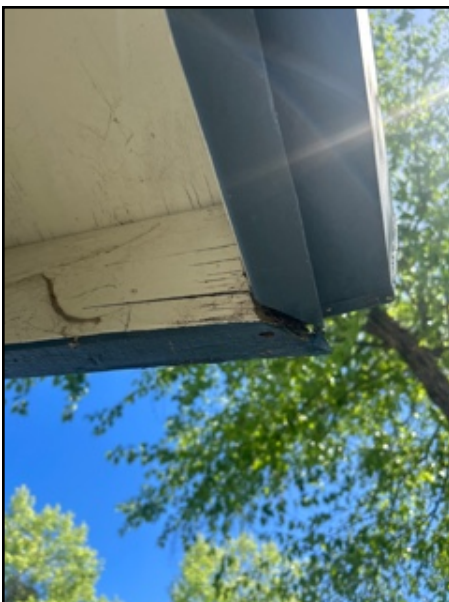
Figure 8-1

-
- ⚠ Comment 8:
Wood deterioration was noted at the eaves at the front left corner of the garage.
Recommend repairing or replacing all affected materials as needed.

8) Comment 8: Wood deterioration was noted at the eaves at the front left corner of the garage. Recommend repairing or replacing all affected materials as needed.

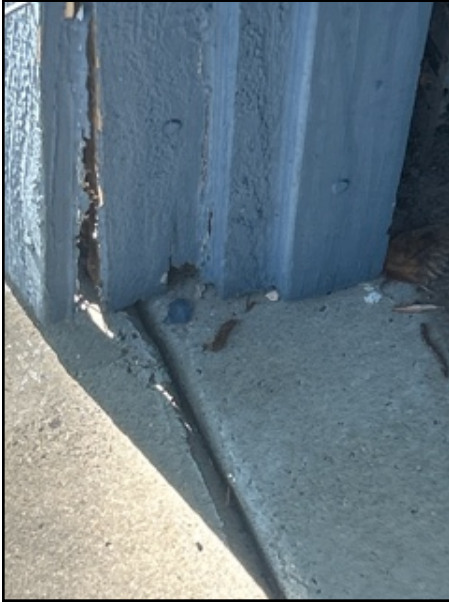
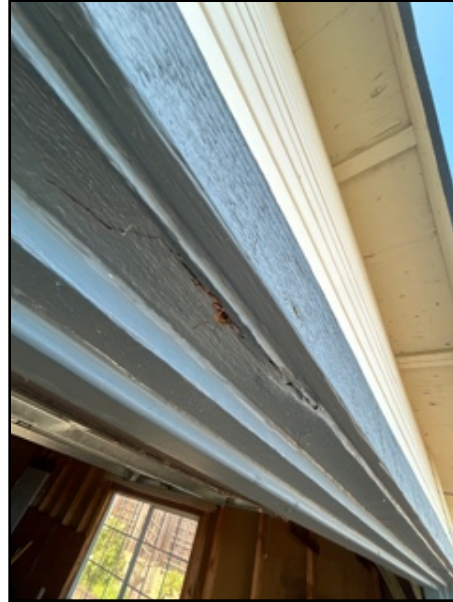
**Comment 9:**
Wood deterioration was noted at the side and overhead garage door casing. Recommend repairing or replacing all affected materials as needed.

9) Comment 9: Wood deterioration was noted at the side and overhead garage door casing. Recommend repairing or replacing all affected materials as needed.

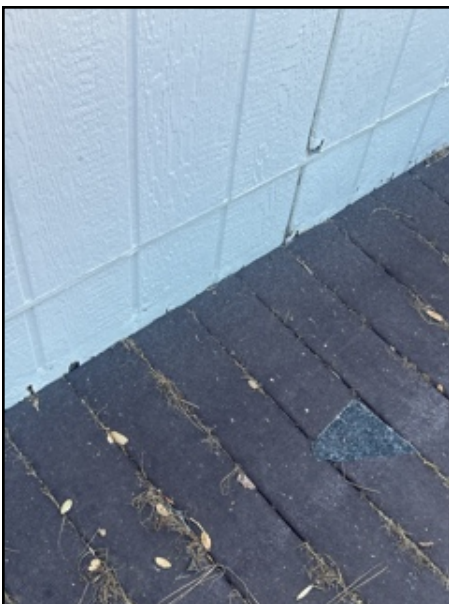
Figure 10-1

**Comment 10:**
Wood deterioration was noted at areas of the siding at the right side of the garage. Recommend repairing or replacing all affected materials as needed.

10) Comment 10: Wood deterioration was noted at areas of the siding at the right side of the garage. Recommend repairing or replacing all affected materials as needed.

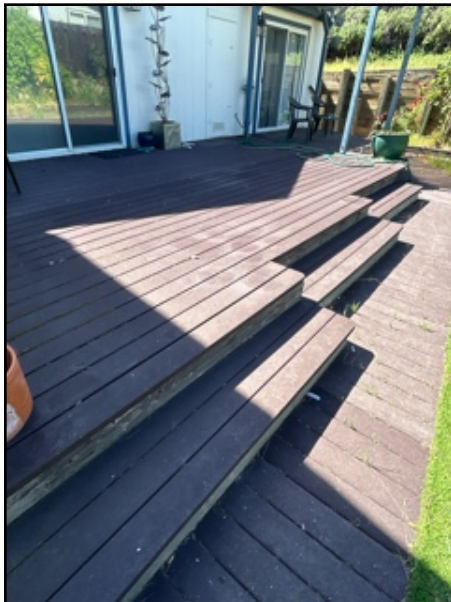
Figure 11-1

**Comment 11:**
The inspector was unable to access beneath the rear deck due to insufficient clearance.

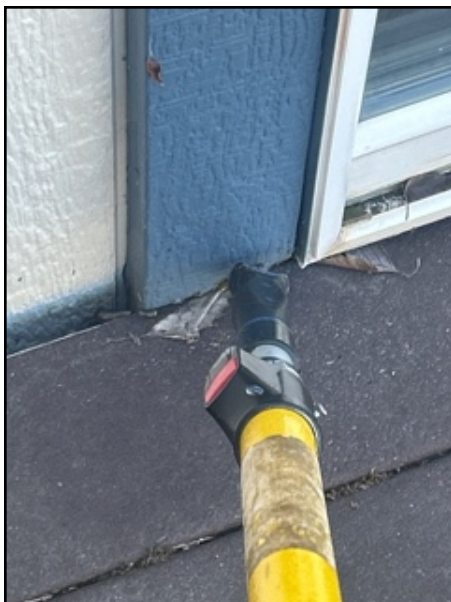
Figure 12-1

**Comment 12:**
Wood deterioration was noted at the trim at the living room slider. Recommend repairing or replacing all affected materials as needed.

11) Comment 12: Wood deterioration was noted at the trim at the living room slider. Recommend repairing or replacing all affected materials as needed.

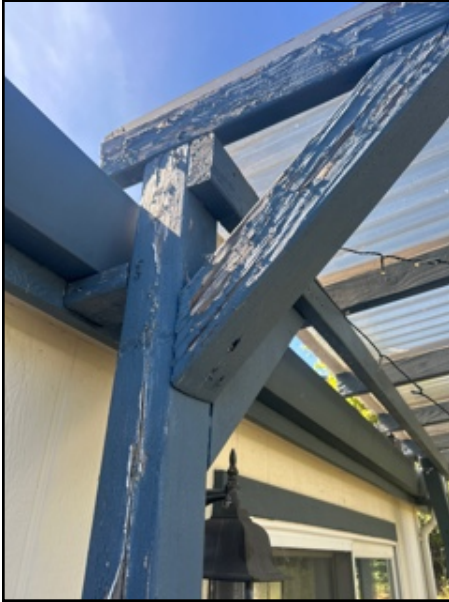
Figure 13-1

The rear pergola was weathered. Recommend repainting this to prevent moisture damage.

12) Comment 13: The rear pergola was weathered. Recommend repainting this to prevent moisture damage.

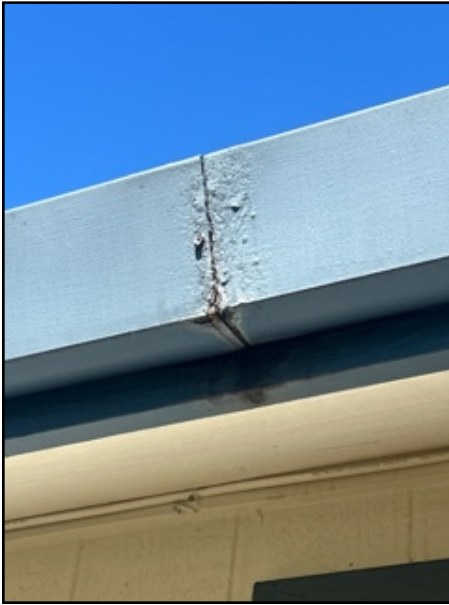
Figure 14-1

Rusted gutter seams were noted at multiple areas of the eaves around the structure. Recommend repairs or replacement to properly divert roof water away from the building.

13) Comment 14: Rusted gutter seams were noted at multiple areas of the eaves around the structure. Recommend repairs or replacement to properly divert roof water away from the building.

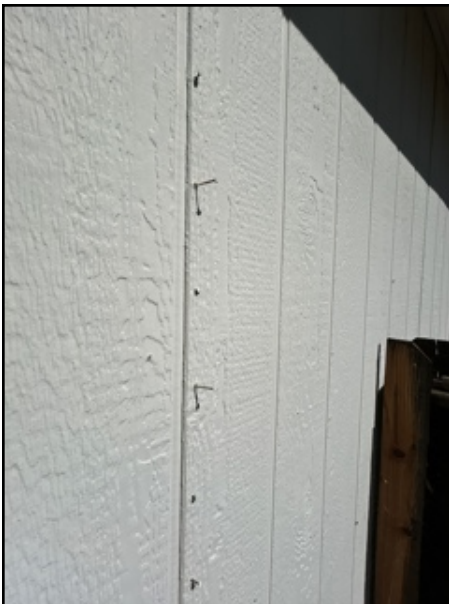
Figure 15-1

**Comment 15:**
Loose and unsealed fasteners were noted at areas of the siding around the structure. Recommend repairs to prevent moisture intrusion beneath wood members.

14) Comment 15: Loose and unsealed fasteners were noted at areas of the siding around the structure. Recommend repairs to prevent moisture intrusion beneath wood members.

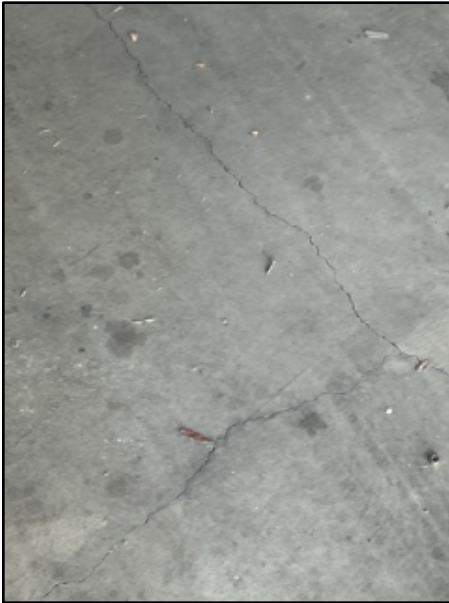
Figure 16-1

Garage floor cracking was noted, this is common for the age of the house as reinforcement was not required in the slab. This is not considered structural to the foundation of the house.

15) Comment 16: Garage floor cracking was noted, this is common for the age of the house as reinforcement was not required in the slab. This is not considered structural to the foundation of the house.

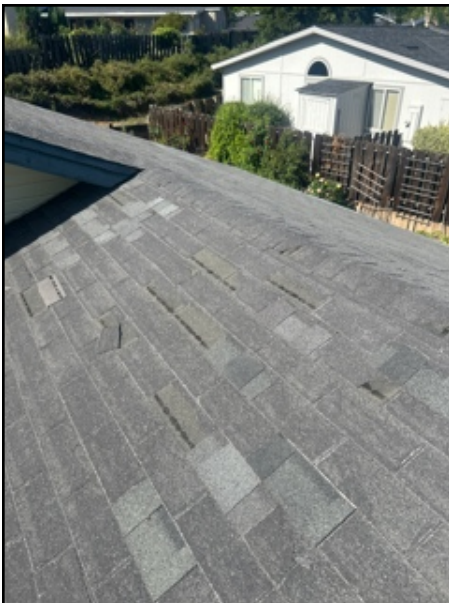
Figure 17-1

The roof is suggested to be at the end of its usable life and should be repaired or replaced by a qualified person.

16) Comment 17: The roof is suggested to be at the end of its usable life and should be repaired or replaced by a qualified person.

When the roof is repaired it is suggested to have roof ventilation reviewed and repaired by a qualified person. Additional ventilation such as a ridge vent will dramatically increase the lifespan of the new roofing material.

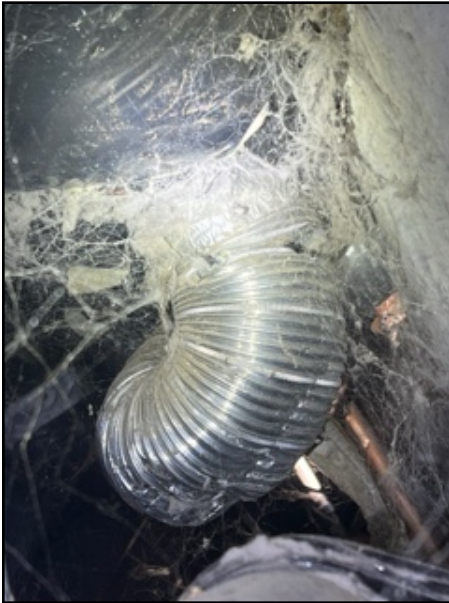
Figure 19-1

The dryer vent was disconnected in the subarea. This was not ducted to the exterior of the house. This should be repaired by a qualified person to ensure moisture cannot access the subarea.

18) Comment 19: The dryer vent was disconnected in the subarea. This was not ducted to the exterior of the house. This should be repaired by a qualified person to ensure moisture cannot access the subarea.

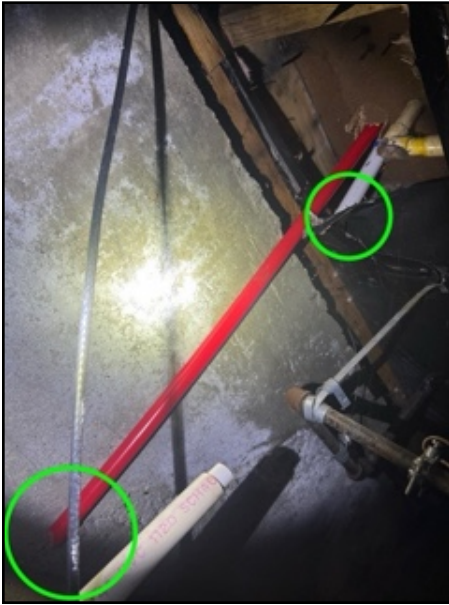
Figure 20-1

Noted that the water heater blow off leg and drip pan were plumbed into the sub area. This could cause moisture intrusion into the sub area and proper repairs should be made.

19) Comment 20: Noted that the water heater blow off leg and drip pan were plumbed into the sub area. This could cause moisture intrusion into the sub area and proper repairs should be made.

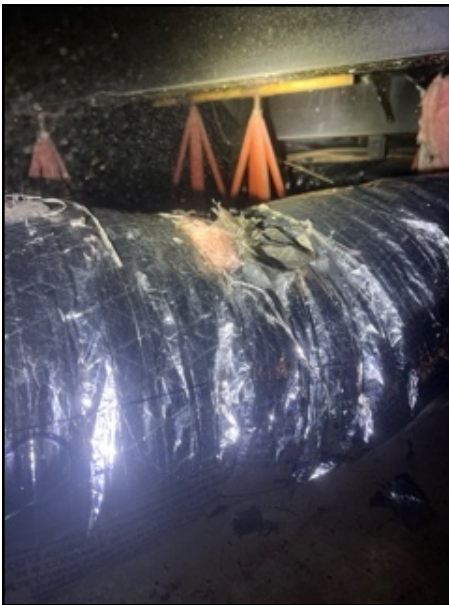
Figure 21-1

Damage was noted to areas of the HVAC ducting. Recommend repairs by proper trades

20) Comment 21: Damage was noted to areas of the HVAC ducting. Recommend repairs by proper trades

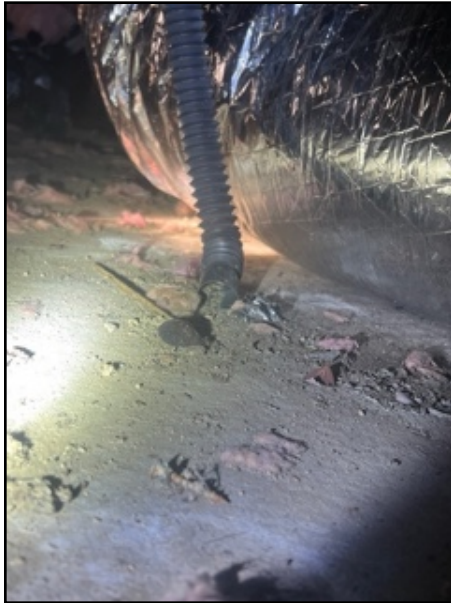
Figure 22-1

Noted that the condensate line for the HVAC system was draining in the sub area. This may cause a moisture intrusion issue into the sub area and proper repairs should be made.

21) Comment 22: Noted that the condensate line for the HVAC system was draining in the sub area. This may cause a moisture intrusion issue into the sub area and proper repairs should be made.

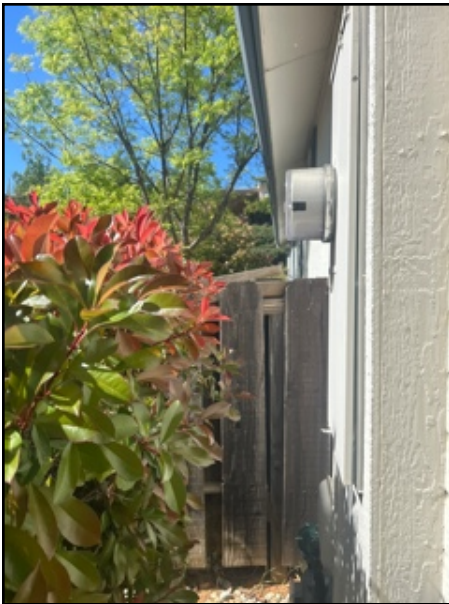
Figure 23-1

Improper clearance noted at electrical panel door. It is noted that electrical panels are required to have 3 feet of unobstructed space. Suggest repairing as needed.

22) Comment 23: Improper clearance noted at electrical panel door. It is noted that electrical panels are required to have 3 feet of unobstructed space. Suggest repairing as needed.

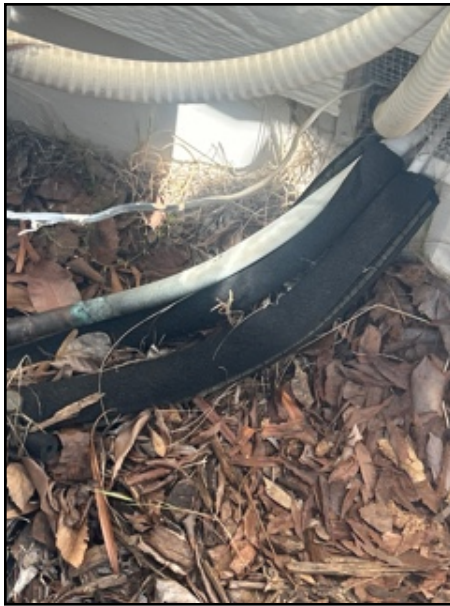
Figure 24-1

Noted that insulation around the line set for the AC system is damaged. This unit should be repaired to ensure that the AC system is operating efficiently.

23) Comment 24: Noted that insulation around the line set for the AC system is damaged. This unit should be repaired to ensure that the AC system is operating efficiently.

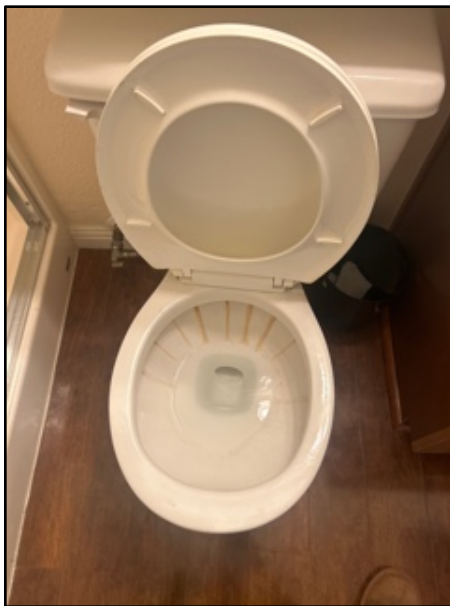
Figure 26-1

The toilet was loose. Suggest removing/replacing wax ring and reinstalling a new wax ring. When the toilet is removed, it is recommended to inspect subfloor for wood deterioration.

25) Comment 26: The toilet was loose. Suggest removing/replacing wax ring and reinstalling a new wax ring. When the toilet is removed, it is recommended to inspect subfloor for wood deterioration.

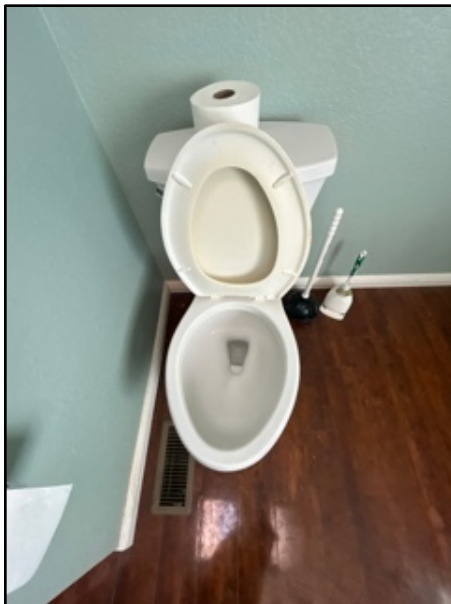
Figure 27-1

The toilet was loose. Suggest removing/replacing wax ring and reinstalling a new wax ring. When the toilet is removed, it is recommended to inspect subfloor for wood deterioration.

26) Comment 27: The toilet was loose. Suggest removing/replacing wax ring and reinstalling a new wax ring. When the toilet is removed, it is recommended to inspect subfloor for wood deterioration.

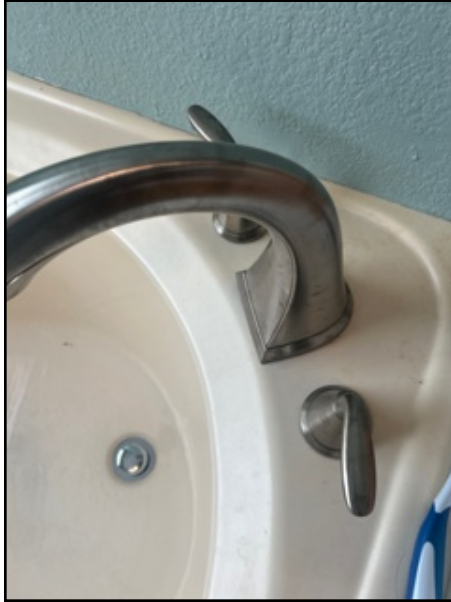
Figure 28-1

The bathtub faucet was loose from the surround. Recommend repairs to prevent moisture intrusion beneath the tub.

27) Comment 28: The bathtub faucet was loose from the surround. Recommend repairs to prevent moisture intrusion beneath the tub.

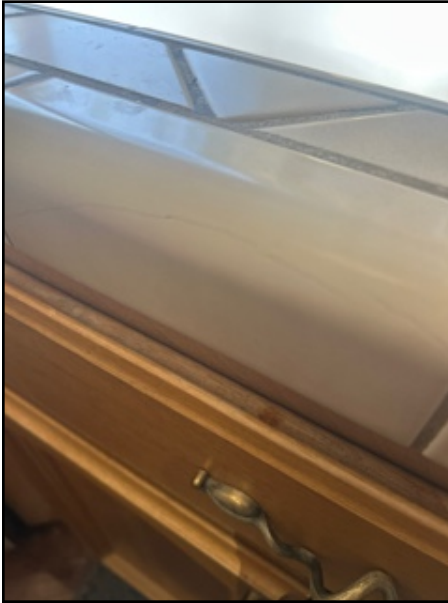
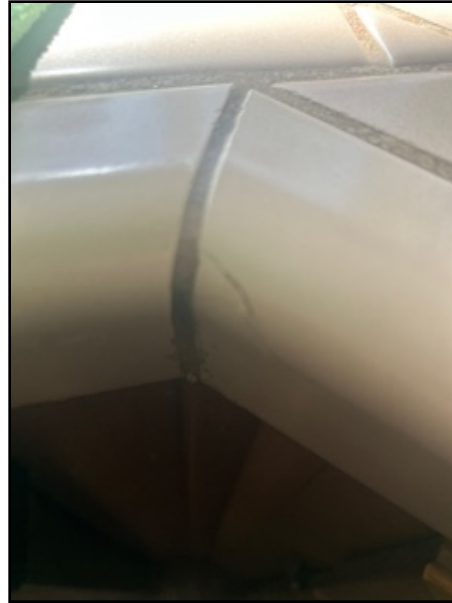
**Comment 29:**
Minor damage was noted to areas of the tiles at the kitchen countertops.

28) Comment 29: Minor damage was noted to areas of the tiles at the kitchen countertops.

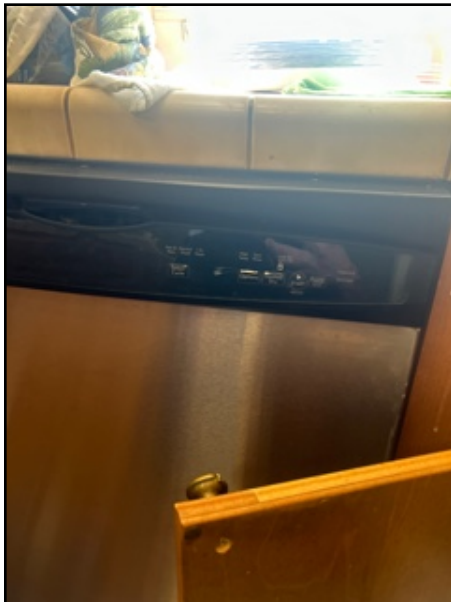
Figure 30-1

The dishwasher was nonfunctional at the time of inspection. The power cord was not located and this may be disconnected. Recommend further review by proper trades.

29) Comment 30: The dishwasher was nonfunctional at the time of inspection. The power cord was not located and this may be disconnected. Recommend further review by proper trades.

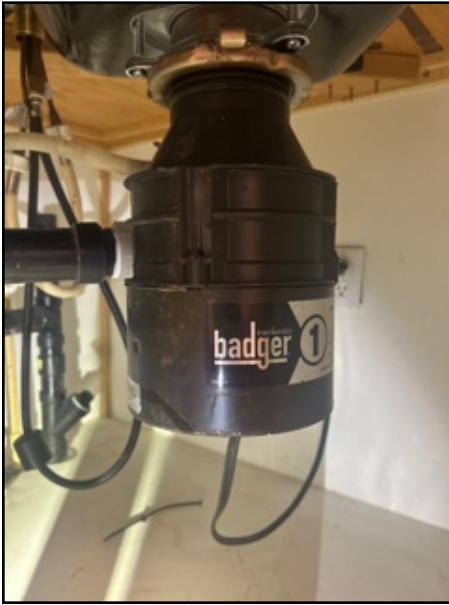
Figure 31-1

The garbage disposal motor would not engage suggesting a blockage or a seized motor. Recommend further review by proper trades.

30) Comment 31: The garbage disposal motor would not engage suggesting a blockage or a seized motor. Recommend further review by proper trades.

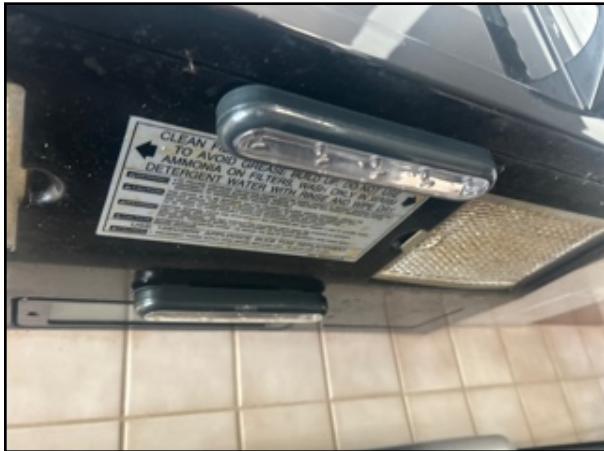
Figure 32-1

**Comment 32:**
The light fixture at the range hood was non-functional. This may be due to a missing or burnt out bulb.

31) Comment 32: The light fixture at the range hood was non-functional. This may be due to a missing or burnt out bulb.

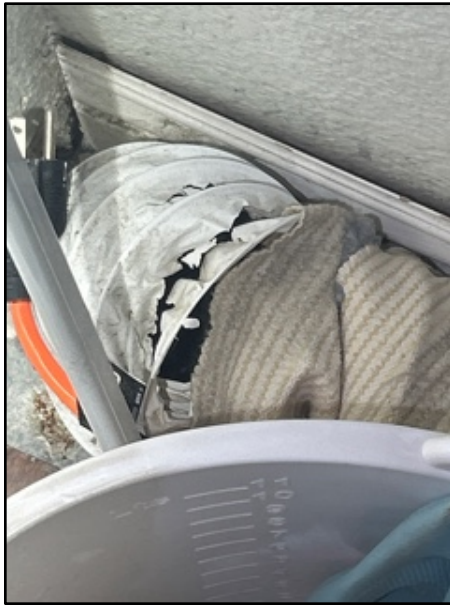
Figure 33-1

Comment 33:
The dryer vent was damaged behind the unit.

32) Comment 33: The dryer vent was damaged behind the unit.

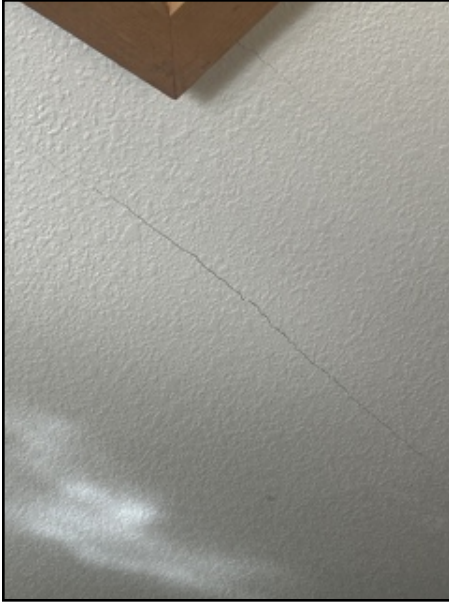
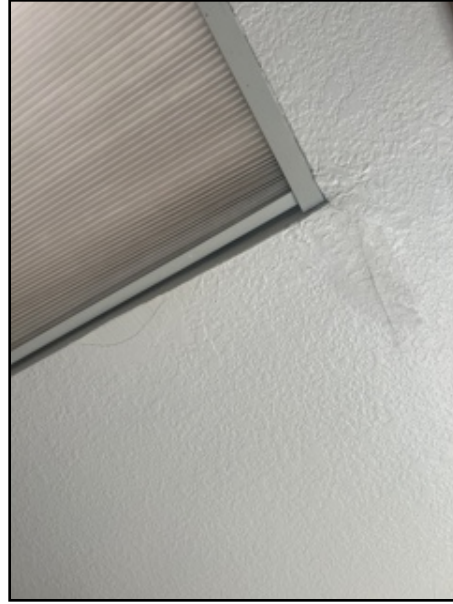
Comment 34:
Drywall damage was noted at the ceiling around the kitchen skylight.

33) Comment 34: Drywall damage was noted at the ceiling around the kitchen skylight.

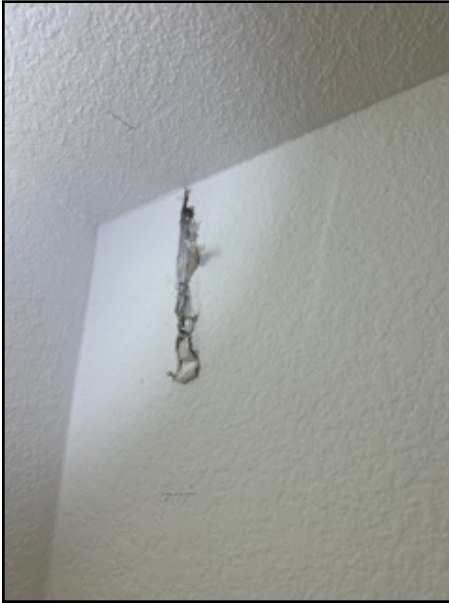
Figure 35-1

Drywall damage was noted at the wall at the front bedroom closet.

34) Comment 35: Drywall damage was noted at the wall at the front bedroom closet.

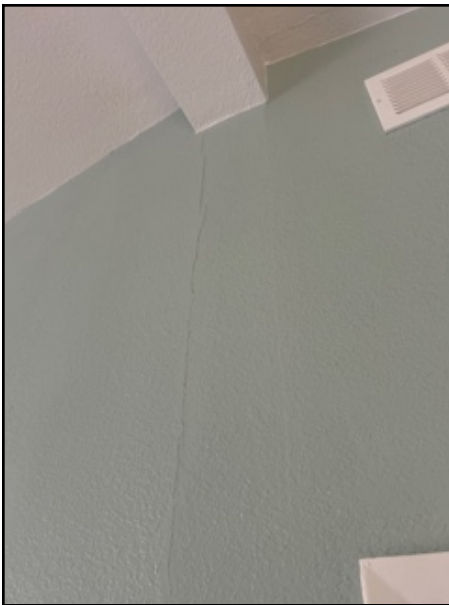
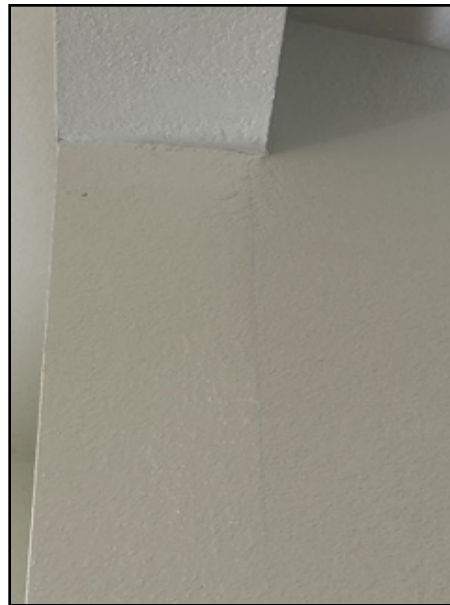
Multiple drywall tape joint cracks were noted throughout the structure. These cracks are not considered settling or structural cracks as they run parallel to the structure.

35) Comment 36: Multiple drywall tape joint cracks were noted throughout the structure. These cracks are not considered settling or structural cracks as they run parallel to the structure.
