WOOD DESTROYING PESTS AND ORGANISM INSPECTION REPORT

Building No. 4506	Street Lilac Ridge Road	City San Ramon	ZIP 94582	Date of Inspection 5/2/2024	Number of Pages Page 1 of 13

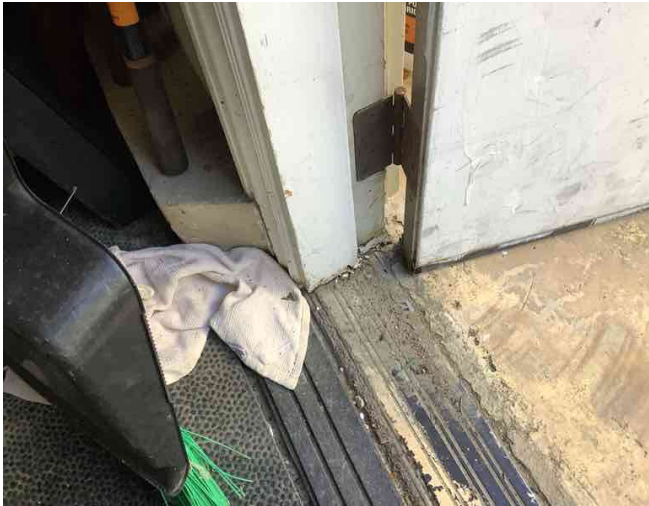
Photo 01

- 1A.** FINDING: The garage man door jamb at the right side was found to be fungus damaged.
(See Photo 1)

RECOMMENDATION: Remove and replace the door jamb to correct this condition. The contributing
Estimated Cost moisture source appears to be exposure to the weather.

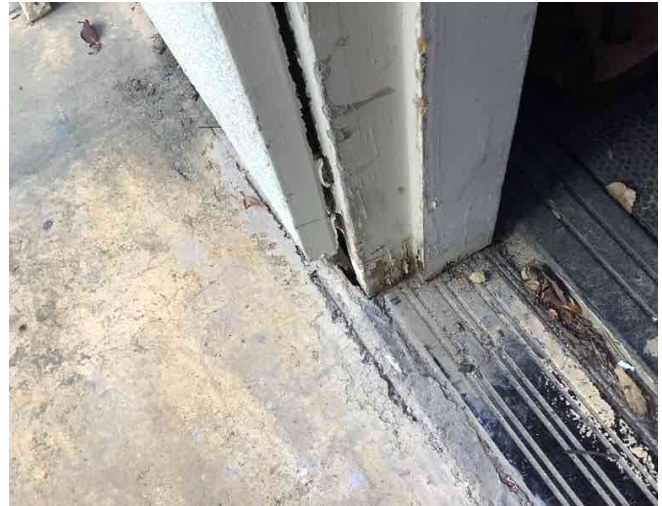
Photo 02

- 1B.** FINDING: The jamb has been damaged by fungus at the garage man door. This damage appears to be minor. The contributing moisture source appears to be exposure to the weather. (See Photo 2)

RECOMMENDATION: Hollow out this area and fill the void with an appropriate wood filler.
Estimated Cost

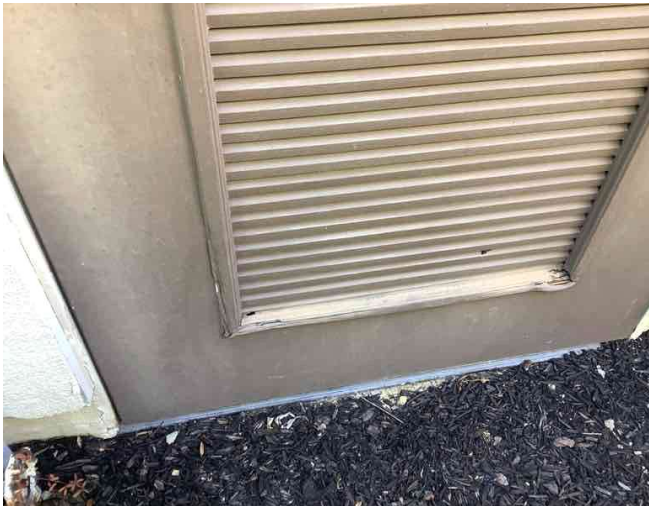
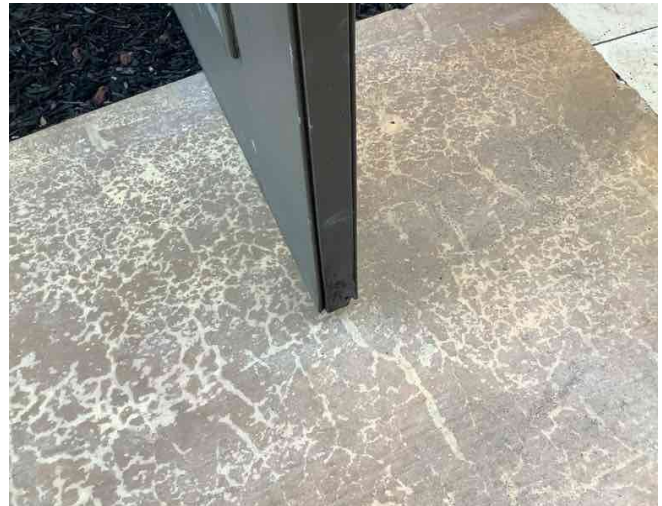
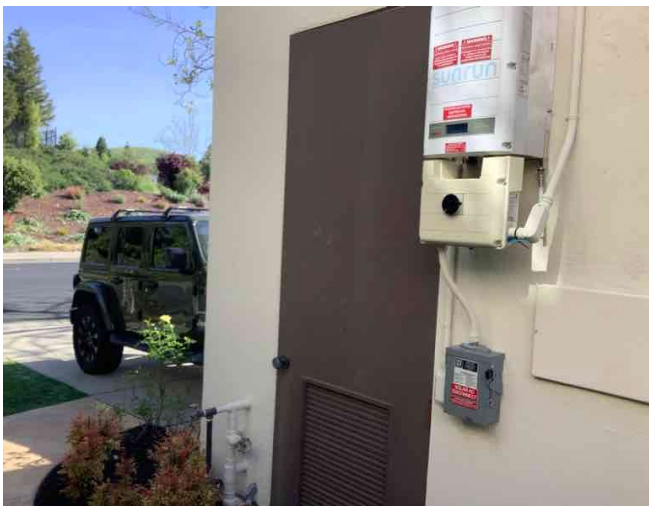
1C. FINDING: The utility door has been damaged by fungus. It appears the damage is a result of exposure to the weather. (See Photo 3) (See Photo 4) (See Photo 5)

RECOMMENDATION: Supply and install a new door. We intend to reuse the existing hardware. We at *Estimated Cost* HomeGuard Incorporated are upgrade experts and can provide proposals that include upgraded windows and doors or any other option you may desire. This bid is based on the installation of a readily available door of similar size. An exact match of the existing door may not be possible. If a more exact match is desired, additional fees may apply. Please note that if a special order door is needed to complete this item, there could be a three week delay in getting a replacement door.

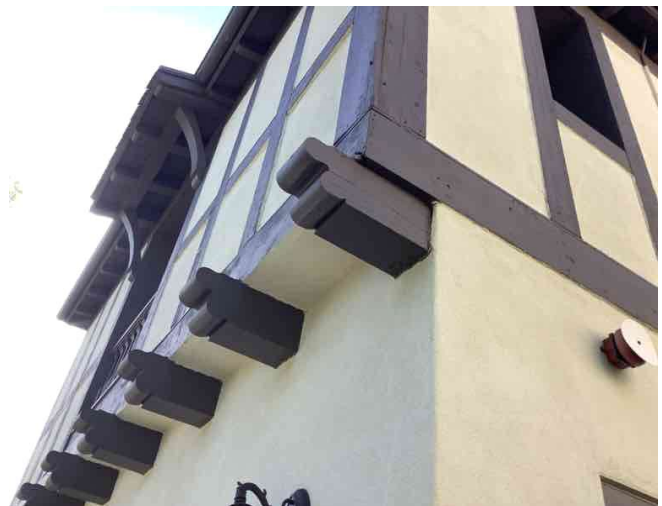
Photo 06

1D. FINDING: The belly band trim has been damaged by fungus at the front. The contributing moisture source appears to be exposure to the weather. (See Photo 6)

RECOMMENDATION: Remove and replace all the damaged wood members. If any damage is found to *Estimated Cost* extend into any enclosed areas a supplemental report and bid will be issued.

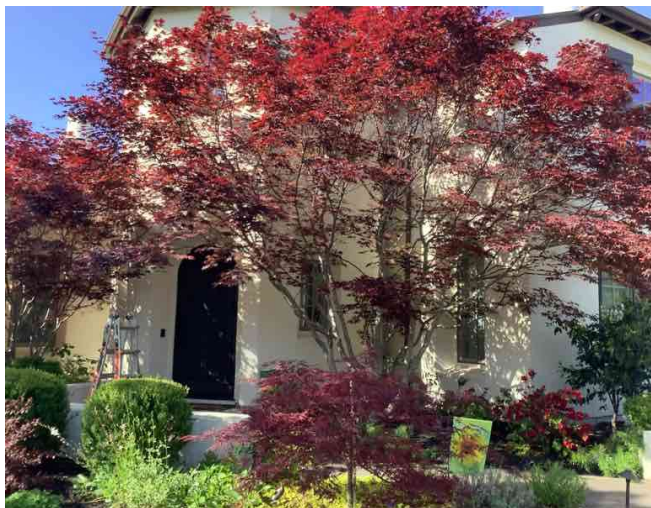
Photo 07

3A. FINDING: The exterior of the structure, as indicated on the diagram, is inaccessible for inspection due to heavy plant growth. (See Photo 7)

RECOMMENDATION: The owner is to cut back the plant growth as necessary to allow for physical *Estimated Cost* inspection of the exterior. Upon performing further inspection a supplemental report will be issued with any findings, recommendations, and bids.

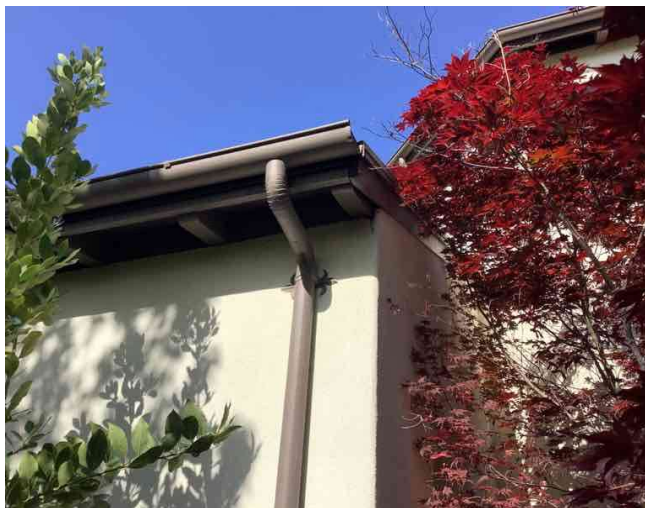
Photo 08

1E. FINDING: The barge rafter(s) as indicated on the diagram are damaged by fungus. The contributing moisture source appears to be exposure to the weather. (See Photo 8)

RECOMMENDATION: Remove and replace a section of the damaged barge rafter(s) to correct this *Estimated Cost* condition. This bid includes repair of the roof covering if disturbed by our repairs. If existing gutters need to be removed to perform the repairs then our bid also includes reinstallation of original gutters. If it becomes necessary or desirable to install new gutters this will be done only if authorized and at an additional cost. The guarantees on the roof covering are limited to the areas where the work was performed.

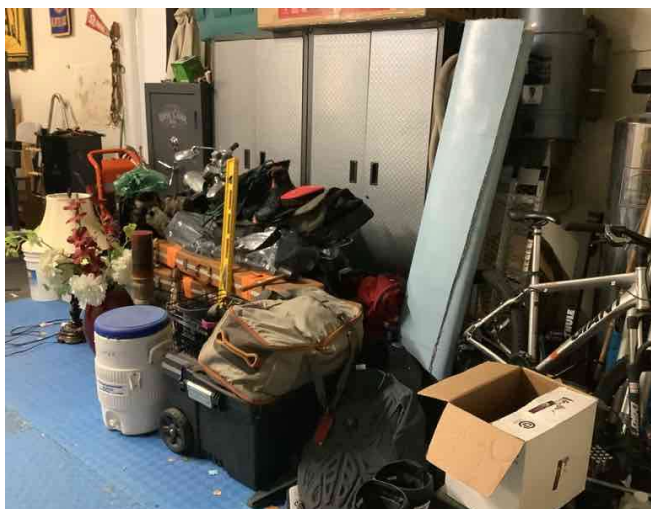
Photo 09

3B. FINDING: We were unable to inspect a portion of the interior of the garage due to stored personal property. (See Photo 9)

RECOMMENDATION: The owner should move the storage away from the garage walls to allow for *Estimated Cost* further inspection. All findings, recommendations, and bids will be issued in a supplemental report.

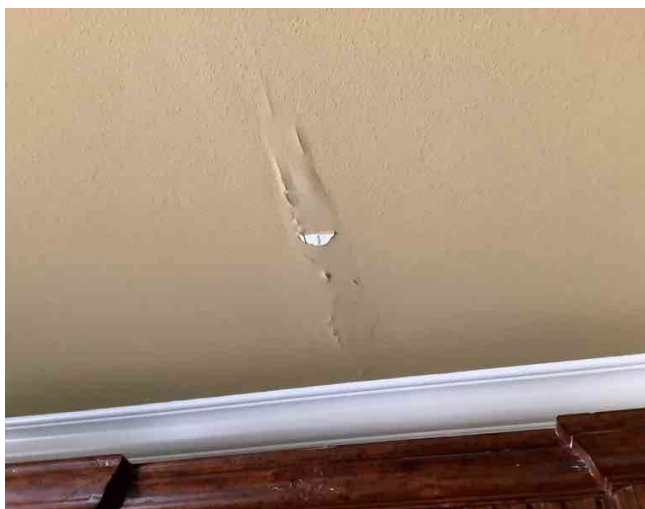
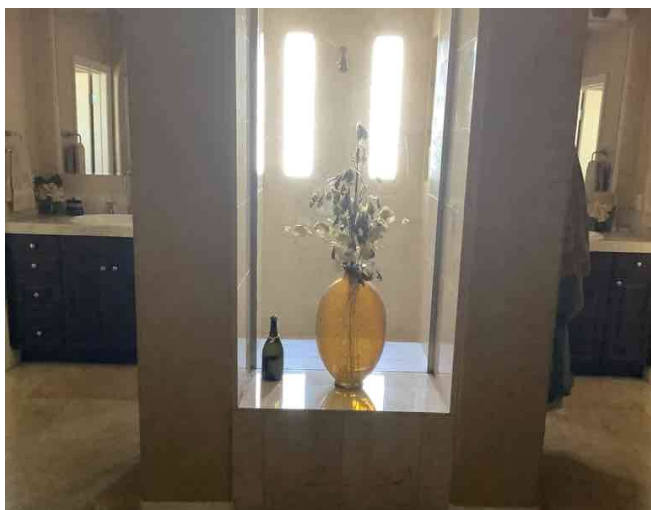
3C. FINDING: Water stains were noted on the ceiling in the library room. (See Photo 10) (See Photo 11)

The master bathroom mortar shower was noted to be directly above this area.

RECOMMENDATION: Open this area to determine the source of these stains and if any damage exists. *Estimated Cost* All findings, recommendations, and bids will be issued in a supplemental report.

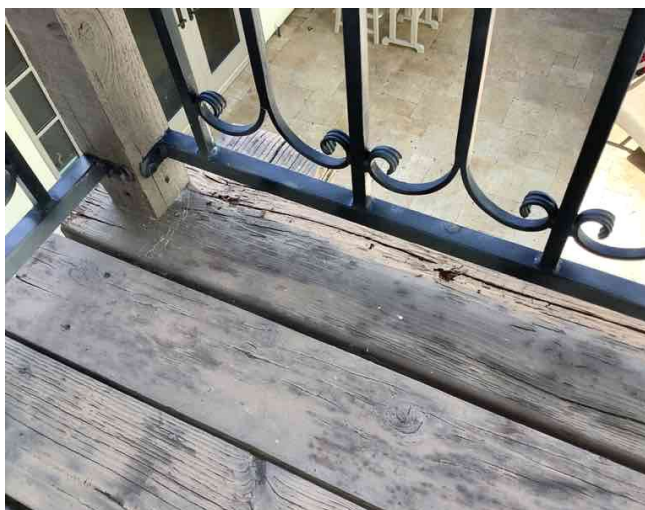
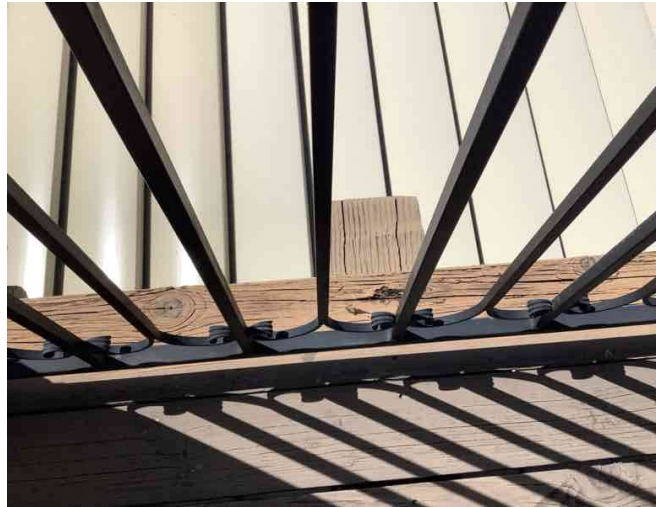
1F. FINDING: The deck boards have been damaged by fungus at the front atrium balcony, rear master bedroom balcony. The contributing moisture source appears to be exposure to the weather. (See Photo 12) (See Photo 16)

NOTE: The damaged wood members are at the upper level or second story of the structure.

RECOMMENDATION: Remove and replace all the damaged wood members. If any damage is found to *Estimated Cost* extend into any enclosed areas a supplemental report and bid will be issued.

This bid includes removing and reinstalling the existing handrailing in these areas to facilitate for the repairs as mentioned above.

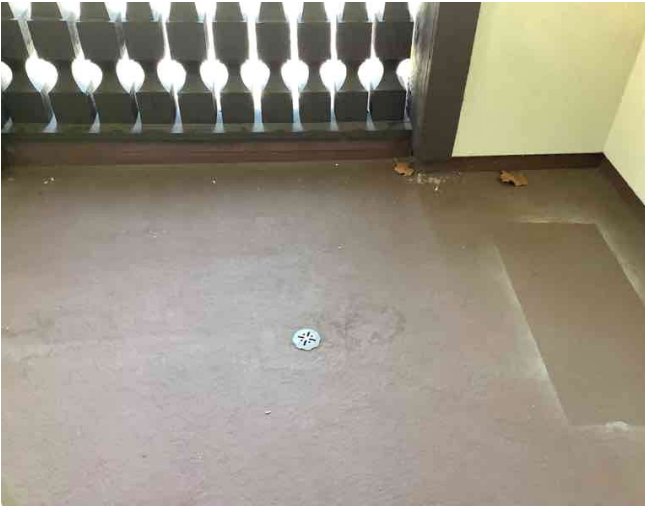
Photo 13

3D. FINDING: The exterior balcony surface was not water tested as the area immediately below the balcony has a finished ceiling which makes it impossible to perform a proper water test or to inspect this area. (See Photo 13)

RECOMMENDATION: If further information is desired about this area it will be necessary to install several *Estimated Cost* test holes in the ceiling and run water on the balcony to determine if any leakage or damage is evident. All findings recommendations and bids will be issued in a supplemental report. Note: this bid includes closing this area if no leakage or damage is noted.

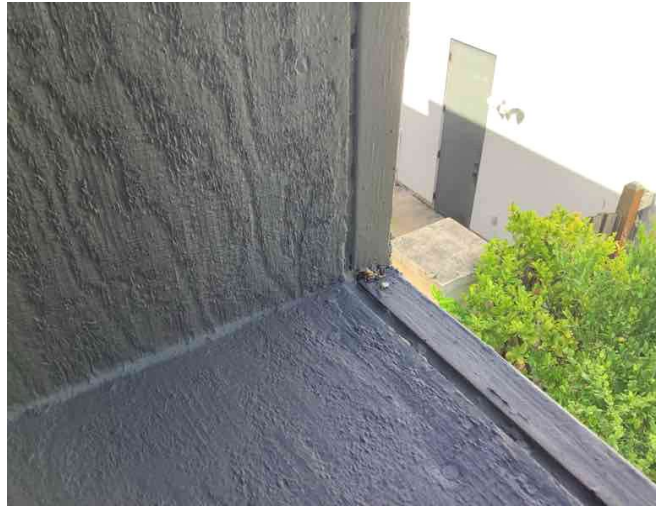
Photo 14

1G. FINDING: The trim has been damaged by fungus at the right side. The contributing moisture source appears to be exposure to the weather. (See Photo 14)

NOTE: The damaged wood members are at the upper level or second story of the structure.

RECOMMENDATION: Remove and replace all the damaged wood members. If any damage is found to *Estimated Cost* extend into any enclosed areas a supplemental report and bid will be issued.

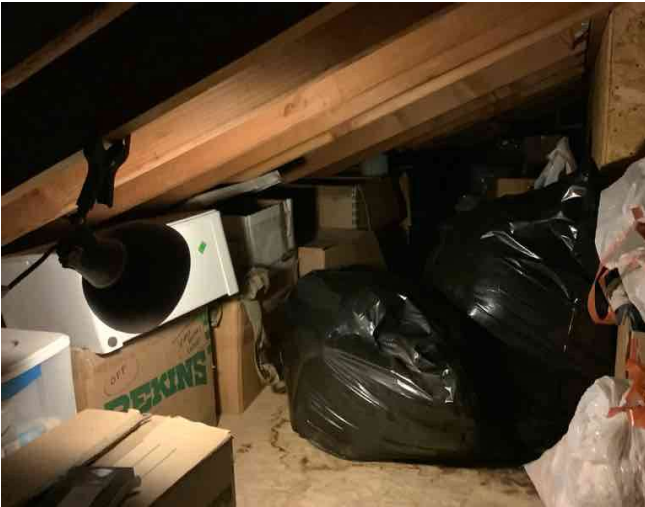
Photo 15

3E. FINDING: A portion of the attic was inaccessible for inspection due to storage. (See Photo 15)

RECOMMENDATION: After the storage has been removed from this area, HomeGuard Incorporated *Estimated Cost* should be contacted to further inspect. We will list all findings, recommendations, and bids in a supplemental report.
