WOOD DESTROYING PESTS AND ORGANISMS INSPECTION REPORT

Building No. 26175	Street Janice Way	City MiWuk	Zip 95346	Date of Inspection 05/11/26	Number of Pages 1 of 21
------------------------------	-----------------------------	----------------------	---------------------	---------------------------------------	-----------------------------------

Report # 7369

General Description:
Multi level, single family residence, wood frame construction, log style wood siding, metal roof.

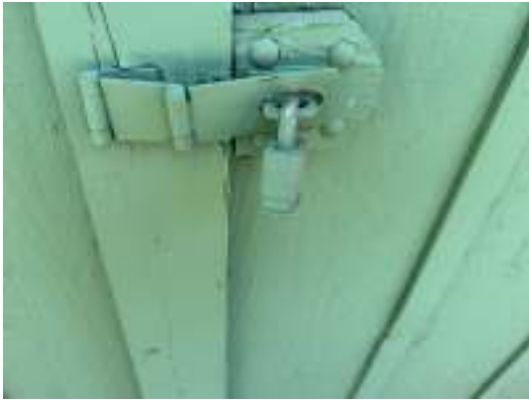
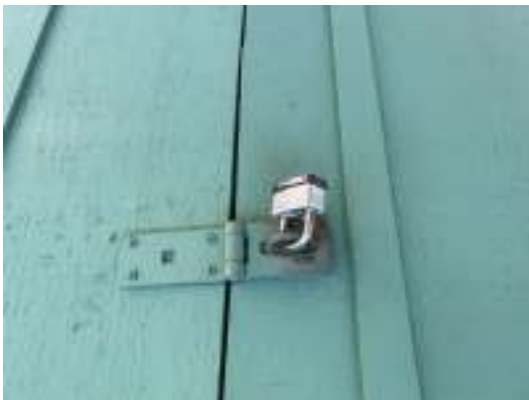
1A:

The subarea is inaccessible for inspection due to locked accesses. Streamline Inspections assumes no responsibility for any infection, infestation or damage which may be present in inaccessible areas.

RECOMMENDATION: Unlock and give access to allow for further inspection of this area; any/all adverse findings, recommendations, and prices for repairs/treatment will be given in a supplemental report; a reinspection fee will apply.

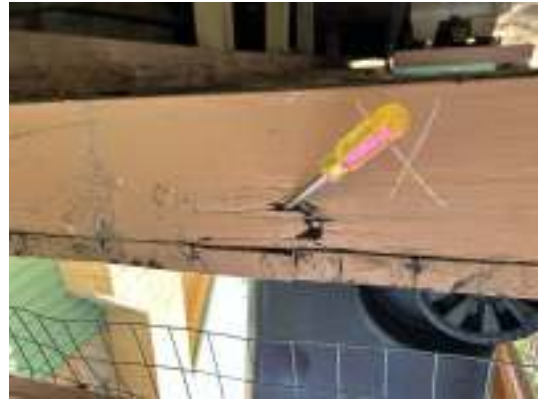
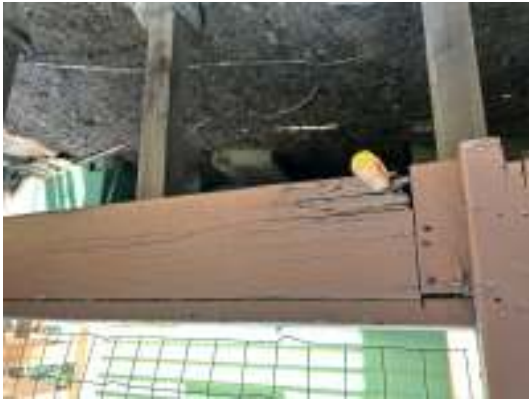
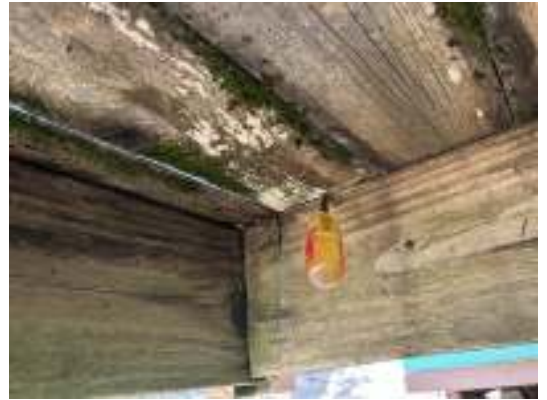
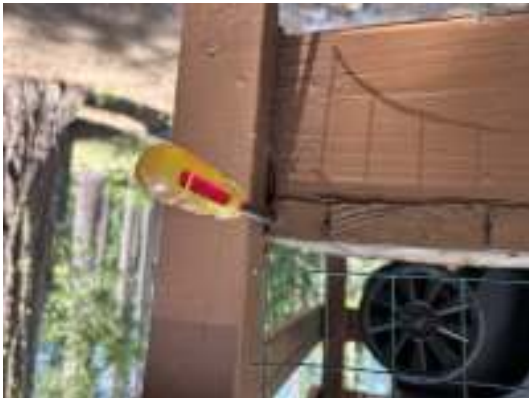
9C:

Wood decay fungus is infecting and damaging the deck fascia, decking boards, and joists.

RECOMMENDATION: Remove and replace up to 45 linear feet of damaged 2x8 fascia, up to 96 linear feet of damaged 2x6 decking boards, and up to 126 linear feet of damaged 2x8 joist; price for repairs does not include paint / stain. Treat all exposed wood members with (Tim-bor) disodium octaborate tetrahydrate to arrest the growth of wood decay fungi. All chemicals are to be applied by a state licensed applicator in accordance with manufacturer labels. *Upon request, prices can be given for others to perform repairs and Streamline Inspections to chemically treat only.

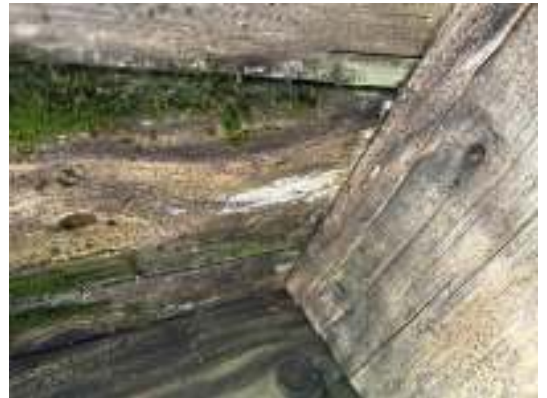
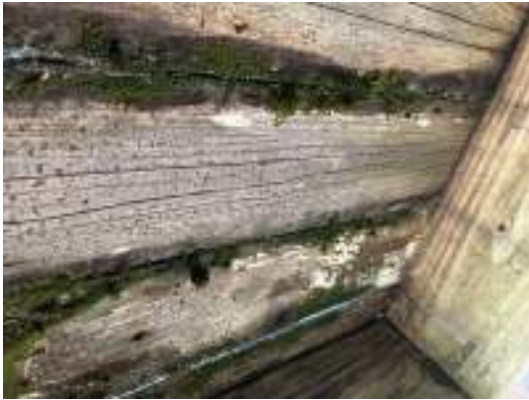
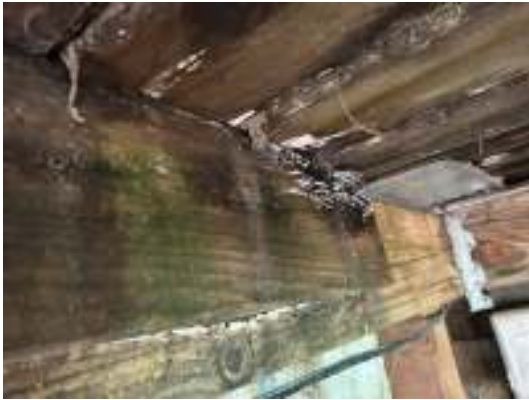
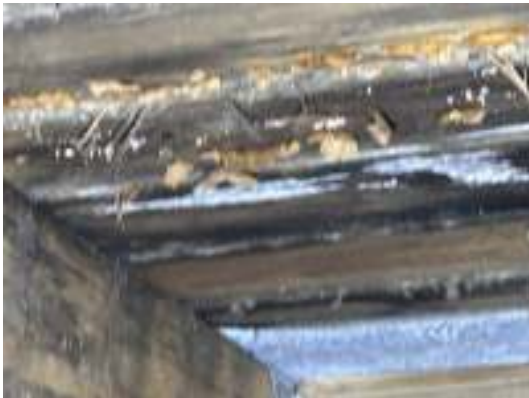
9D:

Wood decay fungus is infecting the surface of the underside of the accessible portion of deck.

RECOMMENDATION: Scrape and treat infected wood with (Tim-bor) disodium octaborate tetrahydrate. All chemicals are to be applied by a state licensed applicator in accordance with manufacturer labels.

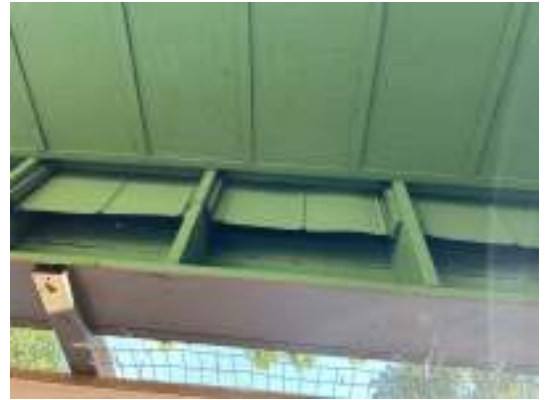
9E:

The underside of the back portion of the deck is inaccessible for inspection due to corrugated metal and locked structure. Streamline Inspections assumes no responsibility for any infection, infestation or damage which may be present in inaccessible areas.

RECOMMENDATION: Others to unlock and remove the corrugated metal as necessary to allow for further inspection of the inaccessible areas. Any/all findings, recommendations, and prices for repairs will be given in a supplemental report. If no adverse findings are exposed, reinstall existing treads. *Price given is for further inspection only.

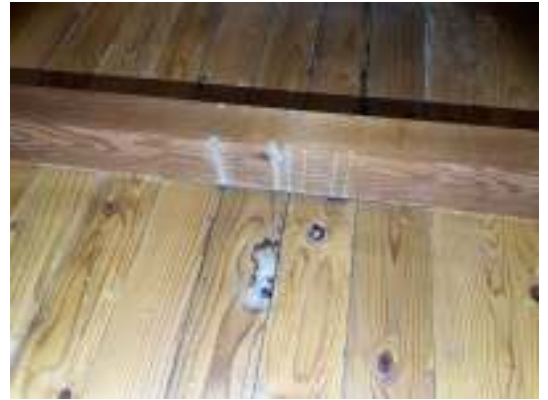
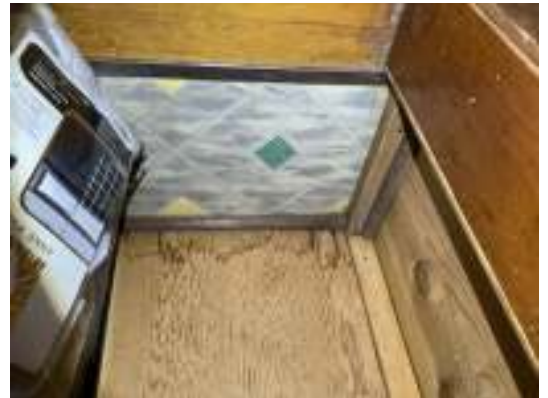
10A:

NOTE: Moisture stains are present at the living room ceiling and closet wall; this appears to be from a previous leak.

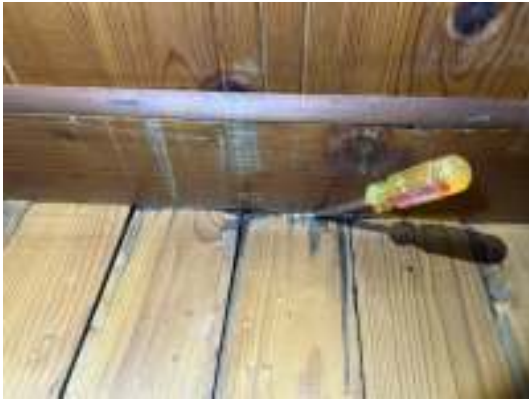
10B:

Wood decay fungus and moisture stains are present at the tongue and groove ceiling/wall indicating a previous leak.

RECOMMENDATION: Remove wood material as necessary to allow for further inspection of the wall cavity. Any/all adverse findings, recommendations, and pricing for repairs/treatment will be given in a supplemental report; a re-inspection fee will apply.

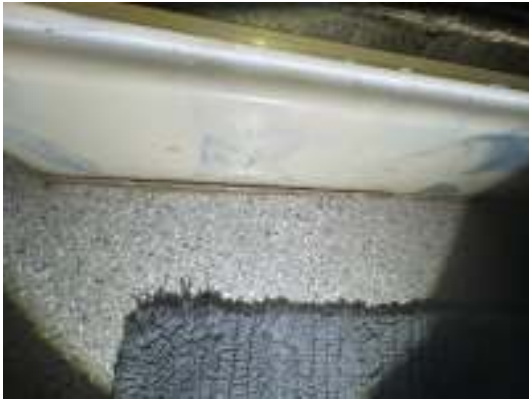
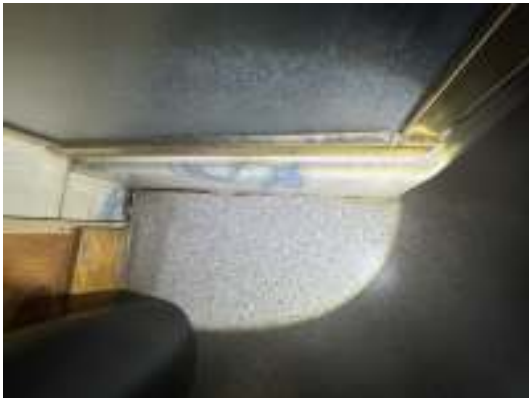
10C:

A void was noted between the base of the shower pan and the vinyl floor covering. This can allow excessive moisture to accumulate at the adjacent wood members.

RECOMMENDATION: Seal void.

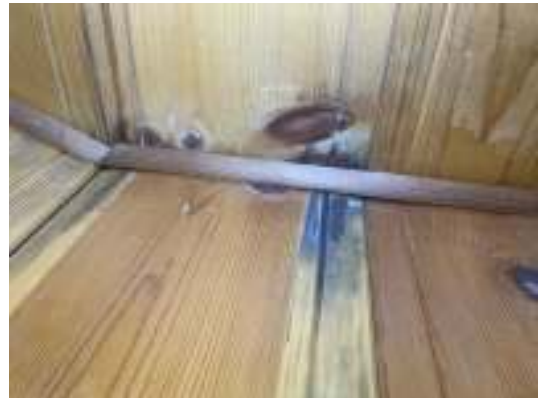
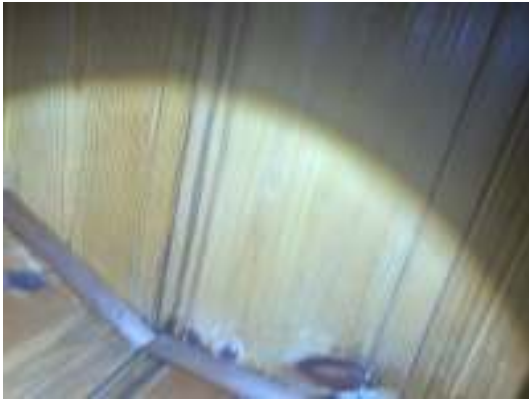
10E:

NOTE: Moisture stains are present at the upstairs bedroom ceiling and wall; this appears to be from a previous leak.

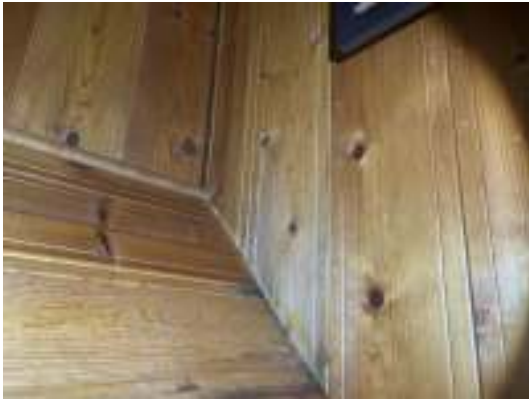
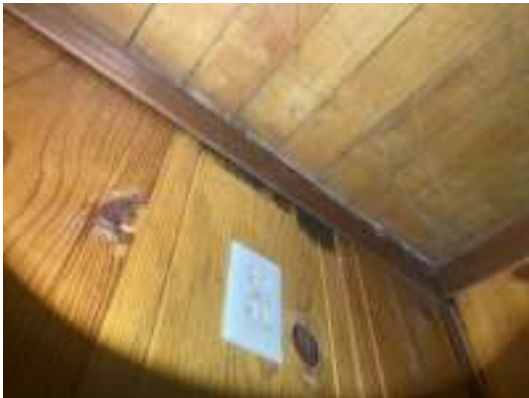
10F:

Wood decay fungus is infecting and damaging the upstairs bedroom wood paneling.

RECOMMENDATION: Remove and replace up to 8 square feet of damaged wood paneling; price for repairs does not include paint / stain. Treat all exposed wood members with (Tim-bor) disodium octaborate tetrahydrate to arrest the growth of wood decay fungi. All chemicals are to be applied by a state licensed applicator in accordance with manufacturer labels. *Upon request, prices can be given for others to perform repairs and Streamline Inspections to chemically treat only.

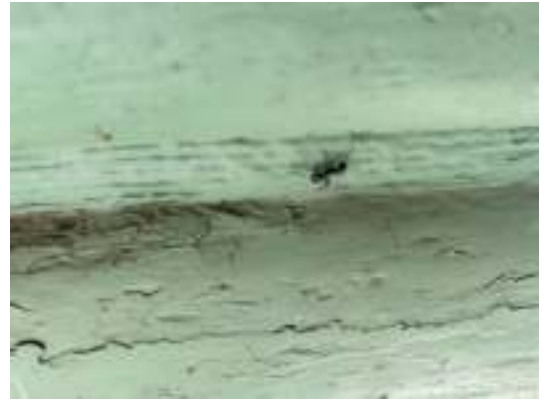
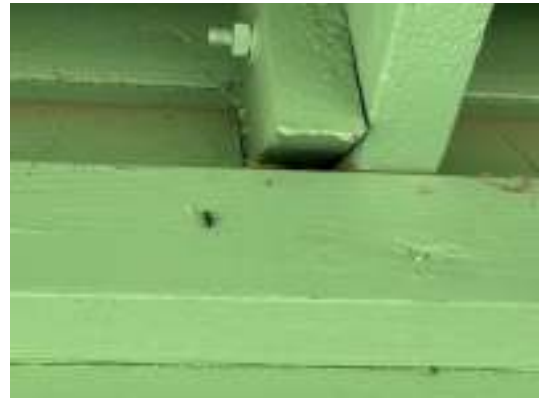
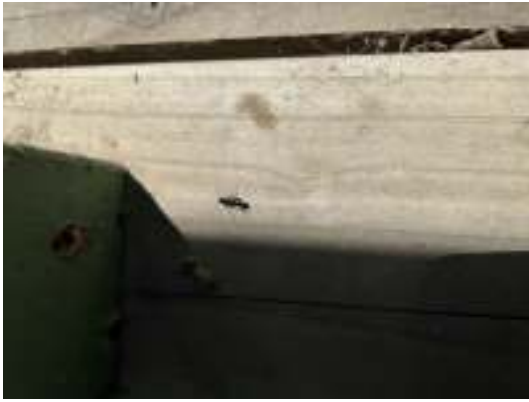
11A:

Carpenter ants were noted infesting the exterior of the dwelling.

RECOMMENDATION: Treat interior and exterior of the dwelling for the control of carpenter ants with CENTERFIRE 75, Phantom, Cy-cick, and Advance Carpenter Ant Bait. All chemicals are to be applied by a state licensed applicator in accordance with manufacturer labels.

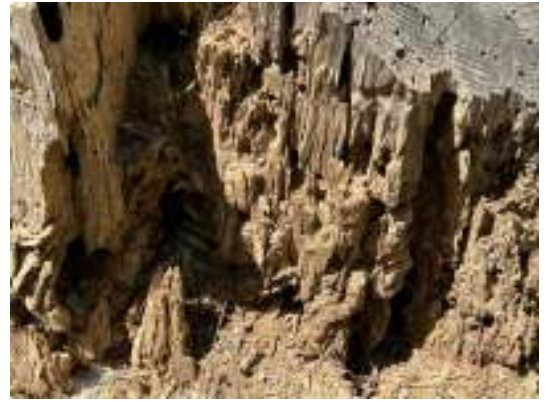
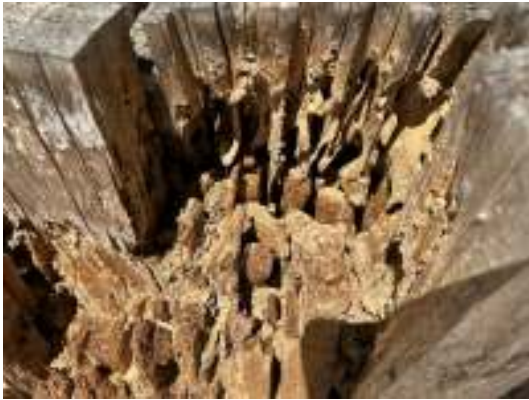
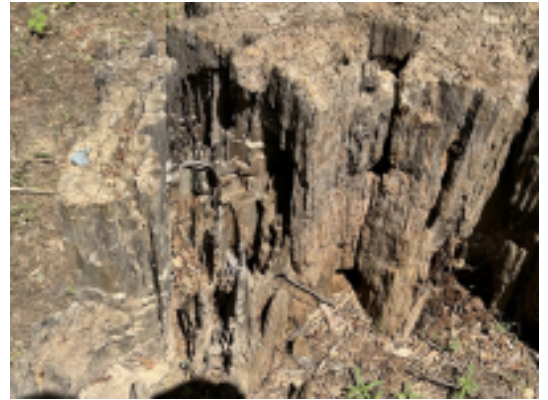
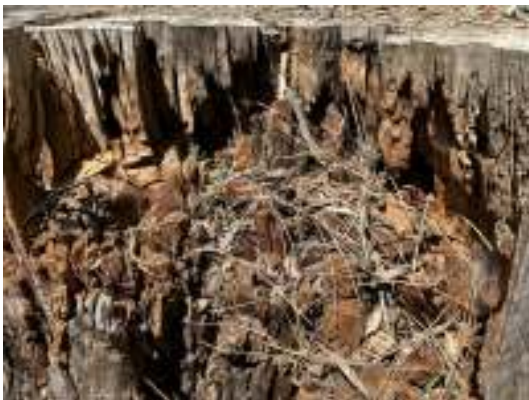
11B:

Tree stumps were noted in multiple locations around the structure. Evidence of subterranean termites and powder post beetles is present. Carpenter ants are present.

RECOMMENDATION: Others to remove stumps as practical. Streamline to treat any remaining portions of stumps and/or root systems with CENTERFIRE 75 / Termidor for the control of subterranean termites, powder post beetles, and carpenter ants. All chemicals are to be applied by a state licensed applicator in accordance with manufacturer labels.

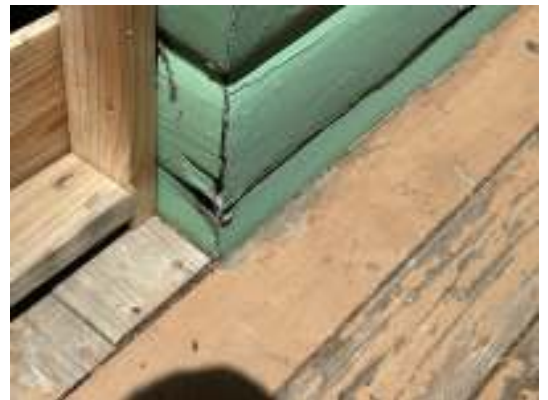
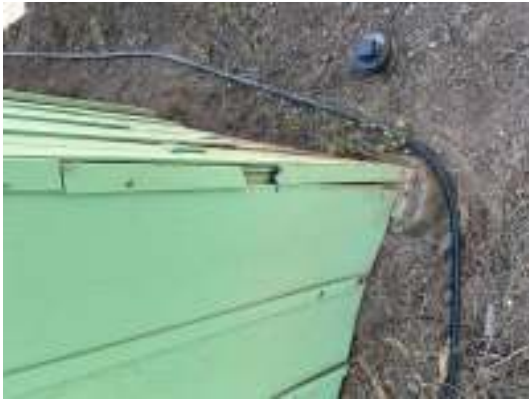
11C:

Voids are present where the siding abuts; this can allow excessive moisture into the wall cavity.

RECOMMENDATION: Seal siding as necessary.

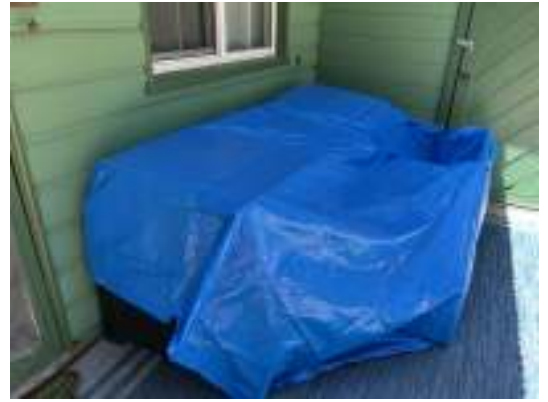
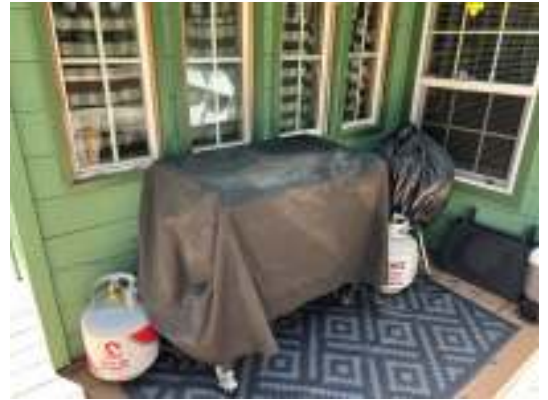
11F:

NOTE: Deck furniture and bbq prevents a complete inspection of the exterior. Streamline Inspections assumes no responsibility for any infection, infestation or damage which may be present in inaccessible areas. Upon request and removal of occupant belongings by others, a further inspection will be made of these areas; any/all adverse findings, recommendations, and prices for repairs/treatment will be given in a supplemental report; a reinspection fee will apply.

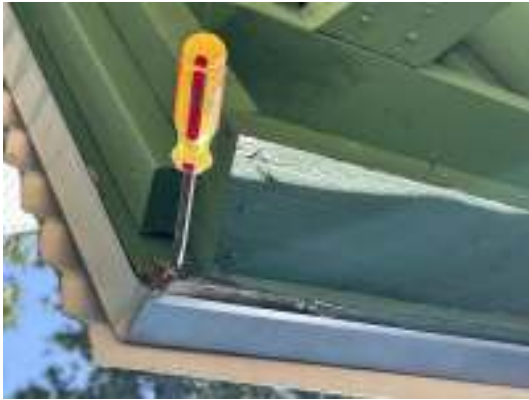
11D:

Wood decay fungus is infecting and damaging the fascia.

RECOMMENDATION: Remove and replace up to 2 linear feet of damaged 1x3 fascia; price for repairs does not include paint / stain. Treat all exposed wood members with (Tim-bor) disodium octaborate tetrahydrate to arrest the growth of wood decay fungi. All chemicals are to be applied by a state licensed applicator in accordance with manufacturer labels. *Upon request, prices can be given for others to perform repairs and Streamline Inspections to chemically treat only.

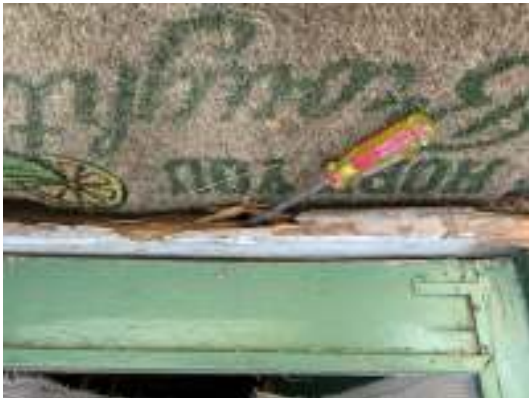
11E:

Wood decay fungus is infecting and damaging the back door threshold.

RECOMMENDATION: Remove door, door trim, and door casing as necessary. Remove and replace up to 3 linear feet of damaged 8" door threshold; price for repairs does not include paint / stain. Treat all exposed wood members with (Tim-bor) disodium octaborate tetrahydrate to arrest the growth of wood decay fungi. All chemicals are to be applied by a state licensed applicator in accordance with manufacturer labels. *Upon request, prices can be given for others to perform repairs and Streamline Inspections to chemically treat only.

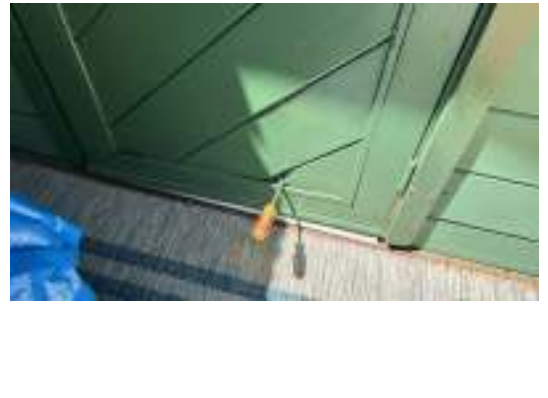
11G:

Wood decay fungus is infecting and damaging the wood exterior door.

RECOMMENDATION: Remove and replace damaged door; price for repairs does not include paint / stain. Treat all exposed wood members with (Tim-bor) disodium octaborate tetrahydrate to arrest the growth of wood decay fungi. All chemicals are to be applied by a state licensed applicator in accordance with manufacturer labels. *Upon request, prices can be given for others to perform repairs and Streamline Inspections to chemically treat only.

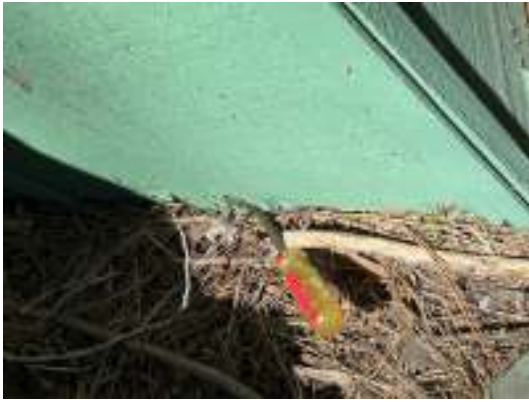
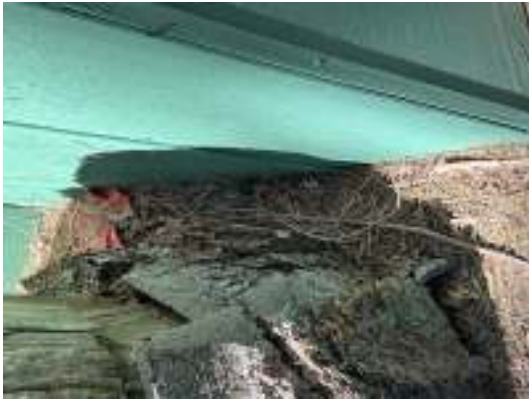
11H:

Wood decay fungus is infecting and damaging the base of the siding. Earth to wood contacts are present.

RECOMMENDATION: Cut up the base of the siding and install Z metal flashing. Install up to 24 square feet of new siding; price for repairs does not include paint / stain. Treat all exposed wood members with (Tim-bor) disodium octaborate tetrahydrate to arrest the growth of wood decay fungi. All chemicals are to be applied by a state licensed applicator in accordance with manufacturer labels. (Price for others to do repairs and Streamline Inspections to reinspect and apply chemical only for this item is \$35.00)
