INSPECTION REPORT

3815 3RD AVENUE, 35
SAN DIEGO, CA 92103

Inspection Date: Wednesday, February 21, 2024

RE: Report No. 3331
3815 3rd Avenue, 35
San Diego, CA
92103

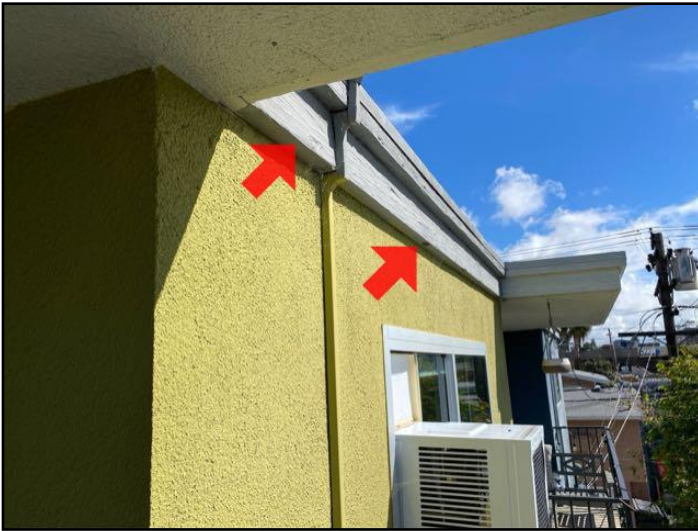
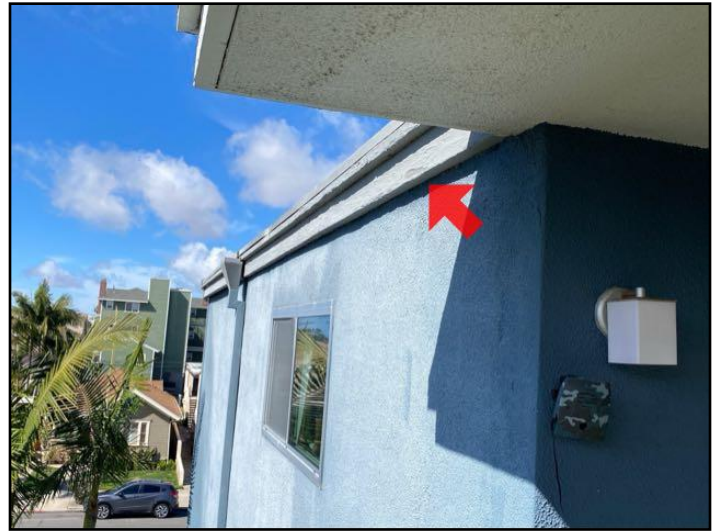
2. Condition: • Paint improvement recommended

Observed deteriorated/missing paint on the exterior fascia, eaves and/or wood trim of the home. Wood or other materials with deteriorated paint are susceptible to premature deterioration due to exposure to seasonal changes. Recommend contacting the HOA/Property Maintenance, or a qualified Paint Contractor to evaluate the deteriorated paint for improvement as needed.

Location: Exterior fascia, eaves or trim

4. *Paint improvement recommended*

5. *Paint improvement recommended*

Task: Improvement recommended

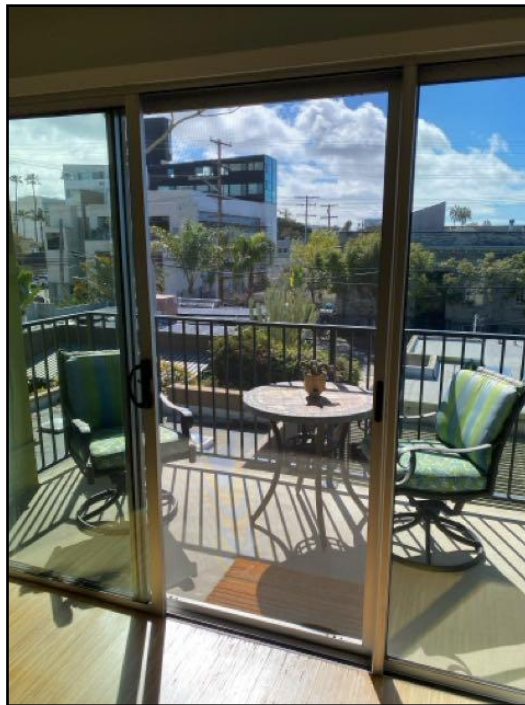
3. **Condition:** • Binding sliding screen door

Observed one or more binding/difficult to operate exterior sliding screen door(s) during the inspection. Recommend contacting a qualified Contractor or handyman for repair or adjustment as needed.

Implication(s): Difficult to operate

Location: Exterior sliding screen door

6. *Binding sliding screen door*

Task: Repair or adjustment recommended

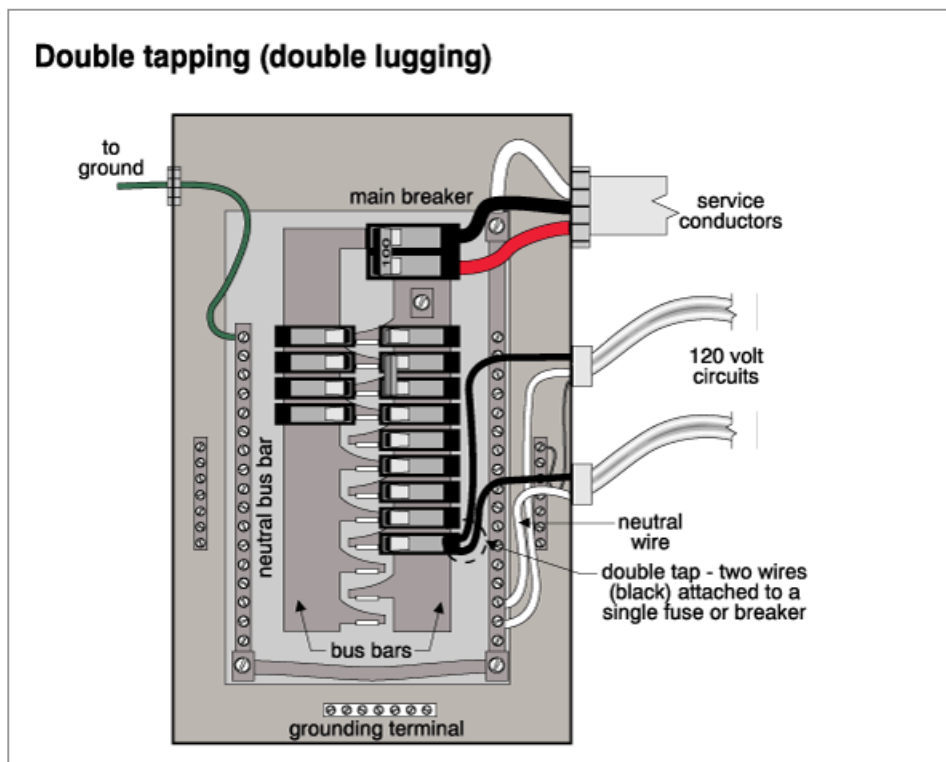
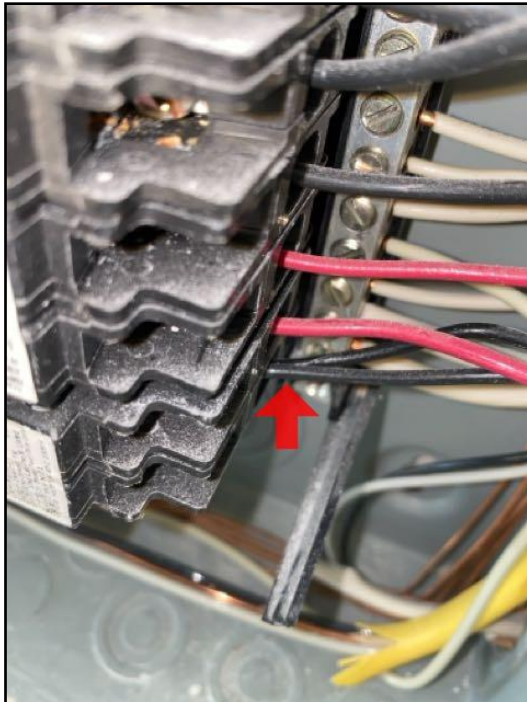
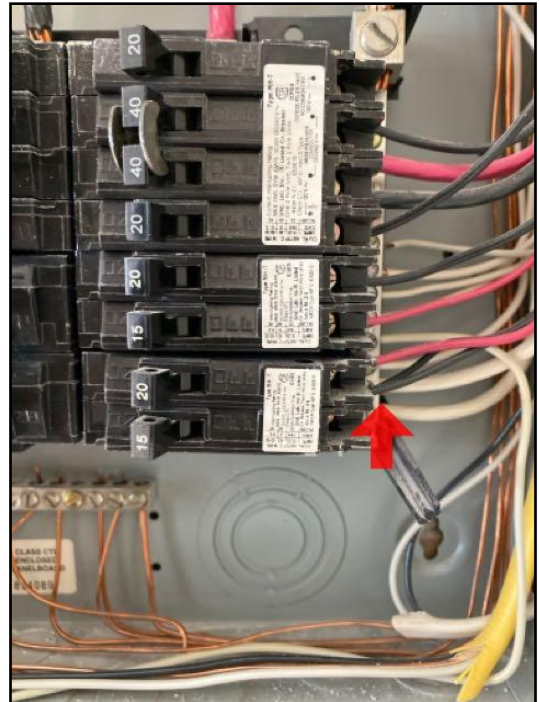
4. Condition: • Double tapped breakers or lugs

Observed one or more double tapped breakers in the electrical subpanel at the time of the inspection. A double tapped breaker indicates two wires connected to one circuit breaker that is designed for only one wire. Double tapped breakers can result in a loose connection that can potentially spark or arc causing a fire, or an overloaded breaker causing the breaker to continuously trip or overheat. Recommend contacting a qualified to evaluate the double tapped breaker(s) for corrective action.

Implication(s): Fire hazard

Location: Electrical subpanel (Interior bedroom wall)

10. Double tapped breakers or lugs

11. Double tapped breakers or lugs

Task: Repair or corrective action recommended

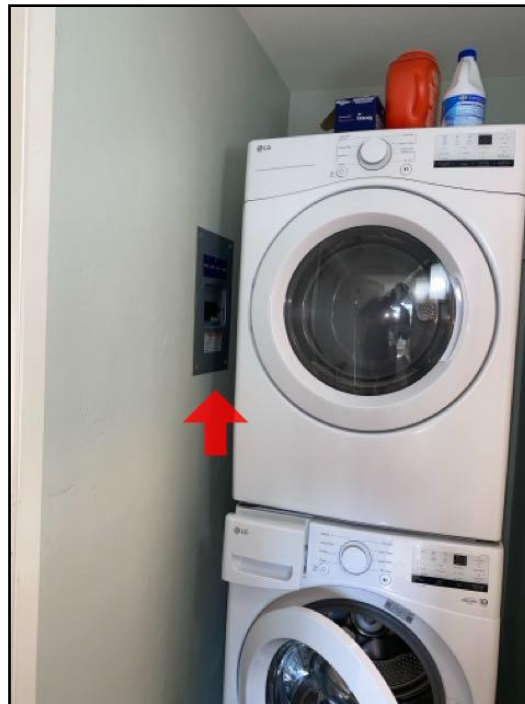
5. Condition: • Inaccessible electrical subpanel

Observed an inaccessible electrical subpanel at the time of the inspection. Due to the location of the panel in relation to the dryer, the Inspector was unable to remove the panel cover to evaluate the interior components of the panel. Recommend contacting a qualified Electrician to evaluate the interior components of the panel once its made accessible. If deficiencies are observed, repair as needed.

12. Inaccessible electrical subpanel

Note: Relocation of the panel, or reconfiguration of the laundry closet may be a logical long term improvement. Recommend discussing improvement options with your preferred Contractor.

Task: Further evaluation

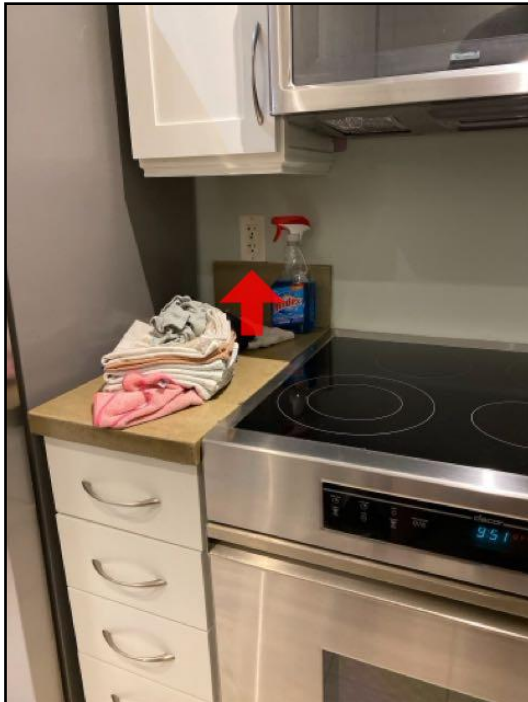
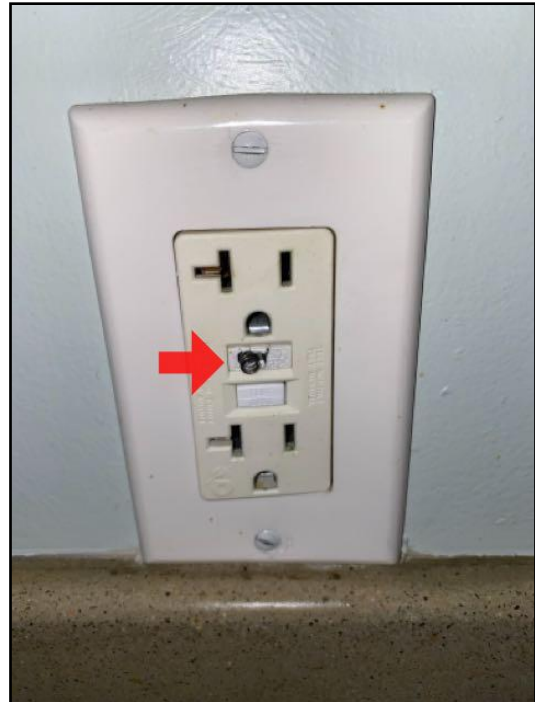
6. Condition: • Damaged outlet

Observed one or more damaged outlet(s) in the home during the inspection. Damaged outlets can result in shock injury to the occupants, or fire hazards to the home. Recommend contacting a qualified Electrician to evaluate the affected outlets for replacement.

Implication(s): Electric shock | Fire hazard

Location: Kitchen GFCI (Left of stove)

13. Damaged outlet (Kitchen)

14. Damaged outlet

Task: Contact a qualified Electrician for replacement of the damaged outlet(s)

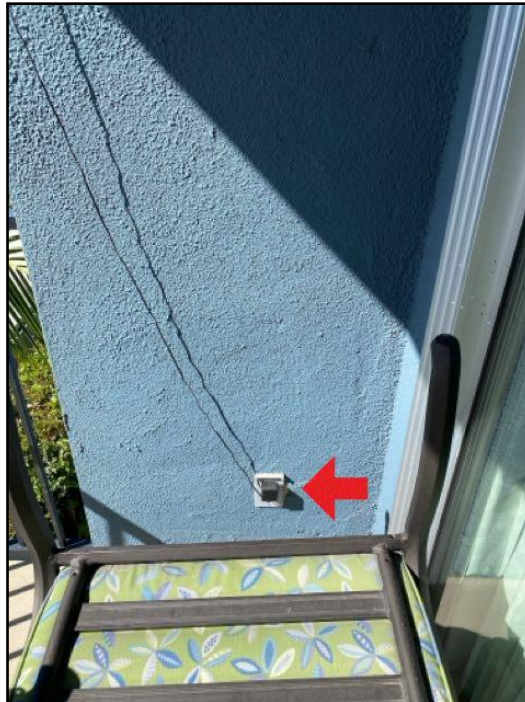
7. Condition: • Missing exterior outlet weather cover

Observed missing weather covers on one or more of the exterior outlets of the home during the inspection. Recommend contacting a qualified Electrician for replacement of the missing or damaged weather covers as needed.

15. Missing exterior outlet weather cover

Task: Replacement recommended

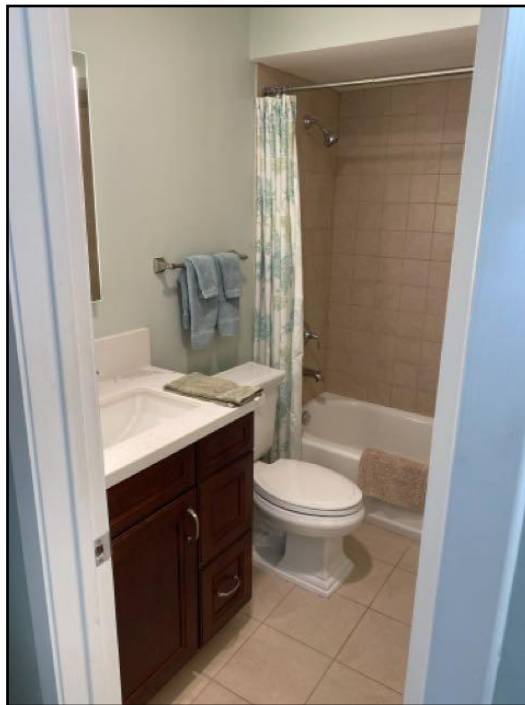
11. Condition: • Below average water pressure/flow

Observed below average water flow inside the home when multiple faucets were turned on simultaneously, or toilets

were flushed during the inspection. This condition may pose an inconvenience to the occupants of the home. Recommend contacting the HOA/Property Maintenance, or a qualified Plumber to evaluate the below average water flow/pressure for improvement as needed.

20. Below average water pressure/flow

Task: Contact a qualified Plumber for improvement as needed

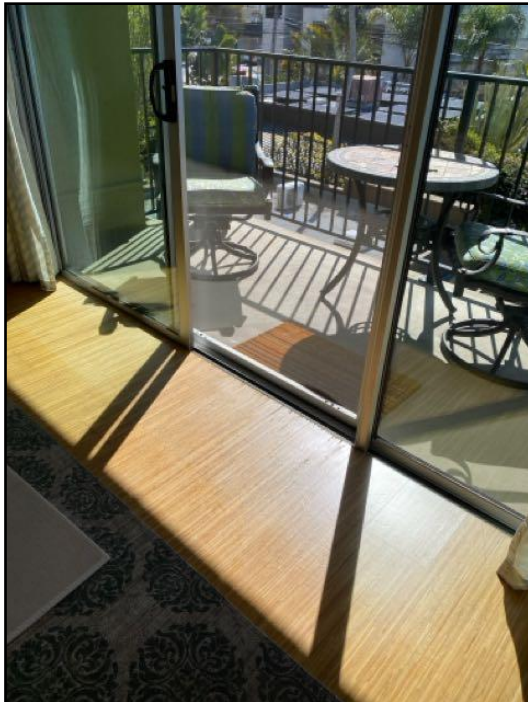
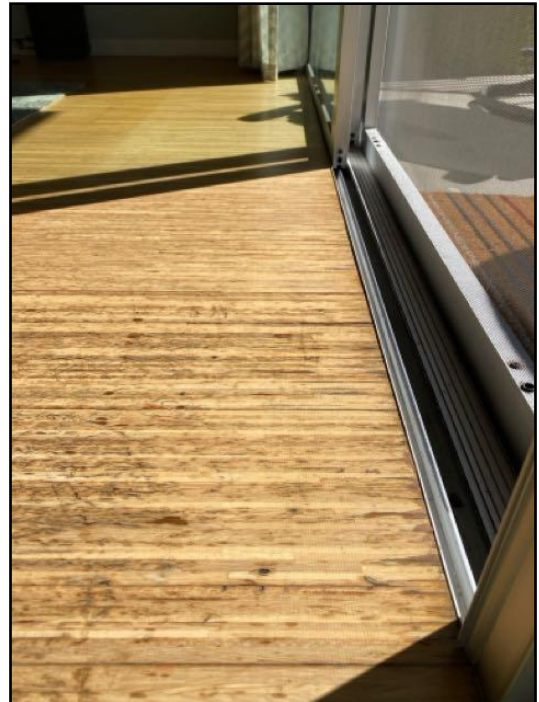
12. Condition: • Damaged flooring

Observed damaged flooring located in front of the exterior sliding glass door during the inspection. Recommend contacting a qualified Flooring Contractor to evaluate the flooring for repair or replacement as needed.

Location: Interior flooring

23. Damaged flooring

24. Damaged flooring

Task: Repair/replace as needed

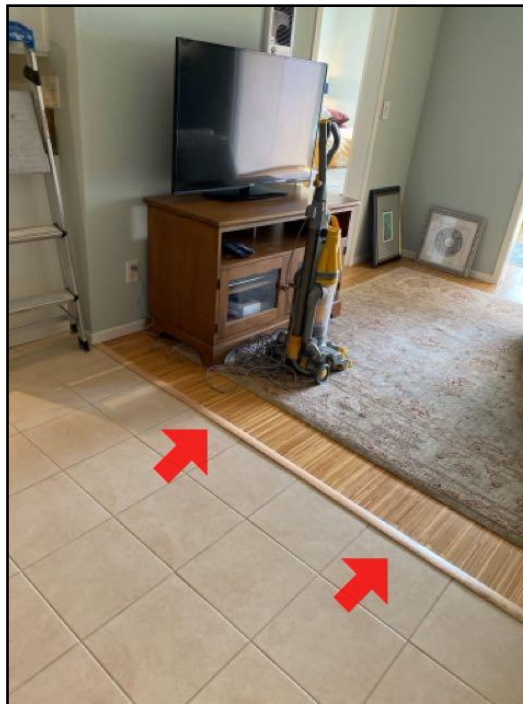
13. Condition: • Damaged/Loose/Missing transition strip(s)

Observed one or more damaged, loose or missing transition strips in the interior flooring in the home during the inspection. Recommend contacting a qualified Flooring Contractor to evaluate the affected transition strips for repair or replacement as needed.

Location: Interior flooring - Transition strip(s)

25. Loose transition strip(s)

Task: Repair or replace as needed

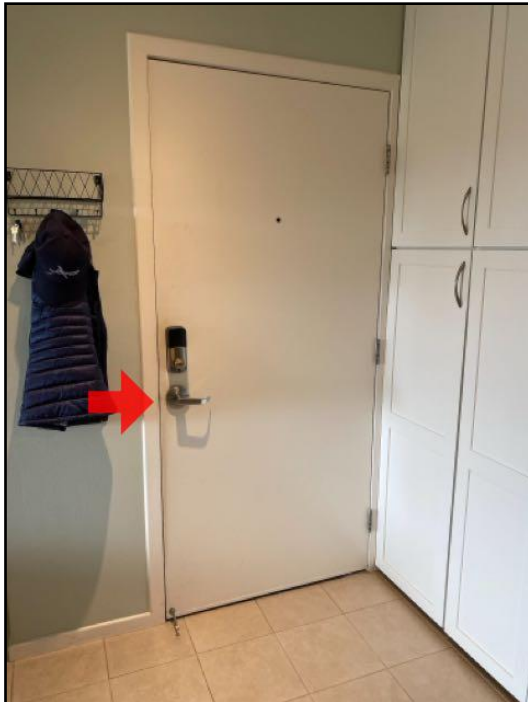
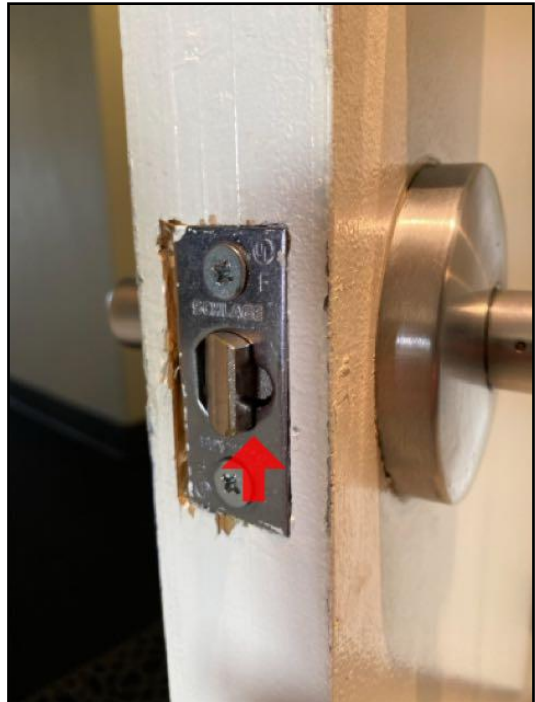
14. **Condition:** • Latch/Lock not effective on exterior door

26. Latch/Lock not effective on exterior door

27. Latch/Lock not effective on exterior door

Task: Contact a qualified Locksmith or Handyman for repair as needed

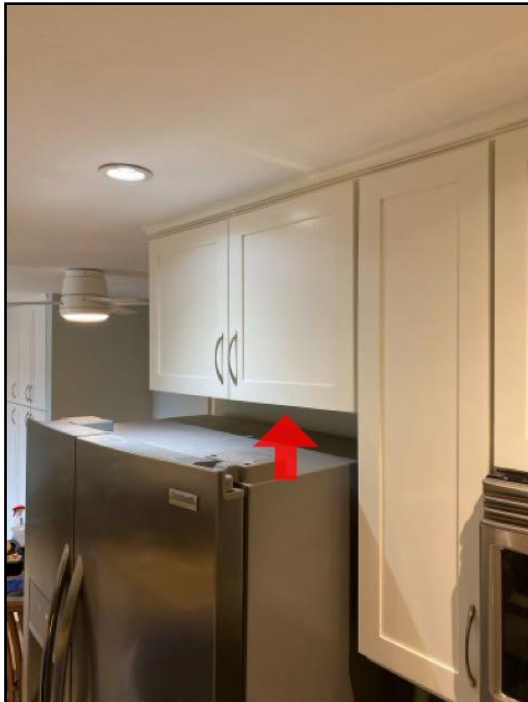
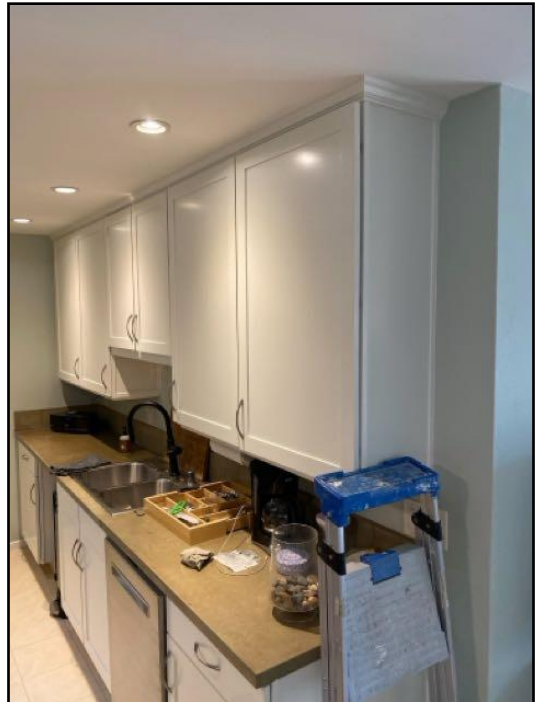
15. Condition: • Cabinet doors/drawers - Adjustment needed

Observed interior cabinet doors and/or drawers that either bind, or do not close/function properly. Recommend contacting a qualified Contractor or Handyman for adjustment to ensure proper function of the affected doors and/or drawers.

Location: Interior cabinets - Doors/drawers

28. Cabinet doors/drawers - Adjustment needed

29. Cabinet doors/drawers - Adjustment needed

Task: Repair or adjust as needed

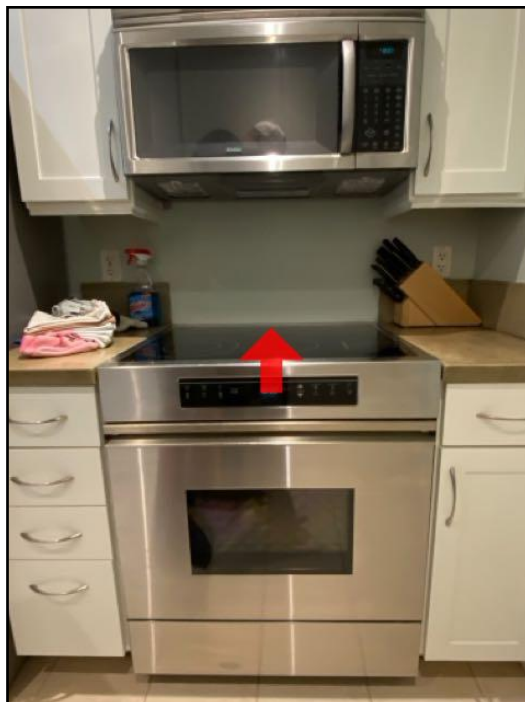
16. Condition: • Backsplash/heat shield recommended

30. Backsplash/heat shield recommended

Task: Contact a qualified Contractor for improvement as needed
