Date of Number of Building No. / Street City Zip Inspection Pages 10767 Jamacha Boulevard 44 Spring Valley 91978 N3/N5/2N2 A LICENSED PEST CONTROL 1331 Morena Blvd OPERATOR IS AN EXPERT IN Suite 300 HIS/HER FIELD. QUESTIONS San Diego, CA 92110 RELATIVE TO THIS REPORT 1.800.570.2847 SHOULD BE REFERRED TO Registration #436 HIM/HER. Report #: 79289 Report sent to: Ordered by: Property Owner and/or Party of Interest Janelle Ramirez & Edgar Figueroa Janelle Ramirez & Edgar Figueroa Janelle Ramirez & Edgar Figueroa 10767 Jamacha Boulevard 44 10767 Jamacha Boulevard 44 10767 Jamacha Boulevard 44 Spring Valley, CA 91978 Spring Valley, CA 91978 Spring Valley, CA 91978 Complete Report Limited Report Supplemental Report Reinspection Report Inspection Tag Posted: General Description: Exterior Occupied Mobile One Story No Garage Other Tags Posted: Raised Foundation with Composition Roof An inspection has been made of the structure(s) shown on the diagram in accordance with the Structural Pest Control Act. Detached porches, detached steps, detached decks and any other structures not on the diagram were not inspected. **Further** Subterranean Drywood Other Fungus/Dryrot Findings X Termites Termit

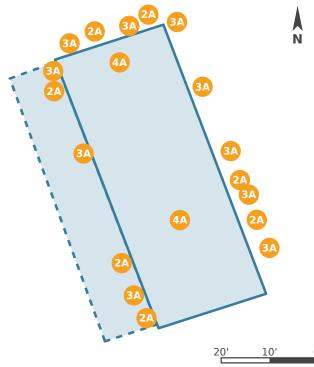
Evidence of drywood termites found in areas marked on Diagram.

Termite and fungus damaged wood found in area marked on diagram. Siding, trim, railing, posts, window trim

Inaccessible area noted in substructure due to clearance & vapor barrier, marked on diagram.

Cover entire structure(s) and fumigate with Sulfuryl Fluoride for the elimination of drywood termites. Chloropicrin will be used as a warning agent. Cover or remove accessible termite pellets. Lloyd Termite Control Company assumes no responsibility for damage to any plant life or roofing caused by fumigation operation.

Remove and replace termite and fungus damaged wood as needed. Painting is included in this estimate. If damaged wood extends into concealed or inaccessible areas, cost of repair will be in addition to estimate given.
