HOME INSPECTION

4973 Brookburn Dr San Diego, CA 92130

Edmond Hsieh 02/25/2025

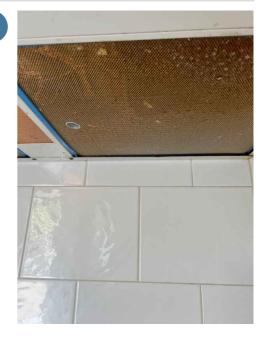
The grease filter is dirty and requires replacement.

Recommendation Contact a qualified professional.

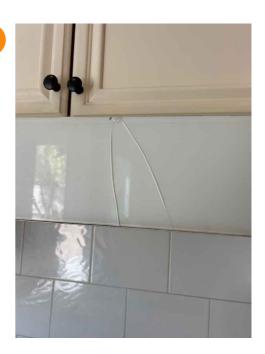
2.5.2 RANGE HOOD/VENT

HOOD/VENT

The range hood vent was damaged. We recommend replacement with a qualified contractor.

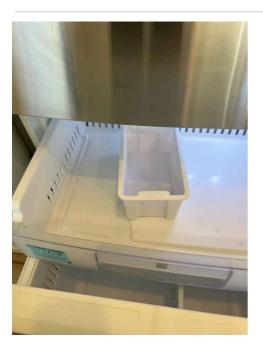
2.8.1 REFRIGERATOR

NO ICE IN FREEZER

No ice was observed in the ice maker in the freezer. The absence of ice may indicate that there is no water supplied, the ice maker was off, or there is a problem with the ice maker. We advise further review with the seller to demonstrate function, or further review with qualified appliance technician.

Recommendation

Contact a qualified appliance repair professional.

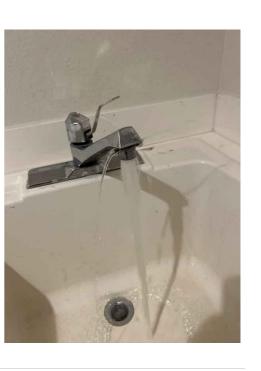
3.3.1 FAUCETS, VALVES AND CONNECTED FIXTURES

AERATOR-CORRODED/CLOGGED

The sink faucet aerator was corroded or clogged. This causes low flow or a coarse flow of water that is more likely to splash out of the sink. We recommend replacement of the aerator or faucet as needed.

Recommendation Contact a qualified professional.

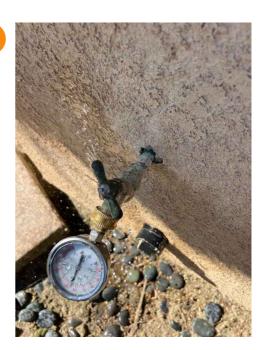
SPIGOT - LEAKING

Hose spigot leaks from handle when operated.

HANDLE

Contact a qualified plumbing contractor.

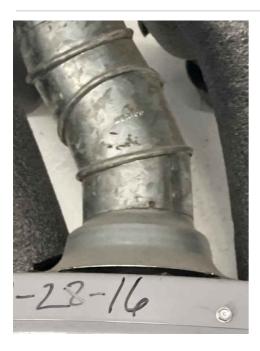
3.7.1 WATER HEATER(S), FLUES AND VENTS

FLUE - NO SCREWS

Recommendation

Contact a qualified professional.

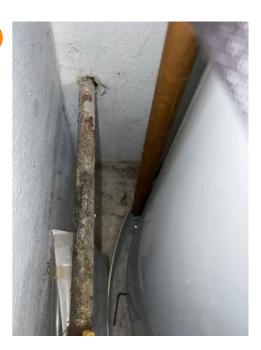
3.8.1 TEMPERATURE AND PRESSURE RELIEF (TPR) VALVE

T&P DISCHARGE - TERMINATES IN LEAK PAN

The discharge pipe at the T & P valve terminates into the water heater leak pan. This is an incorrect installation.

Recommendation

Contact a qualified plumbing contractor.

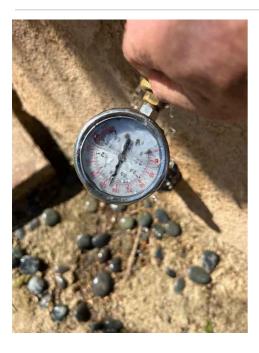
3.10.1 WATER PRESSURE AND REGULATOR

High water pressure noted. This can cause water lines, faucets and water supplied appliances to fail and leak. We advise having a licensed plumber repair or install a new pressure regulator, to allow a PSI range of 50-70.

Recommendation

Contact a qualified plumbing contractor.

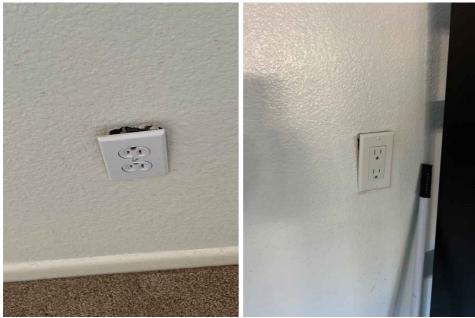
Receptacle was loose in the wall. This puts stress on the circuit wires which should not be moved. We recommend securing the junction box properly in the wall by a qualified person.

Recommendation Contact a qualified professional.

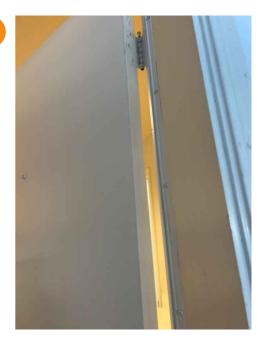
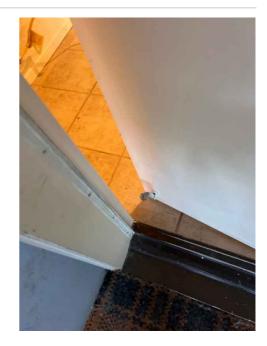
STOPPER

The door to the garage has a door stopper. The door stopper defeats the auto closer, which is required. We recommend the removal of the door stopper to maintain the integrity of the fire wall and fire door.

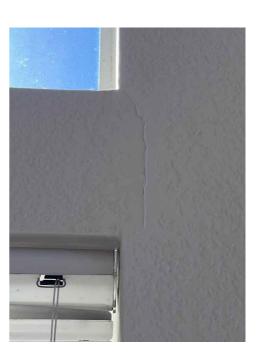
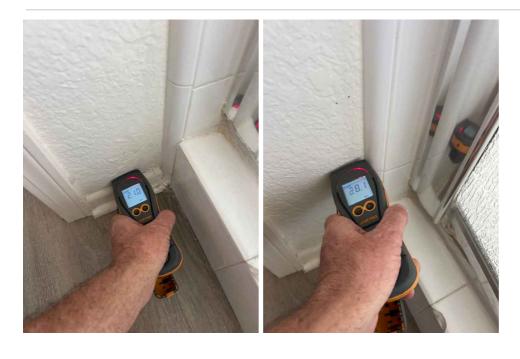
An elevated level of moisture was detected at the wall adjacent to the shower. This can be caused by plumbing leaks or water leaking through grout or the enclosure. There may be moisture damage behind the wall which is concealed, and cannot be identified within the scope of a home inspection. To determine if moisture damage exists inside the walls, a more invasive inspection is required. If not corrected, water damage may occur and create an environment conducive to mold growth. We recommend further evaluation by a qualified contractor.

Recommendation

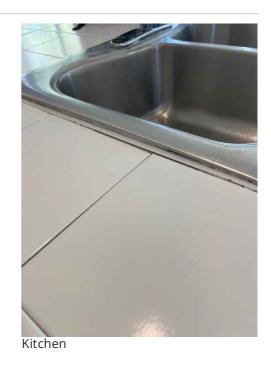
9.7.3 COUNTERS AND A REPRESENTATIVE NUMBER OF CABINETS CAULKING - COUNTER/SINK

A gap was observed at the sink/counter. We advise caulking at the counter/sink to avoid moisture intrusion below.

Recommendation Contact a qualified professional.

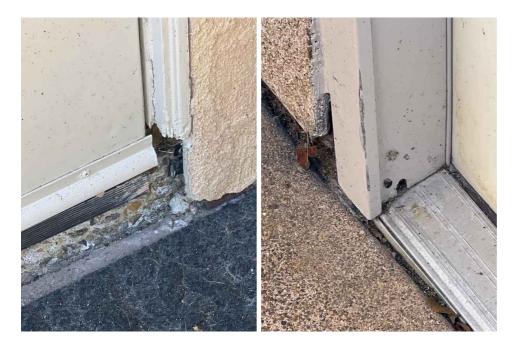
10.5.2 WALL SIDING FLASHING AND TRIM

DAMAGED WOOD TRIM

Recommendation

Contact a qualified pest control specialist.

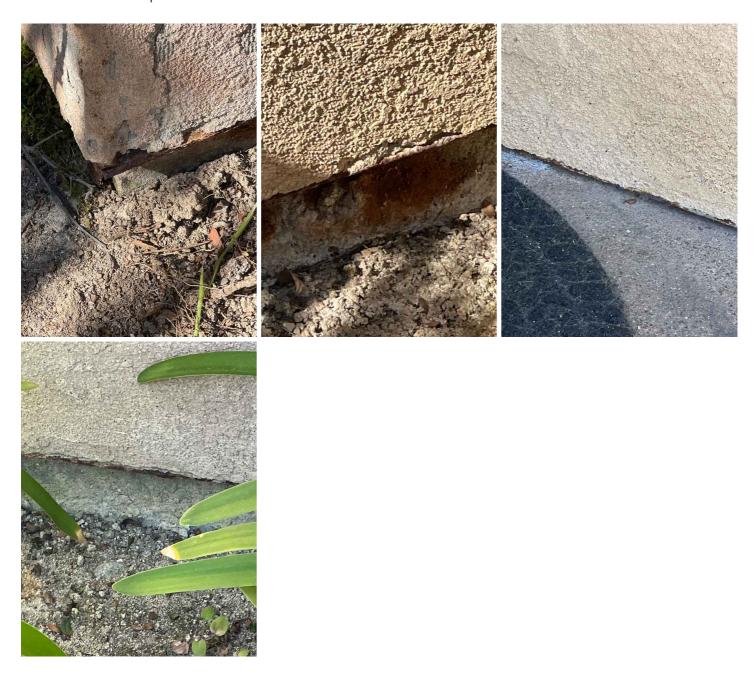
10.5.3 WALL SIDING FLASHING AND TRIM WEEP SCREED RUSTED - REPAIR OR REPLACE

Stucco screed flashing is rusted at the exterior. This may indicate that the sprinklers are spraying the house, or dirt is too close to the screed. The screed is damaged and requires repair/replacement. Recommend obtaining a quotation for this repair prior to the end of your contingency period by a licensed stucco contractor.

Recommendation Contact a stucco repair contractor

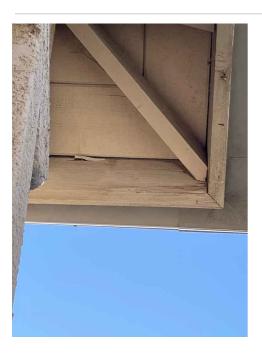
10.11.1 EAVES, SOFFITS AND FASCIAS

FASCIA/EAVES - TERMITES/ROT

Recommendation

Contact a qualified pest control specialist.
