## SUMMARY

1360 Santa Victoria Road 2, Chula  
Vista, CA 91913

Mike Blair  
07/30/2026

Curtis Kelley  
Certified Home Inspector  
West Ivy Inspections  
6197969077  
westivyave@gmail.com

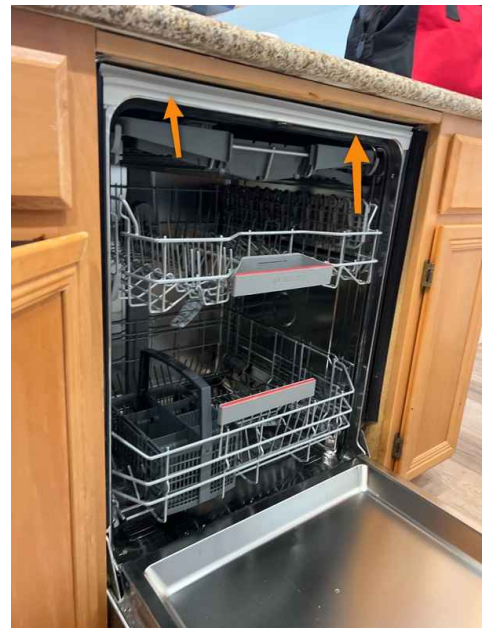
#### UNSECURED DISHWASHER

The dishwasher is not secured to the countertops. Unsecured appliances can shift or tip during operation or if bumped, creating a potential hazard and risking damage to water supply lines and drain connections. The dishwasher should be properly anchored to the countertop using appropriate brackets or fasteners to ensure stability.

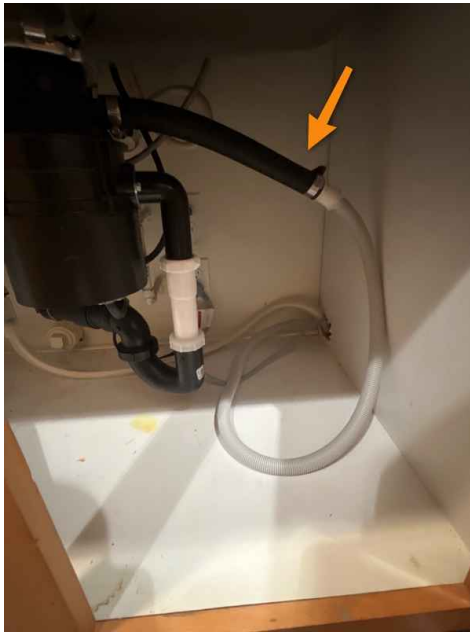
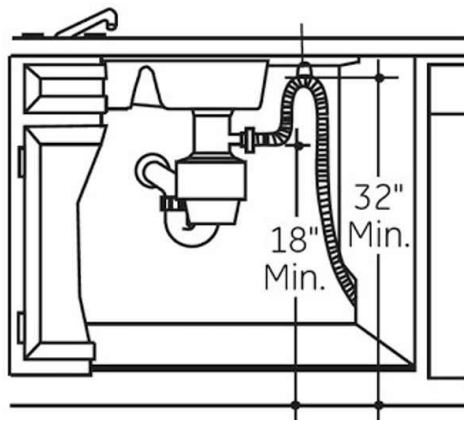
#### HIGH LOOP - NOT SECURED / NOT INSTALLED

The dishwasher drain is not secured in a high loop manner. Recommend a qualified professional to repair as needed.

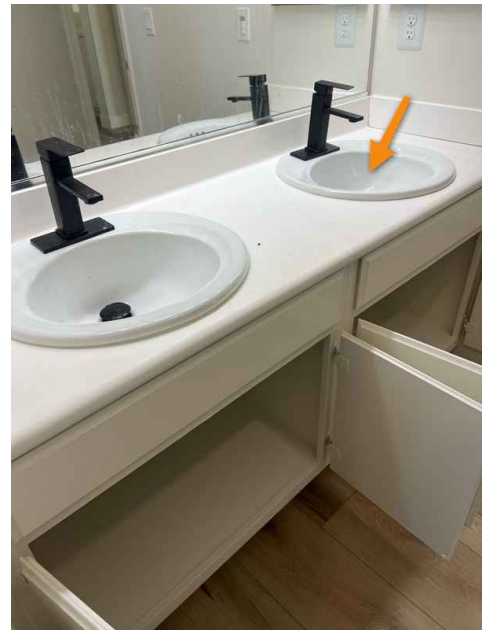
Bedroom 5 Bath Bedroom 3

### 3.3.1 FIXTURES AND CONNECTED DEVICES SINK STOPS - INOPERABLE/NOT INSTALLED

One or more sink stopper(s) did not appear to be functional, was not installed properly or was missing components at the time of the inspection at the sink(s). Recommend further evaluation by a licensed plumbing contractor and repair as necessary at this time to ensure proper function.

Contact a qualified plumbing contractor.

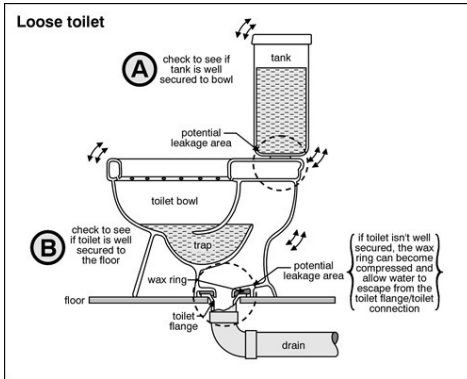
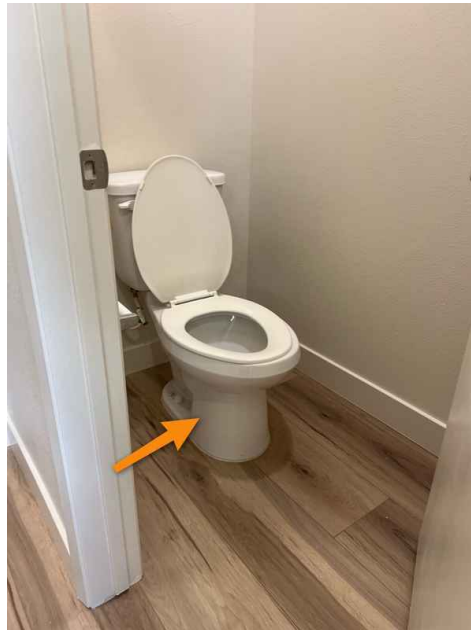
Primary Bathroom 2nd Floor

### 3.3.2 FIXTURES AND CONNECTED DEVICES TOILET LOOSE

The toilet was noted loose to the floor. This can cause damage to the wax ring under the toilet. A damaged wax ring can allow water to leak. Left unchecked, leaking wax rings may cause other problems, to include, but not limited to: Damaging the flooring and adjacent wall materials, organic growth, and can even cause damage to the wood sub-floor or slab. Recommend further evaluation by a licensed plumbing contractor and repair as necessary at this time.

Contact a qualified plumbing contractor.

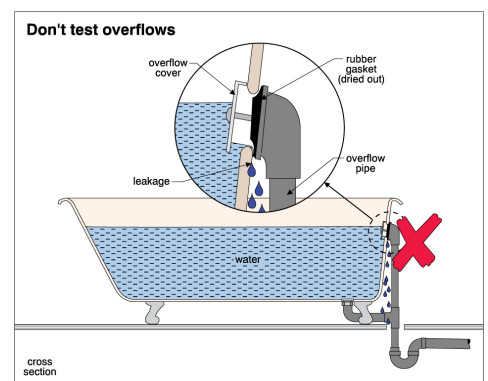
#### DRAIN OVERFLOW - INFORMATION

The drain overflow cover appeared to be installed properly at the bathtub(s). However, determining if the drain line is properly connected behind these covers is beyond the scope of this inspection. To ensure that this line is properly attached to the back of the bathtub, we recommend further evaluation by a licensed plumbing contractor before the removal of contingencies to determine if latent defects exist.

Contact a qualified plumbing contractor.

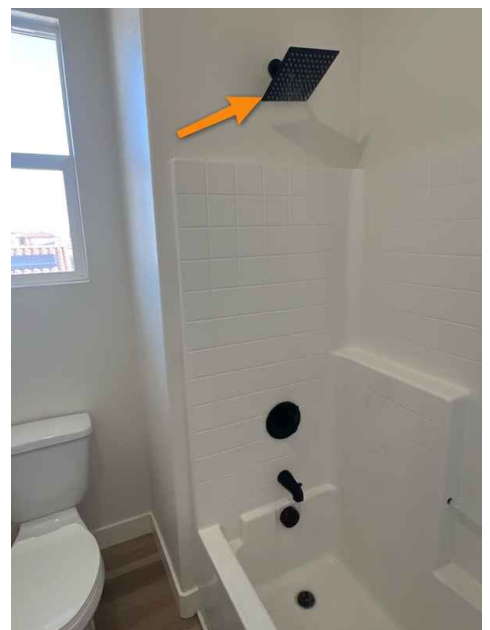
Example Bedroom 5 Bath 3rd Floor

#### SHOWER HEAD - LOW FLOW

Water at one or more shower heads appears to have low flow. Unable to determine the exact cause, but this is typically a result of hard water build-up. Recommend further evaluation by a licensed plumbing contractor before the removal of contingencies to determine corrections necessary at this time to ensure proper function.

Contact a qualified plumbing contractor.

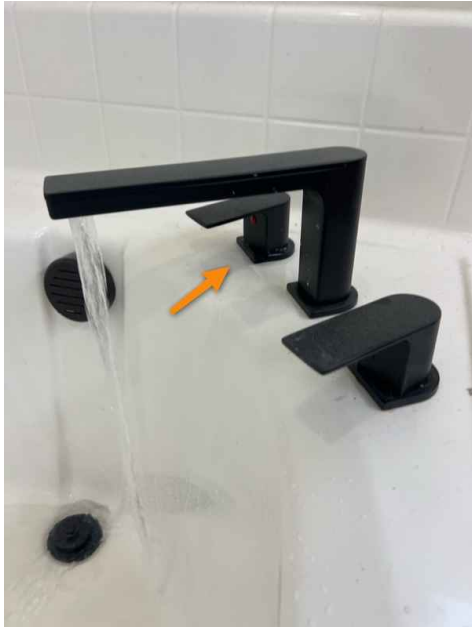
Primary Bedroom 2nd Floor

#### CONTROL VALVE - LEAKING TUB/SHOWER FIXTURES

The tub/shower fixtures appear to be leaking at the base. Recommend further evaluation by a licensed plumbing contractor before the removal of contingencies to determine repairs possible at this time. **Please Note:** Determining if damage exists behind the walls of any surface is beyond the scope of this inspection.

Contact a qualified plumbing contractor.

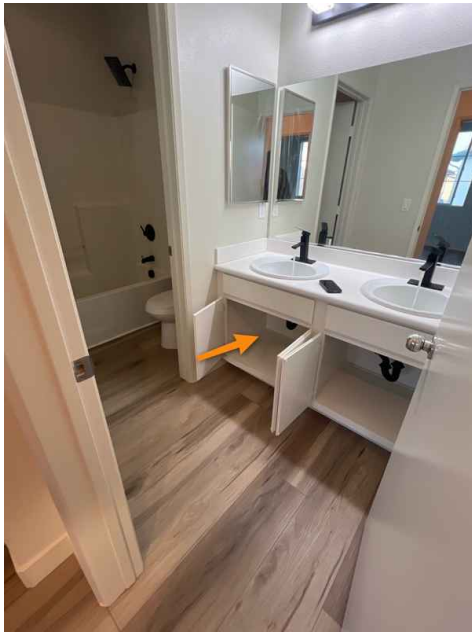
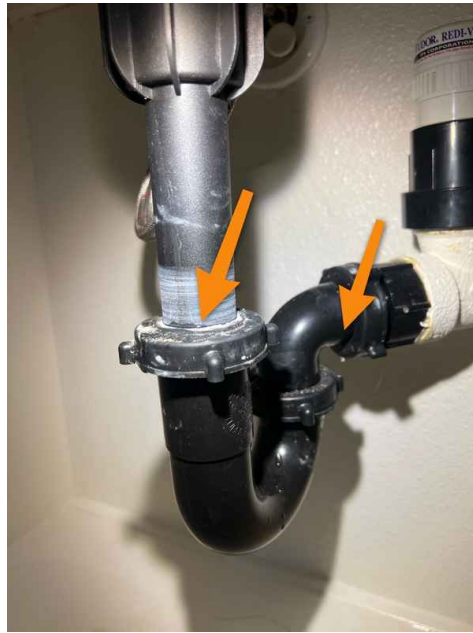
2nd Floor Hall Bath left sink

#### SINK DRAIN - ACTIVE LEAK

Active leak noted at the drain line below the sink. Recommend further evaluation by a licensed plumbing contractor before the removal of contingencies and repair as necessary at this time to ensure proper function.

Contact a qualified plumbing contractor.

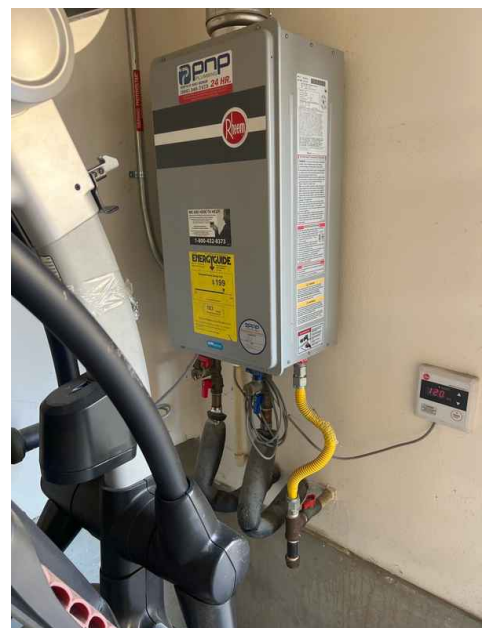
#### **TANKLESS WATER HEATER**

Tankless water heaters require routine maintenance which typically involves flushing the water heater to reduce hard-water build up. We recommend asking the seller if this unit has been recently serviced (within the last 12-18 months). If not, we recommend the unit be serviced by a licensed plumbing contractor.

Contact a qualified plumbing contractor.

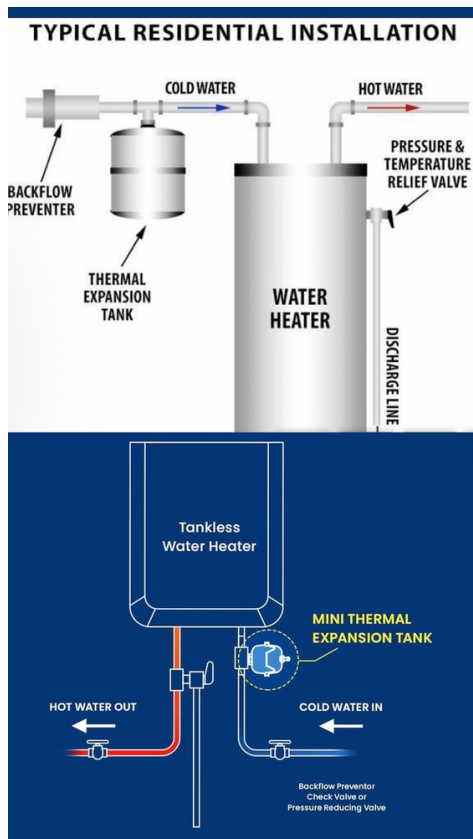
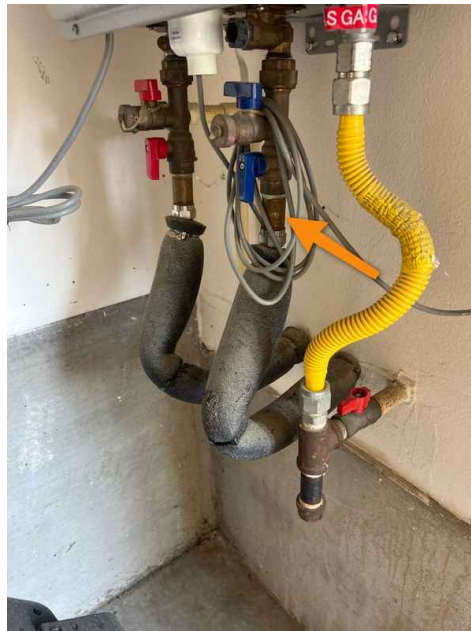
**EXPANSION TANK NOT INSTALLED**

An expansion tank is not installed at the water heater. Most water heater manufacturers recommend an expansion tank be installed whenever the water system is a "closed" system, such as this home. Recommend further evaluation by a licensed plumbing contractor before the removal of contingencies to determine repairs/upgrades necessary at this time to comply with today's standards.

Contact a qualified plumbing contractor.

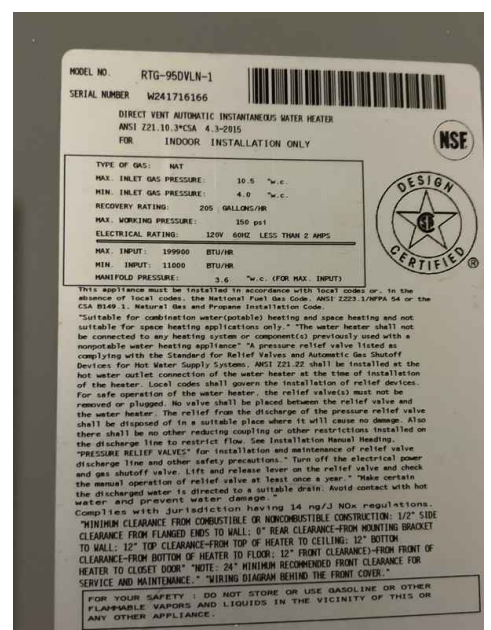
Manufactured 2017

**6-10 YEARS -WATER HEATER**

The water heater appears to be between 6-10 years old based on visual inspection. Water heaters typically have a useful lifespan of 10-15 years depending on maintenance, water quality, and usage patterns. Knowing the age helps establish when replacement or professional servicing may become necessary.

Contact a qualified professional.

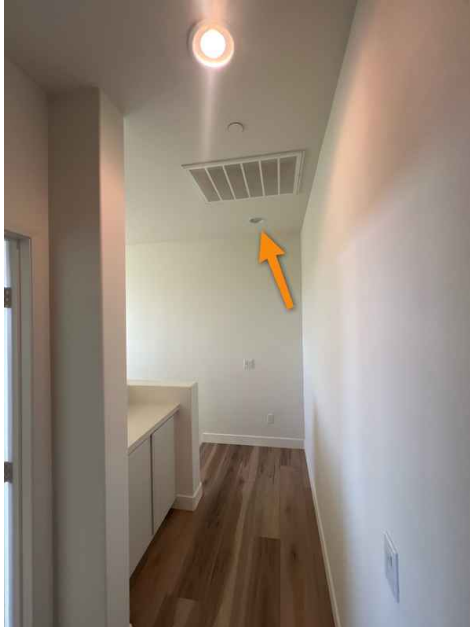
Bedroom 3 Hall

### LIGHTS - INOPERABLE

One or more lights appear to be inoperable at the time of the inspection (possibly due to bulb). Recommend replacing bulb(s) and checking the operation of the fixture(s). If light(s) fail to work, we recommend further evaluation by a licensed electrical contractor before the removal of contingencies to determine repairs necessary at this time.

Contact a qualified electrical contractor.

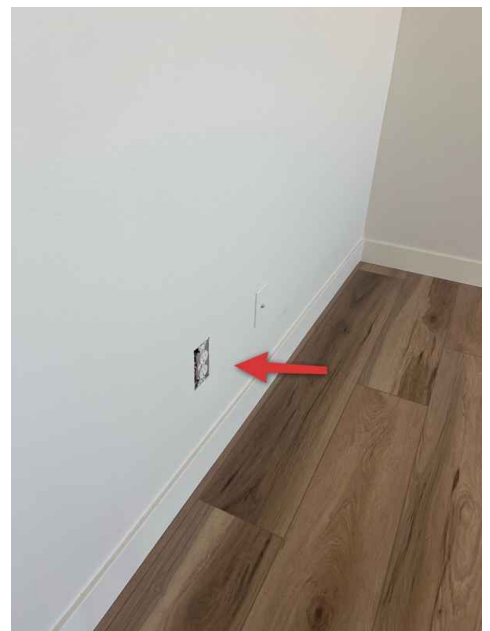
Bedroom 5 3rd Floor

### FACE PLATE - NOT INSTALLED/LOOSE

Not installed or loose (with gaps) face plate (cover) noted at one or more outlets and/or switch(es). Recommend replacement as necessary at this time for safety.

Contact a qualified electrical contractor.

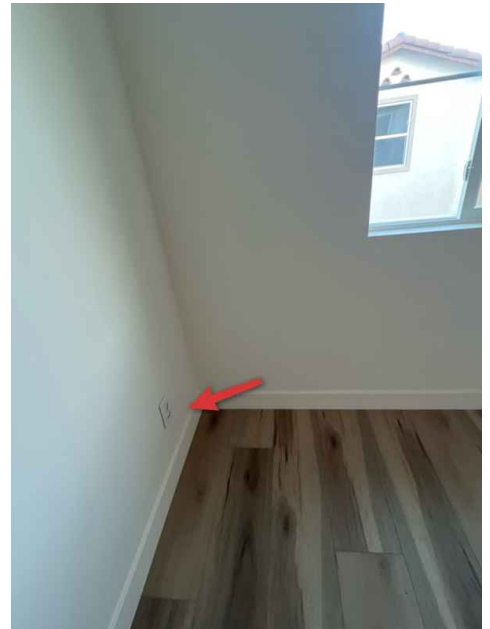
Bedroom 2 2nd Floor

##### RECEPTACLES LOOSE

Loose receptacle(s) noted in one or more areas at the time of the inspection. This condition can put stress on the circuit wires which should not be moved. Recommend further evaluation by a licensed electrical contractor before the removal of contingencies to determine corrections necessary at this time to ensure proper function and safety.

Contact a qualified electrical contractor.

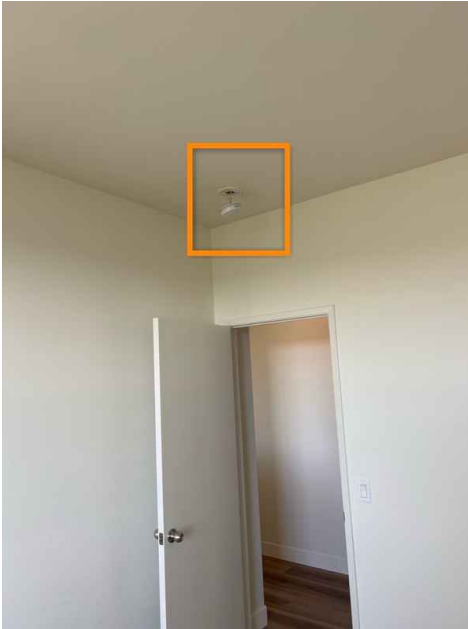
Bedroom 4 3rd Floor

##### SMOKE DETECTOR - LOOSE

Smoke detector(s) noted loose or not secured at one or more locations. Recommend corrections by a qualified professional to ensure continued proper function.

Contact a qualified professional.

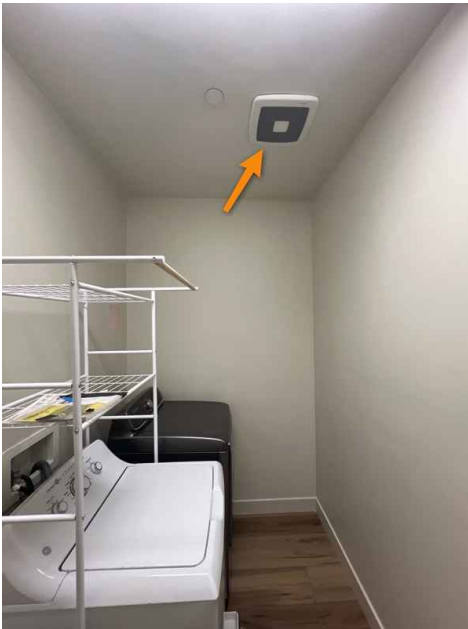
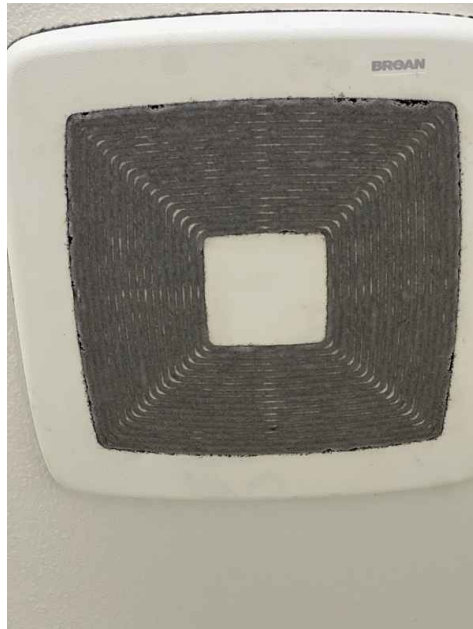
Laundry room Close Up Photo

##### VENT FANS - DIRTY

The ventilation fans at the bathroom/laundry areas need general cleaning. Recommend correction by a qualified professional as necessary at this time to ensure continued proper function.

Contact a qualified professional.

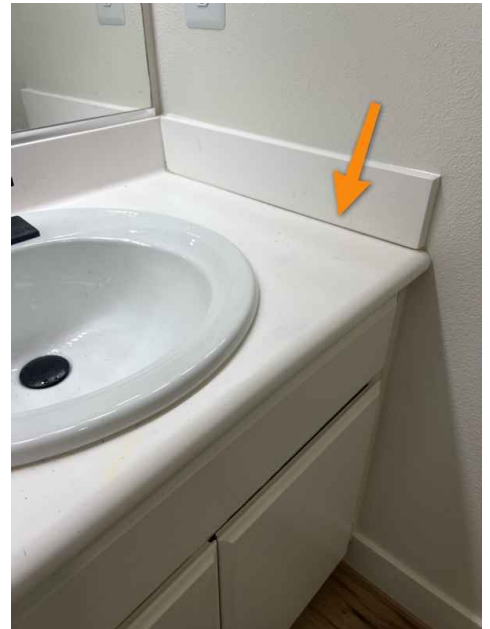
Bedroom 5 Bath 3rd Floor

##### CAULKING/ GROUT - CRACKED OR MISSING

Cracked and/or missing grout noted at counter/backsplash in one or more locations. Recommend corrections by a licensed tile contractor as necessary at this time.

Contact a qualified tile contractor

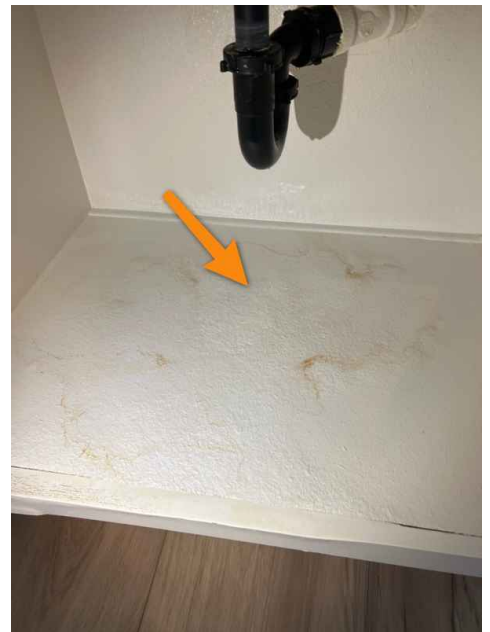
2nd Floor Hall Bath left sink

##### **CABINET FLOOR - MOISTURE STAINS/DAMAGE**

Moisture stain(s)/damage noted at the floor of the cabinet below the sink(s). This appeared to be indicative of a previous leak. The area appeared to be wet at the time of the inspection. Recommend further evaluation by a licensed plumbing contractor to determine any repairs necessary at this time.

Contact a qualified plumbing contractor.

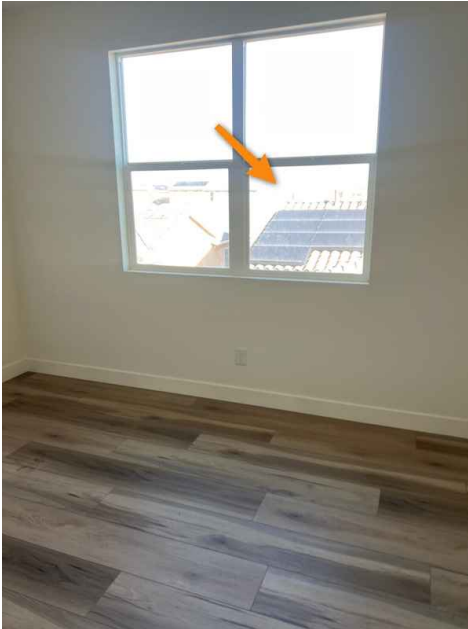
Bedroom 5 3rd Floor

##### **SCREENS - NOT INSTALLED**

Screen(s) noted not installed. Recommend replacement as necessary at this time.

Contact a qualified professional.

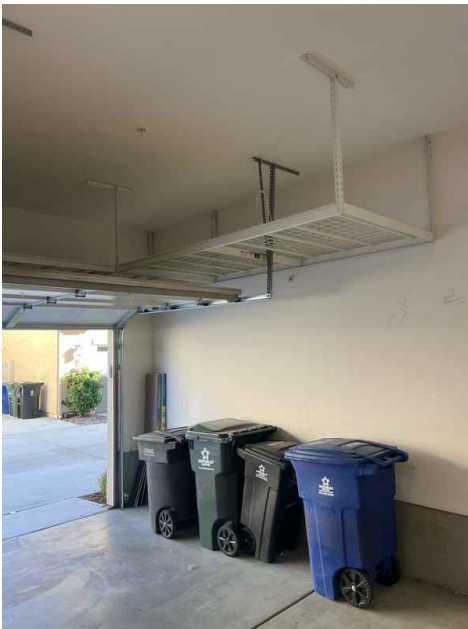
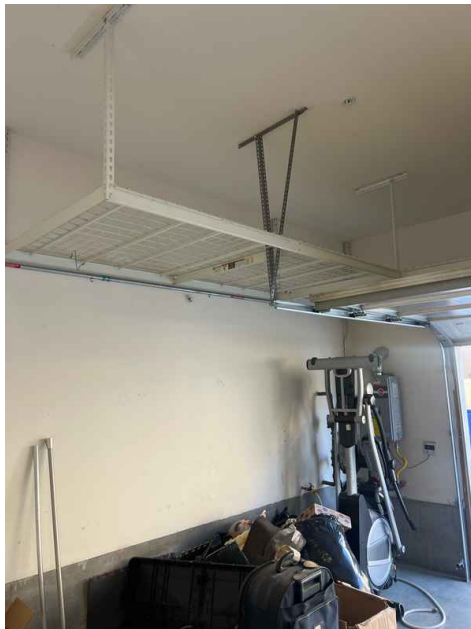
#### OVERHEAD STORAGE

Overhead storage was noted present in the garage. Storing weight on the roof structure of the garage can promote damage and sagging of the roof structure. Recommend consulting a licensed general contractor for further evaluation to determine if corrections are necessary at this time.

Contact a qualified general contractor.

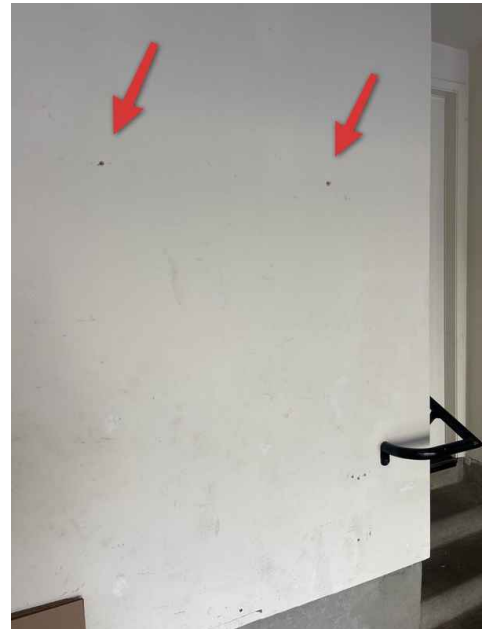
#### FIREWALL GAPS OR HOLES

Gap(s) or hole(s) noted in the firewall at the garage. Wherever the garage shares a wall with adjacent living space, a fire-rated sheetrock must be installed and intact for fire resistive performance. Recommend further evaluation by a licensed drywall contractor and having any gaps/holes patched as necessary at this time for safety.

Contact a qualified drywall contractor.

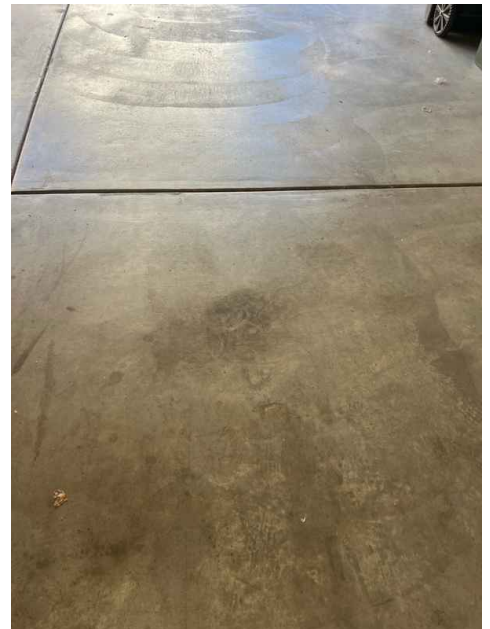
##### **STAINS ON FLOOR (COSMETIC)**

Staining noted on the garage floor in areas. Unable to determine the exact cause. You may wish to view this for yourself and/or have further evaluated by a licensed concrete contractor or restoration contractor to determine if corrections are necessary at this time.

Contact a qualified concrete contractor.

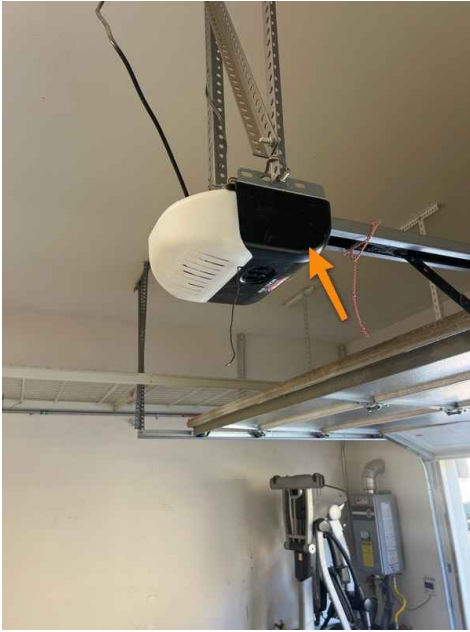
##### **BATTERY BACKUP - NOT EQUIPPED**

This home's garage door opener does not appear to be equipped with a battery backup that will allow the door to function during electrical outages. This can prove to be a safety hazard and may not be in compliance with today's building/safety standards. Recommend further evaluation by a licensed garage door contractor to determine if corrections or upgrades are necessary at this time. To learn more about this recent change please click [HERE](#).

Contact a qualified garage door contractor.

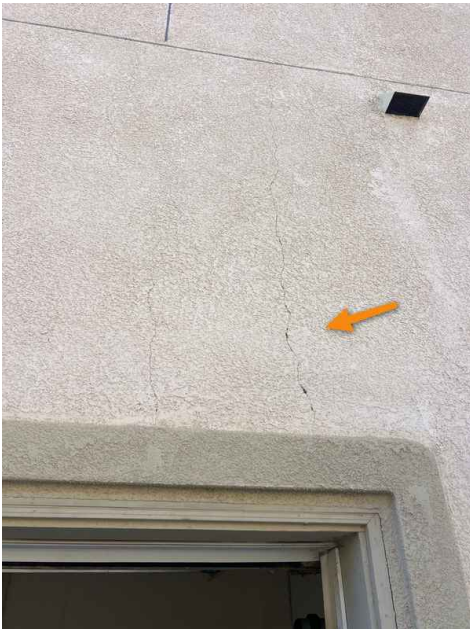
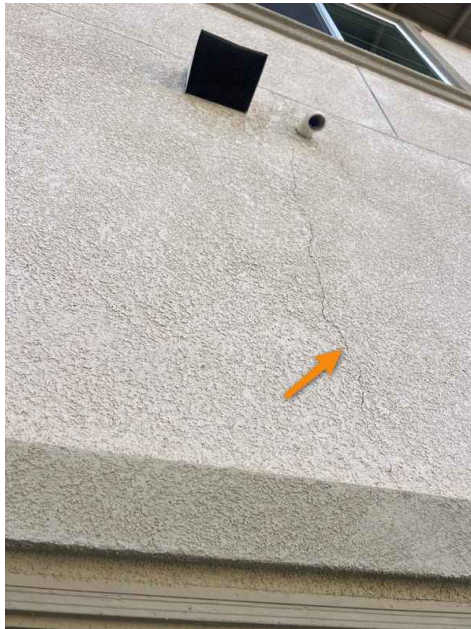
### 9.2.1 WALL CLADDING, TRIM AND FLASHING **STUCCO - CRACKS**

There are crack(s) in the stucco. Crack(s) may result from movement, or poor workmanship. However many of them are cosmetic. Recommend monitoring conditions, and repair/upgrade as necessary, by a licensed stucco contractor.

Contact a stucco repair contractor

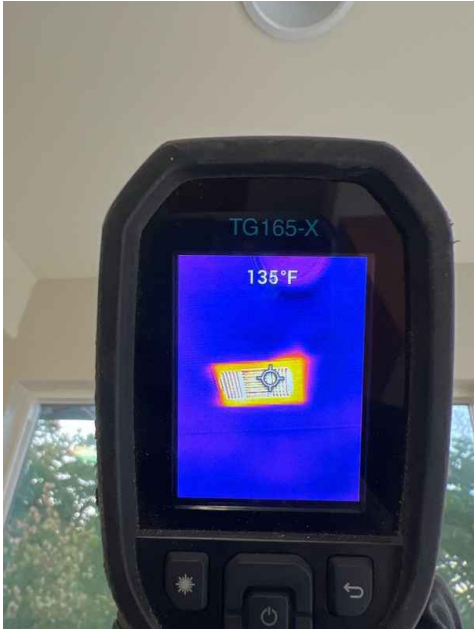
2nd Floor Primary Bathroom

### 11.2.1 HEATING - EQUIPMENT **FURNACE TURNED ON (THERMAL IMAGING PHOTO) - HEAT EXCHANGER NOT VISIBLE**

The furnace(s) appeared to turn on and produce heat at time of inspection. However, due to the many components that are not visible (like the heat exchanger and the entire length of the flue pipe), our inspection of the system(s) is limited. Because of this, we recommend further evaluation/safety check be performed by a licensed HVAC contractor or the local gas company before the removal of contingencies.

Recommendation  
Contact a qualified heating and cooling contractor

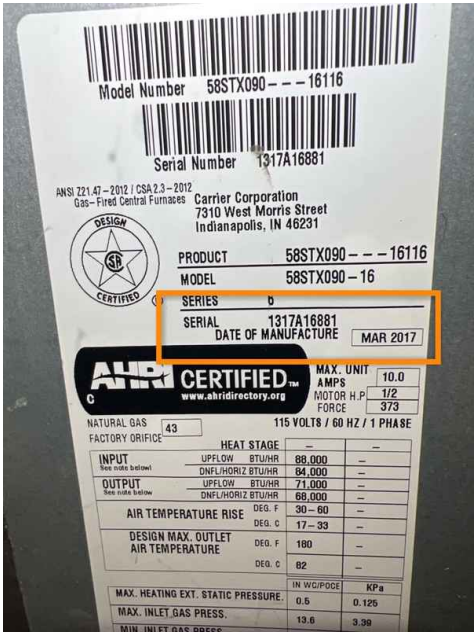
11.2.2 HEATING - EQUIPMENT  
**FURNACE 0-10 YEARS OLD**

The furnace is 0-10 years old. Most furnaces have a typical lifespan of 15-20 years with proper maintenance. While the unit may still be functional, components begin to wear and efficiency typically declines over time. However, due to the many components that are not visible (like the heat exchanger and the entire length of the flue pipe), our inspection of the system(s) is limited. Monitoring performance and scheduling regular maintenance can help extend the system's life and identify potential issues before they become major problems.

Recommendation  
Contact a qualified HVAC professional.

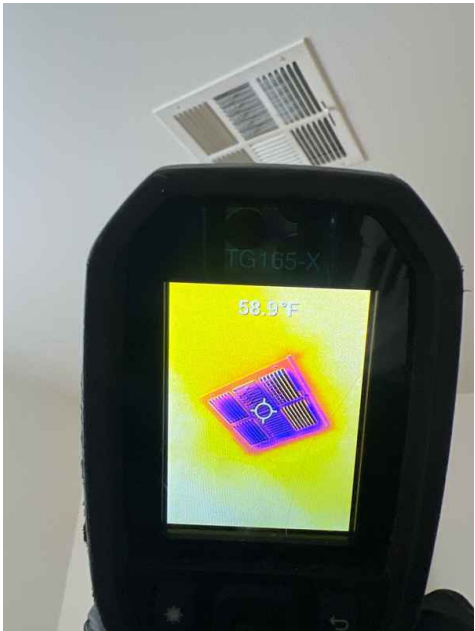
11.6.1 COOLING - EQUIPMENT  
**AIR CONDITIONER - PRODUCED COOL AIR**

During the test of this homes air conditioning system a minimum split of 14 degrees was achieved between the ambient air temperature and the temperature of the air blowing out of the registers. Because of this, the unit(s) appeared to be functional.

We are unable to verify the condition of the entire span of the air conditioner refrigerant line, and condensation drain line due to insulation, wall/floor coverings and other finishes and/or obstructions. We recommend you ask the seller of any prior repair or issues, or have further evaluated by a licensed HVAC contractor to determine if latent defects exist.

Recommendation  
Contact a qualified heating and cooling contractor

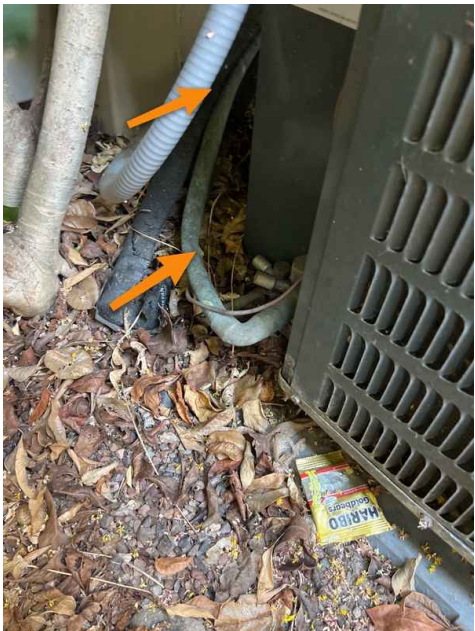
11.6.2 COOLING - EQUIPMENT  
**FOAM MISSING AT REFRIGERANT LINE**

The foam sleeve on the refrigerant line is missing and/or damaged in one or more areas. Missing/damaged foam on the suction line can cause energy loss and condensation. Recommend repair by a licensed HVAC contractor as necessary at this time.

Recommendation  
Contact a qualified heating and cooling contractor

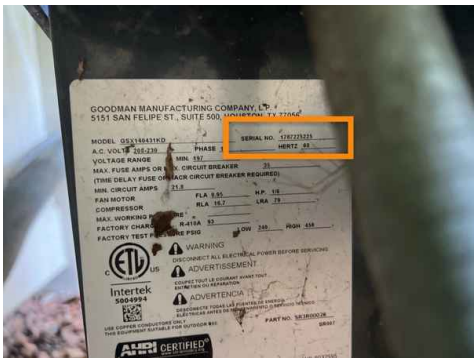
Manufactured 2017

11.6.3 COOLING - EQUIPMENT  
**A/C 0-10 YEARS OLD**

The air conditioning equipment is 0-10 years old. This relatively young system suggests it is still within a typical service lifespan and should be functioning near design capacity. Regular maintenance and filter changes help ensure continued reliable operation and efficiency.

Recommendation  
Contact a qualified heating and cooling contractor

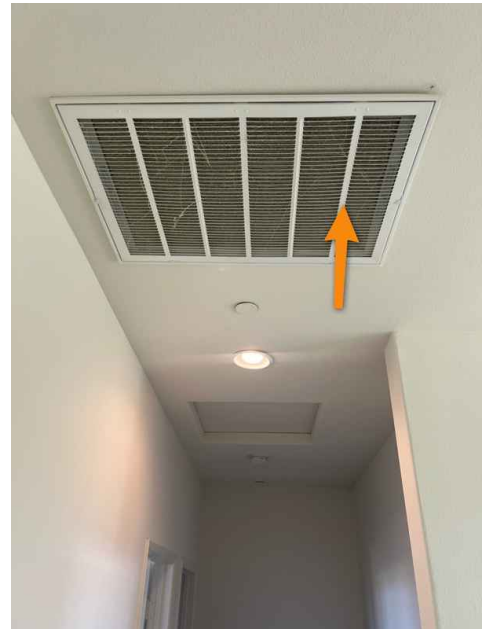
**FILTER - DIRTY**

The air filter appeared to be dirty and should be cleaned and or replaced. Recommend further evaluate by a licensed HVAC contractor.

Contact a qualified professional.
