Home Inspection Report

4506 Lilac Ridge Road, San Ramon

Tomas Carmona
May 2, 2024

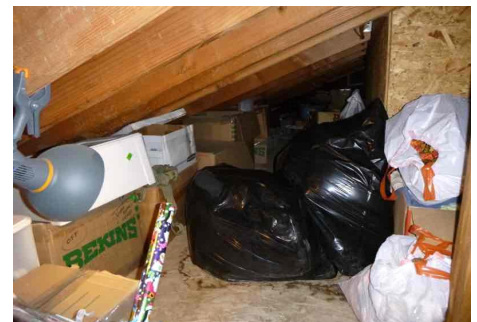
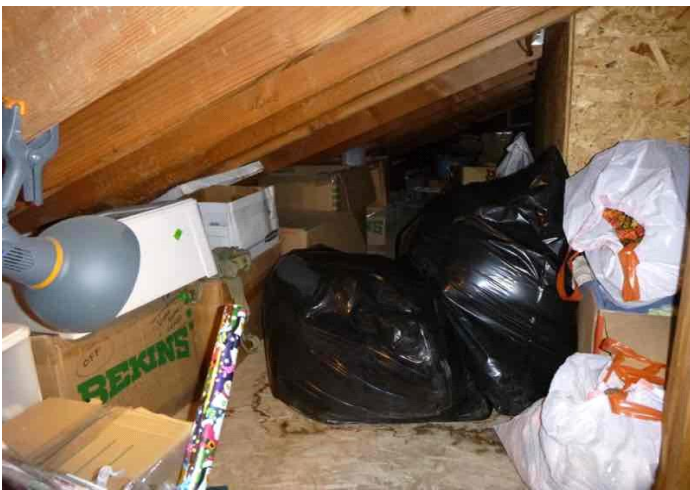
Photo 17

1. Personal storage was blocking the interior of the attic over the lower floor, therefore, this attic was not fully inspected. With access and an opportunity for a complete inspection, conditions in need of attention may be discovered. The personal belongings should be removed so this attic may be fully inspected. (See Photo 17)

- ! 1. Personal storage was blocking the interior of the attic over the lower floor, therefore, this attic was not fully inspected. With access and an opportunity for a complete inspection, conditions in need of attention may be discovered. The personal belongings should be removed so this attic may be fully inspected. (See Photo 17)
- ! 2. Water stains were evident in the attic over the lower floor. This could indicate leakage through the roof covering. We recommend the services of a licensed roofing contractor to further evaluate this condition. (See Photo 19) (See Photo 20) (See Photo 17)

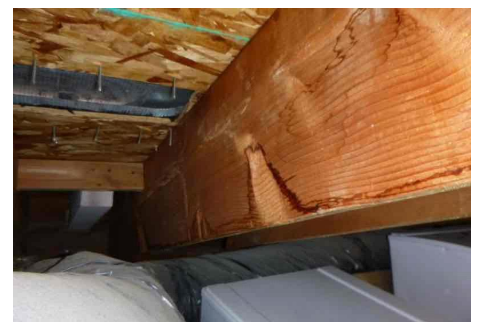
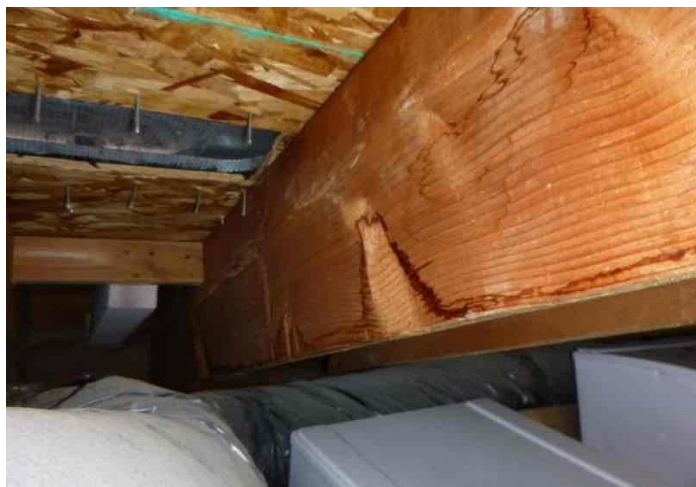
Photo 19

2. Water stains were evident in the attic over the lower floor. This could indicate leakage through the roof covering. We recommend the services of a licensed roofing contractor to further evaluate this condition. (See Photo 19) (See Photo 20) (See Photo 17)

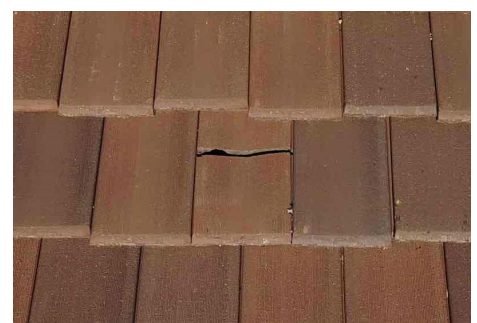
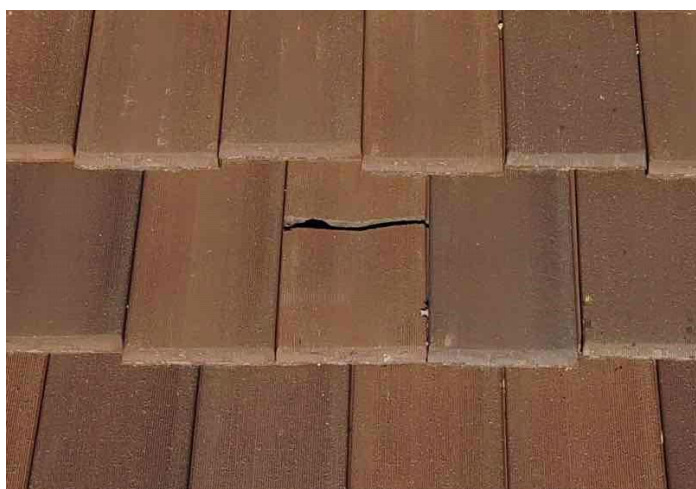
Photo 21

3. There are individual misaligned, cracked, and chipped tiles along the ridge and/or in the field. The number of affected tiles is small and no exposure of the underlayment membrane was evident. Further evaluation by a licensed roofer is recommended. (See Photo 21) (See Photo 22)

- ! 1. There are individual misaligned, cracked, and chipped tiles along the ridge and/or in the field. The number of affected tiles is small and no exposure of the underlayment membrane was evident. Further evaluation by a licensed roofer is recommended. (See Photo 21) (See Photo 22)

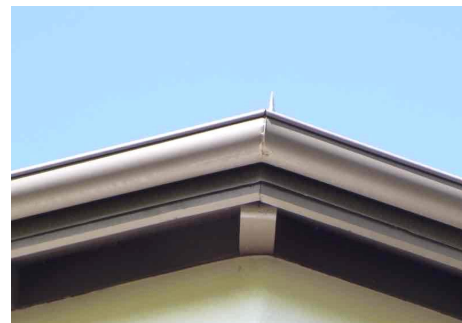
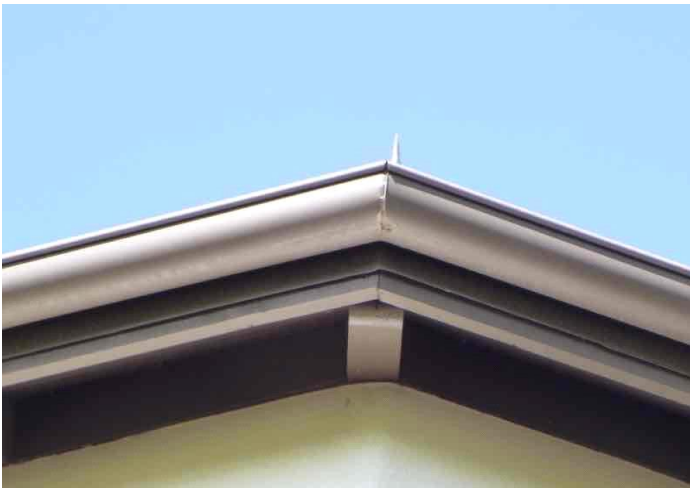
Photo 09

4. Leaks were noted in the downspouts and/or gutters at the front and various areas. During wet weather conditions these areas are more obvious and during dry weather conditions they are noted from the stains at the areas where the leaks have occurred. We recommend all leaks be repaired. (See Illustration 2D) (See Photo 9)

- ! 2. Leaks were noted in the downspouts and/or gutters at the front and various areas. During wet weather conditions these areas are more obvious and during dry weather conditions they are noted from the stains at the areas where the leaks have occurred. We recommend all leaks be repaired. (See Illustration 2D) (See Photo 9)

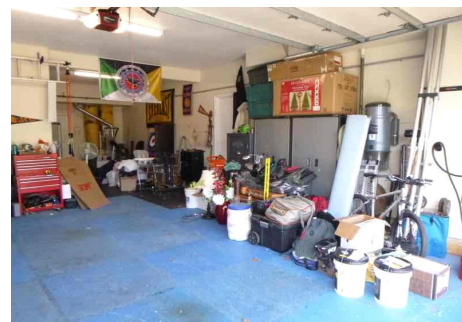
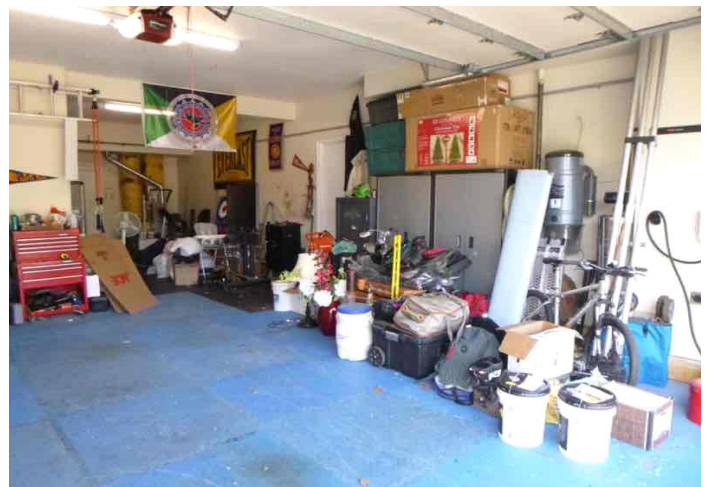
Photo 04

5. Personal storage was partially blocking access to the interior of the garage. Therefore, the area is considered partially inaccessible and was not fully inspected. With access and an opportunity for complete inspection, conditions in need of attention may be discovered. Ideally, the personal belongings should be removed so the area may be fully inspected. (See Photo 4)

Personal storage was partially blocking access to the interior of the garage. Therefore, the area is considered partially inaccessible and was not fully inspected. With access and an opportunity for complete inspection, conditions in need of attention may be discovered. Ideally, the personal belongings should be removed so the area may be fully inspected. (See Photo 4)

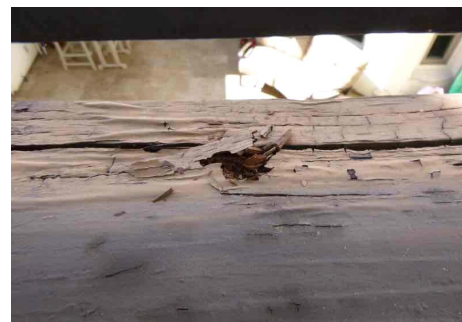
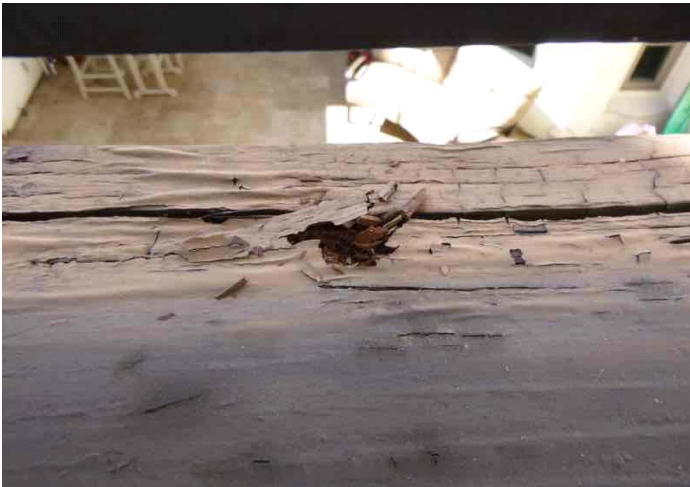
Photo 13

6. Water damage was noted at the atrium front deck and master bedroom rear deck. We recommend the services of a licensed general contractor and/or structural pest control company. (See Photo 13) (See Photo 16)

- ! 1. Water damage was noted at the atrium front deck and master bedroom rear deck. We recommend the services of a licensed general contractor and/or structural pest control company. (See Photo 13) (See Photo 16)

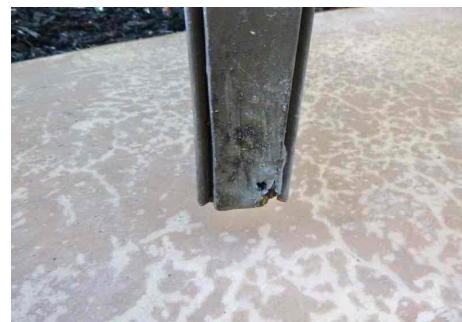
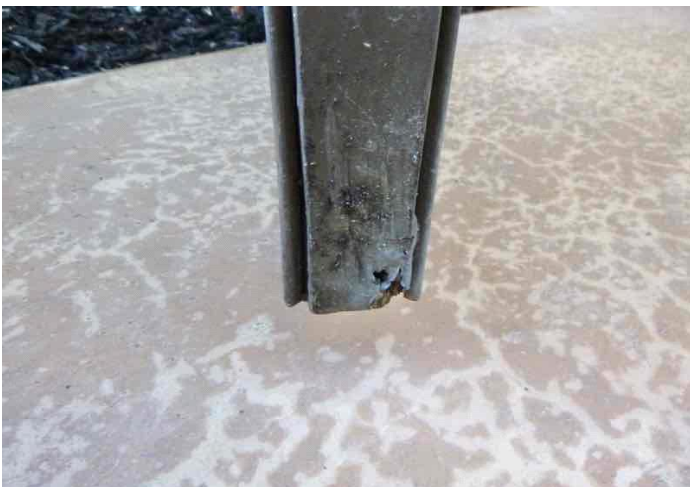
Photo 03

7. Water damage was noted at the electric meter closet door. We recommend the services of a licensed general contractor and/or structural pest control company regarding repairs. (See Photo 3)

- ! 2. Water damage was noted at the electric meter closet door. We recommend the services of a licensed general contractor and/or structural pest control company regarding repairs. (See Photo 3)

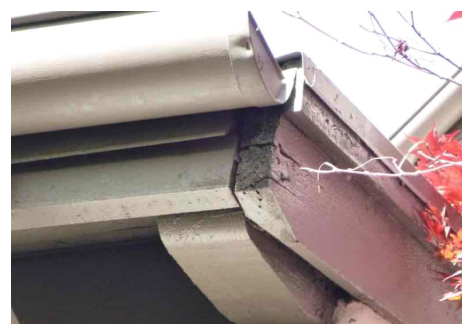
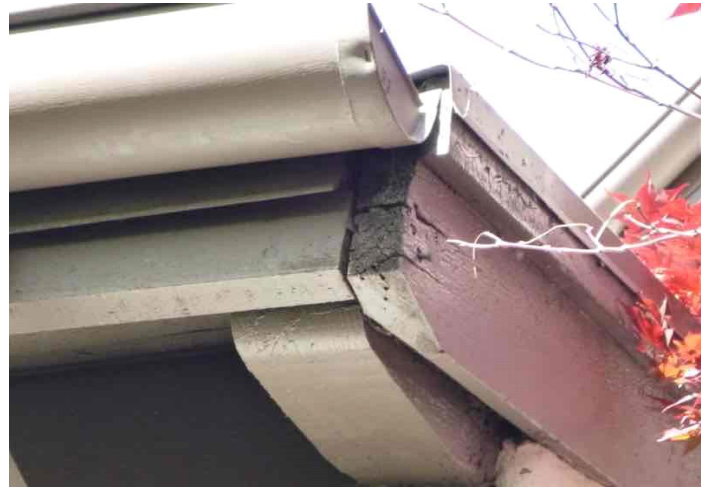
Photo 08

8. Water damage was observed to the rafters at the front. We recommend the services of a licensed general contractor and/or structural pest control company. (See Photo 8)

- ! 3. Water damage was observed to the rafters at the front. We recommend the services of a licensed general contractor and/or structural pest control company. (See Photo 8)

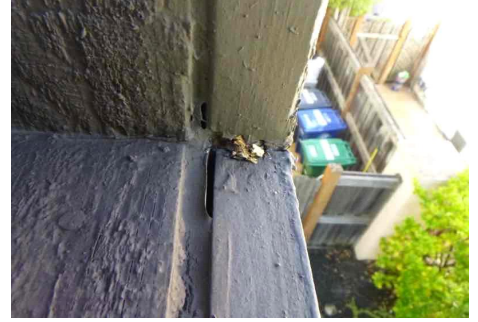
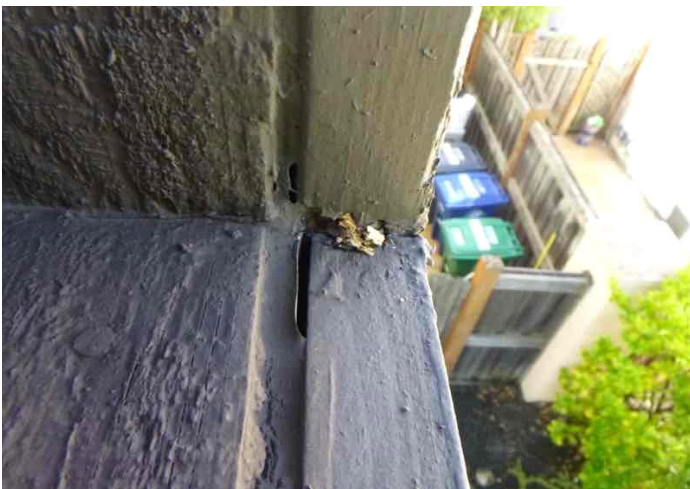
Photo 15

9. Water damage was observed to the exterior trim at the right side. We recommend the services of a licensed general contractor and/or structural pest control company. (See Photo 15)

- ! 4. Water damage was observed to the exterior trim at the right side. We recommend the services of a licensed general contractor and/or structural pest control company. (See Photo 15)

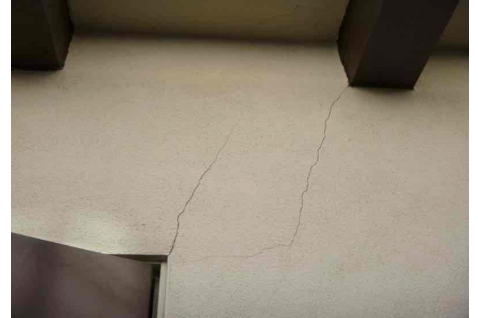
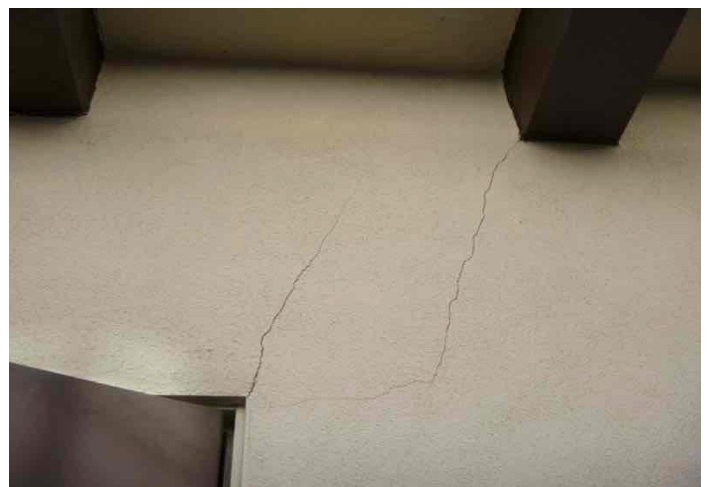
Photo 06

10. Localized damage and/or large stucco cracks at the right side and various areas should be further evaluated by the appropriate tradesperson to determine if any moisture intrusion has occurred and to repair the stucco in this area. (See Photo 6)

- ! 5. Localized damage and/or large stucco cracks at the right side and various areas should be further evaluated by the appropriate tradesperson to determine if any moisture intrusion has occurred and to repair the stucco in this area. (See Photo 6)

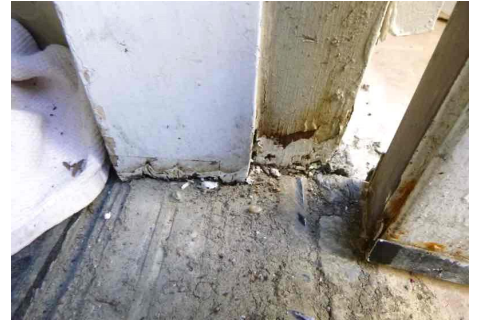
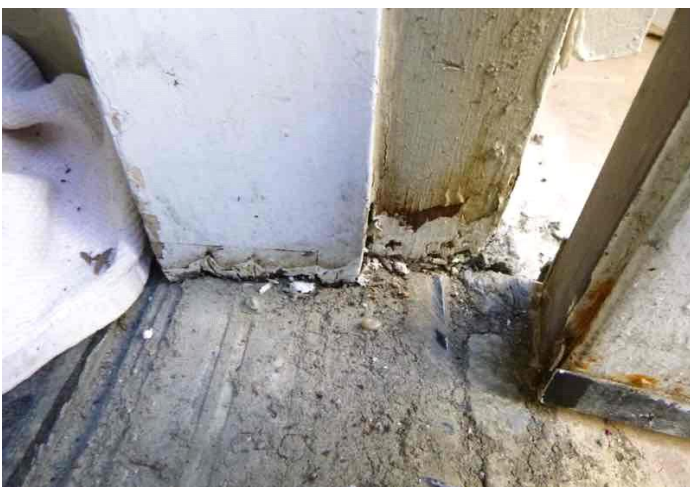
Photo 05

11. Water damage was noted at the garage side door jambs. We recommend the services of a licensed general contractor and/or structural pest control company. (See Photo 5)

- ! 6. Water damage was noted at the garage side door jambs. We recommend the services of a licensed general contractor and/or structural pest control company. (See Photo 5)

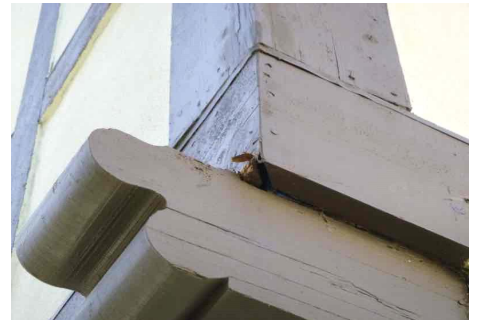
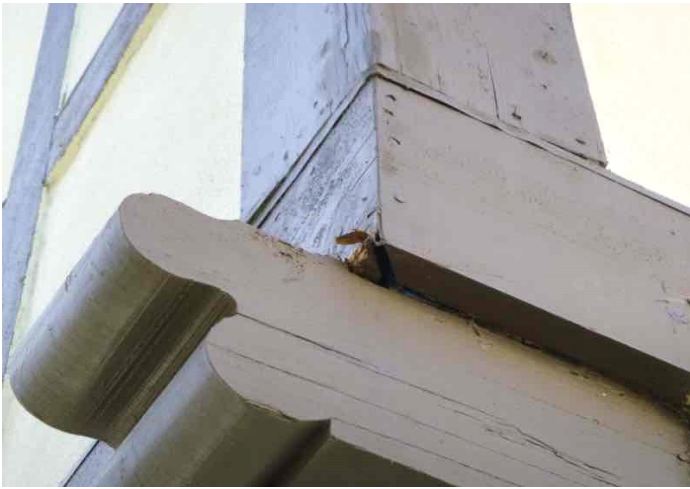
Photo 07

12. Water damage was observed to the exterior trim/belly band at the front. We recommend the services of a licensed general contractor and/or structural pest control company. (See Photo 7)

- ! 7. Water damage was observed to the exterior trim/belly band at the front. We recommend the services of a licensed general contractor and/or structural pest control company. (See Photo 7)

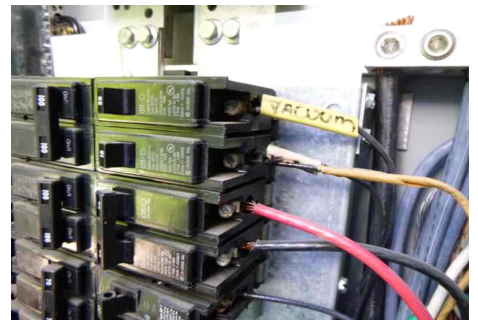
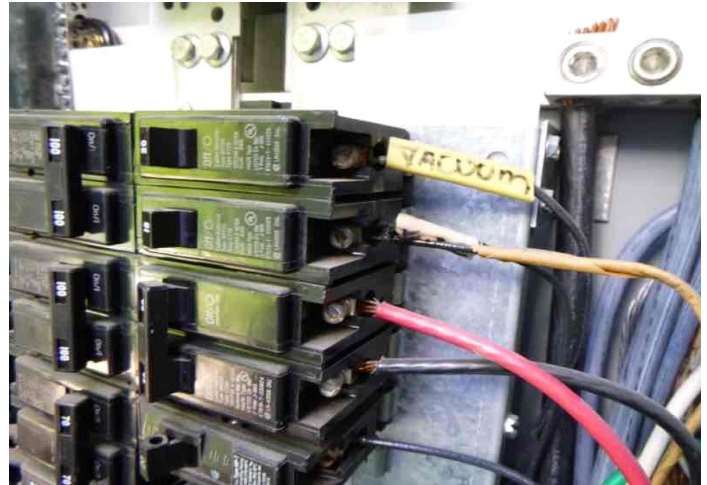
Photo 02

13. Double-tapping was observed in the main electrical panel (when two or more wires are connected to one circuit breaker) These breakers may not be rated for Double-tapping. Therefore further evaluation by a licensed electrician is advised (See Illustration 4V) (See Photo 2) (See Photo 1)

- ! 1. Double-tapping was observed in the main electrical panel (when two or more wires are connected to one circuit breaker) These breakers may not be rated for Double-tapping. Therefore further evaluation by a licensed electrician is advised (See Illustration 4V) (See Photo 2) (See Photo 1)
- ! 2. Overheated wiring within the main electrical panel should be further evaluated by a licensed electrician and repaired as necessary. (See Photo 1)
- 3. Several of the interior outlets and/or switches are loose in their boxes. We recommend a general tightening and "tune-up" of all of the loose receptacles.
- 4. One of the attic branch/auxiliary panel "Dead Front" screws is missing. We recommend proper blunt-end screws be installed.
- 5. One or more of the main panel screws are incorrect. We recommend proper blunt-end screws be installed.

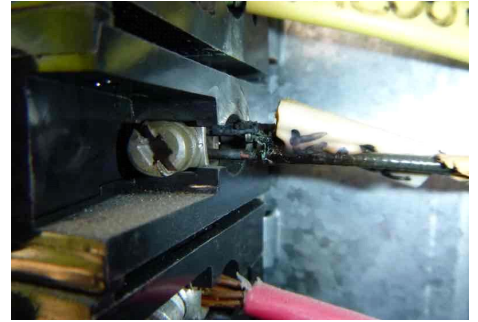
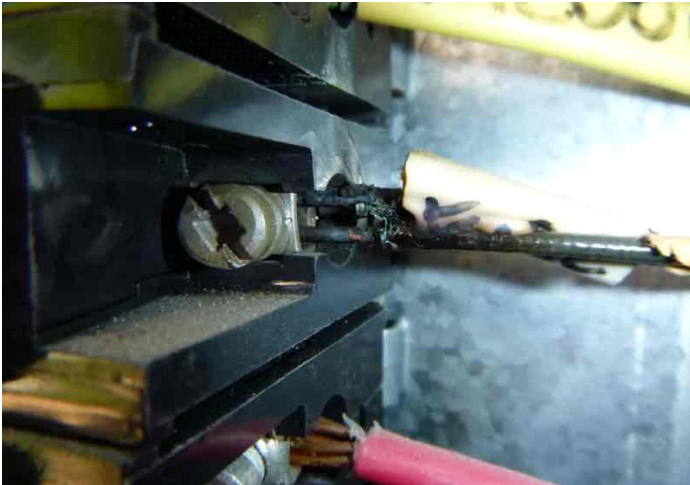
Photo 01

- 14. Overheated wiring within the main electrical panel should be further evaluated by a licensed electrician and repaired as necessary. (See Photo 1)

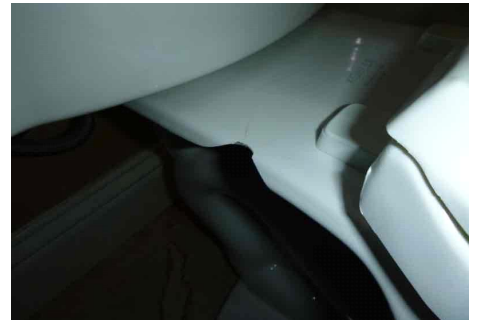
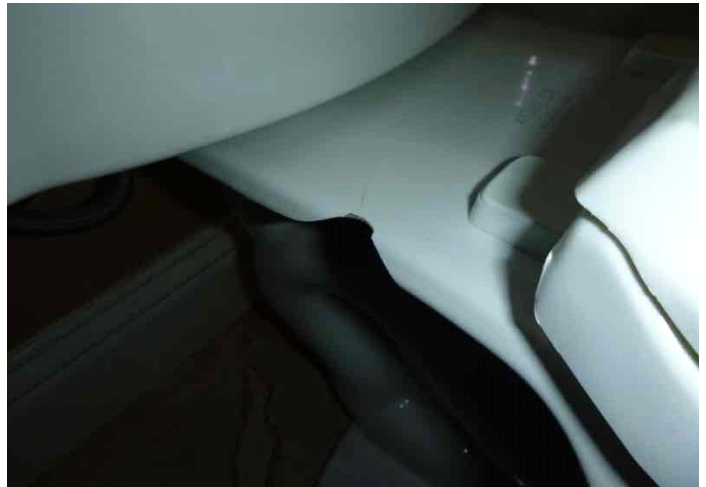
Photo 14

- 15. The toilet in the upstairs front left guest bathroom is cracked. We recommend the toilet be replaced. (See Photo 14)

- The installation of sediment traps at the water heater and furnaces appliance gas lines is recommended.
- ! 2. The toilet in the upstairs front left guest bathroom is cracked. We recommend the toilet be replaced. (See Photo 14)**

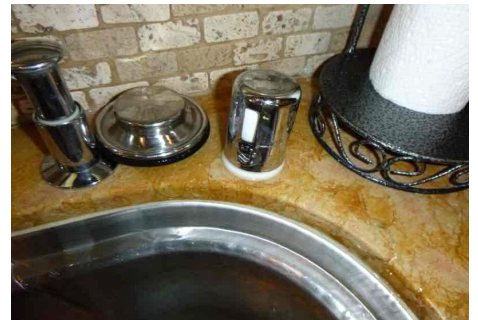
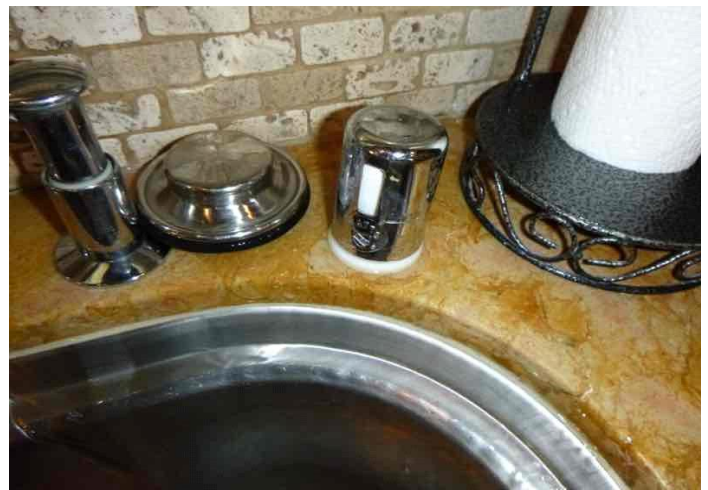
Photo 12

- 16. The air-gap or its connection to the disposal, appears to be restricted, causing water to flow out of the air-gap during the drain cycle of the right side dishwasher. We recommend that the drain system be cleaned or modified to correct this deficiency. (See Illustration 9F) (See Photo 12)

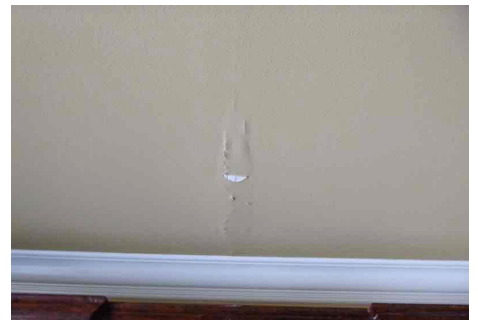
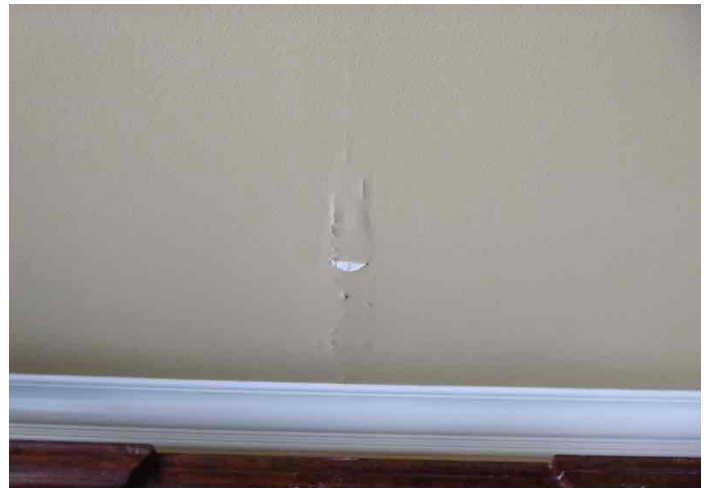
Photo 10

- 17. The ceiling at the downstairs library shows evidence of water damage. We recommend the services of a licensed structural pest control company for investigation of this area. (See Photo 10)

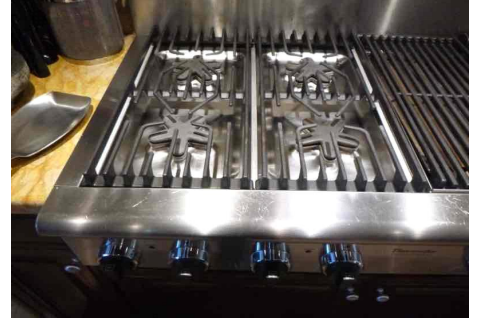
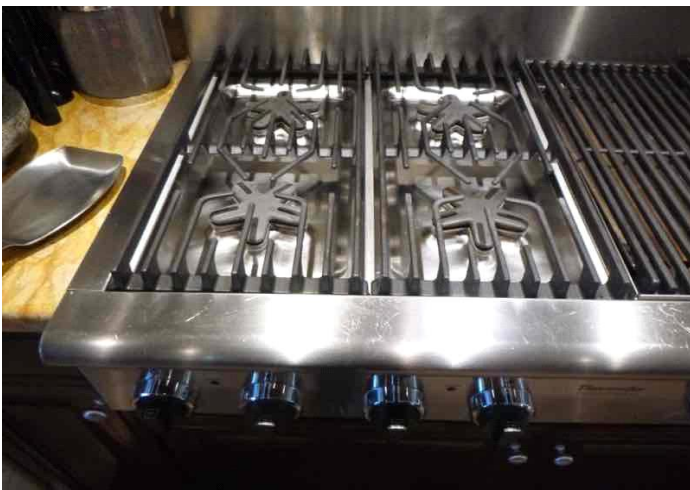
Photo 11

18. One of the burners on the cooktop/range top is inoperative or will not light. The pilot light or electronic igniter is in suspect. For attention to the conditions noted and/or cost estimates, if necessary, we recommend the advice of a qualified appliance technician. (See Photo 11)

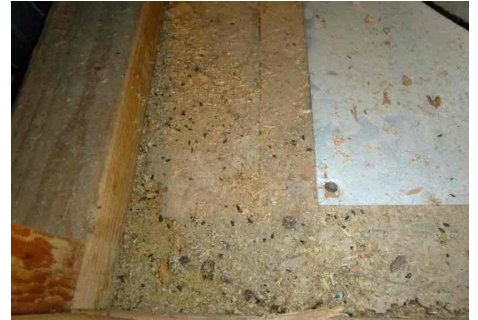
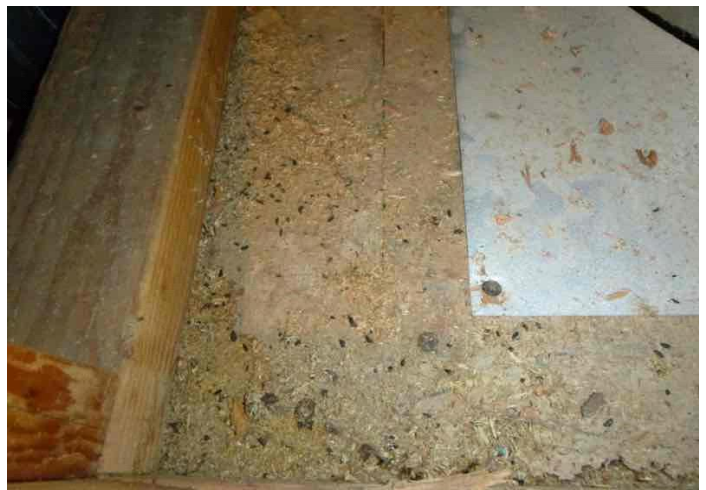
Photo 18

19. Evidence of vermin activity was observed within the structure. It is likely this evidence will extend into inaccessible areas. The owner is advised to contact the appropriate trade for further evaluation and remedial measures if necessary. (See Photo 18)

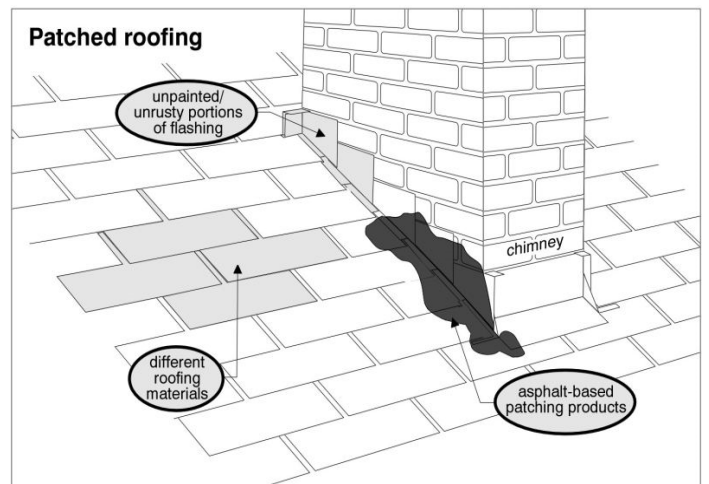
Illustration 2J

- 5. Debris was noted inside the gutters at the atrium and various areas. We recommend the downspouts and gutters be cleaned out.
- 6. Prior repairs to the roofing are evident. For further evaluation of these repairs we recommend a licensed roofing contractor be consulted. (See Illustration 2J)

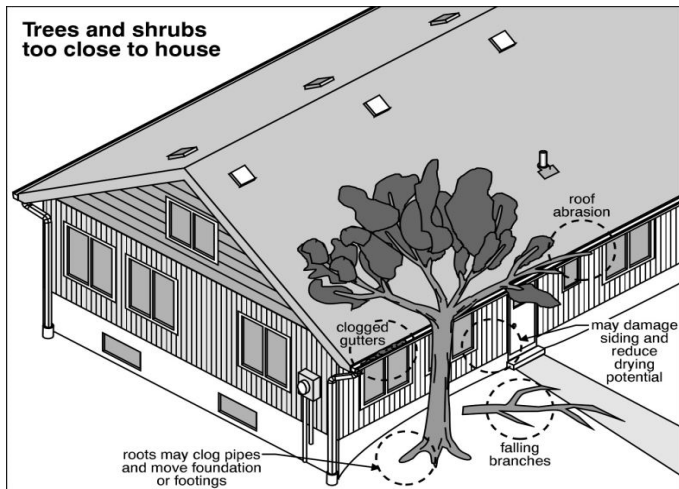
Illustration 3T

10. The tree proximity at the front and right side could disrupt drainage pipes, cause mechanical damage to the exterior of the house or influence the foundation over time. For additional information and recommendations we recommend appropriate trades be consulted. (See Illustration 3T)

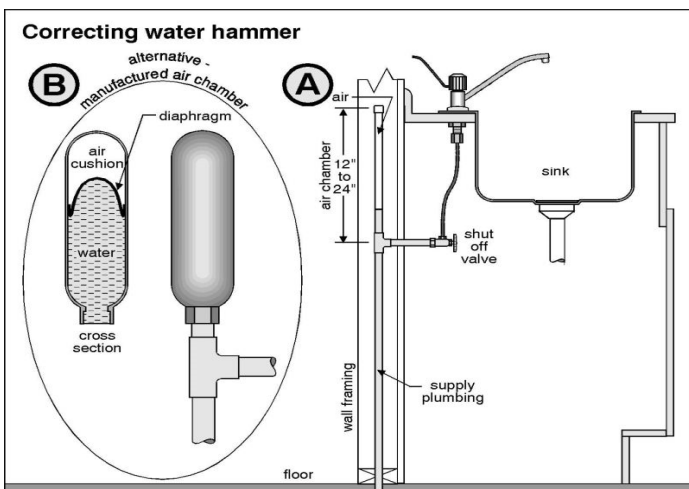
Illustration 8G

- Water hammer in the supply pipings at the downstairs guest bathroom bathtub and master bathroom hydro tub was observed when operating plumbing fixtures. Over time, this condition can influence the integrity of pipe connections. Closing valves and faucets slowly is one approach to avoiding water hammer. Better securing pipes where possible and installing air chambers (shock absorbers) at the risers to fixtures would be another solution. (See illustration 8G)

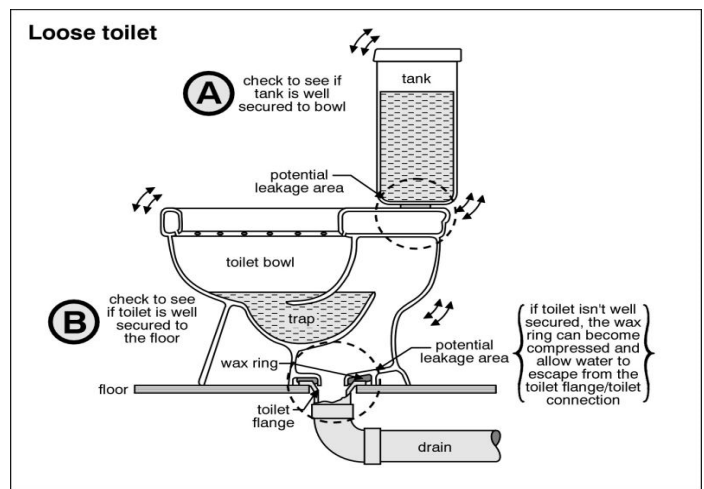
Illustration 8J

- The toilets at the upstairs front right guest bathroom and upstairs hall guest bathroom are loose and should be properly re-secured, tightened and caulked. (See Illustration 8J)
