WOOD DESTROYING PESTS AND ORGANISMS INSPECTION REPORT

| Building No. 29428 | Street Shasta Dr. | City Cold Springs | Zip 95335 | Date of Inspection 04/09/26 | Number of Pages 1 of 10 |

Report # 7345

General Description:
Multi level, single family residence, wood frame construction, wood siding, composition roof.

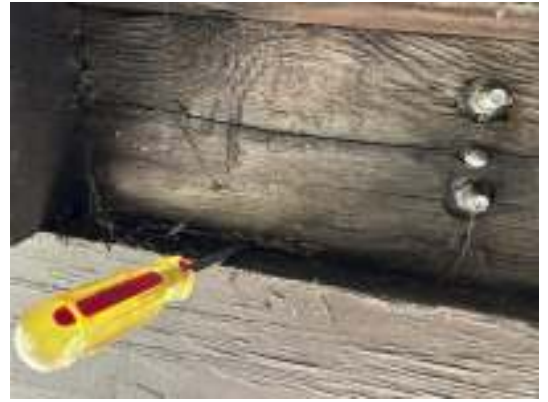
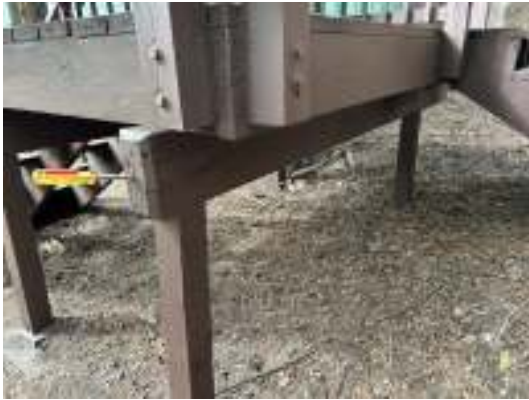
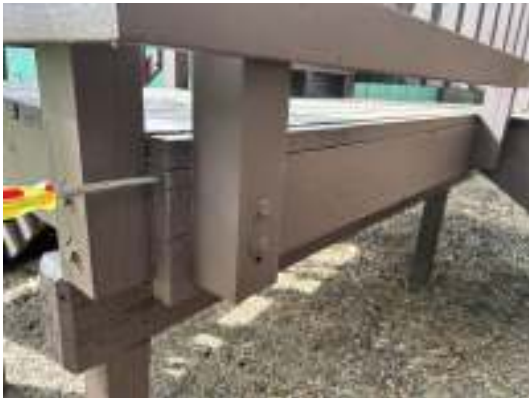
9A.
Wood decay fungus is infecting and damaging the front deck girders and framing.

RECOMMENDATION: Remove and replace up to 18 linear feet of damaged 4x8 girder and up to 18 linear feet of damaged 2x10 framing; price for repairs does not include paint / stain. Treat all exposed wood members with (Tim-bor) disodium octaborate tetrahydrate to arrest the growth of wood decay fungi. All chemicals are to be applied by a state licensed applicator in accordance with manufacturer labels. *Upon request, prices can be given for others to perform repairs and Streamline Inspections to chemically treat only.

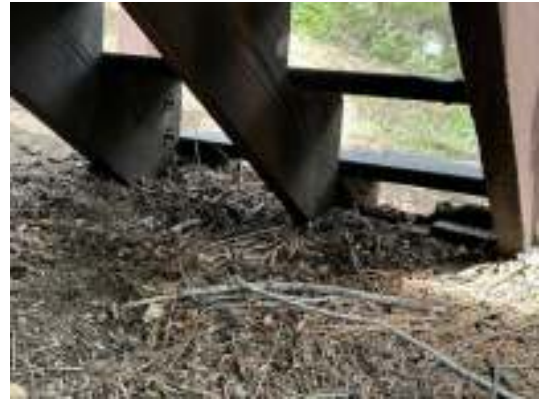
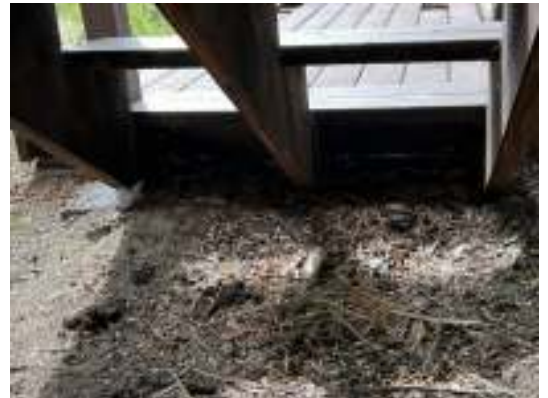
Earth to wood contacts are present at the base of both of the front deck staircases; this can allow wood destroying pests and organisms access to the wood members.

RECOMMENDATION: Regrade the soil to break the earth to wood contacts; owner is advised to maintain grade. *Note: If damage is exposed upon regrading, any/all findings, recommendations and prices for additional scope of work will be given in a supplemental report.

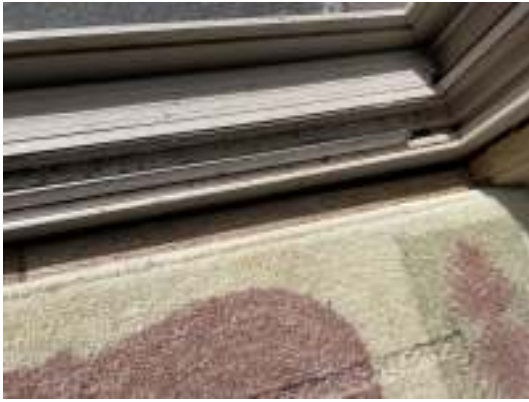
10A:

A void was noted between the main level sliding glass door threshold and the tile flooring. This can allow excessive moisture to accumulate at the adjacent wood members.

RECOMMENDATION: Seal void.

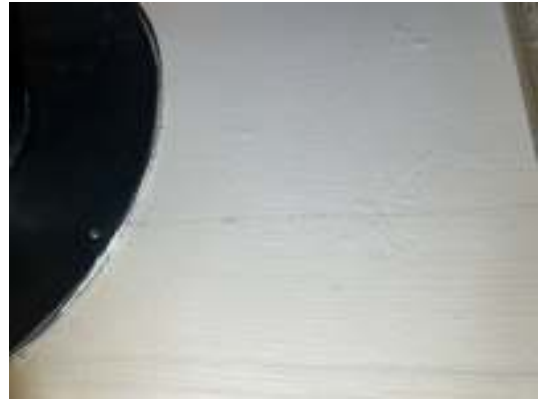
10D:

NOTE: Moisture stains are present at the downstairs wall below wood burning stove pipe; this appears to be from a previous leak.

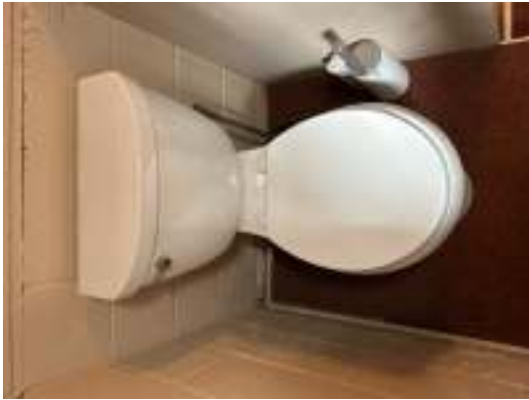
10B:

Toilet was found to be loose in the downstairs bathroom, potentially compromising a wax ring/gasket, if present. It is unknown whether or not a wax ring or rubber ring/gasket is present, if toilet is loose due to an improperly fastened plumbing flange, or if a leak is present.

RECOMMENDATION: Remove toilet and reset with a new rubber gasket, if necessary, or securely reset toilet if a rubber gasket is present.

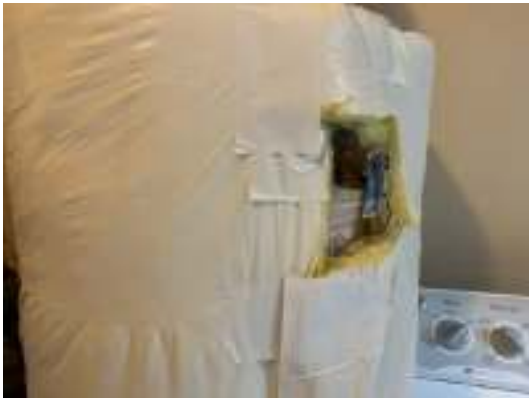
10C:

The water heater pressure relief valve exits in the interior; this can create excessive moisture conditions in the subarea.

RECOMMENDATION: Extend valve to the exterior as necessary.
