WOOD DESTROYING PESTS AND ORGANISMS INSPECTION REPORT

Building No. 12650	Street LAKESHORE DR. #155	City LAKESIDE 92040	Zip 92040	Date of Inspection 03/17/23	Page 1 of 4
  Mt. Helix Pest and Termite Control 4401 Twain Ave. Suite 29 San Diego, CA 92120 Phone: 619-584-6794 Fax: 619-584-3864 www.mthelixpestcontrol.com Registration # PR3799			  Report # 2032471 LI		
Ordered by: RICHARD MENSER 12650 LAKESHORE DR. #155 LAKESIDE 92040, CA SEABEE9112002@YAHOO.COM H: 619-647-9674		Property Owner and/or Party of Interest: RICHARD MENSER 12650 LAKESHORE DR. #155 LAKESIDE 92040, CA SEABEE9112002@YAHOO.COM H: 619-647-9674		Report sent to: THE HELM MANAGEMENT COMPANY WILL REILAND xt.122 4668 NEBO DR. STE. #A LA MESA, CA 91942 WILL@HELMMANAGEMENT.COM P: 619-589-6222	
COMPLETE REPORT <input type="checkbox"/> LIMITED REPORT <input checked="" type="checkbox"/> SUPPLEMENTAL REPORT <input type="checkbox"/> REINSPECTION REPORT <input type="checkbox"/>					
General Description: SECOND FLOOR CONDOMINIUM UNIT				Inspection Tag Posted: SINK

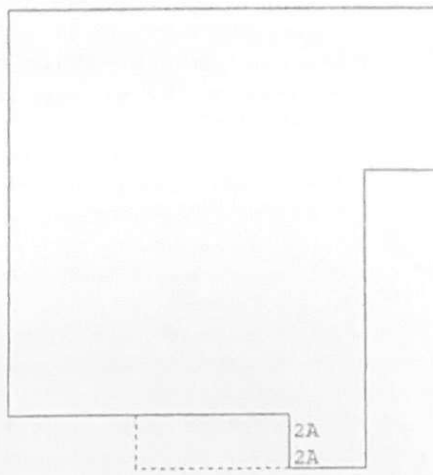
Evidence of Drywood Termites were noted at the DOOR JAMB AND SURROUNDING WALL FRAMING AT BALCONY STORAGE.

Locally treat for the control of drywood termites. Treat with a registered termiticide (TIM-BOR, PREMISE FOAM OR TERMIDOR SC). Cover or remove termite fecal pellets in accessible areas. There is a one year guarantee of the areas treated. Local treatment is not intended to be an entire structure treatment method. If infestations of wood-destroying pests extend or exist beyond the area(s) of local treatment, they may not be exterminated.
