WOOD DESTROYING PESTS AND ORGANISMS INSPECTION REPORT

BUILDING NO.	STREET, CITY, STATE, ZIP	Date of Inspection	No. of Pages
3914	Aqua Vista Street, Oakland CA 94601	8/11/2025	11

EAST VALLEY TERMITE COMPANY
2273 Fourth Street, Livermore, CA 94550
Tel: (925) 443-6040 or (510) 538-8744
Fax: (925) 443-0147 or (800) 443-5890
Email: eastvalleytermite@sbcglobal.net

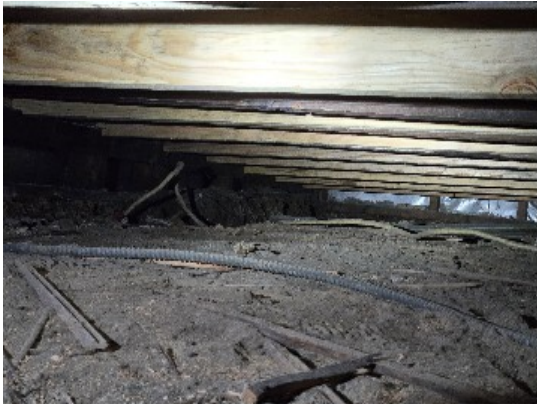
- ITEM 1A Subarea clearance is minimal between the wood members and soil at the area indicated on the diagram.
REC: If interested parties desire further inspection, we will return to the property after soil has been lowered and inspect this area. This will be done upon request and at an additional charge. We will issue a Supplemental report with the findings, recommendations and additional costs, if any.

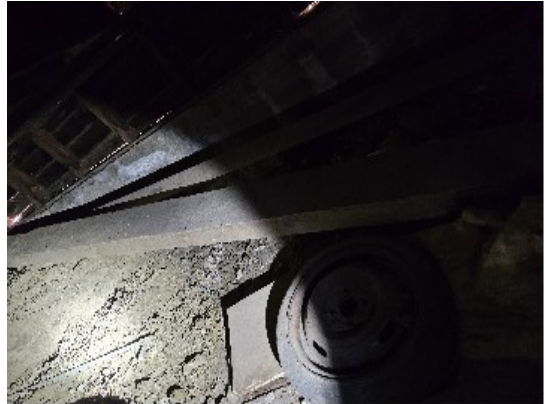
***** This is a Section 1 Item *****
- ITEM 1C There is excessive fungus infected cellulose debris noted on sub-area soil.
REC: Remove and dispose of cellulose debris.

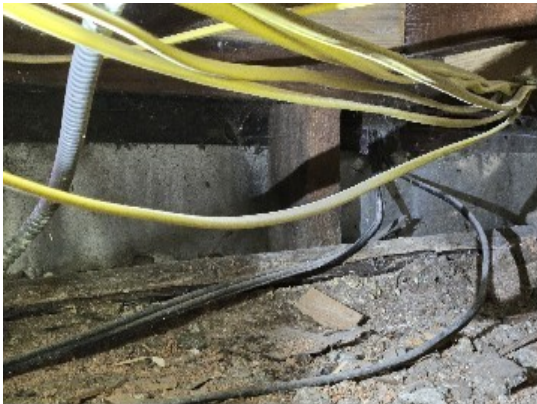
***** Unknown Further Inspection Recommended *****
- ITEM 1B The mudsill is fungus damaged.
REC: Remove the damaged wood members and replace with new material as necessary.
NOTE: THIS REPAIR WILL BE ATTEMPTED FROM BLOW, IF THIS REPAIR CANNOT BE COMPLETED IN THIS MANNER OR IF DAMAGE EXTENDS INTO ANY ADJACENT AREA, A SUPPLEMENTAL REPORT WILL BE ISSUED STATING FINDINGS, RECOMMENDATIONS AND ADDITIONAL COST.

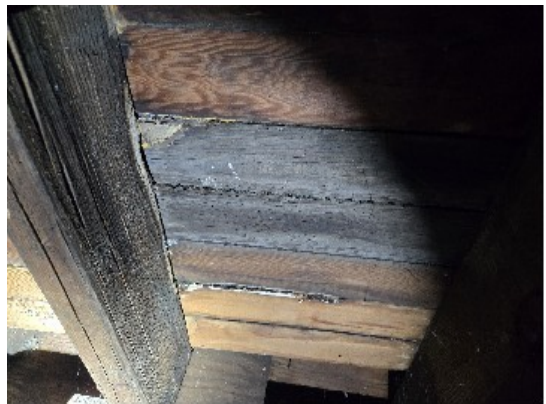
***** Information Item *****
- ITEM 1E Fungus damage was found below the front porch at the area indicated on the diagram.
REC: Remove the damaged wood members and replace with new material as necessary.
NOTE: THIS REPAIR WILL BE ATTEMPTED FROM BELOW IF THIS REPAIR CANNOT BE COMPLETED IN THIS MANNER OR IF DAMAGE EXTENDS INTO ANY ADJACENT AREA, A SUPPLEMENTAL REPORT WILL BE ISSUED STATING FINDINGS, RECOMMENDATIONS AND ADDITIONAL COST.

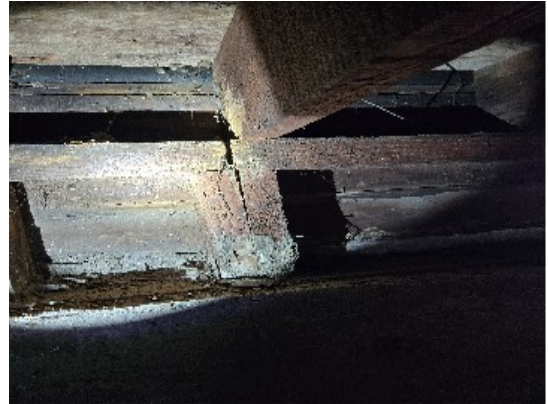
***** This is a Section 1 Item *****
- ITEM 1F Evidence of past subterranean termite activity was noted at this property. No current activity was detected to warrant any chemical treating in our opinion. We do not guarantee this property against a subterranean termite infestation.

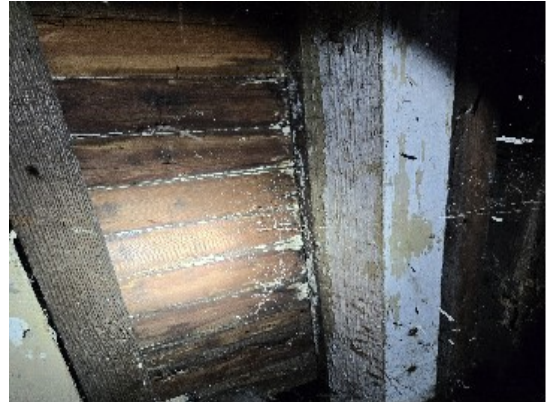
***** Information Item *****
- ITEM 1G Surface fungus was found on the substructure framing at the area indicated on the diagram.
REC: Wire brush the infected area and chemically treat the fungus with Tim-Bor to inhibit further infection. (This chemical application requires a licensed applicator.)

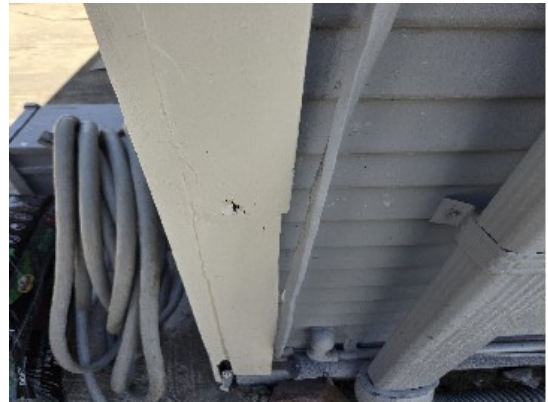
ITEM 11D The window and house trims at the area indicated on the diagram are fungus damaged.
REC: Remove damaged wood members and replace with new materials as necessary to eliminate fungus infection.

NOTE: IF DAMAGE EXTENDS INTO ANY ADJACENT AREA, A SUPPLEMENTAL REPORT WILL BE ISSUED WITH OUR FINDINGS, RECOMMENDATIONS AND ADDITIONAL COSTS.

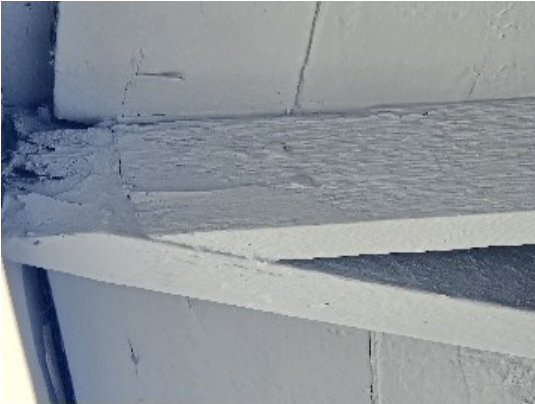
ITEM 11E The wood member(s) of roof eaves is fungus damaged at the areas indicated on the diagram.
REC: Remove damaged wood members and replace with new materials as necessary to eliminate fungus infection. One coat primer only. No painting included. Our job quotation for this item does not include patching the disturbed areas of the roof covering/gutters or re-installing gutters removed to facilitate repairs, if any.

NOTE: UPON COMPLETION OF WOOD REPAIR, OWNER TO ENGAGE A LICENSED ROOFER/GUTTER FIRM TO REPAIR OR REPLACE DISTURBED ROOF COVERING OR GUTTERS, IF ANY.

NOTE: IF DAMAGE EXTENDS BEYOND ADJACENT AREAS, A SUPPLEMENTAL REPORT WILL BE ISSUED STATING FINDINGS, RECOMMENDATIONS AND ADDITIONAL COST.
