April 21, 2025

Subject: Visual On-Site Evaluation (OSE) Report for the Subject Property Located  
at 1234 Oribia Road, Del Mar, CA

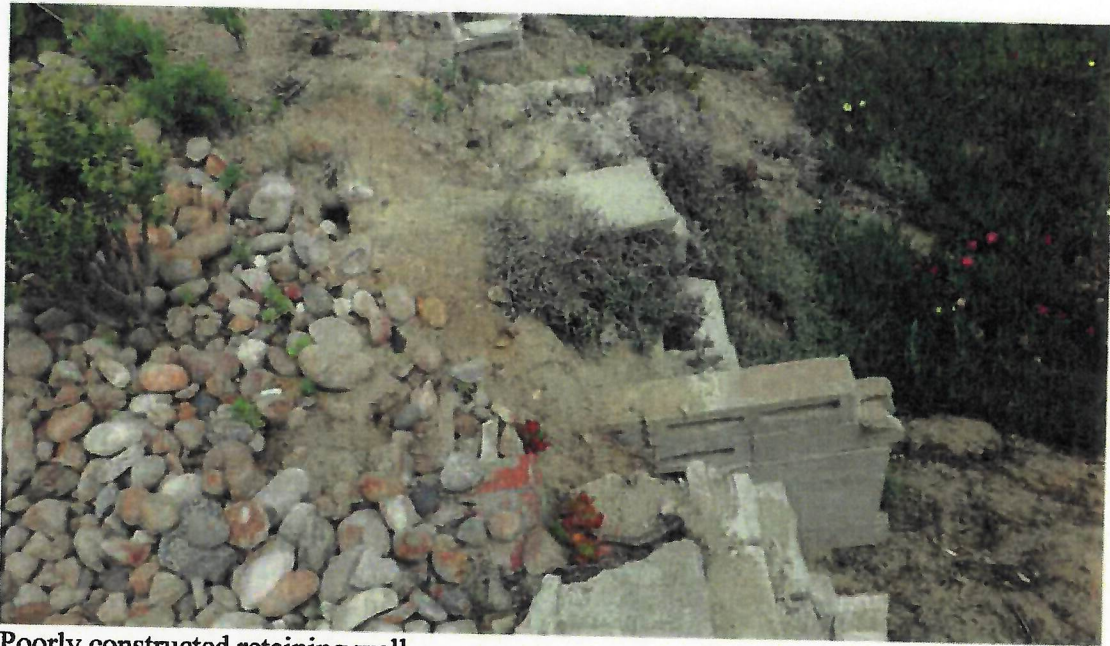
10. Confined planters were noted adjacent to the residence.
11. A retaining wall system was noted at top of slope. The retaining wall consists of stacked, unreinforced blocks. The retaining wall is a safety issue.

Poorly constructed retaining wall

The rear yard wood deck and retaining wall are unsafe. The wood deck has deteriorated due to general aging and exposure. The retaining wall was poorly constructed.

2. The rear yard wood deck and retaining wall shall be removed and replaced in conformance with the City of San Diego standards.
3. The brick flatwork shall be removed, and the upper soils shall be compacted to greater than 95% of optimum density. New flatwork with an incorporated area drain system shall be installed.

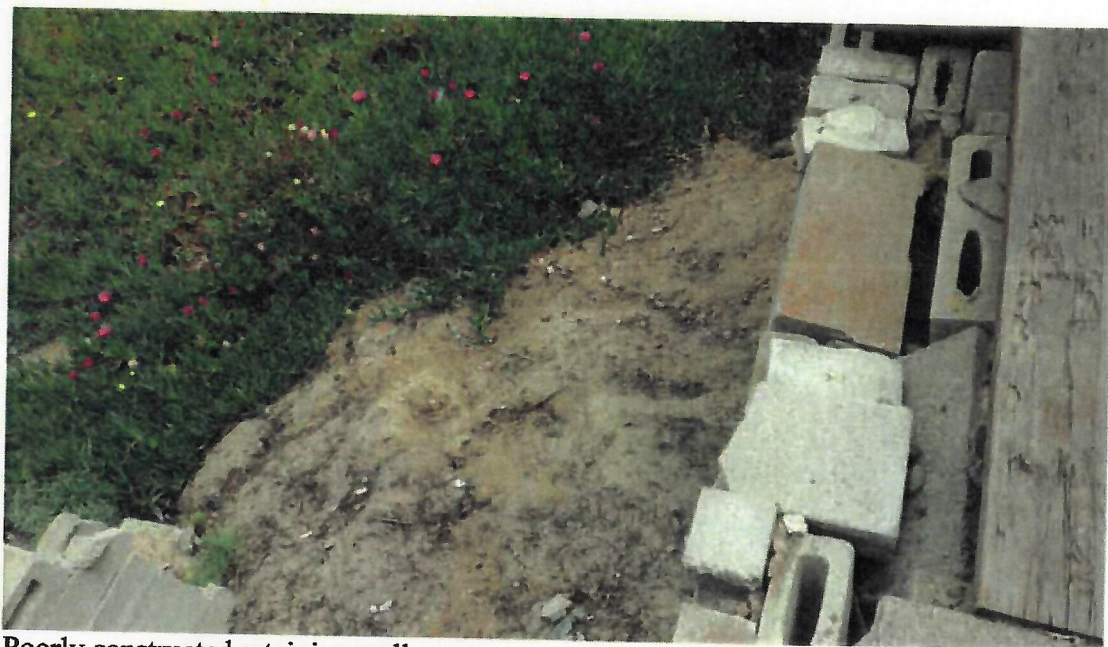
Poorly constructed retaining wall

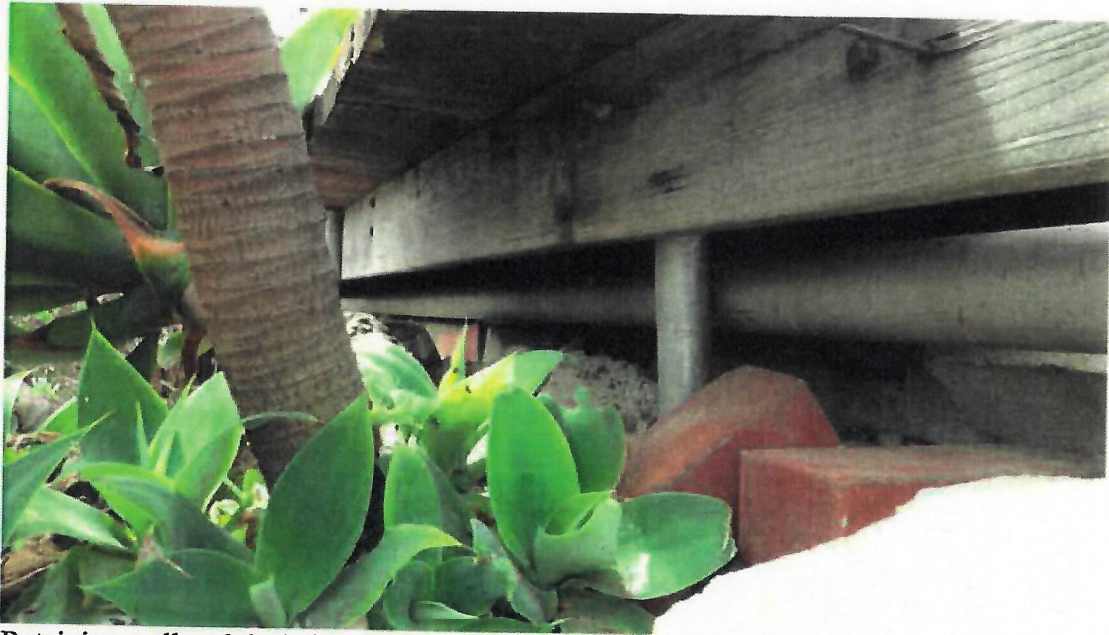
8. A wood deck was noted along the descending slope. The wood deck is substantially deteriorated and is a safety issue.
9. A poorly constructed French drain and water spigot was noted along the wood deck post.

Retaining wall and deck framing

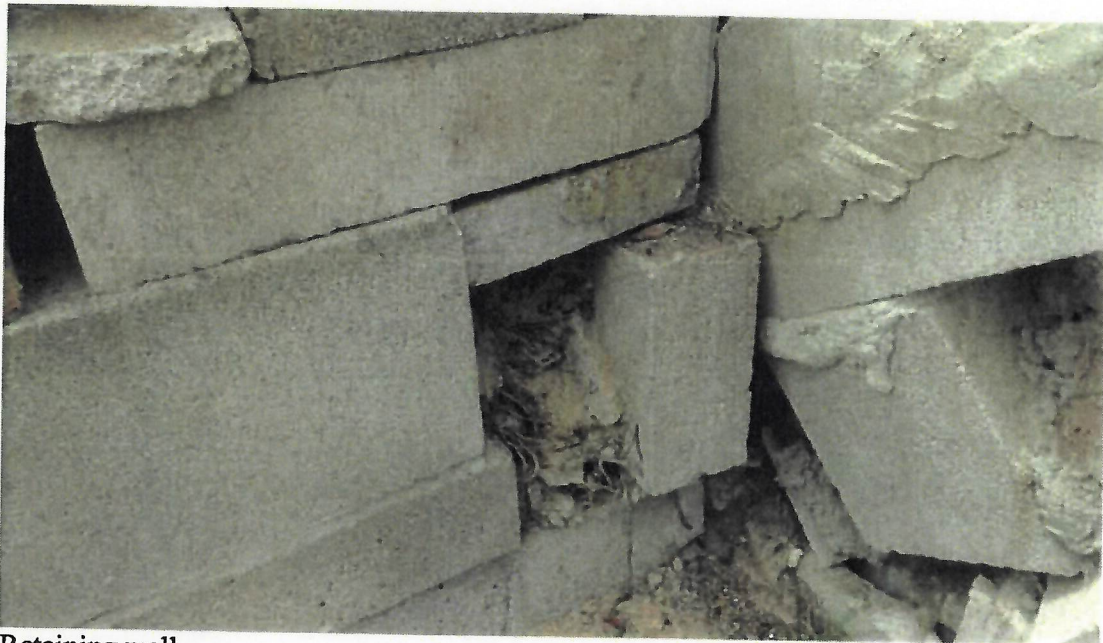
Retaining wall

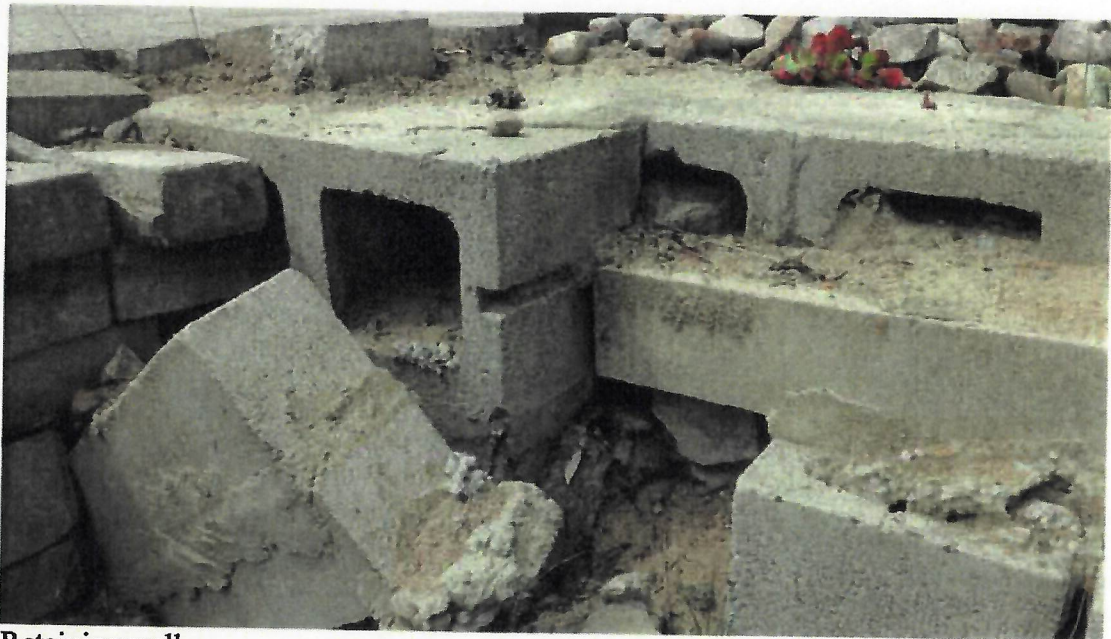
Retaining wall

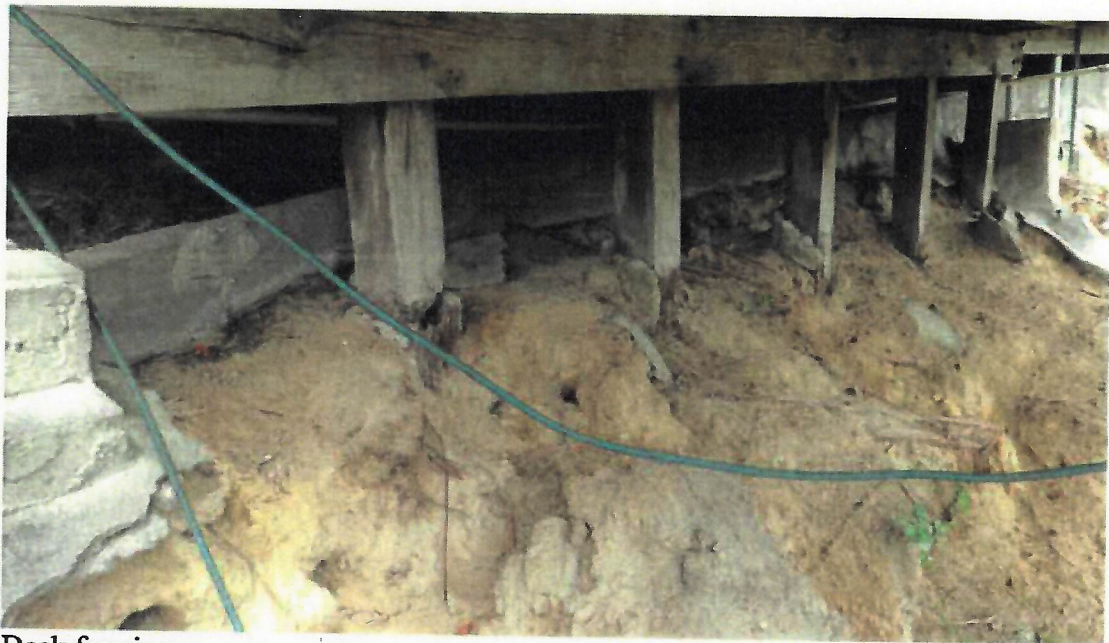
Deck framing

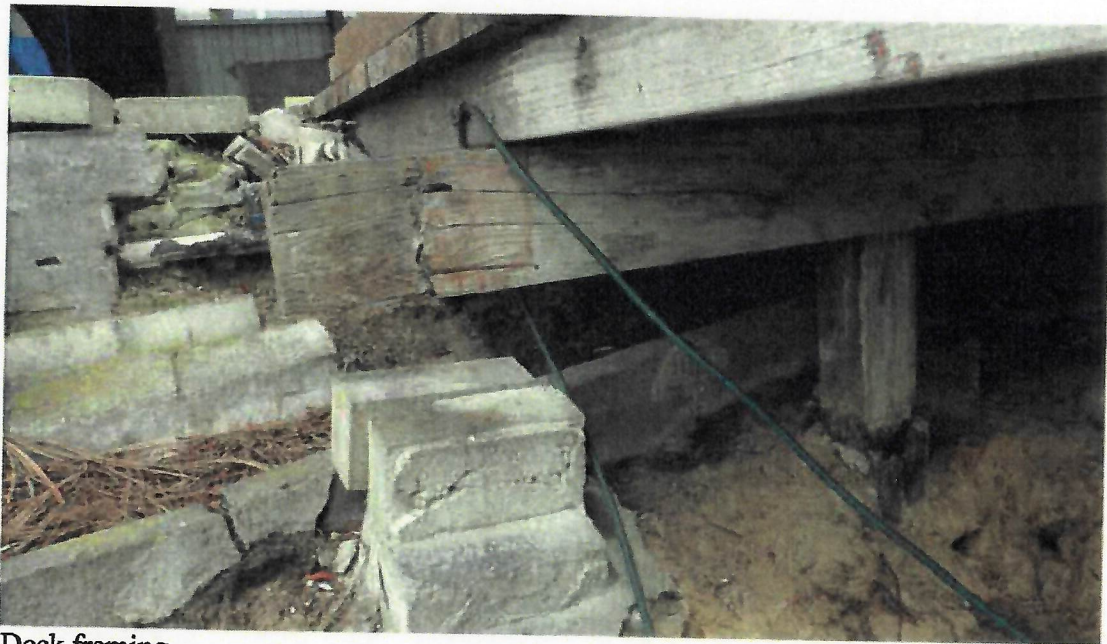
Deck framing

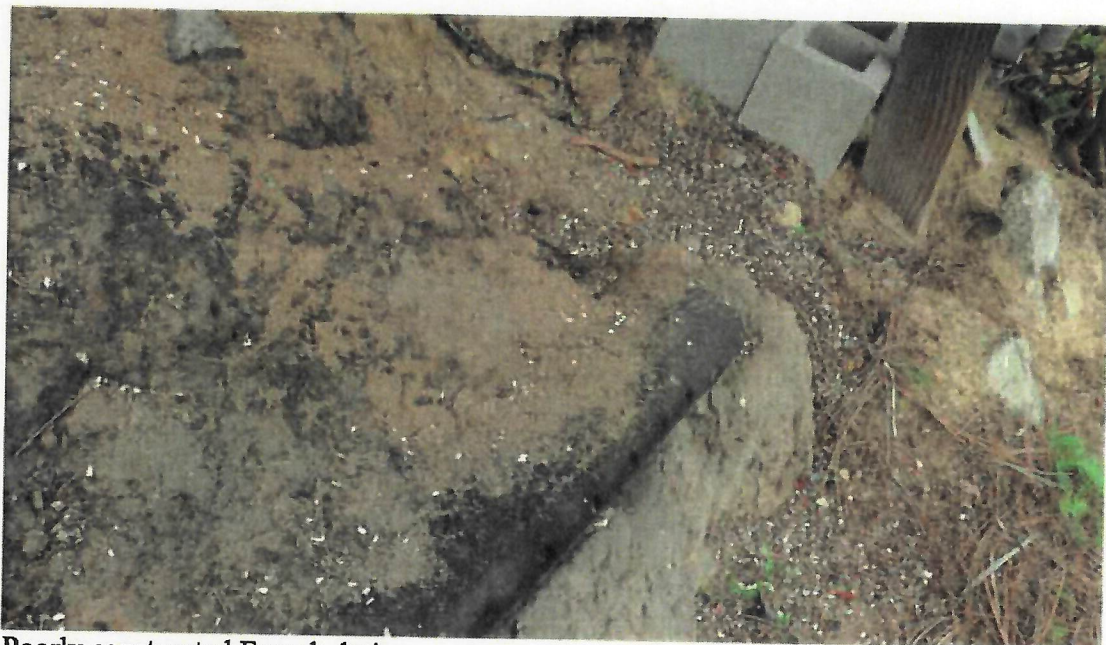
Poorly constructed French drain

4. A drainage system shall be designed and installed around the residence. The drainage system shall discharge water away from the residence, towards the lower level bench. An energy dissipitator (rip rap) shall be used to reduce erosion.

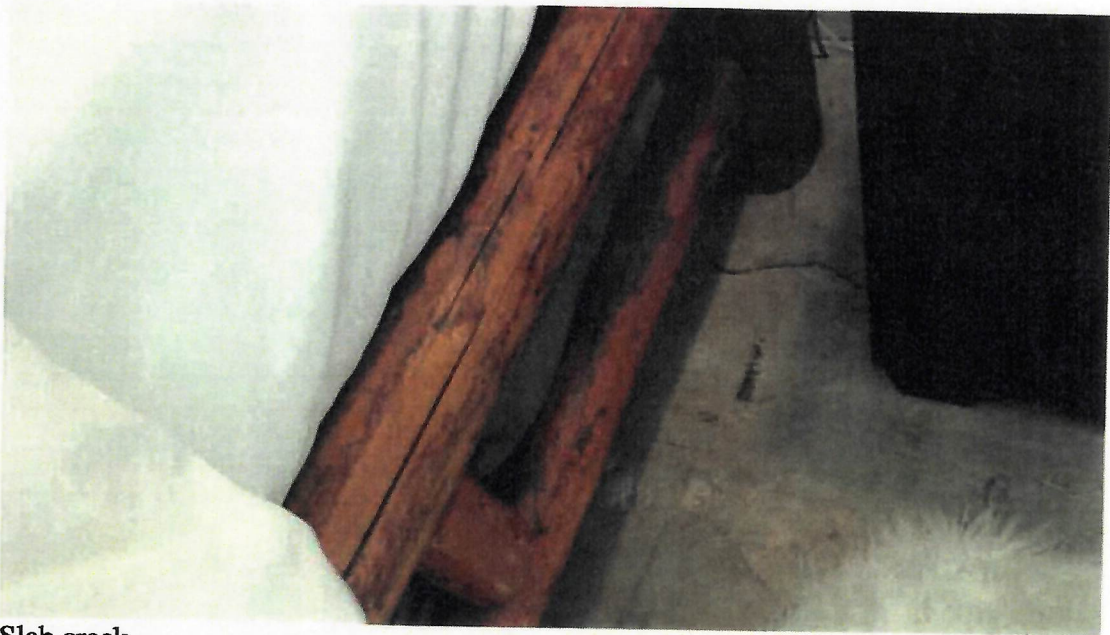
- a. Sections of the residence slab were exposed. Other sections were covered with floor coverings.
  - b. Minor cracks in the residence slab were noted. The exposed slab cracks had minimal vertical differential and maximum horizontal separation of  $\frac{1}{4}$ ".

Slab crack

The residence slab on grade foundation system has several cracks. We could not determine if the cracks continue through the footings.

1. The exposed floor slab cracks shall be repaired in conformance with the following:
  - Floor slab cracks, 1/32-inch to 1/8-inch wide, shall be v-notched and repaired by pressure injection with engineered epoxy cement that is stronger than the existing concrete. Floor slab cracks less than 1/32-inch wide shall be surface sealed with epoxy cement.

- Floor slab cracks more than 1/8-inch wide but less than 3/8-inch wide shall be repaired by rebar crack stitching, whereby 2-foot lengths of #5 rebar are placed in 1 inch wide and 1-1/2-inch deep slots saw cut or drilled across the crack at a spacing of 2 feet maximum along the alignment of the crack, and epoxy cemented in place. The remainder of the crack shall then be pressure injected or cavity filled with engineered epoxy cement that is stronger than the existing concrete.

- Floor slab cracks more than 3/8-inch wide, or with a vertical crack displacement in excess of 1/8-inch, shall be repaired by saw cutting on either side of the crack for a minimum total width of 3 feet, and replacing the saw-cut section with a new slab section. The new slab section should be at least 6

inches thick and reinforced with #3 rebar spaced at 18 inches on center in two directions and placed at mid-height in the slab. The new slab section shall be doweled to the existing slab with #3 rebar spaced at 18 inches apart horizontally and extending at least 6 inches into the adjacent slab. New slab sections shall be underlain by 2 inches of clean sand over a 6-mil visqueen moisture barrier placed on grade.

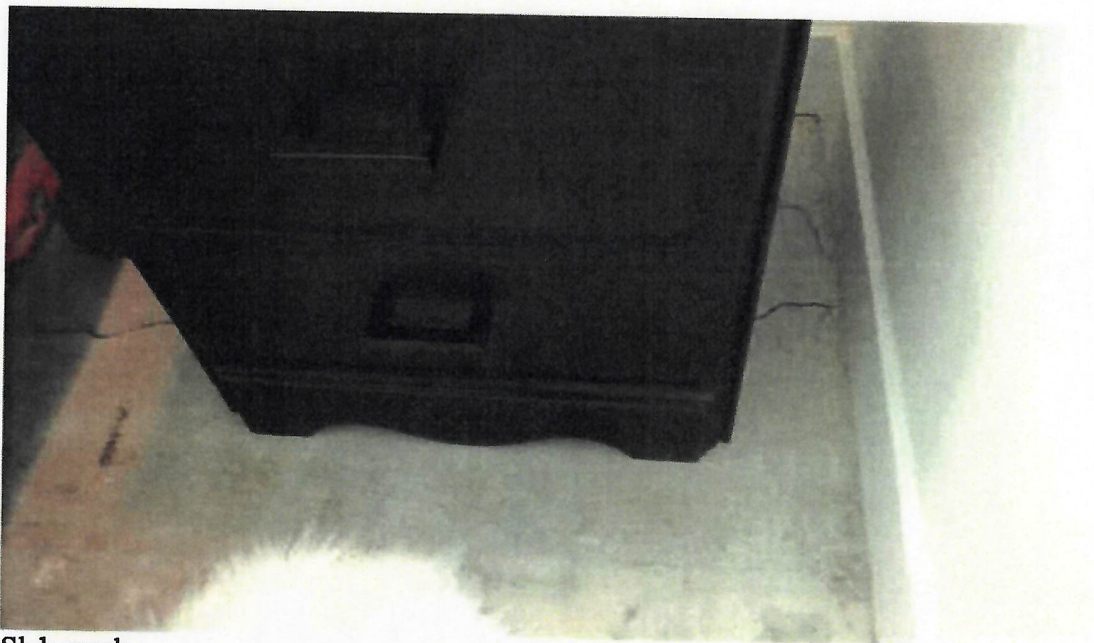
Slab crack

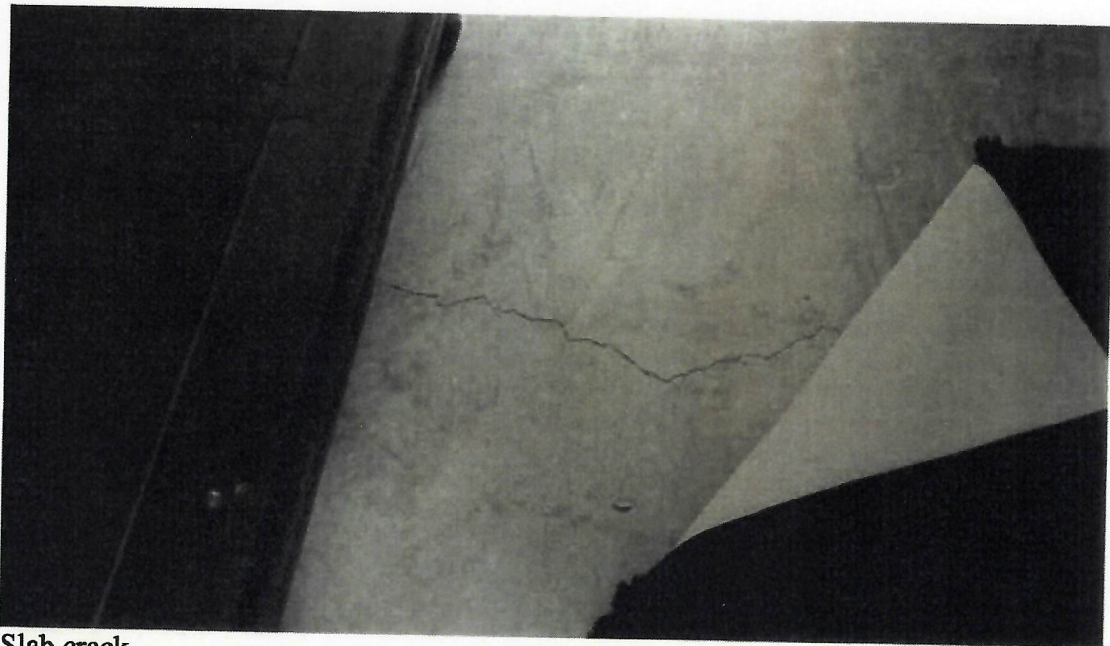
Slab crack

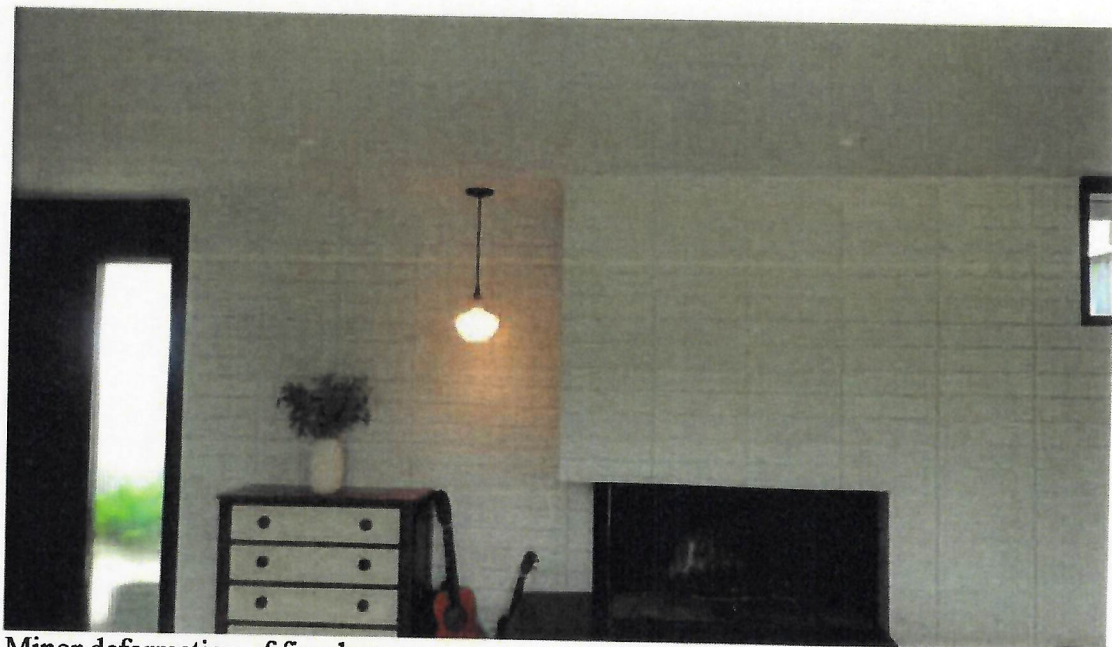
- c. The residence windows and doors appear to be relatively square and level.
  - d. No substantial interior drywall or plaster cracks were noted.
  - e. Minor deflection of the masonry fireplace was noted. No substantial crack in the masonry was noted.

Minor deformation of fireplace area

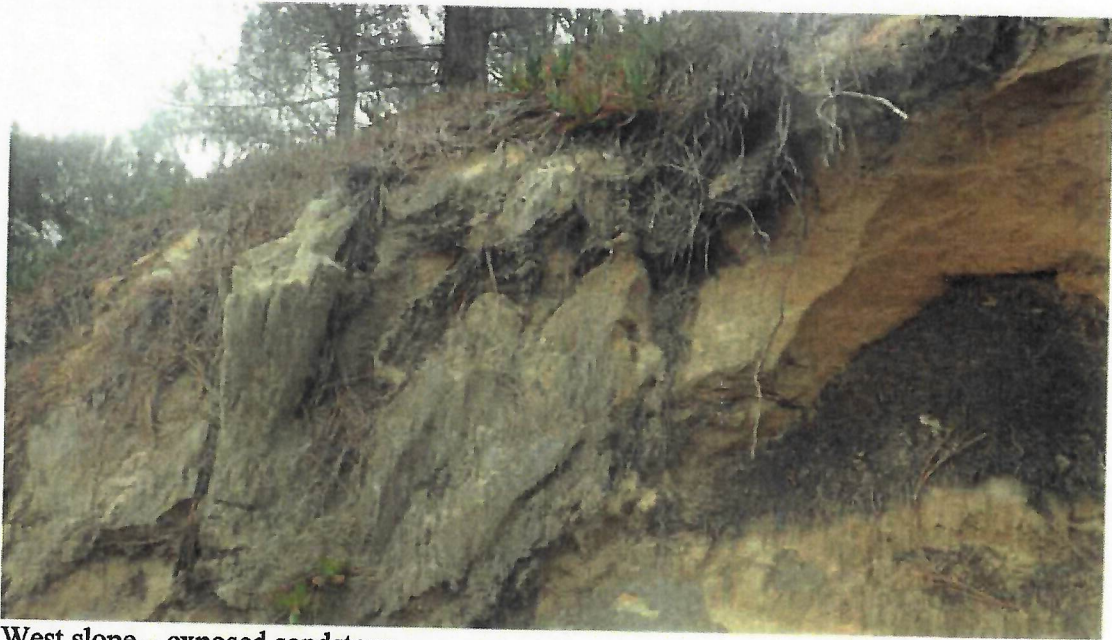
5. To the west of the residence is a soil vertical cut - ascending. The off-site property to the west is at a higher elevation than the subject property. The vertical cut exposed a competent sandstone. Erosional debris was noted at bottom of slope. The residence is approximately ten feet from the west vertical cut.

West slope – exposed sandstone

The exposed soils from the vertical cuts is Torrey sandstone. The exposed sandstone appears competent. However, the sandstone is vertical and will be susceptible to erosion and surficial slope failures.

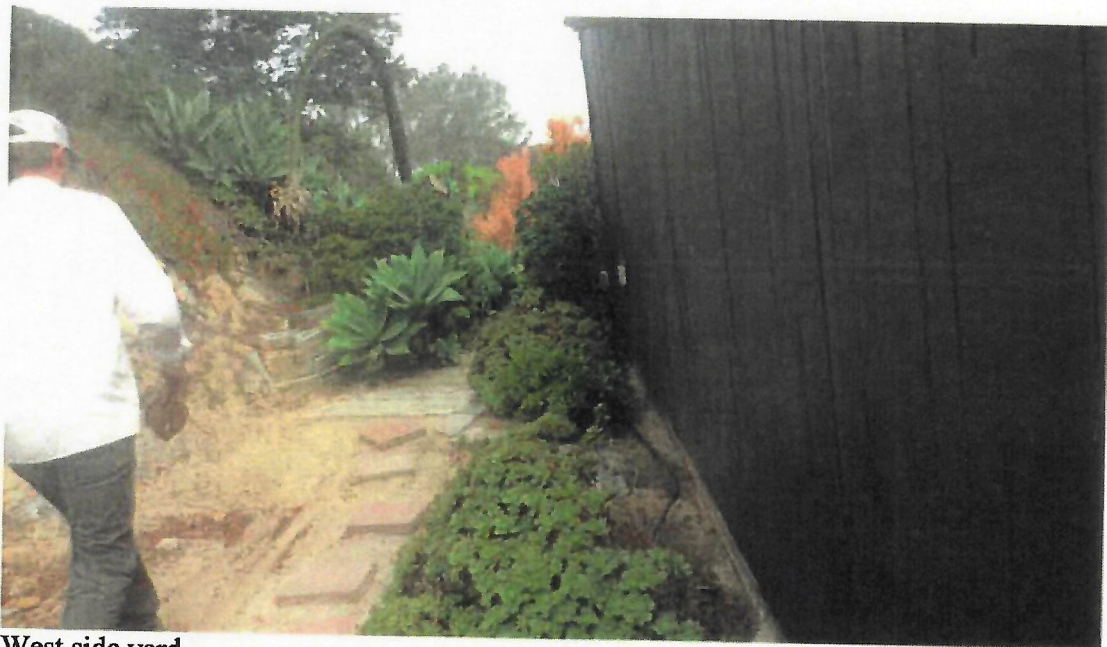
West side yard

The west vertical cut is adjacent to the residence. The residence will be subject to erosional debris and runoff from the uphill neighbor. Due to the proximity of the vertical cut to the residence, periodic clearing of debris materials will be required.

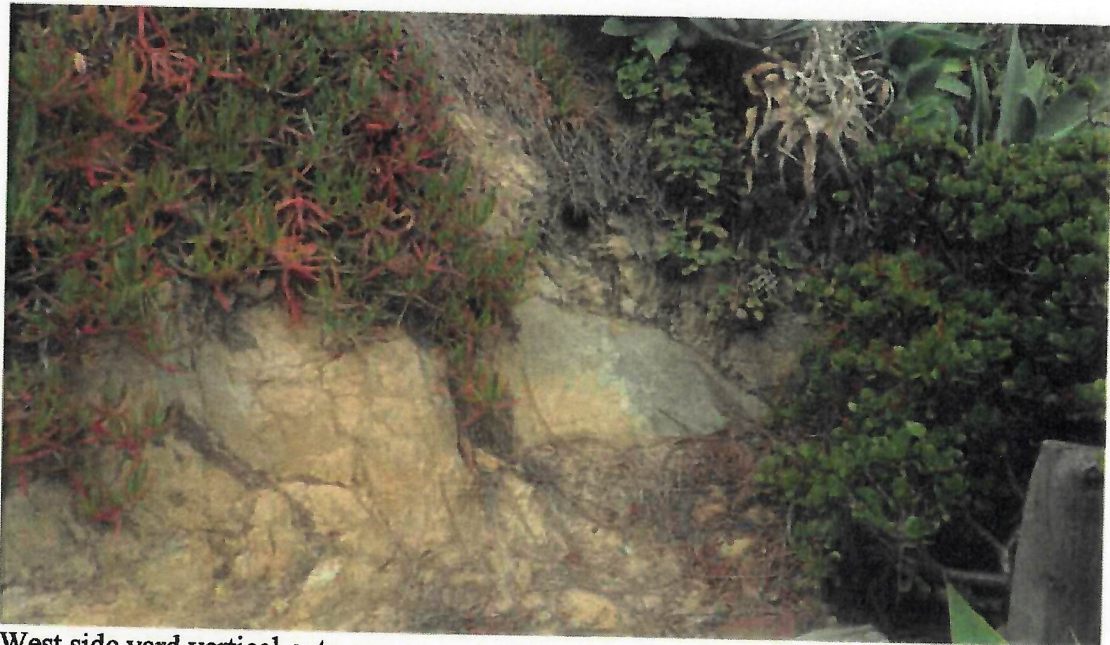
West side yard vertical cut

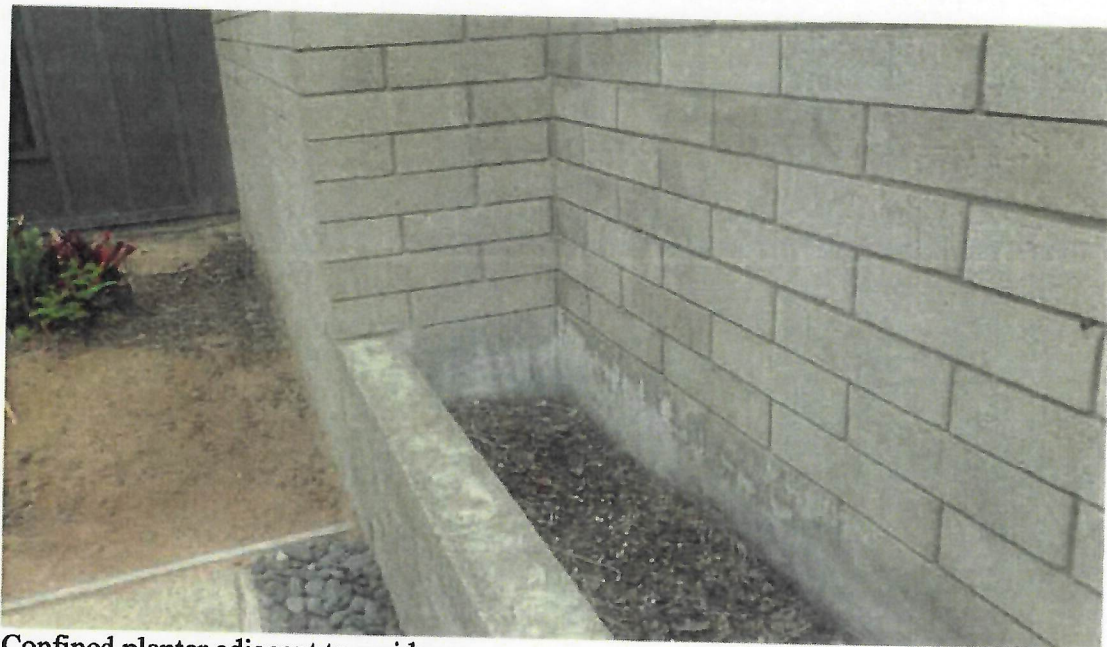
Confined planter adjacent to residence

6. Wet utility lines shall be checked for leaks and mitigated as necessary.
7. Irrigation around the structure shall be minimized.
8. If concrete flatwork is installed it shall conform to the following:

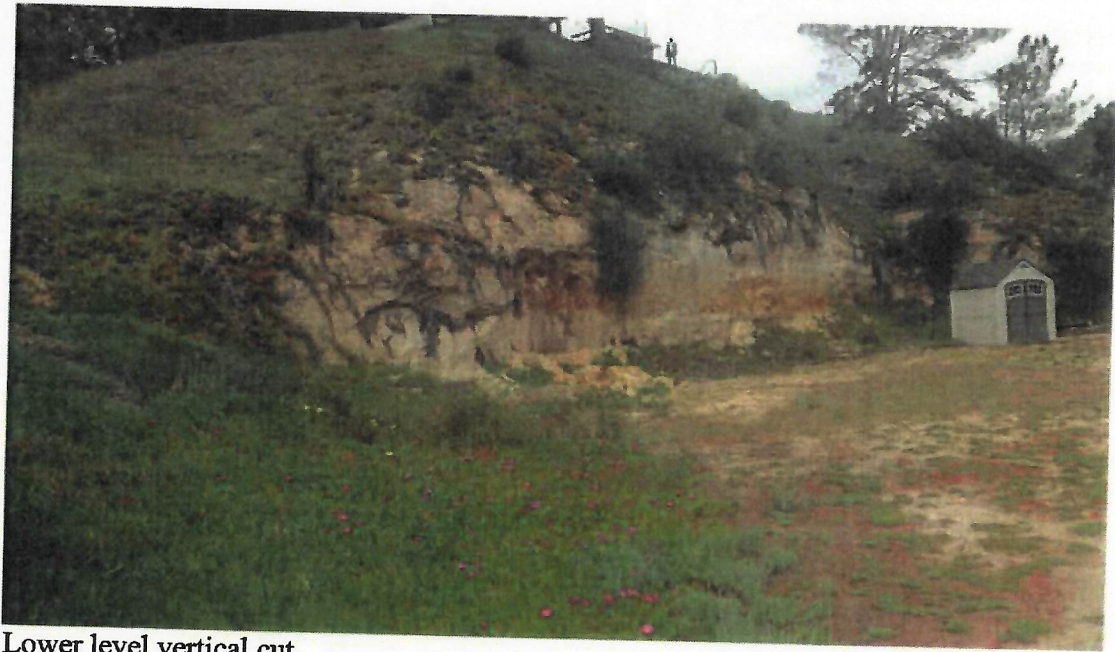
6. To the east of the residence is a soil vertical cut – descending. The vertical cut is approximately fifty feet from top of slope. The vertical cut exposed a sandstone. The sandstone has been failing in blocks. Vegetation growth was noted in the sandstone fractures.

Lower level vertical cut

The east vertical cut is a substantial distance away from the residence. We anticipate movement of these soils. However, we do not anticipate movement of the vertical cut to substantially affect the residence.

5. A biologist shall be consulted to determine the appropriate slope stabilizing vegetation for the subject property or if the existing vegetation is adequate. Slope vegetation shall be established and maintained.
