Date of Number of Building No. / Street City Zip Pages Inspection 3535 Linda Vista Drive spc 158 San Marcos 92078 A LICENSED PEST CONTROL 1331 Morena Blvd OPERATOR IS AN EXPERT IN Suite 300 HIS/HER FIELD. QUESTIONS San Diego, CA 92110 RELATIVE TO THIS REPORT 1.800.570.2847 SHOULD BE REFERRED TO Registration #436 HIM/HER. Report #: 78818 Report sent to: Ordered by: Property Owner and/or Party of Interest Jan Carlson Garrett and Lutz Garrett Jan Carlson Garrett and Lutz Garrett Jan Carlson Garrett and Lutz Garrett 3535 Linda Vista Drive spc 158 3535 Linda Vista Drive spc 158 3535 Linda Vista Drive spc 158 San Marcos, CA 92078 San Marcos, CA 92078 San Marcos, CA 92078 Complete Report Limited Report Supplemental Report Reinspection Report Inspection Tag Posted: General Description: Closet Occupied Mobile One Story No Garage Other Tags Posted: Raised Foundation with Composition Roof An inspection has been made of the structure(s) shown on the diagram in accordance with the Structural Pest Control Act. Detached porches, detached steps, detached decks and any other structures not on the diagram were not inspected. **Further** Subterranean Drywood Other Fungus/Dryrot Findings X Termites Te

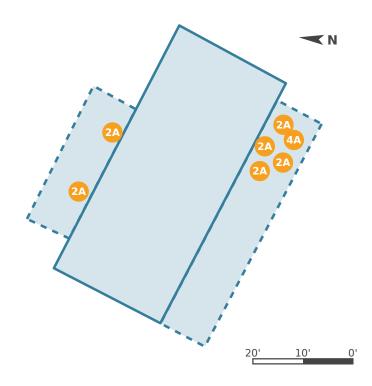
Evidence of drywood termites found in areas marked on Diagram.

Water damage found in areas marked on diagram. Plywood on deck

Cover entire structure(s) and fumigate with Sulfuryl Fluoride for the elimination of drywood termites. Chloropicrin will be used as a warning agent. Cover or remove accessible termite pellets. Lloyd Termite Control Company assumes no responsibility for damage to any plant life or roofing caused by fumigation operation.

Remove and replace plywood
