# WOOD DESTROYING PESTS AND ORGANISMS INSPECTION REPORT

| BUILDING NO.<br><b>4140</b> | STREET, CITY, STATE, ZIP<br><b>Bandini Street, San Diego CA 92103</b> | Date of Inspection<br><b>9/2/2026</b> | No. of Pages<br><b>4</b> |
| Firm Registration No. <b>PR 1164</b> | | Report No. <b>452403</b> | Escrow No. |
| General Description:<br>One story, single family residence, frame and wood construction, composition roof, attached garage | | Inspection Tag Posted:<br>Attic | |

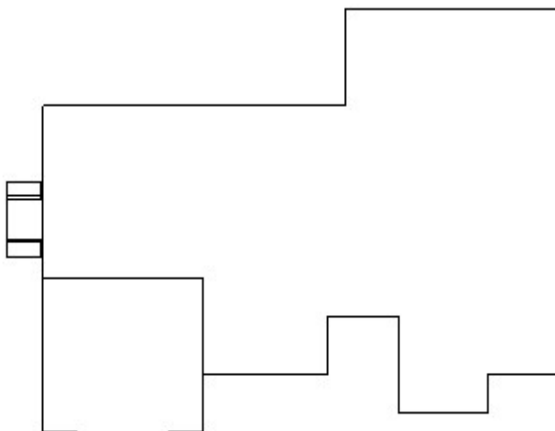
Diagram not scale, clear report.
