Home Inspection Report

98 Madonna Lane Newbury Park, CA

Prepared For: Anne Obriecht
Inspected On Wed, Nov 6, 2024 at 8:47 AM

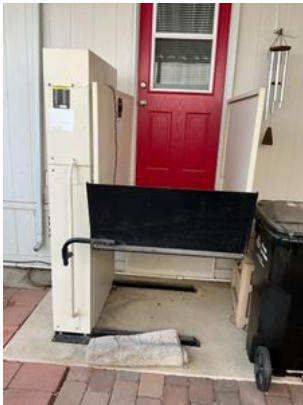
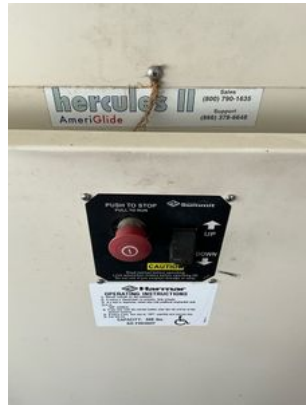
RESIDENTIAL WHEELCHAIR PLATFORM LIFT: This was a limited inspection, checking various components and functions to ensure the lift is operating safely. Inspection allowed for operating controls to go all the way down to ground level and then back up to the side entry porch.

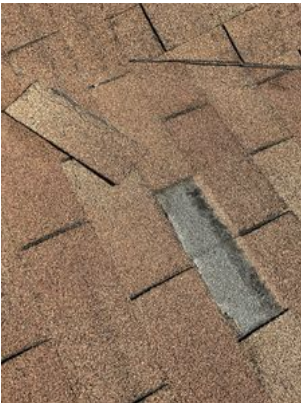
A couple sections of shingles were observed to be broken off from high winds. Wind damage can lead to leaks, or other issues. Recommend contacting a roofing company for repairs.

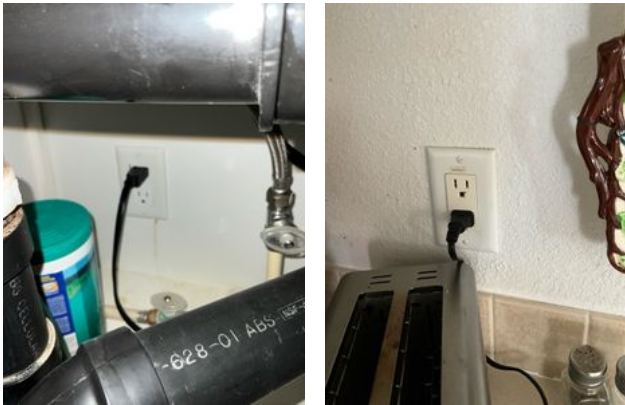
GFCI outlets are mandated in areas that can become damp or wet, and are therefore required in kitchens as a safety measure. They are fast-acting circuit breakers designed to shut off electric power in the event of a ground-fault. I recommend having a licensed electrician replace existing outlets with GFCI outlet

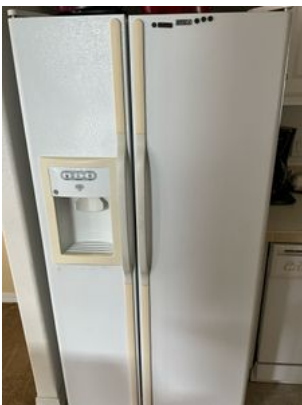
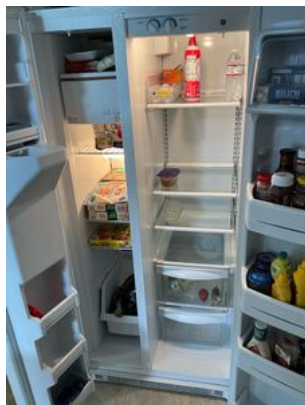
Minor punishes observed on the exterior of the refrigerator. This is typical for age of unit.

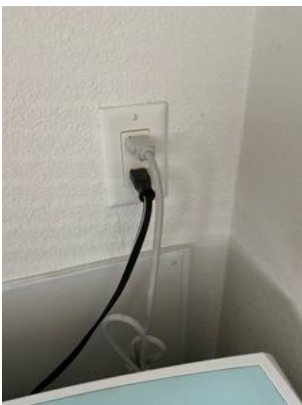
Condition: Repair or Replace

GFCI outlets are mandated in areas that can become damp or wet. They are fast-acting circuit breakers designed to shut off electric power in the event of a ground-fault. I recommend having a licensed electrician replace existing outlet.

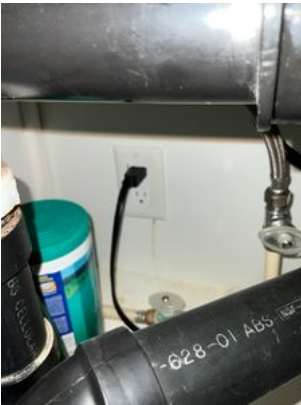
GFCI outlets are mandated in areas that can become damp or wet, and are therefore required in kitchens as a safety measure. They are fast-acting circuit breakers designed to shut off electric power in the event of a ground-fault. I recommend having a licensed electrician replace existing outlets with GFCI outlet

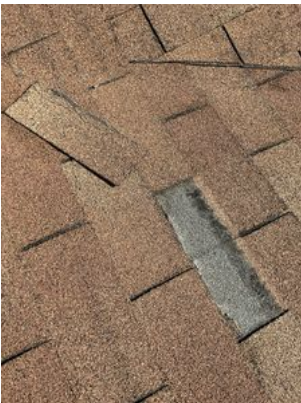
A couple sections of shingles were observed to be broken off from high winds. Wind damage can lead to leaks, or other issues. Recommend contacting a roofing company for repairs.
