# WOOD DESTROYING PESTS AND ORGANISMS INSPECTION REPORT

| BUILDING NO.<br><b>42650</b> | STREET, CITY, STATE, ZIP<br><b>ISLE ROYAL STREET, FREMONT CA 94538</b> | Date of Inspection<br><b>9/25/2026</b> | No. of Pages<br><b>14</b> |
| <b>TERMWRIGHT STRUCTURAL PEST CONTROL</b><br><b>40797 Blacow Road, Fremont, CA 94538</b><br><b>Ph: (510) 651-3702 Fax: (510) 490-6370</b><br><b>Email: termwright@gmail.com</b><br><b>www.termwrightstructuralpestcontrol.com</b> | | | |

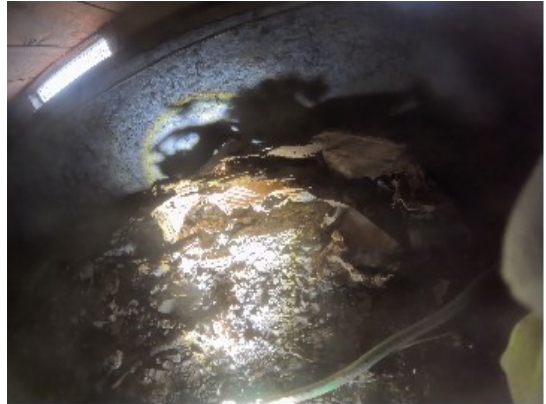
- ITEM 1C Cellulose debris (wood,paper products) with evidence of subterranean termites was noted in the subarea.

RECOMMENDATION Remove the cellulose debris of a rakable size. Treat the subarea soil with Premise per manufacturers label. Chemical treatment is guaranteed for area of treatment only. Note-this method of treatment will not eradicate any other undetected, if any, which may be located in other areas of the structure.

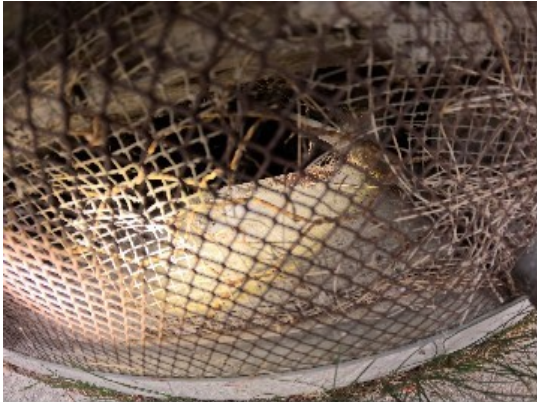
- ITEM 1A Evidence of drywood termites was noted in the subarea on framing of vents, with evidence extending above floor line.

RECOMMENDATION Fumigate the entire structure with Vikane gas. Fumigation is guaranteed for 3 years. We will have the gas shut off prior to fumigation, however, it will be the owners responsibility to contact PG&E to have gas turned back on after fumigation process has been completed. We assume no liability for any damage to the roof covering, solar panels, tv antenna or plants adjacent to the structure. NOTE-When authorized, we will send a fumigation packet for you to read and sign. NOTE-The price quoted here is for fumigation only. Any prep work is the responsibility of the owner. NOTE-There is an additional charge for the NYLOFUME bags for food.

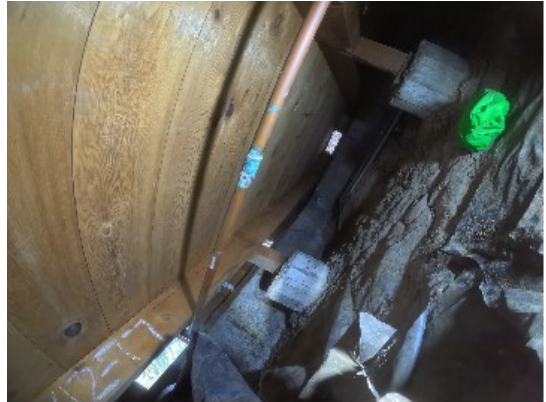
- ITEM 1D A plumbing leak was noted to water supply line.

RECOMMENDATION Others to contact a licensed plumber for repairs.

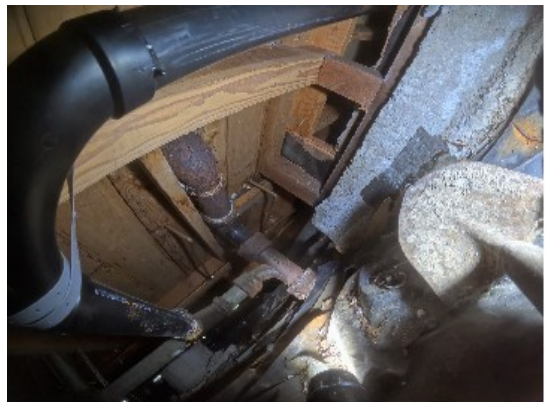
- ITEM 1E Surface fungus and dry water stains were noted under the hall bath.

RECOMMENDATION Scrape and treat the infected wood members with (TIM-BOR) a registered fungicide in accordance with the manufacturers label. Note-if fungus damage is found, a supplemental report will be issued with additional findings and cost.

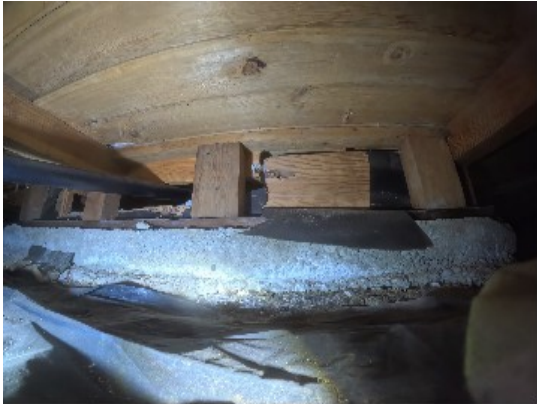
- ITEM 1F The additional framing under the hall bath for sunken tub is inaccessible for inspection due to insufficient clearance. See Inaccessible Areas on page 2.

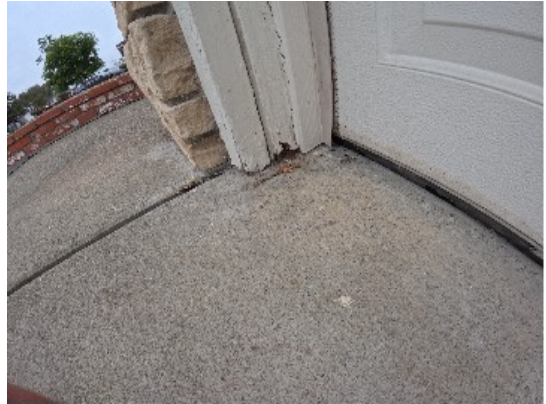
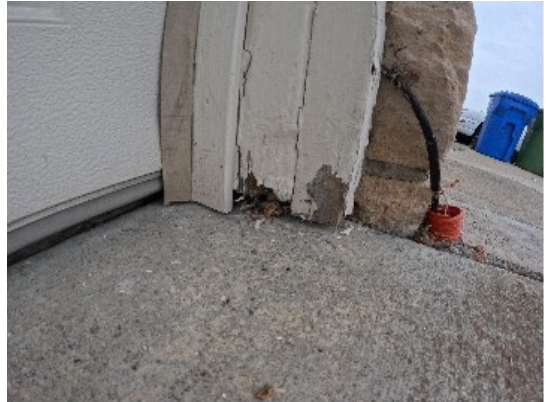
ITEM 8A Fungus has damaged the large garage door jambs.

RECOMMENDATION Remove the damaged wood. If no further damage is exposed, repair with new material. No painting is included in this bid. Note-if damage is found to extend into inaccessible areas, a supplemental report will be issued with additional findings and costs.

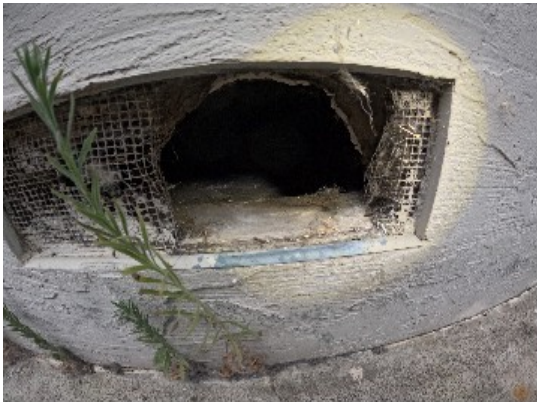
ITEM 5A Vent screen(s) were noted to be torn and/or missing per diagram.

RECOMMENDATION Install new nail on type vent screens per diagram.

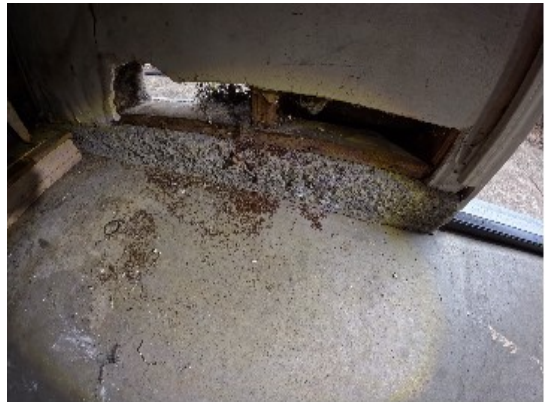
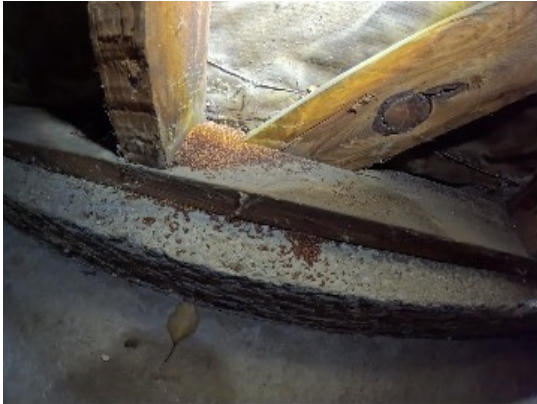
ITEM 8B Drywood termites pellets noted in various areas of the garage. See item 1A.

RECOMMENDATION Clean up and/or cover up all pellets to aid in future inspections. (Note It is common for additional pellets to sift down over a period of time due to normal household vibrations and scavenger insect activity. Our bid is for cleaning/covering the pellets one time only)

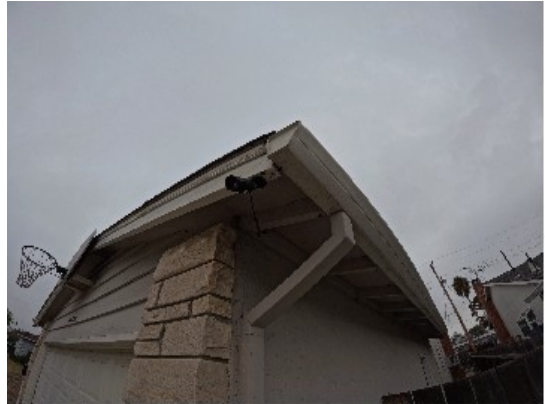
- ITEM 11C Drywood termite damage to the barge rafter. See item 1A.

RECOMMENDATION Dig/cut out the damage, wood fill and sand. NO PAINTING IS INCLUDED IN THIS BID. Note-if damage is found to extend into inaccessible areas, a supplemental report will be issued with additional findings and costs.

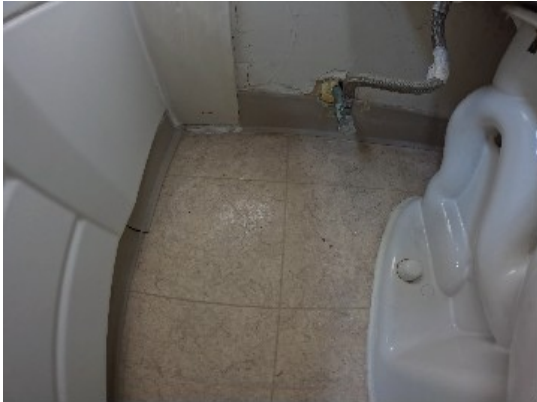
ITEM 10A Fungus damage noted to the hall bath floor behind the toilet.

RECOMMENDATION Remove the toilet. Remove the floor covering and underlayment as needed. If additional fungus damage is exposed and/or if the herk rink is found to be damaged, a supplemental report will be issued with additional findings and costs. Install new underlayment and new standard grade floor covering, using the flat lay method. Install new 4 rubber covebase as needed. Reset the toilet on a new wax ring.

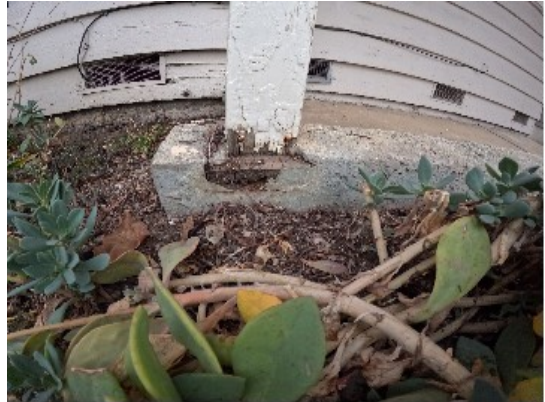
- ITEM 11D Fungus damage was noted to the post and pier.

RECOMMENDATION Remove and replace the damaged post and pier with new material. No painting is included in this bid. Note-if damage is found to extend into inaccessible areas, a supplemental report will be issued with additional findings and costs. Note- We do not guarantee against present or future cracks in the wood.

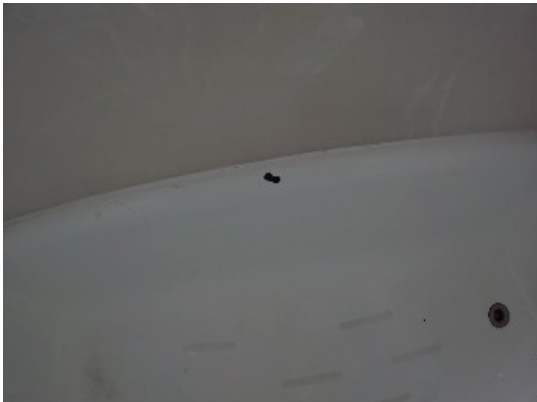
ITEM 10B Chips were noted in the hall bath tub. No visible signs of leakage noted at this time. Others may want to apply porcelian paint to prolong the life of the tub.

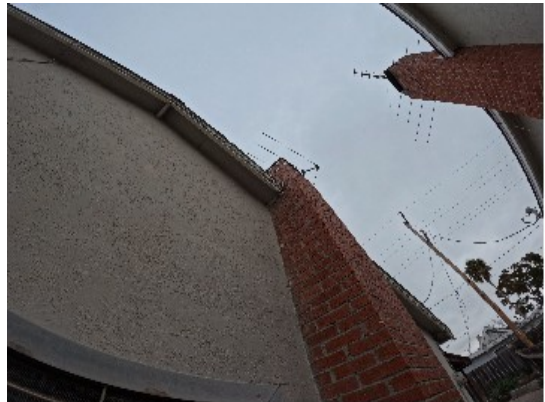
- ITEM 11H Minor fungus damage was noted to barge rafter.

RECOMMENDATION Dig/cut out the damage, chemically treat, wood fill and sand. NO PAINTING IS INCLUDED IN THIS BID. Note-if damage is found to extend into inaccessible areas, a supplemental report will be issued with additional findings and costs.

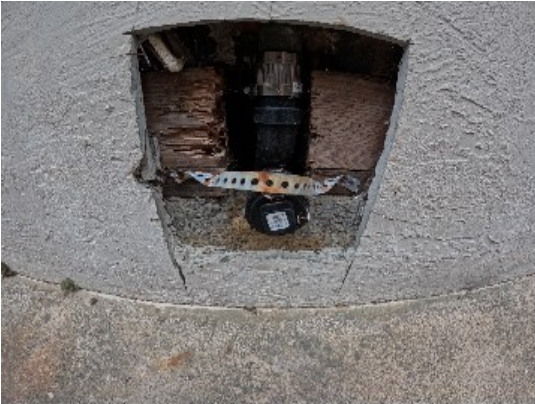
- ITEM 11I Others have cut out the stucco to access the tub plumbing.
