# Inspection Report

**Property Address:**  
20455 Elfin Forest Rd  
Escondido CA 92029

**The Property Inspection Pros**

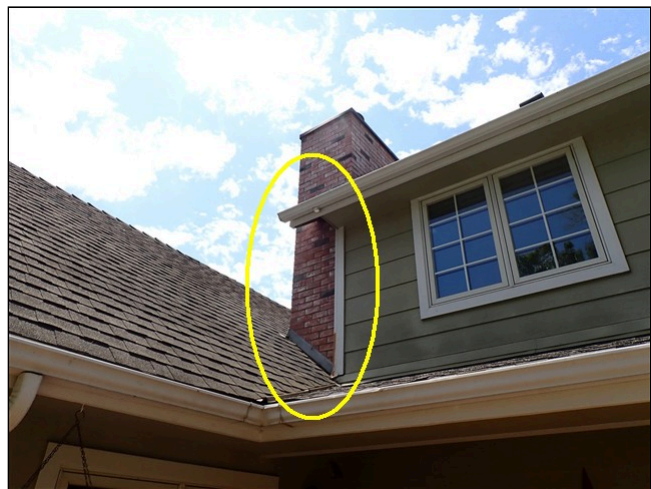
1.2.A Item 1 (Picture)

- (1) There is a downspout missing at the rear of home. We recommend installing downspouts to properly divert water away from the roof and the structure where

missing. Missing downspouts can damage the house due to the quantity of water concentrated in this area. We recommend immediate replacement by a qualified licensed contractor.

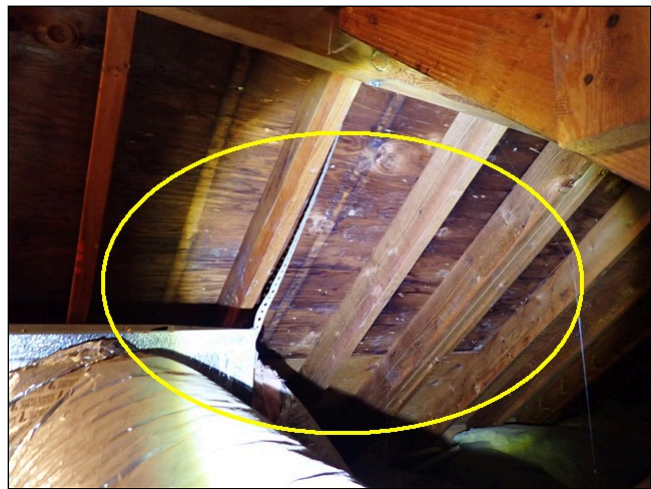
1.3.A Item 1 (Picture)

**Comments:**  
Stain(s) observed in the roof sheathing at various areas in attic. Water stains on the

ceilings, or on the framing within attics will not necessarily confirm an active leak without some corroborative evidence (or recent rain), and such evidence can be deliberately concealed. This roof has had past repairs preformed since the roof covering was installed; visible on the roof at the time of the inspection. Staining found in the attic may have resulted from previous roof leaks which may have been repaired. However, due to the lack of recent rain, I was unable to confirm if the repairs were adequate. Staining in the attic was dry at the time of the inspection.

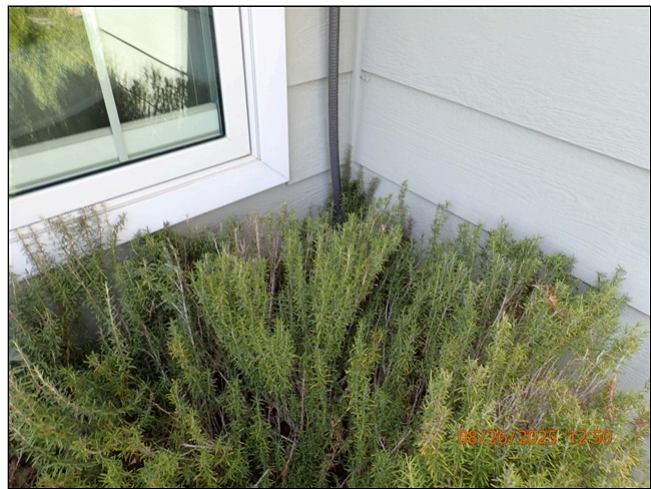
2.1.A Item 1 (Picture)

Vegetation is in contact with the siding/ stucco at several areas. Vegetation can create moisture problems by preventing siding from drying out. Vegetation also allows rodents to easily access the roof where they can enter through small voids. We recommend removing vegetation from the siding/ stucco. We also recommend referring to the pest control report for their recommendations.

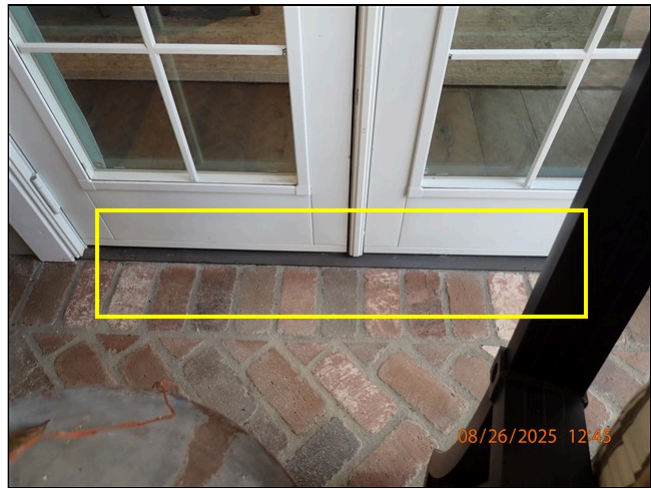
2.2.A Item 1 (Picture)

**Comments:**  
(1) Similar elevations are noted between the interior floor and exterior grade levels. This is not ideal and moisture intrusion remains a possibility whenever this condition exist. We recommend further evaluation by a qualified licensed contractor and grading/ drainage contractor to determine repairs options.

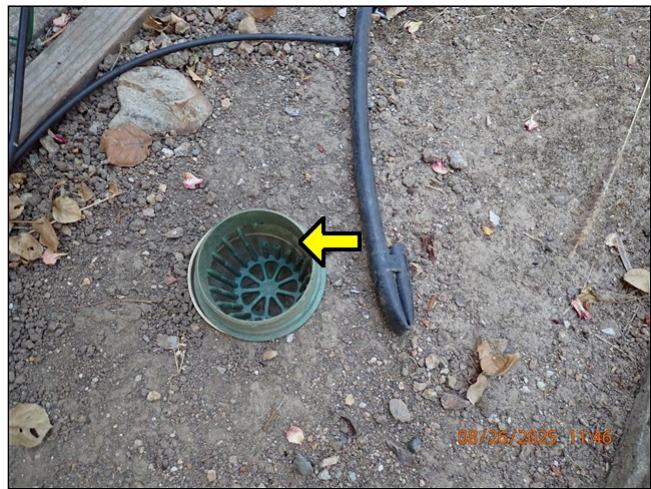
2.2.A Item 2 (Picture)

(2) Some yard drains were noted with missing or damaged screens or covers. The drains will be subject to debris and may become blocked. This can be problematic during heavy rain or extended irrigation. We recommend installing new drain covers and keeping them cleared as regular maintenance of your yard.

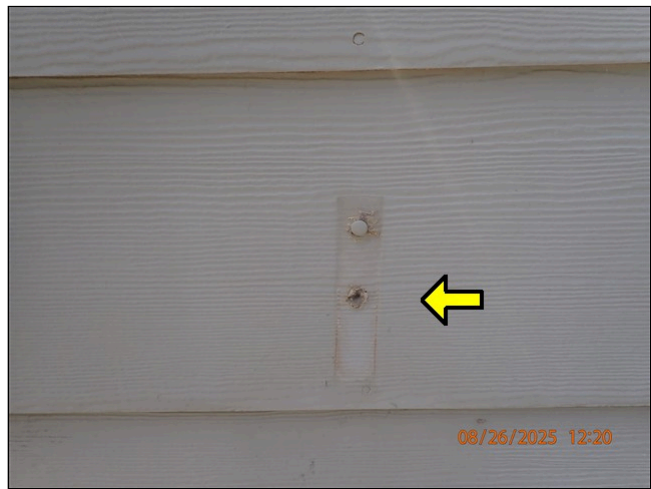
2.3.A Item 1 (Picture)

(1) Several holes are observed in the siding at several areas. We recommend sealing these holes to prevent rodent or water intrusion.

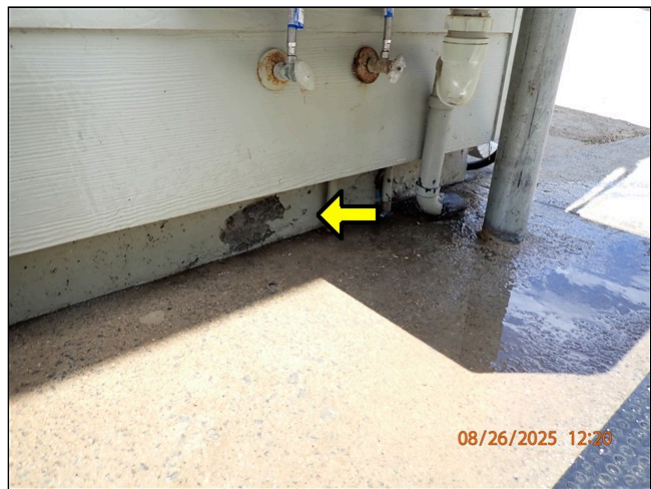
2.3.A Item 2 (Picture)

(2) The stem wall paint is deteriorating in areas around the foundation stemwall. This is typical cosmetic damage. If concerned we recommend necessary repairs by a licensed qualified contractor.

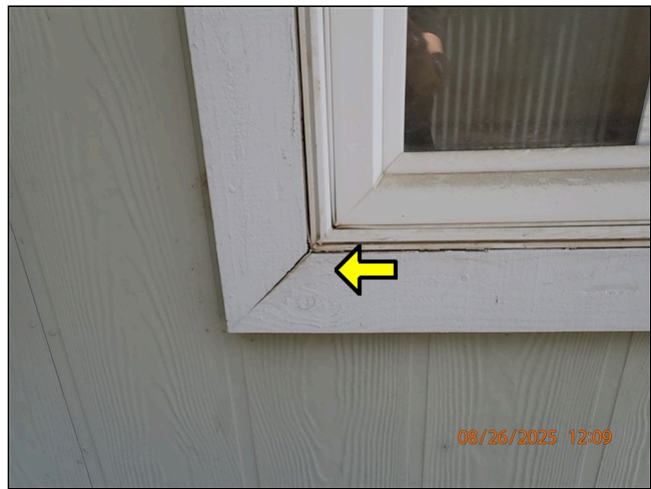
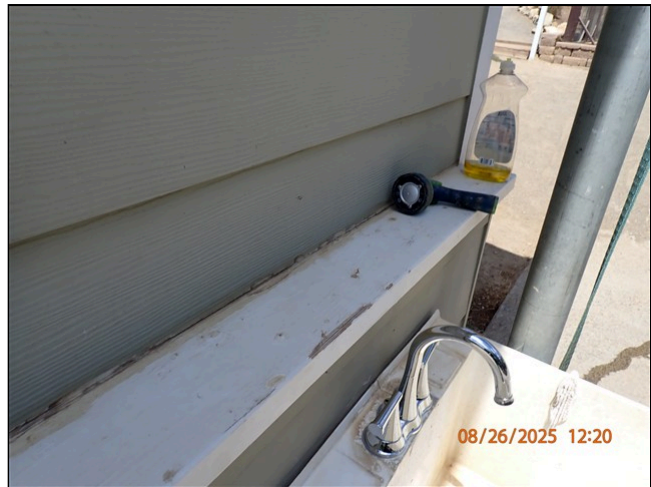
(3) Some damaged wood siding and wood trim is observed at several areas. We recommend referring to the pest inspection report for a detailed evaluation of the wood. We also recommend necessary repairs or replacing the wood siding and wood trim as needed by a qualified licensed contractor.

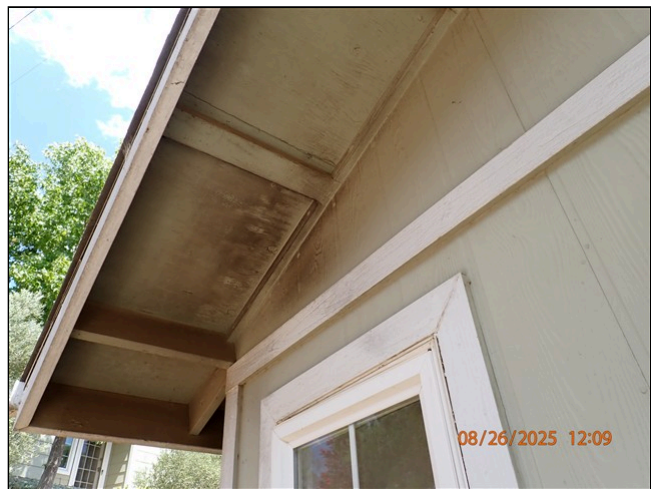
2.4.A Item 1 (Picture)

- Comments:**
- (1) There are several stains noted at the eaves. Due to lack of recent rain, determining the presence of an active roof leak was not possible. These stains were dry at the time of the inspection. The roof may be leaking in these areas. We recommend further evaluation by a licensed roof contractor or leak detection company prior to the end of your contingency period.

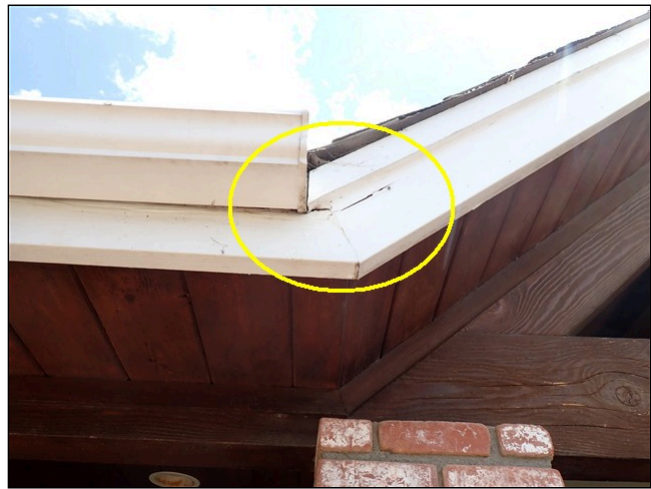
2.4.A Item 2 (Picture)

(2) Some damaged wood was observed at the eaves and fascia boards at several areas. Determining if this damage was caused by termites is beyond the scope of a home inspection. Home inspectors do not have the authority to comment on termites or dry rot, which is the responsibility of a state licensed pest inspector. We recommend referring to the pest inspection report for a full evaluation and necessary repairs made by a qualified licensed contractor.

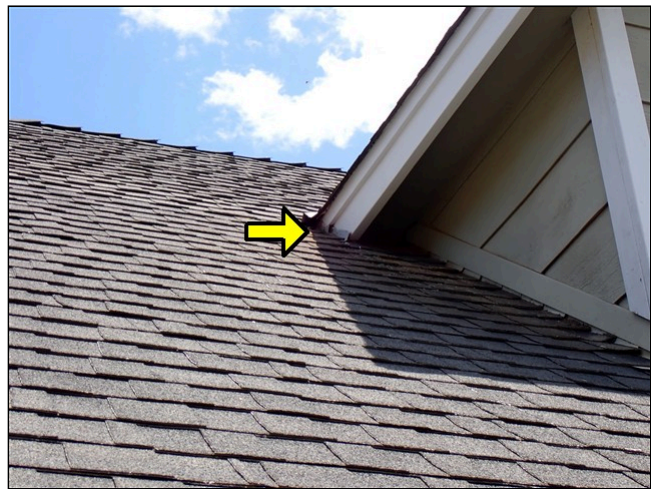
2.4.A Item 4 (Picture)

(3) Some of the fascia boards that are in contact with the roof. This condition could result in moisture damage to the wood where the wood touches the roof. We recommend a gap be created between the wood and the roof by a qualified licensed contractor.

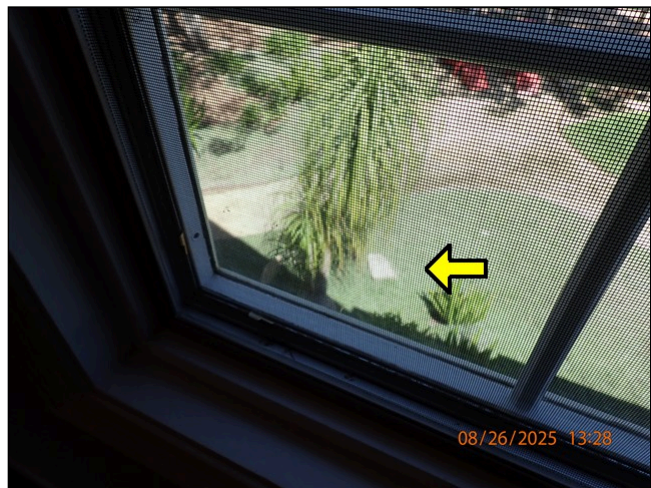
2.6.A Item 1 (Picture)

(1) There are several window screens that are damaged throughout the house. We recommend repair or replace as needed by a qualified person.

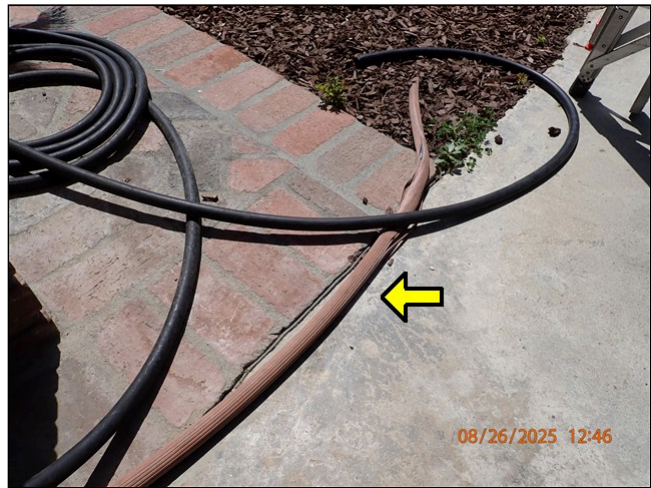
2.8.A Item 1 (Picture)

(1) A tripping hazard exists at the pathway at the front of the house. We recommend necessary repairs by a qualified licensed contractor to avoid injuries.

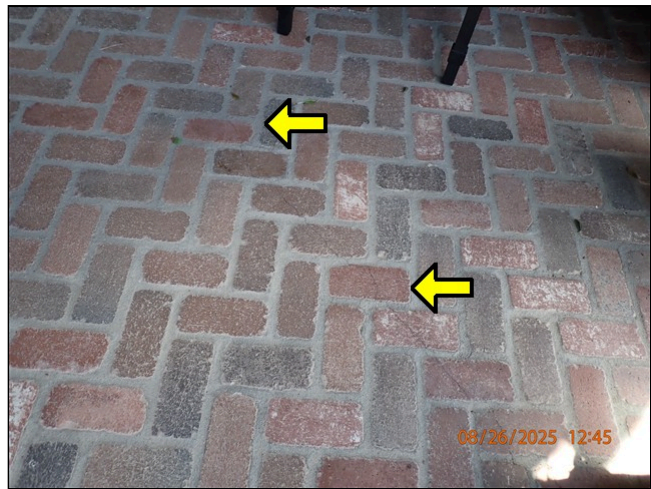
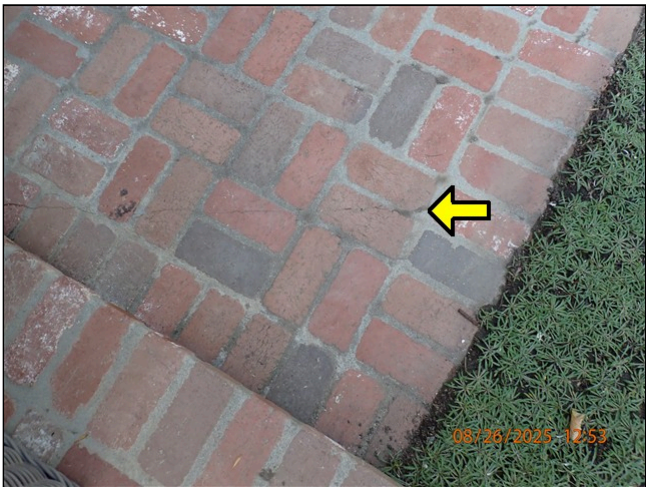
(2) Several cracks were observed in the front and rear patio bricks. We recommend further evaluation and any necessary repairs made by a qualified licensed contractor.

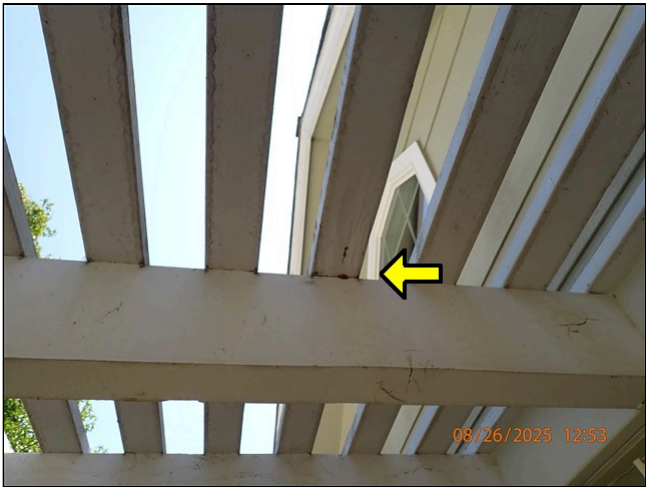
2.8.A Item 4 (Picture)

(3) Some damaged wood is observed at the patio cover at several areas. We recommend referring to the pest inspection report for a detailed evaluation of the wood. We also recommend necessary repairs or replacing the damaged wood as needed by a qualified licensed contractor.

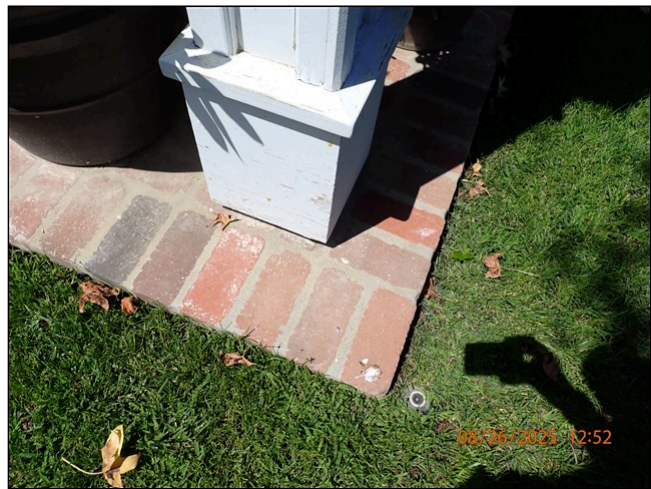
2.8.A Item 5 (Picture)

(4) The footing connection for the patio cover could not be verified due to concealment by finished surfaces or soil; since the structural integrity of the connection is not visible, its adequacy and compliance with current standards could not be confirmed. We recommend further evaluation and any necessary repairs made by a qualified licensed contractor.

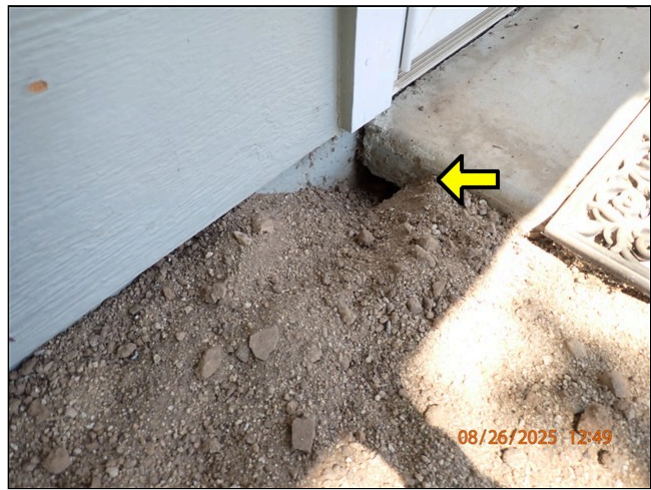
2.8.A Item 6 (Picture)

(5) A hole/digging was observed at the right side exterior door slab. We recommend further evaluation and any necessary repairs made by a qualified licensed contractor.

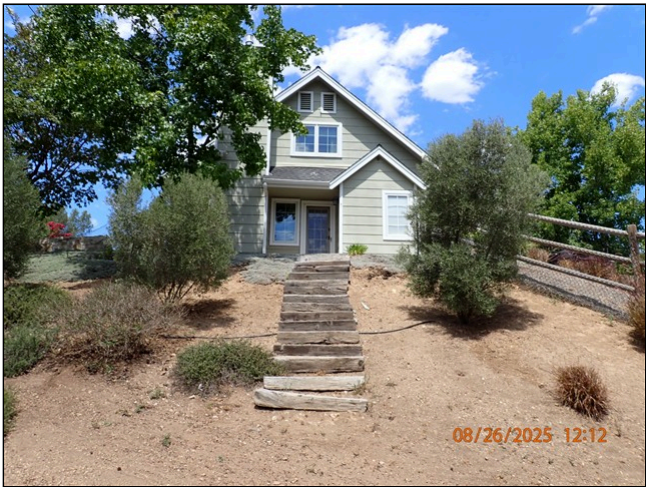
2.9.A Item 1 (Picture)

**Comments:**  
There is no handrail installed at the right side exterior stairs/ steps. A handrail is required at least one side of the stairs when four or more steps are present. This is a safety hazard and corrections are needed. We recommend installing a handrail for safety by a qualified licensed contractor.

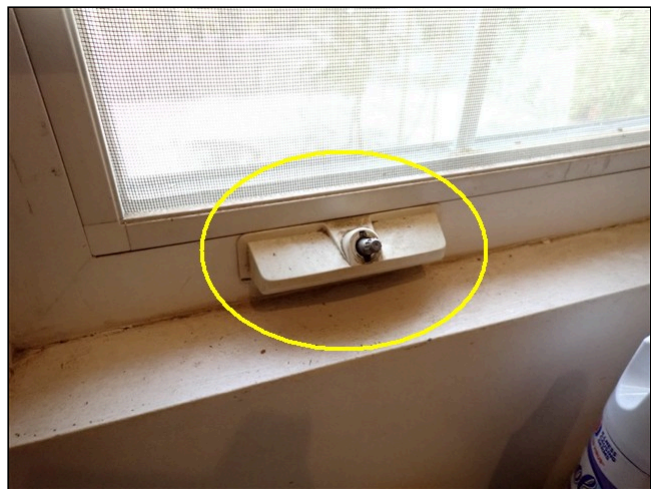
2.2.B Item 1 (Picture)

(1) A window had a missing crank handle. This window could not be tested for proper operation. We recommend replacing the handle and testing this window for proper operation prior to the end of your contingency period.

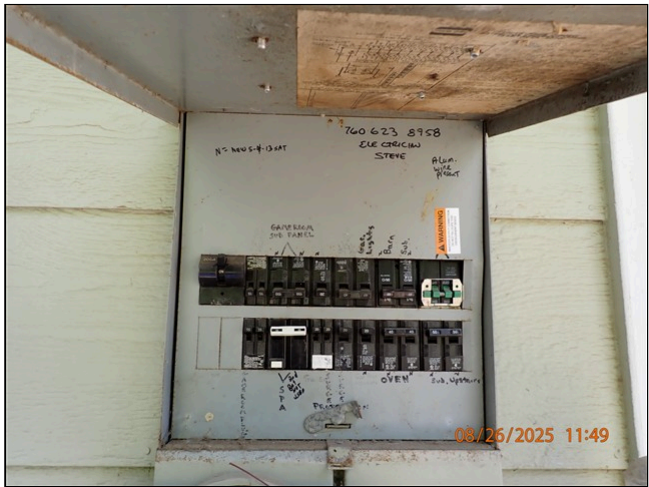
3.0 Item 3 (Picture)

(2) The main panel breakers are illegible or confusing. We recommend having the breakers properly labeled for safety by a qualified person.

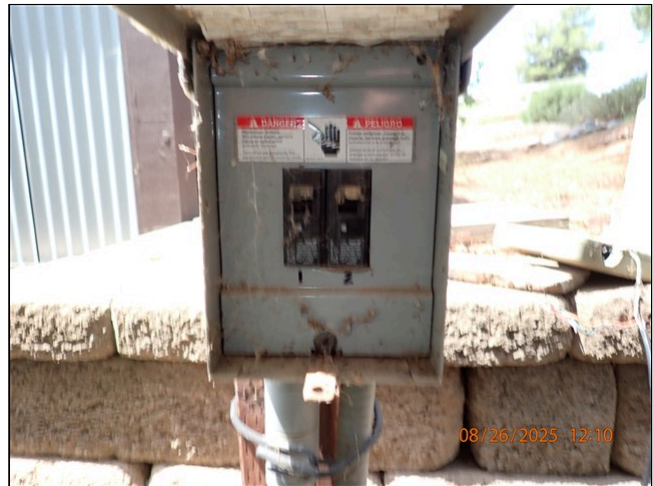
3.1 Item 1 (Picture)

**Comments:**  
(1) The breaker box and adjacent wire on the exterior of the ADU were observed to be loose. We recommend further evaluation and any necessary repairs made by a qualified licensed electrician.

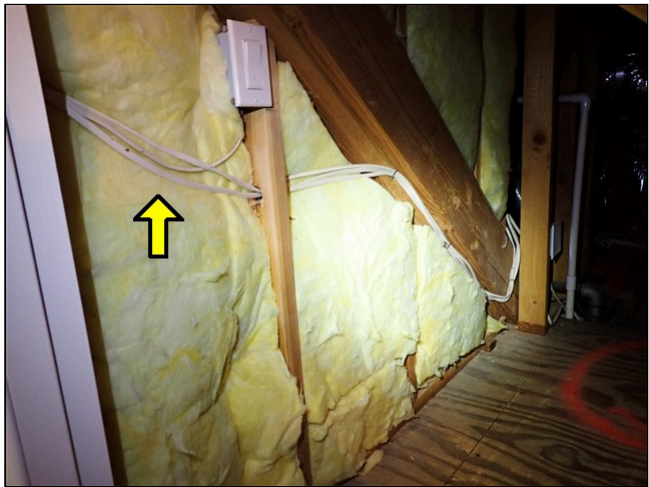
3.3 Item 1 (Picture)

**Comments:**  
(1) Unprotected Romex was present in the attic adjacent to the attic scuttle. Romex located within 6 feet of the attic scuttle must be protected from damage. We recommend adding protection to the Romex in attic by the access a qualified licensed electrician.

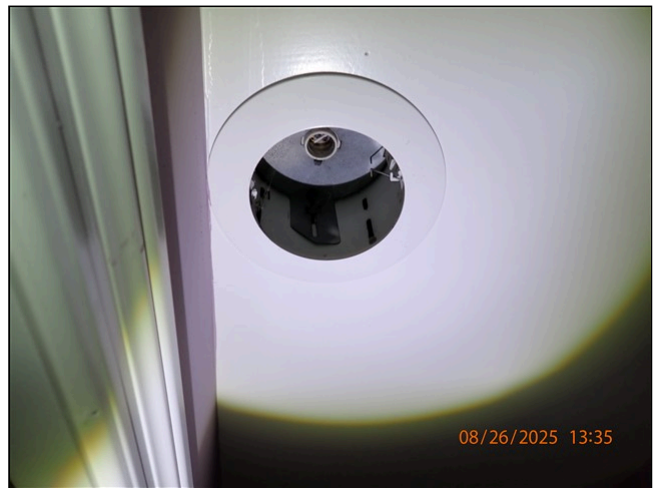
3.5 Item 1 (Picture)

(1) A light in the right side upstairs closet did not function when tested due to no bulb installed. Occasionally there may something wrong with the fixture which cannot be determined without a working bulb. We recommend asking the seller to demonstrate that the light is working prior to the end of the inspection contingency period, or changing the bulb and testing again. If the light does not function we recommend further evaluation by a qualified licensed electrician and necessary repairs or replacement as needed.

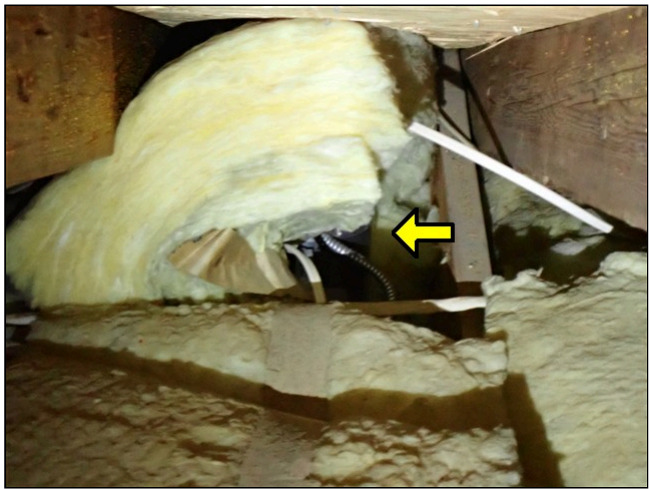
3.5 Item 5 (Picture)

(3) There are several recessed light fixtures (can lights) in contact with insulation observed in the attic. I was not able to determine if the fixtures are Non-IC (Insulation contact) rated. A minimum 3" clearance is required around these fixtures from insulation. This condition is non standard and a potential fire hazard. We recommend further evaluation by a qualified licensed electrician and necessary corrections made if needed.

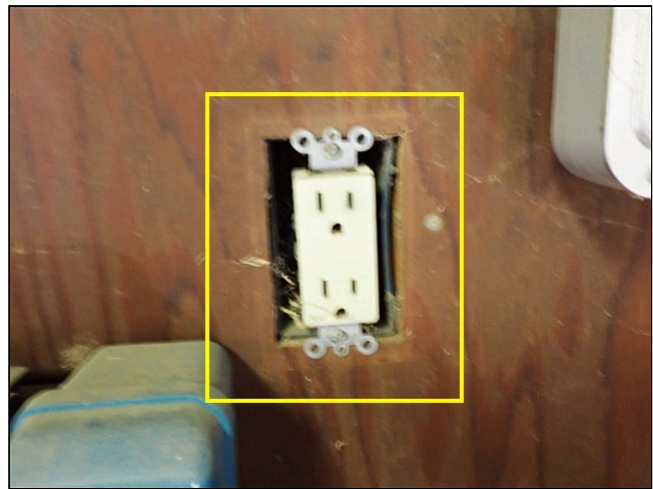
3.8 Item 1 (Picture)

**Comments:**  
There are several receptacle covers missing in the barn. This is non standard and a potential shock hazard. We recommend installing receptacle plates by a qualified person where needed for safety.

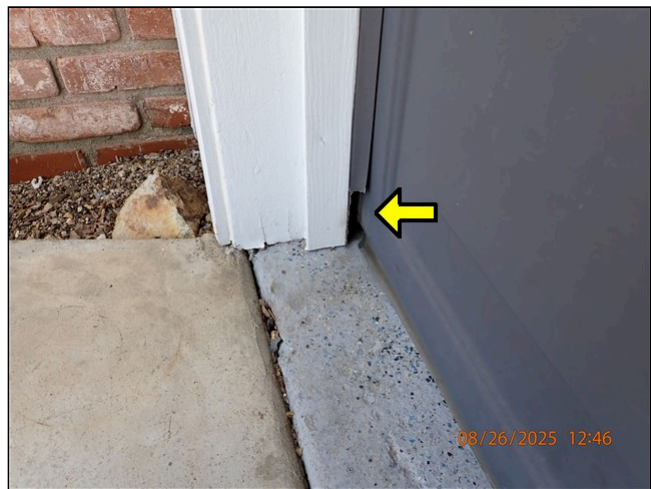
4.0.A Item 1 (Picture)

(1) The side weather seal is damaged at the garage vehicle door. The weather seal is needed at garage vehicle door to properly seal the sides of this door for moisture and pest intrusion. We recommend replacing the weather seal by a qualified licensed garage door contractor.

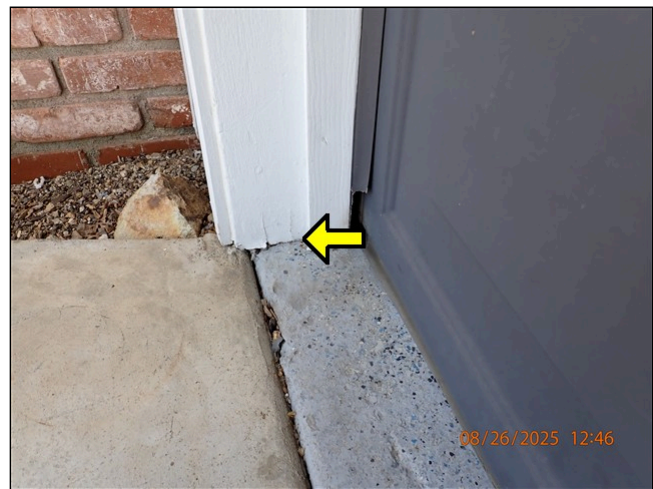
4.0.A Item 2 (Picture)

(2) The garage vehicle door wood trim is damaged in some areas. Determining if this damage was caused by termites is beyond the scope of a home inspection. Home inspectors do not have the authority to comment on termites or dry rot, which is the responsibility of a state licensed pest inspector. We recommend referring to the pest inspection report for a full evaluation and necessary repairs made by a qualified licensed contractor.

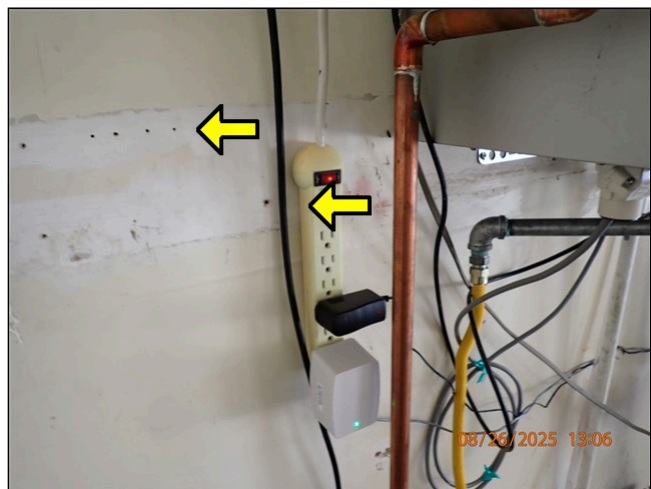
4.3.A Item 1 (Picture)

(1) There are several holes observed in the fire wall in the garage. Wherever the garage shares a wall with adjacent living space, the fire-rated sheetrock must be installed and intact for fire resistive performance. We recommend having the holes patched with fire-rated drywall or necessary corrections by a qualified licensed contractor.

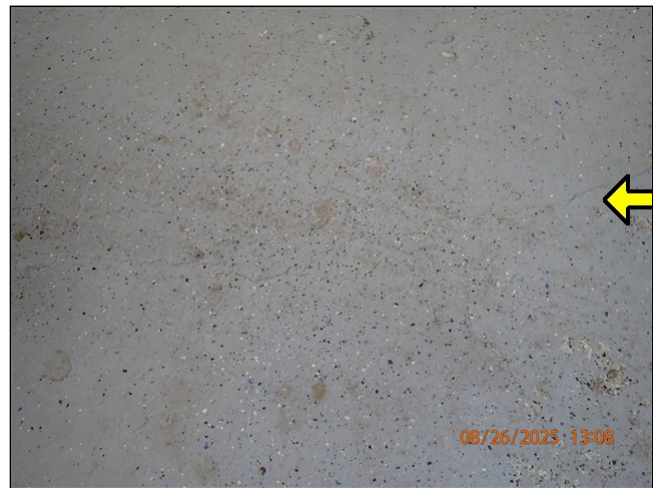
4.4.A Item 1 (Picture)

(1) Typical shrinkage cracks were observed at the garage slab in several areas. Shrinkage cracks can appear as part of the concrete's natural curing process and are not a structural concern. No standards exist for evaluating cracks in concrete. Cracks appear for a wide variety of reason, some of which may not be apparent at the time of the inspection. Cracks less than 1/8-inch that do not exhibit displacement are typically not considered to be structural issues unless they appear in conjunction with another condition.

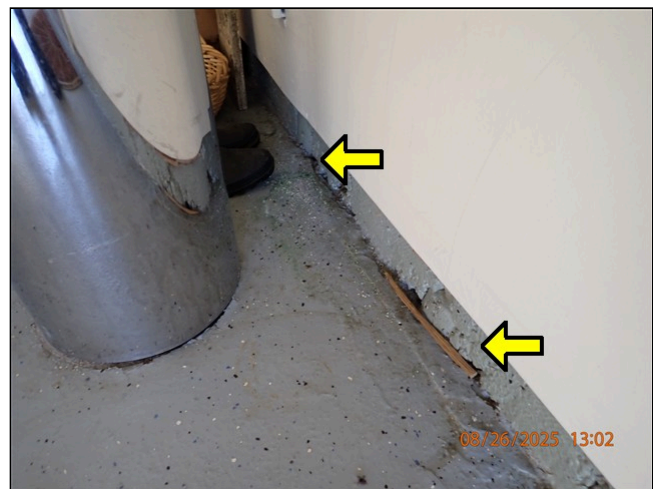
4.4.A Item 2 (Picture)

(2) Several cracks are observed in the garage stemwall. Cracks like these are usually repaired with epoxy. However, the exact evaluation of slab cracks is beyond the scope of a general home inspection. We recommend necessary repairs by a qualified licensed contractor.

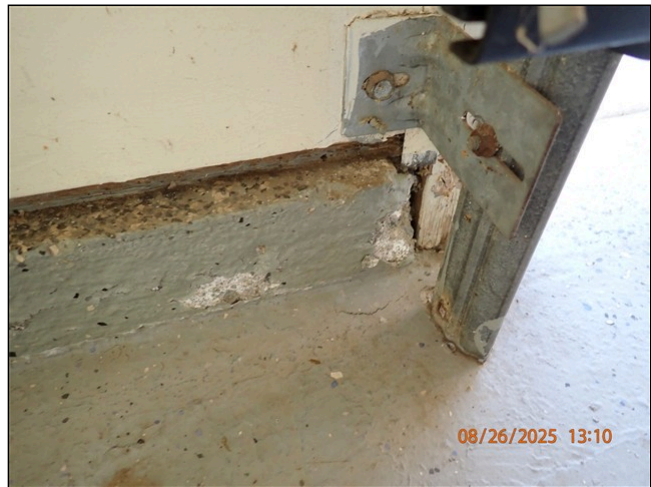
4.4.A Item 3 (Picture)

(3) There is white efflorescence (powder substance) is observed on the garage stem wall and slab in some areas. This condition indicates that moisture is in contact with the masonry. We recommend checking the gutters, downspouts, and drain lines for proper operation. A water proofing paint could be applied the foundation if necessary. Efflorescence is found on many homes without water intrusion occurring. We recommend necessary corrections to help this condition from occurring.

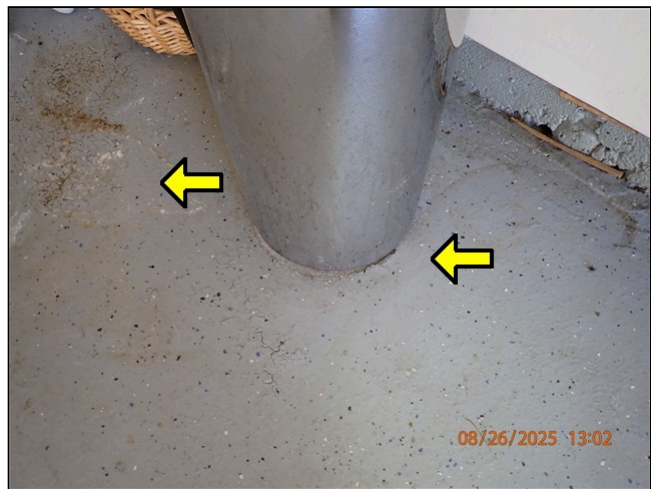
4.4.A Item 4 (Picture)

(4) The garage slab is deteriorated/ pitted in several areas. We recommend necessary repairs by a qualified licensed foundation contractor.

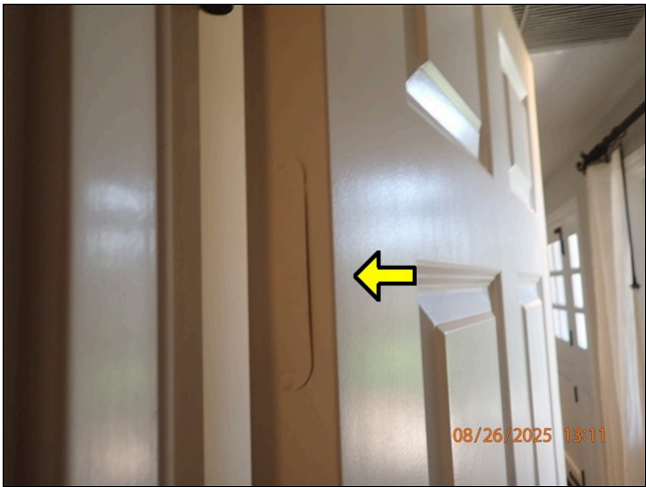
4.5.A Item 1 (Picture)

In order to comply with current fire and safety standards and regulations, fire doors must be fire rated. The fire rating plate was observed to be painted over and I was unable to verify its rating. We recommend further evaluation and any necessary repairs/replacement by a qualified licensed contractor.

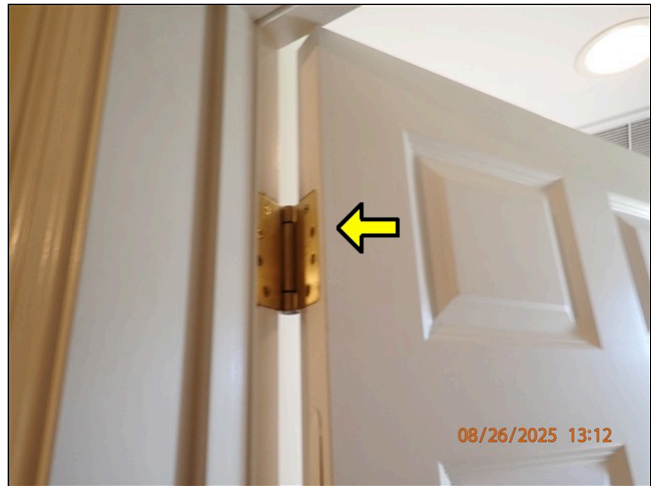
4.6.A Item 1 (Picture)

**Comments:**  
The self closing device at the fire door did not adequately close the door. The auto closer must close the door within 3 seconds with enough force to latch the door. We recommend adjusting or replacing the device or hardware by a qualified licensed door contractor.

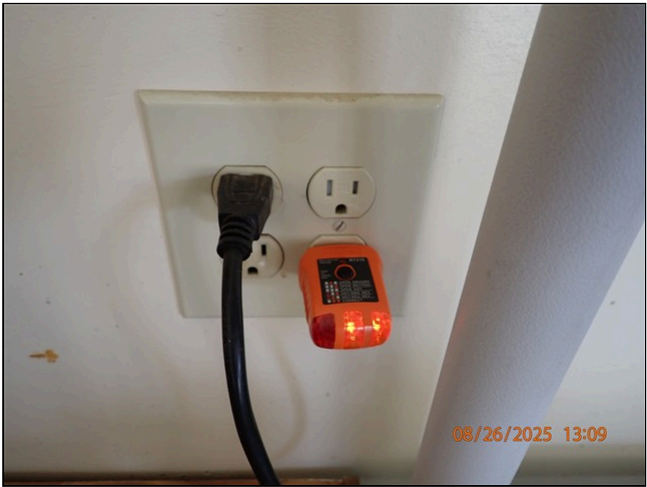
4.10.A Item 1 (Picture)

**Comments:**  
Several GFCI receptacles are not operating properly, or have failed as they did not trip when tested. These outlets may be defective or mis-wired. We recommend replacement as needed by a qualified licensed electrician.

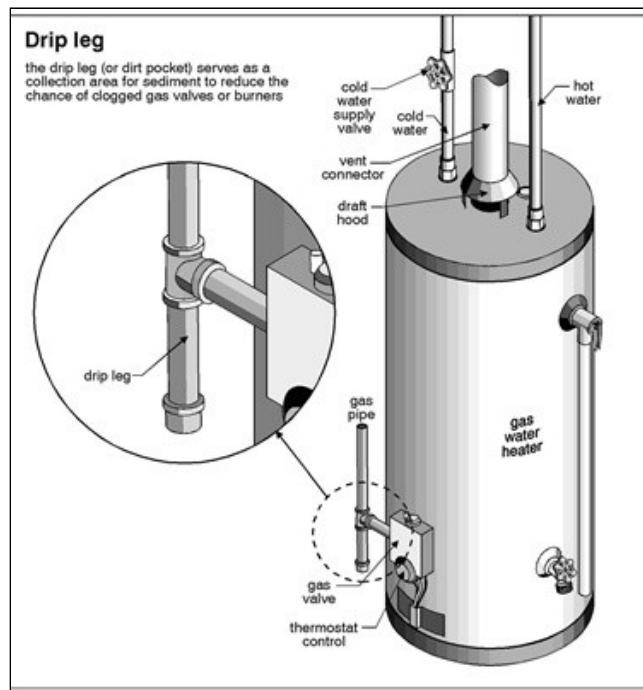
5.0.A Item 6 (Picture)

(5) The gas supply pipe at the water heater did not contained a drip leg/ sediment trap. This may have been standard at the time of installation but now is highly recommended. The purpose of a drip leg is to prevent sediment/ debris from entering and clogging the water heater gas valve which could cause the water heater to shut down. We recommend having a drip leg installed by a qualified licensed plumber.

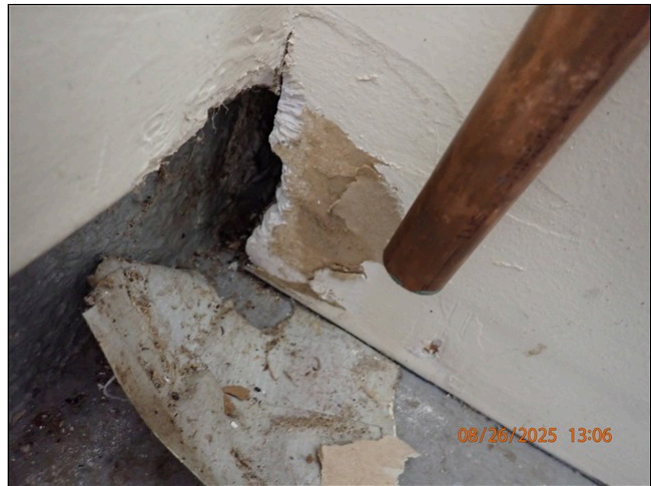
5.1.A Item 1 (Picture)

**Comments:**  
The water heater platform is damaged. The water heater platform appears to have been weakened and or damaged by a previous leak. We recommend necessary repairs or replacement by a qualified licensed plumber.

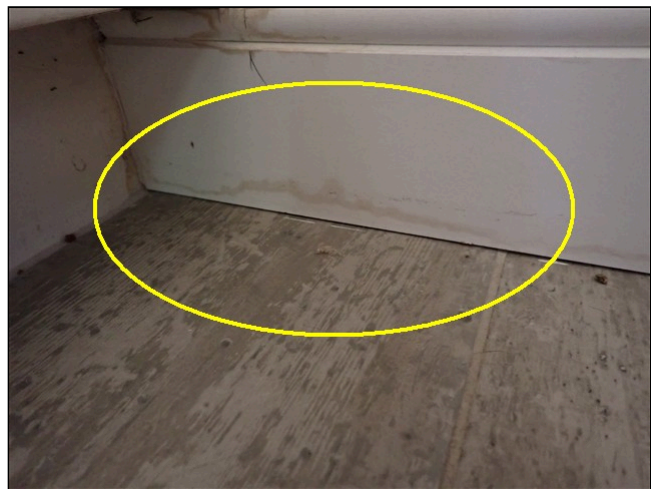
6.2.A Item 1 (Picture)

- (2) Moisture damaged is noted at the baseboards in the laundry room. These baseboards were tested for moisture and were found to be dry at the time of the inspection. We recommend further evaluation by a licensed termite inspector and repair as needed.

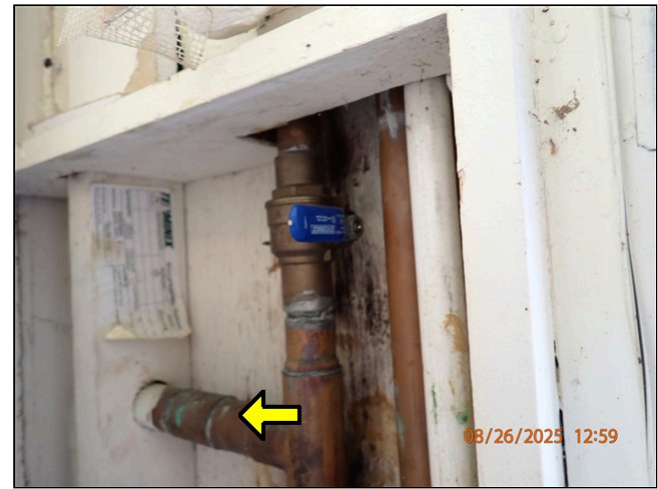
7.1 Item 1 (Picture)

**Comments:**  
(1) Several corroded pipes were observed in the garage. We recommend further evaluation by a qualified licensed plumber and necessary repairs made.

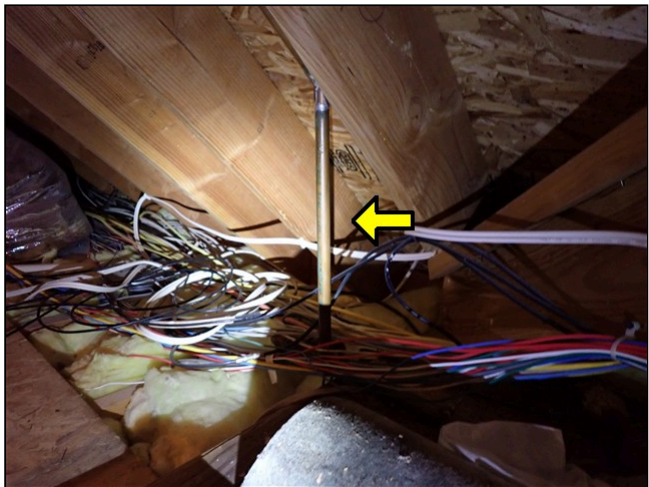
7.1 Item 5 (Picture)

(3) There were un-insulated water supply pipes noted in several areas. All exposed water supply pipes, hot or cold should be insulated to help minimize heat loose. We recommend necessary corrections by a qualified licensed plumber.

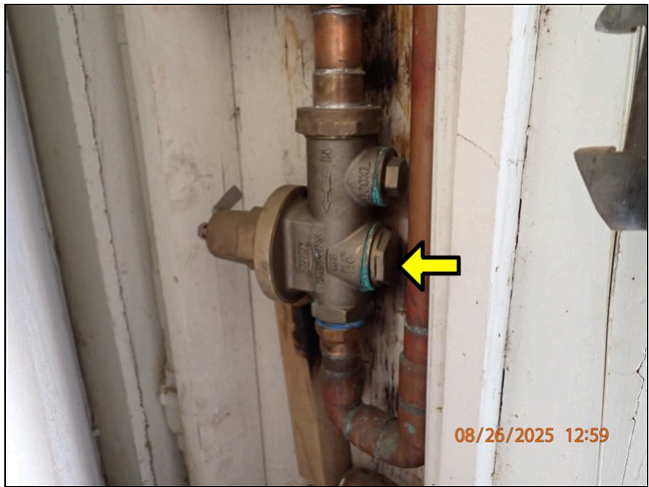
7.2 Item 1 (Picture)

(1) The water pressure regulator is rusted/ corroded. We recommend replacement by a qualified licensed plumber.

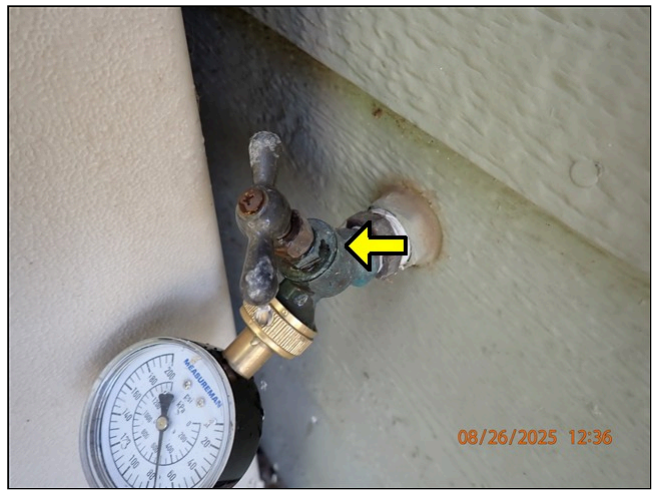
7.3 Item 1 (Picture)

(1) Several exterior hose spigot handles leak when turned on. We recommend necessary repairs or replacement by a qualified licensed plumber.
