RAE Project ID: R201499

Ameriprise Insurance  
**Attn: Claims Department**  
P.O. Box 19018  
Green Bay, Wisconsin 54307-9018  
**Claim No. 2815751BT505**  
**Code Blue Control No. 480041**

**RE: Limited Asbestos Survey and XRF Lead Inspection Report**  
**Rubin Residence**  
**6363 Rancho Mission Road, Unit 3**  
**San Diego, California 92108**

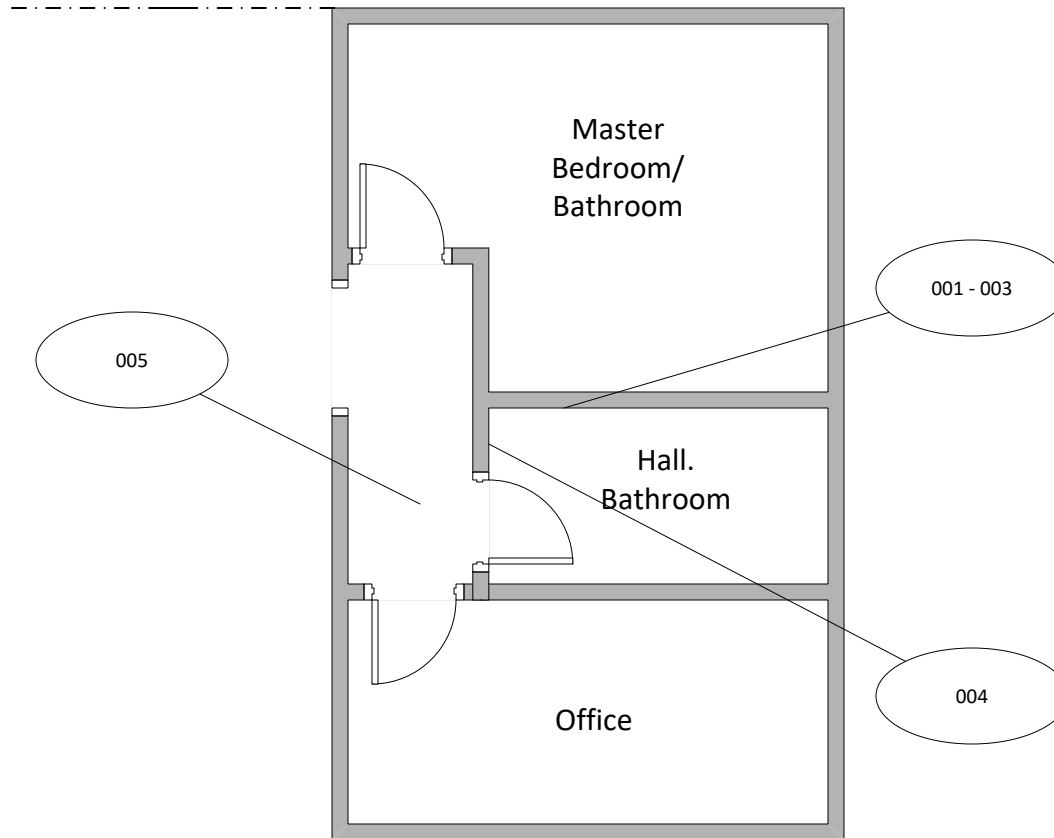
**Asbestos Bulk Sample Locations Map**

**No asbestos was detected** in any of the samples collected based on the limitations of the analytical method. The following table summarizes the building materials samples that were found to contain **no asbestos** based on the limitations of the analytical method:

Sample #	Material	Material Location
001 - 005	Drywall and joint compound	Hallway, Hallway Bathroom and Master Bathroom

**Due to the absence of asbestos in the above referenced materials, a California state licensed asbestos abatement contractor will not be required to remove the above referenced materials** to be disturbed as a result of planned or other renovations to the subject property.
