Core Inspection Services

Home Inspection Report

12933 Chaparral Road

Inspected on Fri, Mar 23 2018 at 12:00 PM

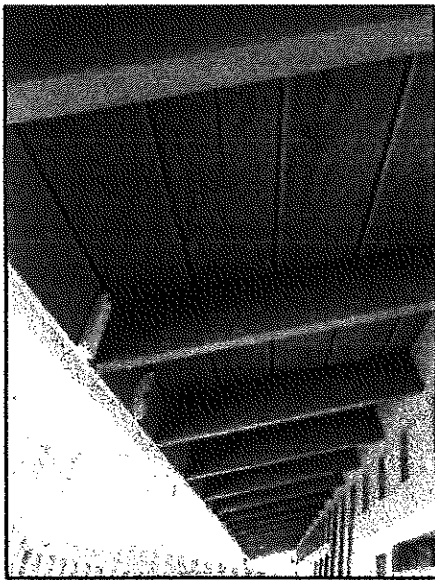
Figure 1-1

Moisture staining was noted under the front of house eve. This may be caused by the arbor tie-in. No active moisture was present at the time of inspection.

- 1) Moisture staining was noted under the front of house eave. This may be caused by the arbor tie-in. No active moisture was present at the time of inspection.

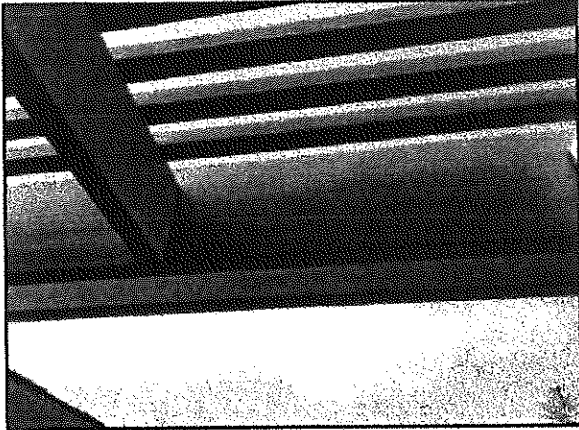
Figure 2-1

Wood deterioration was noted at areas of the covered porch arbor right side of the entryway. It is suggested to remove and replace any affected material as needed.

- 2) Wood deterioration was noted at areas of the covered porch arbor right side of the entryway. It is suggested to remove and replace any affected material as needed.

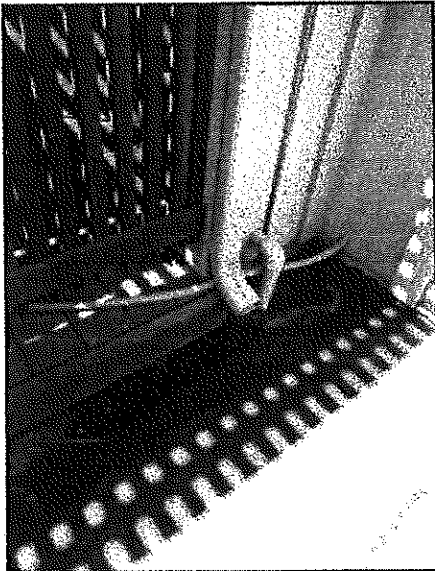
Figure 3-1

Downspout extensions are suggested to all downspouts on the property. They help divert the gutter water away from the sub-area of the house.

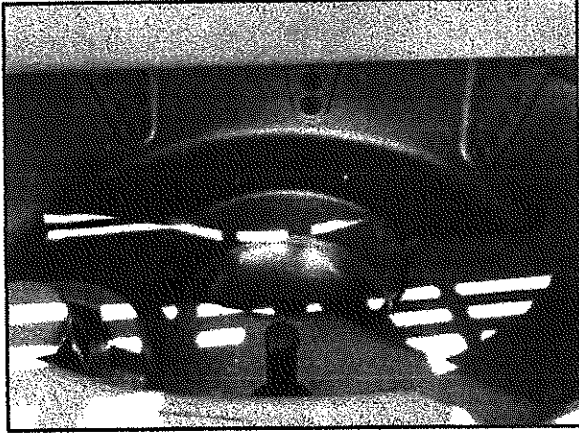
Figure 4-1

The spa was not inspected due to no water.

Had spa inspected 3/15/19
see receipt

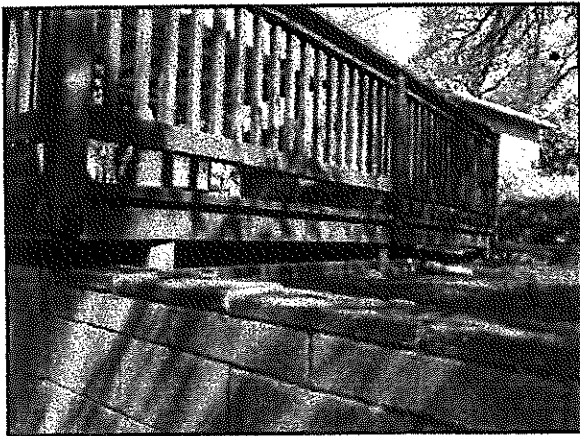
Figure 5-1

The underside of the rear of house deck was not inspected due to a lack of clearance.

2/4/19
Neighbors Tree Fell took out De
Deck Replaced - Started
working on it 9/20/19

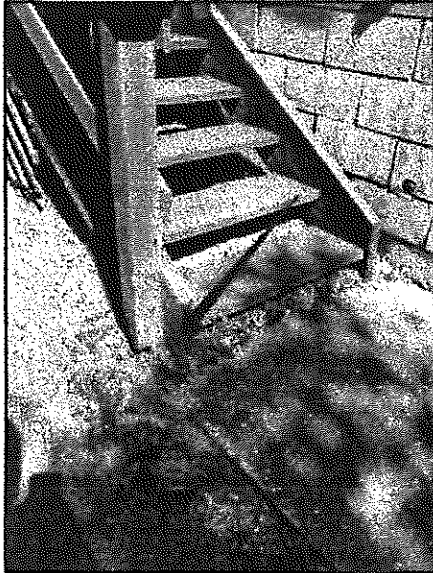
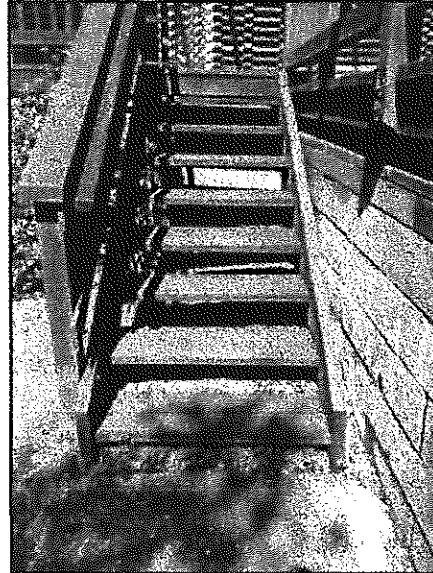
Wood deterioration was noted at the base of the stair stringer on the rear of the house. The inspector also noted that the stair stringer spacing is considered too wide and deflection was noted when walking down the steps.

- 5) The underside of the rear of house deck was not inspected due to a lack of clearance.
- 6) Wood deterioration was noted at the base of the stair stringer on the rear of the house. The inspector also noted that the stair stringer spacing is considered too wide and deflection was noted when walking down the steps.

Stairs Replaced 3/10/24

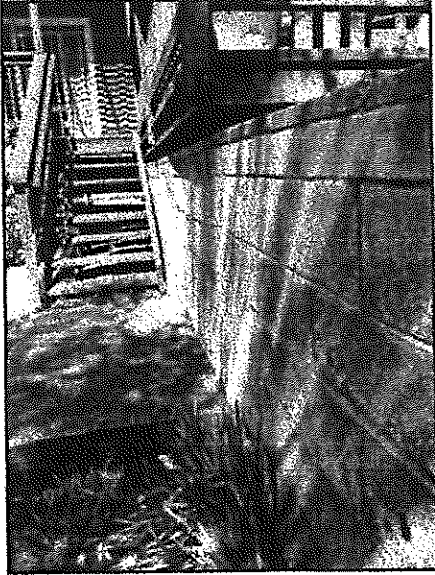
Figure 7-1

Portions of the retaining wall at the rear of the house were leaning.

- 7) Portions of the retaining wall at the rear of the house were leaning.

Fixed this part when deck was done

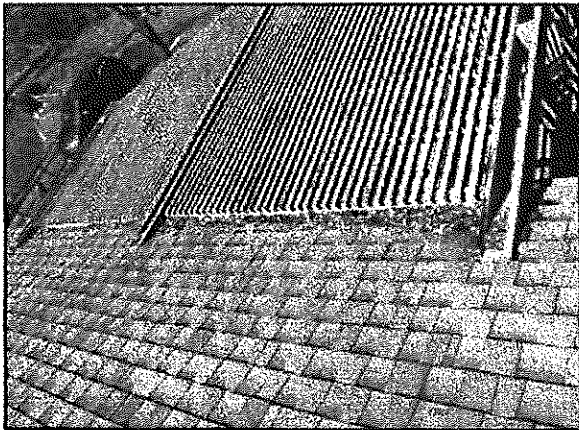
Figure 8-1

Comment 8:
Wood deterioration was noted at the front of house arbor. The deterioration was mainly located at the roof connection points.

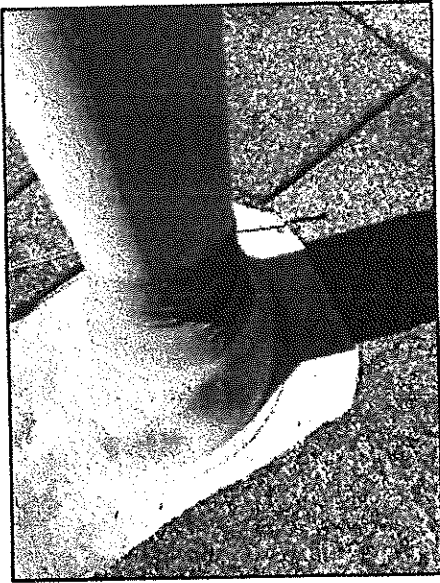
Figure 9-1

Comment 9:
Noted that vent pipe flashings are damaged and are suggested to be repaired. Suggest having repairs done to ensure moisture cannot access the underside of the roofing material. A qualified person should make all repairs.

Completed by Contractor Friend 5/1/18

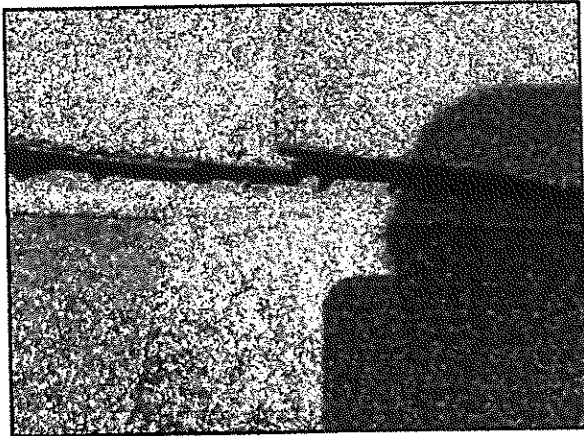
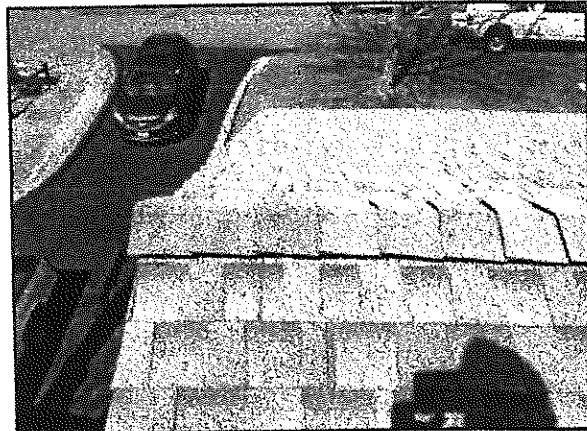
Ten exposed fasteners were noted at the ridgeline on the right side of the structure. These should be sealed to ensure moisture cannot access the underside of the roofline.

Fixed/Repaired 5/1/18

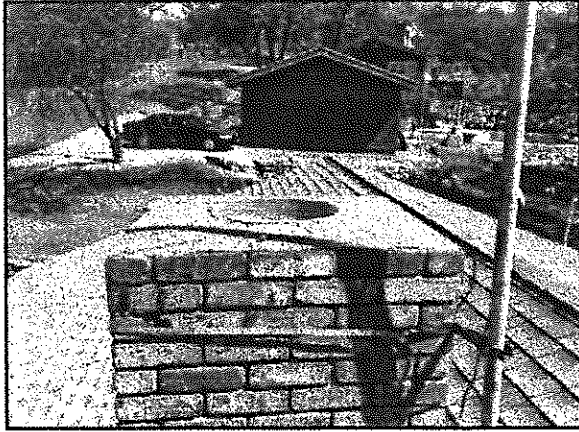
Figure 11-1

, Chimney cap should be installed on the roof line.

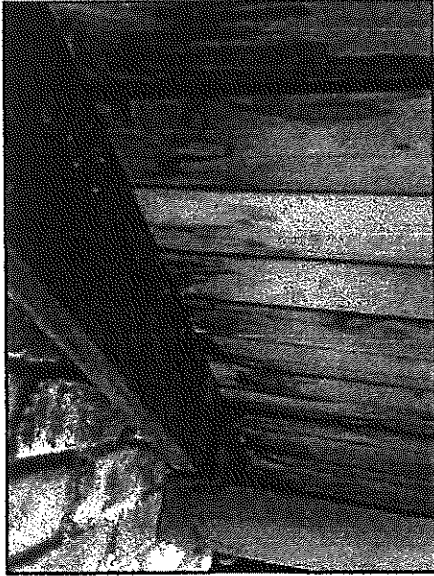
Figure 12-1

Moisture staining was noted around the chimney, visible in the attic. This was tested with a moisture meter and no active moisture was present.

- 12) Moisture staining was noted around the chimney, visible in the attic. This was tested with a moisture meter and no active moisture was present.

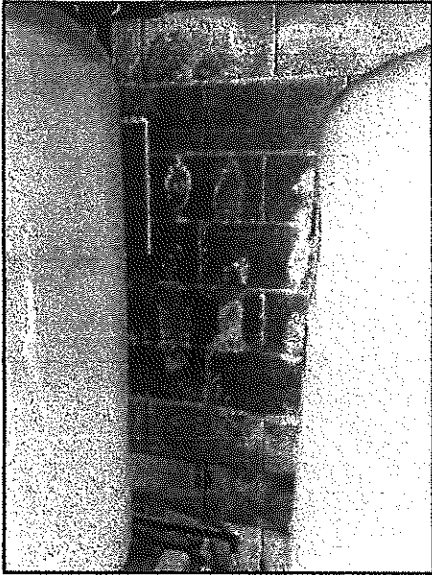
Figure 13-1

Efflorescence was present at the foundation wall in multiple locations. This is caused by moisture intrusion.

13) Efflorescence was present at the foundation wall in multiple locations. This is caused by moisture intrusion.

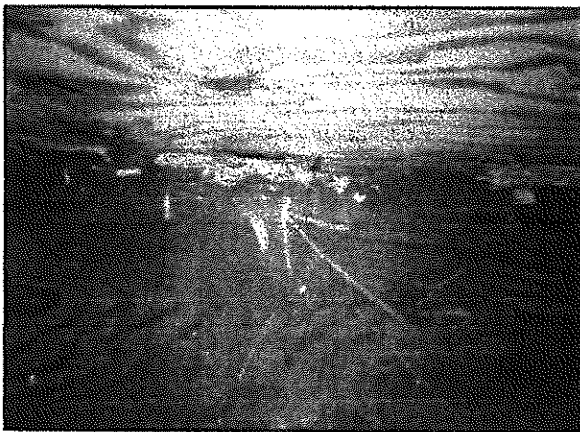
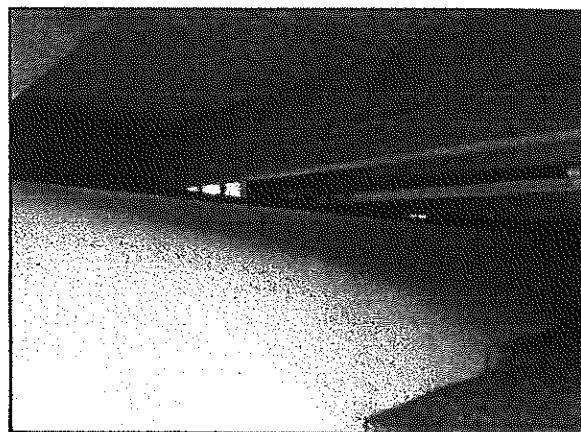
Evidence of termites were noted in the subarea at the front of the structure. It is suggested to review the pest inspection to determine the extent of the damage.

14) Evidence of termites were noted in the subarea at the front of the structure. It is suggested to review the pest inspection to determine the extent of the damage.

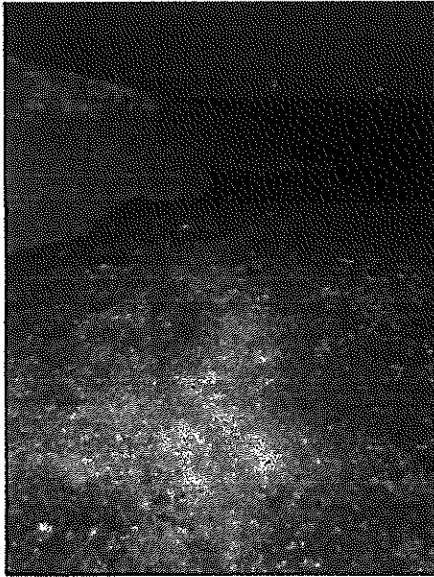
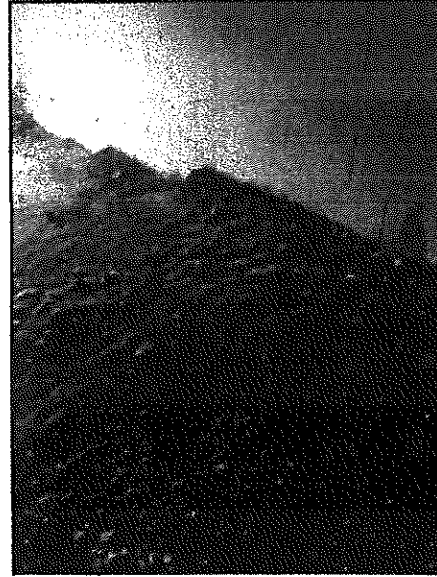
Moisture staining was evident in the crawl space. This appears to be caused by the downspouts that divert the water towards the sub-area. This is suggested to be repaired as moisture should not be in the sub-area.

Limited sub-area ventilation may also cause this. It is suggested to add additional ventilation.

15) Moisture staining was evident in the crawl space. This appears to be caused by the downspouts that divert the water towards the sub-area. This is suggested to be repaired as moisture should not be in the sub-area.

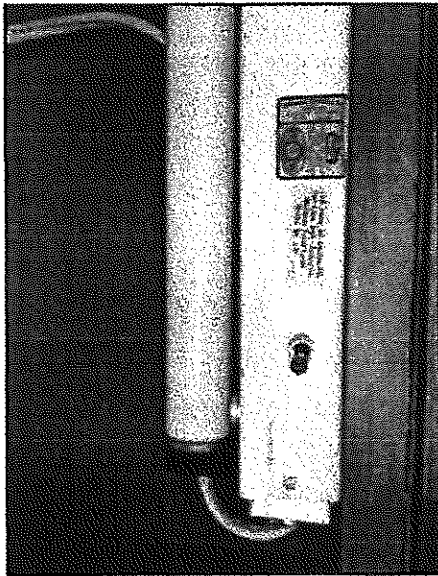
Figure 16-1

Fluorescent fixture mounted under the kitchen cabinet was not working at the time of inspection.

16) Fluorescent fixture mounted under the kitchen cabinet was not working at the time of inspection.

owner Fixed

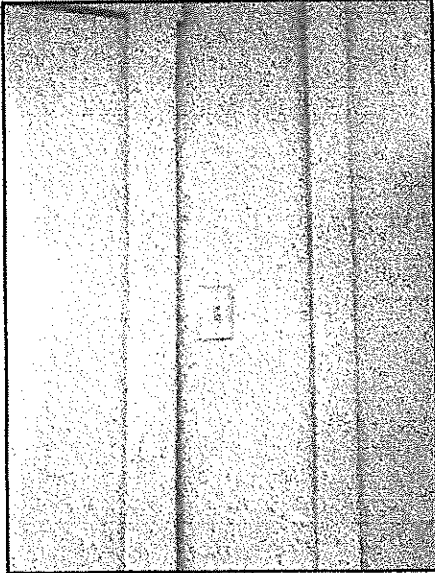
Figure 17-1

An electrical outlet was noted at the front of the structure. It was unclear what this switch turned on. However, if active, an exterior cover plate should be installed on top.

17) An electrical outlet was noted at the front of the structure. It was unclear what this switch turned on. However, if active, an exterior cover plate should be installed on top.

owner completed
power for outside outlet

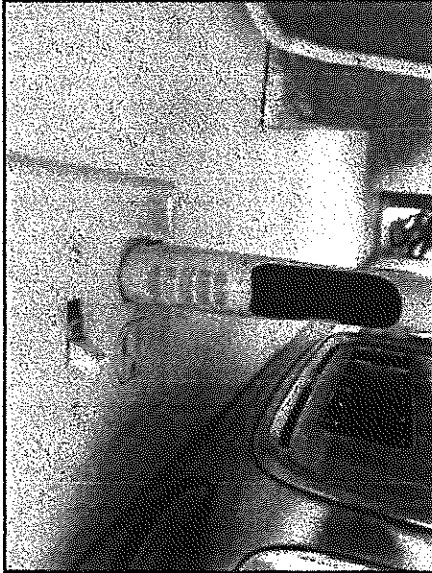
Figure 18-1

Comment 18:
Open ground at kitchen.

18) Open ground at kitchen.

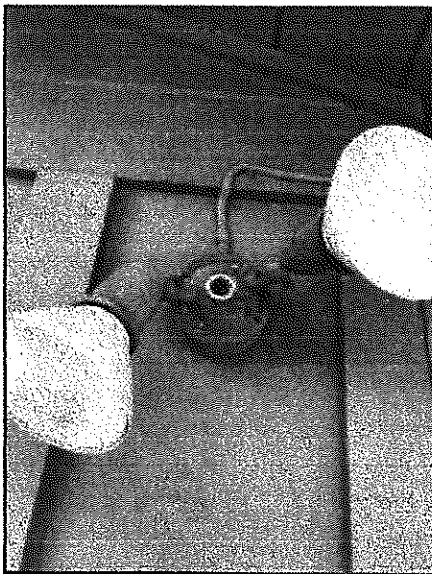
Figure 19-1

Comment 19:
A missing knockout plug was noted on the front left corner of the structure at the exterior light. This should be repaired to ensure no access to live power.

19) A missing knockout plug was noted on the front left corner of the structure at the exterior light. This should be repaired to ensure no access to live power.

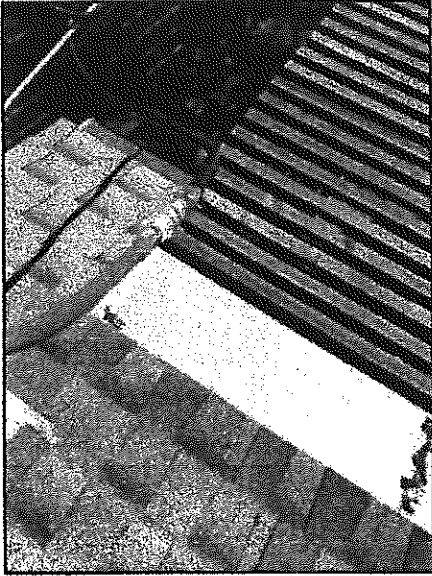
Figure 20-1

Noted that the main electrical service wire connections were visible. This should be repaired to ensure no access to live power.

20) Noted that the main electrical service wire connections were visible. This should be repaired to ensure no access to live power.

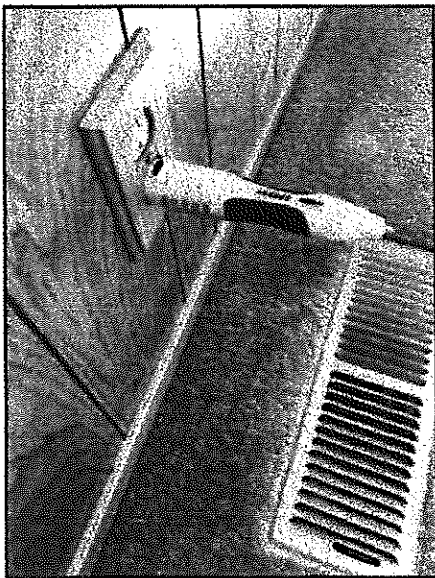
Figure 21-1

There is a dead plug found in the master bedroom underneath the west facing window.

21) There is a dead plug found in the master bedroom underneath the west facing window.

Repaired by owner

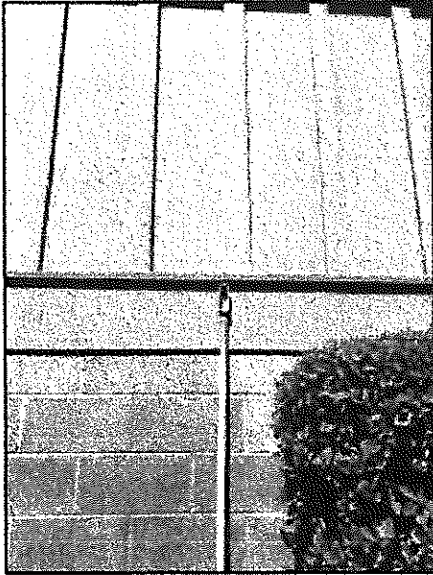
Figure 22-1

An electrical cover plate was missing at the rear of the structure near a junction pull box. This should be repaired to ensure no access to live power.

22) An electrical cover plate was missing at the rear of the structure near a junction pull box. This should be repaired to ensure no access to live power.

owner completed

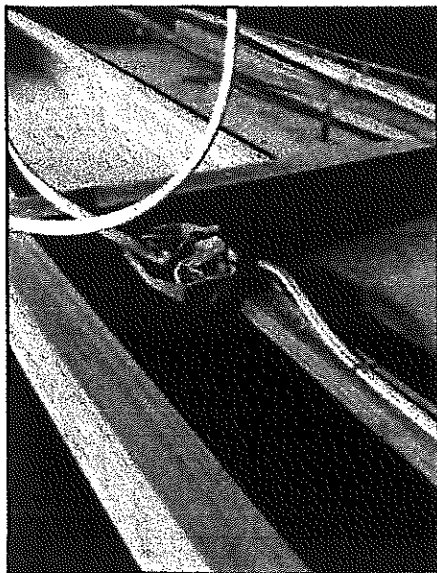
Figure 23-1

An unboxed electrical connection was noted in the attic near the access door. This should be repaired or replaced to ensure no access to live power.

23) An unboxed electrical connection was noted in the attic near the access door. This should be repaired or replaced to ensure no access to live power.

owner completed

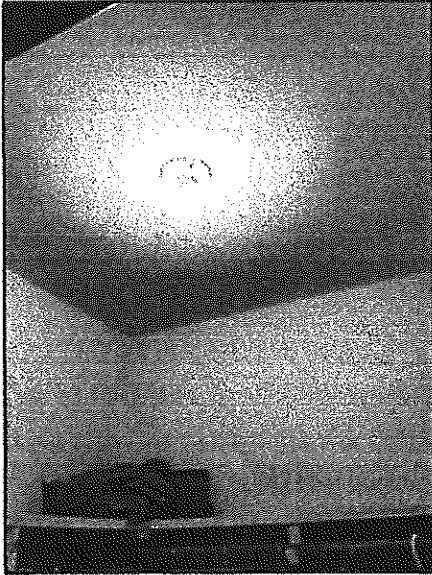
Figure 24-1

The inspector was unable to turn off the rear of house and master bedroom closet lights.

Lights go off when you close door. Comes on when you open door

24) The inspector was unable to turn off the rear of house and master bedroom closet lights.

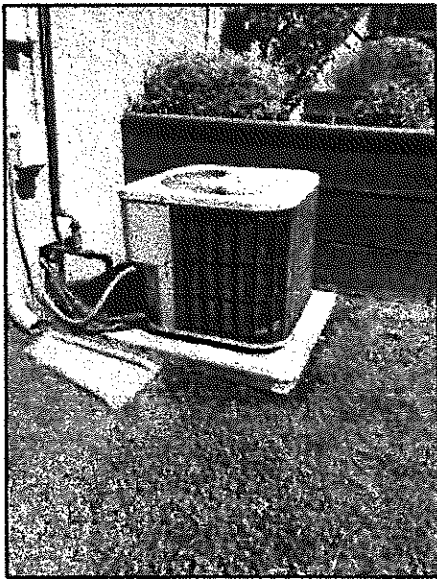
Figure 25-1

Inspector was unable to inspect AC unit due to the ambient temperature being below 65 degrees. The inspector offers no warranty on the condition of the unit itself.

25) Inspector was unable to inspect AC unit due to the ambient temperature being below 65 degrees. The inspector offers no warranty on the condition of the unit itself.

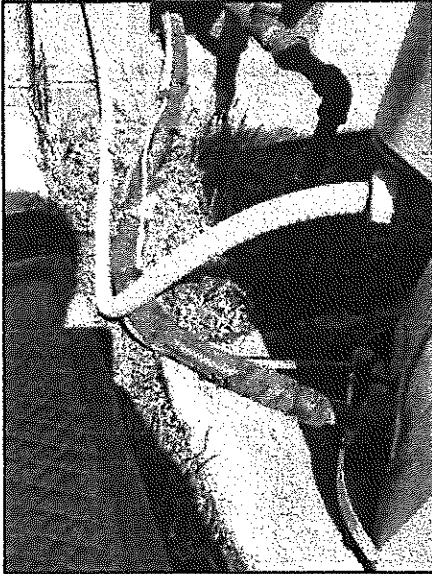
Figure 26-1

Noted that insulation around line set for AC System is damaged. This unit should be repaired to ensure that the AC system is operating efficiently.

26) Noted that insulation around line set for AC System is damaged. This unit should be repaired to ensure that the AC system is operating efficiently.

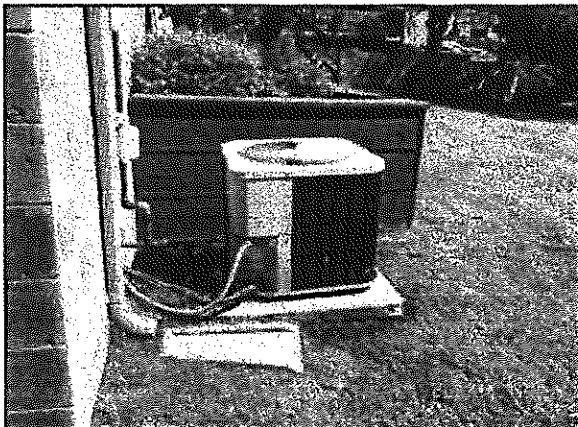
Figure 27-1

The AC condenser was not sitting level. This should be repaired to ensure it cools or functions properly.

27) The AC condenser was not sitting level. This should be repaired to ensure it cools or functions properly.

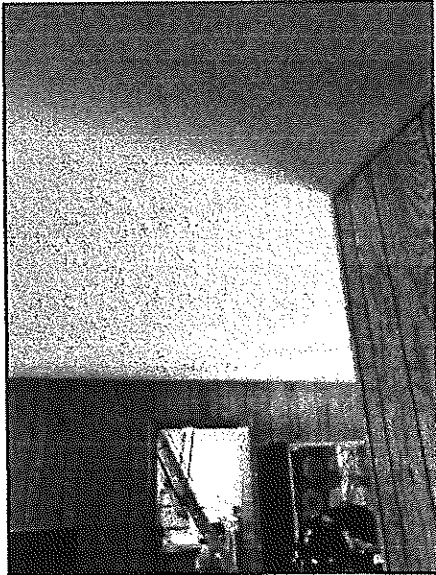
Figure 28-1

A drywall crack was noted at the ceiling of the living room.

28) A drywall crack was noted at the ceiling of the living room.

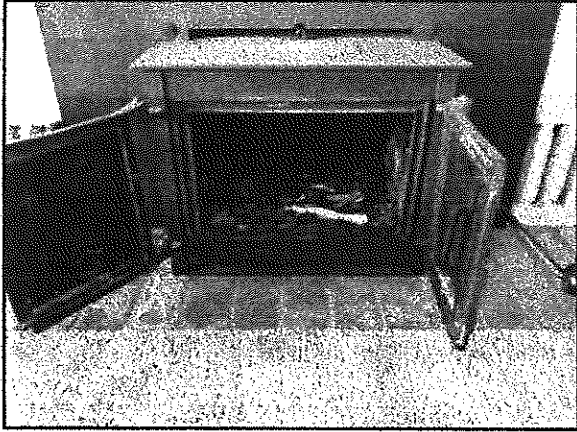
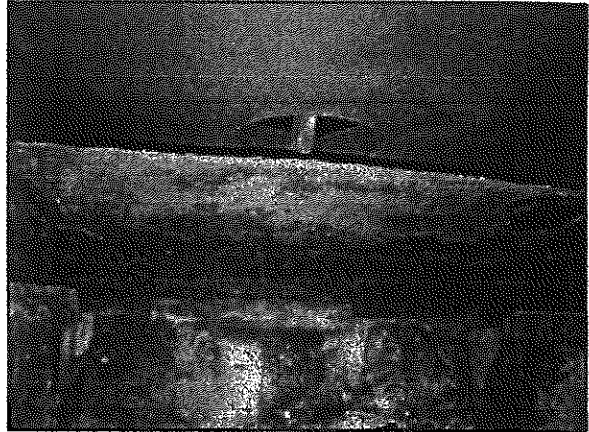
Noted that the wood stove does not meet current requirement of clearances to a non-combustible material.

The inspector also noted that rusting was present at the interior of the fireplace. This unit should be reviewed by a qualified person as it is outside the scope of the general home inspection.

29) Noted that the wood stove does not meet current requirement of clearances to a non-combustible material.

The door should be 18 inches away from any combustible surface. This includes laminate floor, carpet, and hardwood. This can be resolved by adding a stone rug at the front or extending the current hearth.
