Confidential Inspection Report

LOCATED AT:
38820 Maracaibo Cir
Palm Springs, CA 92264

INSPECTED ON:
Friday, February 16, 2024

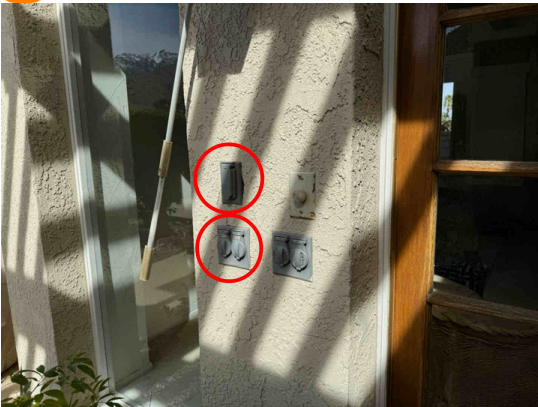
EXTERIOR/SITE/GROUND SWITCHES

REPA s-152: Items to note: Mystery switches

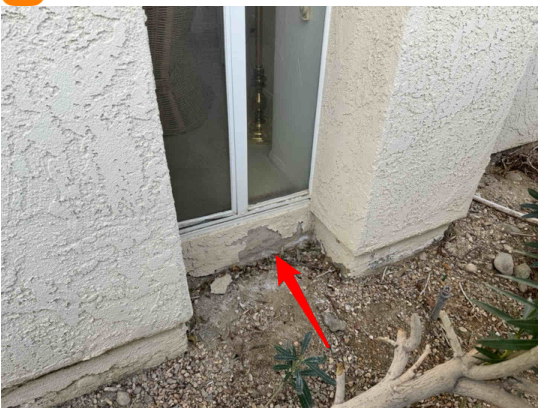
EXTERIOR/SITE/GROUND STUCCO

REPA s-153: Sections of the stucco are stained/cracked/peeling paint and/or deteriorated.

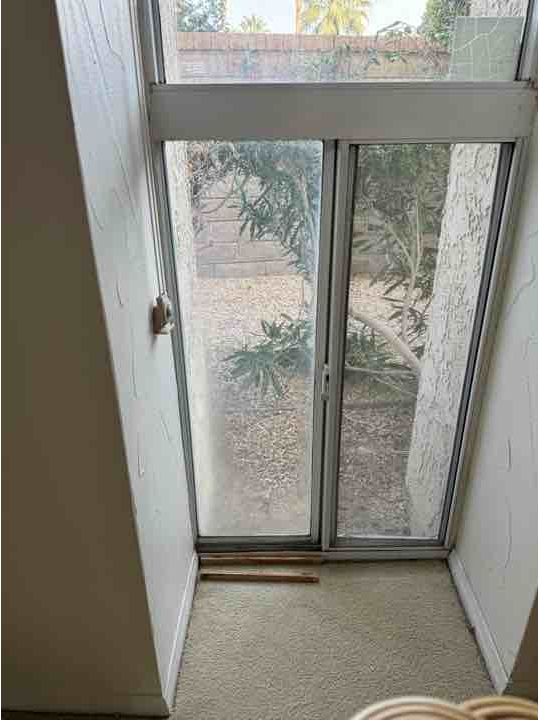
PRIMARY BEDROOM WINDOWS

REPA s-202: Items to note: Mineral deposits on the glass

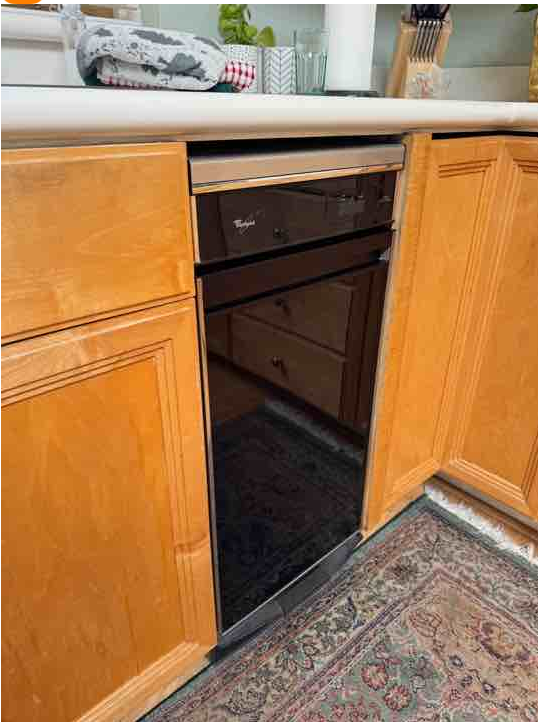
KITCHEN TRASH COMPACTOR

REPA s-224: Trash compactor was inoperable at the time of the inspection

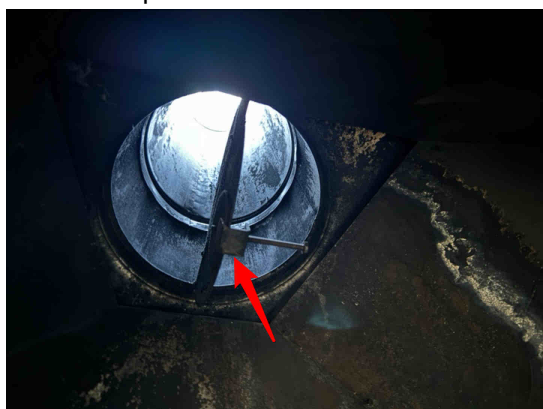
83: C-clamp installed

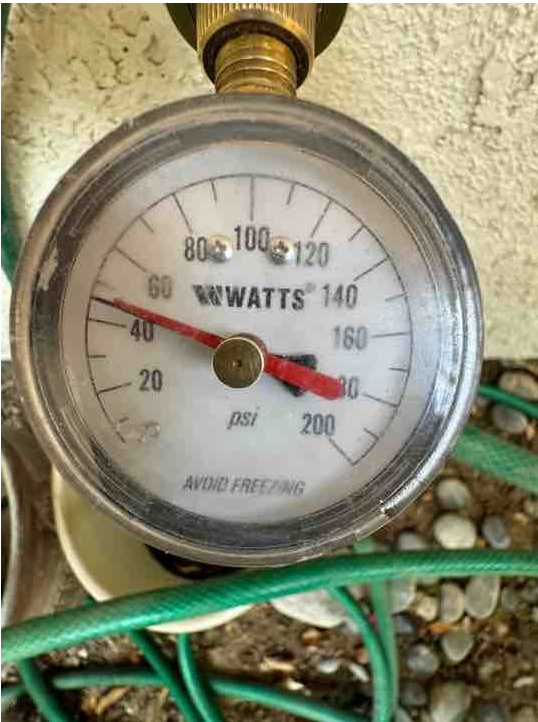
92: Water pressure: Low-range of normal water pressure

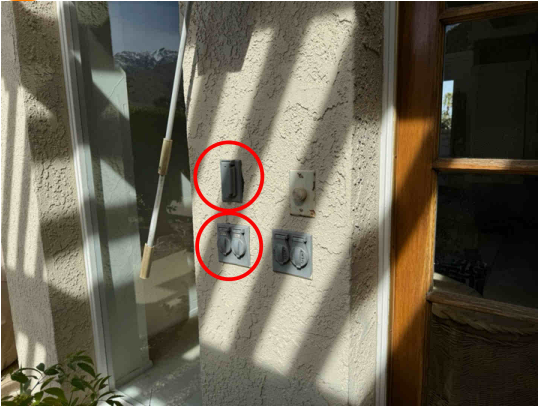
SWITCHES

REPA 152: Items to note: Mystery switches

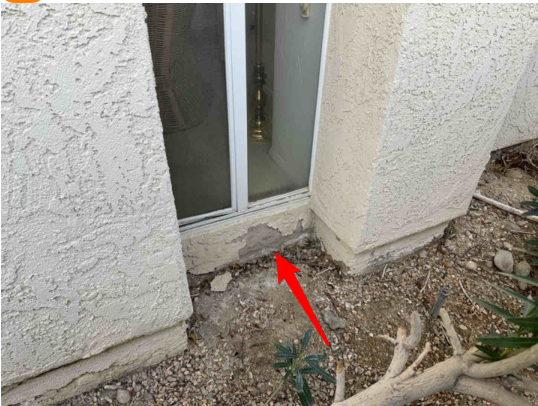
STUCCO

REPA 153: Sections of the stucco are stained/cracked/peeling paint and/or deteriorated.

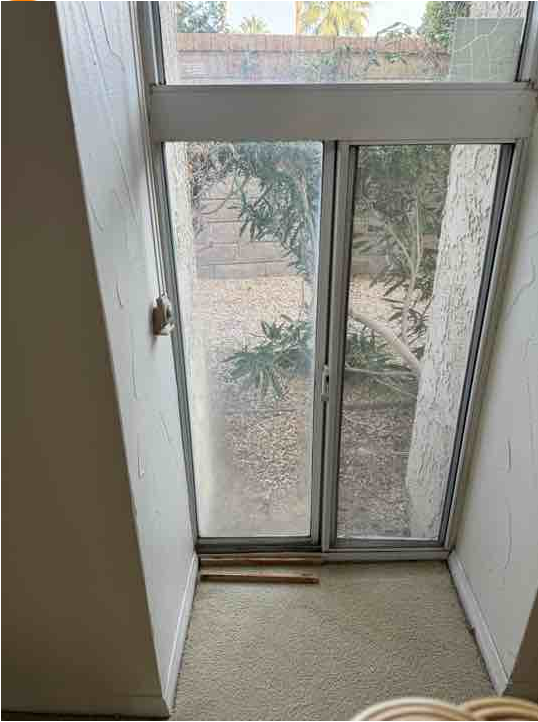
WINDOWS

REPA 202: Items to note: Mineral deposits on the glass

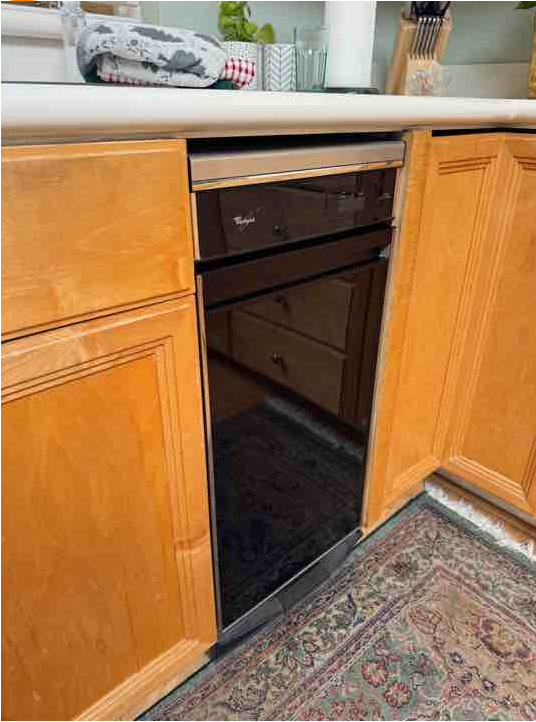
TRASH COMPACTOR

REPA 224: Trash compactor was inoperable at the time of the inspection
