Property Address:

2030 Black Canyon Rd  
Ramona Ca 92065

January 10, 2018

RE: 2030 Black Canyon Rd #29  
Ramona, CA 92065

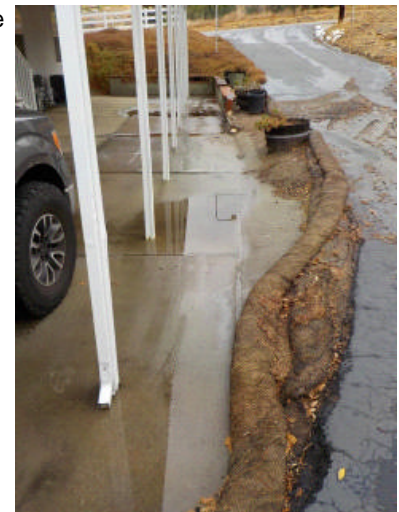
Type: Concrete. Cracks noted are typical.

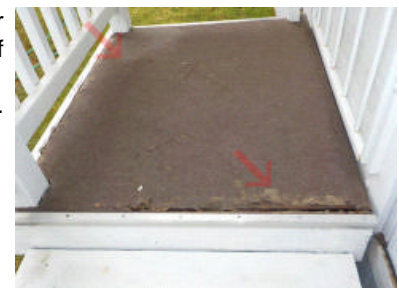
Type; Wood. South side exterior stairs are showing signs of weathering / moisture damage. Landing at top of stairs is worn. Maintenance is needed.

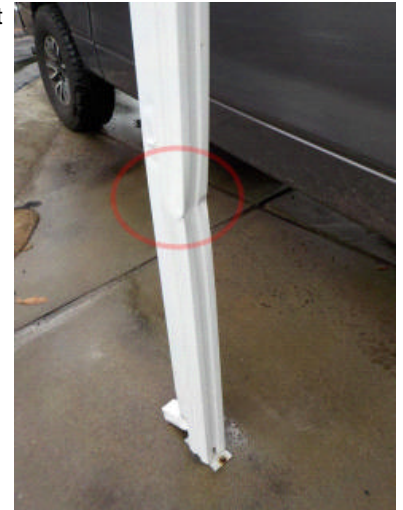
- ⌋ Minor damage is viewed at aluminum carport posts.

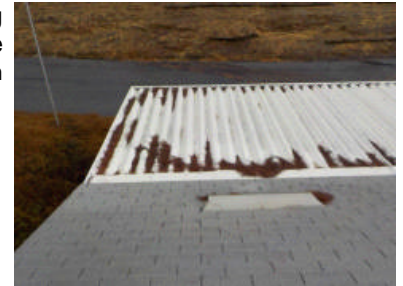
- OK MM RR ⌋ Recommend cleaning / servicing roof areas from debris / pine needles. This will help with drainage at gutters.

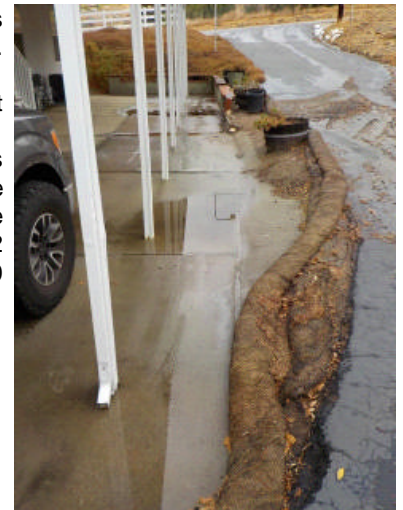
- ⌋ Evidence of poor drainage is viewed at north side of property. Water is ponding in driveway. Poor drainage is also viewed at West side of property. Recommend Pitch slope of soils away from foundation. Slope should fall away from the foundation at a minimum of 1/2 inch per foot and extend at least 10 feet away from the foundation.

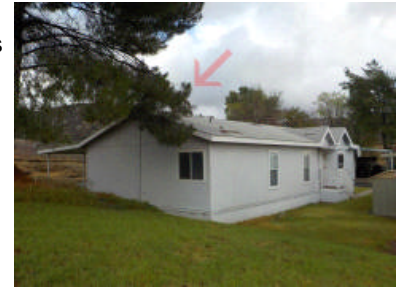
Tree limbs touch / over hang roof.  
Recommend trimming branches  
away from structure.

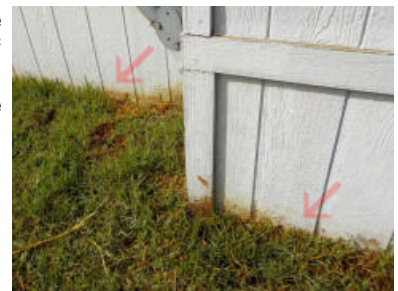
*Materials & Condition:* OK MM RR  
Type: Hardboard siding. Some areas are showing signs of weathering / moisture damage. Soil / landscape is too high at base of exterior walls. Recommend trim grass / landscape away. This will help prevent moisture damage and extend the life of the siding.

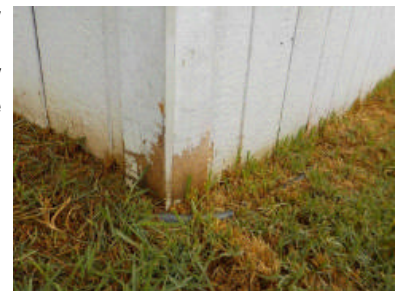
*Exterior Siding:* Some areas are showing signs of weathering / moisture damage. Soil / landscape is too high at base of exterior walls. Recommend trim grass / landscape away. This will help prevent moisture damage and extend the life of the siding.

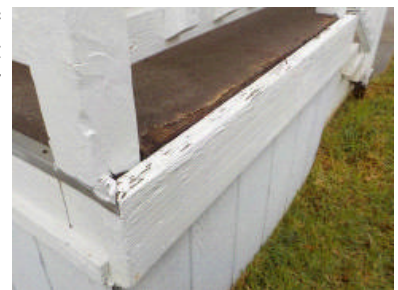
*Flashing & Trim:* Wood trim showing signs of weathering / moisture damage at some areas. Recommend further evaluation for wood destroying organisms by a qualified professional.

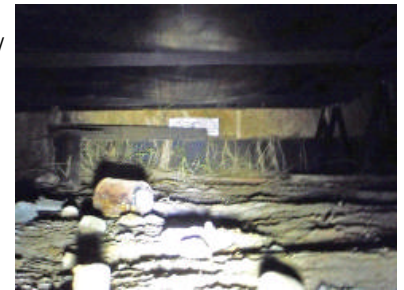
␣ Type: Raised Foundation.  
Recommend cleaning debris /  
grass out of crawlspace area.  
Eliminate soil contact is needed.

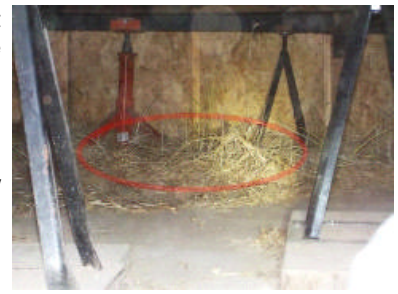
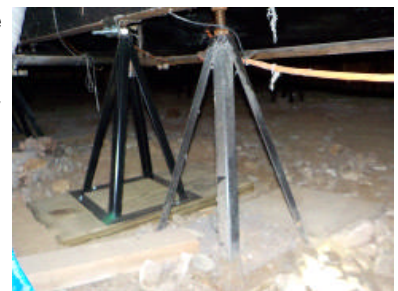
<i>Access:</i>		Access located under carport.
	OK MM RR	
<i>Walls:</i>	.. .. p	Type: Wall materials are Hardboard siding / wood. Earth to wood contact is viewed at all sides of exterior walls. Recommend eliminate soil contact. This will help extend the life of the siding.
<i>Beams/Underfloor:</i>	p .. ..	Underfloor insulation restricts viewing. No readily visible problems noted.
<i>Ventilation:</i>	p .. ..	Satisfactory - The cross-ventilation in the crawlspace appears to be adequate.
<i>Floor:</i>	.. .. p	Type: Soil. Earth-to-Wood contact is found. Grass is growing at some areas. Recommend trim landscape / grass away from exterior walls. Recommend removing grass / debris from crawlspace area. Cleaning / servicing is needed.
<i>Posts / Piers:</i>	p .. ..	Type: Metal. Satisfactory - There are multiple metal post supporting the overhead beams in the crawl space. It appears to be adequately installed.

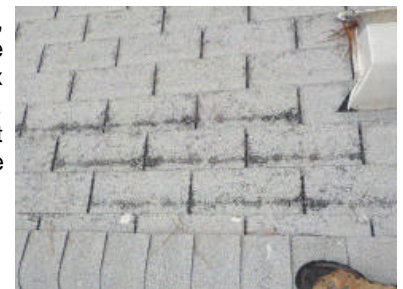
Roof shingles show signs of deterioration, especially at the front south facing field. The aggregate surface has shed, leaving the matrix exposed. The roof is near the end of its useful life. Water penetration may occur. Roof replacement will be necessary in the near future and should be budgeted for.

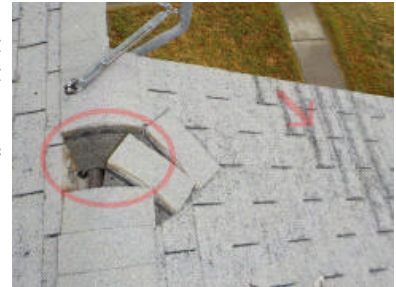
⌋ Type: Three tab composition shingles. Opening is viewed at ridge cap above living room east side of roof. Repairs are needed by a qualified professional roofer. Roof covering is showing signs of moderate weathering and age. Cracking and clawing of shingles are the result of long term weathering and an advanced shingle age. Roof shingles show signs of deterioration, especially at the front south facing field. The aggregate surface has shed, leaving the matrix exposed. The roof is near the end of its useful life. Water penetration may occur. Roof replacement will be necessary in the near future and should be budgeted for.

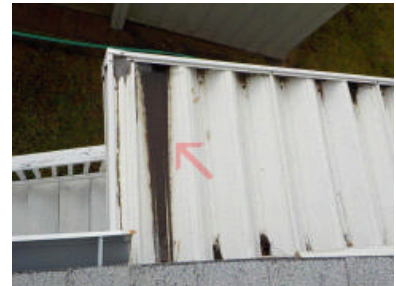
⌋ Debris / pine needles viewed in gutters. Some gutters are holding water. Annual cleaning / servicing is needed.

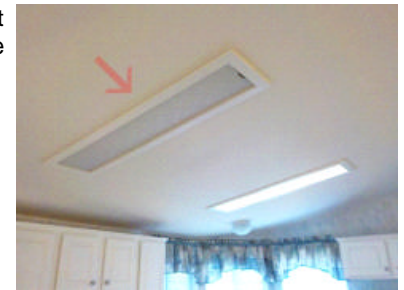
The ceiling lights installed in this room did not function using the wall switch. I did not determine if the switch is bad or if the light bulb is bad.

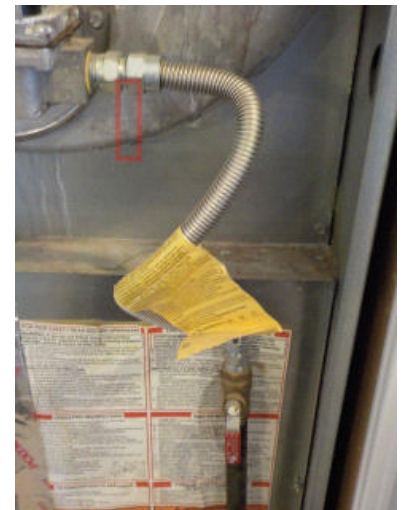
Natural Gas. Note: Gas pipe lacks a drip leg.

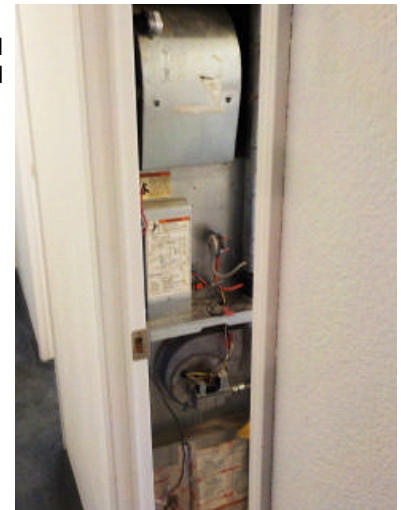
Operational at time of inspection. Heater is dirty, recommend annual cleaning / servicing by a qualified HVAC professional.

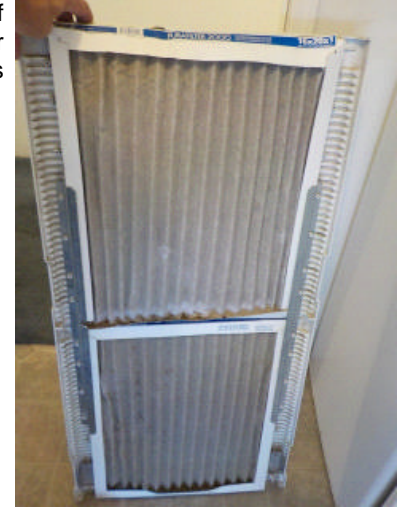
" " ␣ The filters are in need of replacement. Replacing or cleaning filters every 30 to 45 days is recommended.

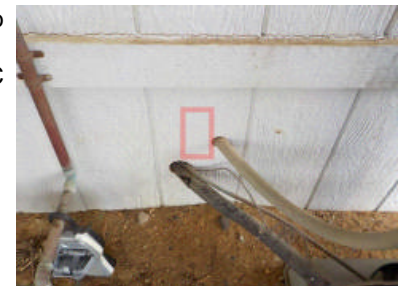
No electrical disconnect in line of site / next to exterior condenser. This item is required. Recommend further evaluation by a qualified HVAC professional.

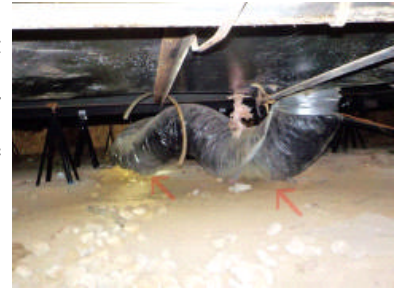
Type: Flex Round / Metal. Earth contact is viewed in crawlspace at ductwork. Eliminate soil contact is needed. Debris is viewed in floor registers at interior. Recommend having a annual cleaning of ductwork.

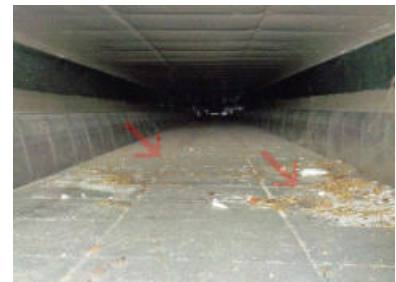
Debris is viewed in floor registers at interior. Recommend having a annual cleaning of ductwork.

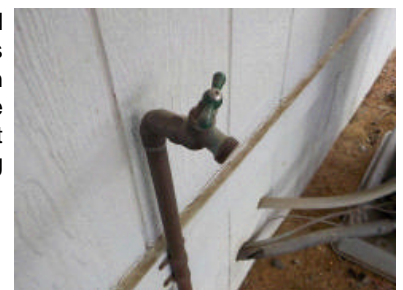
General: " p " Sample operated, appeared serviceable, No anti-siphon valves installed on hose bibs. Anti-siphon valves are required. These are safety devices that prevent contaminated water from flowing into the house water supply.

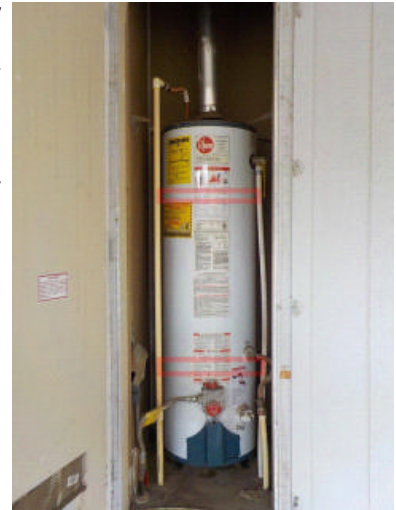
Corrosion is viewed at supply line / tank connection. Water heater is not correctly or inadequately secured and needs to be strapped in accordance with local standards. Gas line is missing drip leg. Tanks listed age is 2003. Water heaters typical lifespan is 10yrs. Tank is Past life expectancy, replacement is recommended.

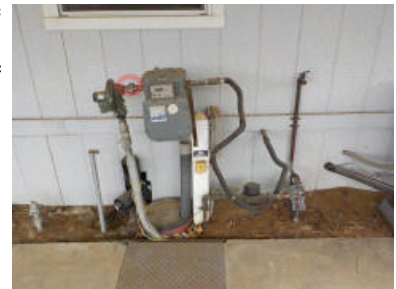
No leaks detected at time of inspection. Gas meter is missing earth quake automatic shut off valve. This item is recommended based on today's standards.

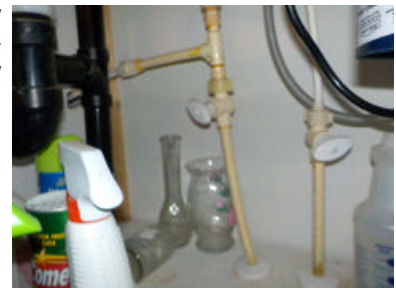
No leaks detected at supply lines / drain line connections. Minor corrosion viewed at faucet. Minor / typical wear is viewed at porcelain sink.

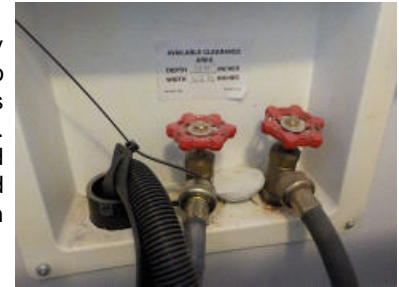
Plumbing appears serviceable. Minor corrosion viewed on supply valves, recommend upgrade to quarter turn valves. No leaks detected at time of inspection. There is a connection box installed in the wall with both hot and cold water and a drain pipe. The drain pipe was not flood tested.

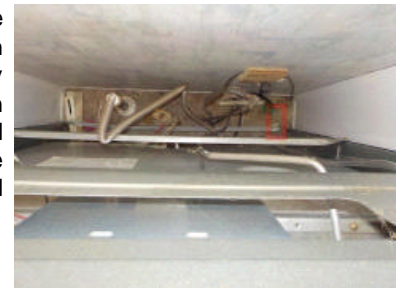
<i>Type &amp; Condition:</i>	OK   MM   RR	"   "   p	Cooktop / oven operational at time of inspection. Stove has not been secured as required by manufacturer's installation instructions. A tip-over hazard exists for small children. Stove should be properly secured right-away.
------------------------------	--------------	-----------	---

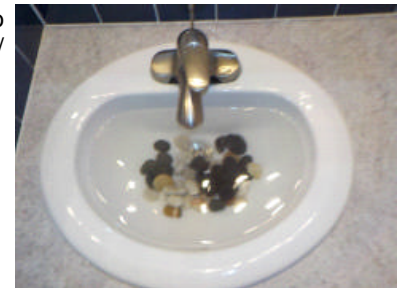
Drain stopper not operational. No leaks detected at supply valves / drain line.

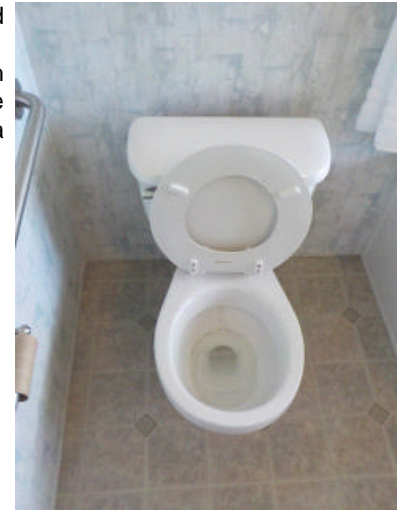
The following problems were noted at the toilet: Toilet is loose at floor. Recommend upgrade to modern dual flush toilet. These toilets use about 25% less water than a regular 1.6 gpf toilet.

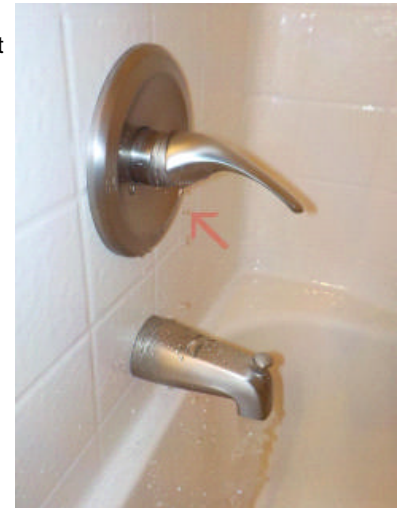
Minor leak is viewed at faucet. Caulking / sealant is needed at fixture / wall connections.

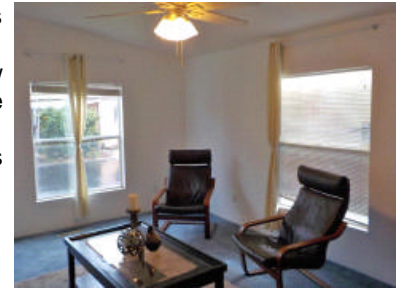
␣ Living room / bedroom windows are difficult to operate. Recommend servicing window hardware. The thermal seals are showing signs of weathering. Although it is keeping the elements out, it has a clouded appearance. This condition will worsen.

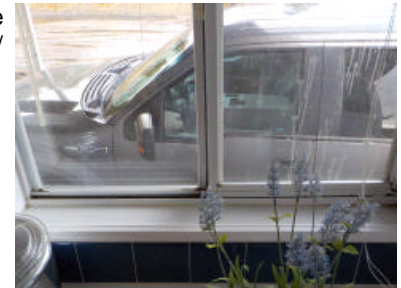
Type: Metal dual pane. Windows at sink are difficult to operate. Recommend cleaning / servicing tracks.

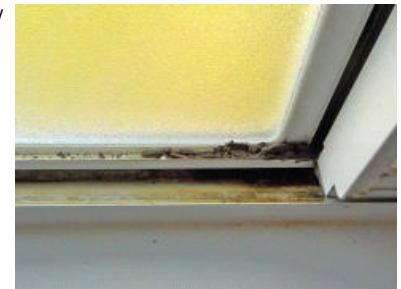
Window tracks are dirty, recommend cleaning / servicing window hardware.

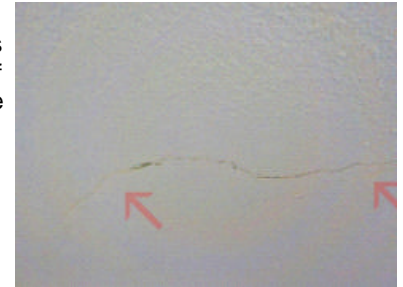
Some cracks noted at top of vaulted ceiling. Moisture test at top of ceiling vault reading less than 6%, considered dry. Be sure to take note of any future movement. Most minor cracking is due to shrinkage of the construction materials.

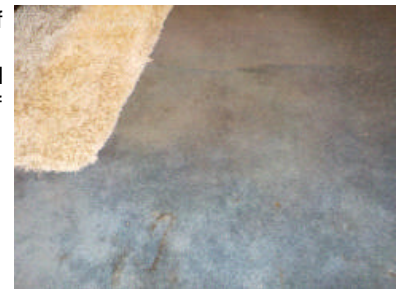
⌋ Carpeting showing signs of moderate wear / stains noted. Loose carpeting noted. Rugs and floor coverings prevent viewing of primary floor materials.

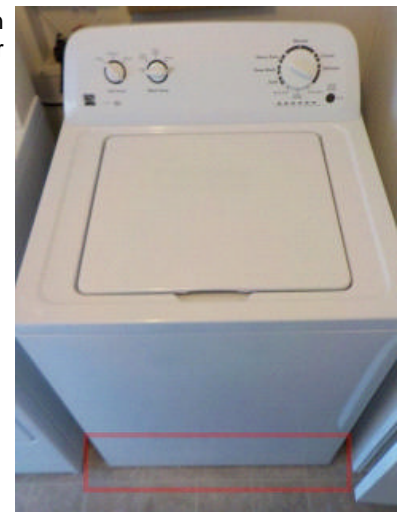
␣ Recommend installing a catch pan with exterior drain line under clothes washer.

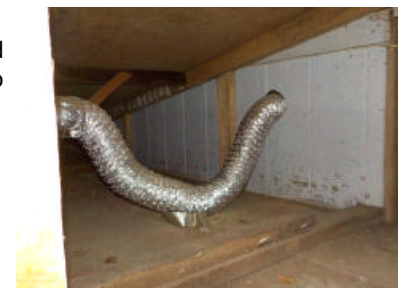
Improper Vinyl / foil type vent used for dryer vent. Foil & Vinyl dryer vents are no longer a permitted material used for dryer ventilation. Upgrade to Metal / rated type vent is needed.
