# Home Inspection Report

2420 Canyon Lakes Dr San Ramon, CA 94582

3/7/2024

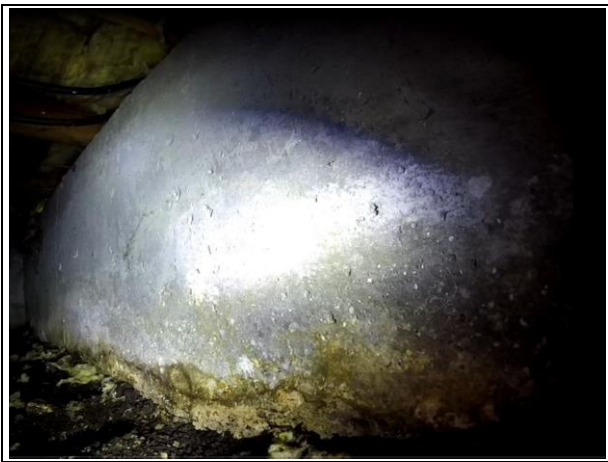
1A

• **Observation:** The structure is supported with a raised concrete perimeter foundation with stem wall support. (See Picture 1A) The foundation was visually inspected where accessible. Anchor bolts were noted at the inspected structure. Bolting the sill plate to the foundation is a basic precaution to help prevent a home from sliding off it's foundation in an earthquake. Noted interior wallboard cracking is an indication of settlement/movement and or stress cracking. Noted foundation cracks are indicators of structure or earth settlement. (See Picture 1B-1C) These types of cracks are commonly found on foundations of this type and age. The cracks appear to be caused from some settling of the foundation at some time in the past. The size and type of cracking does not appear to represent an immediate concern to the structures integrity but should be monitored over time to identify if the structure is continuing to settle. The inspection did not discover evidence of substantial structural movement. Other noted cracks in driveway and garage floor were detected. These are cosmetic cracks due to typical concrete curing, normal settlement, building stresses from changes in temperature and expansive soil conditions common in the region. *No major defects* were observed in the accessible structural components of the house.

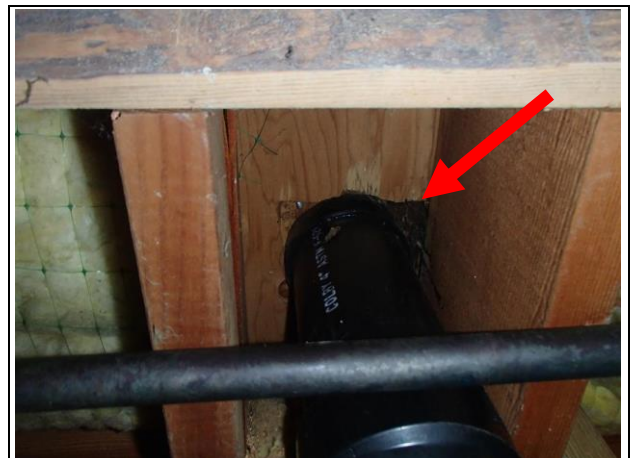
1D

**1.2 Further evaluate:** It was noted the *sub-flooring* underneath the *first floor bath appears damaged*. Recommend reviewing termite report for estimate of repair. (See Picture 1D)

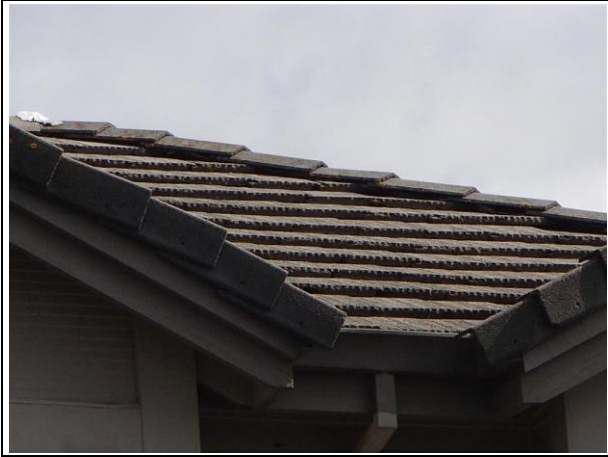
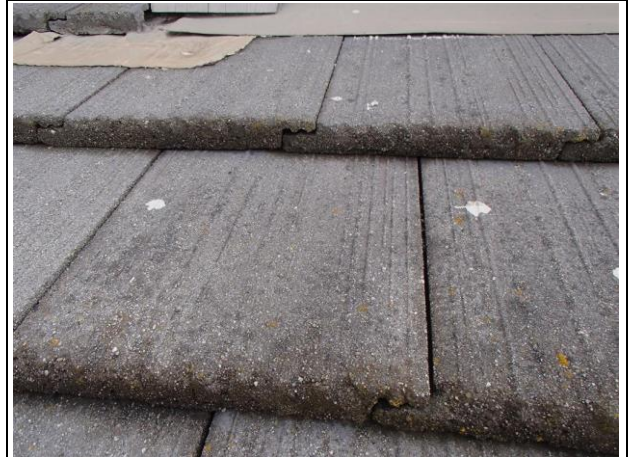
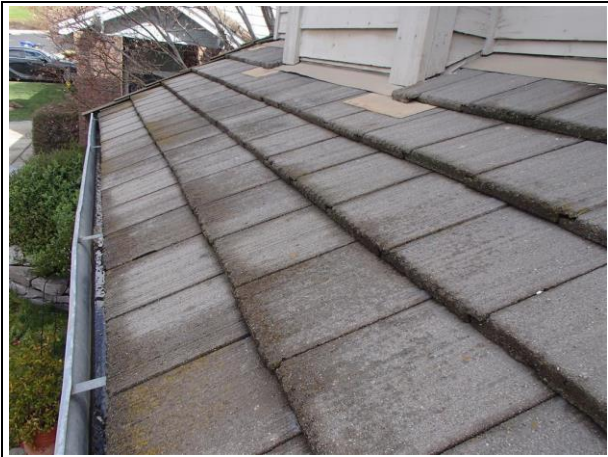
- **Observation:** The visual inspection of the roof is to determine the presence of adverse conditons, non-functional items and excessive or unusual wear. Roof inspection is a general review of the roof material, roof drainage systems, flashing, skylights and roof penetrations. The inspected roof will require regular maintenance from licensed roofing contractor in the next few years. Roof is estimated to be 36 years old. (see Roof "Remarks" page for estimated life of roof). In all, the visible roof covering show evidence of normal wear and tear for a roof of this age and is in *satisfactory condition*. (SEE PICTURE 2A-2C)

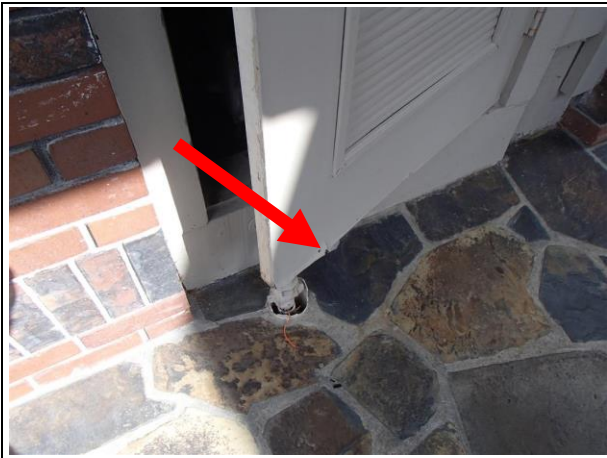
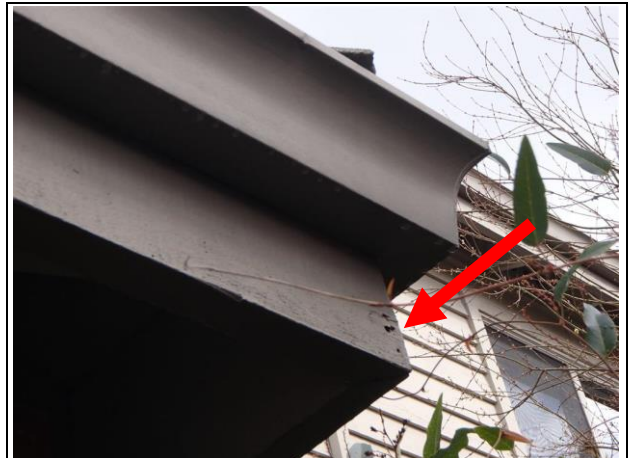
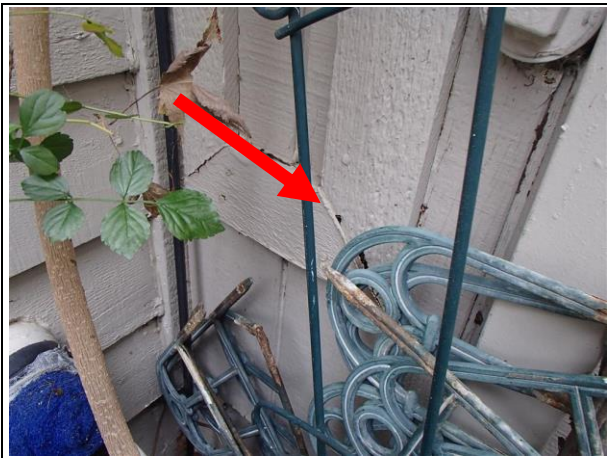
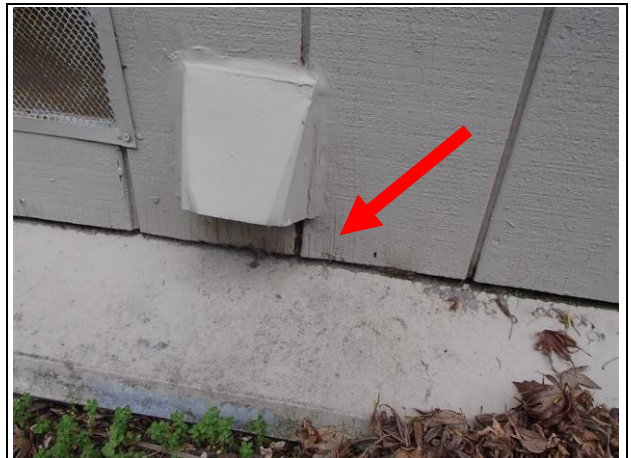
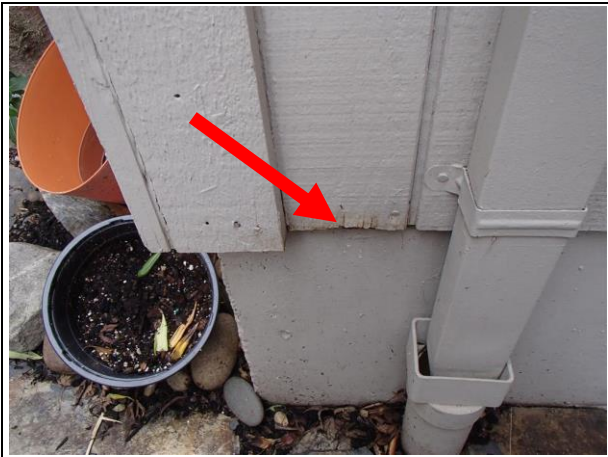
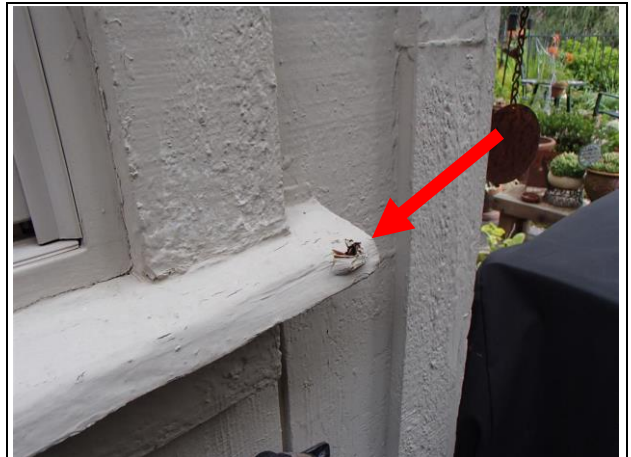
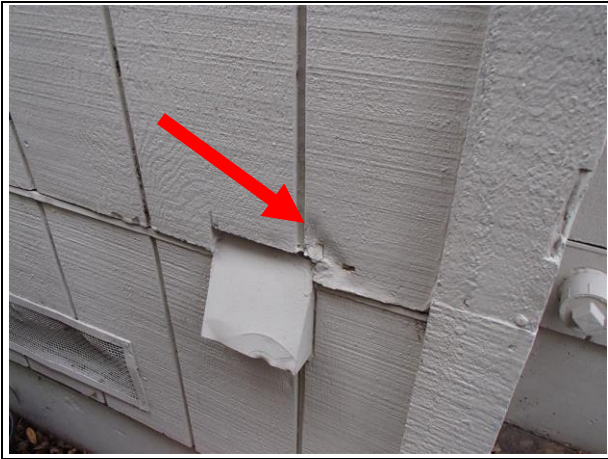
**3.27 Maintenance Repair:** There is *damage* or *deterioration* to sections of *fascia* board (front side), *eaves* (left side), *siding* (left and right sides), *window sills* (right side), *utility door* and *trim* (right side). Only a sample was identified in this report. We recommend having termite inspection and review their report for additional details of all damage and for estimates of repairs. (See Picture 3A - 3G)

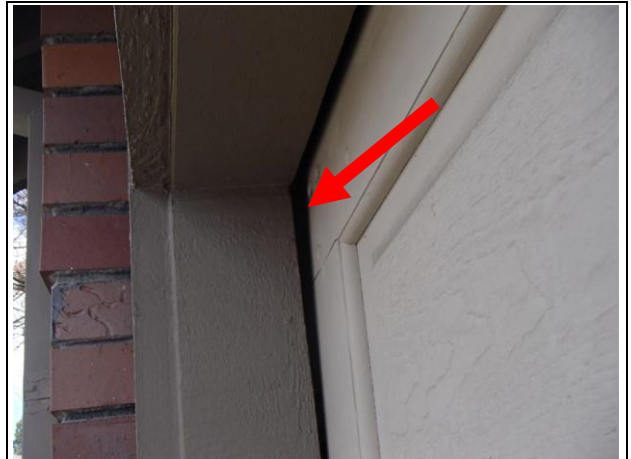
3H

**3.70 Improve:** *Gaps noted* at the *sides garage door (top panel)*. Recommend adding weather-stripping to keep rodents from entering area. (See Picture 3H)

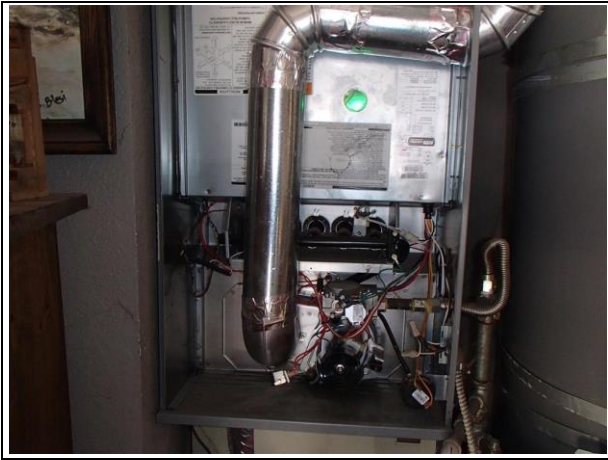
5A

- Observation:** Unit operated at the time of inspection. Visible burners inspected, proper combustion air, proper venting (where visible), electrical disconnection and visible fittings checked for gas leaks. The life expectancy of a Furnace is 20 - 25+ years and the inspected furnace is estimated to be 12 years old. Recommend having unit serviced and cleaned as on going maintenance program. (See picture 5A)

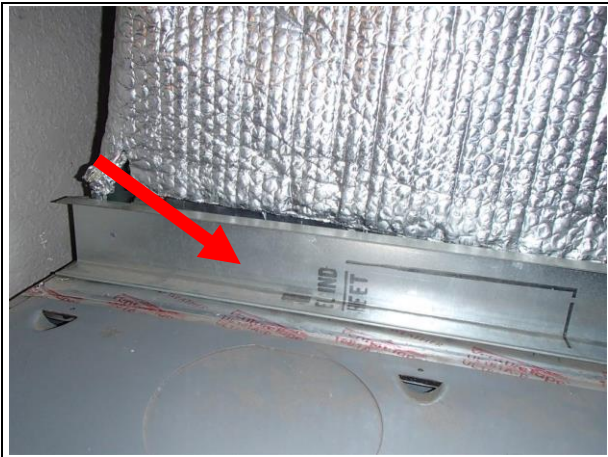
5C

- Note:** Inspected house has a *1- zone system* that has one thermostat on the lower level to control temperature for the entire house.
  - Note:** The *air filter* located in the *upper furnace* compartment *was relatively clean* at the time of inspection. Filters should be cleaned (if filter is the type that can be cleaned) or replaced every 3-6 months depending on use of heating or air conditioning units. Recommend using the middle grade filters. (See picture 5B) *Filter door noted to need secured and sealed for optimal performance.* (See picture 5C)

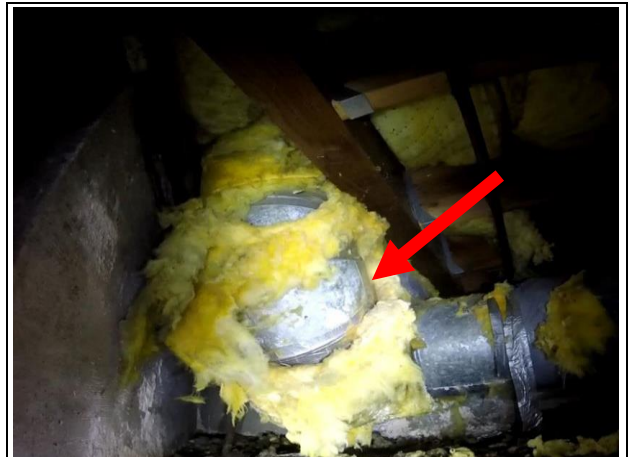
5D

- 5.31 Improve:** Few of the HVAC *air ducts* in *sub-area* did not have *insulation* covering them. To improve heating/cooling efficiency, it is recommended that insulation cover all HVAC ducts. (See picture 5D)

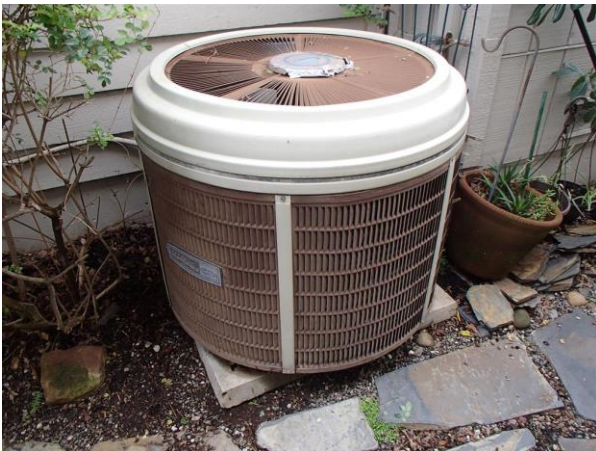
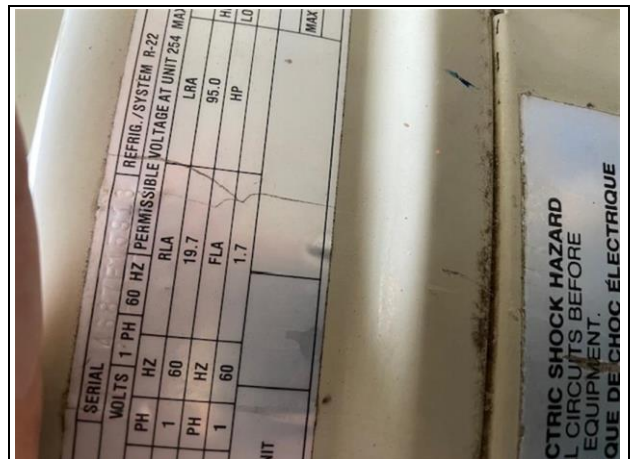
**6.3 Deferred Cost:** Life expectancy of an A/C unit is 15+ years. A/C System was not tested for proper operation due to the outside temperature not being at **least 65 degrees** at the time of inspection. Running A/C system could possibly damage the compressor and does not allow for proper differential readings. Compressor/condenser unit was visibly inspected by reviewing disconnect switch, checking for obstruction around outdoor unit, check for signs of leaking refrigerant lines at the exterior unit and any damage to the condenser fins. A/C unit is considered in **marginal condition**; showing signs of rust, condenser fins are slightly damaged and unit is estimated to be **37** years old and **past its life expectancy**. Recommend budgeting for repairs or replacement anytime in the next five years. Client may also consider caring home warranty to cover in case of repairs. (See **picture 6A, 6B**)

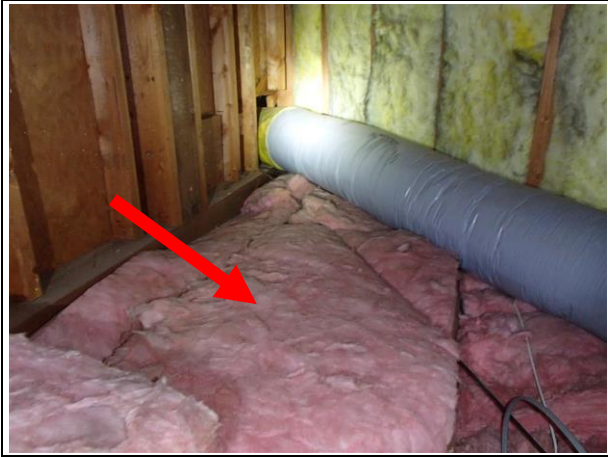
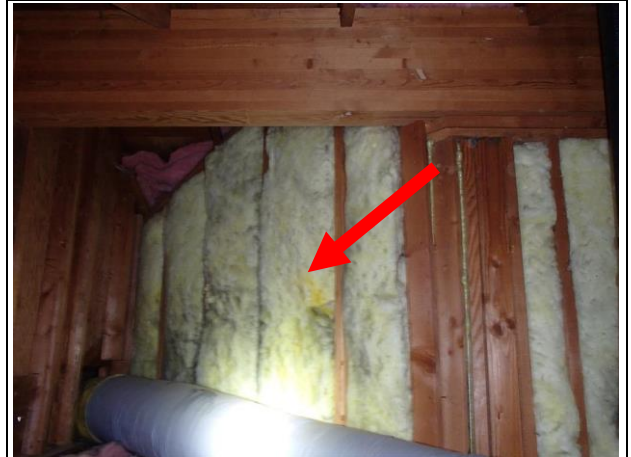
**• Observation:** Insulation levels are lower than today's standards but typical for a home of this age and construction. (See [Picture 7A, 7B](#)) Ventilation appears adequate for the size of the home. Left side vents appear to be blocked from the exterior, however there is a diverter to lower level of foundation wall inside sub-area. **Note:** *Insulation to the floor* above the crawl space between the floor joists is a value added feature only typical in new construction. (See [Picture 7C](#)) *A few areas noted to have fallen or pulled down and should be re-installed.* (See [Picture 7D](#))

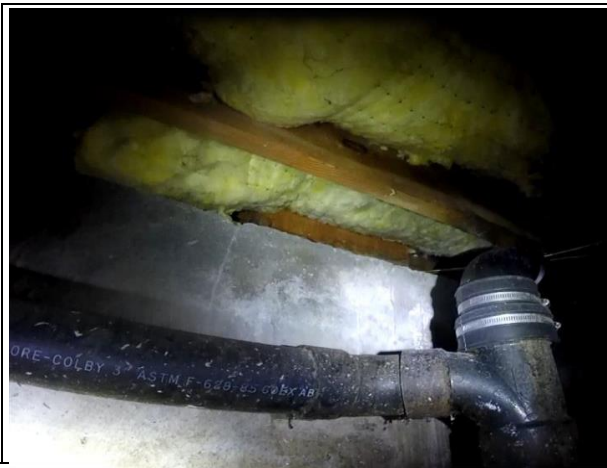
8A

- **Observation:** All visible drain pipes and supply lines were inspected for leaks. One leak was detected at the time of inspection. The visible water supply and drain pipes are in *satisfactory condition*. (See [Picture 8A](#)) Waste drains tested for proper drainage by running water through drain pipes. The water pressure supplied to the fixtures is above average. Only a slight drop in flow was experienced when two fixtures were operated simultaneously. All Bathroom and kitchen fixtures are inspected, using normal operating features and controls for function and leakage. Visible gas fixtures valves and entry piping were all checked for leaks and all appear in *satisfactory condition*.

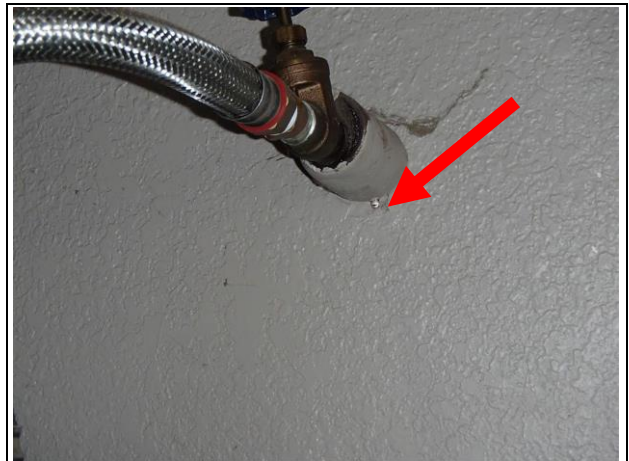
8B

**8.50 Maintenance repair:** *Hot water tank supply line* is *leaking near the top of tank* and will need repaired by a licensed plumber. No damage to building material below unit was noted at the time of inspection. (See [Picture 8B](#))

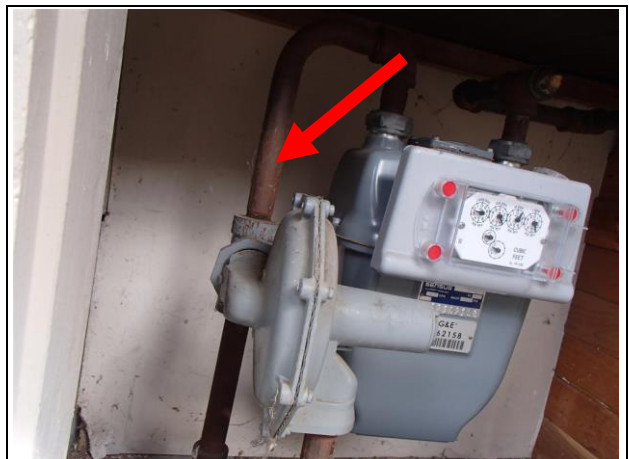
8D

- 8.62 Toilet** in the *1/2 bath & 2nd floor hall bath display movement when tested* and will require tightened to keep from leaking. Loose toilet can cause waste leak and damage to floor structure and interior services. No leak at the time of inspection. Recommend using qualified contractor to repair as required.
- 8.69 Shower head** in the *2nd floor hall shower* is *leaking* inside the shower enclosure. Unit may need washer changed; Teflon tape applied or head may need replaced by licensed plumber. Current condition will waste water. (See [Picture 8C](#))
- 8.94 Gas piping** shows evidence of *corrosion/rust at main meter*. Recommend contacting PG & E to clean and paint gas lines. Typically they will complete this at no charge. (See [Picture 8D](#))
