Inspection Report

Property Address: 450 E Bradley Ave #46

El Cajon CA 92021

BHI San Diego / Bailey's Home Inspections

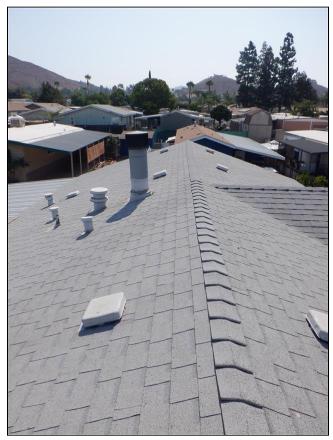
1.0 The roof is a 3-tab fiberglass shingled roof that can last upwards of 20-25 years. The ridge line is straight with no evidence of sagging. No evidence of curling shingles, missing or damaged shingles on day of inspection. There is normal wear and tear at the shingles. There is life left in the roof. Recommend clearing debris from carport and patio covers.

1.0 Item 4(Picture) Roof covering

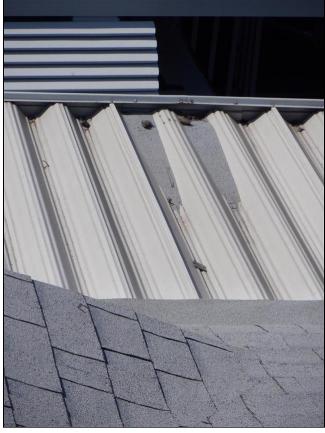
1.0 Item 13(Picture) Debris in carport cover

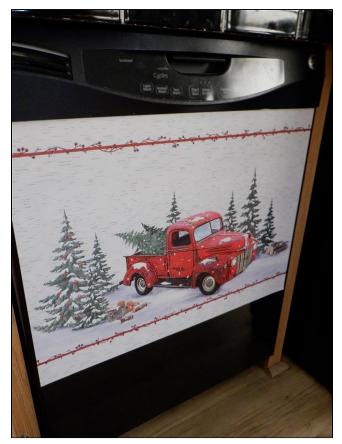
- 3.7 Good GFCI in kitchen as required.
- 3.8 The dishwasher does not appear to have been used.

3.8 Item 1(Picture) Dishwasher

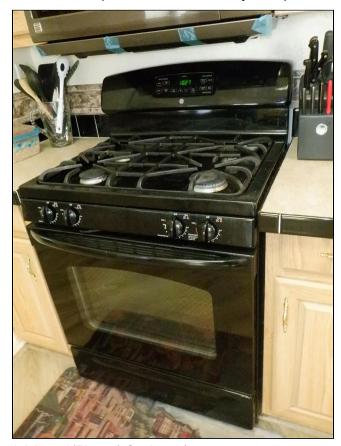
3.9 The cook top burners worked on day of inspection and the oven pre-heated to 350 degrees.

3.9 Item 1(Picture) Cook top / oven

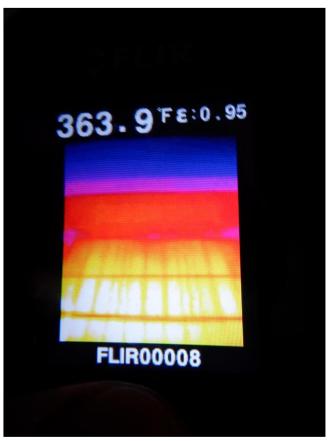
3.9 Item 2(Picture) Thermal imager test on oven

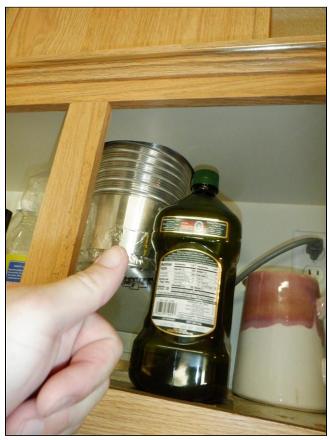
3.10 The vent fan worked on all speeds and the cook top light worked.

3.10 Item 1(Picture) Vent fan worked

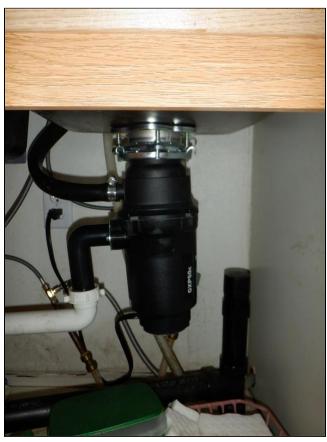
3.11 The garbage disposal worked on day of inspection.

3.11 Item 1(Picture) Garbage disposal

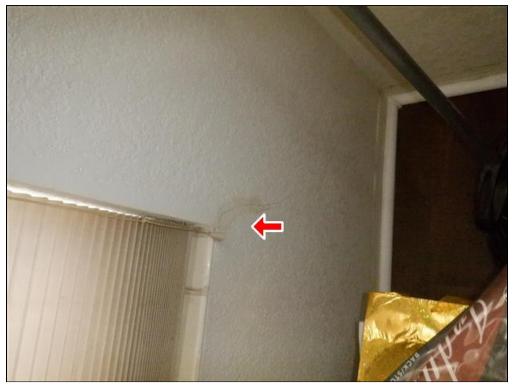
450 E Bradley Ave Page 18 of 53 **4.1** Cracking around bedroom window. Cracking less than 1/8th of an inch are considered normal cracking caused from settling of home/structure and expansion of building materials.

4.1 Item 1(Picture) Settling cracks

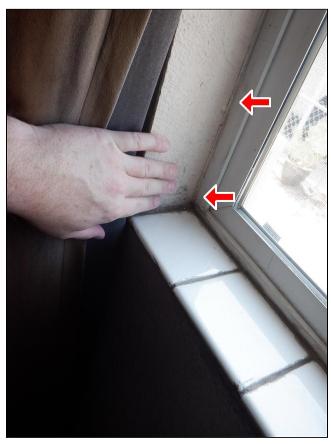
4.4 Item 1(Picture) Windows not sealed

4.4 Recommend re-sealing all windows inside and outside to avoid moisture intrusion.

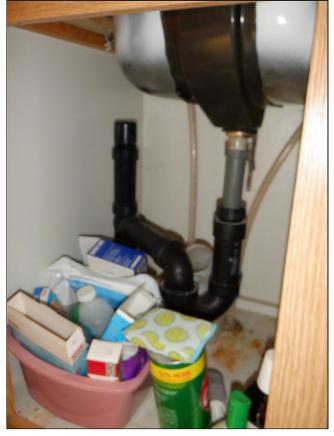
5.6 No leaks noted under any of the bathroom sinks on say of inspection. The primary sink drains slowly, the tub stopper is missing, and the hallway bath sink drain is damaged. Recommend evaluation and repair by a licensed plumber.

5.6 Item 2(Picture) Primary bath sink plumbing

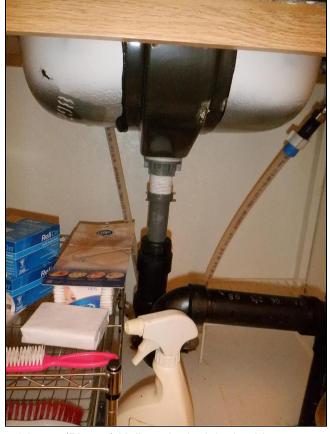
5.6 Item 5(Picture) Hallway bath sink plumbing

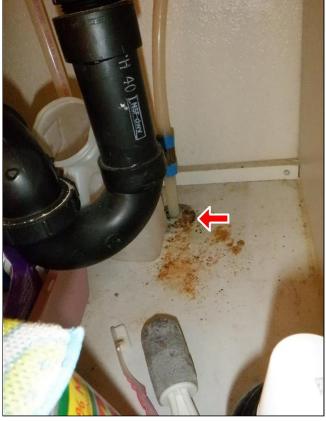
5.7 Recommend replacing caulking on shower/tub fixtures, shower doors, and replace the damaged trim around the primary shower enclosure. The supply valves under the bathroom sinks are corroded. Recommend replacement. Recommend repair/replacement by a licensed plumber.

5.7 Item 4(Picture) Corrosion

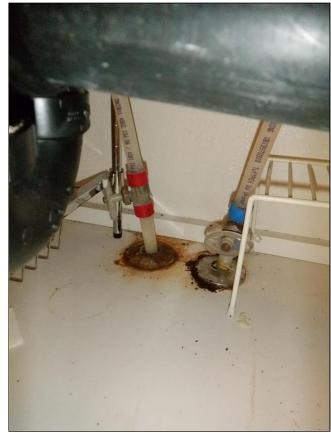
5.7 Item 6(Picture) Corrosion

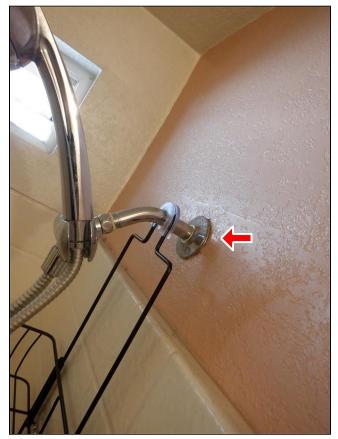
5.7 Item 7(Picture) Hallway showerhead not sealed

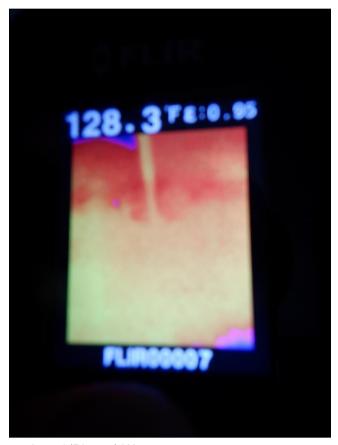
5.7 Item 9(Picture) Water temperature

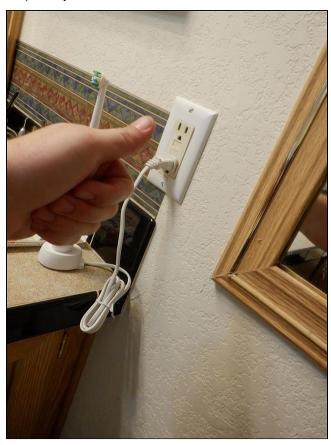
5.8 The bathroom receptacles are properly GFCI protected as required. The master GFCI for both bathrooms is located in the primary bathroom.

5.8 Item 1(Picture) Good GFCI (master for both bathrooms)

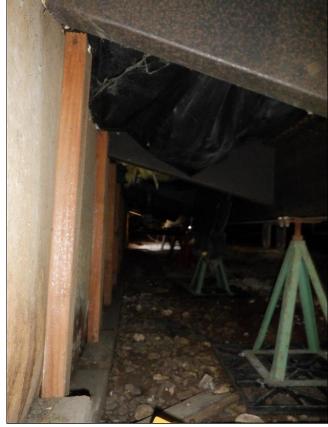
6.0 The skirting is damaged and should be replaced. Recommend installing tight screens on inside of crawlspace vents. There are termite droppings under the deck. Recommend referring to full termite inspection report and all recommendations for treatment/repair. There is evidence of moisture intrusion under the home. No sinking or movement noted at steel jacks.

6.0 Item 6(Picture) Crawlspace

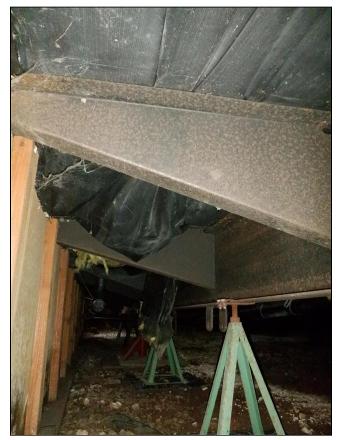
6.0 Item 8(Picture) Crawlspace

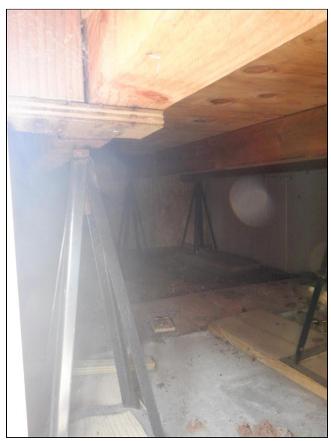
6.2 There are a lot of steel jacks under the home and there are also earthquake supports installed under the home.

6.2 Item 1(Picture) Steel jacks under deck

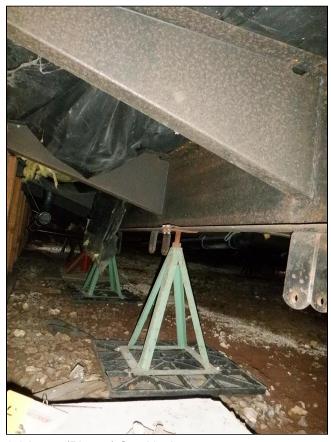
6.2 Item 5(Picture) Steel jacks

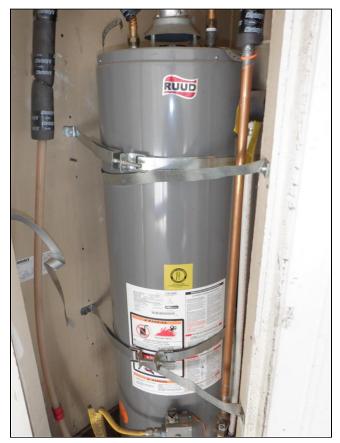
- **7.0** No leaks noted from plumbing under the home on day of inspection.
- **7.1** The water heater is a Ruud / 30 gallon / 2013 model. Typical life span for a water heater is 8-12 years. The system worked on day of inspection. The gas line is missing the required sediment trap, there is no drip pan installed, flue venting is in tact, no corrosion or leaks at the water lines, no expansion tank is installed, and the T&P plumbing is in tact. Recommend tightening the belly straps. Recommend upgrade by a licensed plumber.

7.1 Item 2(Picture) Ruud water heater

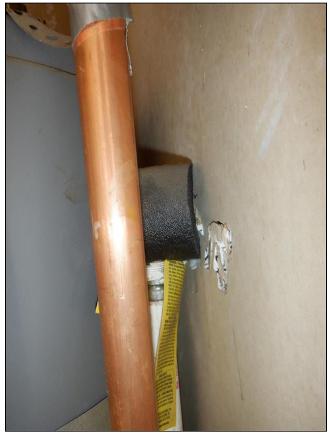
7.1 Item 6(Picture) Flue venting and water lines

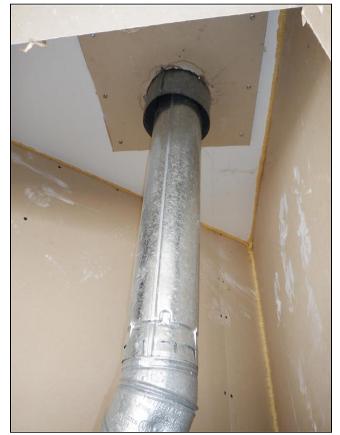
7.1 Item 7(Picture) Flue venting

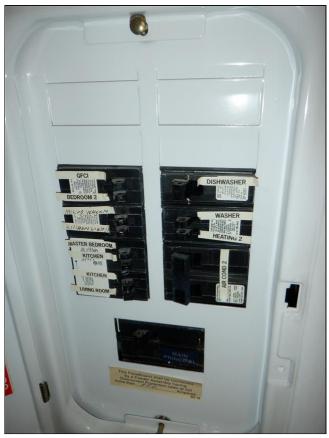
8.0 The electrical panel is a 100 amp panel. The panel is labelled, clean on the inside, no corrosion found at grounding/neutral boards, none of the circuit breakers are double tapped with wires, and all connections were in tact.

8.0 Item 2(Picture) Labelling

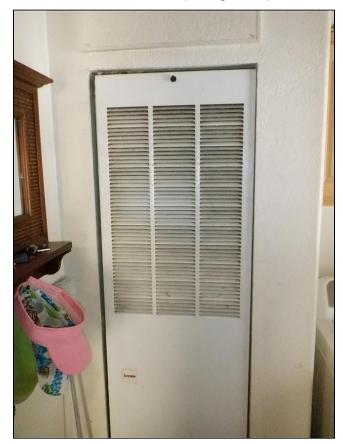
9.0 The furnace is located in the laundry room. Typical life span for a furnace is 20-25 years. The system did work on day of inspection. The filter is in need of replacement. The flue venting is in tact. The system was tested using a thermal imager. The temperature was set to 78 degrees. The air coming out of each vent should be, at minimum, 90 degrees (+12 degree jump in temperature). The air was reading in the low to mid 90 degree range. This system does require periodic servicing/ maintenance. Recommend replacing filter upon move in.

9.0 Item 2(Picture) Dirty filter

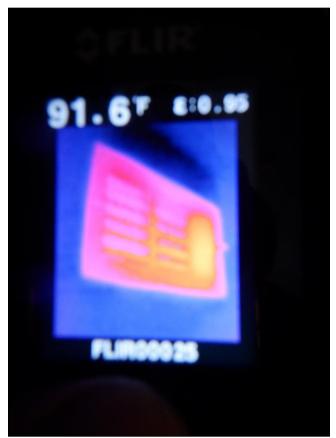
9.0 Item 3(Picture) Thermal imager test

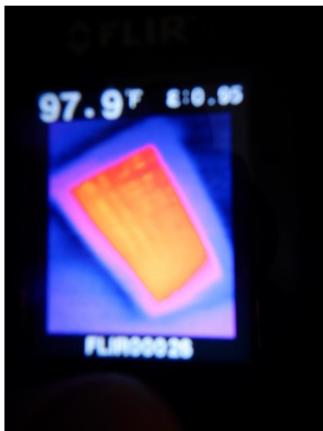
9.0 Item 4(Picture) Thermal imager test

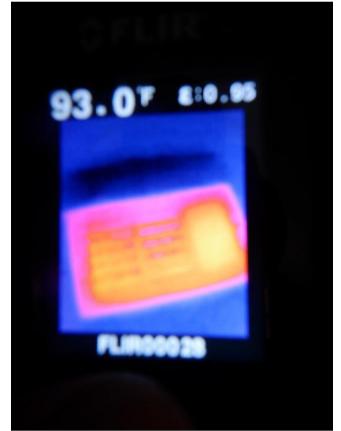
9.0 Item 5(Picture) Thermal imager test

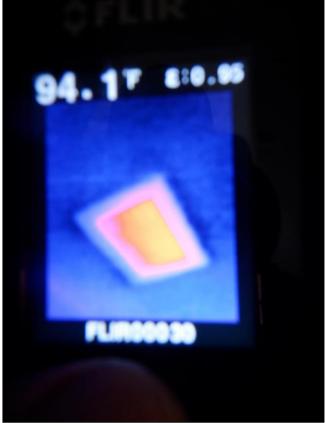
9.0 Item 6(Picture) Thermal imager test

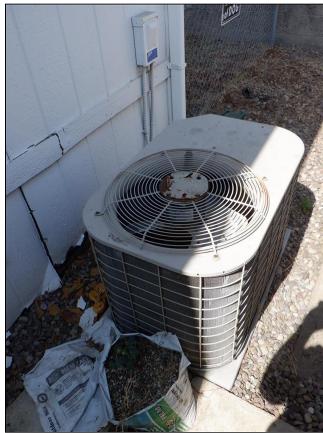
9.6 The condenser is located on the side of the home. It is a 1998 model. Typical life span for a condenser is 15-20 years. The system worked on day of inspection but needs to be serviced. The condenser line insulation is worn/missing and needs to be sealed at the skirting. The central air conditioning system was tested with a thermal imager. The temperature was set to 76 degrees and the air coming out of each vent should read 8-10 degrees below the set temperature. The air was reading in the low 70 degree range.

9.6 Item 1(Picture) Condenser

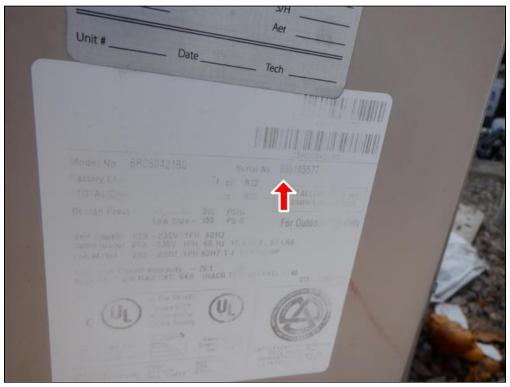
9.6 Item 3(Picture) 1998 model

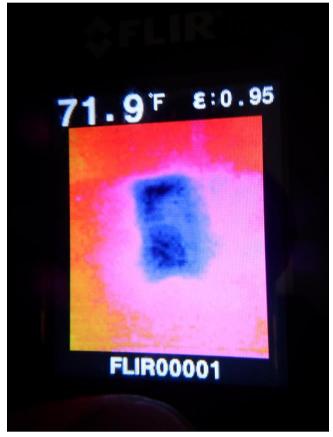
9.6 Item 4(Picture) Thermal imager test

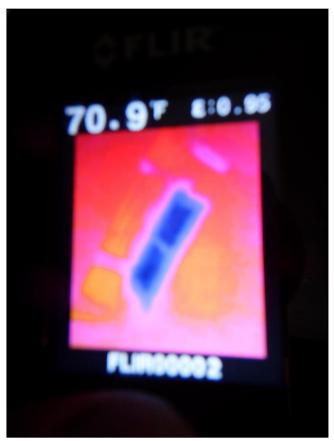
9.6 Item 5(Picture) Thermal imager test

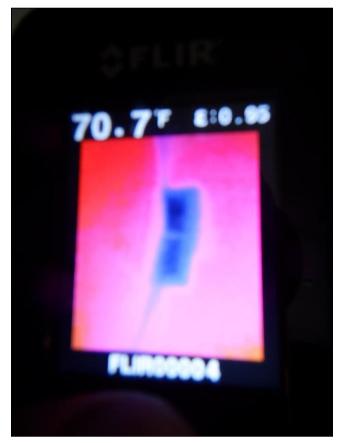
9.6 Item 6(Picture) Thermal imager test
