▀ **La Costa Greens
Homeowners Association
Town Hall Meeting**

**Community Issues and
Required Reconstruction Repairs**

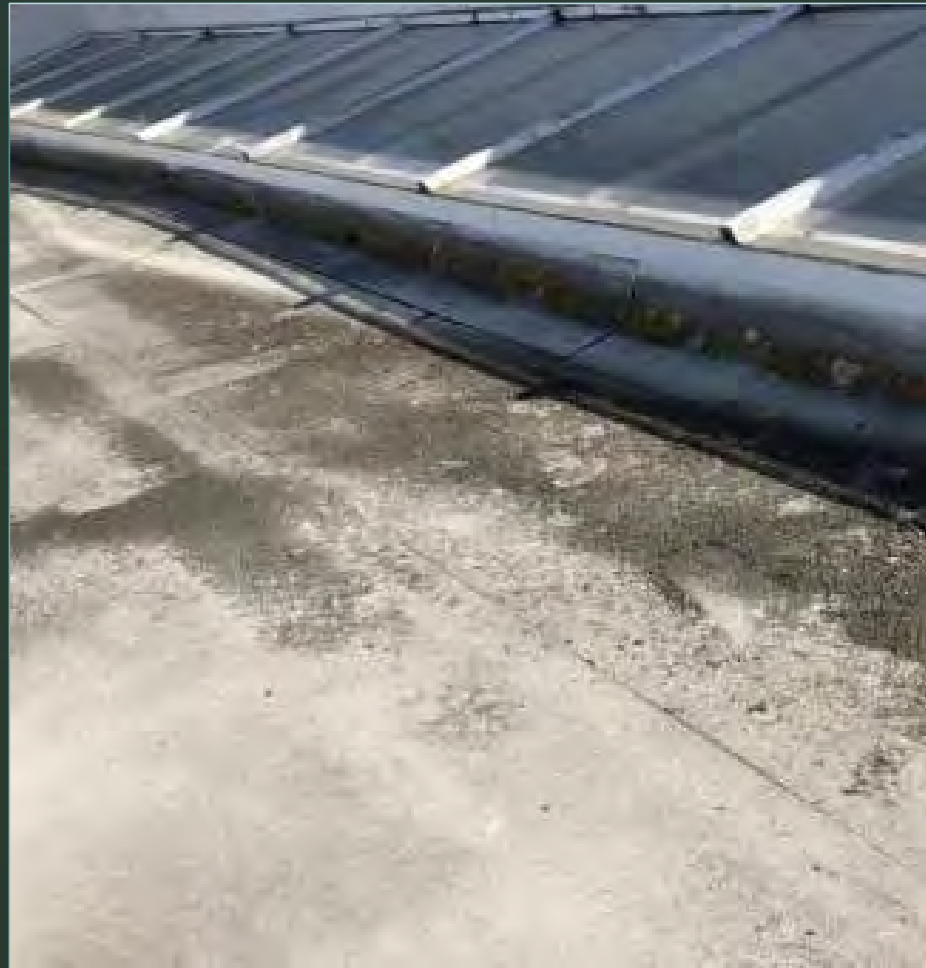
Excessive ponding
at flat roofs.

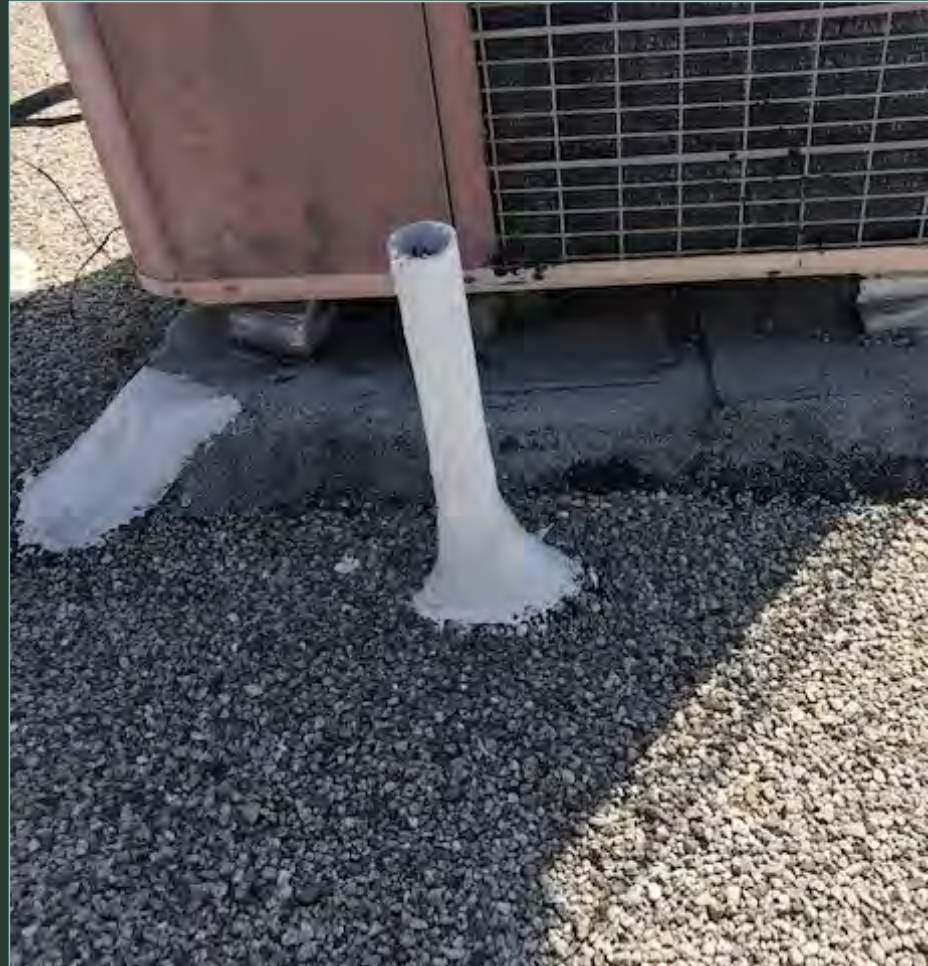
A/C platforms are failing at flat roofs.

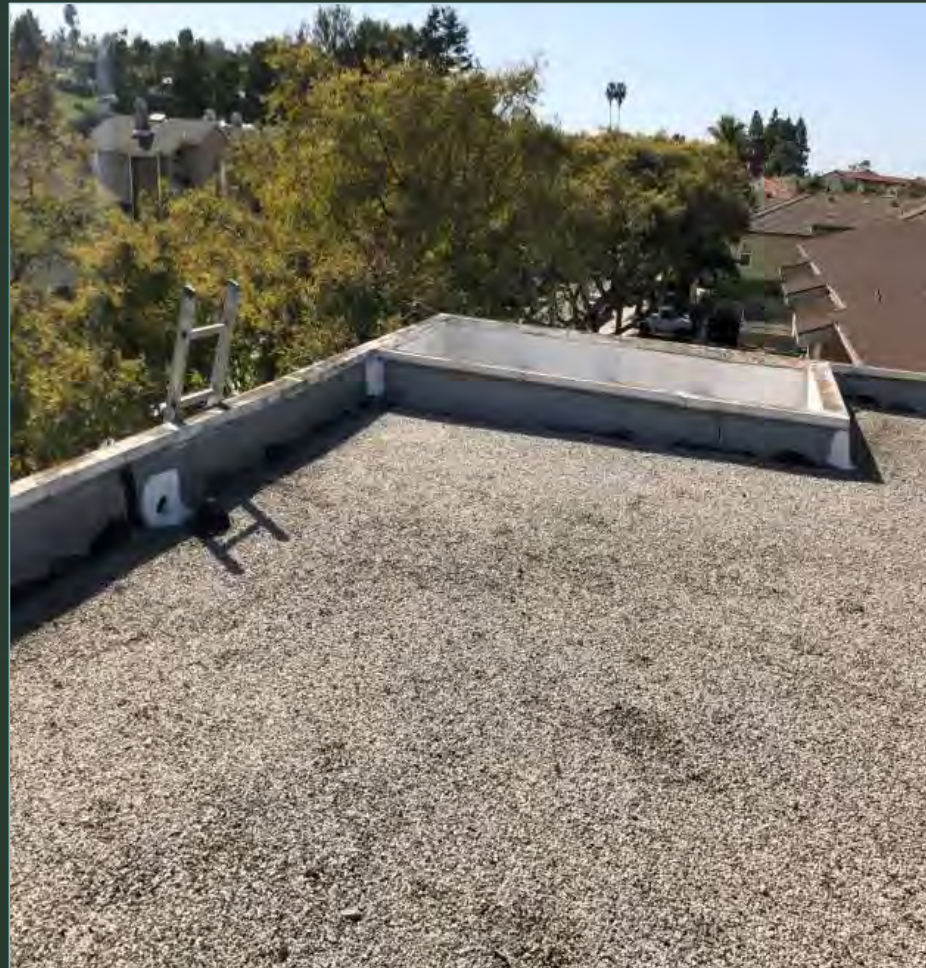
Obvious signs of
rusting and dirt
build up on metal
coping.

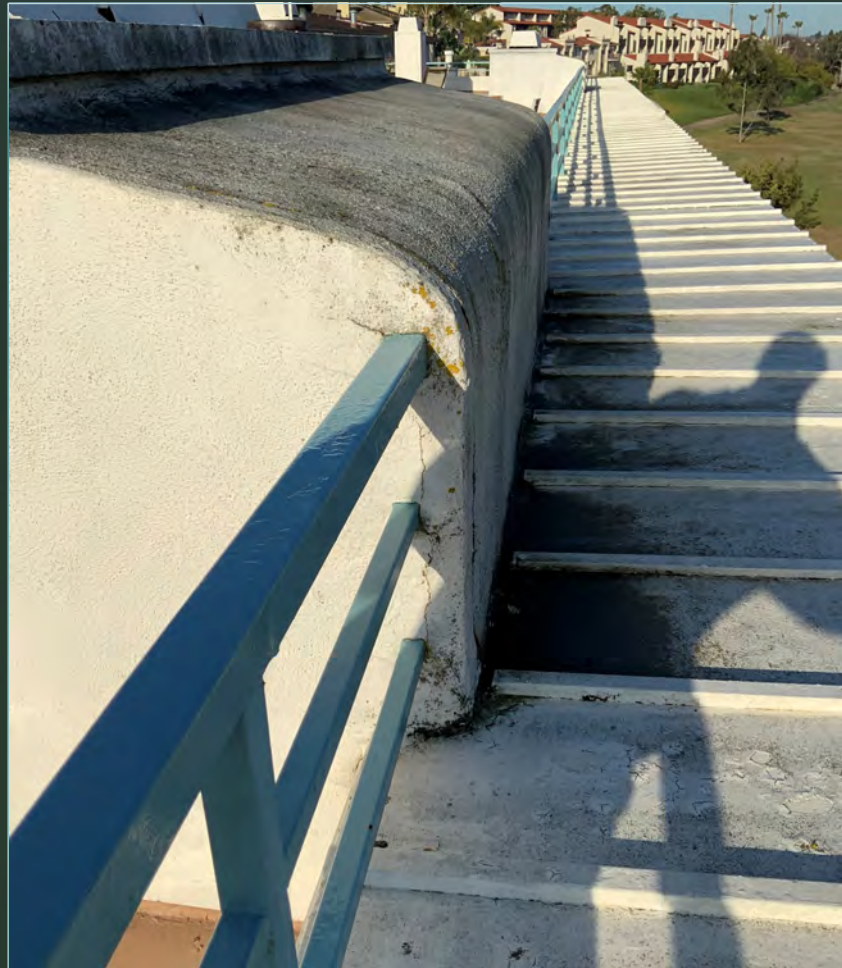
Metal Roof at Building 2556 slopes back into stucco without appropriate crickets for drainage. There does not appear to be proper wall to roof flashing. Metal Roof coating is cracking throughout.

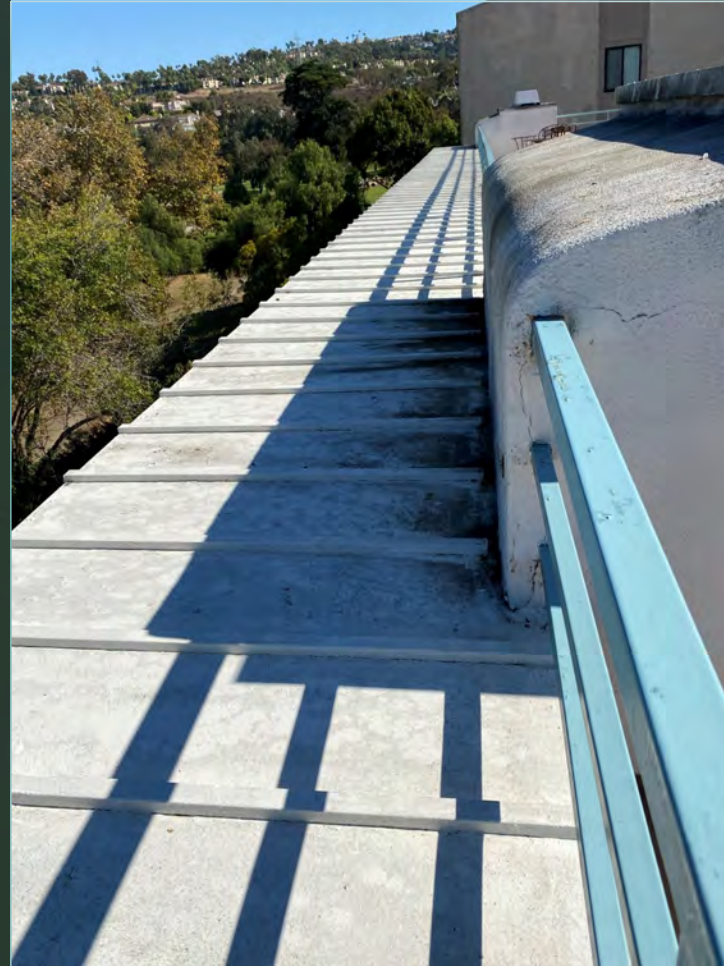
Metal Roof at
Building 2556
slopes back into
stucco. There does
not appear to be
proper wall to roof
flashing. Metal
Roof coating is
cracking
throughout.

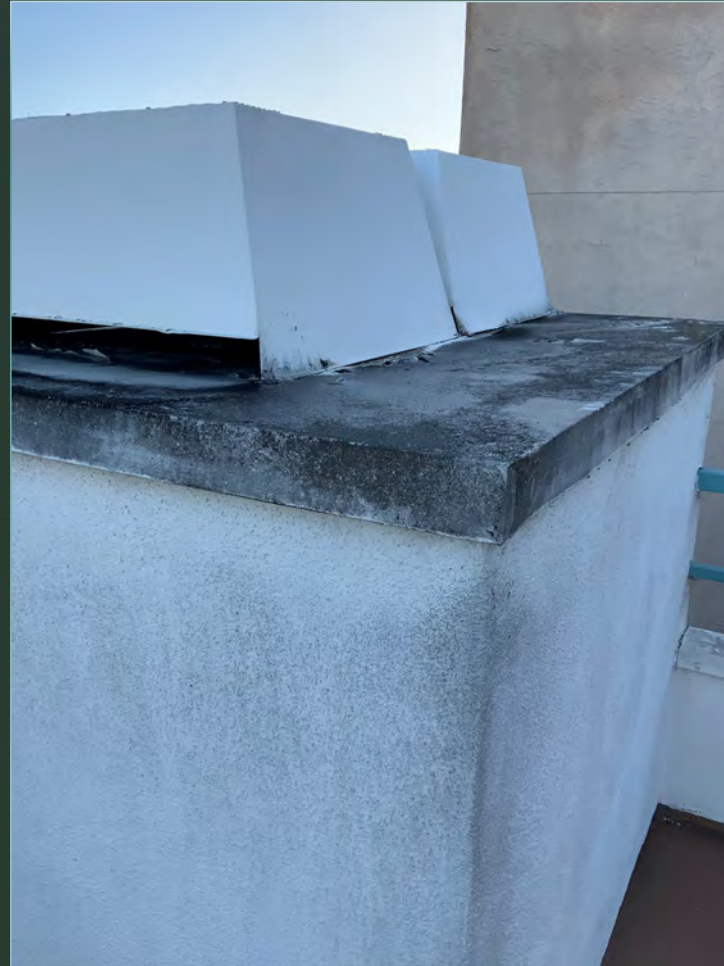
▶
Metal Chimney
Cap and Spark
Arrestor finish is
deteriorating.
Leaking issues
can arise from
moisture seeping
through the
cracks.

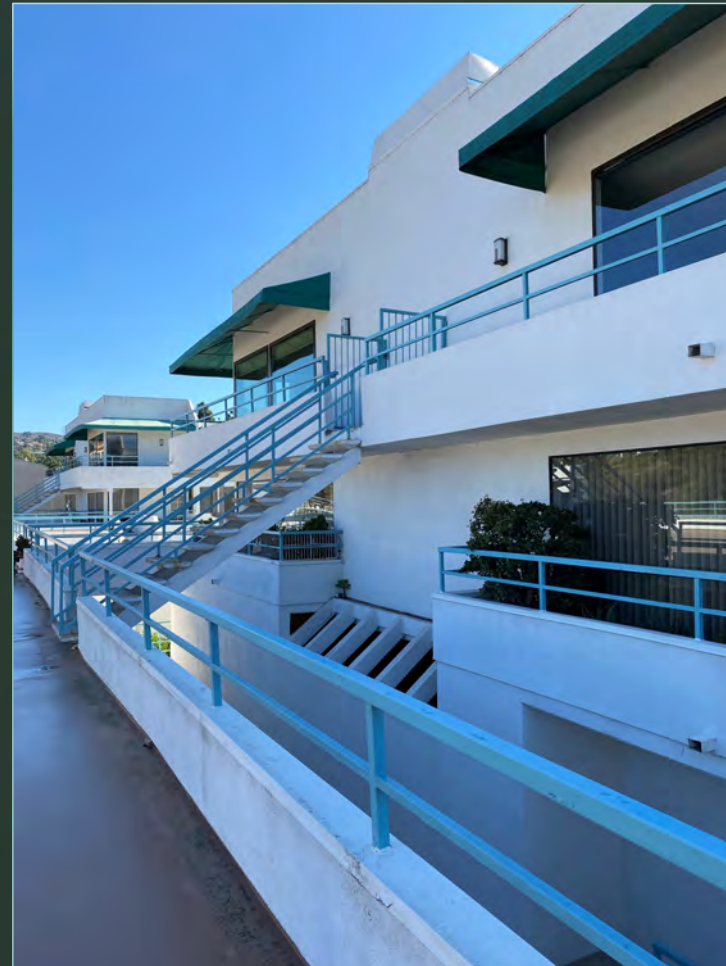
▶ Metal Coping penetrations not sealed properly at guardrail connections. This is causing the stucco at the pony walls to bubble and crack throughout.

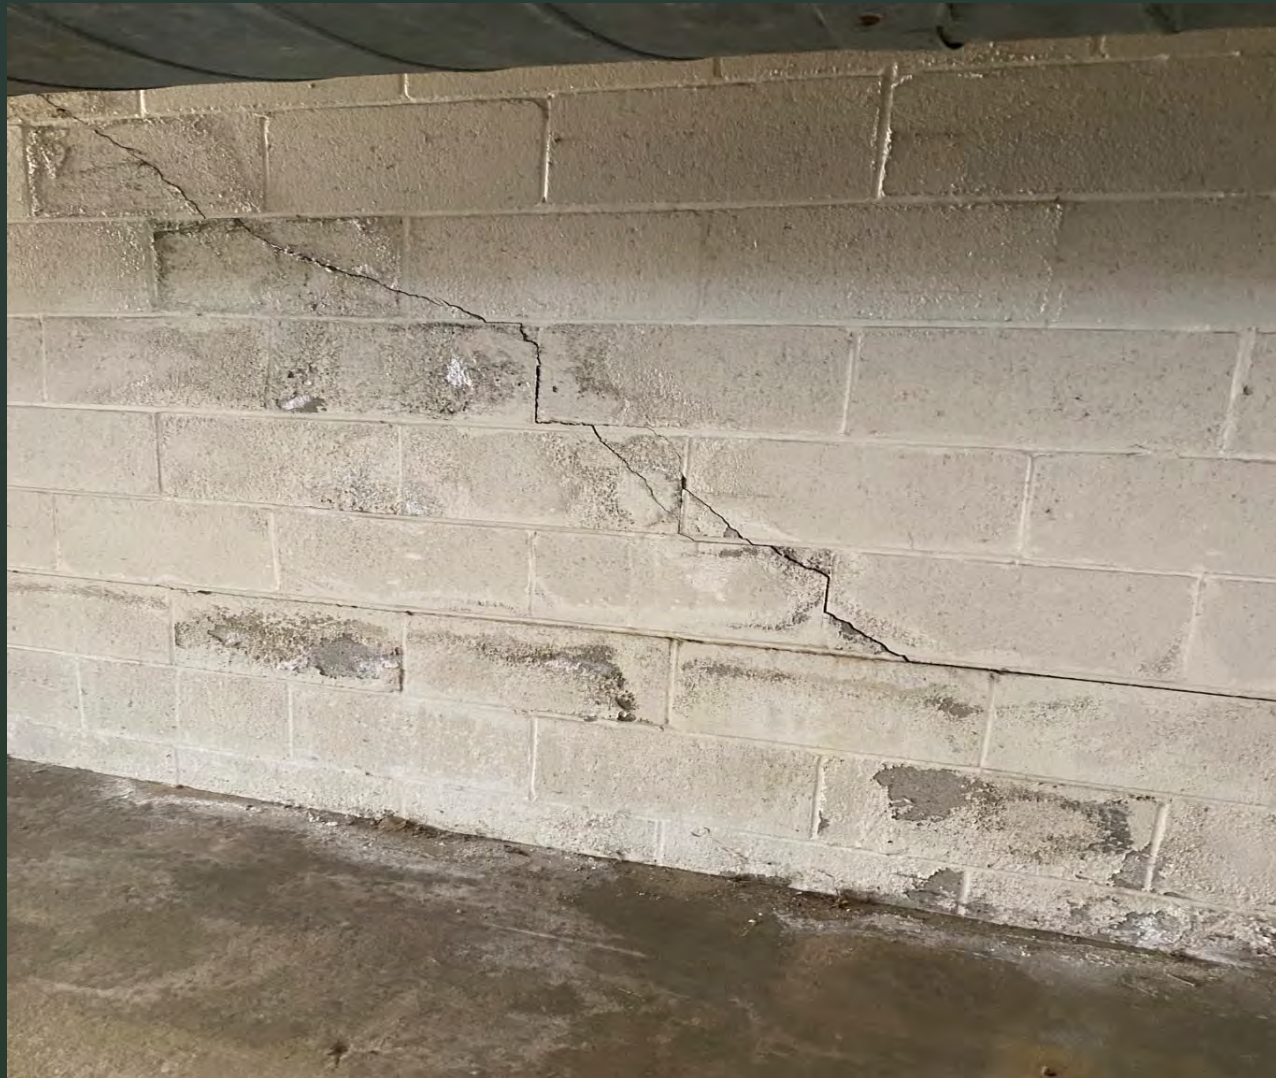
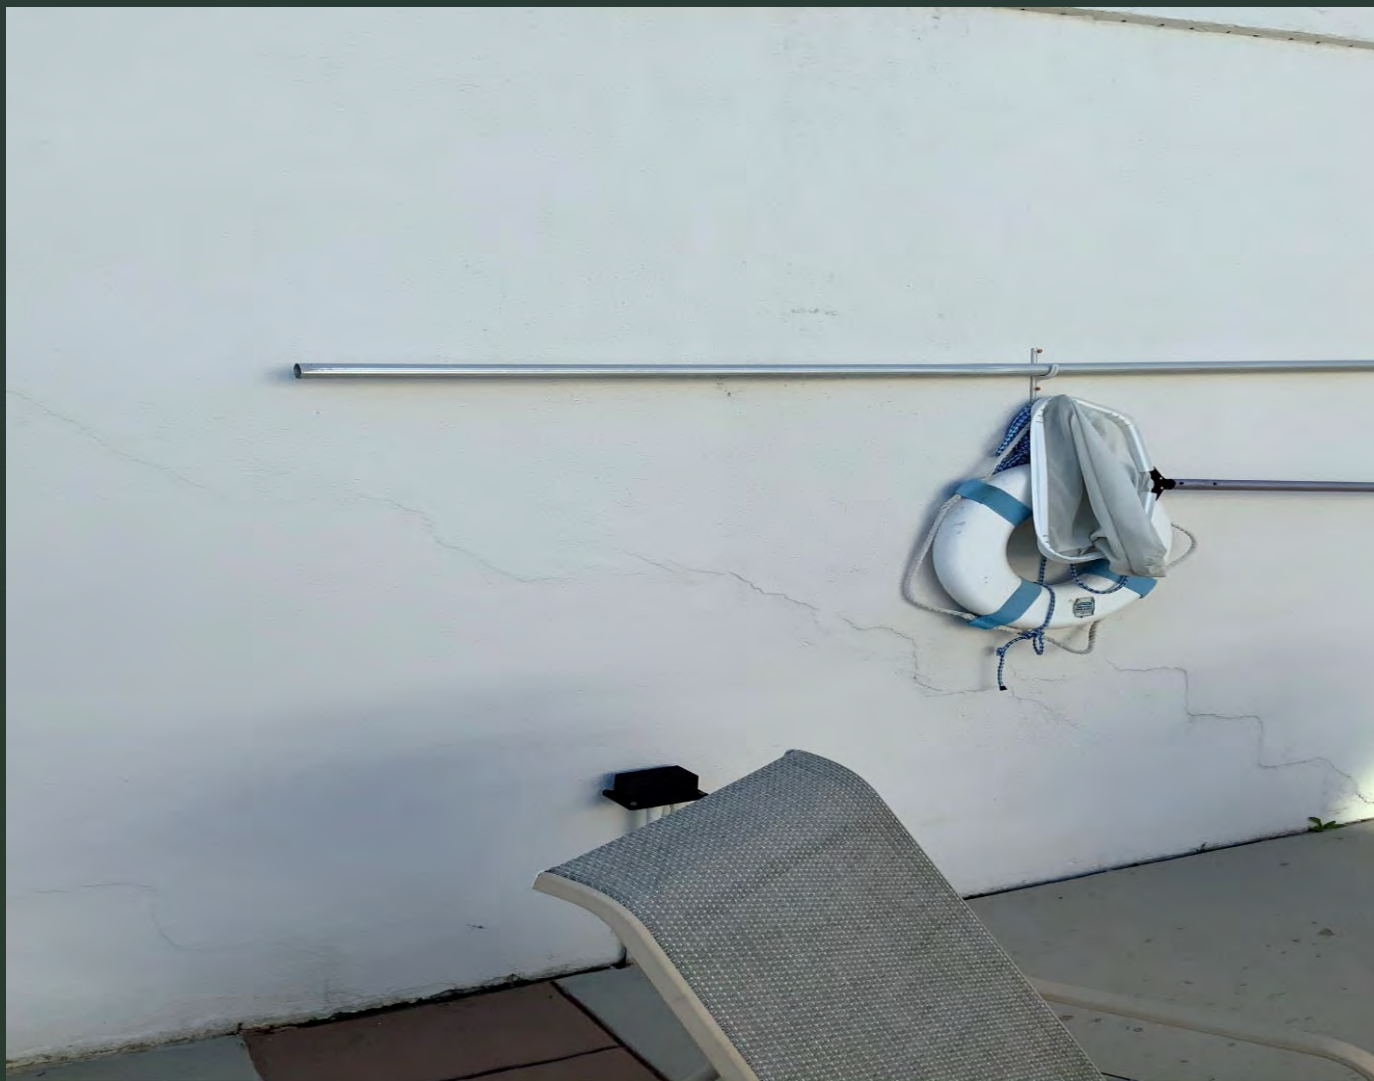
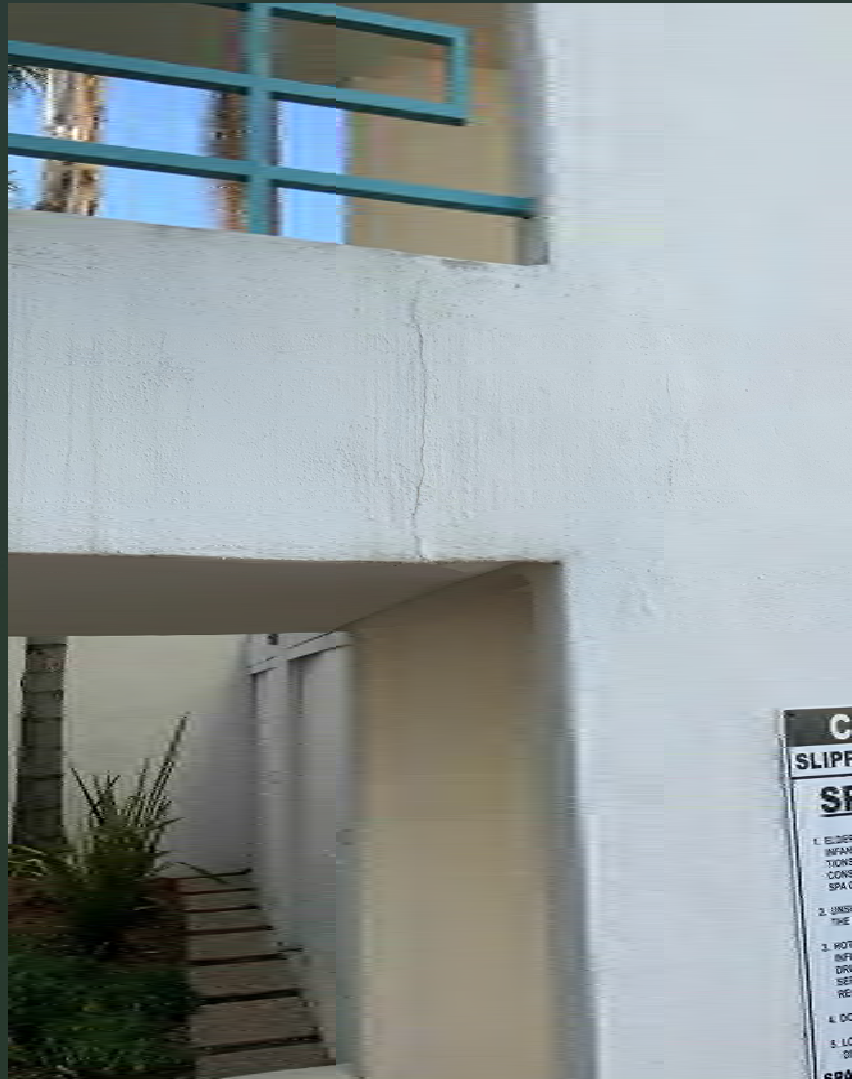
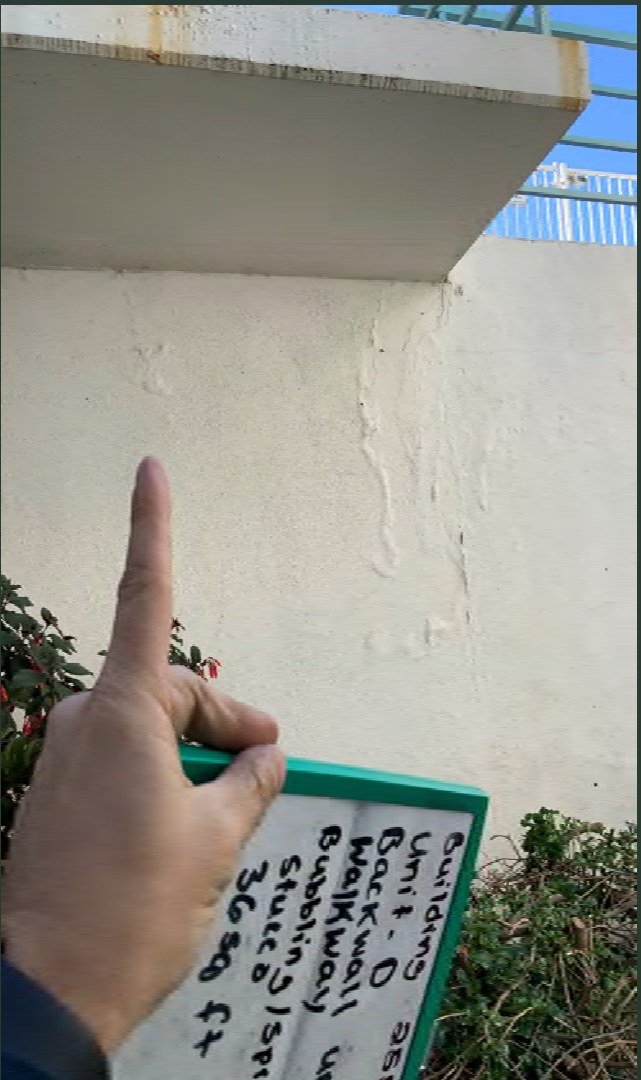
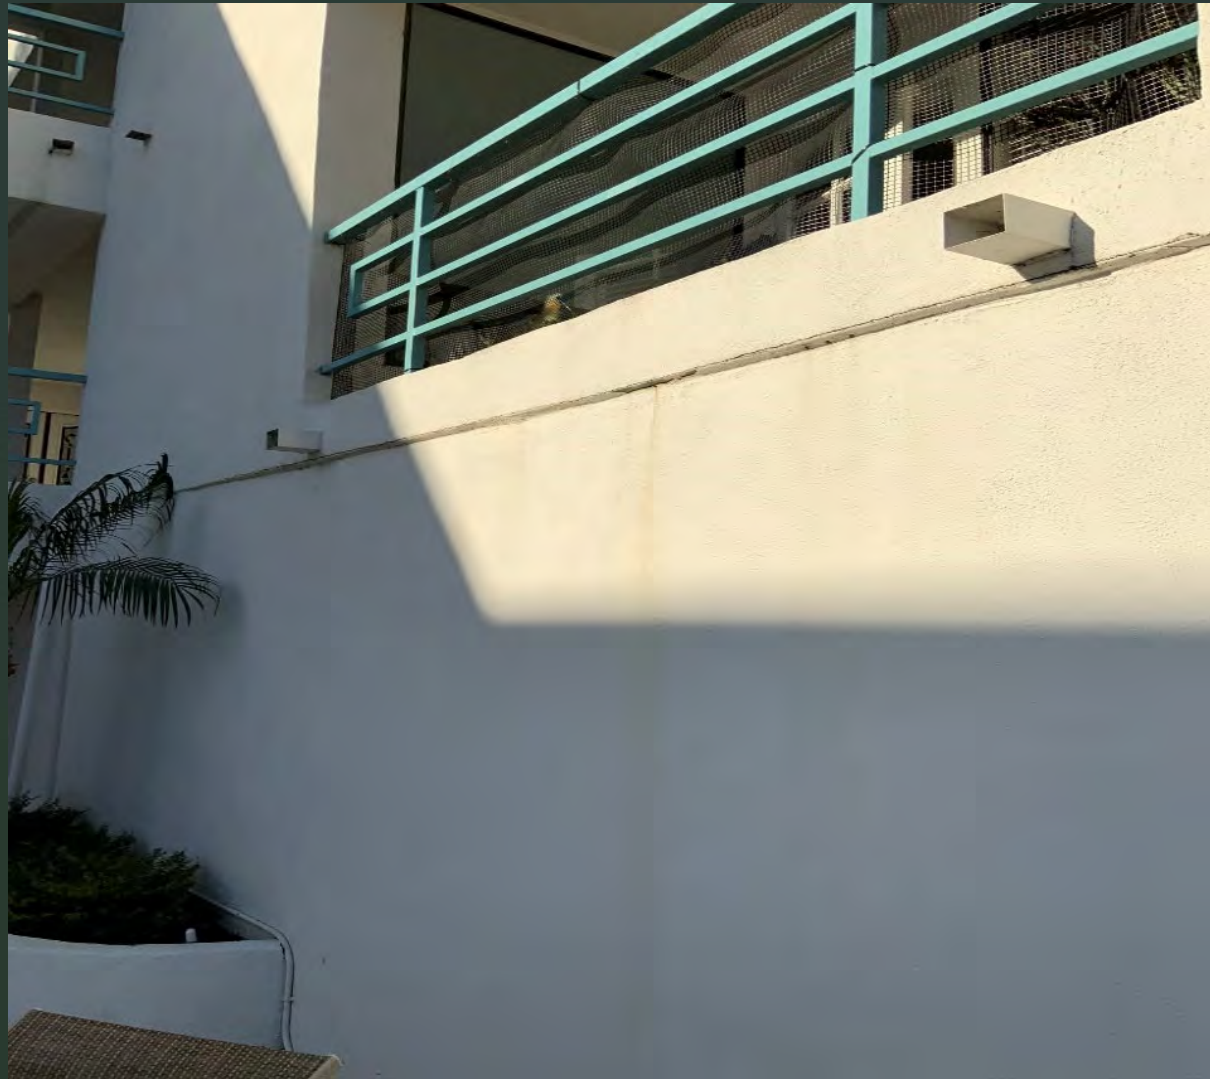
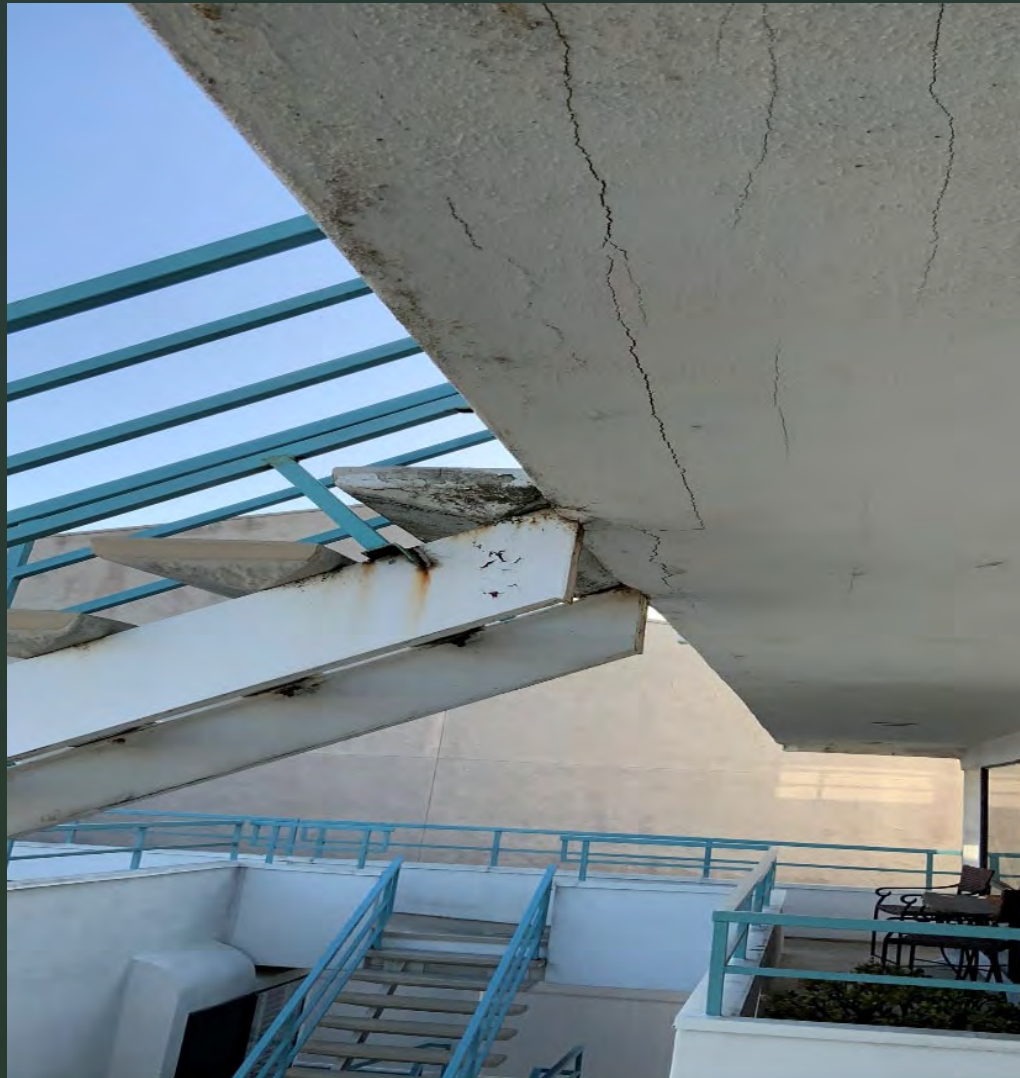
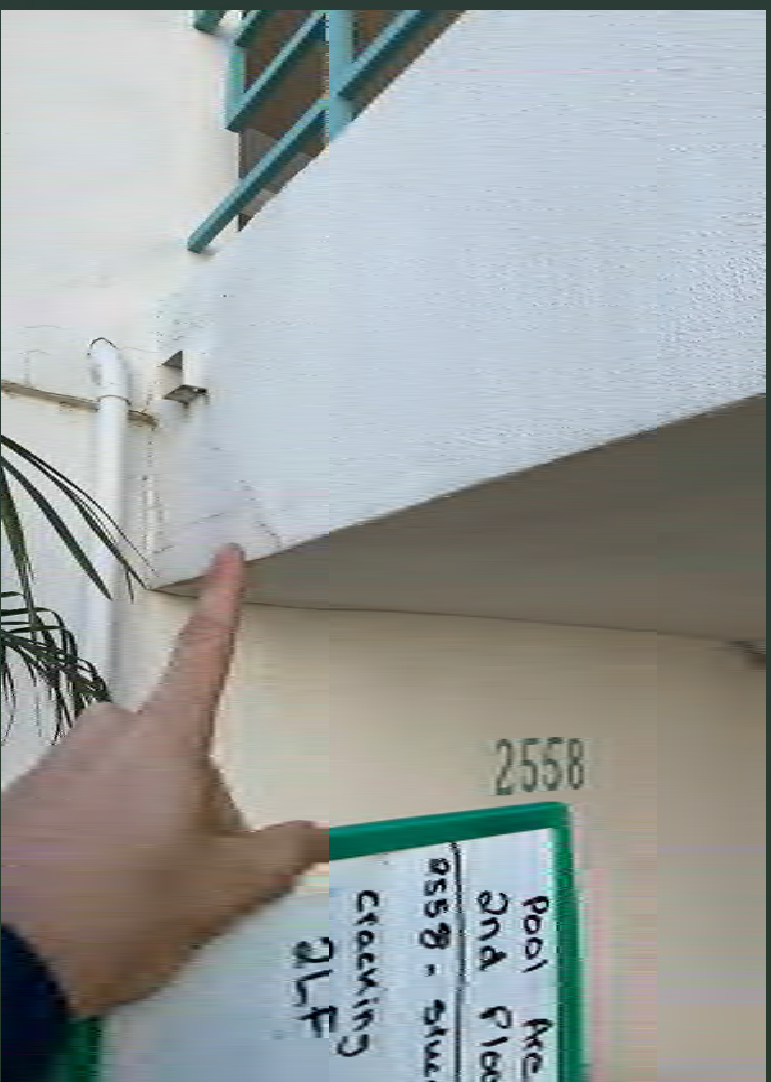
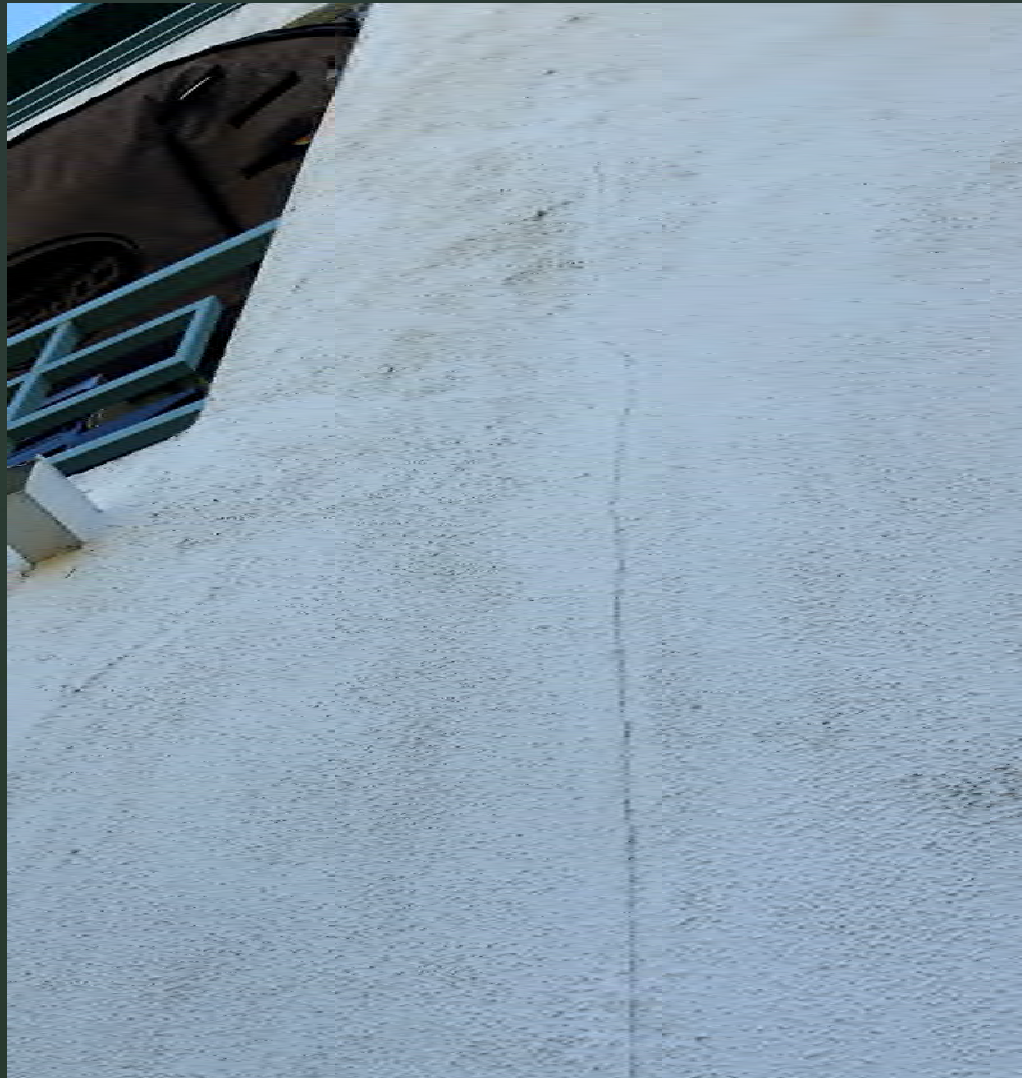
CMU and Stucco Cracking

The CMU block wall has signs of cracking at both garages.
The stucco walls are cracking throughout the community.
The weep screed is rusted out and/or covered over. These
issues allow water intrusion into the structural components
of the buildings.

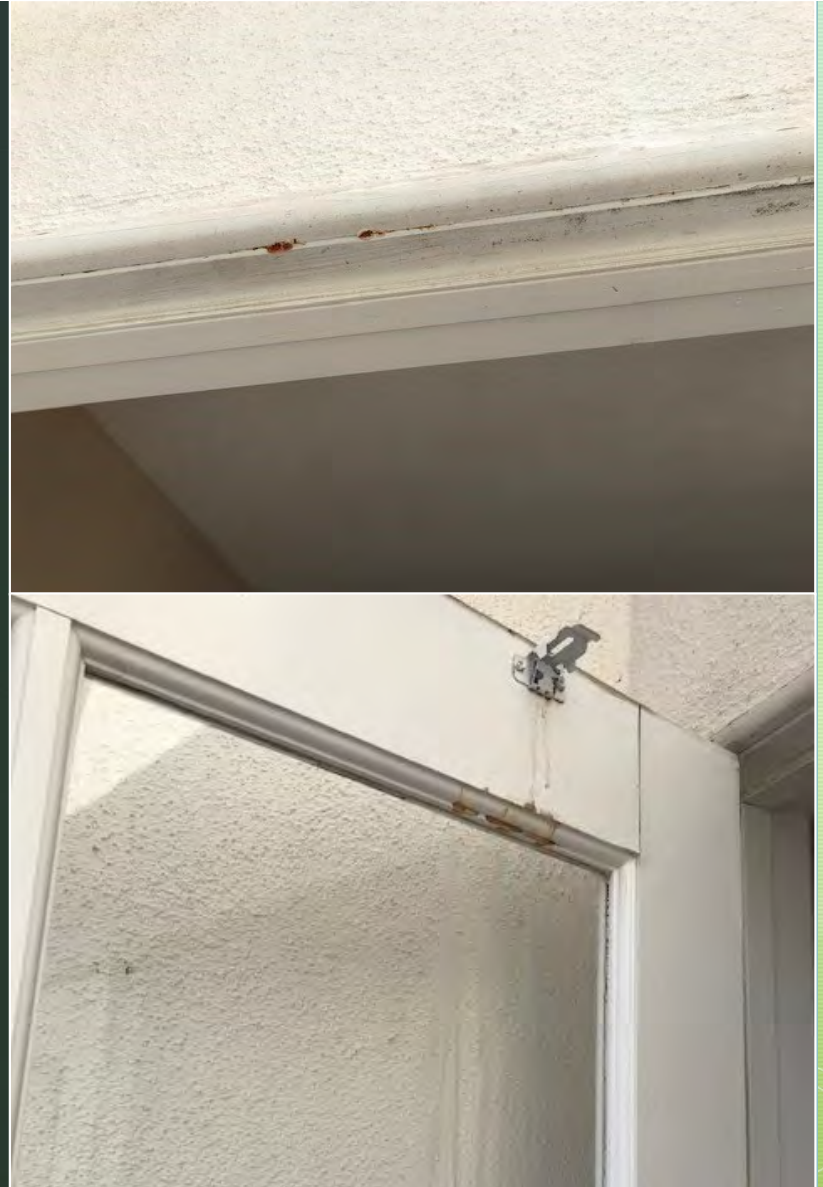
Water is getting behind the stucco and finding its way out of the top of the door assembly. Water is damaging the door assembly.
