▀ **La Costa Greens
Homeowners Association
Town Hall Meeting**

**Community Issues and
Required Reconstruction Repairs**

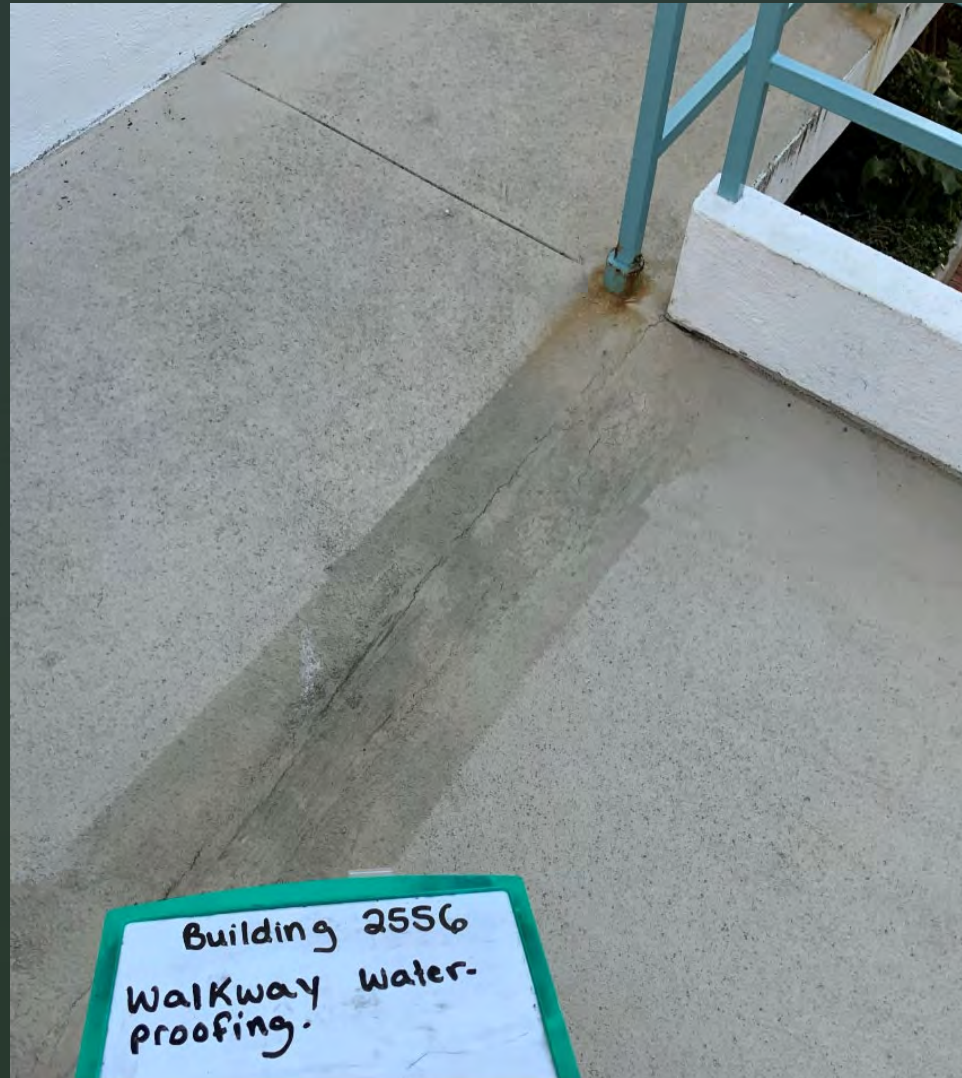
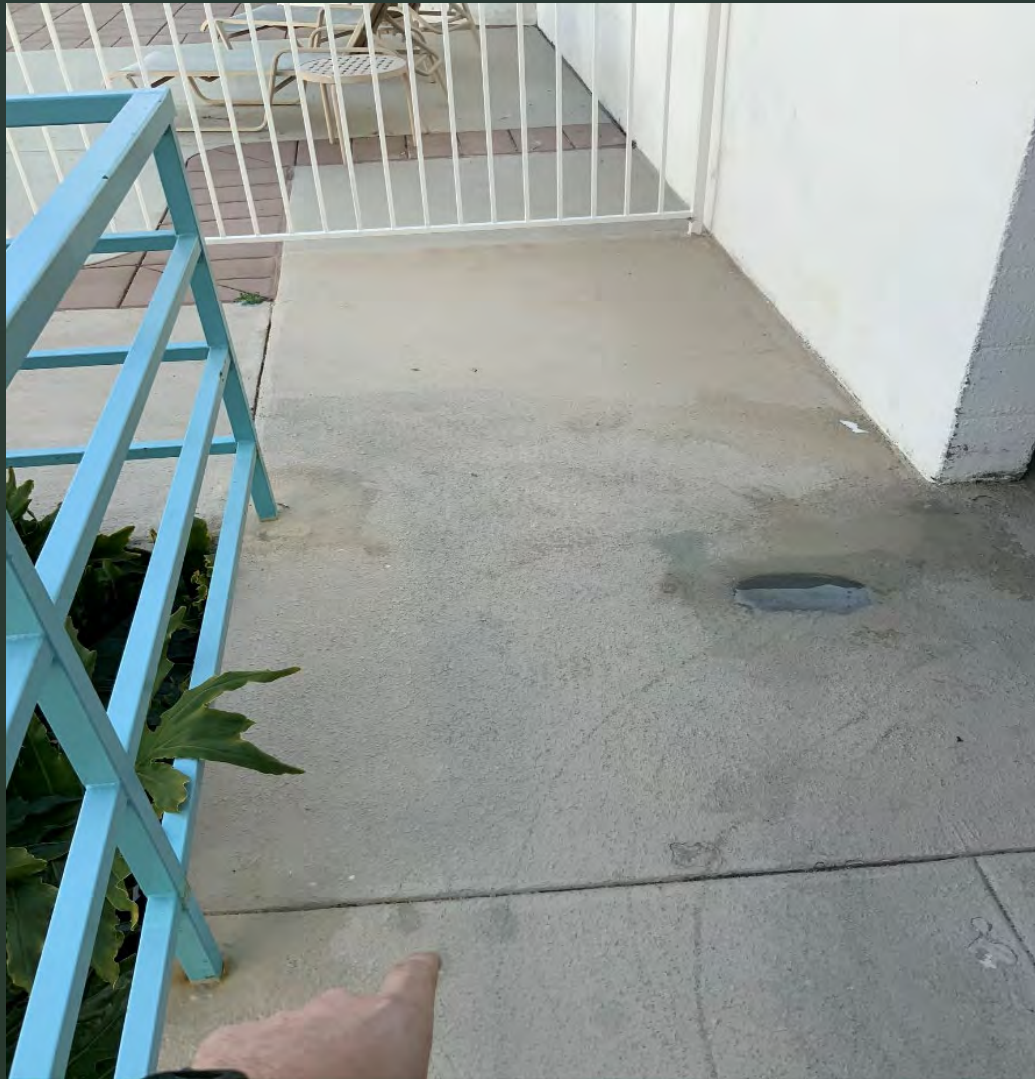
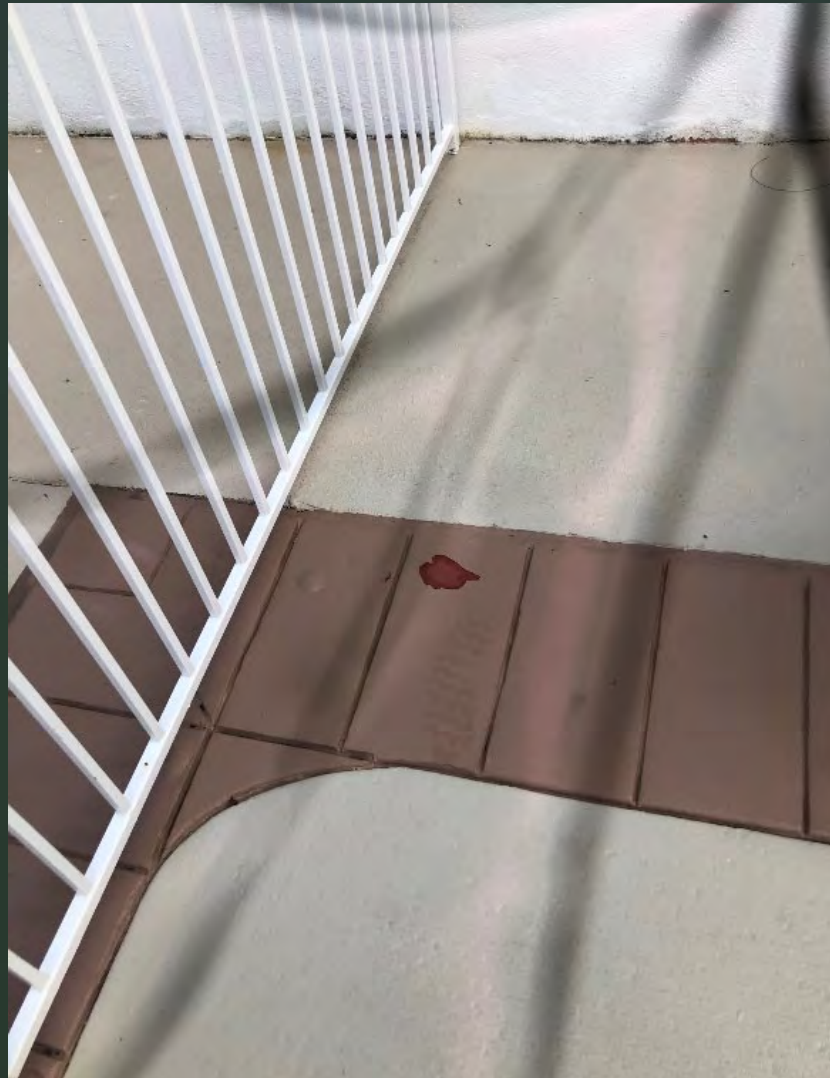
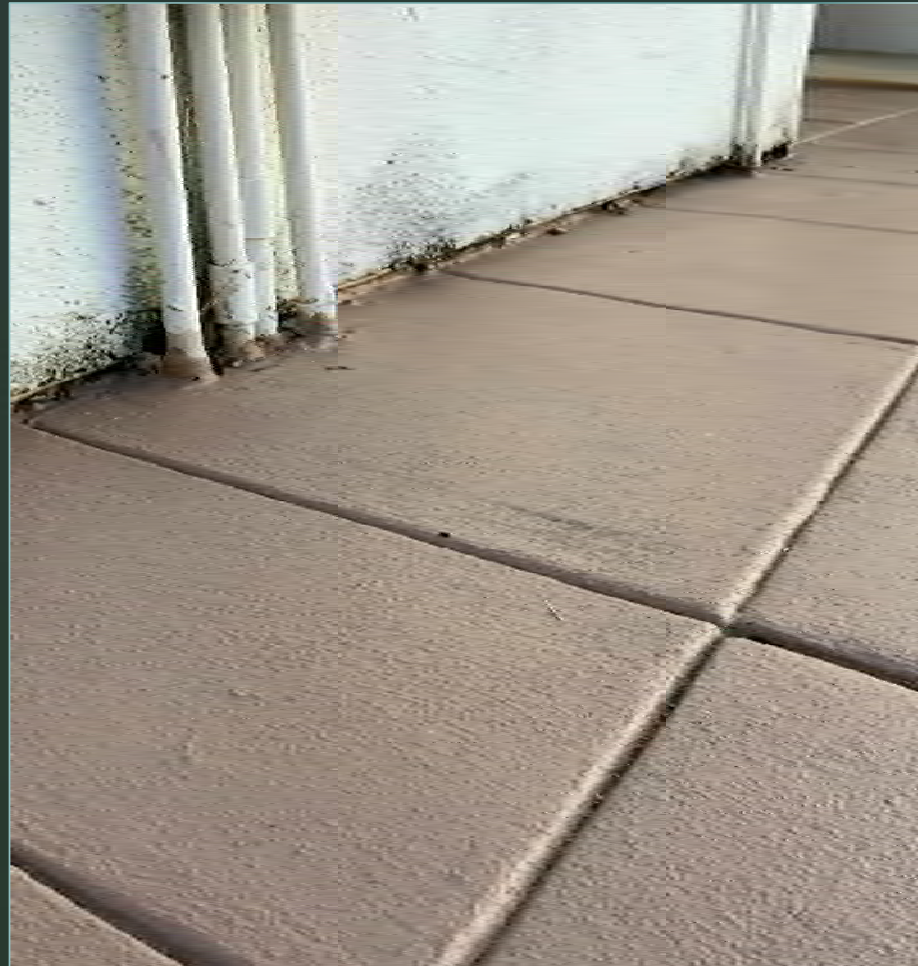
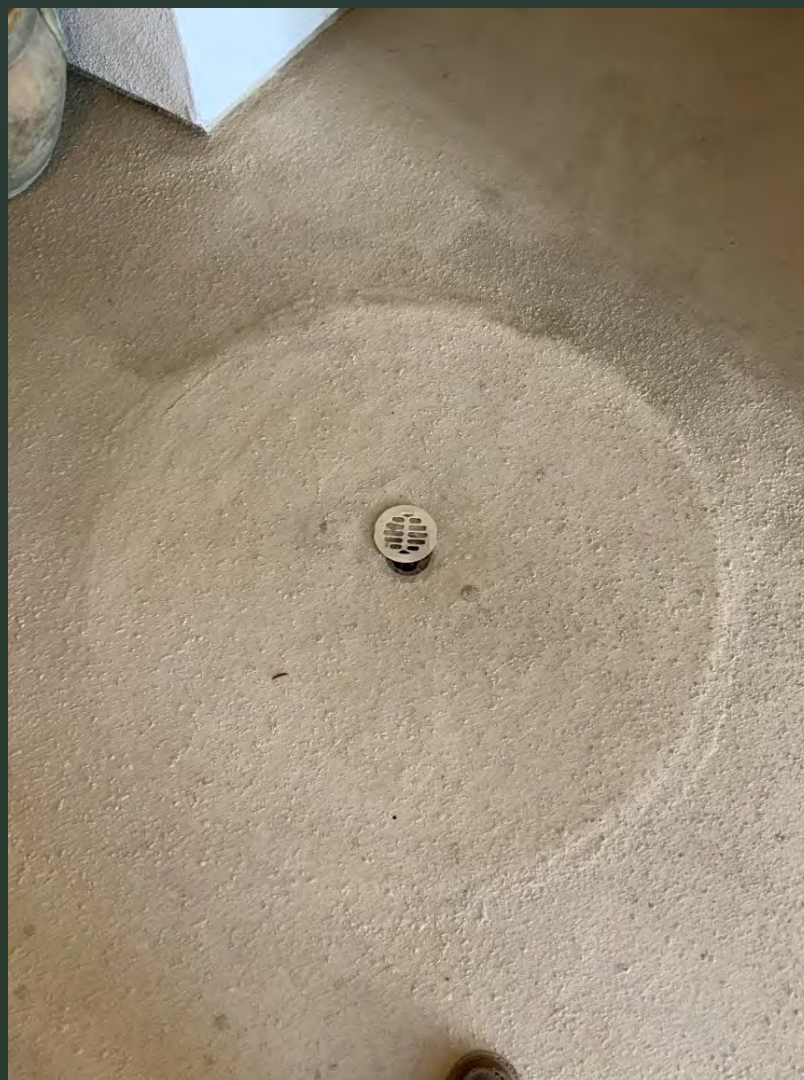
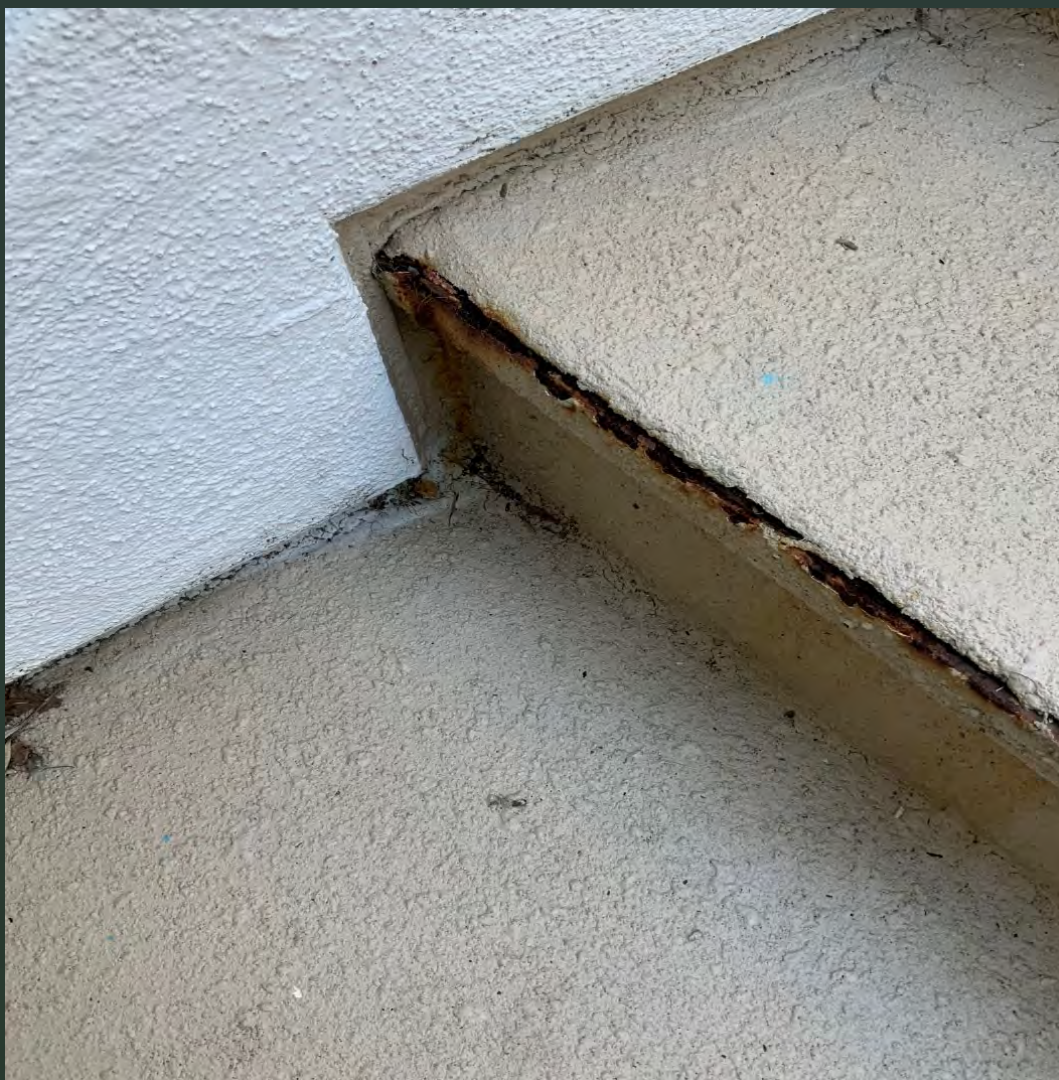
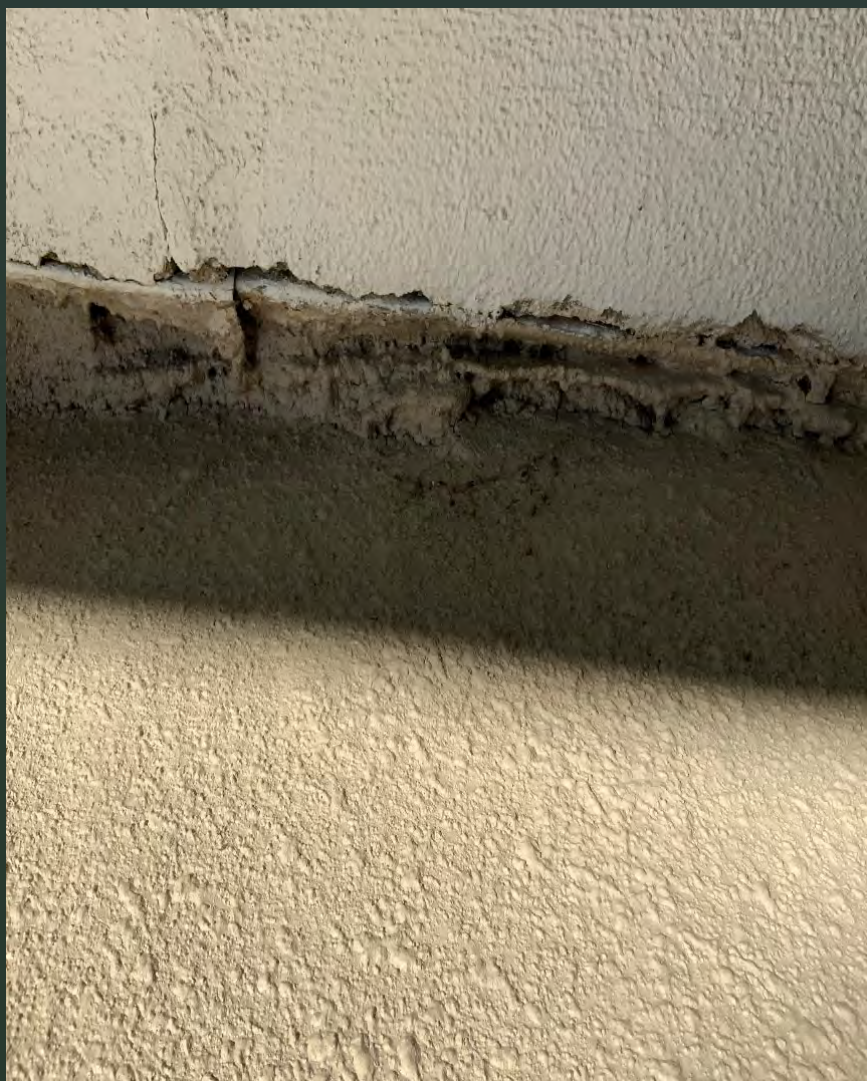
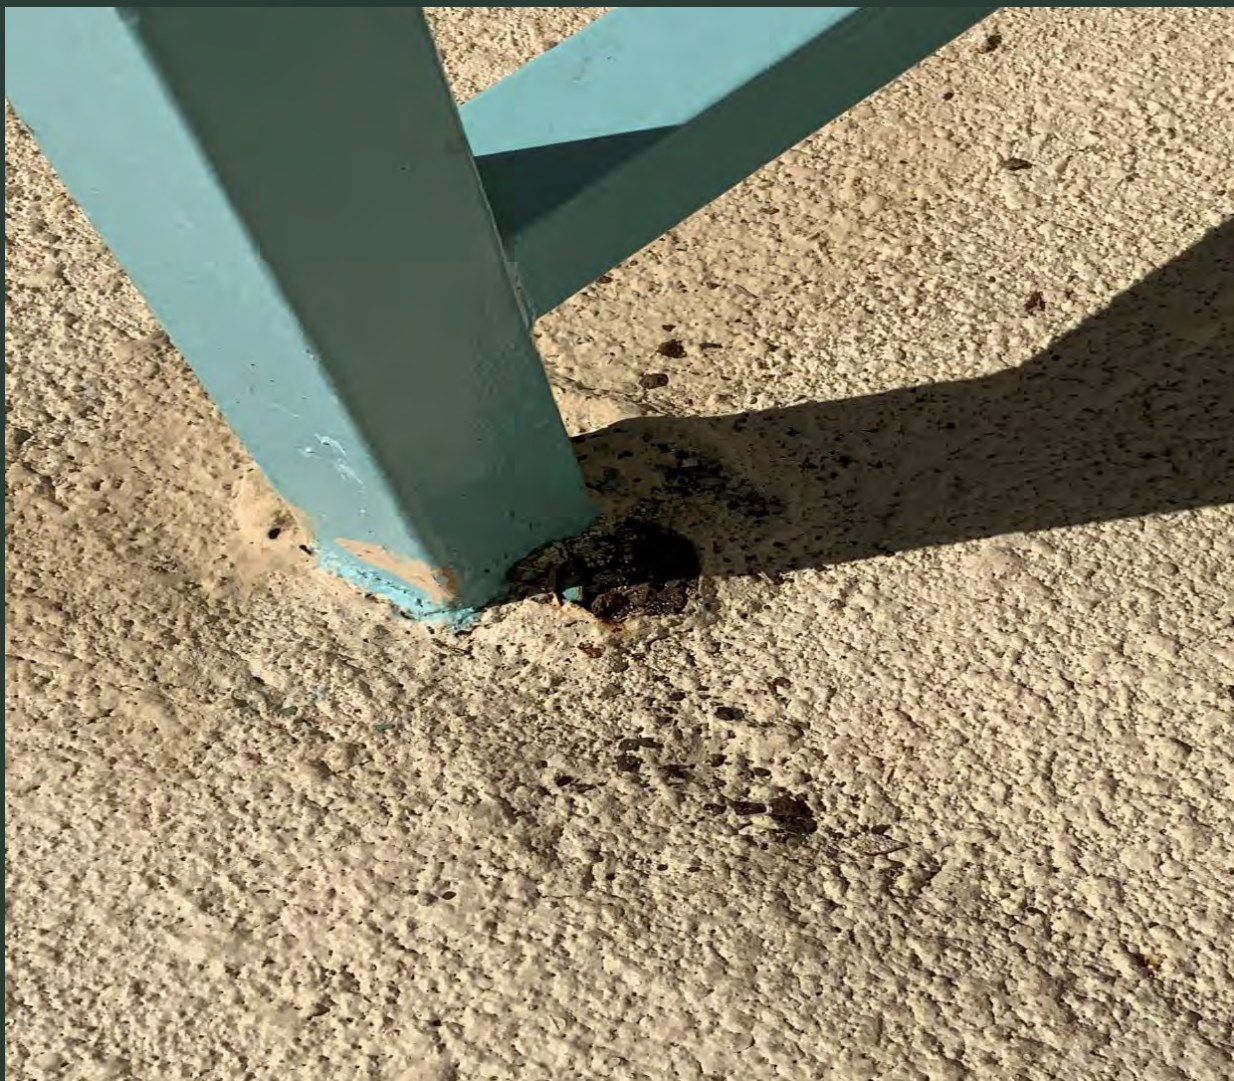
Elevated Walkways and Stairs

Waterproof coating is failing throughout the elevated walkways. Cracking appears at all the expansion joints. Metal stair nosing is rusted out which allows water into the assembly. Weep screed is rusting and/or is covered by the waterproof coating. Handrail / guardrail penetrations at the posts are not properly sealed. There is ponding in many areas and failing waterproofing throughout.

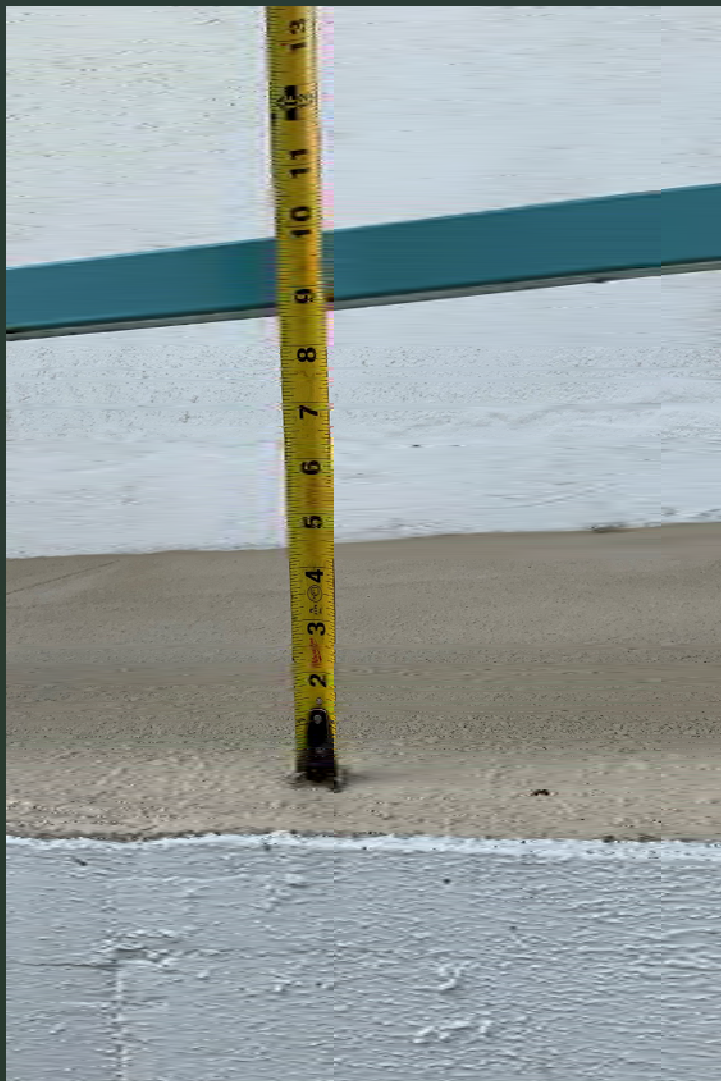
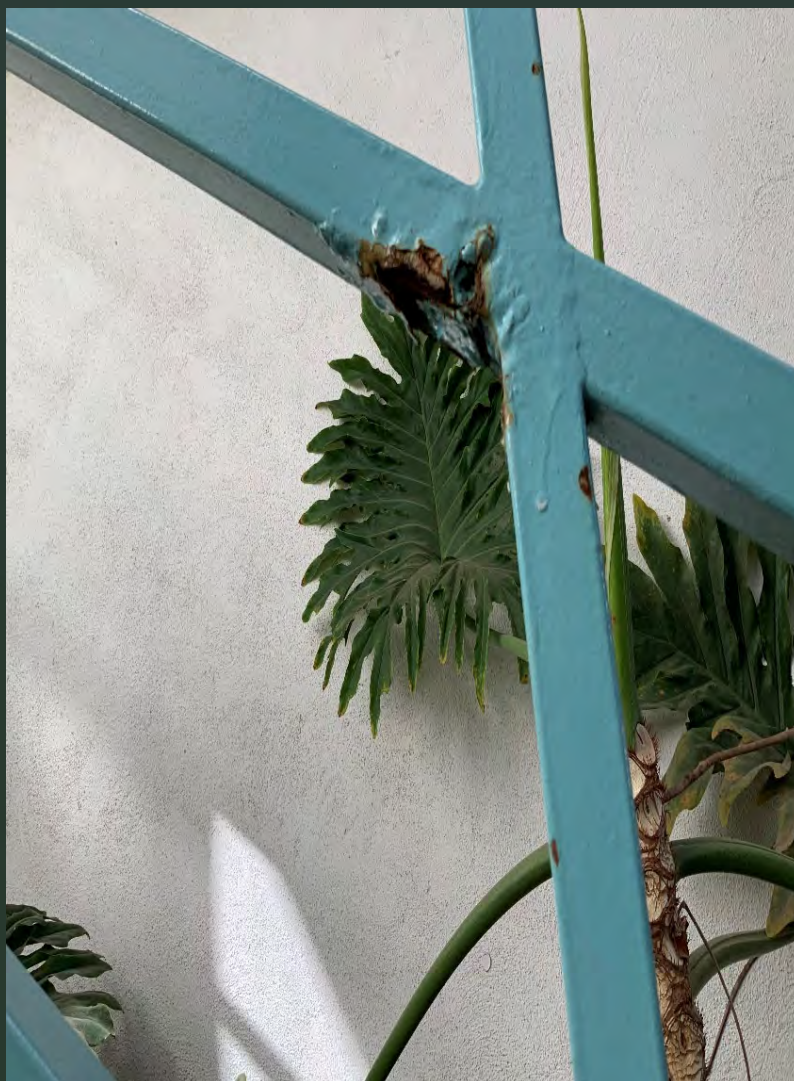
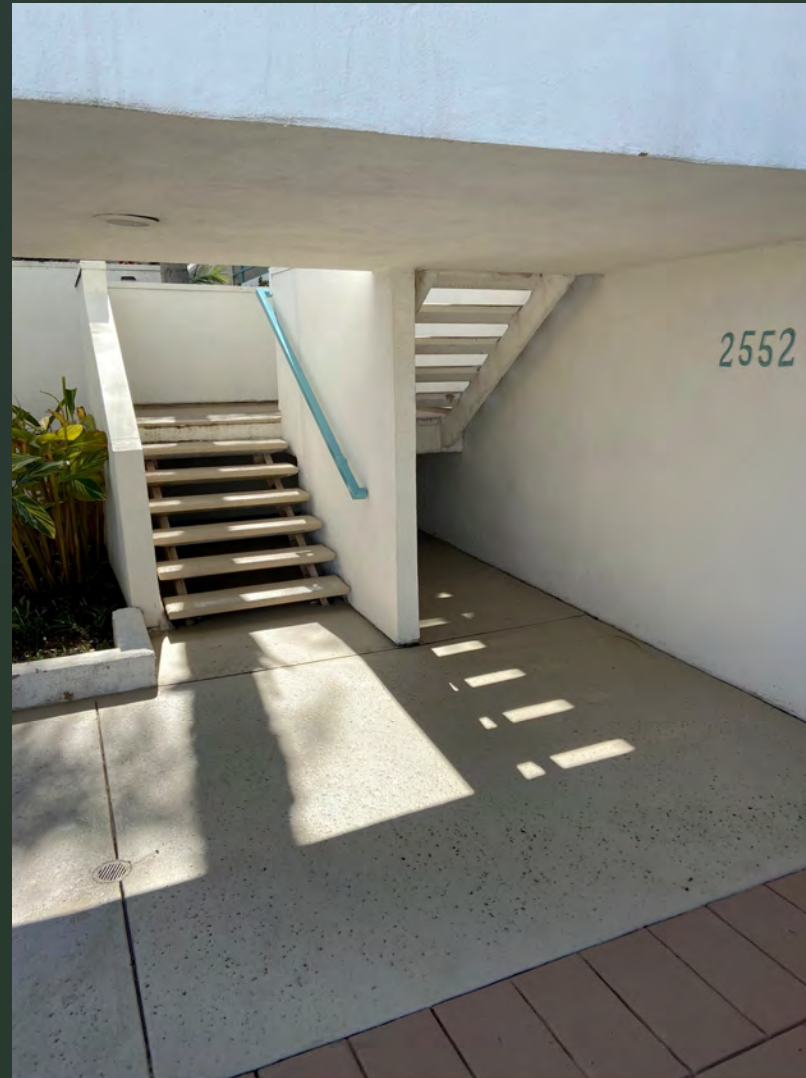
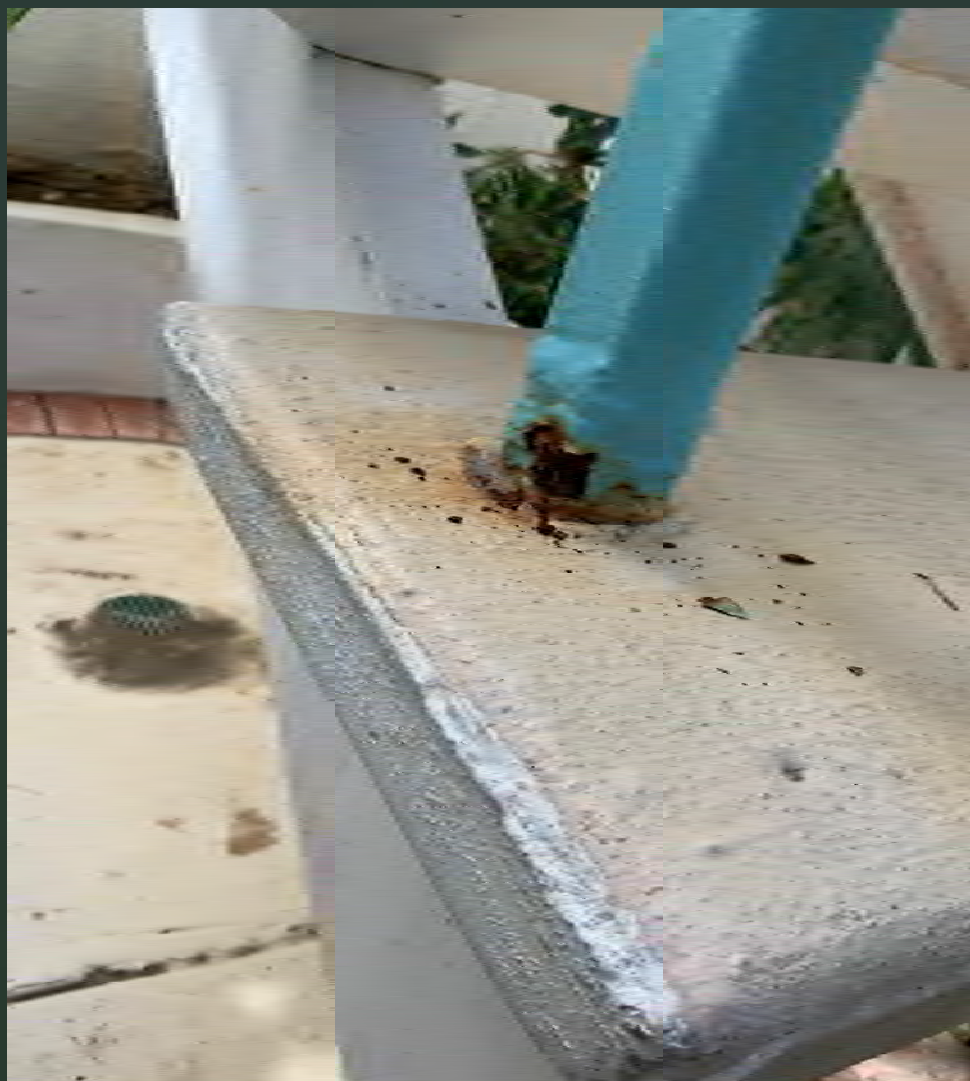
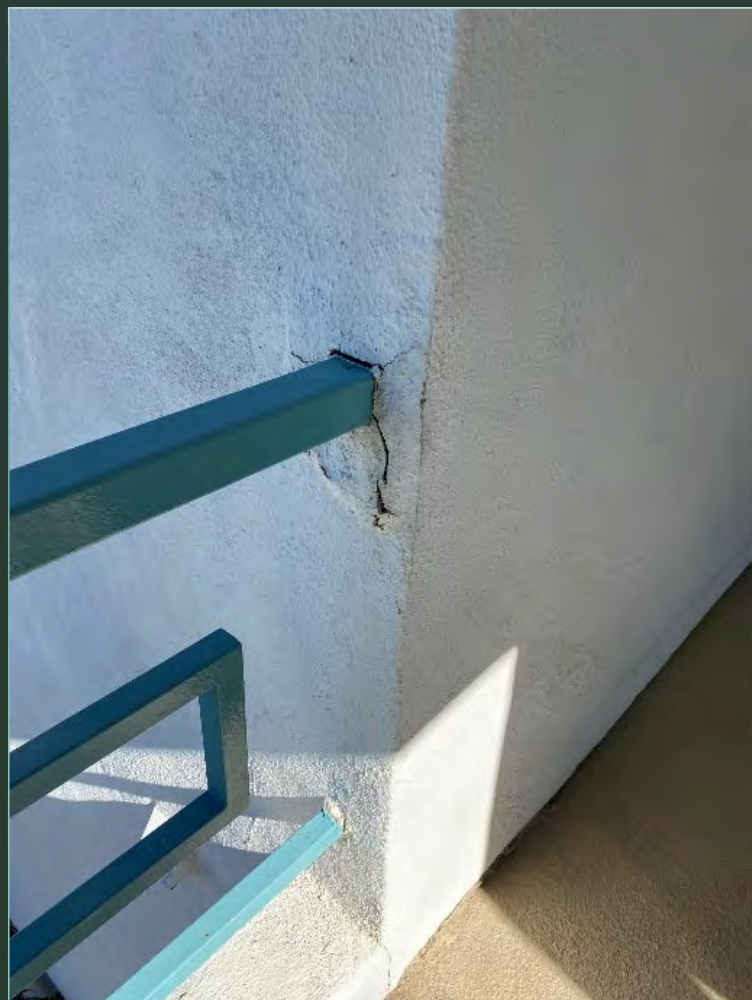
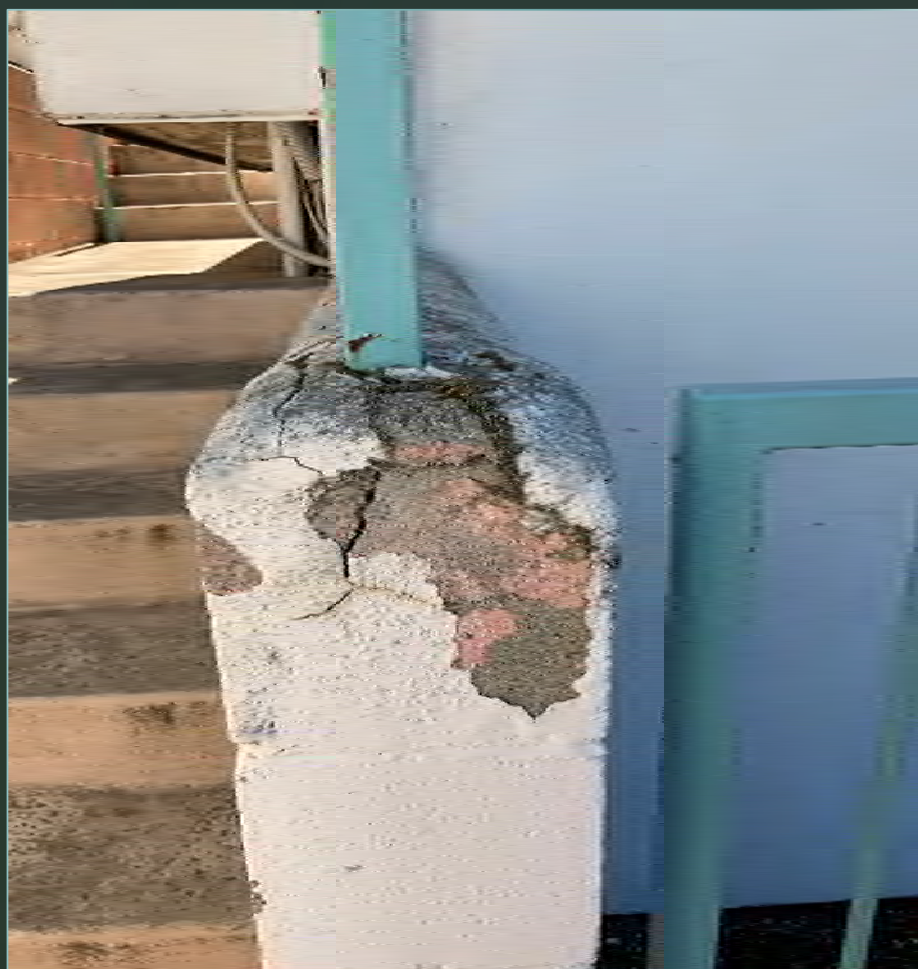
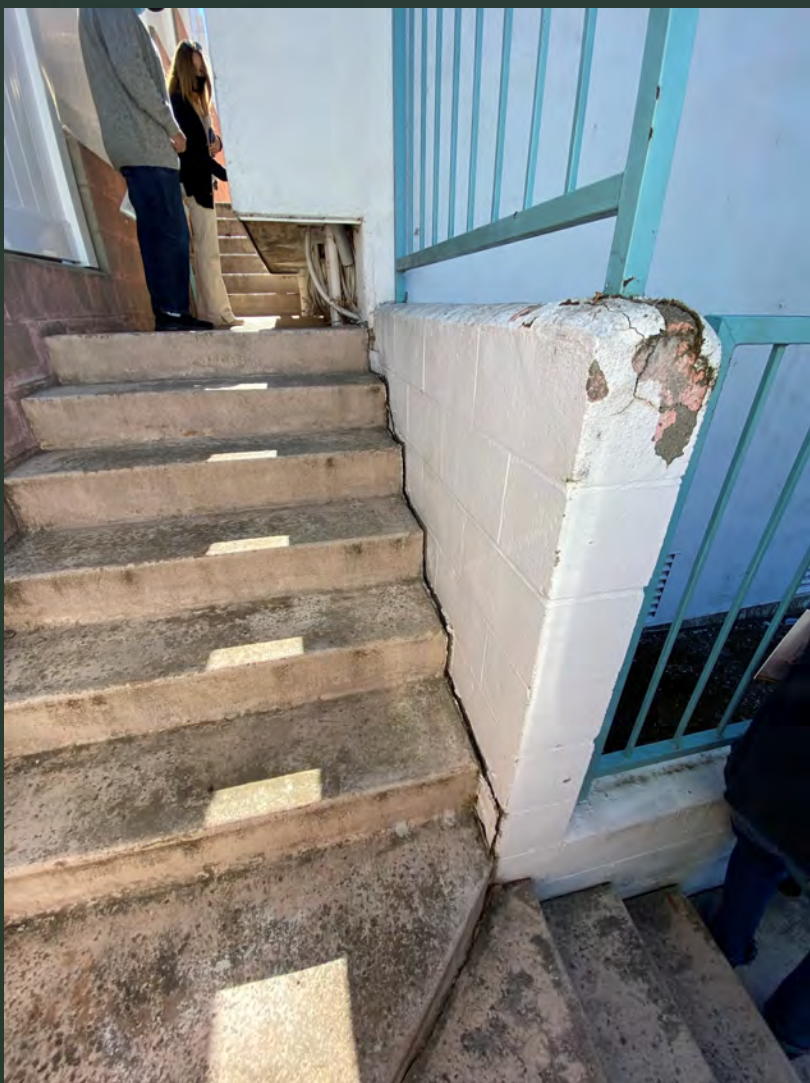
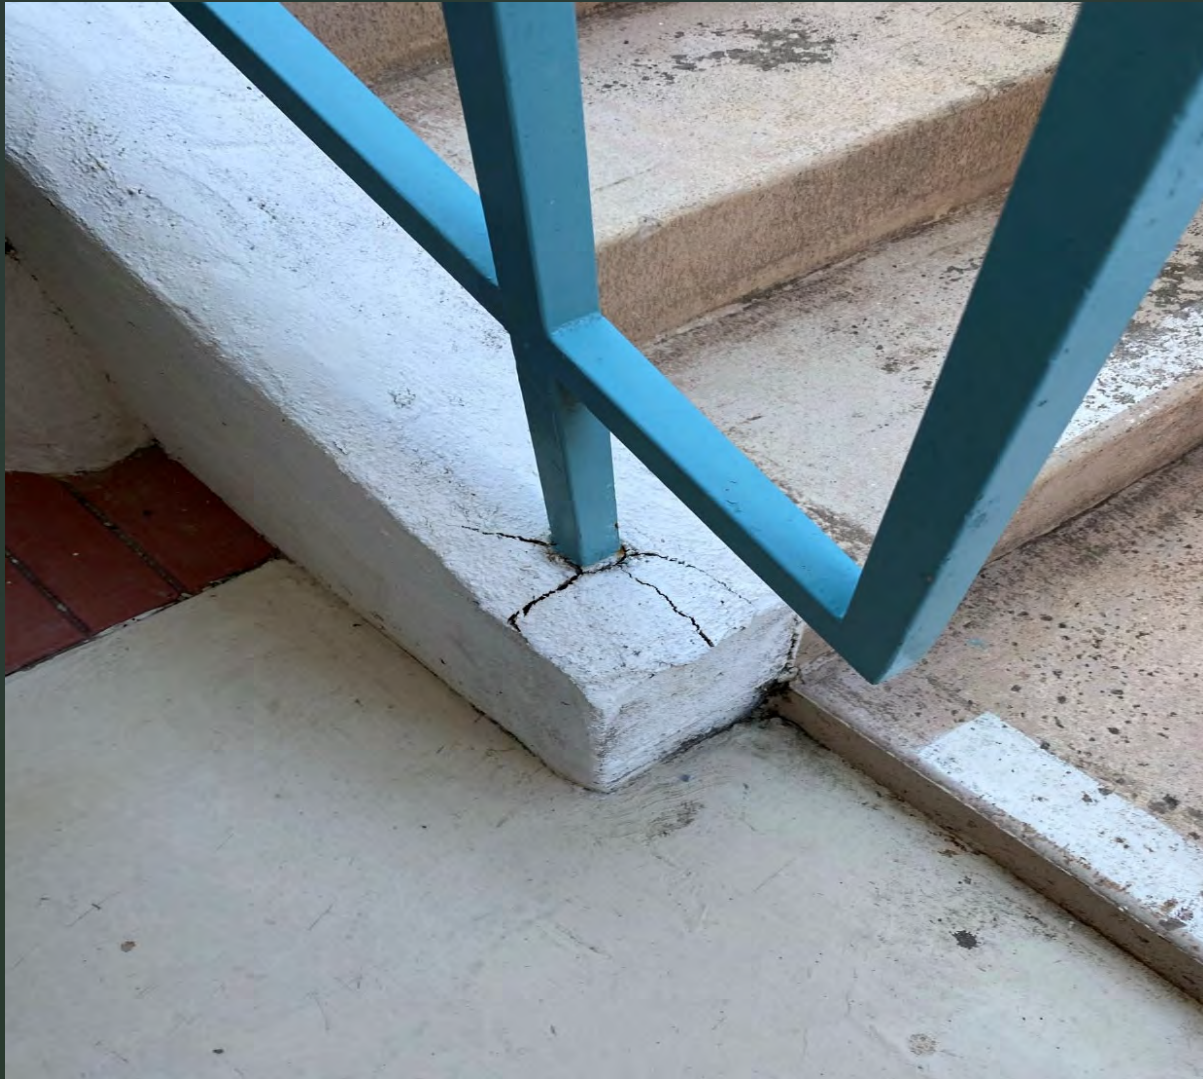
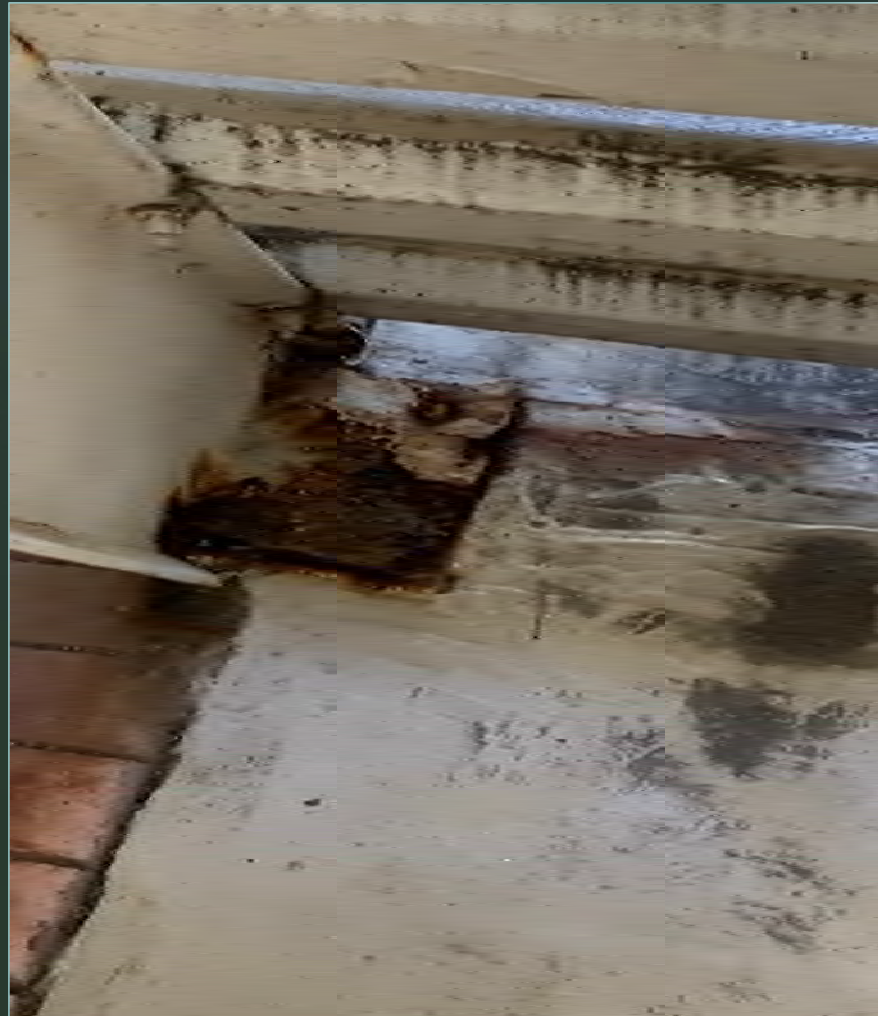
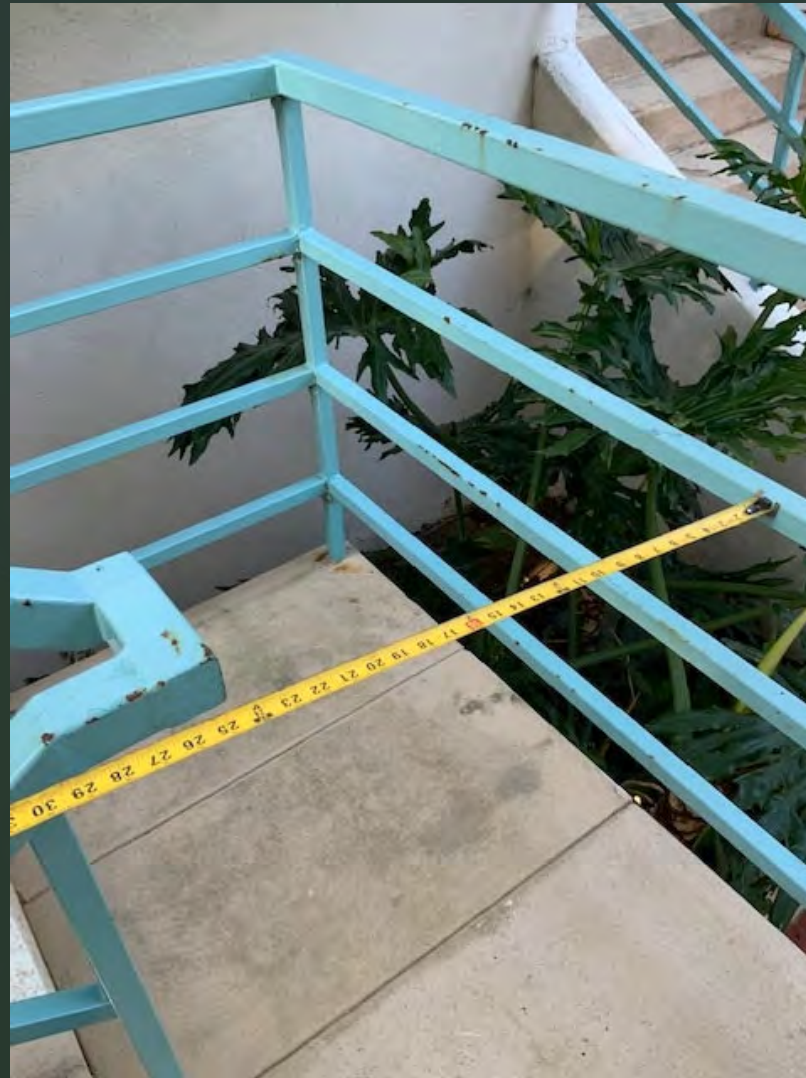
Handrails, Guardrails and Stairs

Handrails / guardrails do not meet current building code requirements. The handrails / guardrails are rusting and failing throughout the community. The post and top rail connections are causing cracking and bubbling in stucco due to being improperly flashed and sealed.
