WOOD DESTROYING PESTS AND ORGANISMS INSPECTION REPORT

Building Address: 2420 Canyon Lakes Dr., San Ramon, CA 94582		Date of Inspection 03/07/2024	Number of Pages 8
Termite Inspection Experts Inc 1749 Luna Bella Ln. Manteca CA 95337 Phone: (925) 487-9153 Fax: (209) 823-2716		Report # W14273	
		Lic. Registration # PR 8097	
		Escrow #	
Ordered by: COMPASS Mr. Paul Zuvella 630 San Ramon Valley Blvd. Danville, CA 94526	Property Owner and/or Party of Interest: Mr. Harry Blesi 2420 Canyon Lakes Dr. San Ramon, CA 94582	Report Sent to: COMPASS Mr. Paul Zuvella 630 San Ramon Valley Blvd. Danville, CA 94526	
COMPLETE REPORT <input checked="" type="checkbox"/> LIMITED REPORT <input type="checkbox"/> SUPPLEMENTAL REPORT <input type="checkbox"/> REINSPECTION REPORT <input type="checkbox"/>			
General Description: 2 Story single family dwelling with wood siding on exterior surface.		Inspection Tag Posted: Garage	
		Other Tags Posted: None	
An inspection has been made of the structure(s) shown on the diagram in accordance with the Structural Pest Control Act. Detached porches, detached steps, detached decks and any other structures not on the diagram were not inspected.

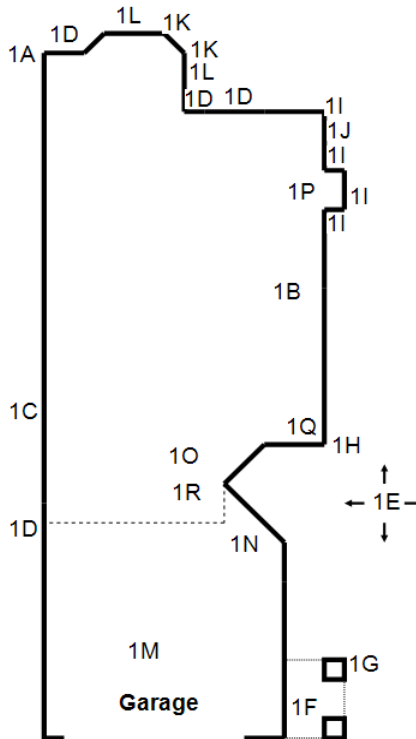
This Diagram is not to scale

- 1A (Section I)
FINDINGS: Fungus damage was found in the barge rafter at the area as indicated on the diagram.
RECOMMENDATION: Cut out damaged wood as necessary and replace it with new material. We will attempt to match existing paint and type of wood , however we can not guarantee it.

- 1B (Section I)
FINDINGS: Fungus infected cellulose debris noted at time of inspection in subarea.
RECOMMENDATION: Clean-out all accessible cellulose debris and remove from premises.

- 1C (Section I)
FINDINGS: The roof eave and/or frame at the area as indicated on the diagram is fungus damaged.
RECOMMENDATION: Remove roof covering as necessary, cut out damaged wood and replace it with new material. We will attempt to match existing roof covering and paint, however we can not guarantee it. If roof covering is made of concrete tiles, existing tiles will be reinstalled.

- 1D (Section I)
FINDINGS: The siding at the area as indicated on the diagram is fungus damaged.
RECOMMENDATION: Cut out damaged siding as necessary and replace it with new material. We will attempt to match existing siding and paint, however we ca not guarantee it.

- 1E (Section II)
FINDINGS: The gutter and/or downspout at the area as indicated on the diagram appears to be leaking.
RECOMMENDATION: Owner to contact the proper tradesman for repairs.

- 1F (Section I)
FINDINGS: The door at the area as indicated on the diagram is fungus/moisture damaged.
RECOMMENDATION: Remove damaged door and replace it with a new prehung door of a similar quality, prime and paint the exterior only.

- 1G (Section I)
FINDINGS: Fungus damage was found in the fascia board at the area as indicated on the diagram.
RECOMMENDATION: Cut out damaged wood as necessary and replace it with new material. We will attempt to match existing paint and type of wood , however we can not guarantee it.

- 1H (Section I)
FINDINGS: Fungus damage was found in the corner trim board at the area as indicated on the diagram.
RECOMMENDATION: Cut out damaged wood as necessary and replace it with new material. We will attempt to match existing paint and type of wood , however we can not guarantee it.

- 1I (Section I)
FINDINGS: Fungus damage was found throughout the chimney chase at the area as indicated on the diagram.
RECOMMENDATION: Cut out fungus damaged wood and replace it with new material. We will attempt to match existing paint and type of wood, however we can not guarantee it.

- 1J (Section I)
FINDINGS: Fungus damage was found in the window trim board at the area as indicated on the diagram.
RECOMMENDATION: Cut out fungus damaged wood and replace it with new material. We will attempt to match existing paint and type of wood, however we can not guarantee it.

- 1K (Section I)
FINDINGS: Fungus damage was found in the first and second floor window trim board at the area as indicated on the diagram.
RECOMMENDATION: Cut out fungus damaged wood and replace it with new material. We will attempt to match existing paint and type of wood, however we can not guarantee it.

- 1L (Further Inspection)
FINDINGS: The area as indicated on the diagram is inaccessible for inspection due to vegetation preventing inspection.
RECOMMENDATION: Owner to make this area accessible for further inspection.

- 1N (Section II)
FINDINGS: A plumbing leak was found on the water heater inlet as indicated in the diagram.
RECOMMENDATION: Repair plumbing leak to eliminate excessive moisture condition.

- 1Q (Section I)
FINDINGS: Surface fungus was found on subarea frame at the area as indicated on the diagram.
RECOMMENDATION: Scrape and chemically treat fungus condition with NISUS (Timbor Disodium Octaborate Tetrahydrate). Chemical treatments must be done by a license Chemical Applicator.

1R (Section I)
FINDINGS: Fungus damage was found in the subfloor around the 1/2 bathroom toilet at the area as indicated on the diagram.
RECOMMENDATION: Remove hardwood floor as necessary, cut out damaged wood and replace it with new material.
Note: No painting is included in this estimate. Owner to contact the proper tradesman to repair the hardwood floor upon completion of our repairs.
