# WOOD DESTROYING PESTS AND ORGANISMS INSPECTION REPORT

BUILDING NO. <b>6712</b>	STREET, CITY, STATE, ZIP <b>Birch Ct, Dublin CA 94568</b>	Date of Inspection <b>6/12/2024</b>	No. of Pages <b>14</b>
  <div style="display: inline-block; vertical-align: middle; margin-left: 20px;"> <p><b>2450 Armstrong Street</b>  <b>Livermore, CA 94551</b>  <b>Tel: (925) 724-9433</b>  <b>Email: bros.reports@gmail.com</b>  <b>www.brothersinspections.com</b></p> </div>			
Firm Registration No. <b>PR 7778</b>	Report No. <b>21640</b>	Escrow No.	
Ordered By: RE/MAX ACCORD 313 SYCAMORE VALLEY RD W DANVILLE, CA 94526 Attn: John Manos (925) 699-864	Property Owner/Party of Interest Owner of Record 6712 Birch Ct Dublin, CA 94568	Report Sent To: RE/MAX ACCORD 313 SYCAMORE VALLEY RD W DANVILLE, CA 94526 Attn: John Manos (925) 699-864	
COMPLETE REPORT <input checked="" type="checkbox"/> LIMITED REPORT <input type="checkbox"/> SUPPLEMENTAL REPORT <input type="checkbox"/> REINSPECTION REPORT <input type="checkbox"/>

General Description: One story single family dwelling stucco exterior		Inspection Tag Posted: Garage	
		Other Tags Posted: None noted	
An inspection has been made to the structure(s) shown on the diag

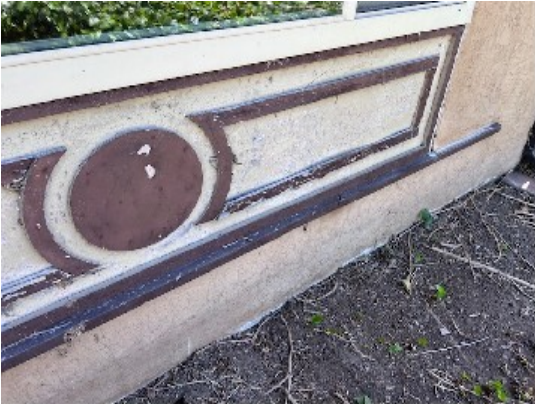
**ITEM 1**

ITEM 1 FINDING: The exterior wood members are weathered and in need of paint.

RECOMMENDATION: The owner should have these areas well sealed and painted as general home maintenance.

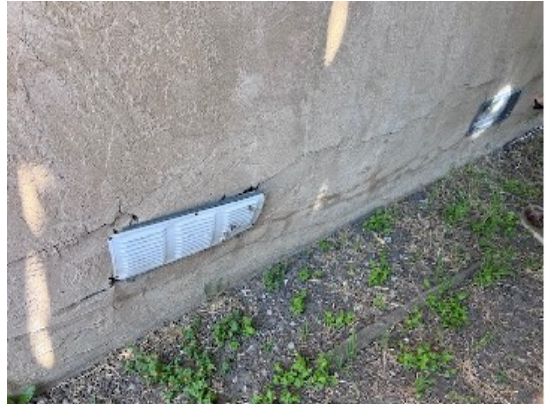
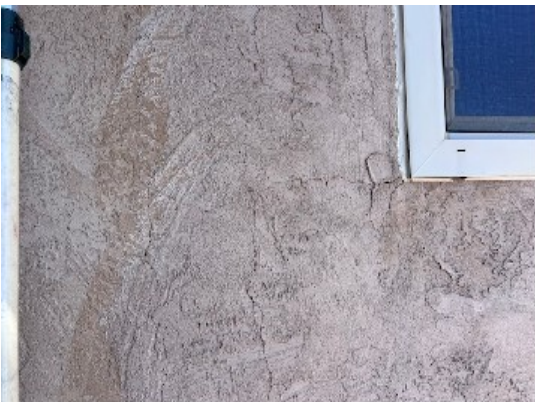
**ITEM 5**

ITEM 5 FINDING: Noted minor exterior stucco cracks at the walls. No outward signs of moisture intrusion noted.

RECOMMENDATION: The owner should keep these cracks well sealed and maintained as general home maintenance.

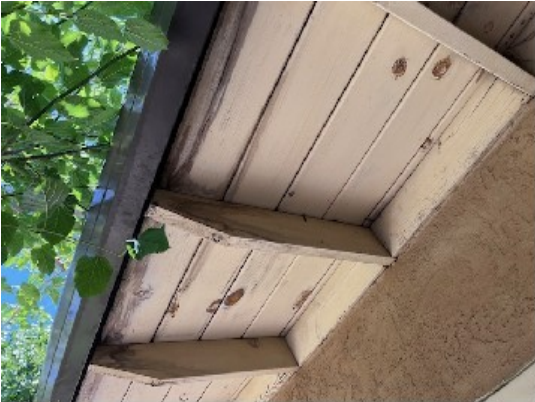
**ITEM 2**

ITEM 2 FINDING: Evidence of past or present roof leakage was observed.

RECOMMENDATION: The owner is advised to contact a licensed roofing contractor and make any revisions deemed necessary.

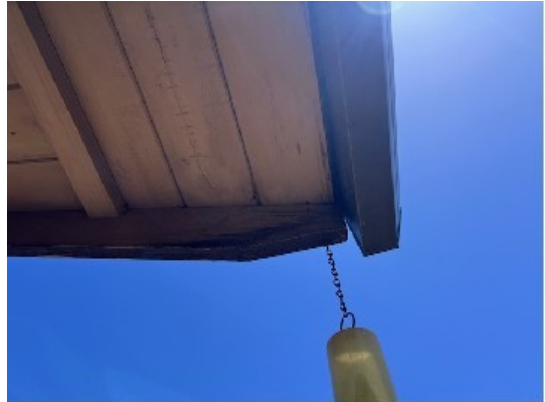
**ITEM 3**

ITEM 3 FINDING: Fungus damage was noted to the sheathing as indicated on the diagram.

RECOMMENDATION: Remove and replace the damaged wood members to correct this condition. This bid includes replacement of the roof covering if disturbed by our repairs. The guarantees on the roof covering are limited to the areas where the work was performed.

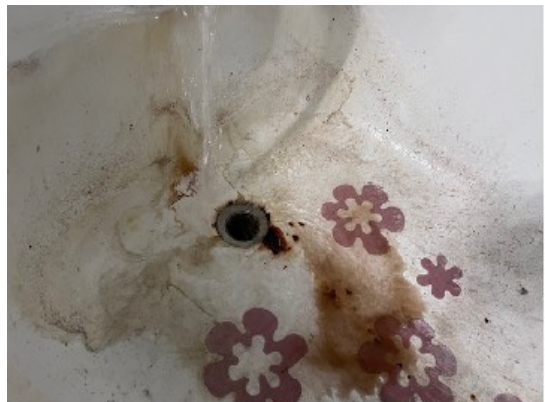
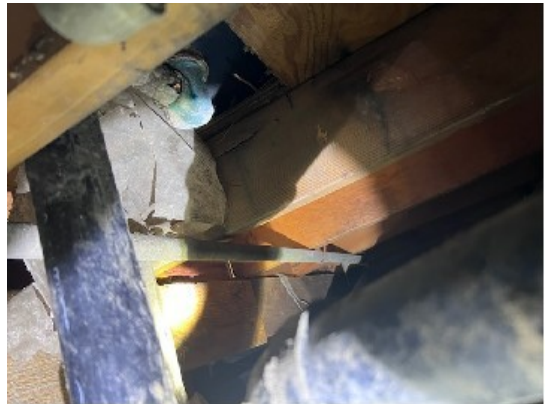
**ITEM 6**

ITEM 6 FINDING: The hall bathtub is rusted and the drain line is leaking.

RECOMMENDATION: The owner should contact a plumbing contractor to inspect and make necessary repairs.

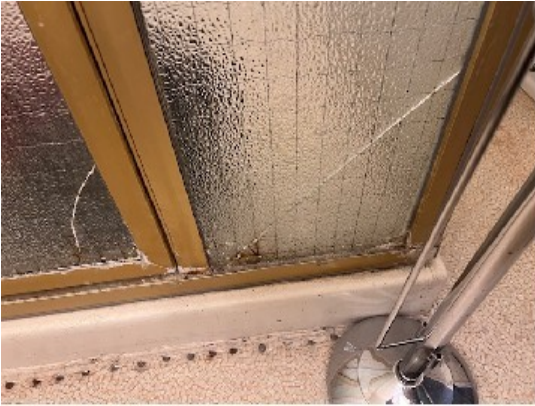
**ITEM 11**

- \*\*\*\*\* This is a Section 2 Item \*\*\*\*\*
- ITEM 11 FINDING: Noted loose grout at the tile shower walls at the guest bathroom.
- RECOMMENDATION: The owner should keep these walls well sealed and maintained.

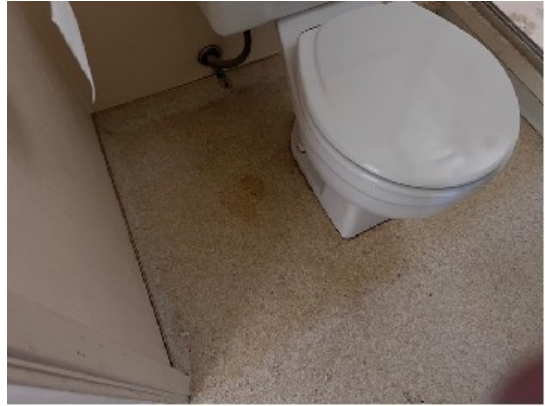
**ITEM 8**

- ITEM 8 FINDING: The primary bathroom floor is fungus damaged adjacent to the shower.
- RECOMMENDATION: Remove the toilet and open the floor to repair the damaged underlayment as required. Install new underlayment. Install new standard grade, neutral colored vinyl floor covering over the bathroom floor area. Reinstall the existing toilet using a new no-seep toilet seal.

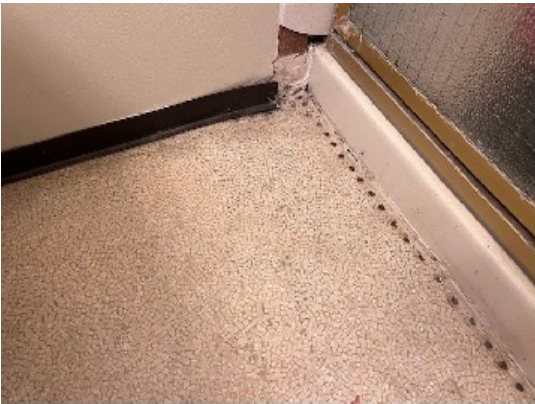
**ITEM 7**

ITEM 7 FINDING: The guest bathroom floor is fungus damaged adjacent to the shower.

RECOMMENDATION: Remove the toilet and open the floor to repair the damaged underlayment as required. Install new underlayment. Install new standard grade, neutral colored vinyl floor covering over the bathroom floor area. Reinstall the existing toilet using a new no-seep toilet seal.

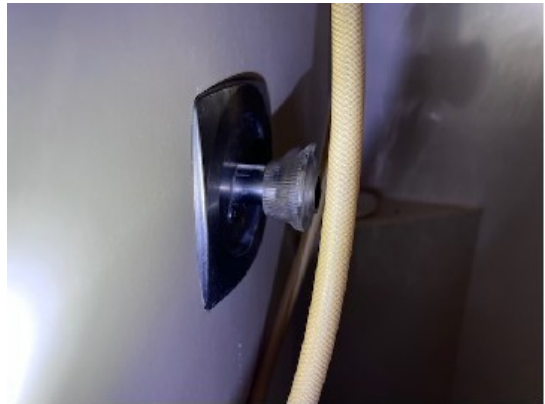
**ITEM 14**

- NOT: THE SINK BASIN WALL WAS NEEDS TO BE REPLACED BECAUSE IT IS CRACKED.
- \*\*\*\*\* This is a Section 2 Item \*\*\*\*\*
- ITEM 14 FINDING: Noted a plumbing leak at the at the primary shower valve.

- RECOMMENDATION: The owner should contact a plumbing contractor to inspect and make necessary repairs.
- \*\*\*\*\* This is a Section 2 Item \*\*\*\*\*

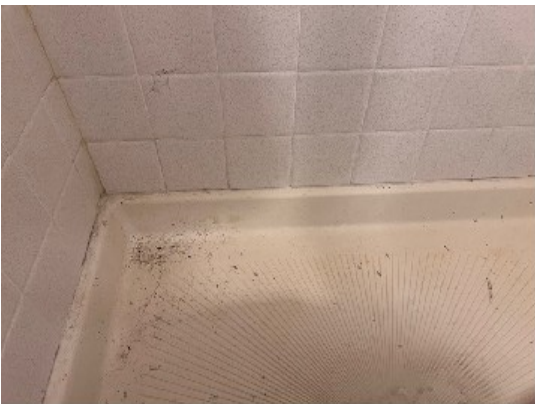
**ITEM 10**

- \*\*\*\*\* This is a Section 2 Item \*\*\*\*\*
- ITEM 10 FINDING: Noted loose tiles at the shower wall in the guest bathroom.
- RECOMMENDATION: The owner is advised to keep these shower walls well sealed and maintained. Upon request we will further inspect the backing to insure no damage has been caused to the membrane.

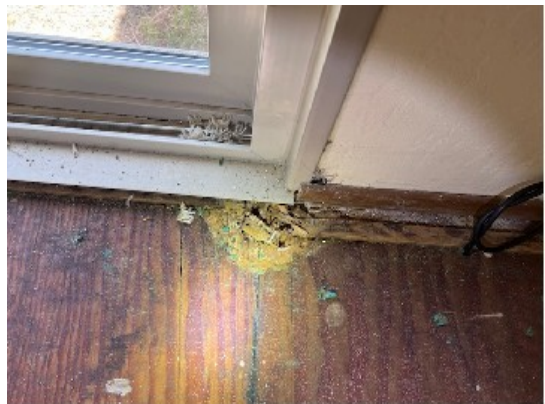
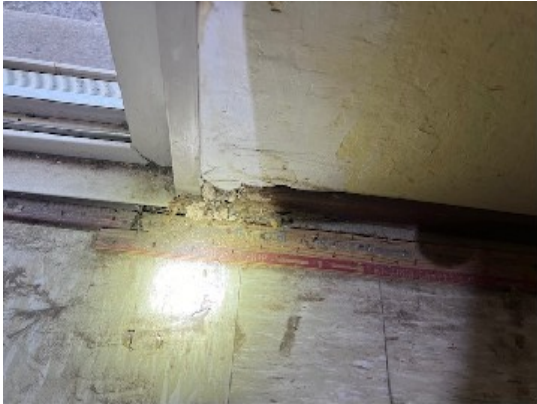
**ITEM 15**

- ITEM 15 FINDING: The plywood has been damaged by fungus adjacent to the slider door.
- RECOMMENDATION: Remove and replace all damaged wood members. If the damage is found to extend into an inaccessible area a supplemental report will be issued with additional findings recommendations and bids. Paint to match as close as possible. No guarantees are made on color match.

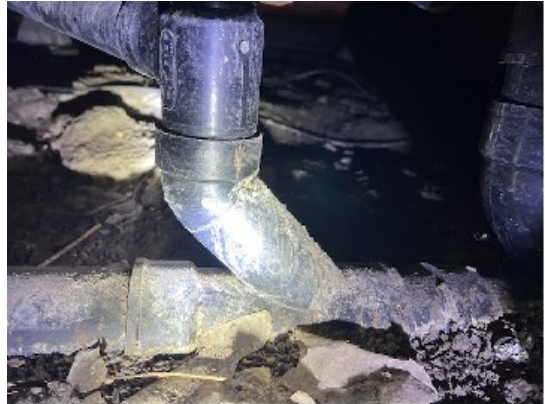
**ITEM 17**

- \*\*\*\*\* This is a Section 2 Item \*\*\*\*\*
- ITEM 17 FINDING: Noted a plumbing leak at the ABS drain below the hall bathroom.
- RECOMMENDATION: The owner should contact a plumbing contractor to inspect and make necessary repairs.

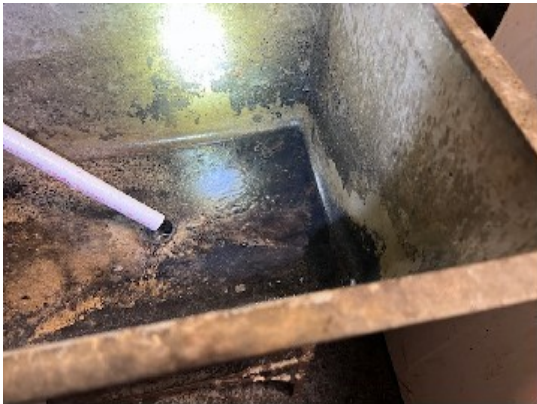
**ITEM 13**

- \*\*\*\*\* This is a Section 2 Item \*\*\*\*\*
- ITEM 13 FINDING: Noted a plumbing leak at the garage sink.
- RECOMMENDATION: The owner should contact a plumbing contractor to inspect and make necessary repairs.

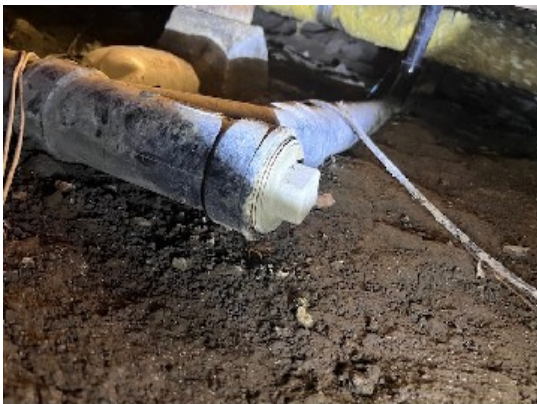
**ITEM 16**

- \*\*\*\*\* This is a Section 1 Item \*\*\*\*\*
- ITEM 16 FINDING: Noted a plumbing leak at the cleanout drain cap.
- RECOMMENDATION: The owner should contact a plumbing contractor to inspect and make necessary repairs.

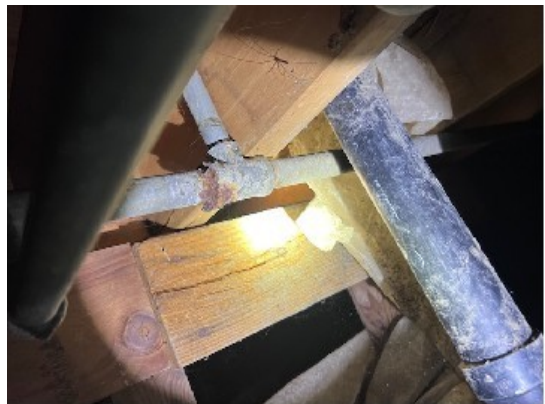
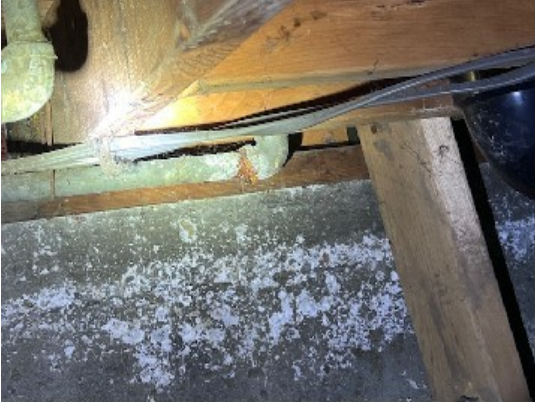
**ITEM 18**

- \*\*\*\*\* This is a Section 2 Item \*\*\*\*\*
- ITEM 18 FINDING: The plumbing supply lines lines show signs of corrosion and/or leakage.
- RECOMMENDATION: The owner should contact a plumbing contractor to inspect and make necessary repairs.

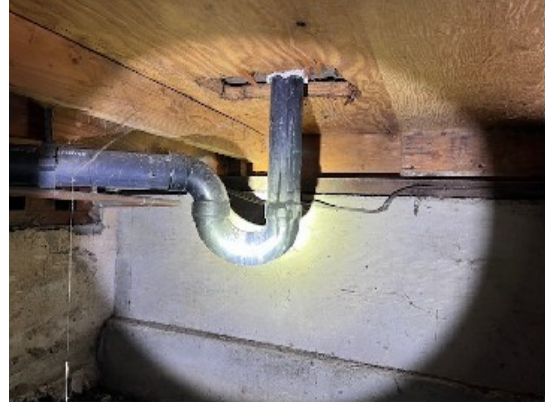
**ITEM 19**

- \*\*\*\*\* This is a Section 2 Item \*\*\*\*\*
- ITEM 19 FINDING: Noted a plumbing leak at the stall shower drain at the primary.
- RECOMMENDATION: The owner should contact a plumbing contractor to inspect and make necessary repairs.

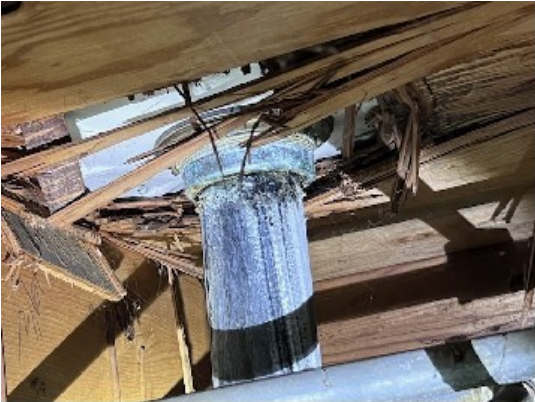
**ITEM 21**

- RECOMMENDATION: Remove the cellulose debris of a rakeable size.
- \*\*\*\*\* This is a Section 1 Item \*\*\*\*\*
- ITEM 21 FINDING: Noted a plumbing leak at the stall shower drain at the guest bathroom.

- RECOMMENDATION: The owner should contact a plumbing contractor to inspect and make necessary repairs.
- \*\*\*\*\* This is a Section 2 Item \*\*\*\*\*

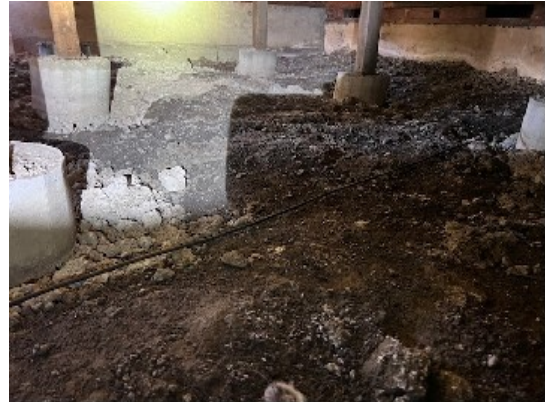
**ITEM 22**

- ITEM 22 FINDING: The soil was damp/wet at the time of the inspection.
- RECOMMENDATION: The owner should have periodic inspections of this area. If additional information is requested an appropriate trades person should be contacted.

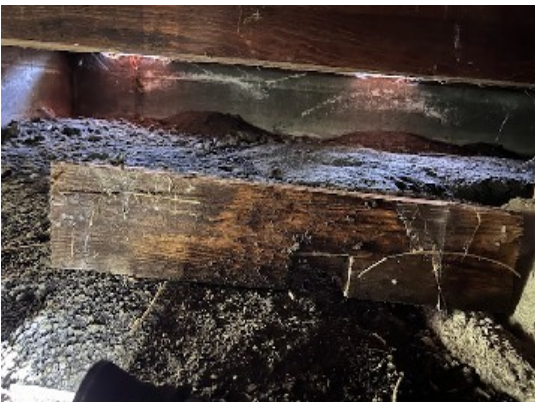
**ITEM 20**

- \*\*\*\*\* This is a Section 2 Item \*\*\*\*\*
- ITEM 20 FINDING: Cellulose debris (wood, paper products) with evidence of fungus was noted in the subarea.

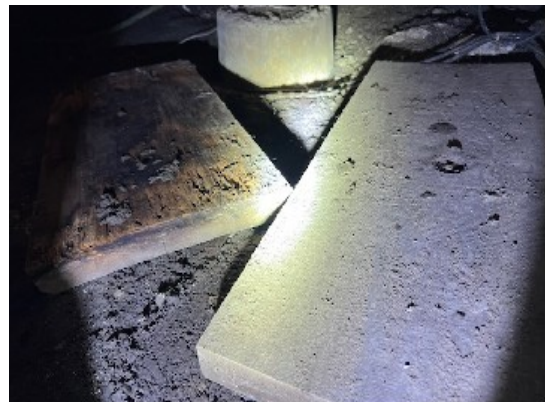
**ITEM 23**

ITEM 23 FINDING: Subterranean termites are noted in the subarea soil.

RECOMMENDATION: Knock down the tubes and treat the subarea soil with (TERMI DOR) for the control of this termite. This chemical will be applied per label instructions. This must be performed by a licensed chemical applicator.
