REAL ESTATE INSPECTION SUMMARY.

LOCATED AT:
686 S Camino Real
Palm Springs, CA 92264

Report# 10777

Executive Summary

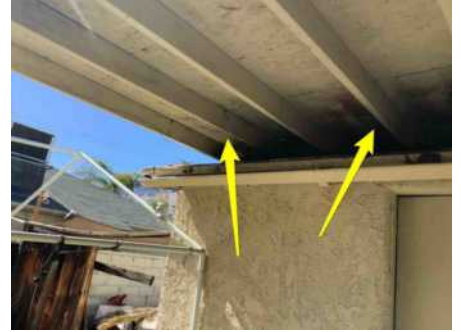
NR 7: Improper installation at patio roof.

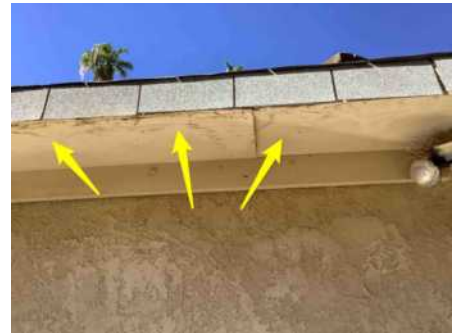
NR 9: Staining noted at eaves, We recommend further review and repairs by a qualified specialist in the appropriate trade.

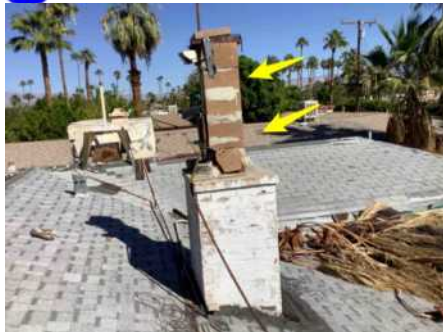
NR 10: Appears to have been improperly altered. Recommend chimney specialist to evaluate and repair as needed.

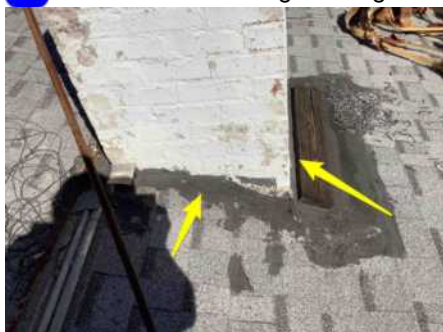
NR 11: Counter flashing missing at chimney.

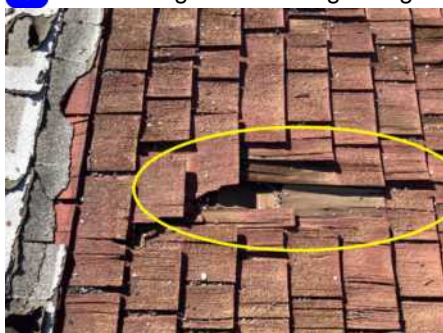
NR 12: Damaged or missing Shingles noted. Repair/Replacement needed.

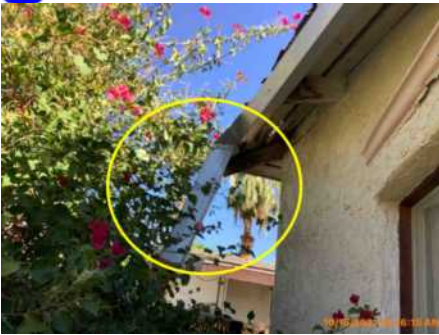
NR 14: Damage gutters viewed

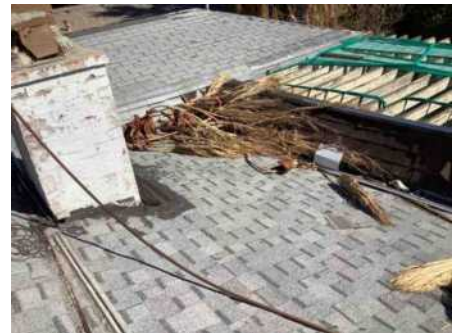
NR 15: The only way to determine whether a roof is absolutely water tight is to observe it during a prolonged rainfall. Many times, this situation is not present during the inspection. Recommend roof be evaluated and certified by a qualified Roofing Contractor due to its age.

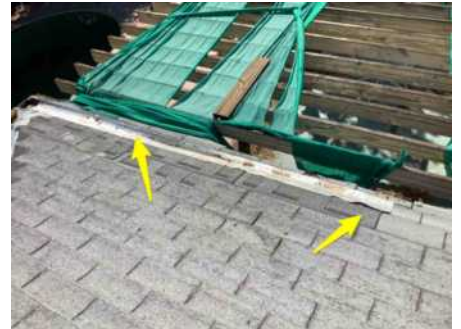
NR 18: Improper installation is found, Recommend the entire roof be evaluated and repaired by a qualified Roofing Contractor

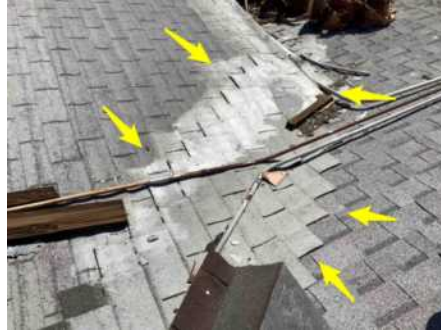
NR 19: Repairs appear to be substandard. Recommend the entire roof be evaluated and repaired by a qualified Roofing Contractor

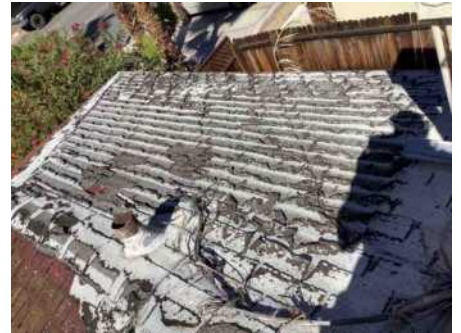
NR 20: Heavy Wear noted to composition roof, composition roof appears to be at its end of its service life. Recommend the entire roof be evaluated and repaired by a qualified Roofing Contractor.

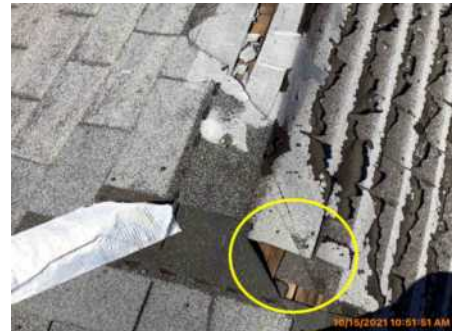
NR 21: Missing composition shingles in several areas

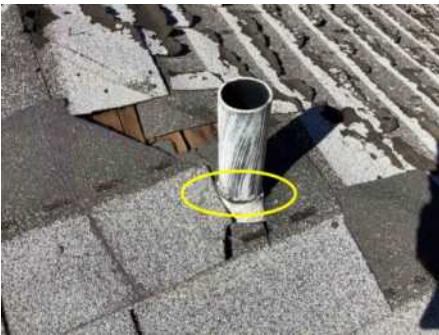
NR 23: All flashing junctions should be re sealed to prevent leaks, We recommend the advice and services of a qualified Roofing Contractor

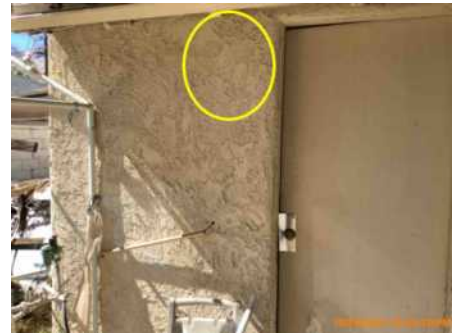
NR 26: Light fixture missing, light fixture required at all grade level doors

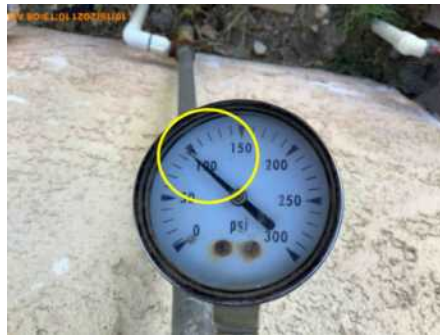
NR 31: The homes water supply pressure exceeded the 80 pounds per square inch (PSI) limit considered the maximum allowable by generally-accepted current standards. Excessively high water pressure is likely to cause leaks. Water pressure noted at time of inspection was **100** psi, recommend the installation of a pressure regulator by a qualified Plumbing Contractor.

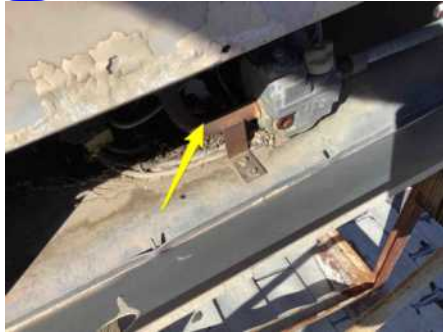
NR 39: Rusty gas line noted at interior of heating unit

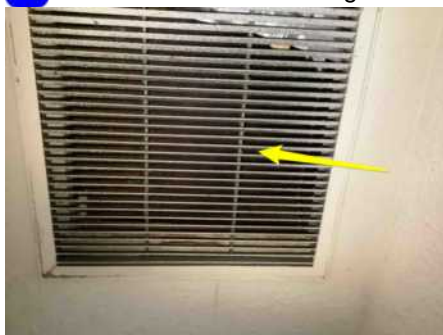
NR 40: Heater filter is missing

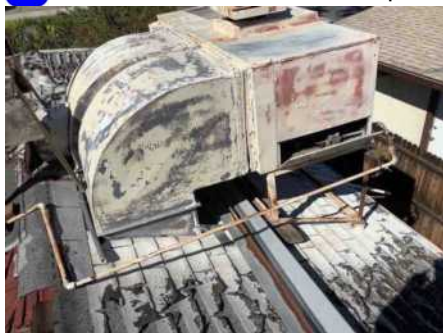
NR 42: Air conditioner failed to operate, We recommend the advice and services of a qualified HVAC Contractor

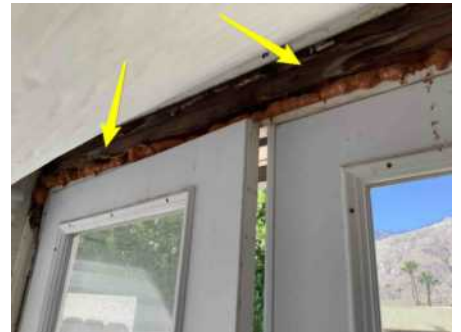
NR 44: Damage and missing wall covering to dining area

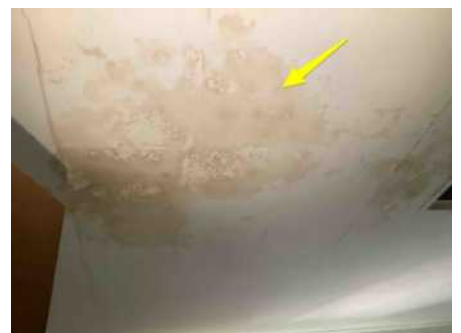
NR 46: Stains noted at throughout home ceilings and walls, possible roof leak . We recommend further review and repairs by a qualified specialist in the appropriate trade.

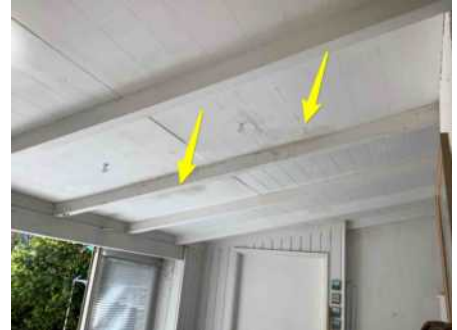
NR 47: Stains noted to ceiling in rear room, roof appears to be leaking. We recommend further review and repairs by a qualified specialist in the appropriate trade.

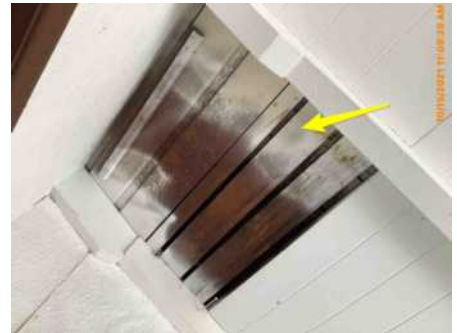
NR 48: Ceiling panels separating, damaged and missing in rear room. We recommend further review and repairs by a qualified specialist in the appropriate trade.

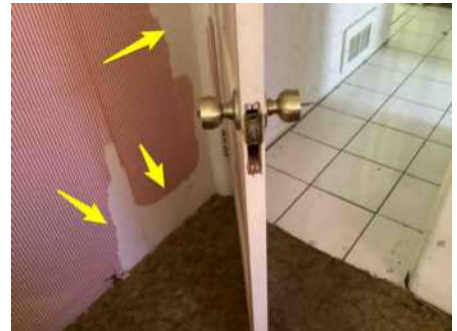
NR 49: Wallpaper peeling/ missing in several areas

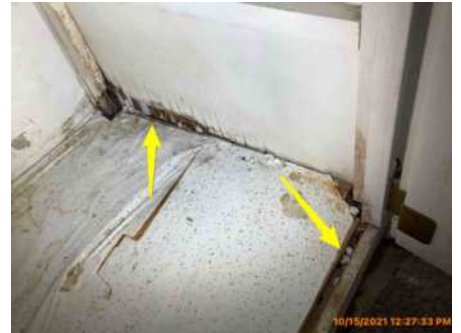
NR 51: I observed evidence of rodents in the hallway and hallway throughout the interior .Ask the Sellers about the rodent history and/or contact a qualified Pest Control Operator to further evaluate.

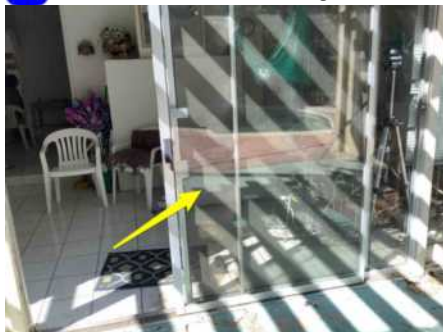
NR 53: Screen door damaged at rear room

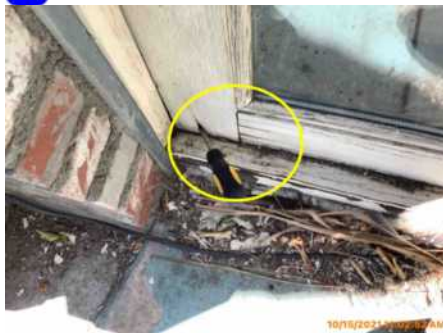
NR 54: Window casing moisture damaged at rear

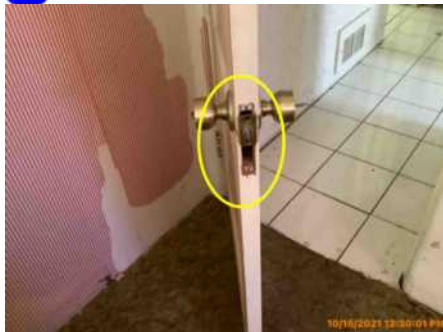
NR 55: Damage noted at master bedroom

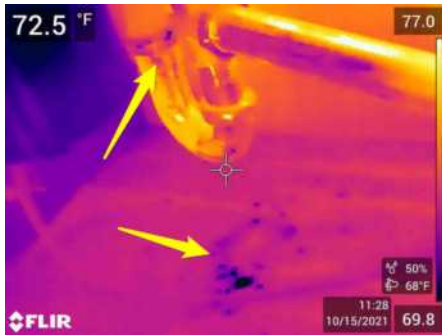
NR 56: Thermal Image shows leak is present under kitchen sink, We recommend the advice and services of a qualified Plumbing Contractor

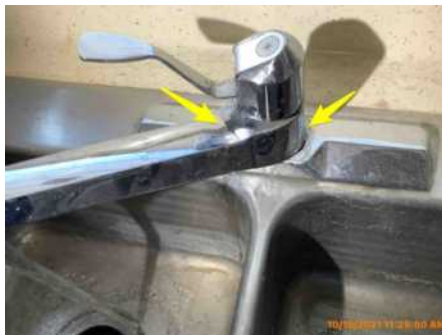
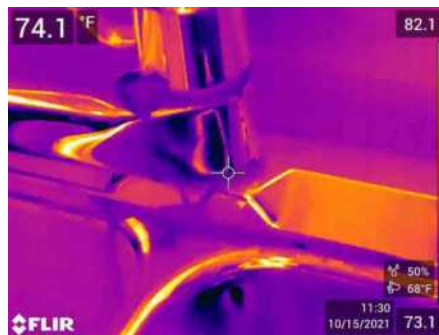
NR 57: Thermal image shows faucet is leaking, We recommend the advice and services of a qualified Plumbing Contractor.

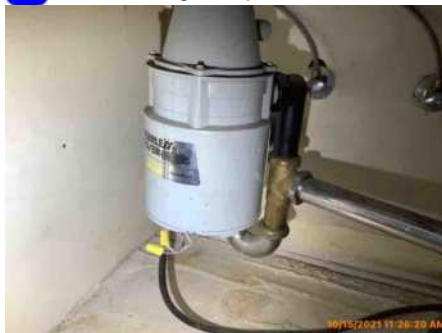
NR 58: Garbage disposal did not work, recommend further review

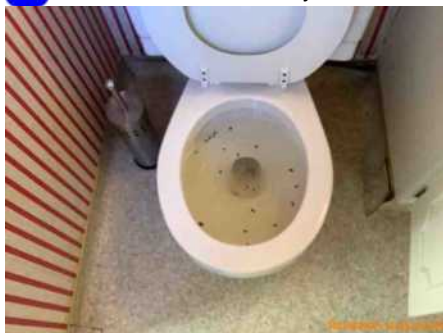
NR 63: Evidence of heavy rodent infestation in toilet, toilet would not flush properly.

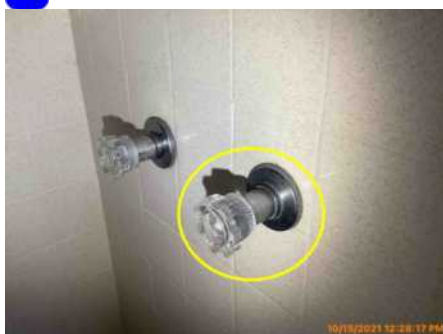
NR 64: Valve seized

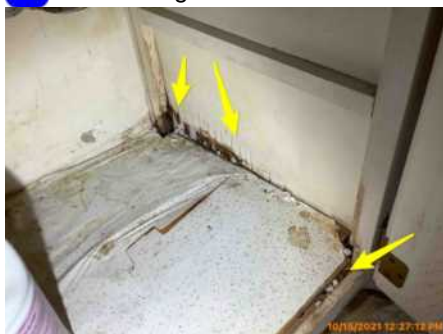
NR 65: Damage noted to cabinet.

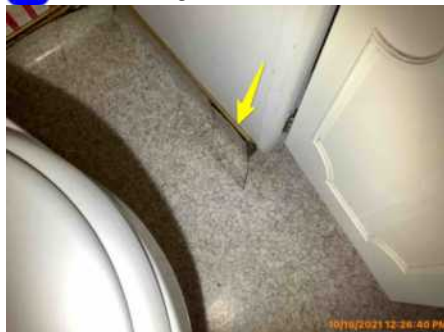
NR 66: Damage noted to floor

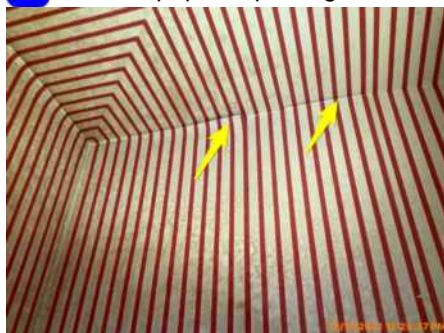
NR 67: Wallpaper is peeling

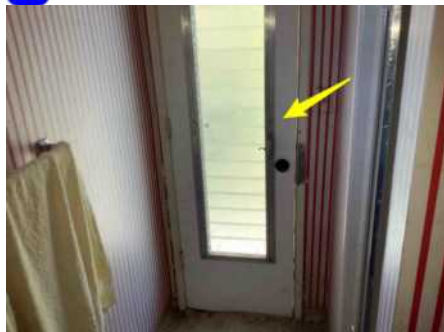
NR 69: Door would not open

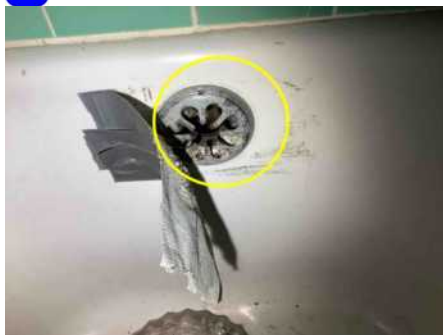
NR 70: Bathtub overflow corroded

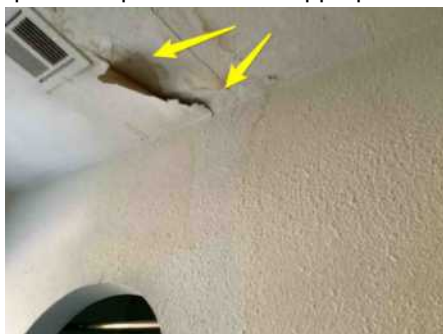
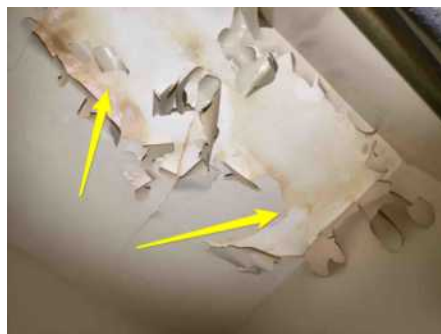
NR 71: Moisture damage noted to ceiling . No moisture was detected. We recommend further review and repairs by a qualified specialist in the appropriate trade.

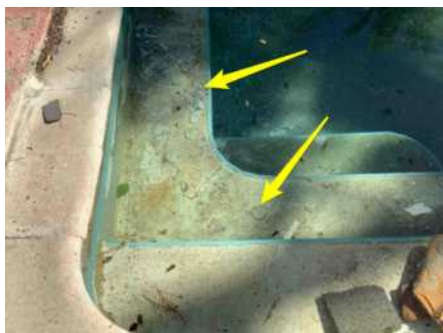
NR 72: Pool surface is worn through, re plastering is needed. We recommend the advice and services of a qualified Pool Contractor

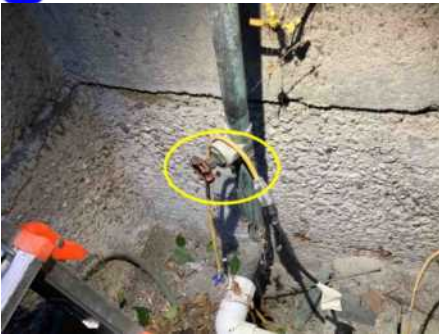
NR 74: Valve seized

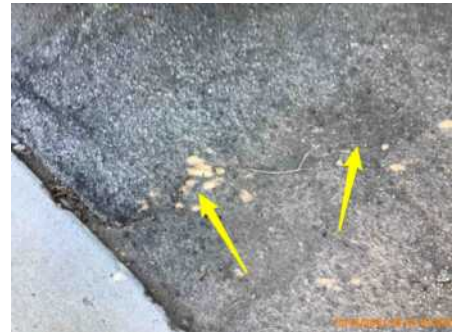
SC 75: Tripping hazards noted at driveway. We recommend further review and repairs by a qualified specialist in the appropriate trade.

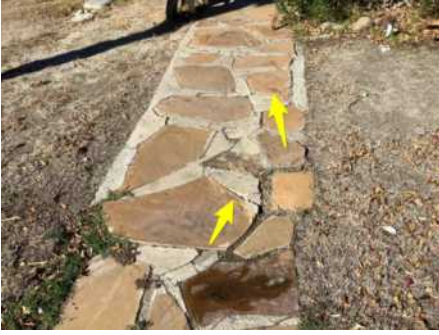
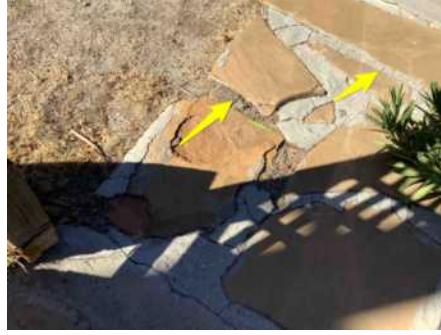
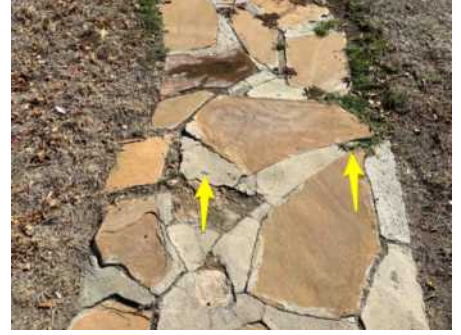
SC 76: Walkway surface is raised/settled, this has created a TRIP - HAZARD at front. We recommend further review and repairs by a qualified specialist in the appropriate trade.

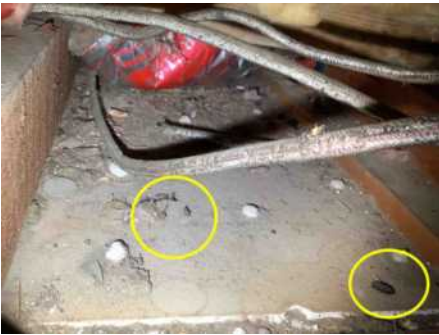
SC 80: I observed evidence of rodents in the attic. Ask the Sellers about the rodent history and/or contact a Pest Control Operator to further evaluate.

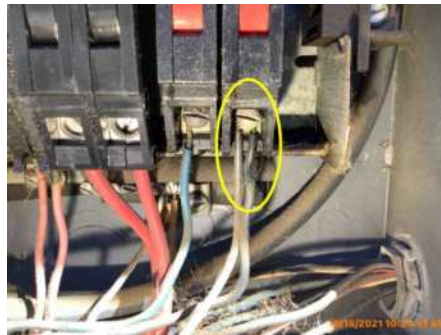
SC 81: Multiple wires are connected to a single lug on a circuit breaker where only one wire should be connected. Recommend further review and repair by qualified Electrical Contractor.

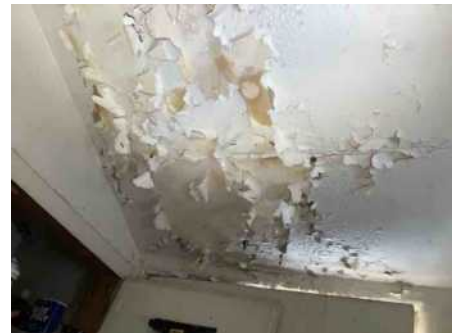
SC 99: Possible lead base paint in walls and ceilings, paint is peeling in several areas throughout home. We recommend further review and repairs by a qualified specialist in the appropriate trade.

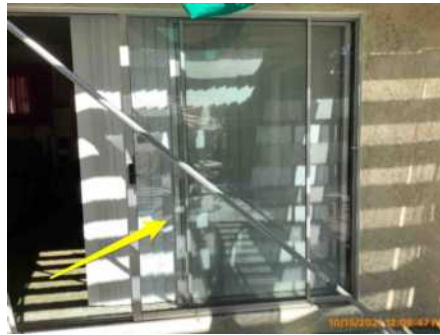
SC 101: Glass tempered markings are not visible at some exterior doors, replacement should be considered to all non tempered sliding doors and fixed windows. Fed law requires companies to replace none tempered glass doors. They are not allowed to repair them.

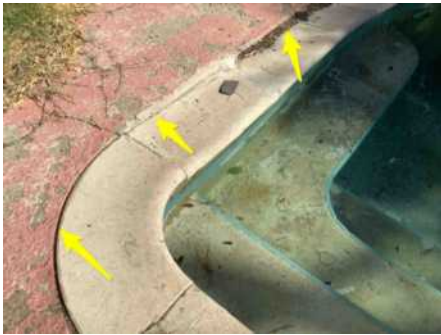
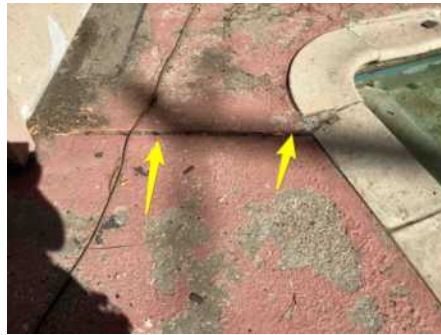
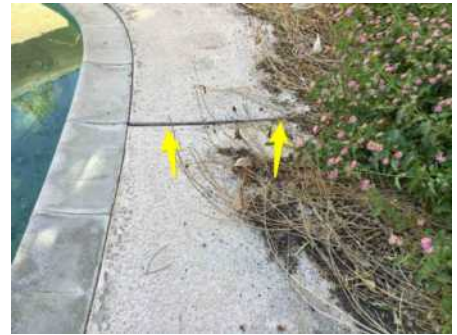
SC 110: The deck has cracked and lifted causing a trip hazard, We recommend further review and repairs by a qualified specialist in the appropriate trade.

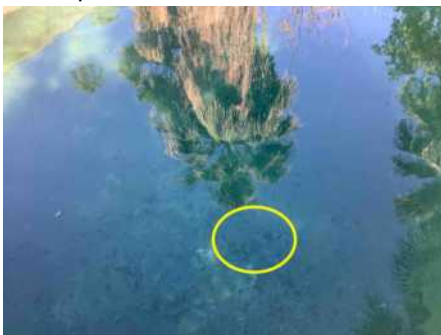
SC 111: Drain cover(s) are older type, recommend installation of a newer type vortex cover(s) and a safety vacuum release at the pool pump. This a major safety/entrapment hazard and the pool or spa should not to be used until repaired is complete. We recommend the advice and services of a qualified Pool Contractor.

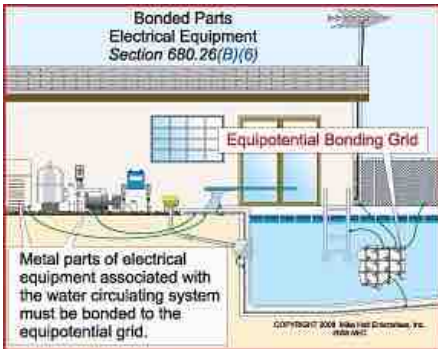
SC 113: External bonding of equipment frames is lacking at the pool pump(s) and the pool heater, All metal pool equipment needs to be bonded to a pool structure. Pool/Spa should not be used until full bonding of the pool system is completed due to the possibility of electrocution. We recommend the advice and services of a qualified Pool Contractor

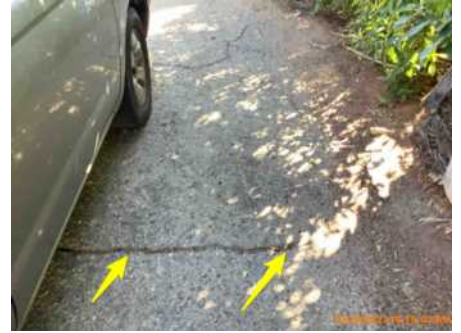
RM 118: Cracks noted to driveway, We recommend further review and repairs by a qualified specialist in the appropriate trade.

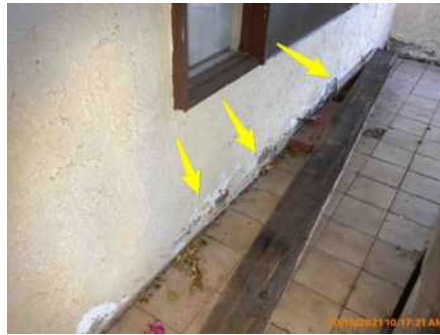
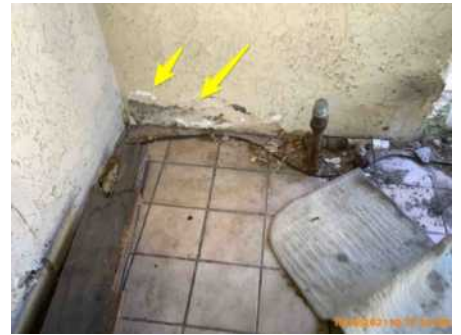
RM 119: Damaged stucco noted at front

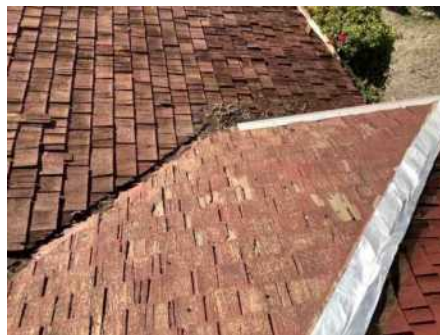
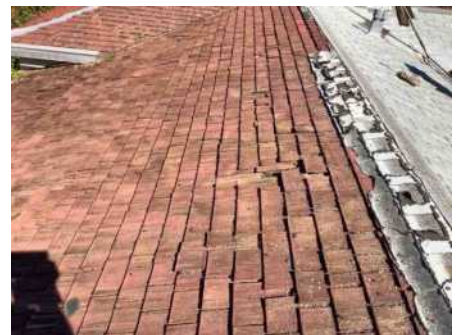
RM 120: The only way to determine whether a roof is absolutely water tight is to observe it during a prolonged rainfall. Many times, this situation is not present during the inspection. Recommend asking the seller for further information on the roof and if they have had any leaks or modifications. Recommend roof be evaluated and certified by a qualified Roofing Contractor.

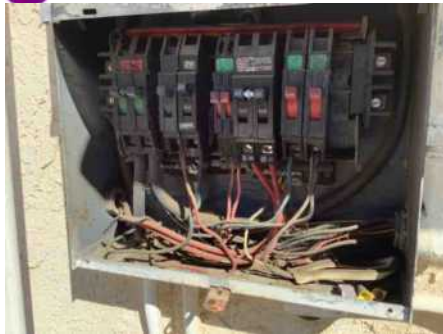
RM 129: Dead front cover was missing , could not verify, recommend verifying breaker size is correct

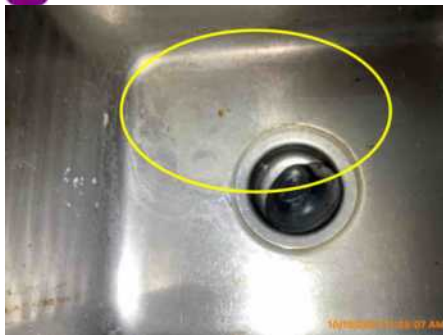
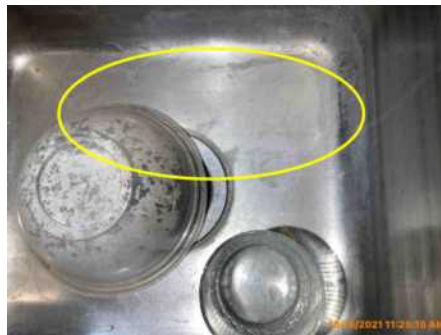
RM 131: Sink stained

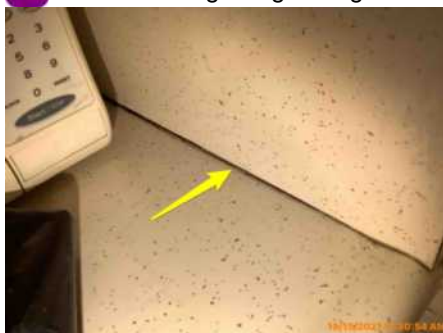
RM 132: Caulking / re grouting needed at backsplash

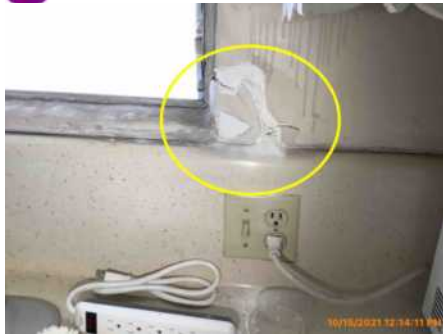
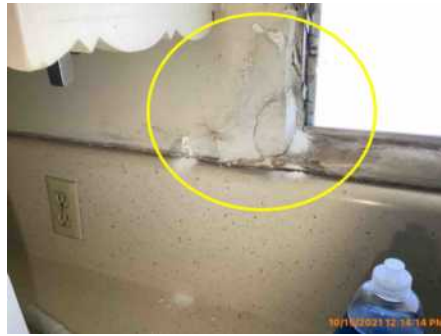
RM 133: Damage noted to wall at near window

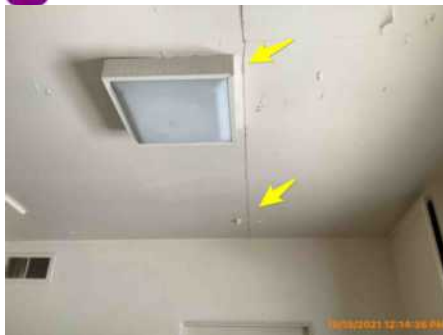
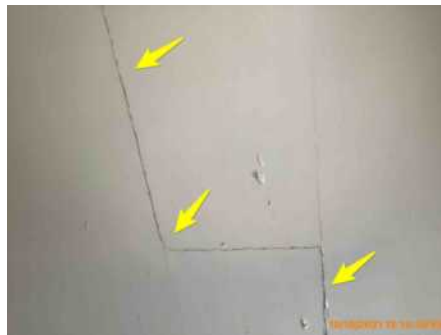
RM 134: Crack noted at ceiling.

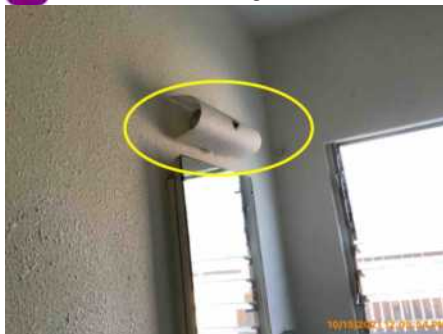
RM 135: Bathroom light did not work

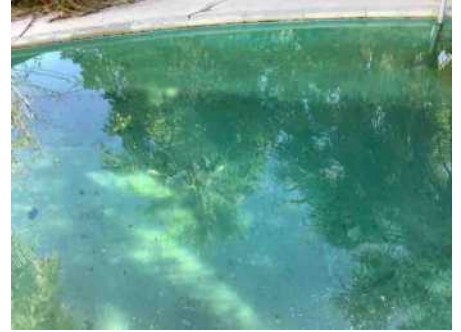
RM 139: Pool was extremely dirty, could not fully inspect surface, recommend further review after pool is cleaned.

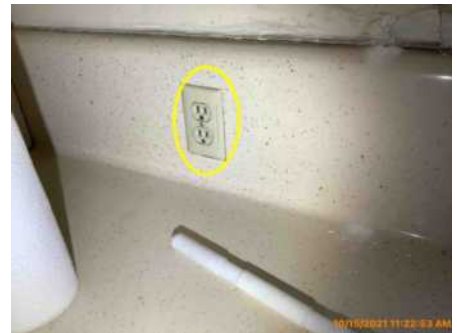
UG 148: All Kitchen receptacles should be GFCI Protected, GFCI protected receptacles were only required by water, the new standard is every receptacles in the Kitchen should be GFCI protected for your safety, installation recommended to all unprotected receptacles, Recommend further review and repair by qualified Electrical Contractor.
