## **Famosa Terrace SB-326 Inspections**

**2828 Famosa Blvd  
San Diego, CA 92107**

**Date: November 18, 2024**

RE: **Famosa Terrace (First Inspection Cycle)**  
**2828 Famosa Blvd, San Diego, CA 92107**  
**SMR Project Number: LGL-24-045**

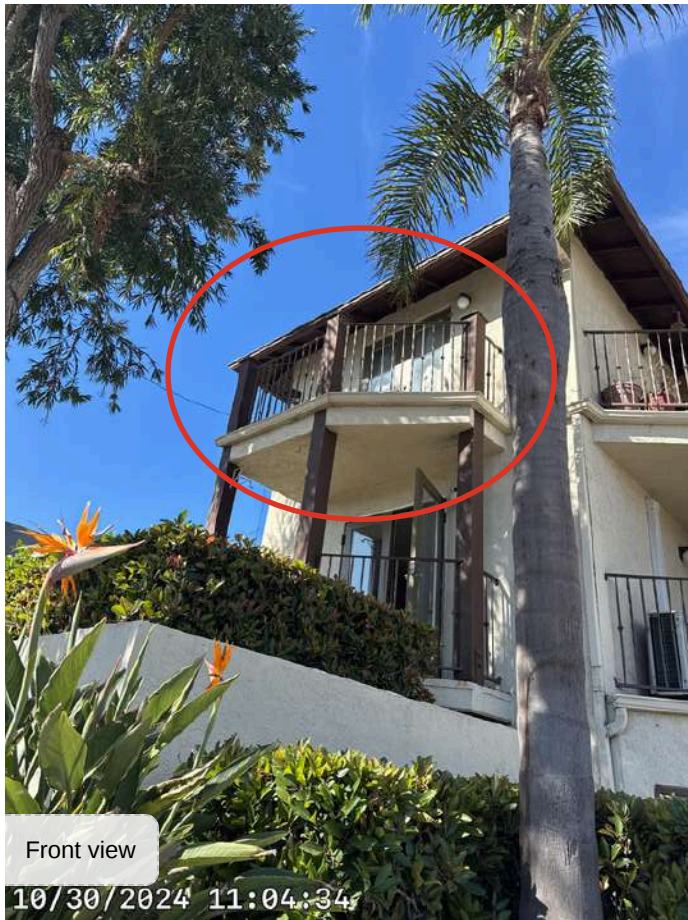
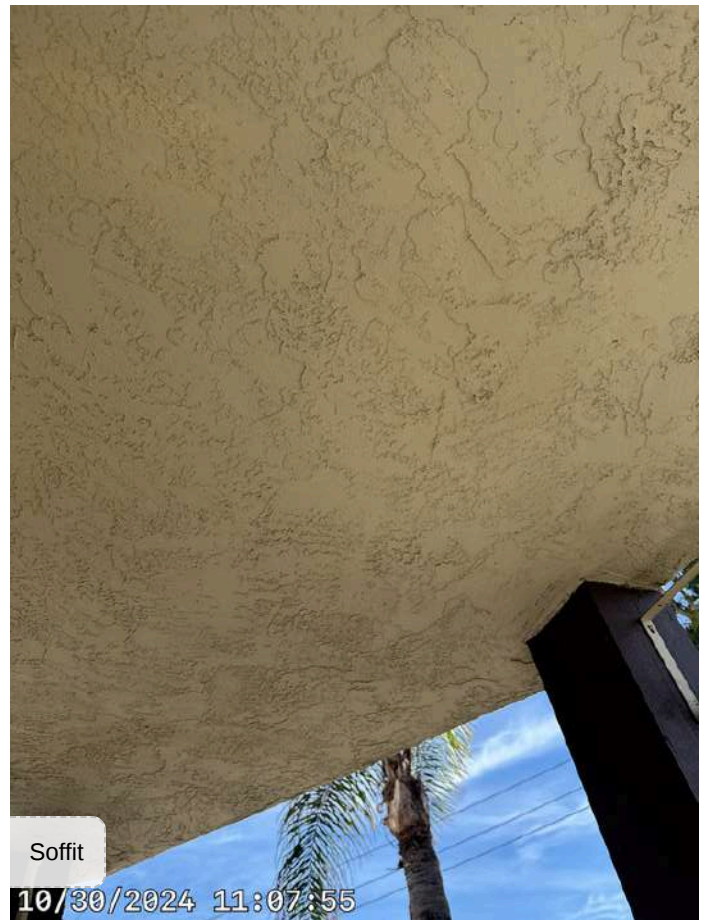
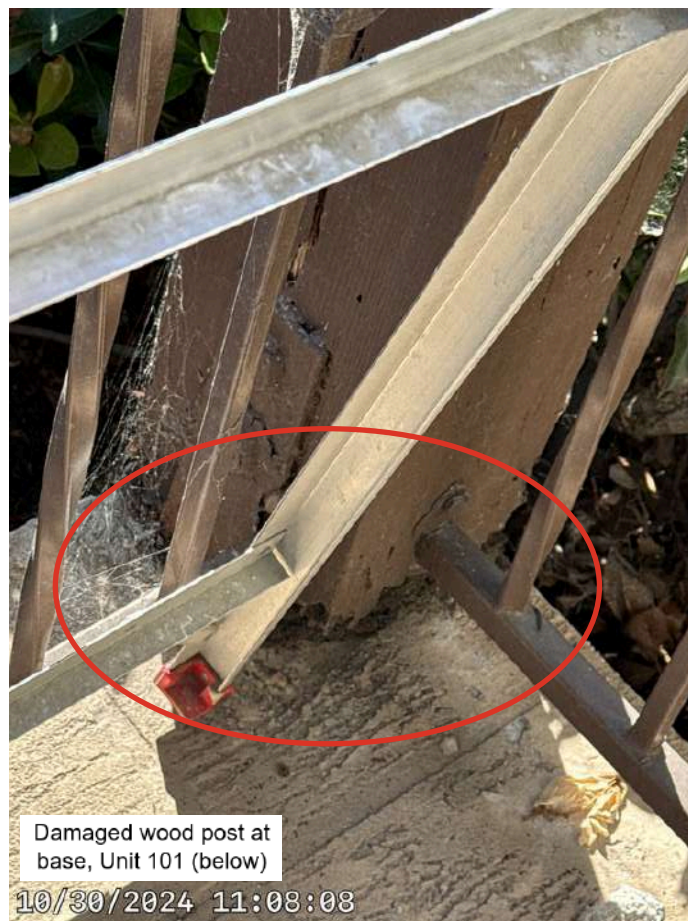
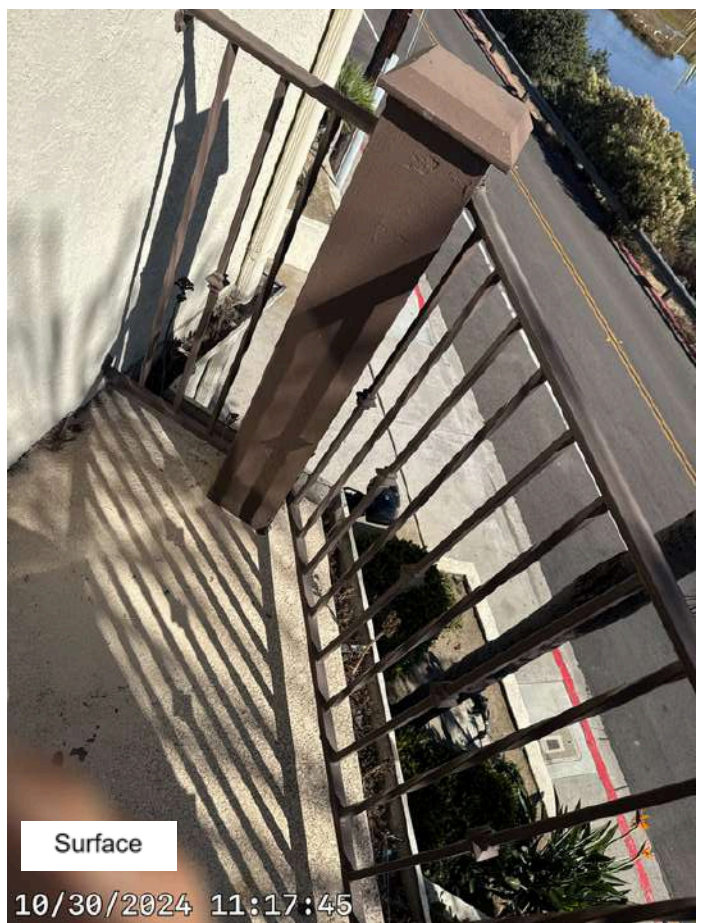
| Framing Remarks | Damage to wood posts at balcony below |

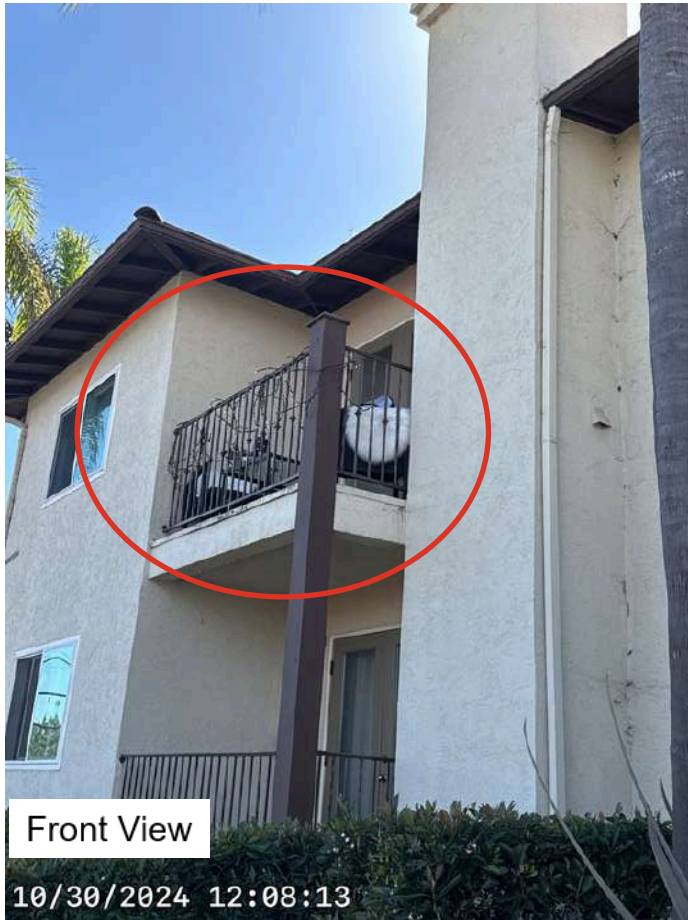
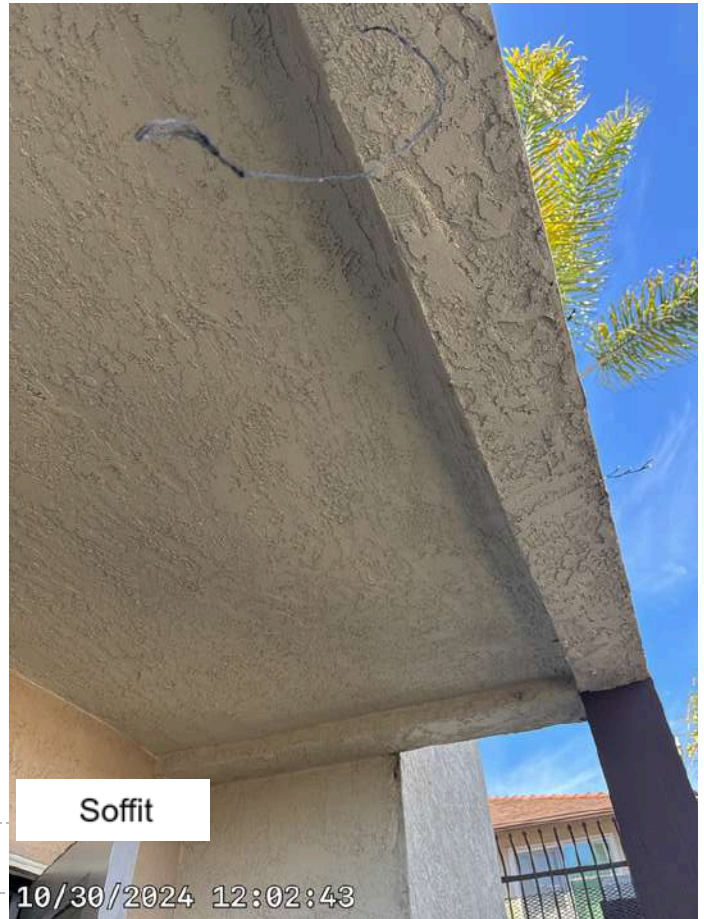
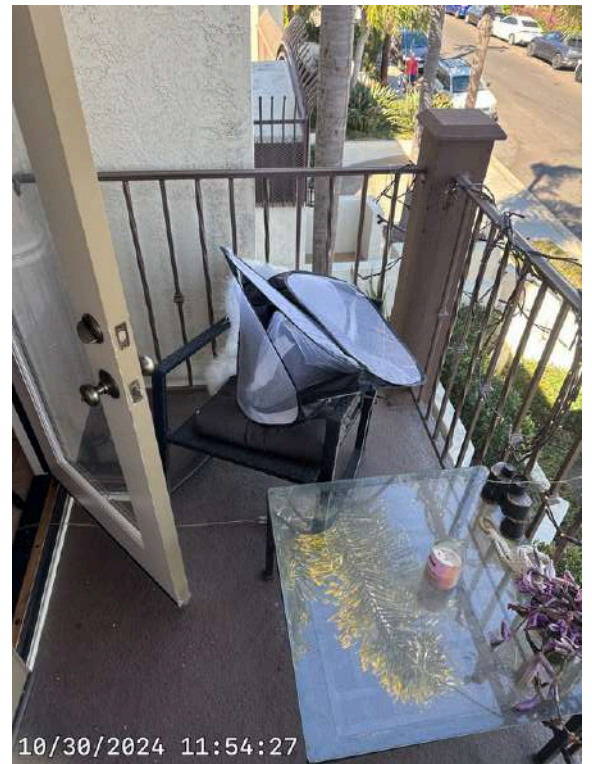
| Framing Remarks | Wood rot on patio below post |
| Guardrail Remarks | Right attachment is slightly loose |

- **Guardrails:** Loose guardrail attachments were observed at units 201 (front balcony) and 209, incapable of safely supporting required loads. Residents are urged to avoid using these guardrails until necessary repairs are carried out.

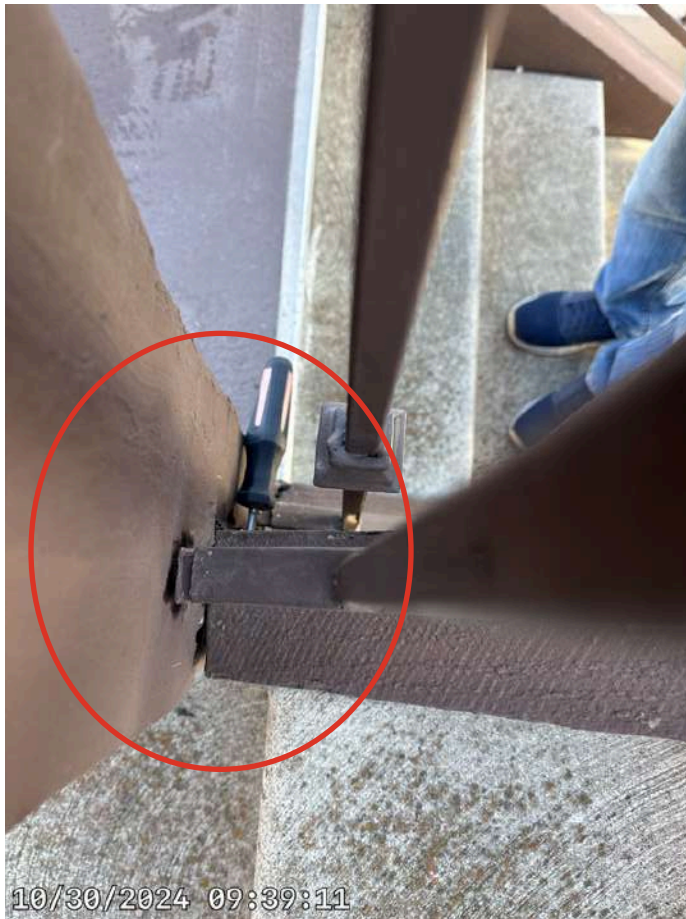
Damage to wood post

- **Wood Posts:** Most of the wood posts supporting the stairs, walkways and balconies near units 201 and 209 were observed to have wood rot/damage and be deteriorating. It is advised to hire a qualified contractor to replace the affected wood and provide repair or replacement recommendations.

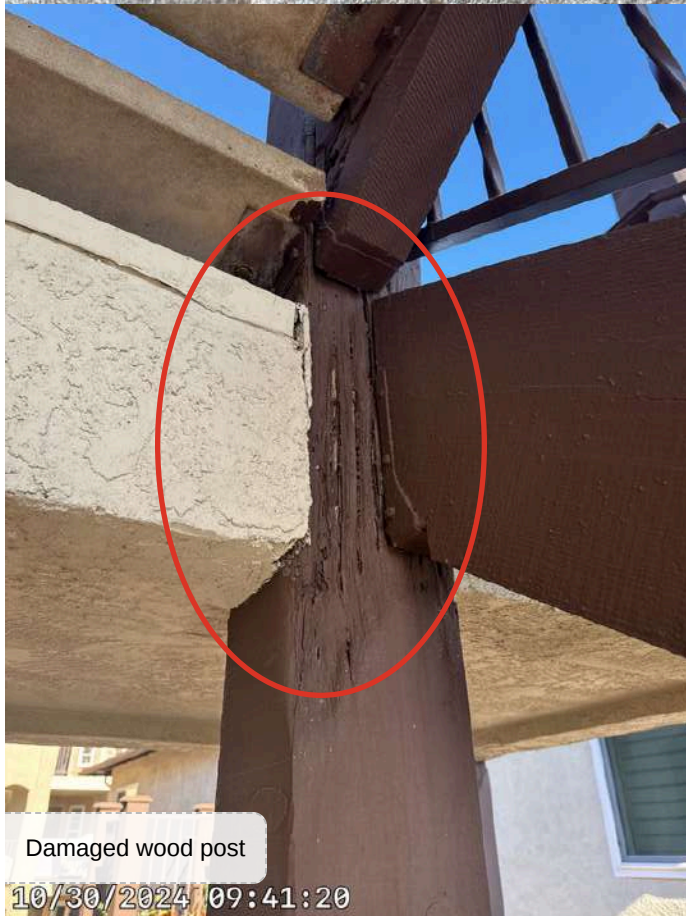
Damaged wood post

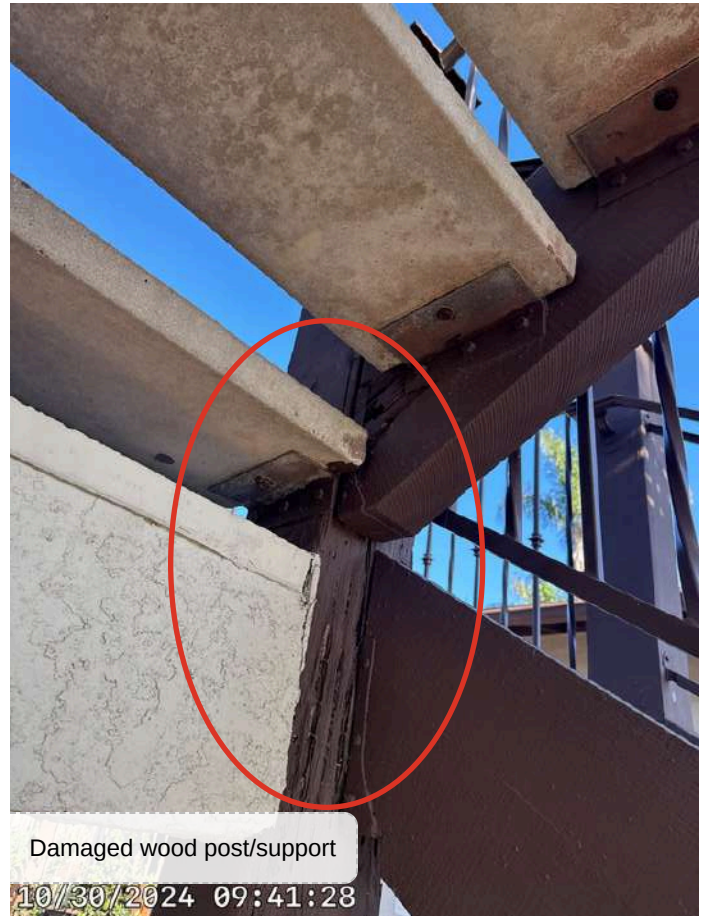
Damaged wood post/support

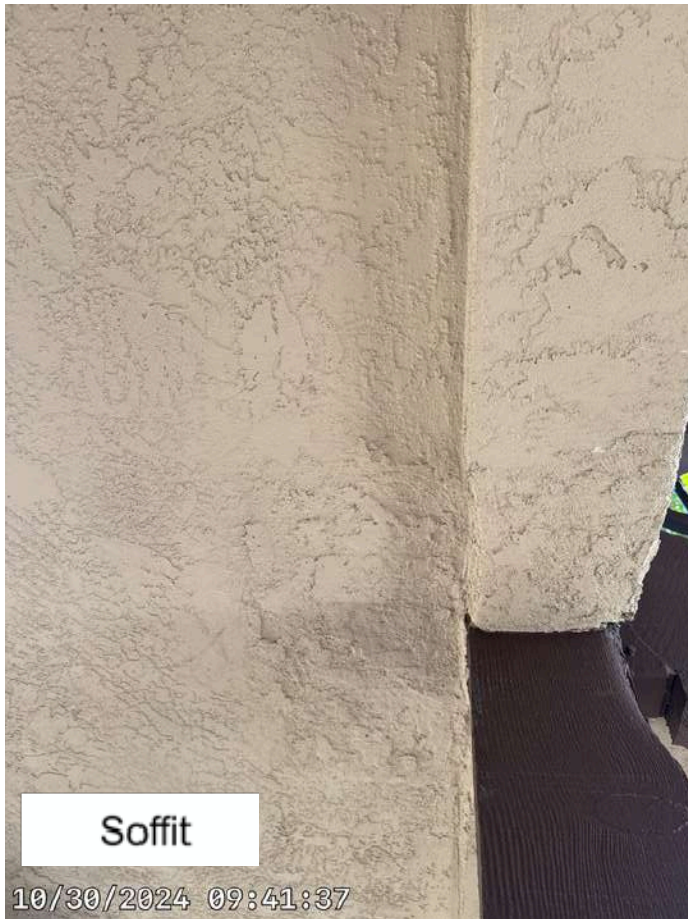
| Framing Remarks | Water intrusion observed on second and third landing framing as well as wood rot/deterioration on almost all stair posts. |

Evidence of Moisture

- **Evidence of Water Intrusion:** Water intrusion has been observed in the wood framing of the top and middle stair landings near units 201, 209, and 210, as well as along the third-floor walkway near units 201 and 203. The full extent of the damage is not yet determined. It is recommended to engage a qualified contractor to assess and replace the affected wood framing and to address any waterproofing deficiencies.

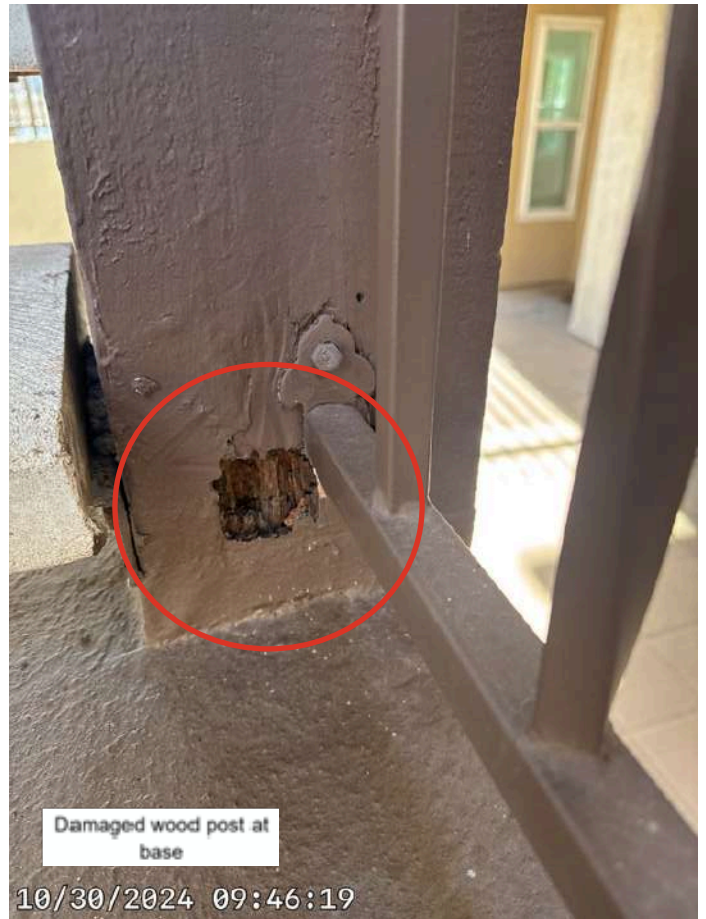
Wood Rot

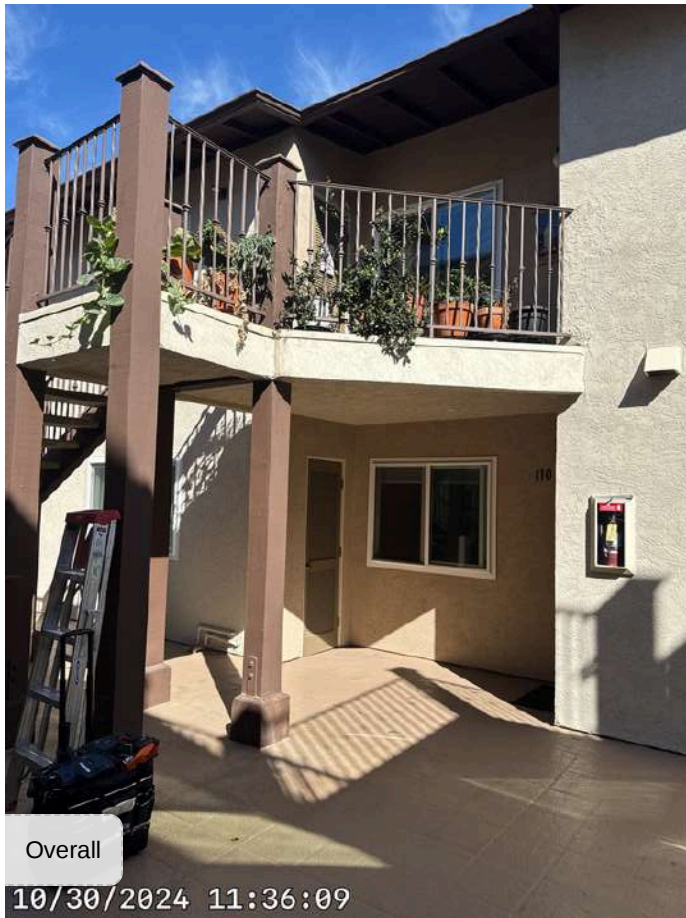
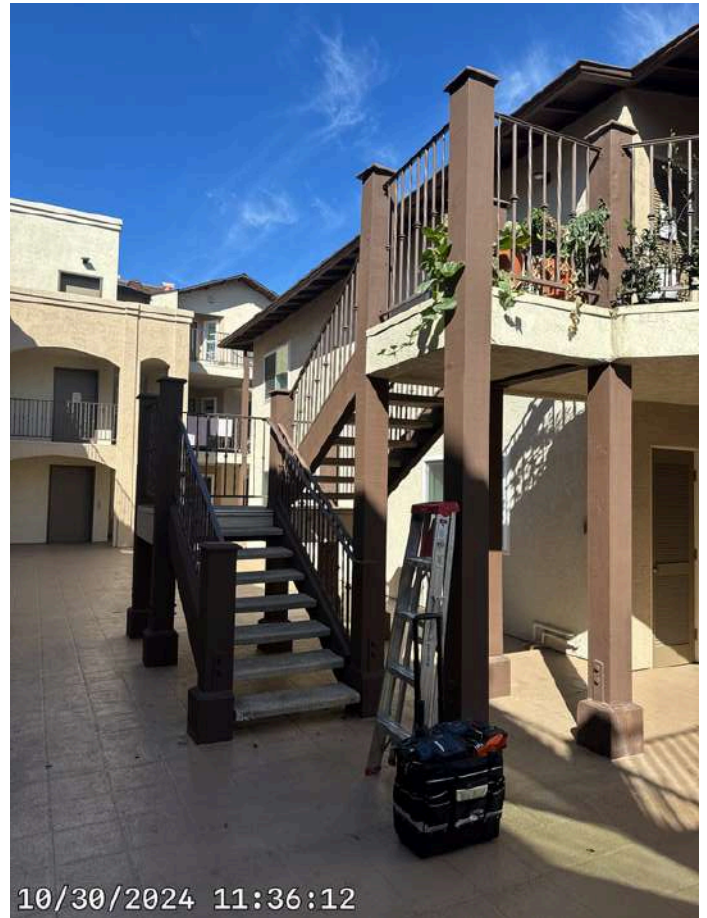
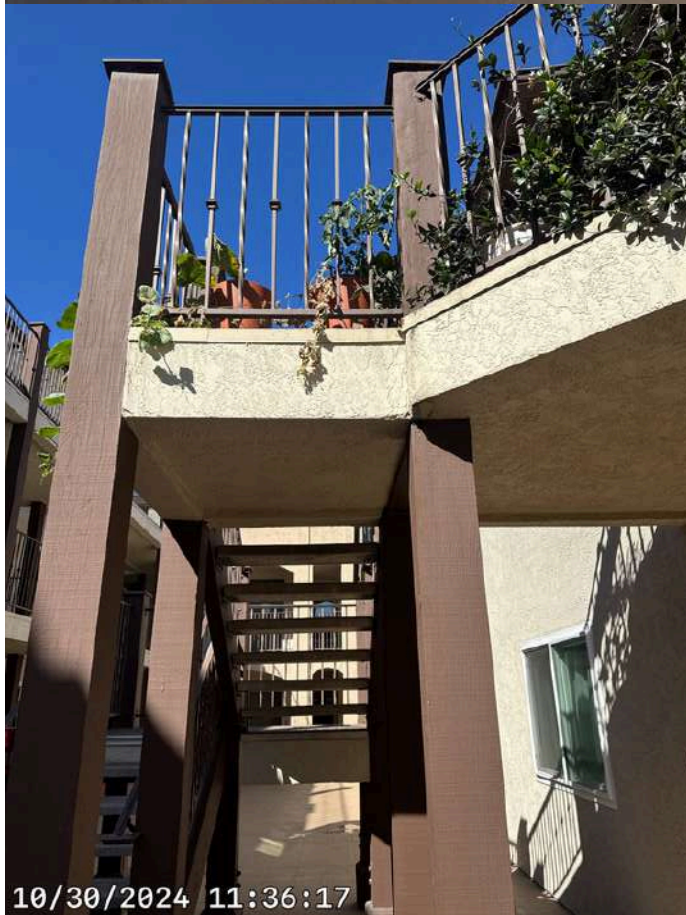
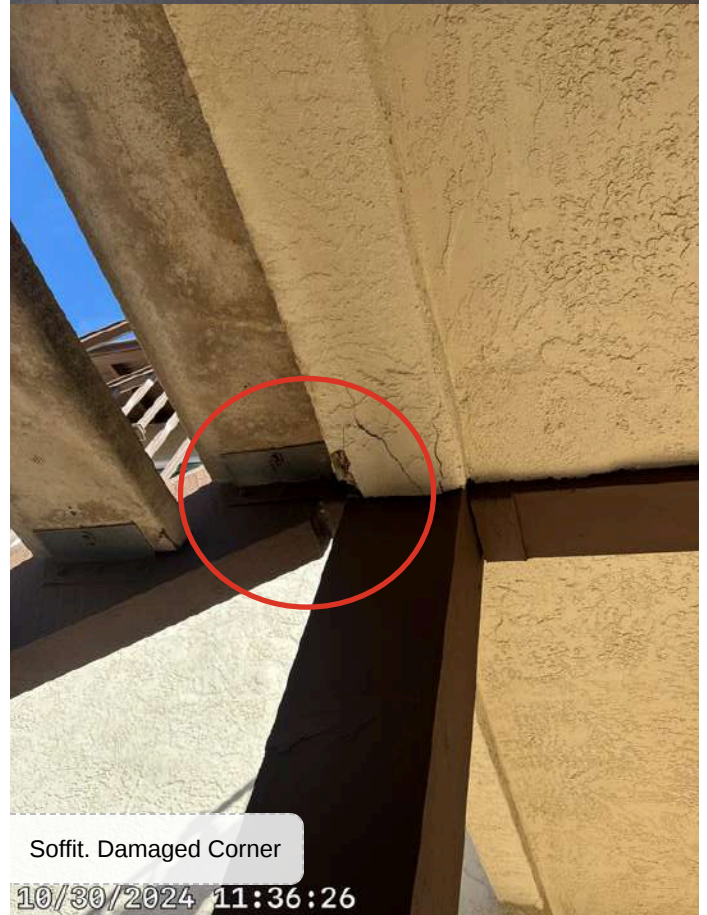
| Framing Remarks | Damaged wood posts |

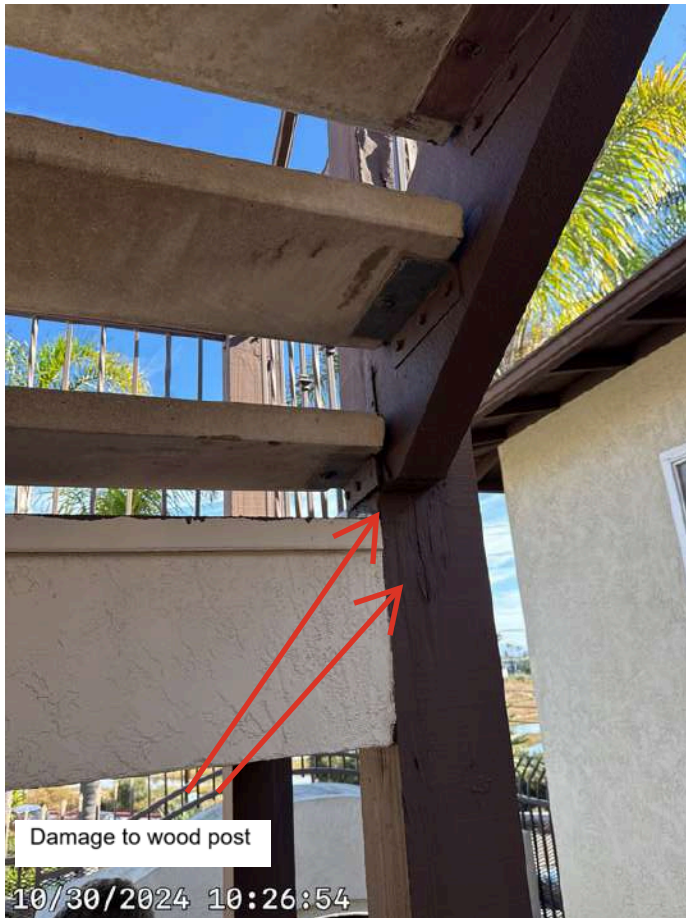
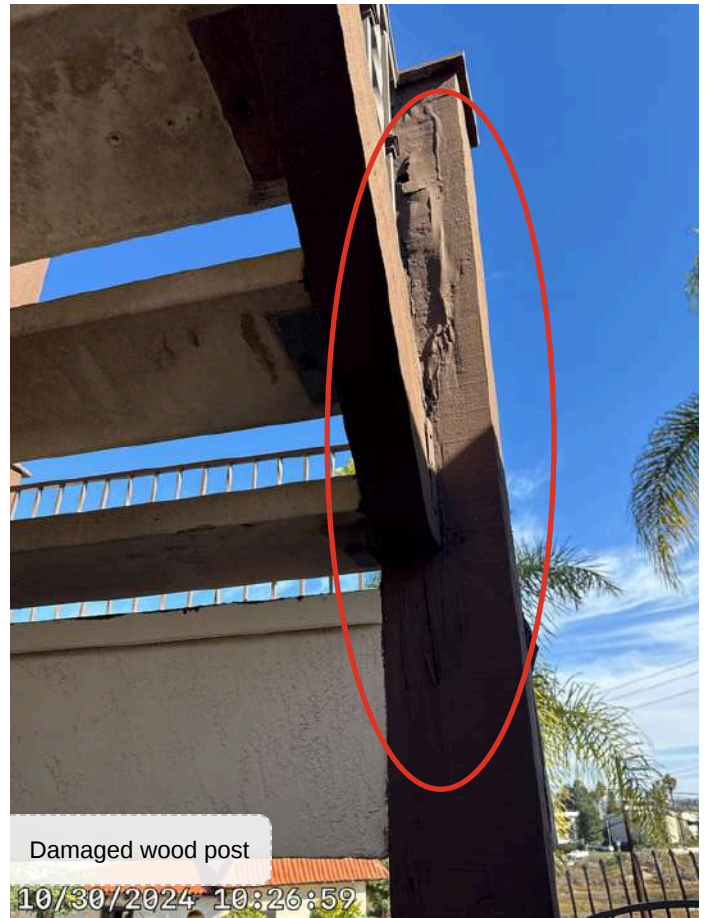
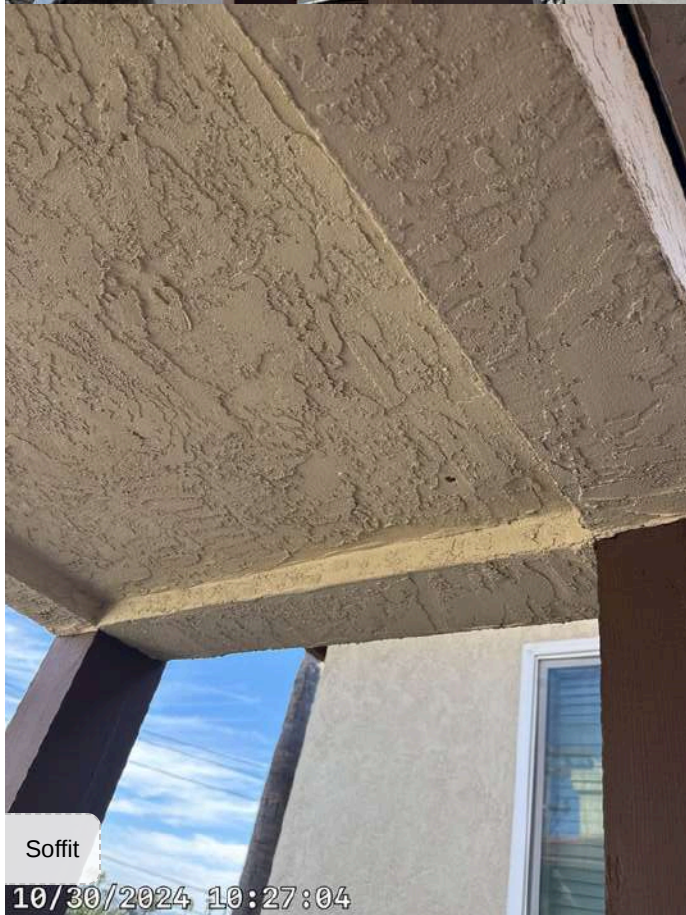
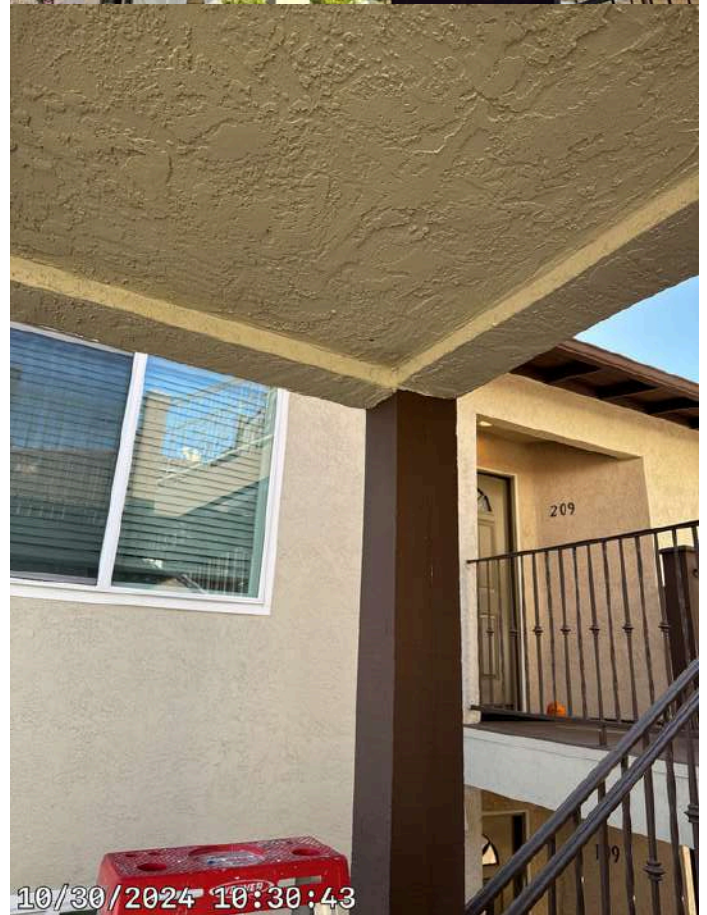
| Framing Remarks | Damaged wood posts |

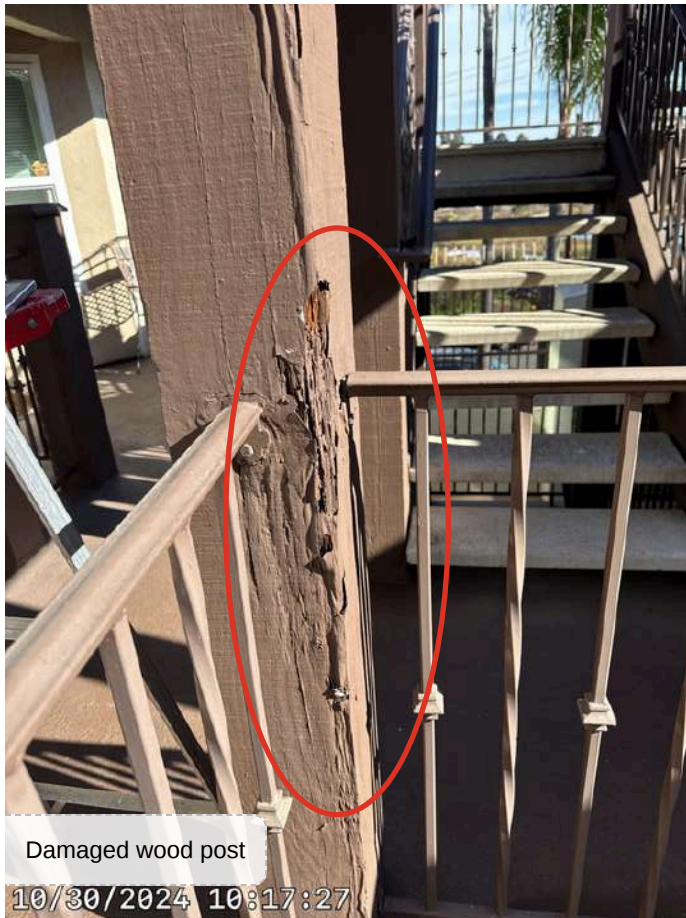
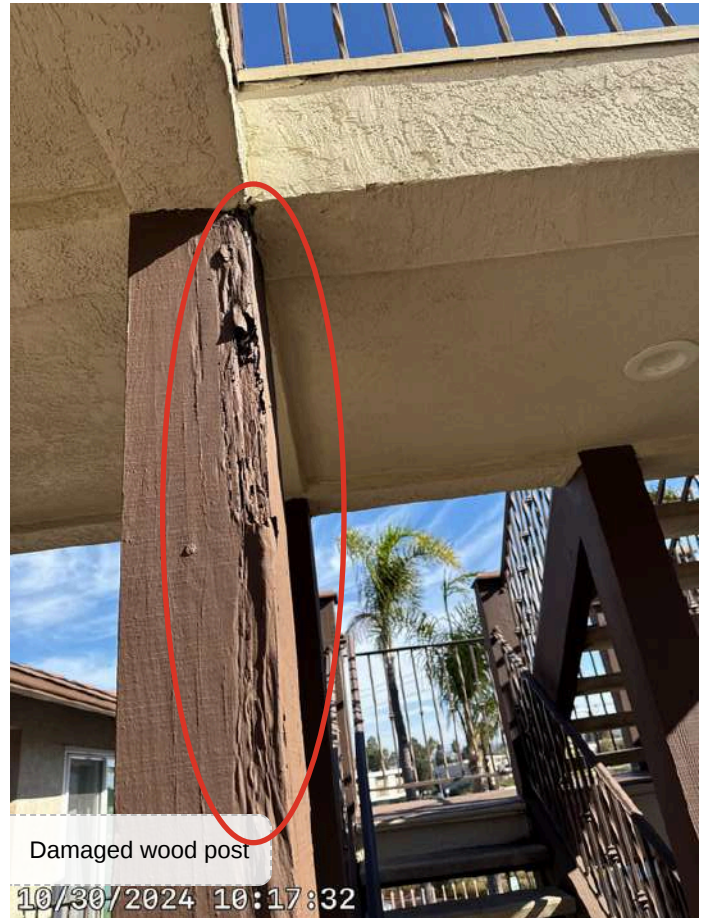
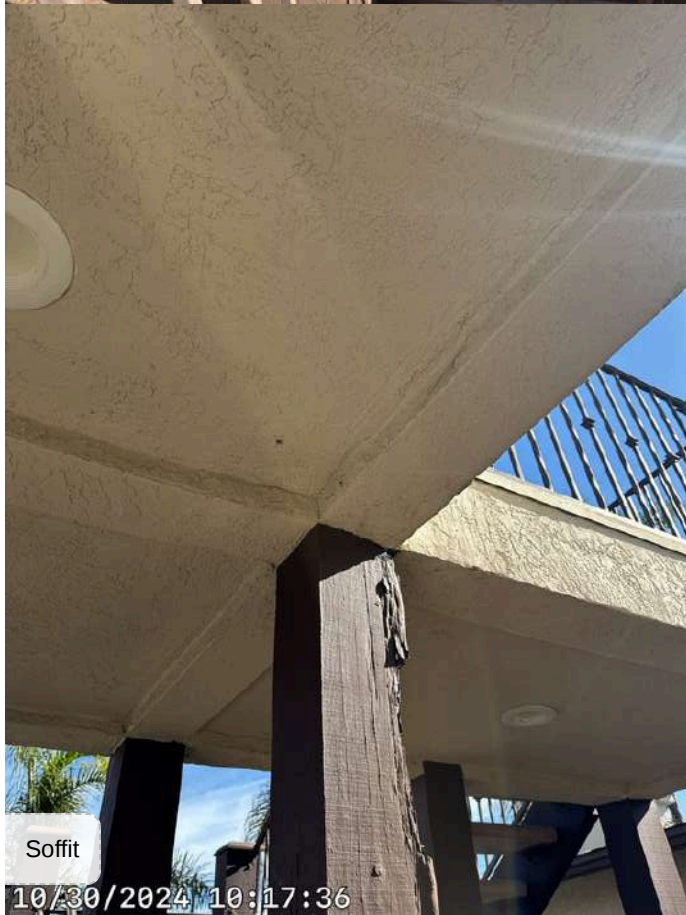
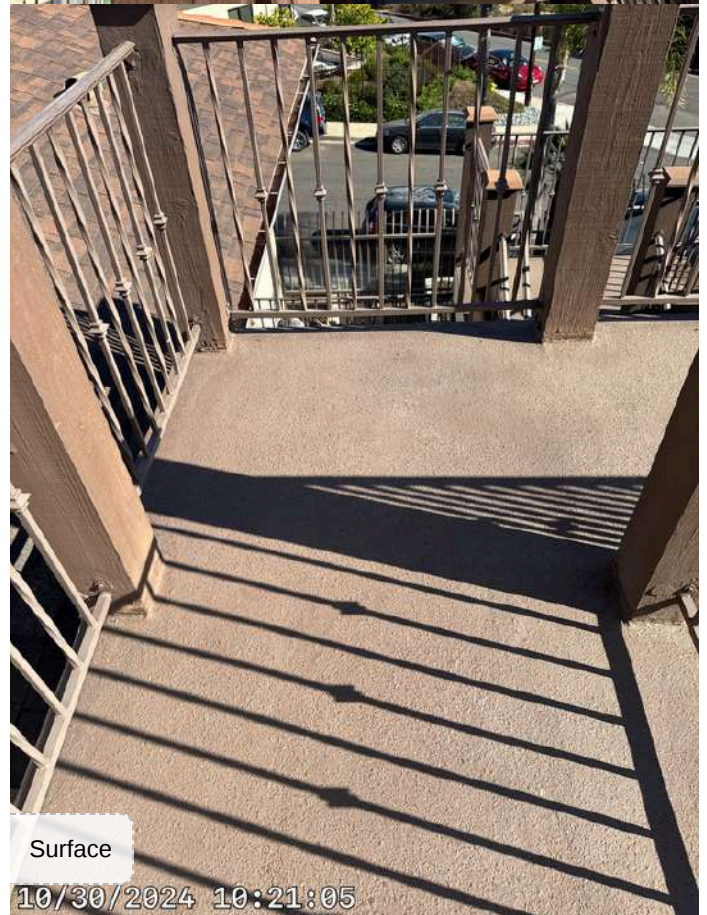
| Framing Remarks | Wood rot/deterioration in stair posts |

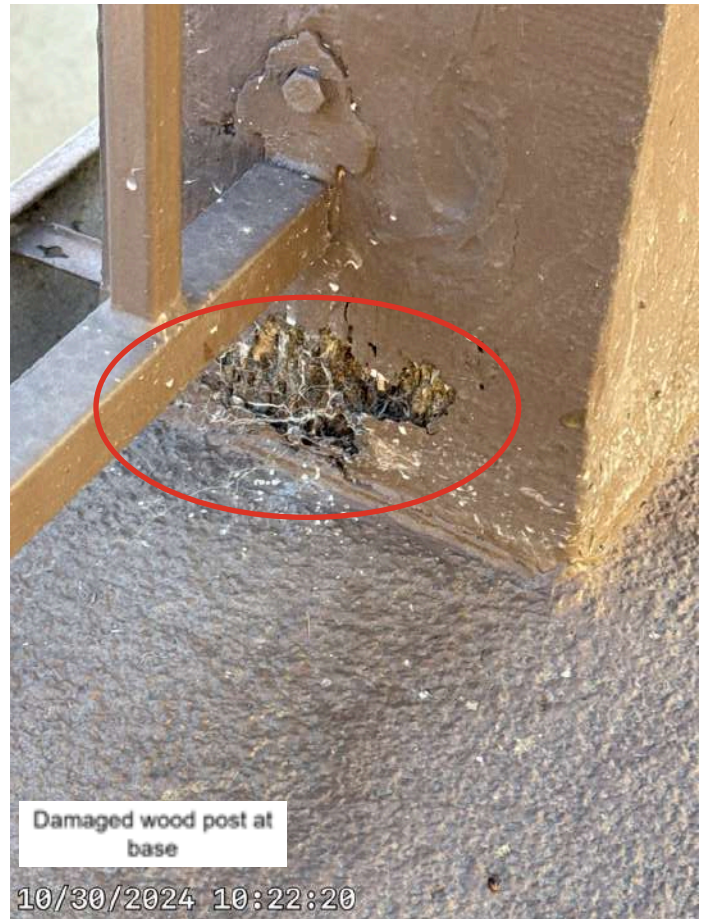
Damaged wood post at base

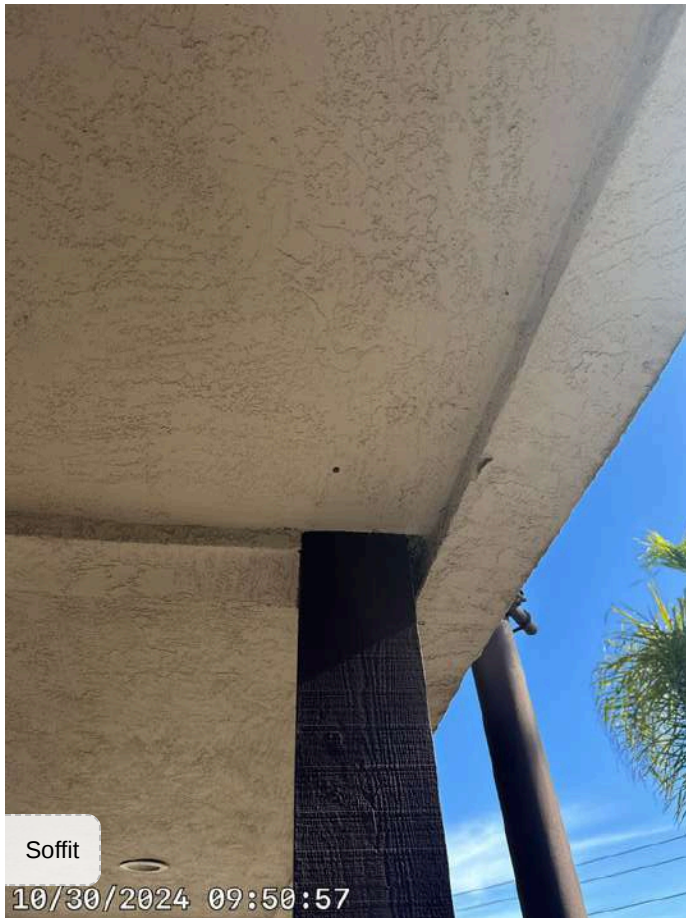
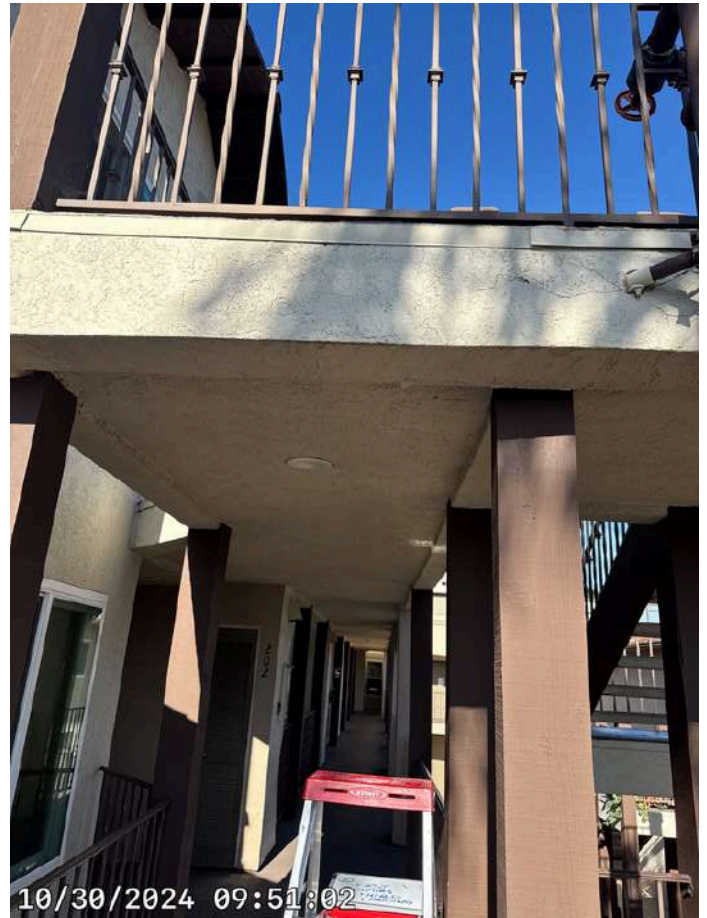
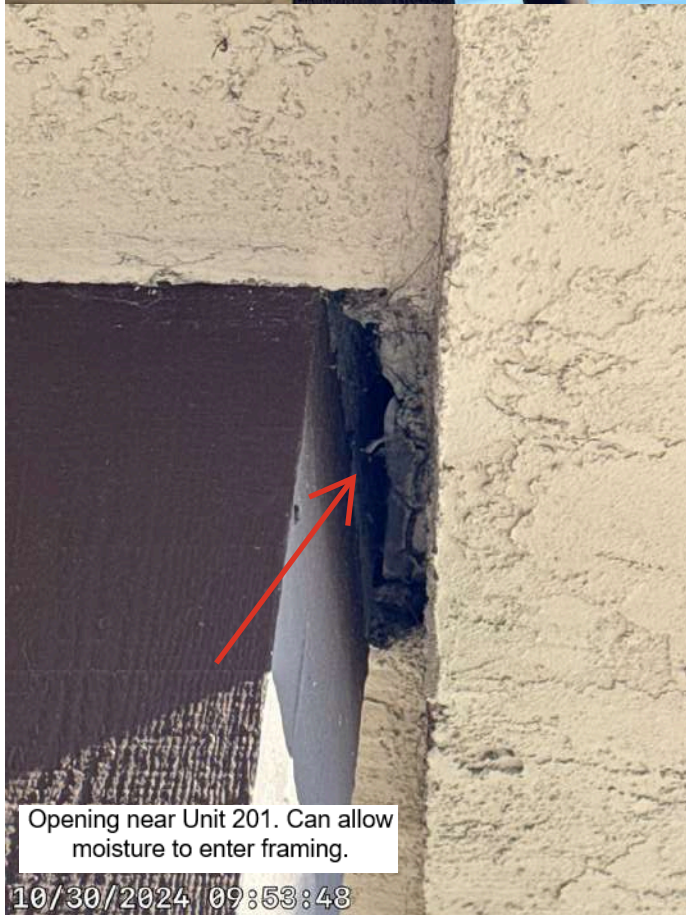
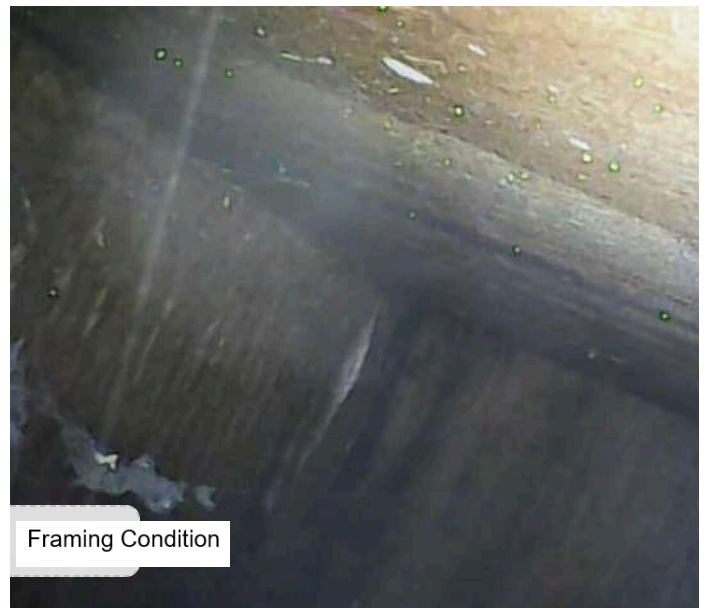
| Framing Remarks | Water intrusion observed |
