## Henry Andrew Schmidt

5350 Lehrer Dr  
San Diego, California 92117

Chris Dembroski NACHI10071406  
Smart Home Inspection  
(619) 846-5737  
chris@smarthomeinspection.net  
5582 Forbes Ave  
San Diego, CA  
92120  
[www.smarthomeinspection.com](http://www.smarthomeinspection.com)

Tuesday  
September 15, 2026

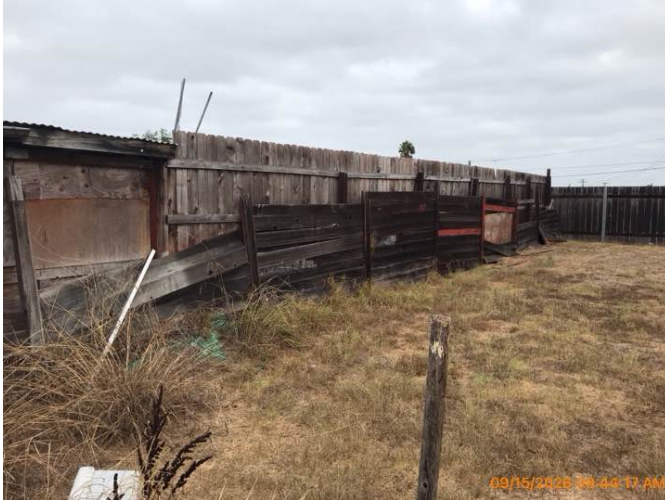
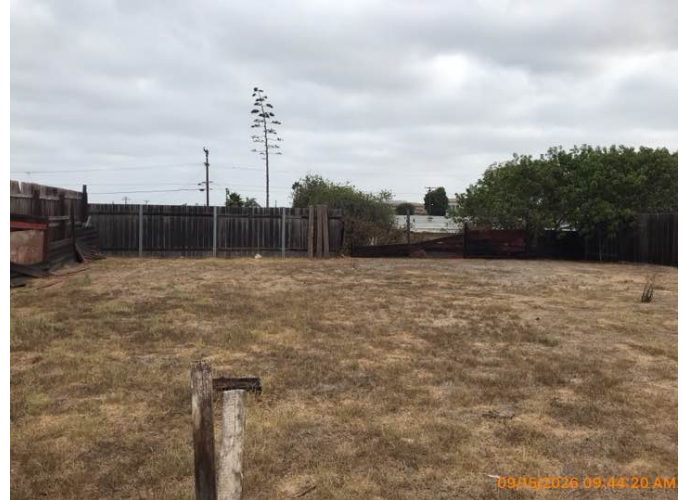
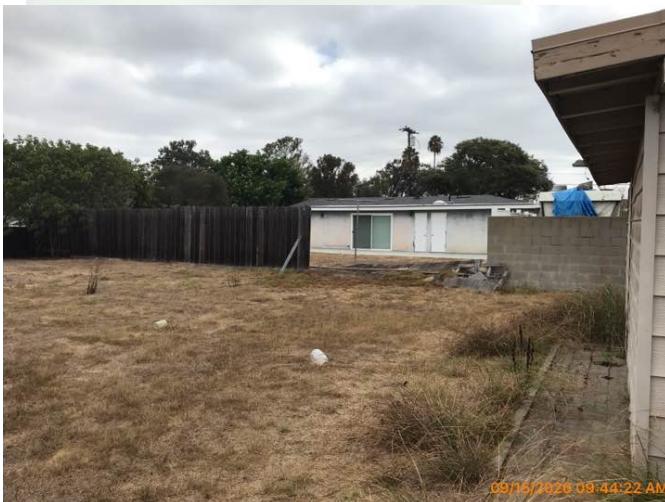
**R 30:** There is major damage to the fencing. We recommend the fencing be repaired and/or replaced.

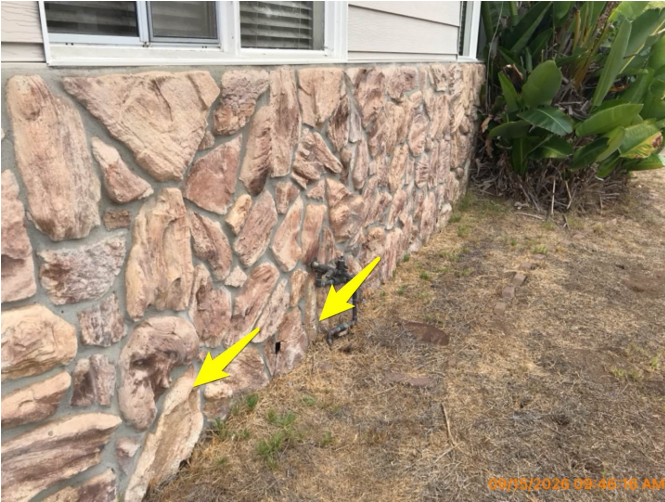
**R 33:** In this case, the veneer has pulled away from the building and/or has become unbonded from the wood frame. This is largely an aesthetic consideration, but we recommend sealing or covering gaps to prevent moisture and pest penetration.

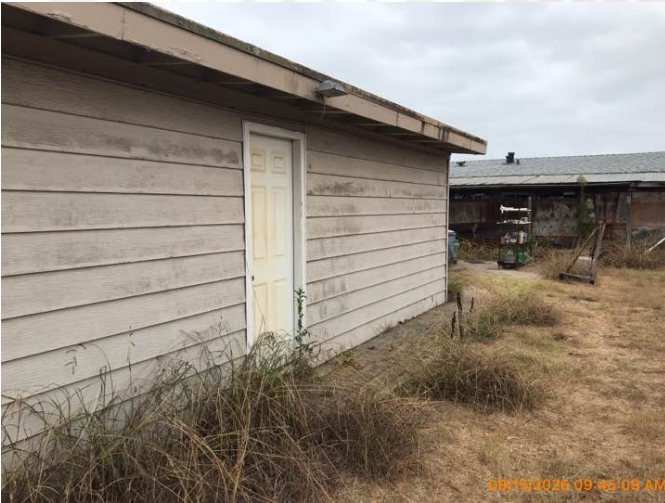
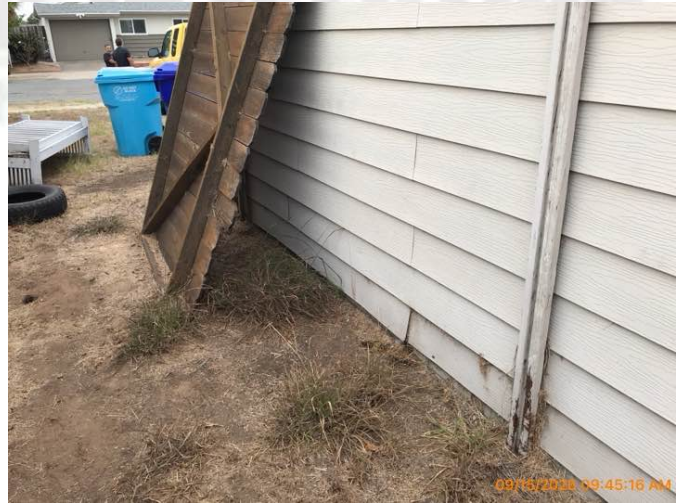
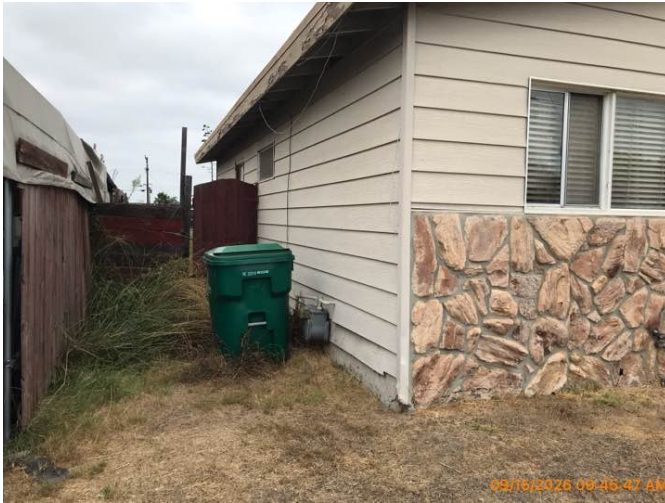
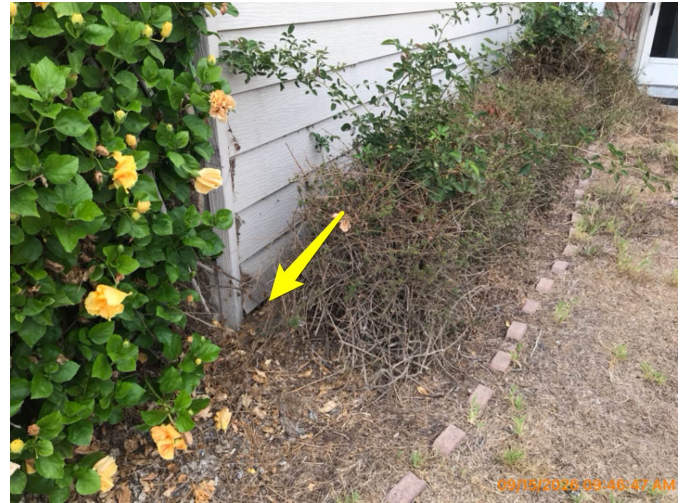
**R 35:** Sections of the aluminum siding at multiple locations are damaged. We recommend they be repaired or replaced.

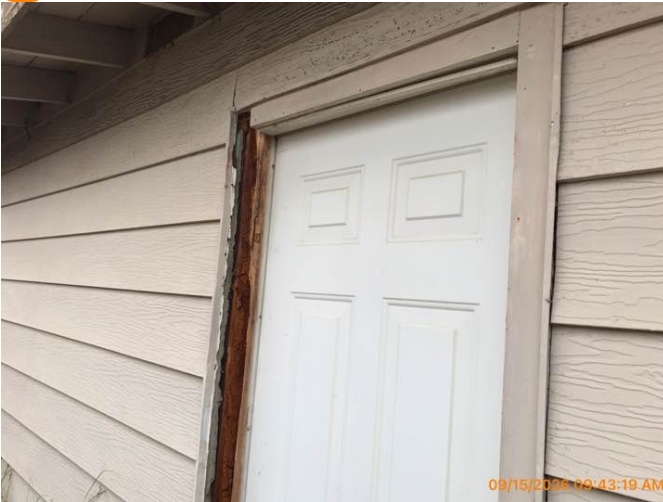
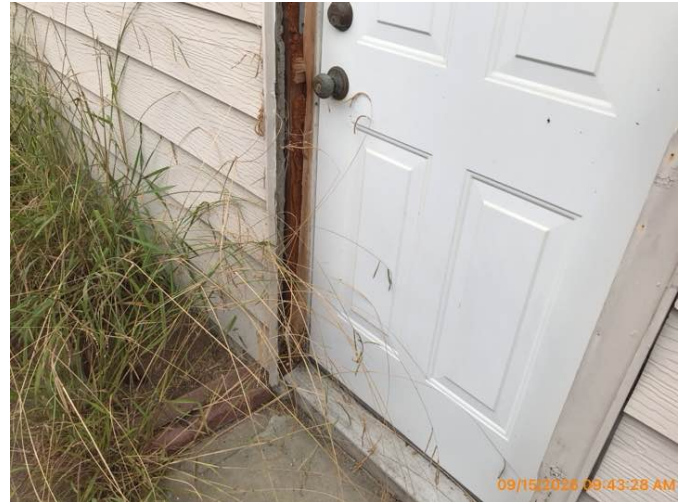
**R 43:** The trim at the side door is damaged. We recommend it be repaired or replaced.

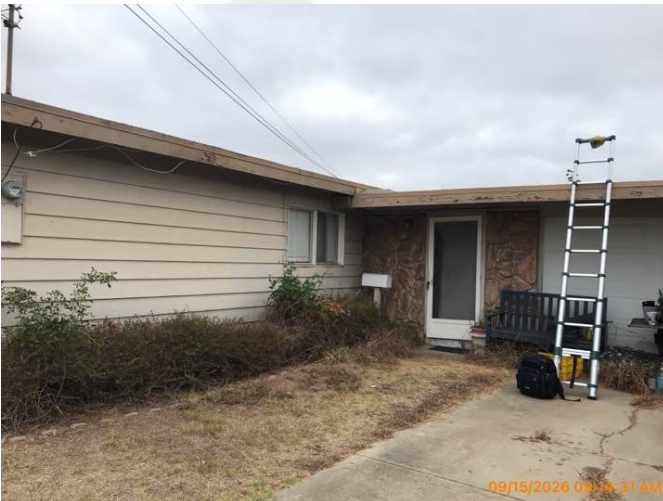
**M 44:** Portions of the fascia are weathered, with blistered and/or peeling paint. This will require surface preparation and refinishing in the course of routine property maintenance to restore surface appearance.

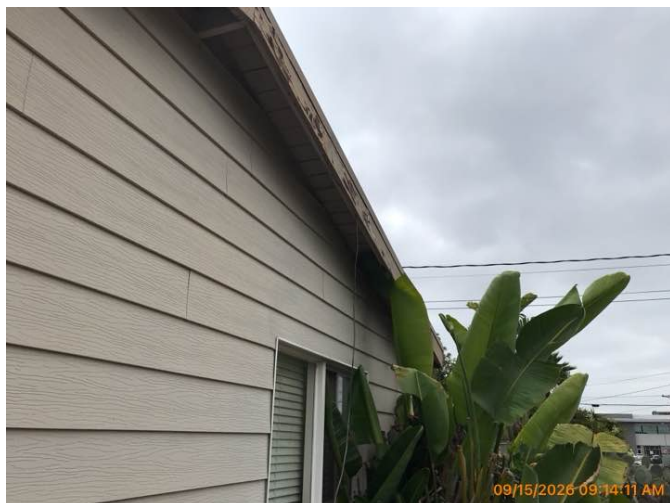
**M 47:** Peeling paint on the soffits may indicate insufficient ventilation and internal damage. We recommend further evaluation of the internal condition of the soffits.

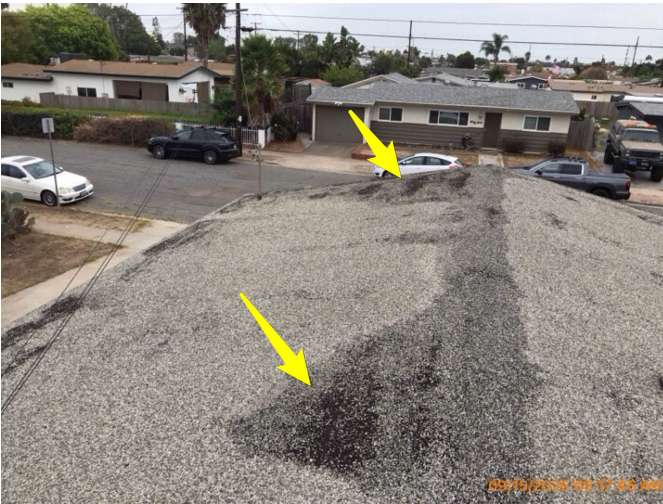
**R 87:** There are splits, and tar build up under the gravel surface. Further evaluation by a roofing professional is suggested.

**88:** For a further evaluation of roofing conditions, cost estimates and/or corrective repair, we recommend that a licensed roofing contractor be retained.

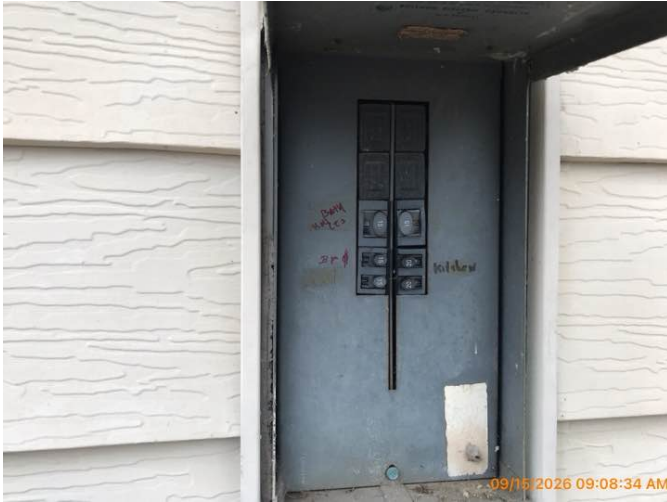
**W 117:** The Bulldog Pushmatic electric panel, which has been known to be problematic. The breaker system has been known to have poor circuit breaker connections and over heating breakers not properly tripping. It is advised that the panel be further evaluated by electrician due determine any need for repairs or replacement.

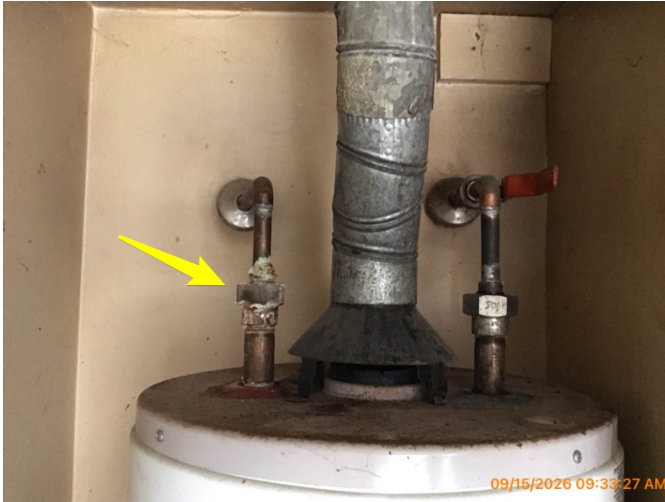
**R 165:** The water connections are heavily corroded and show signs of previous leakage. We recommend replacement or repair.

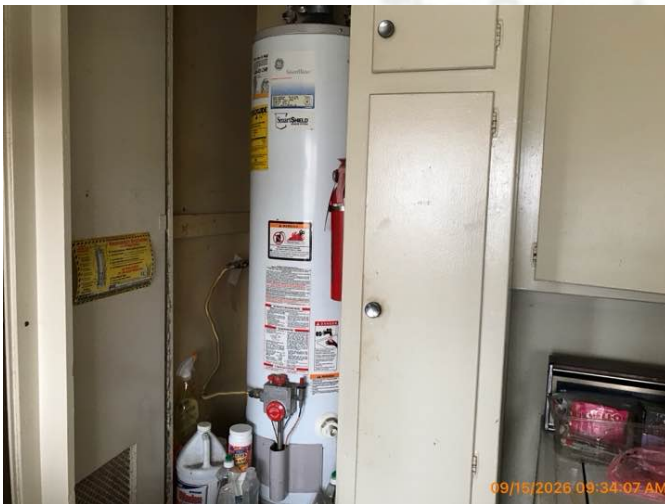
**R 168:** The water heater tank lacks seismic restraint. As an upgrade, we recommend that the water heater be secured to help limit damage and provide a source of usable domestic water in the event of a major earthquake.

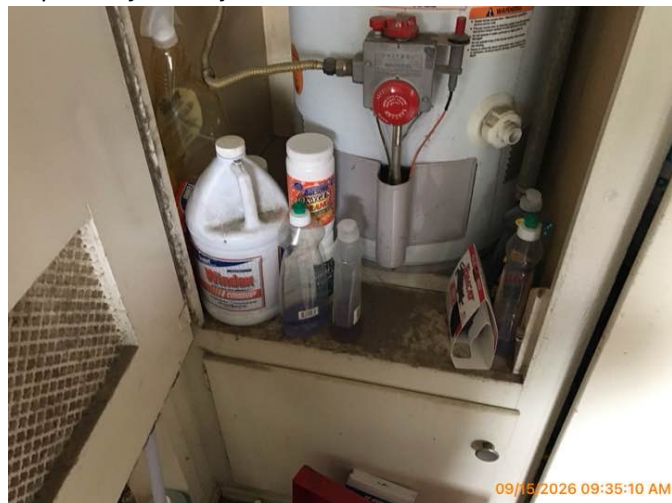
**U 175:** There is no metal pan under the water heater to catch and divert any dripping water to the exterior. This is required by some jurisdictions for water heaters in this location. We suggest installation of such a pan be considered.

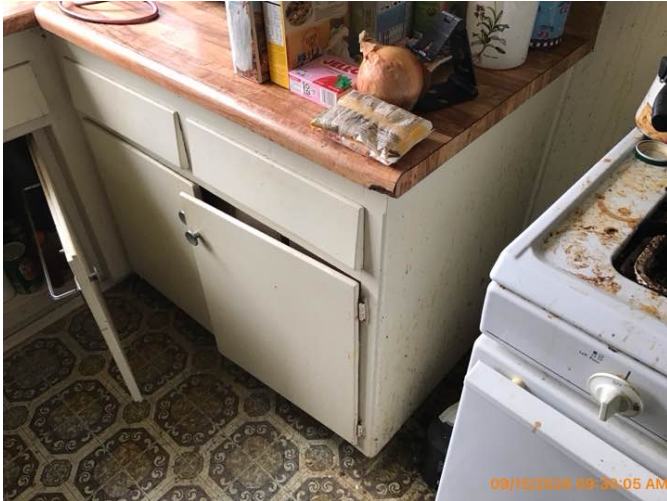
**268:** The countertop is damaged. We recommend it be replaced.

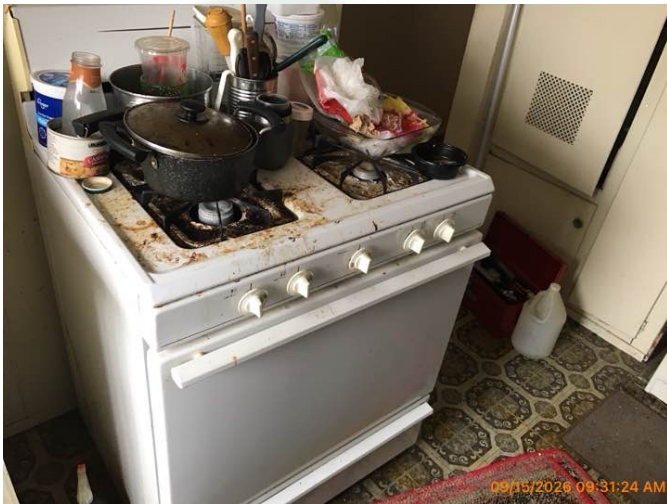
**W 271:** The range could not be fully evaluated because of its condition. After a thorough cleaning, we recommend testing and adjustment of all the various functions.

**R 272:** The range has areas of surface damage and repair is needed.

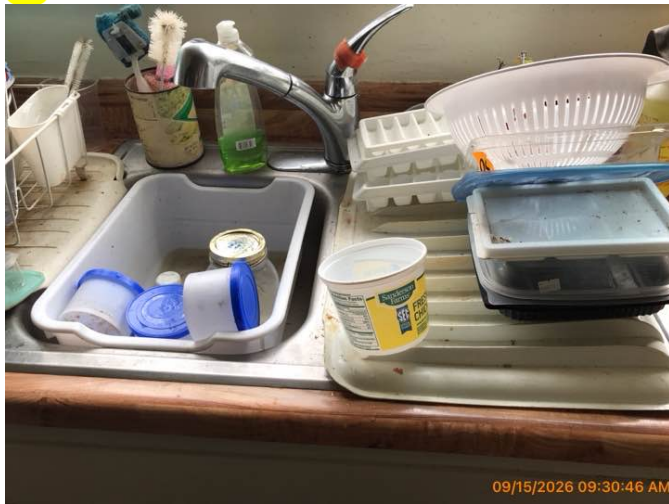
**W 275:** The sink was filled with dishes so the inspection was limited.

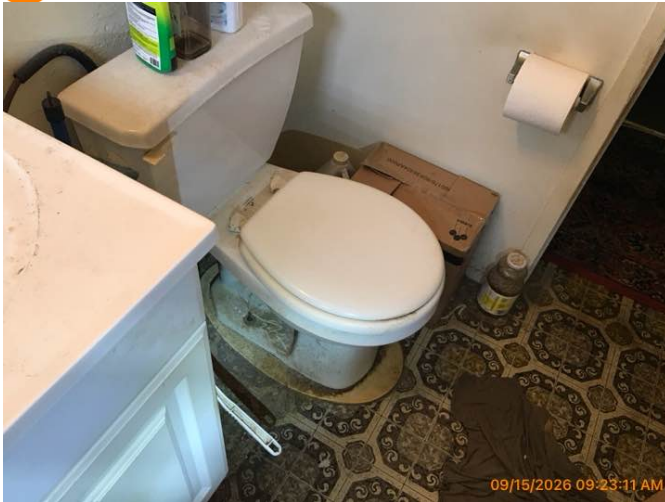
**R** 314: The toilet was not operational. We recommend the toilet be repaired or replaced.

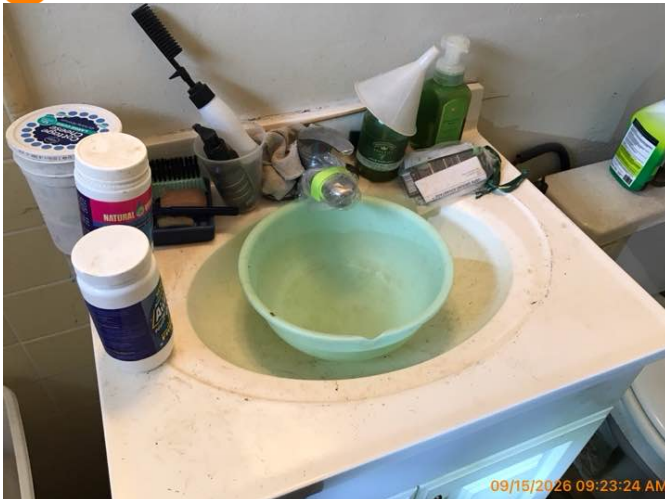
**R** 315: The sink is damaged. We recommend it be replaced.

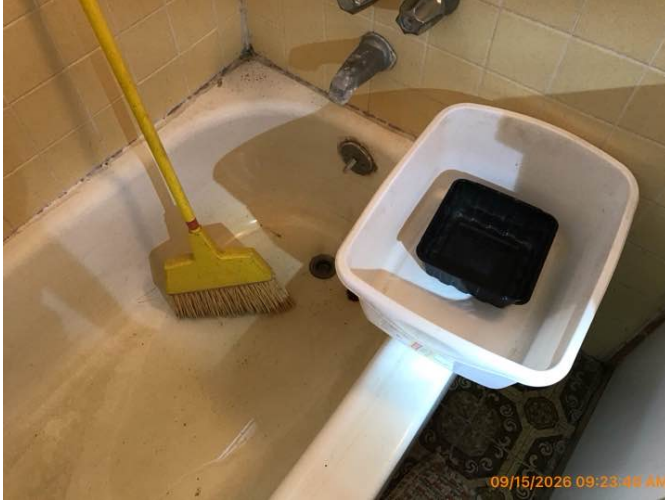
**W 316:** The drain is slow. We recommend the trap be cleaned of grease, hair, sludge, etc. and if this does not correct the problem, we recommend the line be 'snaked' by a professional sewer cleaning service.
