REAL ESTATE INSPECTION FOLLOW UP SUMMARY

LOCATED AT:
403 S Paseo Laredo
Cathedral City, CA 92234

INSPECTED ON:
Friday, September 30, 2022 at 8:30 AM

Report# 11803

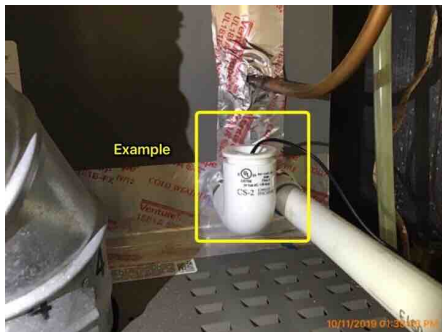
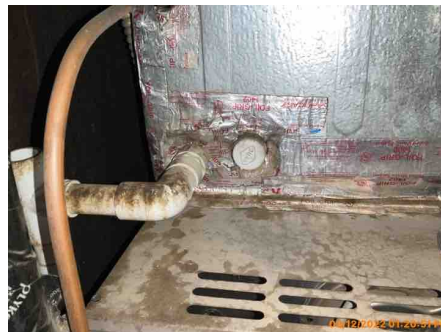
HEATING SYSTEM COILS SECONDARY CONDENSATION LINE

UG 1: Recommend Micro switch be installed on secondary condensation line to prevent moisture damage if primary condensation line becomes blocked.

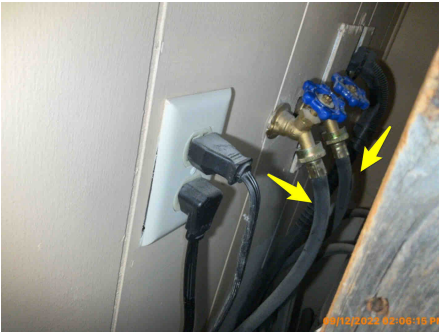
LAUNDRY WATER HOOK-UPS RECOMMENDATIONS

UG 3: It is recommended that you use braided steel flexible water supply lines for washer hook up. The cheaper rubber lines are more prone to rupturing and flooding of the home.

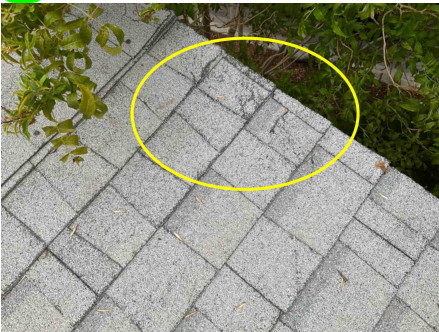
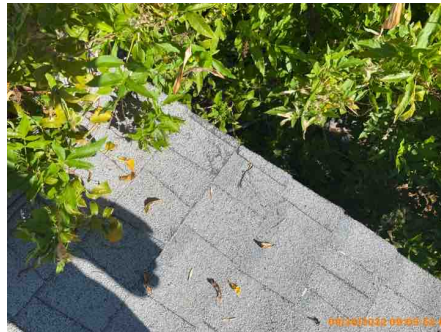
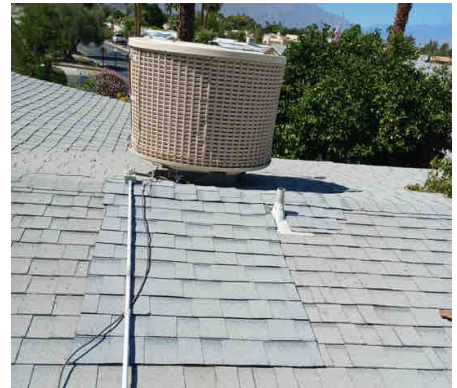
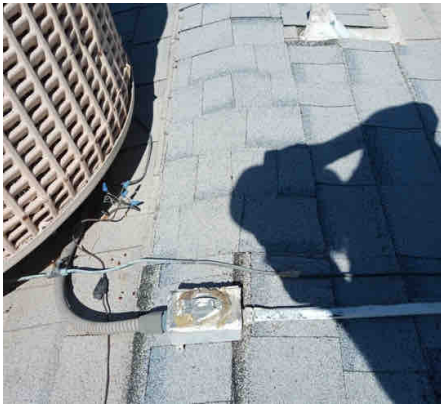
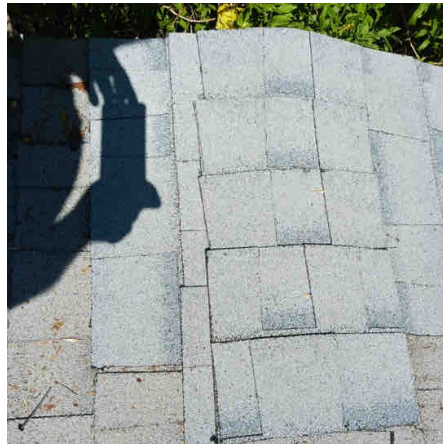
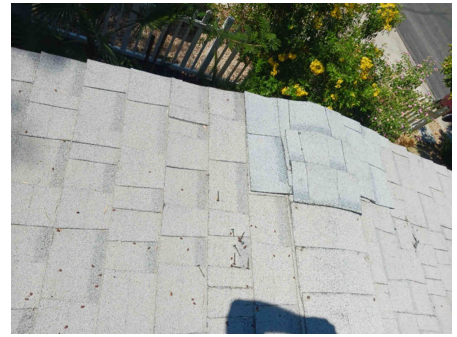
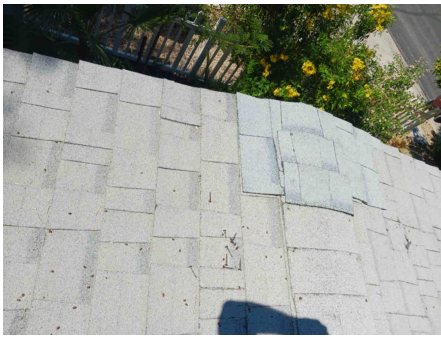
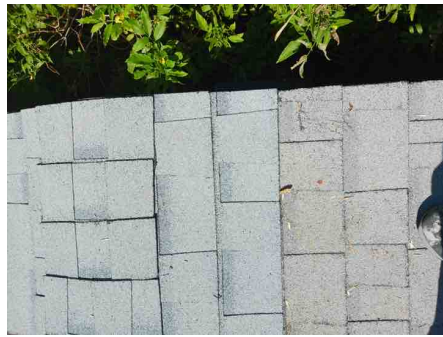
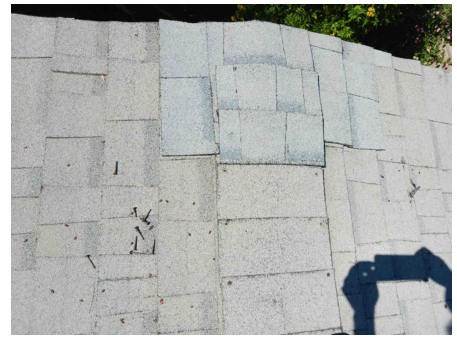
ROOF SYSTEM ROOF CONDITION

COMP 5: Wear is noted to composition roof. Repair was completed as requested.

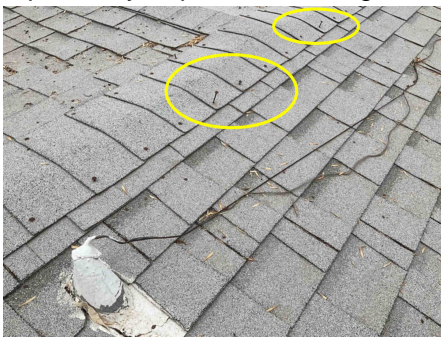
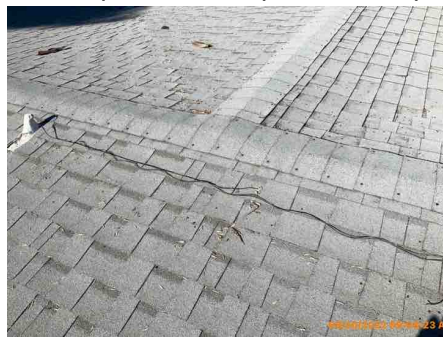
COMP 6: Nails/Fasteners are protruding from the roof surface. Recommend the entire roof be evaluated and repaired by a qualified Roofing Contractor. Repair was completed as requested.

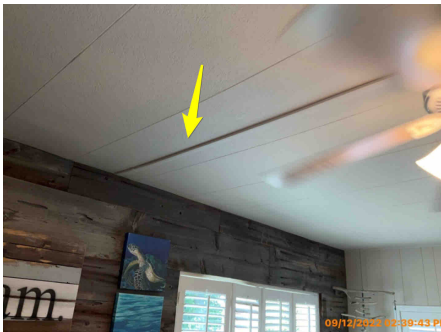
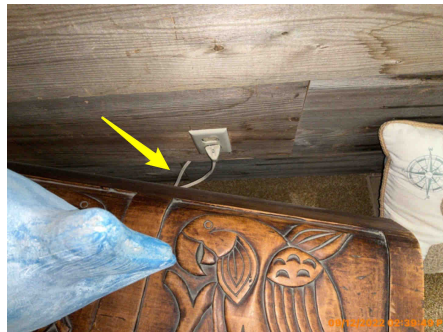
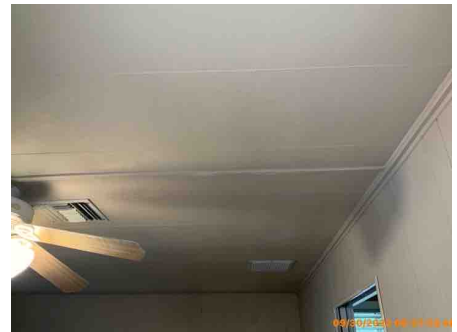
ELECTRICAL SYSTEMS INTERIOR CEILING FANS

COMP 7: Lamp cord used to power ceiling fans, recommend fans be wired with romex type wiring with a ground, We recommend further review and repairs by a qualified specialist in the appropriate trade. Repair was completed as requested.

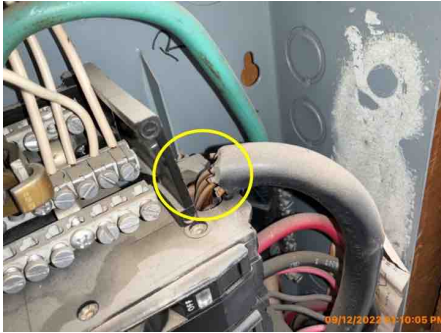
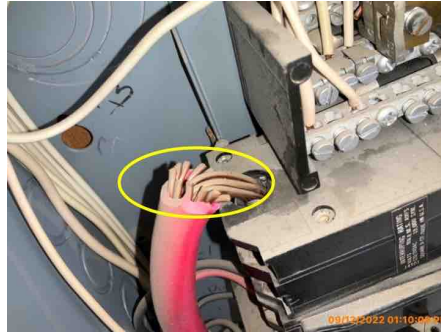
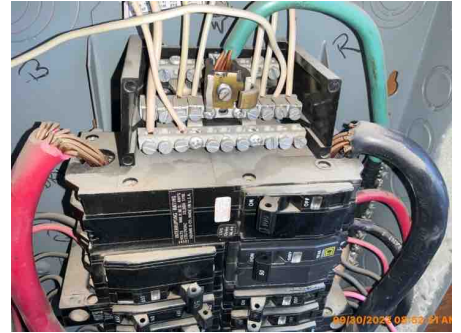
#1 LEFT SIDE SUB PANEL SUB PANELS

COMP 8: Main power supply wires were cut down to fit terminals. Recommend further review and repair by qualified Electrical Contractor. Repair was completed as requested. According to Seller and Desert Electric Licensed Electrician, this is acceptable and does not require correction.

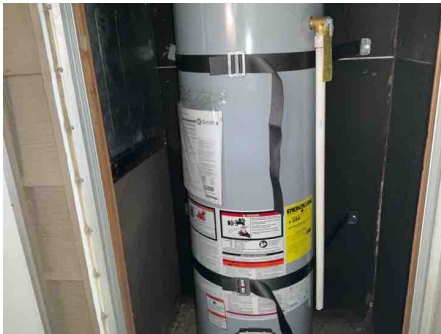
WATER HEATER WATER HEATER AGE NOTE

COMP 9: Water heater is 17 years old and is beyond its service life. Replacement should be considered. Repair was completed as requested.

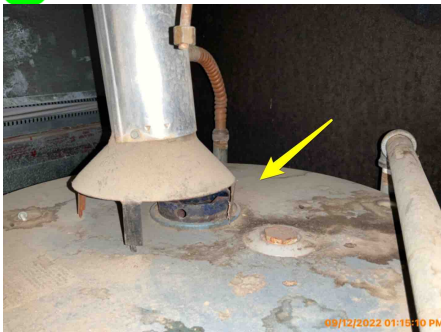
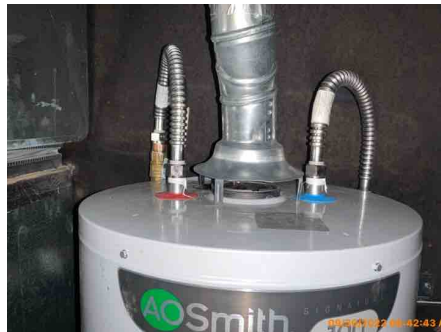
WATER HEATER WATER HEATER VENTING SYSTEM

COMP 10: Water heater vent not lined up with draft hood. Repair was completed as requested.

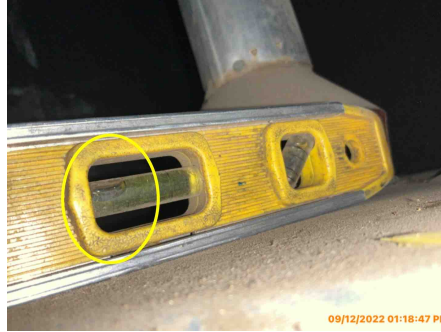
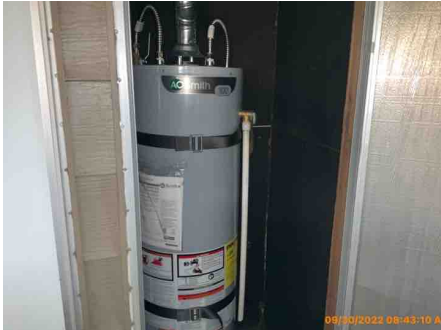
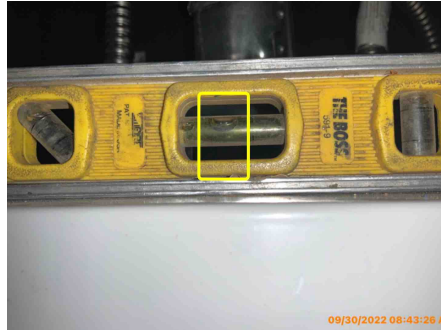
WATER HEATER WATER HEATER TANK

COMP 11: Water heater appears to be leaning and not securely installed. Repair was completed as requested.

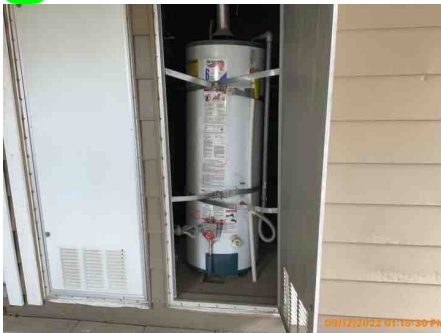
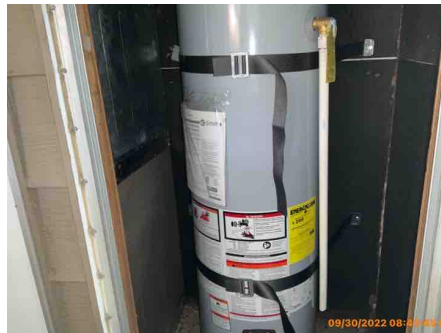
WATER HEATER WATER HEATER SEISMIC BRACING

COMP 12: Straps are loose, tightening is needed. Repair was completed as requested.

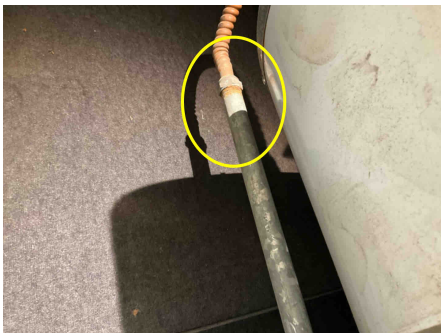
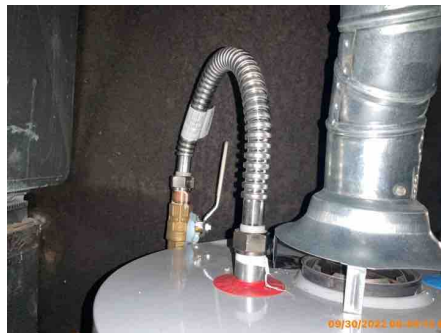
WATER HEATER WATER HEATER SUPPLY PIPING

COMP 13: No shutoff valve at water heater. A valve is required. Recommend the advice and services of a qualified Plumbing Contractor. Repair was completed as requested.

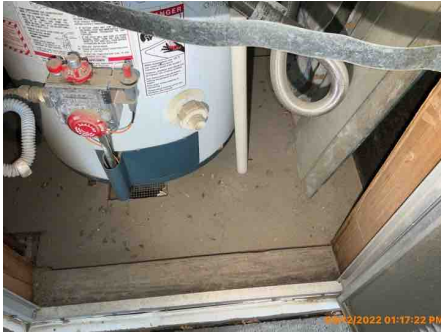
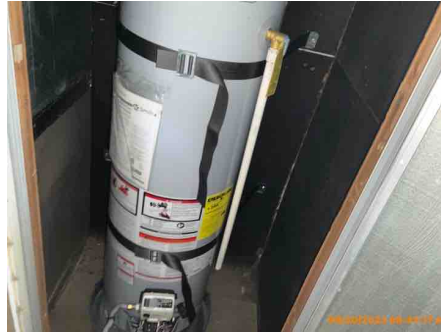
WATER HEATER WATER HEATER TPR VALVE

COMP 14: End water heater Temperature pressure relief valve drain pipe is required to be visible, so you can see the line leaking. We recommend the advice and services of a qualified Plumbing Contractor. Repair was completed as requested.

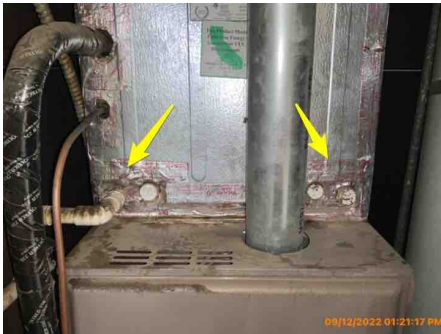
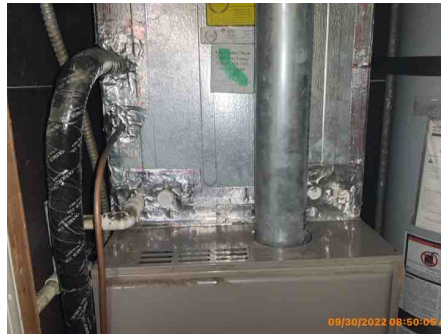
HEATING SYSTEM HEATING SYSTEM SUPPLY PLENUM/COIL

COMP 15: Air was leaking from coil, it is recommended that this area be sealed to prevent leaking of cool air. Repair was completed as requested.

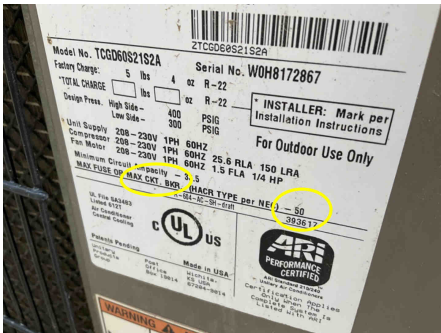
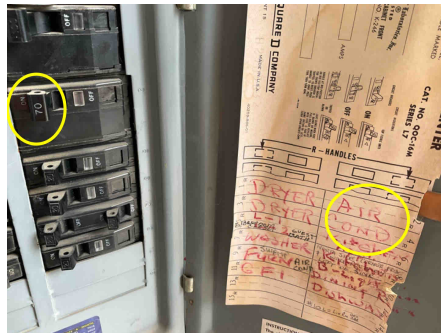
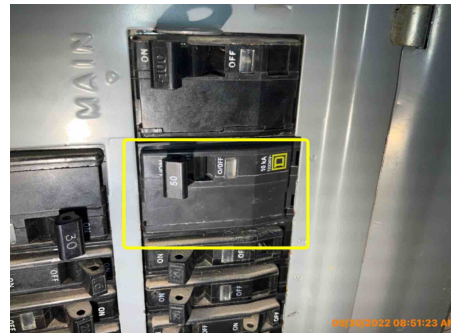
AIR CONDITIONING SYSTEM AC FUSE/BREAKER RECOMMENDATIONS

COMP 16: Air conditioners manufacture max fuse or circuit breaker per the National Electrical Code that should be installed for air conditioner is **50 amps**. **70 amp** breaker is too large for unit. Proper sized breaker or fused disconnect should be installed. Recommend further review and repair by qualified Electrical Contractor. Repair was completed as requested.

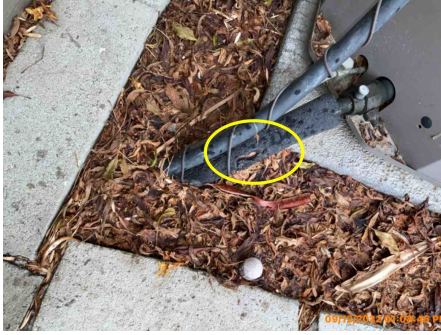
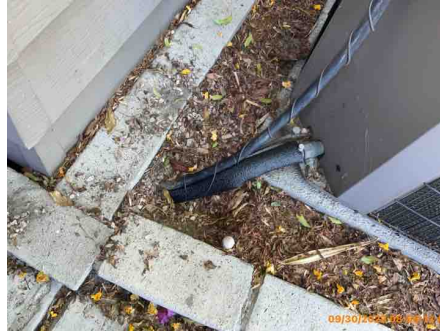
AIR CONDITIONING SYSTEM A/C REFRIGERANT LINES

COMP 17: Refrigerant line insulation is deteriorated, recommend new insulation be installed. Repair was completed as requested.

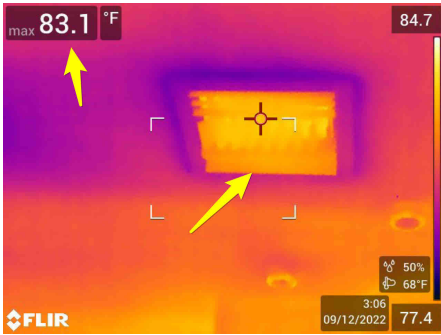
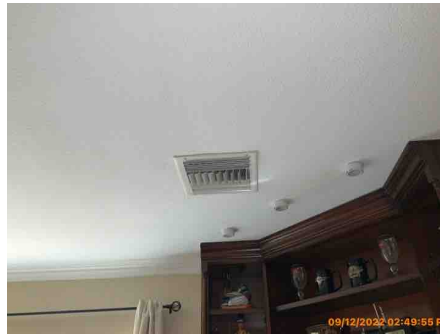
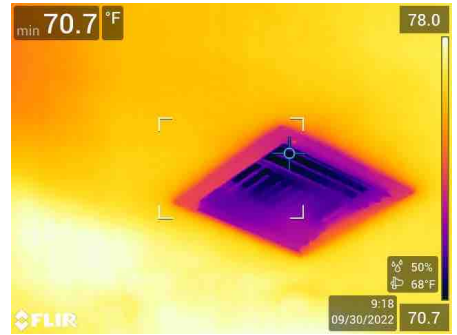
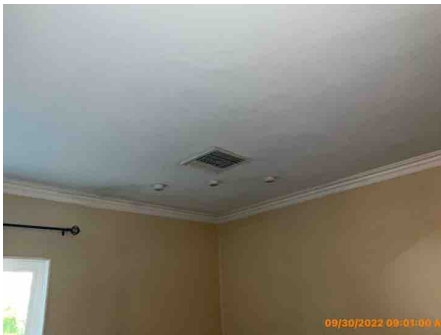
HEATING /AC DISTRIBUTION SYSTEMS HEATING DISTRIBUTION SYSTEMS CONDITION

COMP 18: Thermal image shows register above bar did not work. We recommend further review and repairs of ducting system by a qualified Licensed HVAC Contractor. Repair was completed as requested.

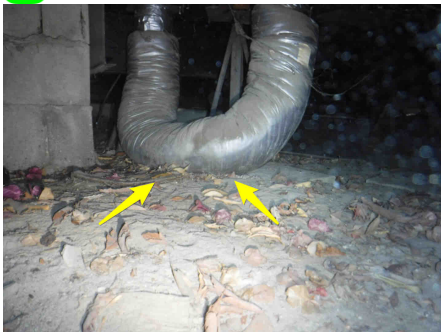
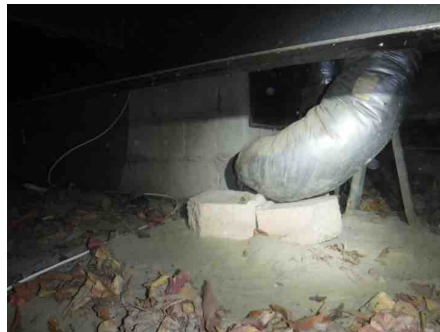
COMP 19: Duct clearance to dirt should be minimum 4" under house. Repair was completed as requested.

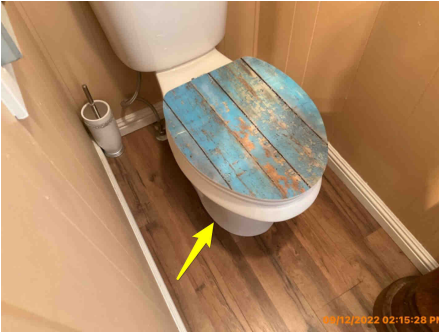
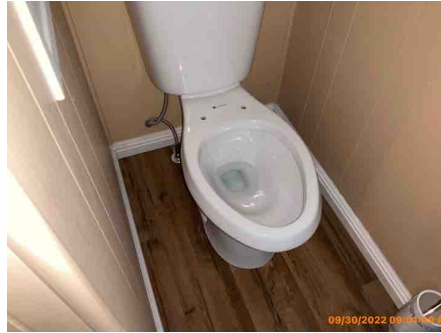
PRIMARY BATHROOM CONDITION OF TOILET

COMP 20: Toilet is loose at floor, correction is advised to prevent leaking. This involves removal of the toilet, inspecting for water damage, replacing the wax seal and re-installing the toilet. We recommend further review and repairs by a qualified specialist in the appropriate trade. Repair was completed as requested.

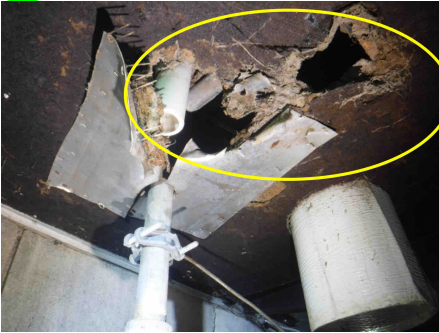
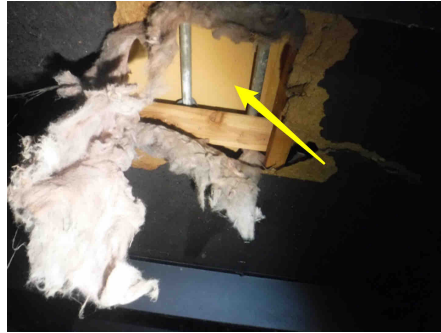
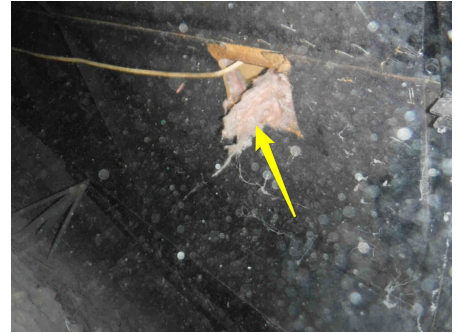
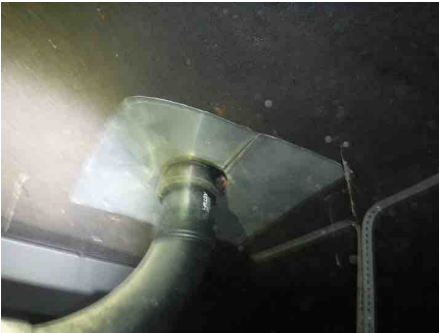
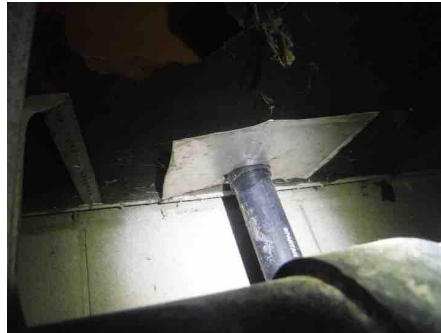
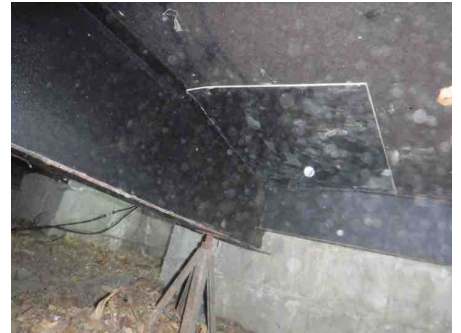
CRAWLSPACE MH UNDER FLOOR CONDITION

COMP 21: Openings to the bladder under the home should be repaired. Repair was completed as requested.

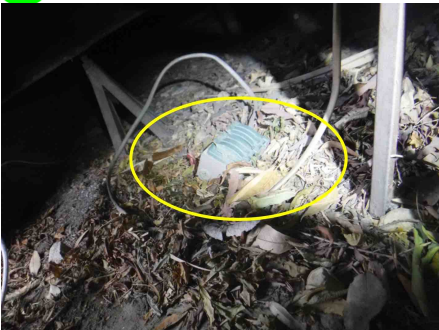
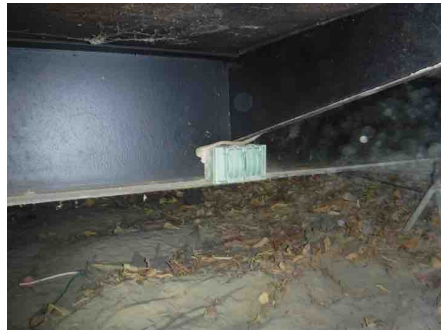
CRAWLSPACE MH ELECTRICAL WIRING

COMP 22: Junction box not mounted to framing. Repair was completed as requested.

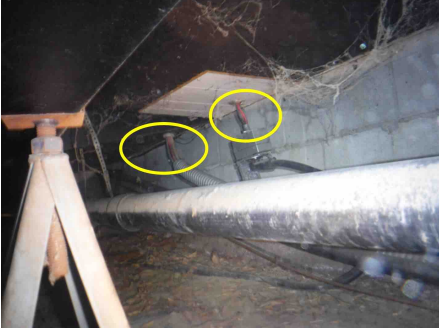
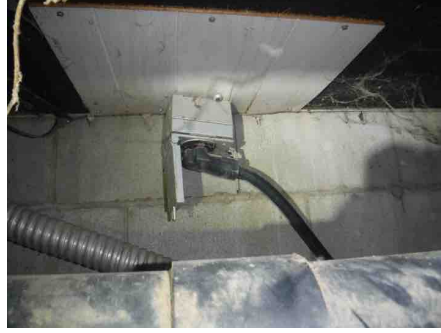
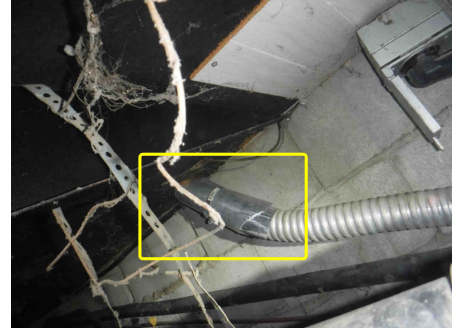
23: Loose junction box and conduit with exposed wiring noted. Recommend further review and repair by qualified Electrical Contractor. Repair was completed as requested.
