Cornerstone Home Inspections

Home Inspection Report

20445 West Walnut Dr

Inspected on Mon, Sep 15 2025 at 9:05AM

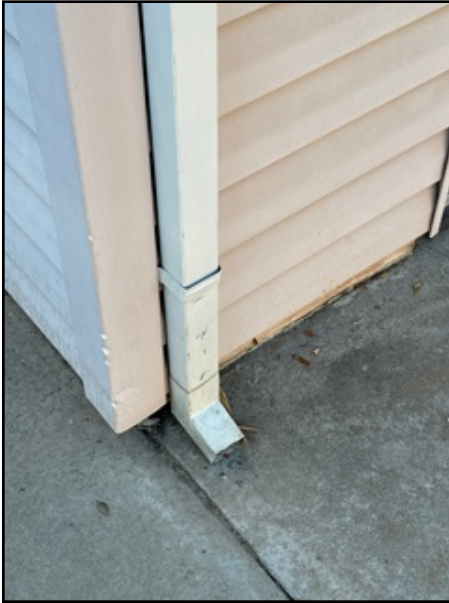
Figure 1-1

Recommend to divert all drainage away from the structure.

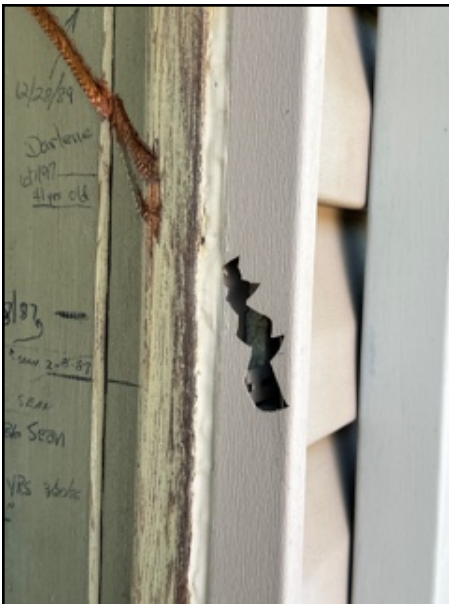
Figure 2-1

Vinyl trim on right side of garage overhead door is damaged.

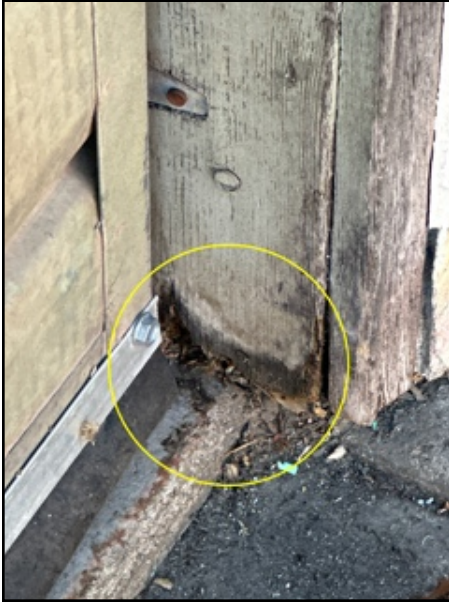
Figure 3-1

-
- ⚠ Comment 3:
Wood decay noted at bottom of overhead door trim on right side. Refer to a licensed pest inspector.

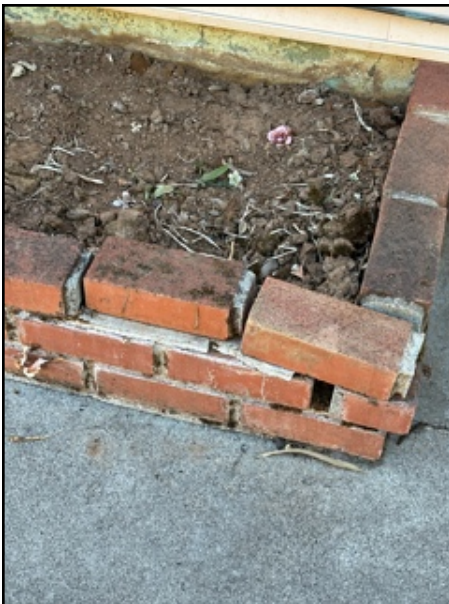
Figure 4-1

-
- ⚠ Comment 4:
Loose bricks noted on built-in brick planters surrounding home. Recommend repair.

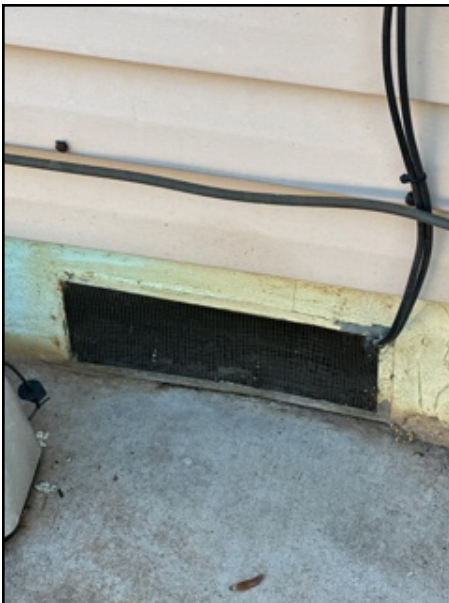
Figure 5-1

Crawl space vent left of chimney is at ground level. This could allow drainage to enter the sub area. Refer to a qualified tradesman for repair.

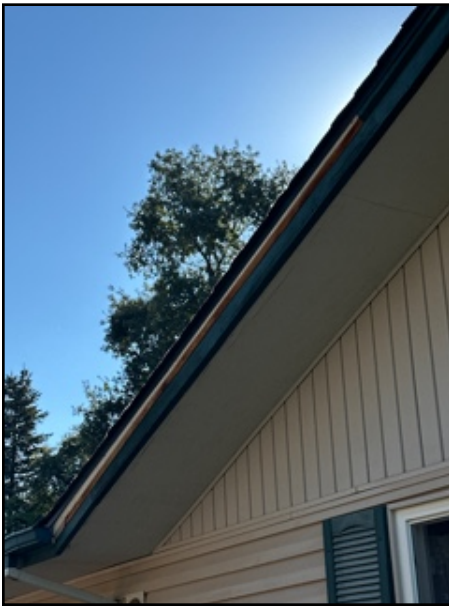
Figure 6-1

Recommend to paint unfinished fascia trim on right side of garage.

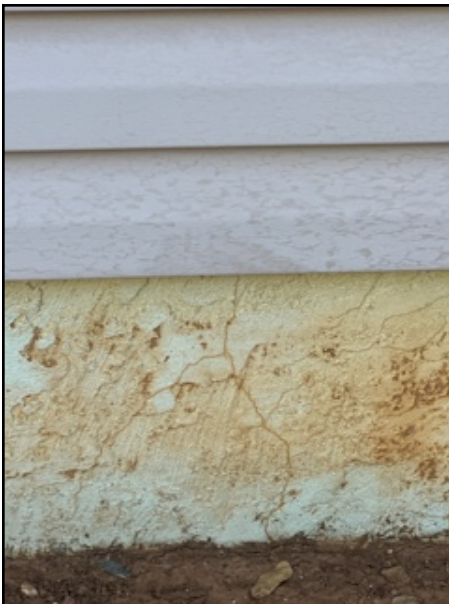
Figure 7-1

Minor cracks noted throughout exposed stucco siding below the vinyl. This is a common find on stucco siding.

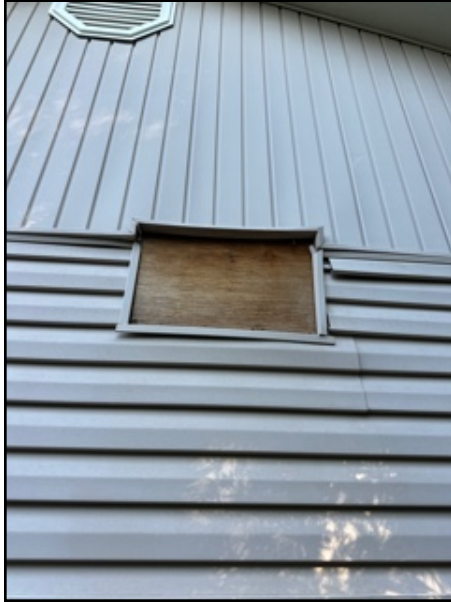
Figure 8-1

Evaporative cooler has been removed from the right side of home. Recommend properly repairing the siding in this area.

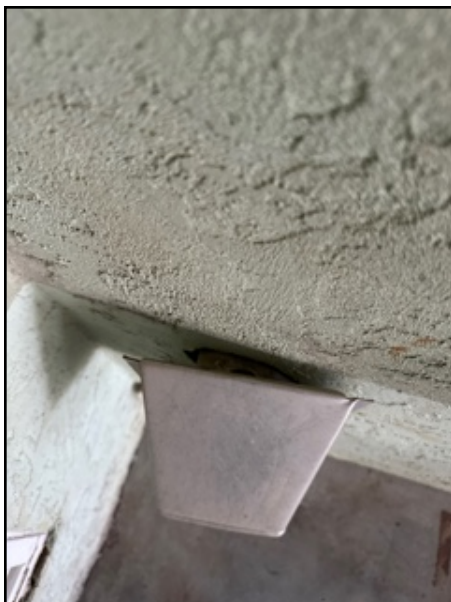
Figure 9-1

Dryer vent termination is not mounted to the wall. Inspector also noted this vent termination is missing the flapper.

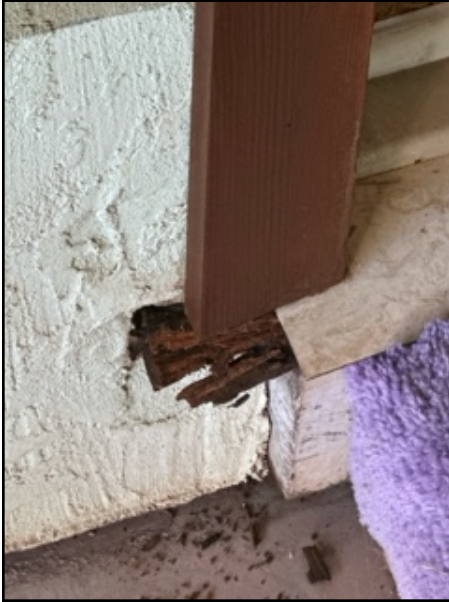
Figure 10-1

Wood decay noted below master bedroom exterior door. Refer to a licensed pest inspector.

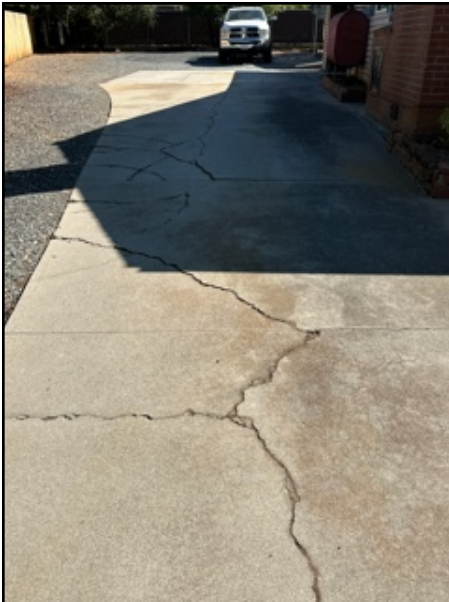
Figure 11-1

Driveway slabs noted as cracked.

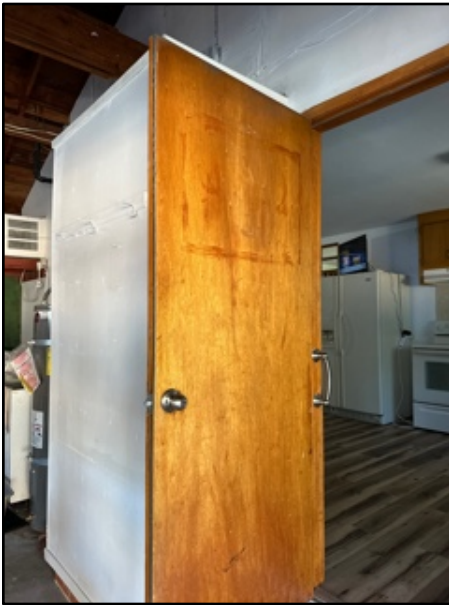
Figure 12-1

Comment 12:
No self closing hinges are installed on garage door into home. Recommend installing as required to protect from carbon monoxide.

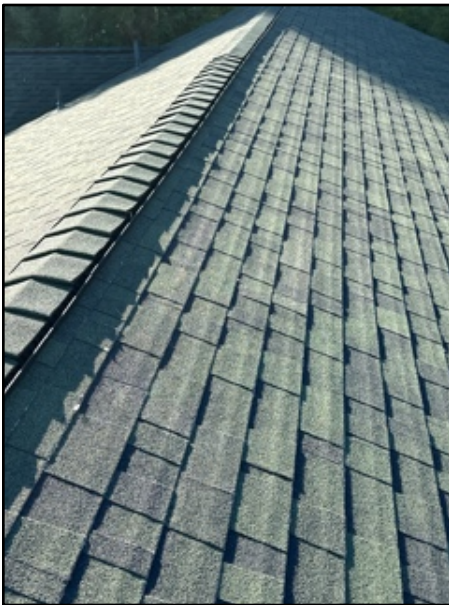
Figure 13-1

Overall roofing appears to be in like new condition with many years of usable life remaining.

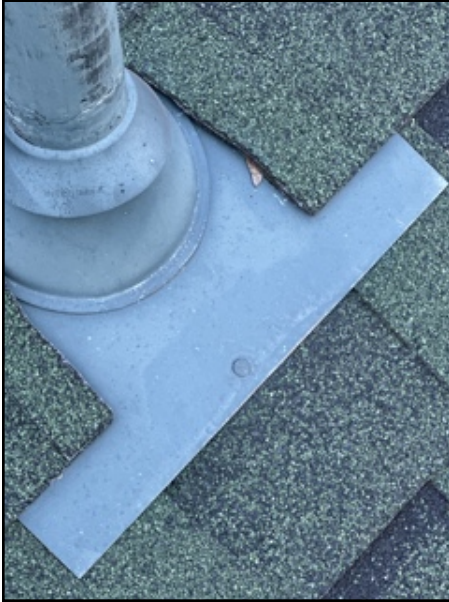
Figure 14-1

Open nails located on roof flashings. Recommend covering in tar to prevent any future leaks.

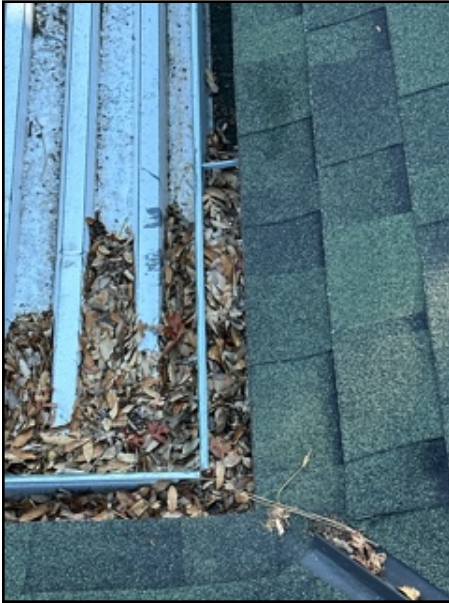
Figure 15-1

Recommend to clean debris from gutters to allow proper drainage.

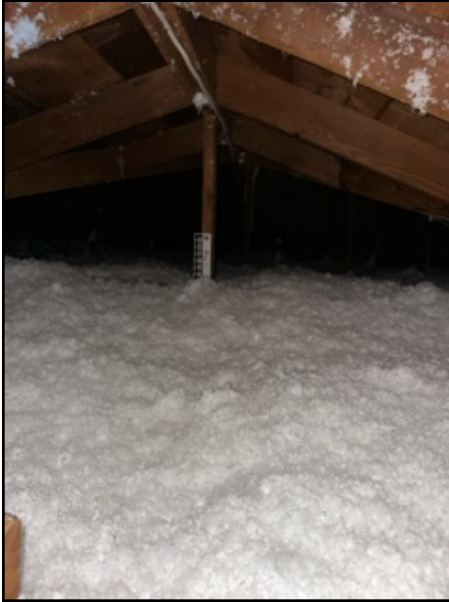
Figure 16-1

Attic was noted to be well insulated with no evidence of leaks or any other issues at time of inspection.

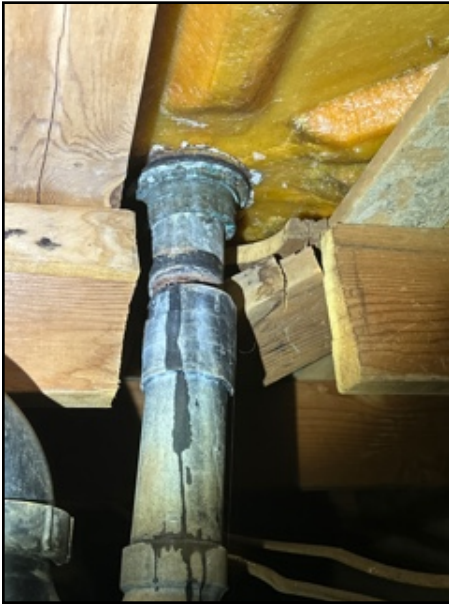
Figure 17-1

The floor joist below the tub/shower has been cut through & compromised. Refer to a licensed contractor for repair.

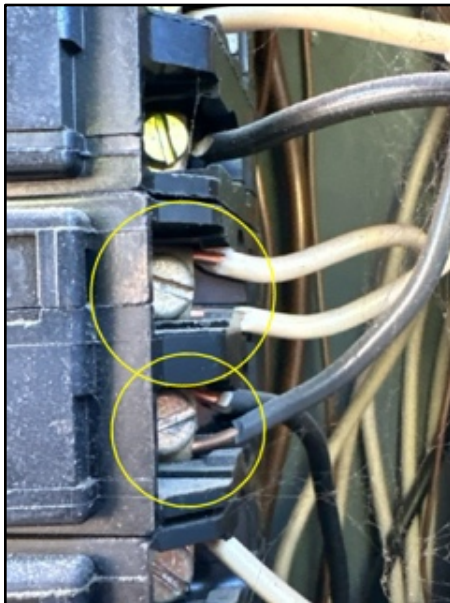
Figure 18-1

**Comment 18:**
The 2 breakers shown in main panel are double tapped. Refer to a licensed electrician for further evaluation/repair.

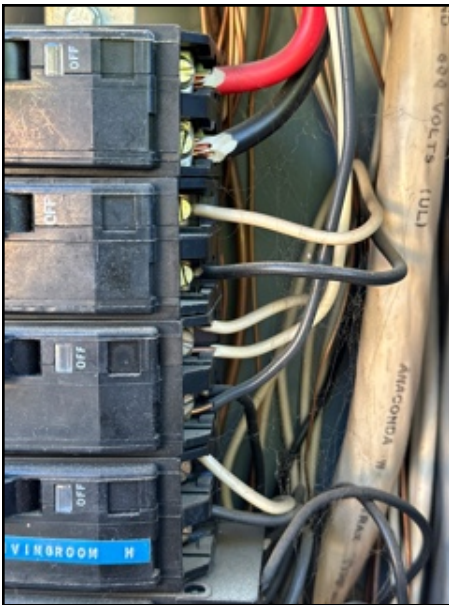
Figure 19-1

Neutral (white) wires that are attached to breakers & used as hot wires should be wrapped with red tape to indicate live current. Recommend repair.

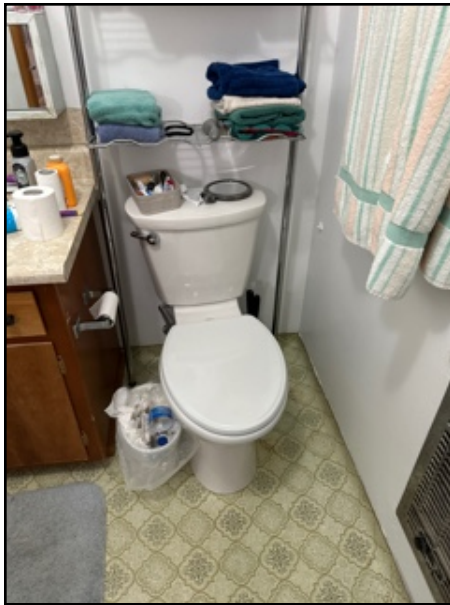
Figure 30-1

Master bathroom toilet noted as loose. Recommend tightening to prevent any future leaks.

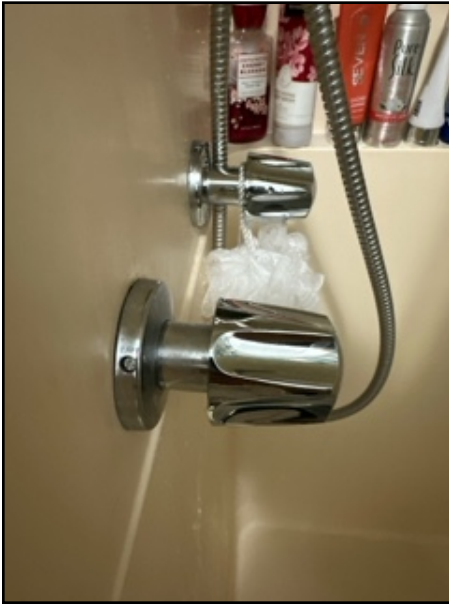
Figure 31-1

Master bathroom shower handles/valves noted to leak when on. Refer to a licensed plumber.

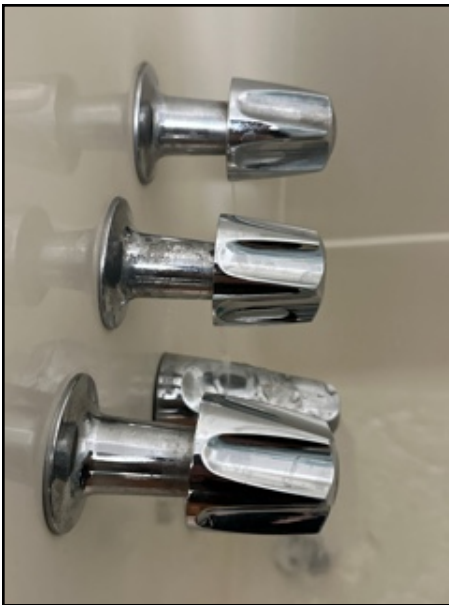
Figure 32-1

Guest bathroom shower handles/valves noted to leak when on. Refer to a licensed plumber.

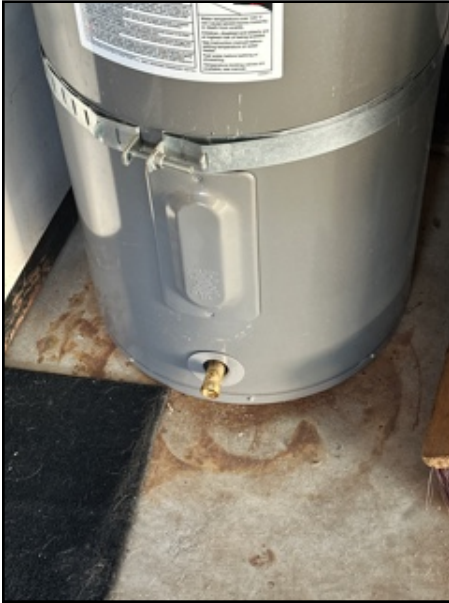
Figure 33-1

**Comment 33:**
No pan installed under water heater. Recommend installing as required.

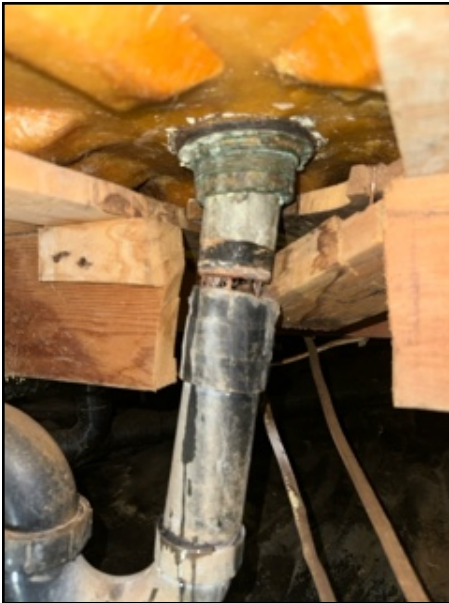
Figure 35-1

Shower drain below home is completely disconnected. Recommend repair before any further use.

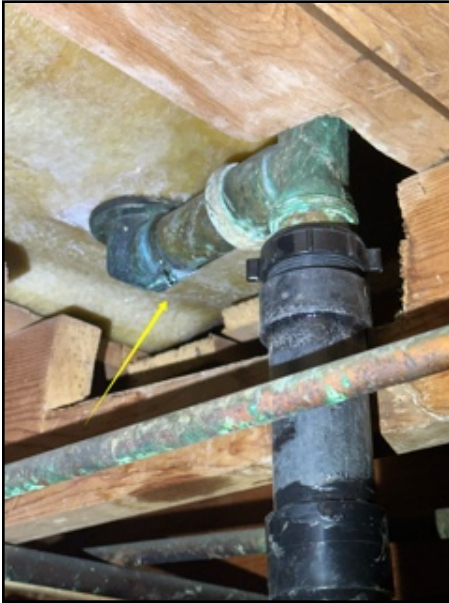
Figure 36-1

Tub drain below home noted to leak. Refer to a licensed plumber.

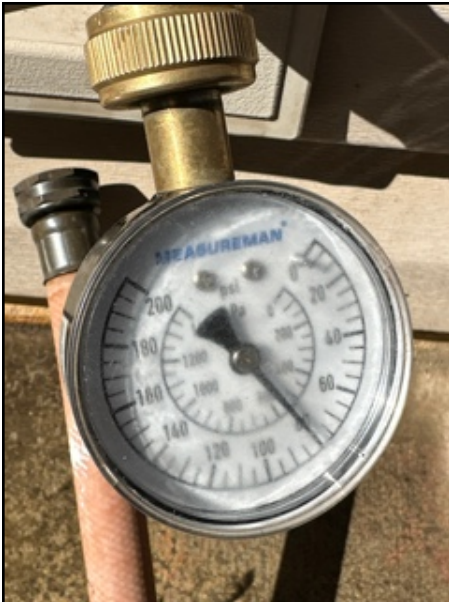
Figure 37-1

Water pressure noted at 80 psi. Current CA building code allows a maximum pressure of 80 psi. Condition is functional.

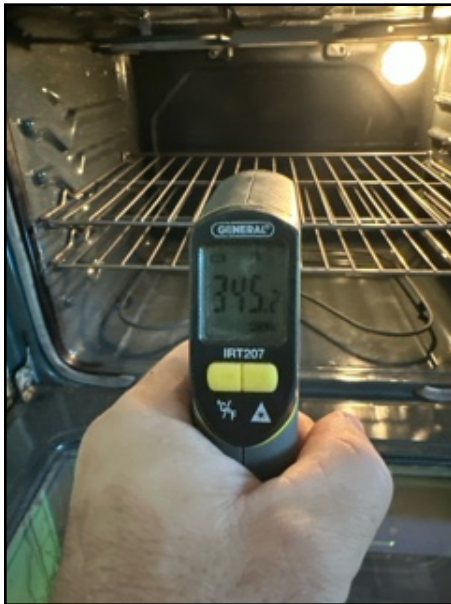
Figure 39-1

Oven set at 350 recorded a temperature of 345 degrees. Condition is functional.

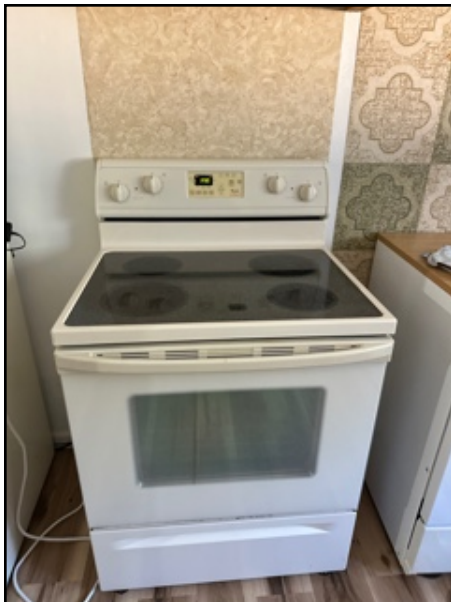
Figure 40-1

No anti-tip bracket installed on oven. Recommend installing to ensure the safety of the appliance.

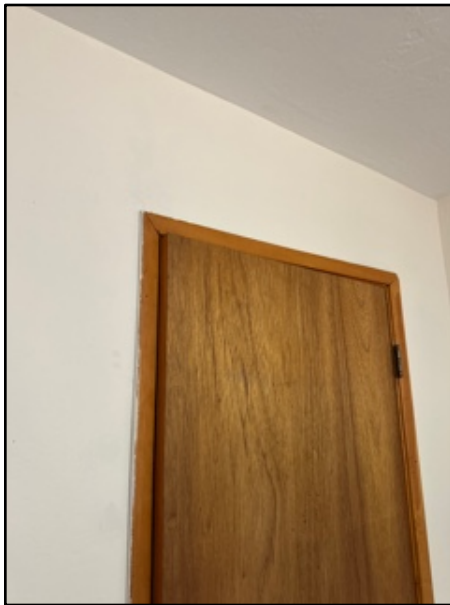
Figure 41-1

2nd guest bedroom closet door fails to fit into the frame.

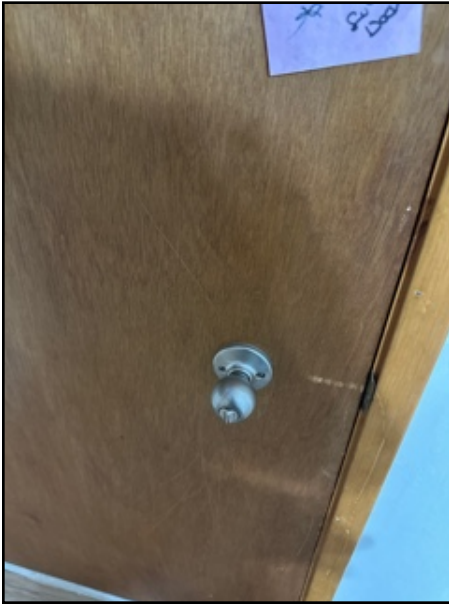
Figure 42-1

Recommend installing deadbolt style locks on all exterior doors to ensure the security of the home.

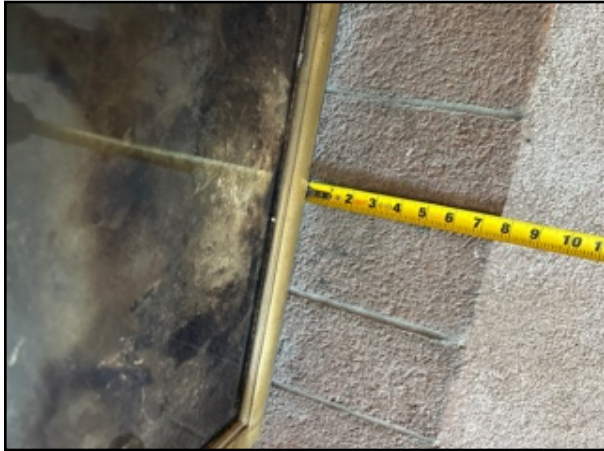
Figure 43-1

Hearth noted at 7.5" in front of wood stove. Current CA building code requires a minimum of 16". Recommend repair.

CA Code R1001.10 - "Hearth extensions shall extend at least 16" in front of, and at least 8" beyond each side of the fireplace opening...."
