Suzanne Markham

8605 Washington
La Mesa, California

Chris Dembroski NACHI10071406
Smart Home Inspection
(619) 846-5737
chris@smarhomeinspection.net
5582 Forbes Ave
San Diego, CA
92120
www.smarhomeinspection.com

Thursday
January 9, 2025

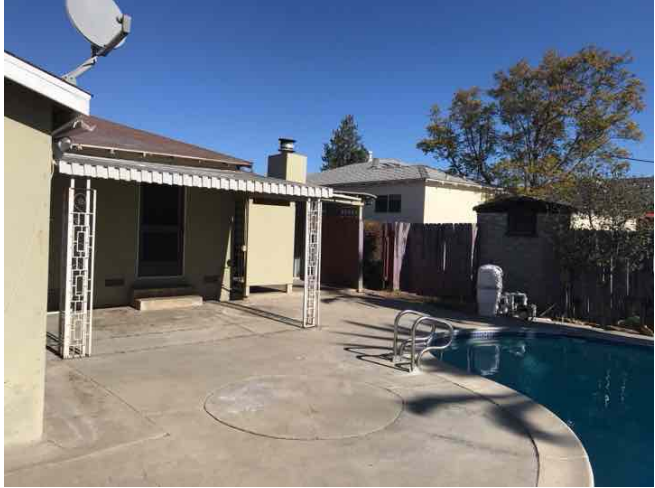
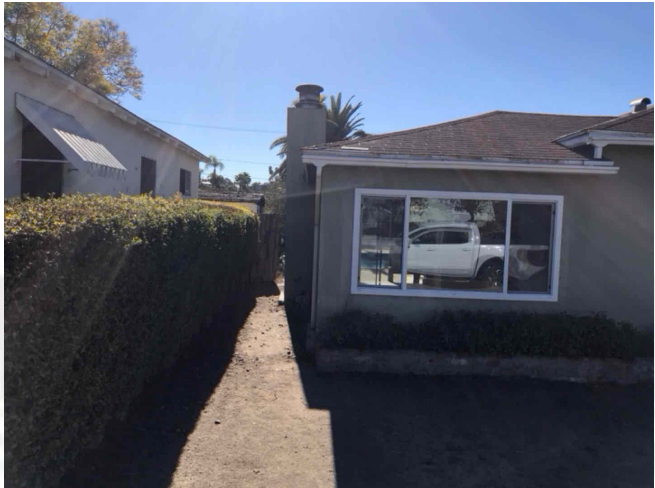
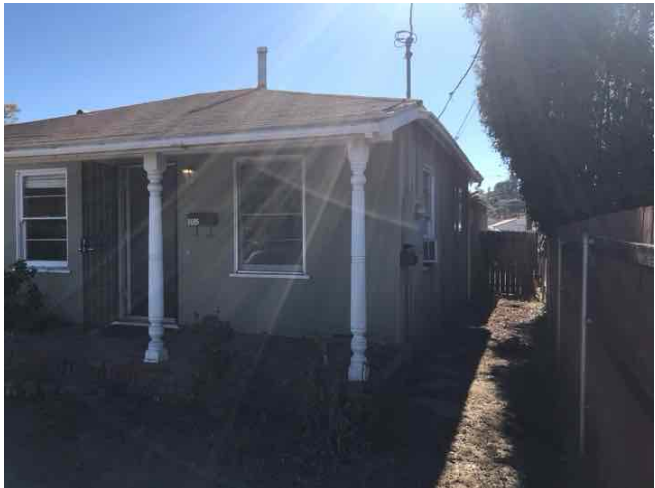
23: Exterior elevation photos

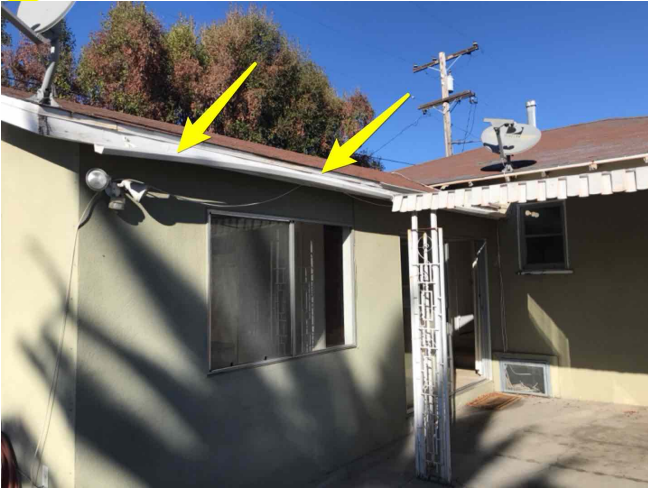
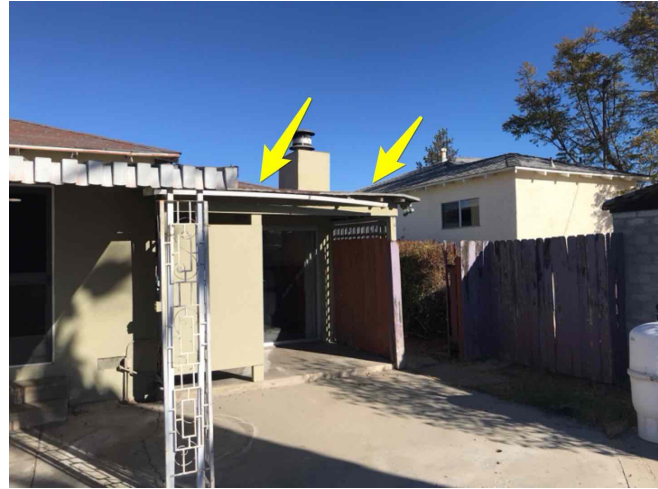
W 30: The gutters are installed in a substandard manner. We recommend repair or replacement.

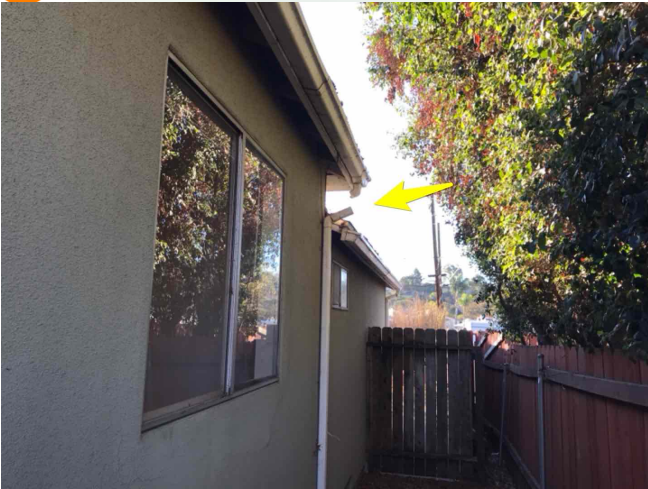
R 32: Several downspouts have been damaged. Replacement is recommended.

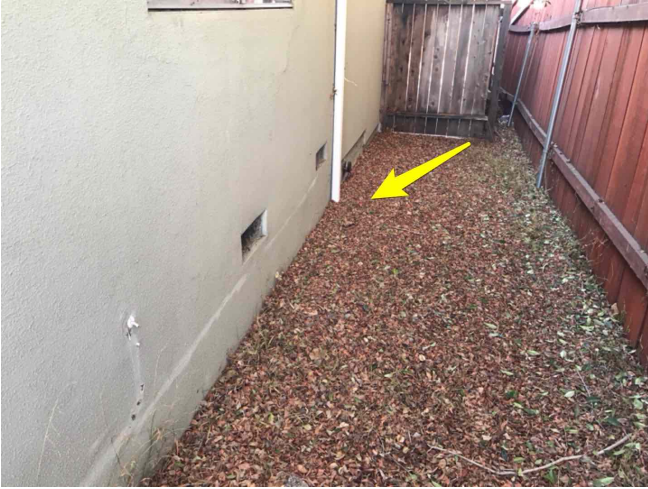
M 33: One or more of the downspouts are buried in soil. We recommend shortening the downspout(s) and installing an extension or a splash block to facilitate flow of water away from the foundation.

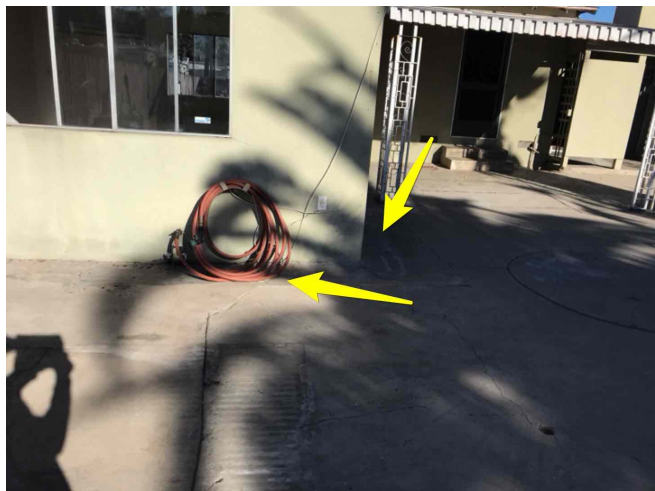
W 36: The patio is not properly sloped away from the house. Water pooling or moisture intrusion could result if this condition is not corrected.

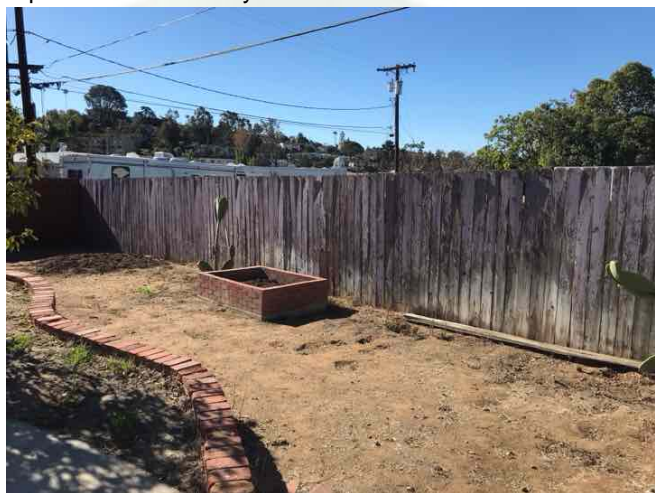
M 38: There is deterioration/damage to the fencing. We recommend the fencing be monitored and repaired and/or replaced as necessary.

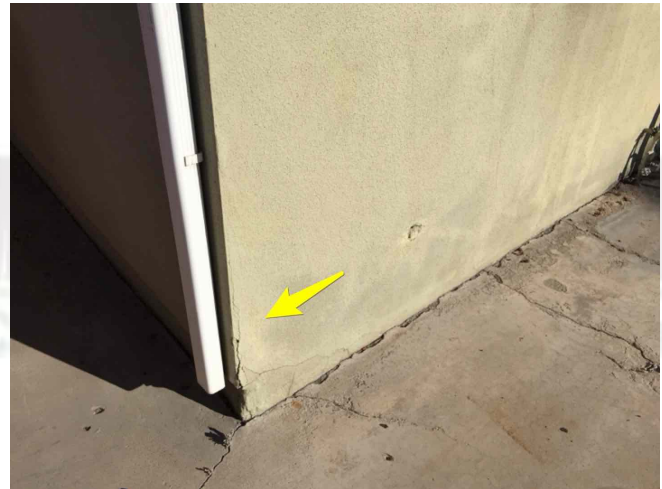
R 43: There are moderate sized cracks in the stucco that should be patched and sealed as part of preparation for the next painting. Flexible patching materials are recommended rather than rigid cementitious patching compounds.

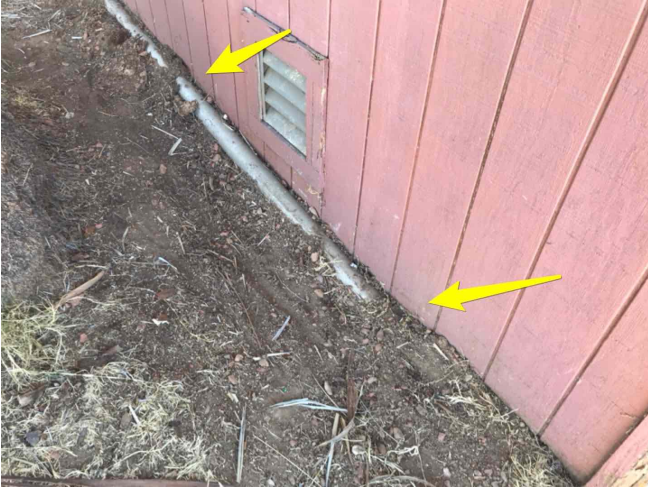
W 50: There is earth-to-wood contact at the garage, which makes the siding vulnerable to deterioration. We recommend all earth-to-wood contacts be broken to prevent moisture or pest related damage.

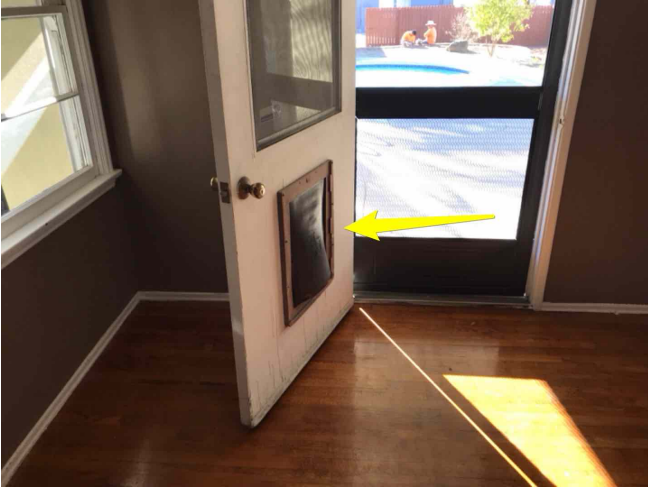
S 52: There is a pet door in the rear of the house. Pet doors can be an easy point to break into a home, it's advised that precautions be made to prevent this from happening.

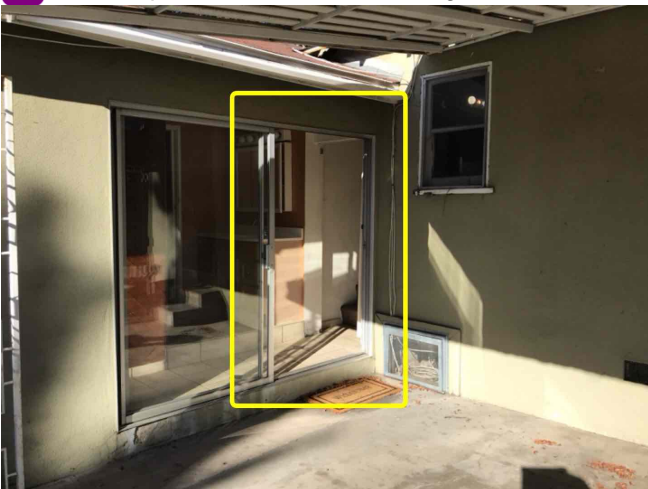
M 59: The patio screen door is missing and should be replaced.

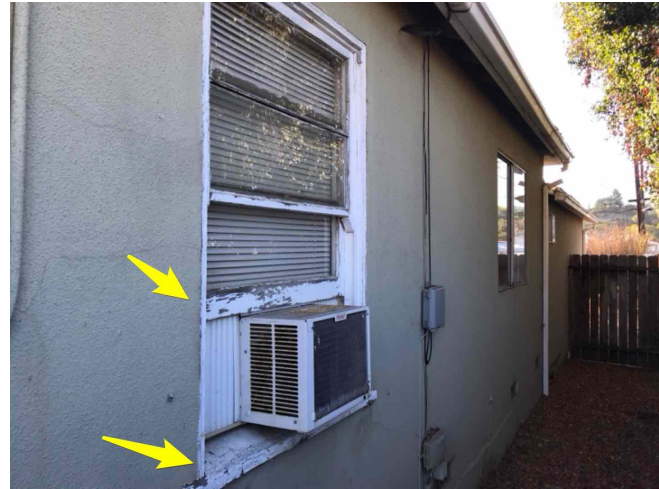
M 61: The trim shows routine wear but appears to be properly installed and in serviceable condition. We advise routine maintenance to ensure maximum service life.

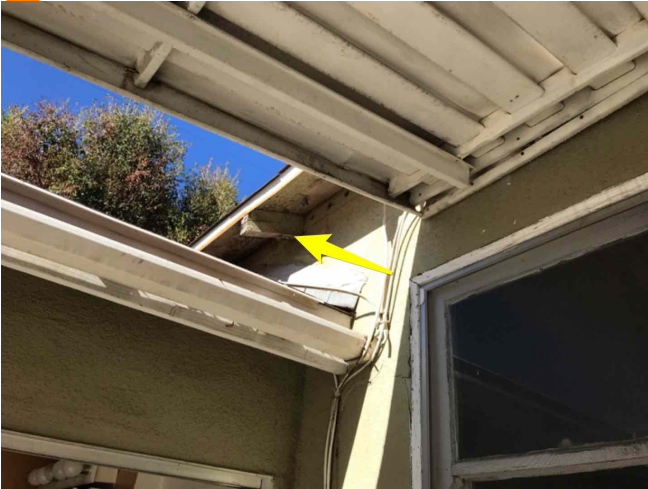
R 64: Sections of the eaves at the rear of the home are deteriorated. We recommend repair or replacement.

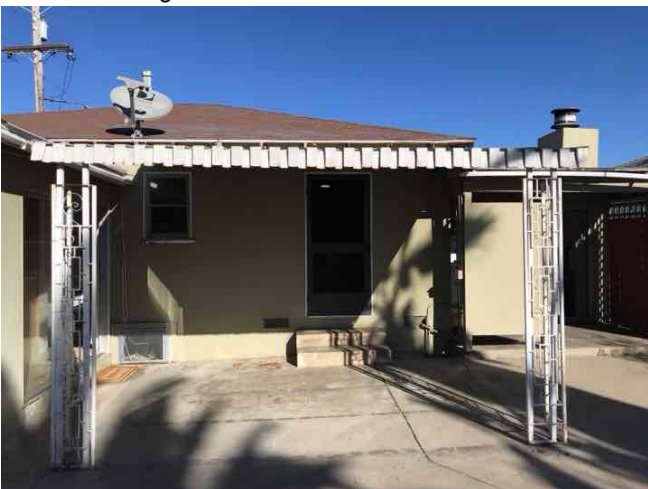
R 71: The patio cover is not adequately braced and is wobbly when pushed from side to side. We recommend the patio cover be strengthened to resist lateral forces.

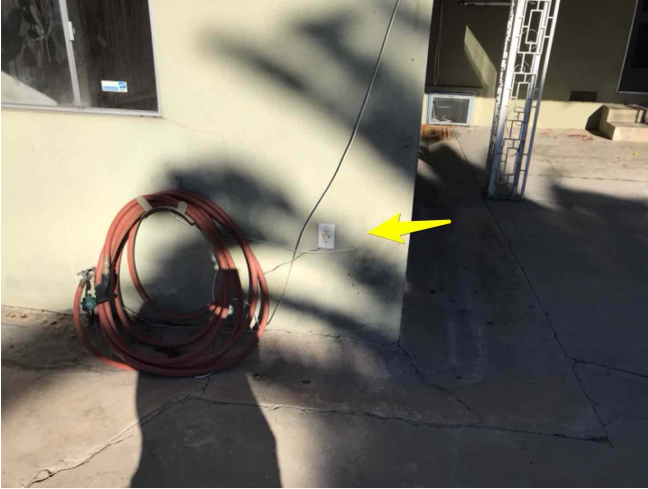
S 75: Some of the exterior receptacles have no waterproof cover plates. We recommend approved covers be installed to reduce the risk of moisture penetration and hazardous shocks.

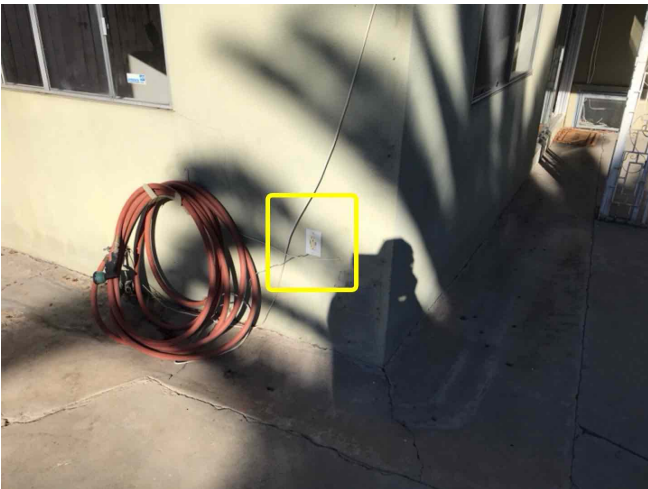
76: The GFCI receptacle on the exterior tripped when tested but would not reset and remained dead. We recommend the source of the problem be identified and corrected.

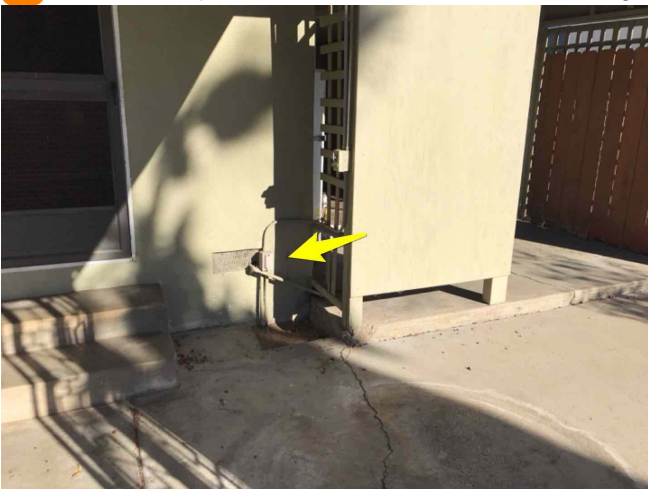
R 77: The receptacle at the rear exterior is not working. We recommend further investigation and repair, if necessary.

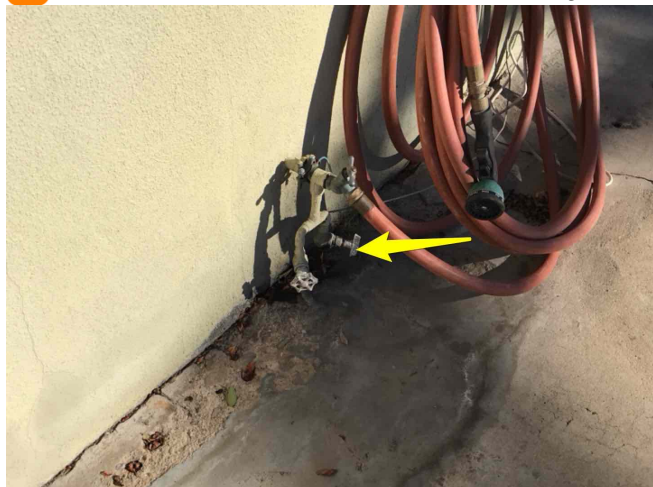
R 80: The water line located at the rear is leaking and needs to be repaired.

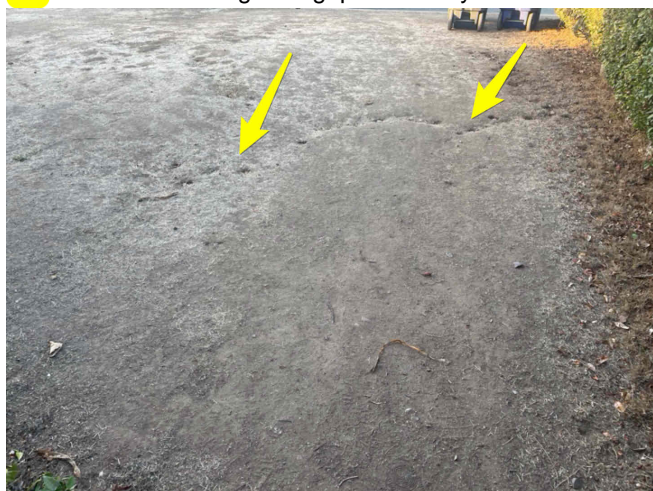
W 83: There are signs of gopher activity around the structure. It's advised that the property be treated for this condition.

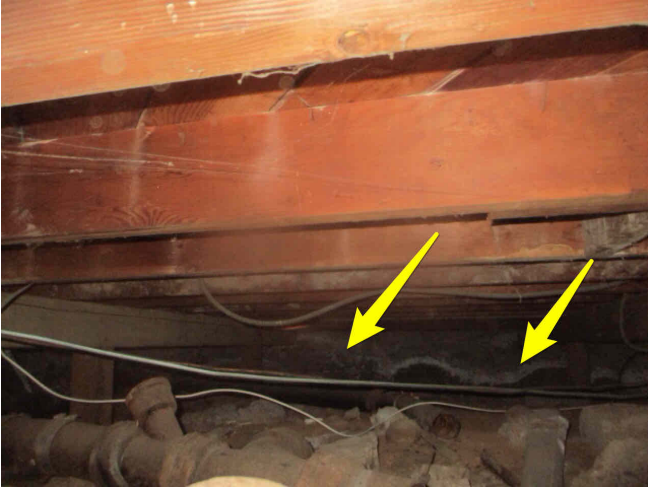
W 108: There is a condition known as efflorescence on portions of the foundation walls. This whitish, fuzzy material is a 'salt' deposit left when moisture in the foundation evaporates on the inside of the foundation.

W 109: This indicates an occasional surplus of moisture on the outside of the foundation. Steps could be taken to improve the exterior drainage but no other action is indicated at this time.

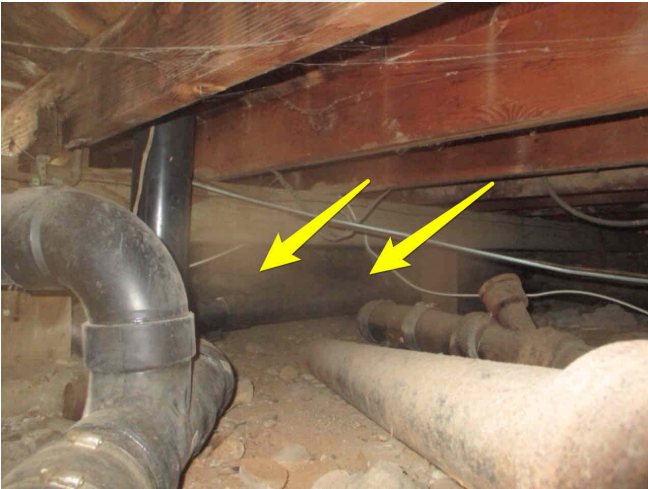
W 110: There is small void in the foundation footing/wall that should be filled and repaired. Further evaluation is advised by an appropriate qualified professional.

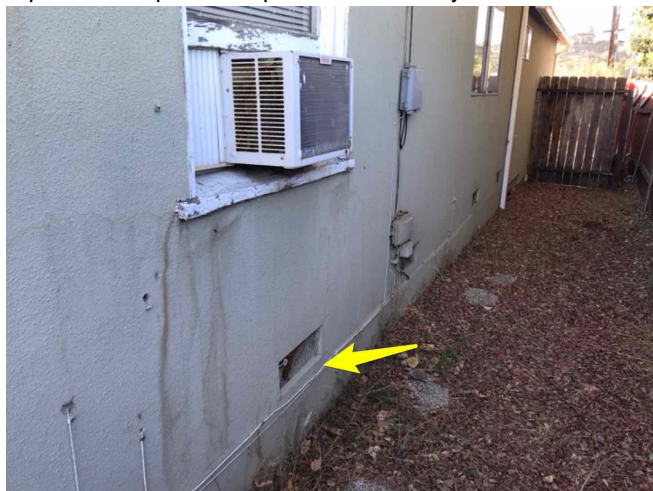
123: One of the crawl space vent screens near the right side exterior are torn. We recommend any damaged screens be repaired or replaced to prevent access by rodents or other pests.

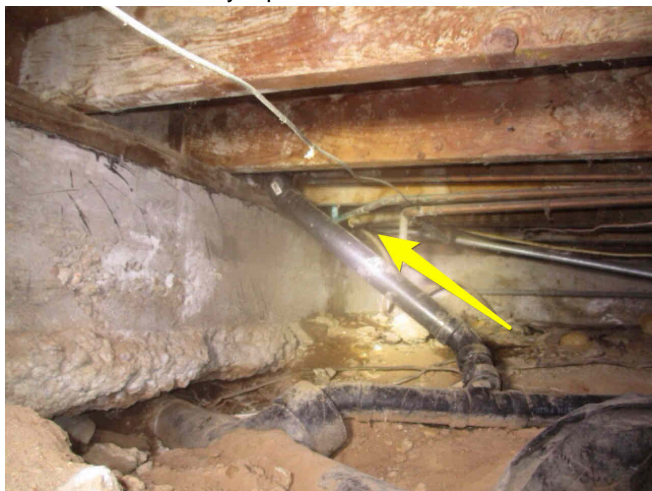
R 128: There is a water leak beneath the kitchen in the crawl space. It could not be determined the cause of the leak. Further evaluation by a plumber is needed.

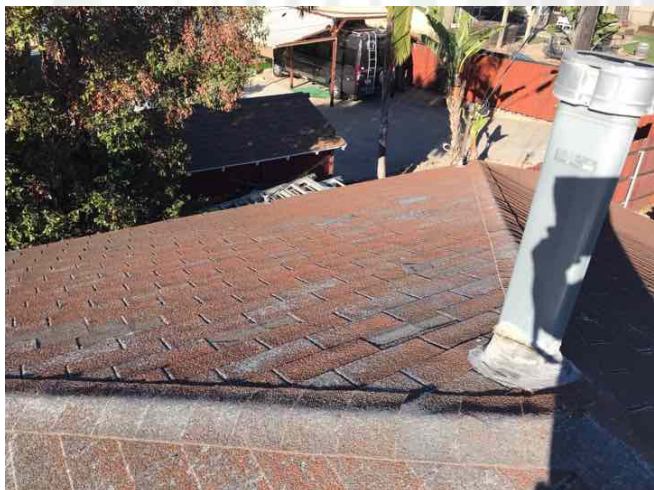
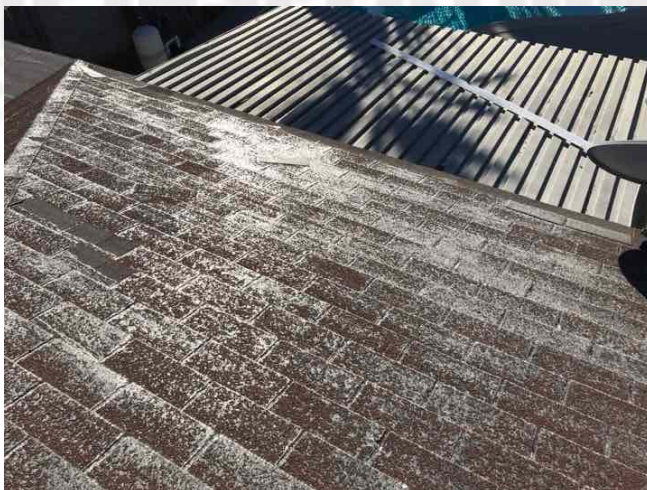
W 147: There is extensive surface granulation failure. Many of the shingles have eroded and cracked. These conditions indicate the end of the useful service life of this material.

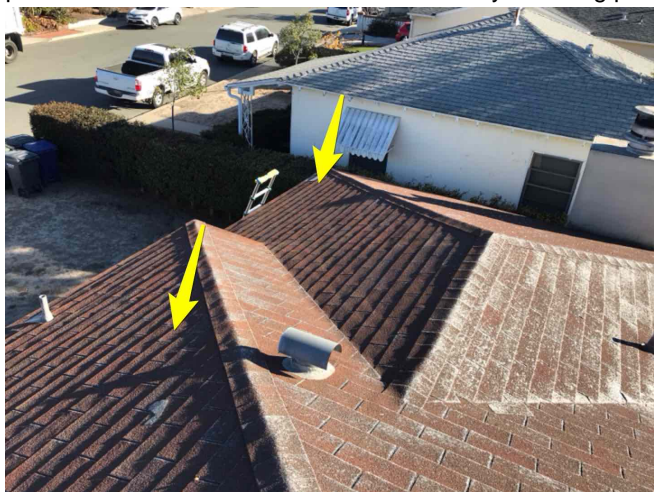
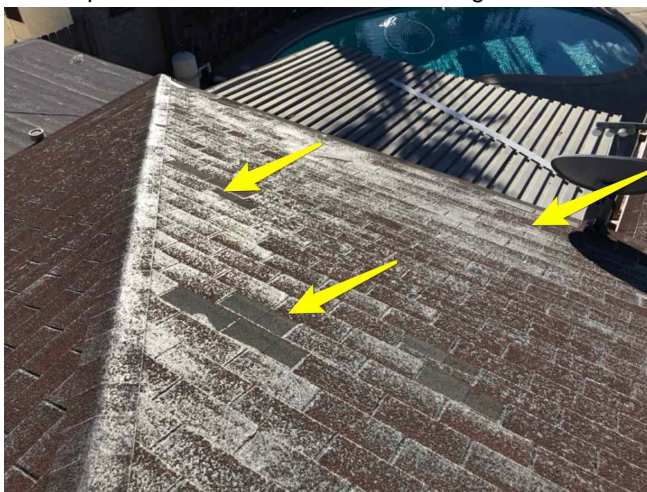
R 151: There are one or more loose or damaged shingles. It is advised that proper repairs be made by a roofing professional. Further evaluation is advised by a roofing professional to prevent moisture intrusion or damage.

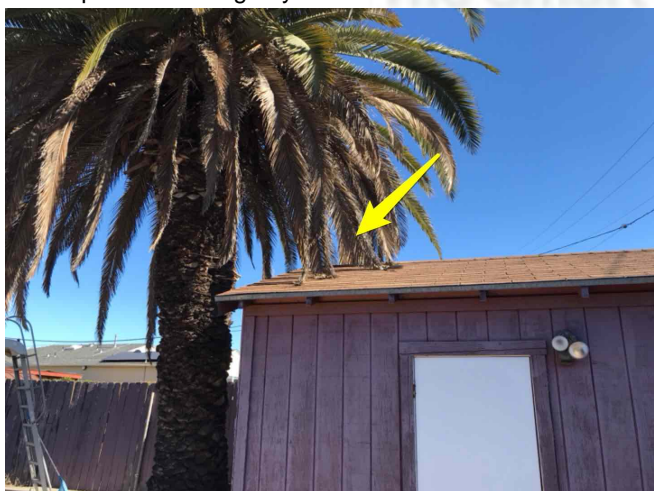
W 156: Trees are overhanging the roof. We recommend they be trimmed to prevent debris from accumulating on the roof and to prevent damage by abrasion.

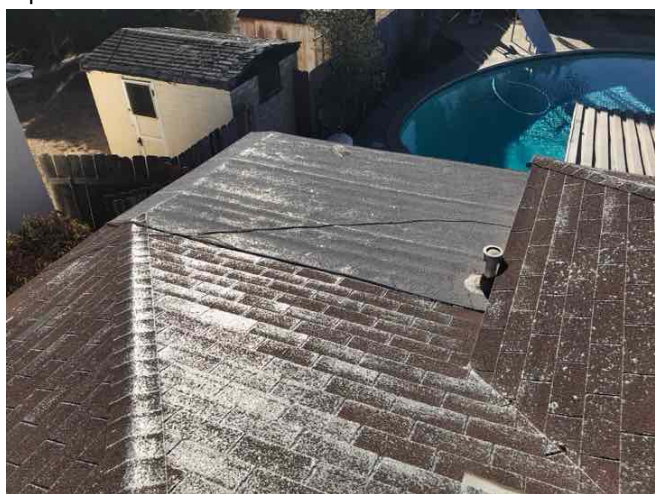
R 164: While it may be possible to patch and repair the roof, there is no guarantee that patching will be effective. Repairs cannot eliminate the need for eventual replacement. In our opinion, this roof is not serviceable and we recommend it be replaced.

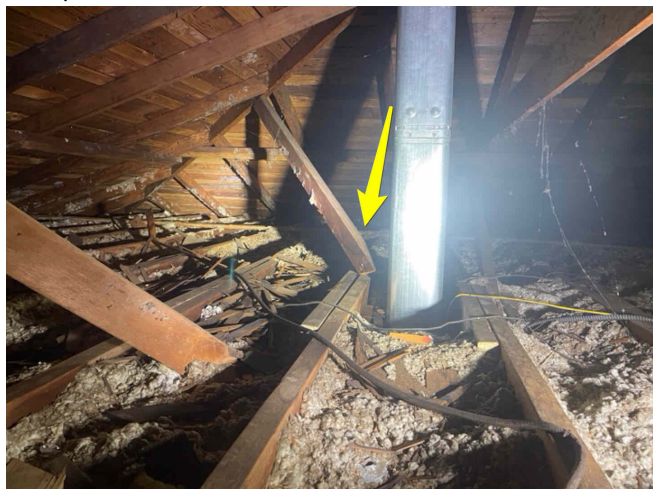
176: A purlin over the living is damaged. This may result in loss of full rafter support. We recommend the defective member be replaced.

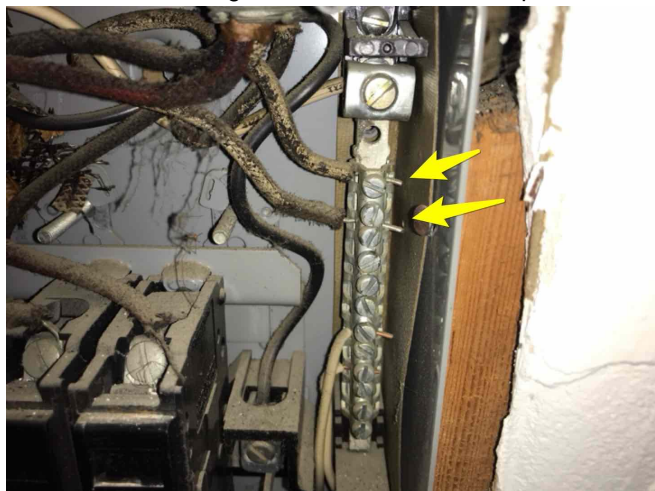
W 211: Aluminum wiring has been used for 120 volt wiring. The Consumer Product Safety Commission has determined that, aluminum wiring can be hazardous and a potential cause of fire.

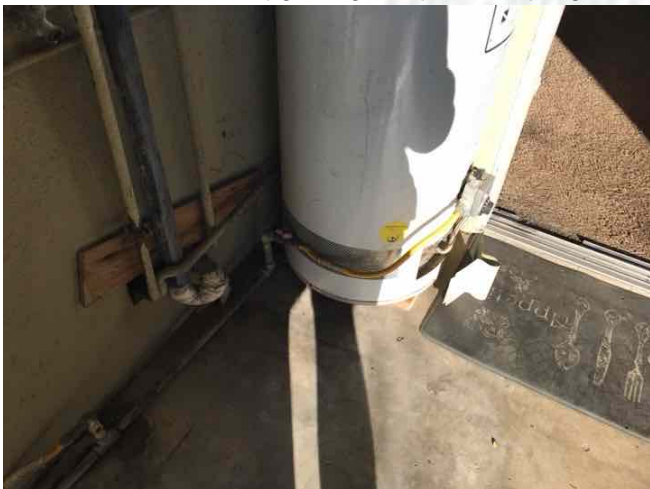
U 271: The fuel piping does not include a 'T' extension to collect condensation and debris, as is considered good practice. In the course of future upgrading or repair, a 'drip leg' should be added to the gas piping just ahead of the connector.

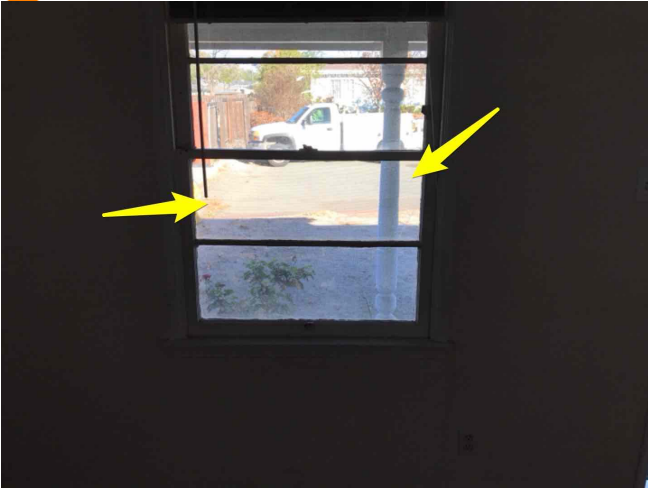
R 344: One or more panes of glass are broken. We recommend all broken glass be replaced.

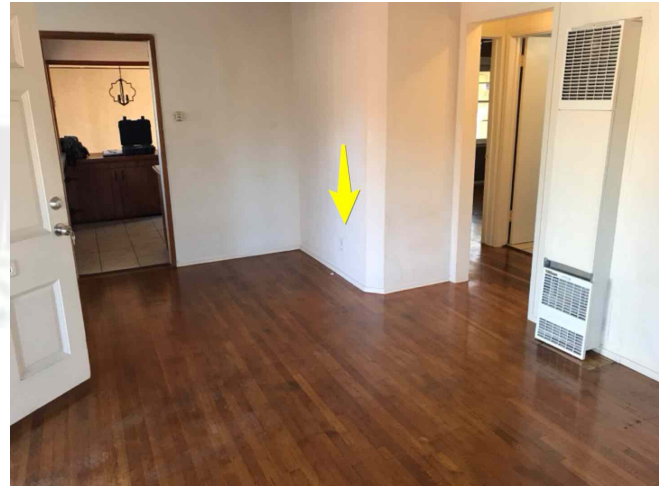
S 345: There are several ungrounded three prong receptacles in this area. We recommend they be properly grounded or restored to their original two prong configuration.

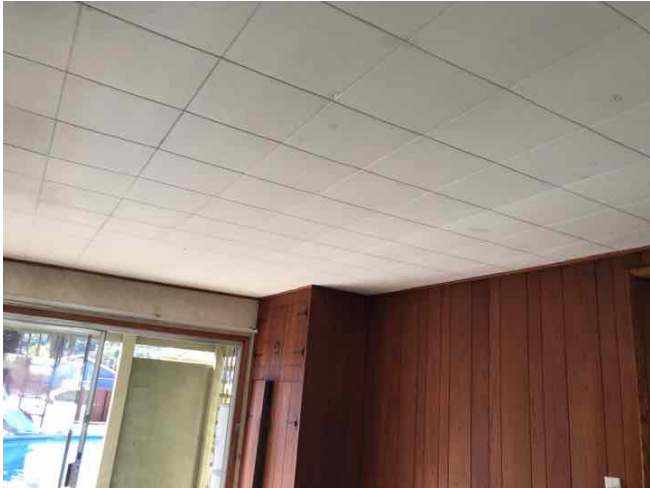
350: The ceiling material is a type that may contain asbestos. Actual asbestos content can only be determined by laboratory testing. Further information on asbestos can be obtained from a licensed asbestos consultant or abatement contractor.

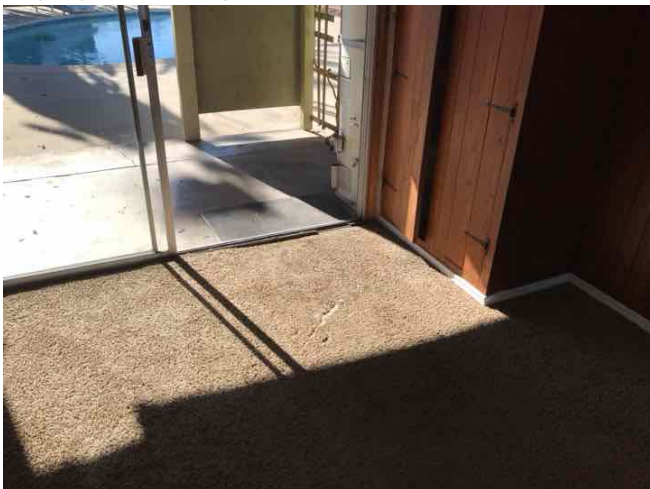
R 351: Comments on carpeting are generally beyond the scope of our inspection but, in this case, the poor condition of the carpet presents a trip hazard. We recommend removal of the carpet for safety reasons.

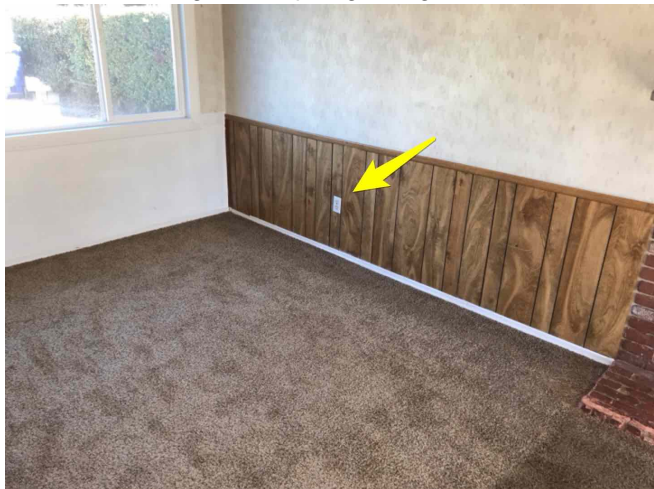
S 354: There is an ungrounded three prong receptacle at the family room. We recommend it be properly grounded or restored to its original two prong configuration.

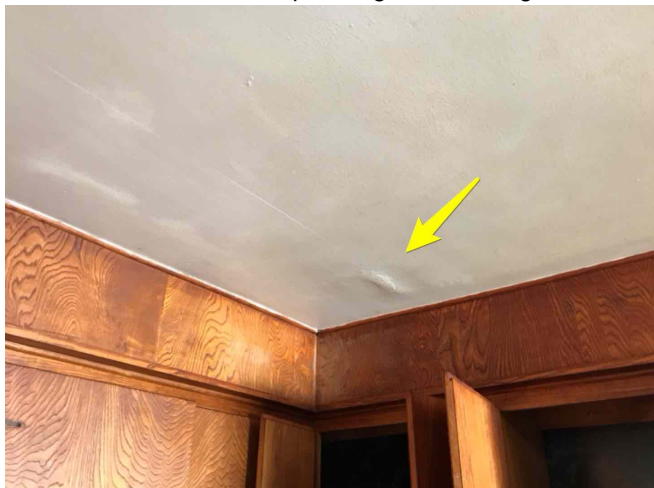
374: There is evidence of patching to the ceiling. It is advised that further inquiry be made regarding this condition.

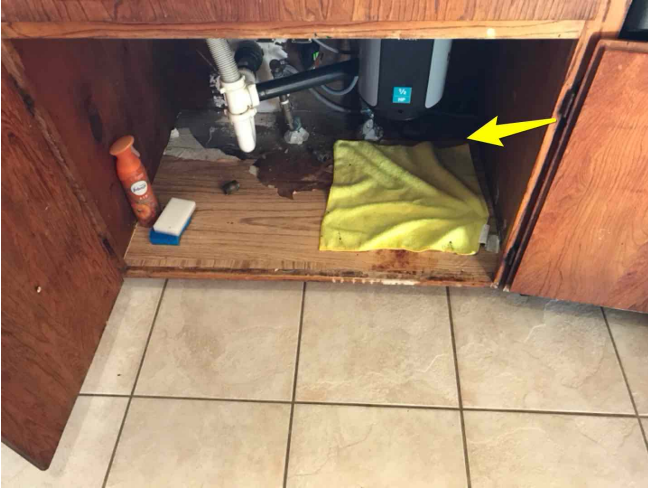
R 376: The cabinet has signs of water damage and needs to be repaired or replaced. It is also advised that the surrounding area be further evaluated for any other water related issues.

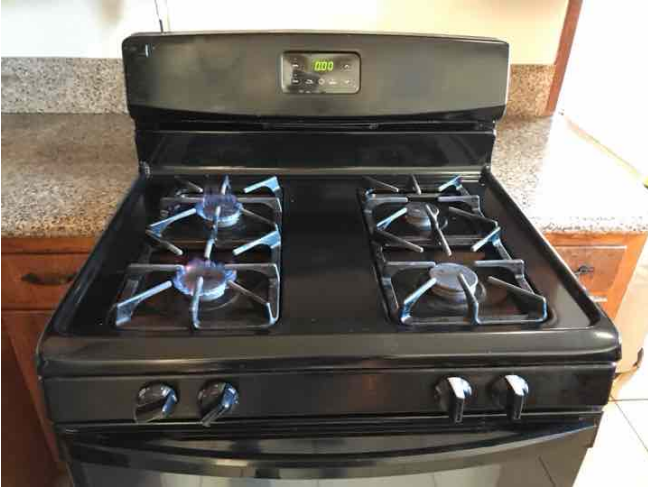
S 383: There is no anti tip bracket installed on the kitchen range. One should be added for safety.

M 384: The range has poor flame quality. It's advised that the burners be cleaned and restored to it original operating condition.

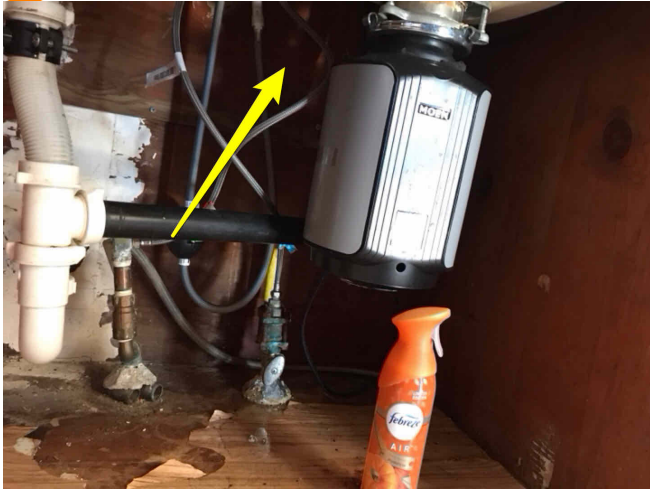
R 392: The dishwasher drain is leaking and needs to be repaired.

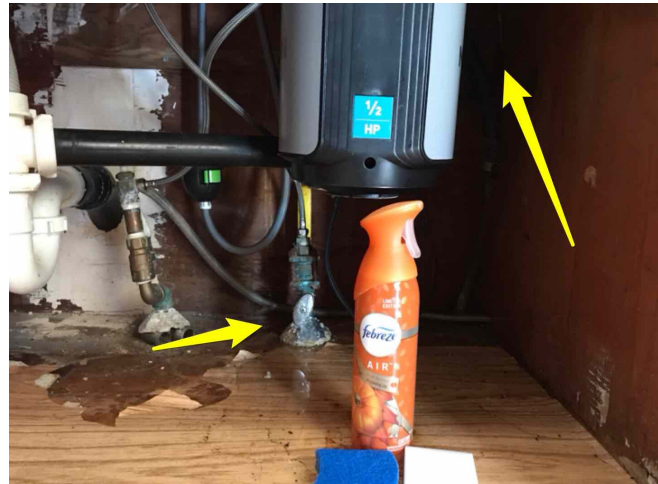
M 394: The dishwasher air gap drain is leaking and needs to be repaired or replaced.

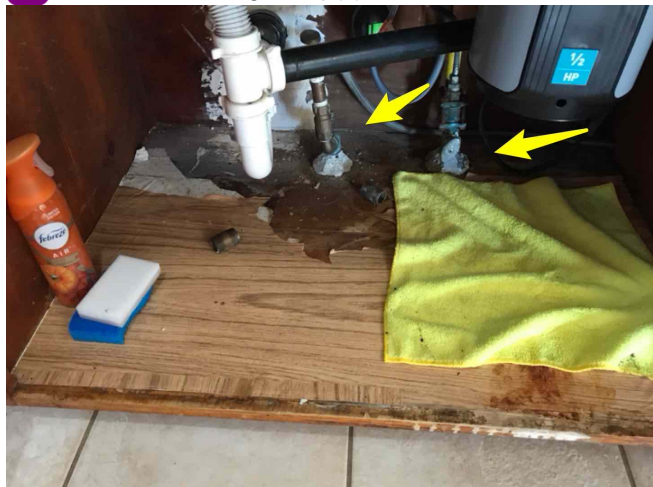
M 396: The sink angle stop(s) have corrosion and need to be serviced.

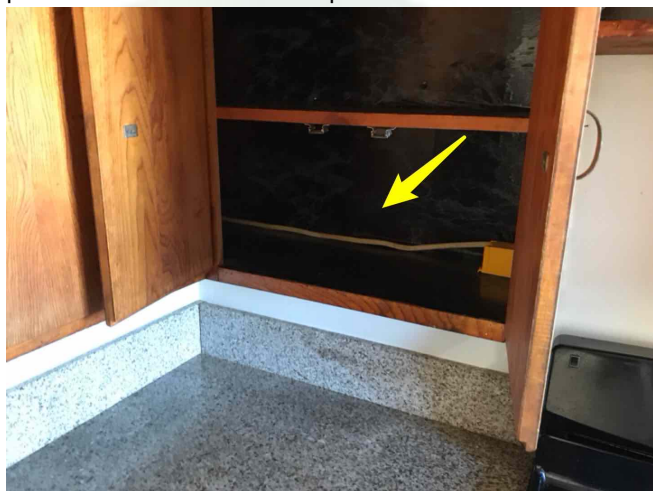
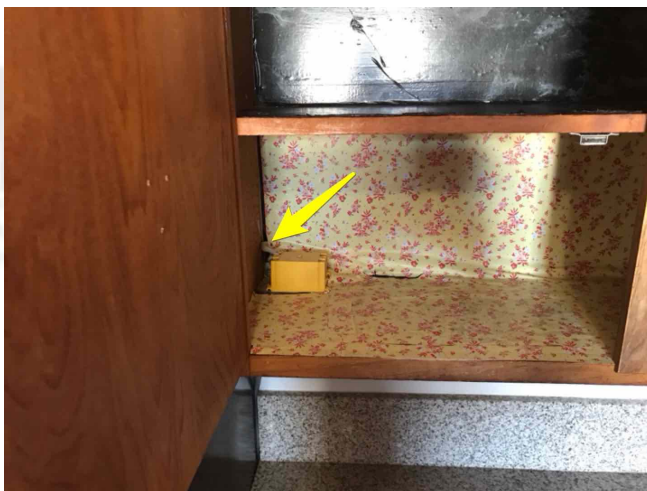
R 397: We found exposed wiring. Even if insulated, we recommend all wiring be encased in a conduit or otherwise protected in accordance with present standards.

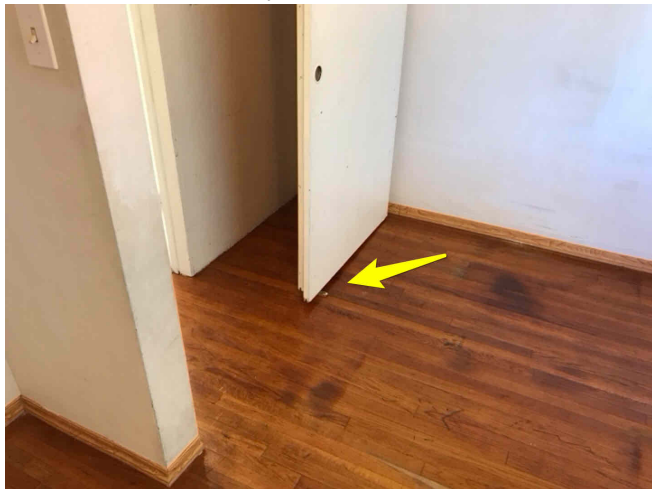
M 410: The closet doors have damaged or missing floor guides. It's advised that they be added to prevent premature wear or the doors and track system.

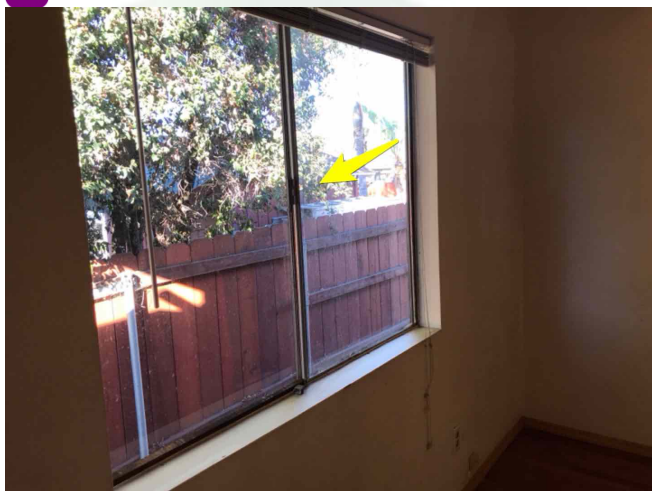
M 412: The window hardware does not latch needs service to function properly.

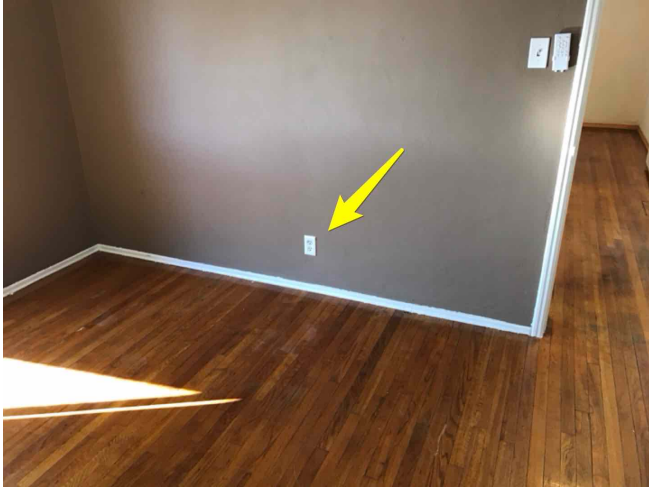
S 425: There is an ungrounded three prong receptacle at the bedroom. We recommend it be properly grounded or restored to its original two prong configuration.

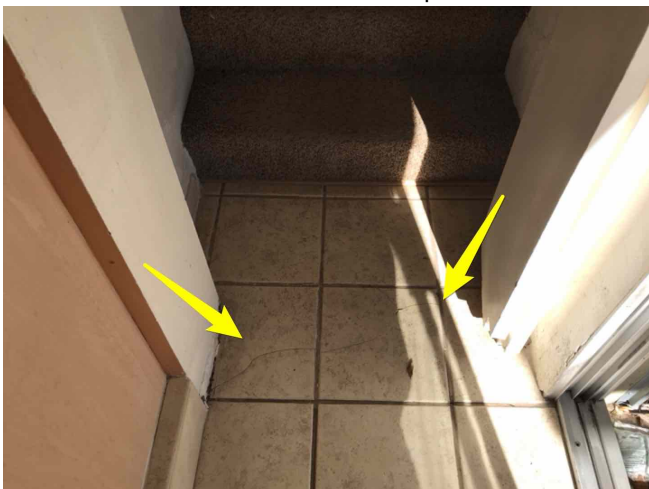
R 431: Some of the floor tiles are cracked and/or damaged. For a better appearance and to minimize additional damage, we recommend the affected tiles be replaced.

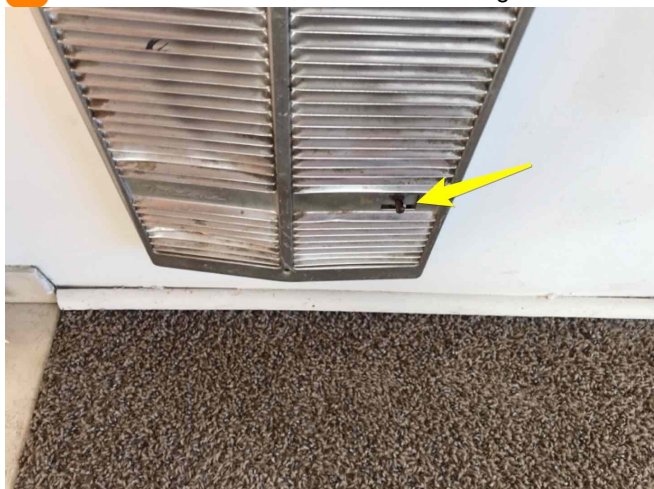
R 438: The resistance heater knob missing and should be replaced.

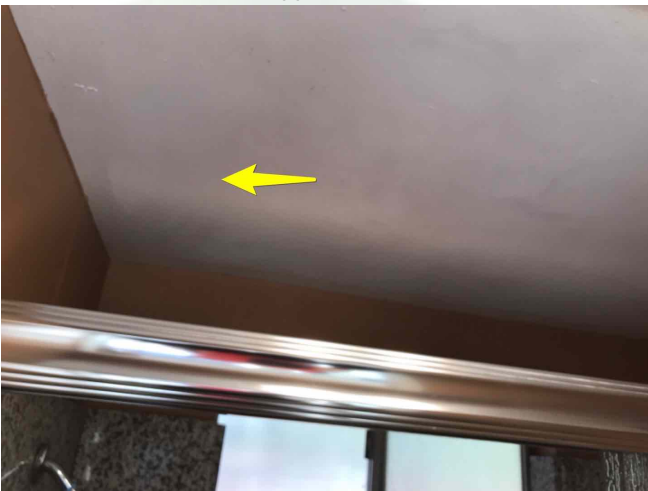
W 445: Mold and mildew have built up on the ceiling, suggesting inadequate ventilation. We recommend that the surfaces be cleaned with several applications of bleach or a similar fungicide and refinished to restore their appearance.

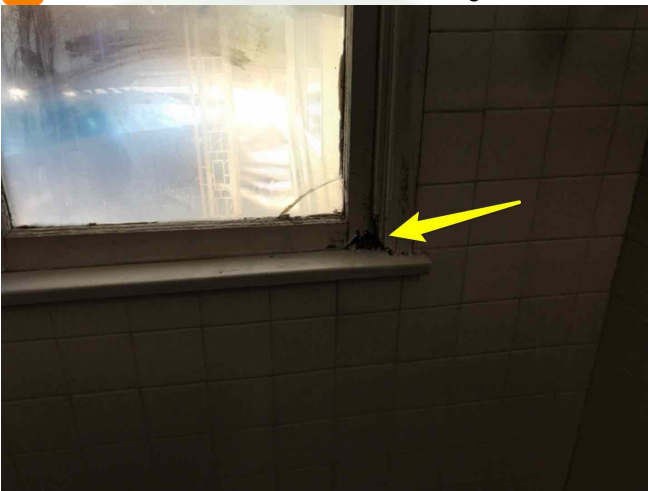
R 476: One or more windows are damaged. We recommend they be repaired or replaced.

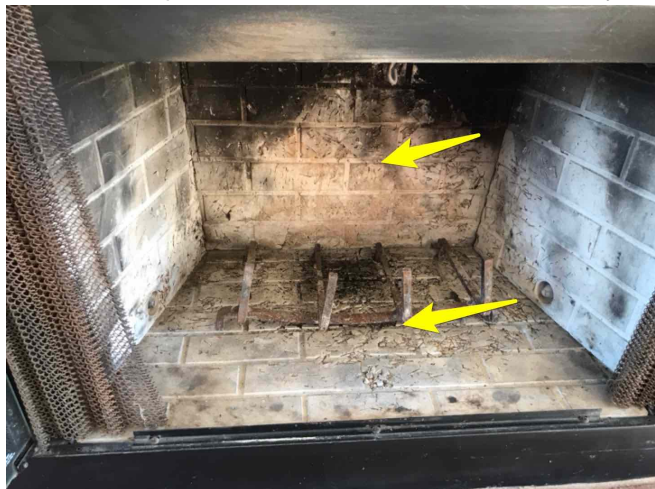
R 496: There are simulated masonry panels in the firebox, designed to help protect the metal from heat damage. One or more of these panels are cracked. We recommend they be replaced prior to use of the fireplace.
