## Your Sewer Inspection Report

**Date:** 08/06/2026

### 434 L Street, Chula Vista, CA 91911

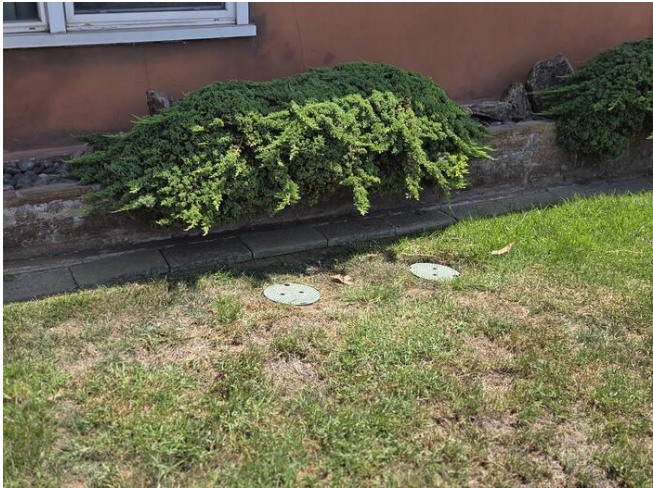
Two way cleanout access in the front yard

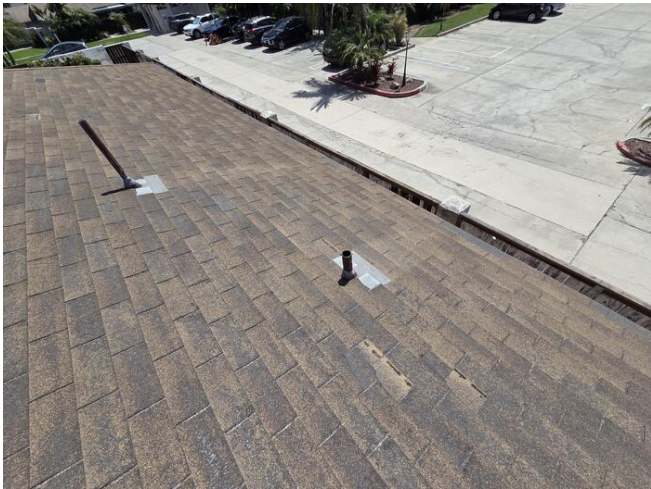
Small roof vent access

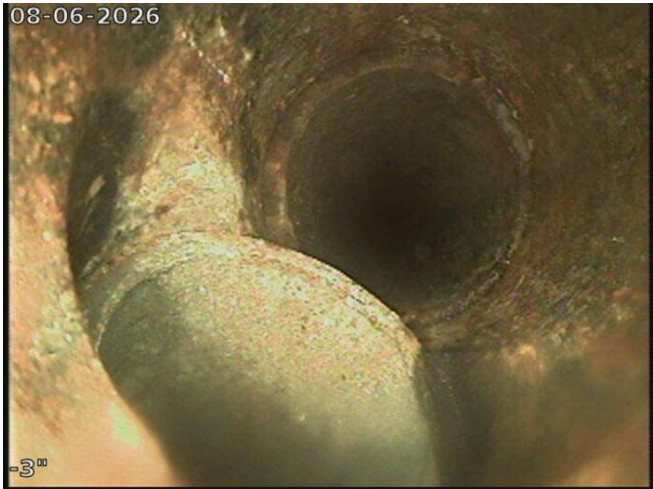
2026-08-06-14-04-44

Damaged connection on small vent line

- 1) Recommend further evaluation and repair of all damaged ABS as needed by a reputable plumbing contractor.
- 2) Recommend hydro jetting by a reputable plumbing contractor to remove buildup and help prevent backups.
- 3) Recommend a re-inspection after the hydro jetting has been done.
- 4) Recommend extending main line cleanout for under the house for the right side restroom by a reputable plumbing contractor to allow proper access to the entire sewer line.
- 5) Recommend further evaluation and repair of the vent line for right side restroom by a reputable plumbing contractor.

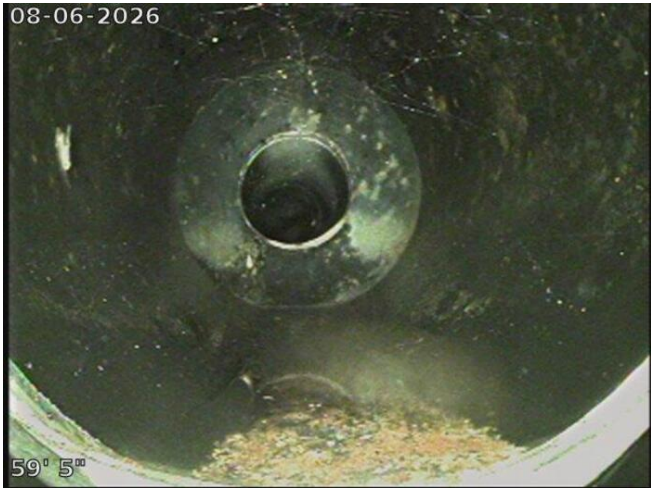
2026-08-06-13-51-47.mp4-thumb

End of the main line under the house

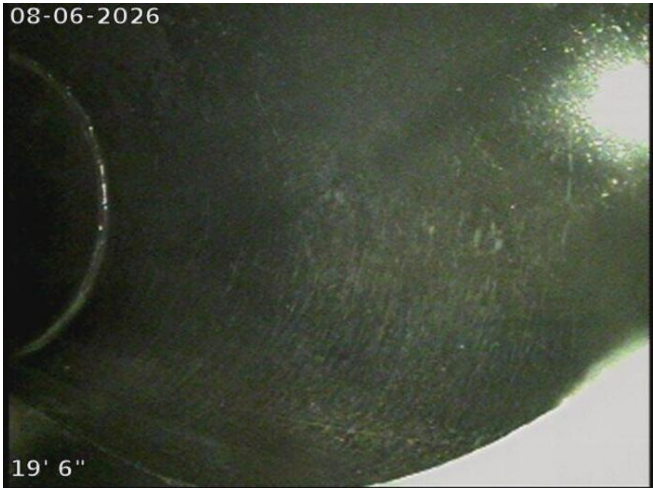
2026-08-06-14-02-17.mp4-thumb

Branch line connection to main line under house

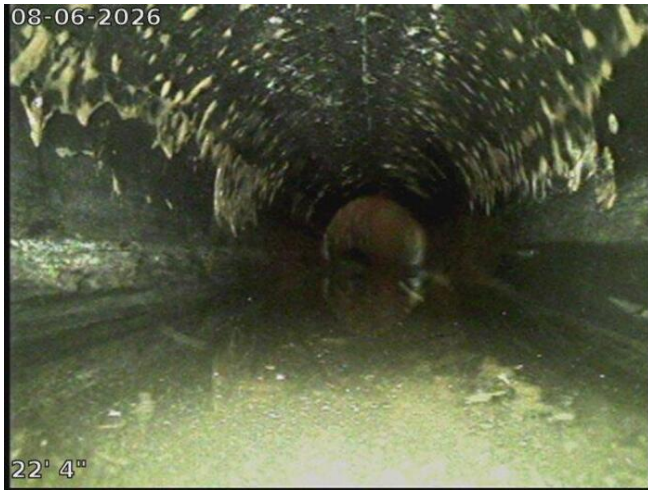
ABS under the house is open and in serviceable condition. ABS outside of the house is damaged (area was located and marked with a flag, about 4' deep). Cast Iron outside of the house has buildup which is restricting the visibility. Clay outside of the house to the city main is open and in serviceable condition.

2026-08-06-13-49-19  
Damaged ABS to Cast Iron connection

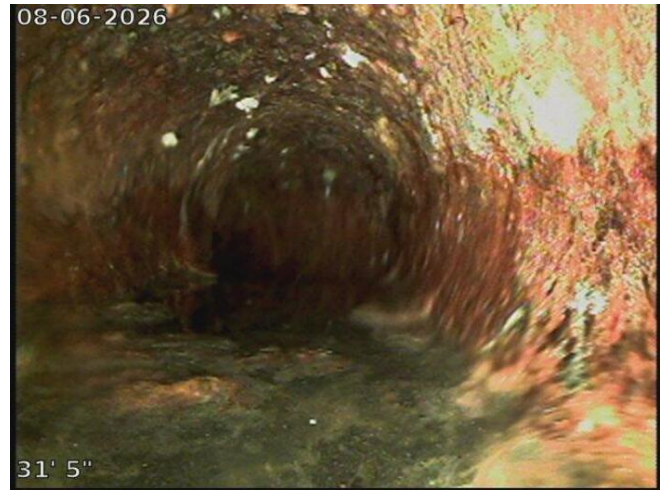
2026-08-06-13-46-34  
Heavy buildup in the Cast Iron

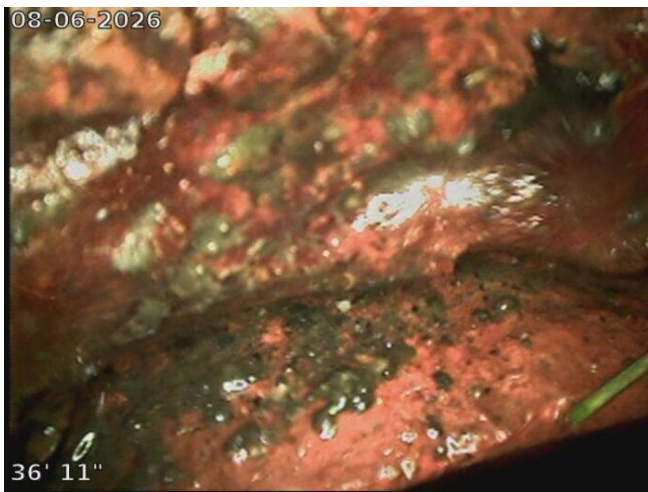
2026-08-06-13-49-49  
Cast Iron to Clay connection

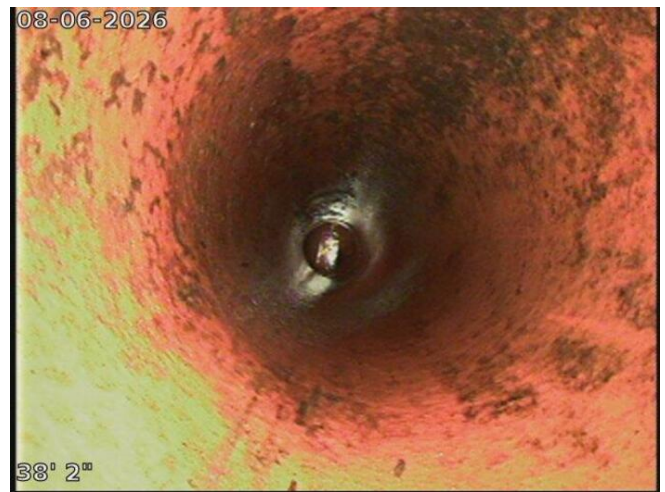
2026-08-06-13-45-55  
Connection to the city main

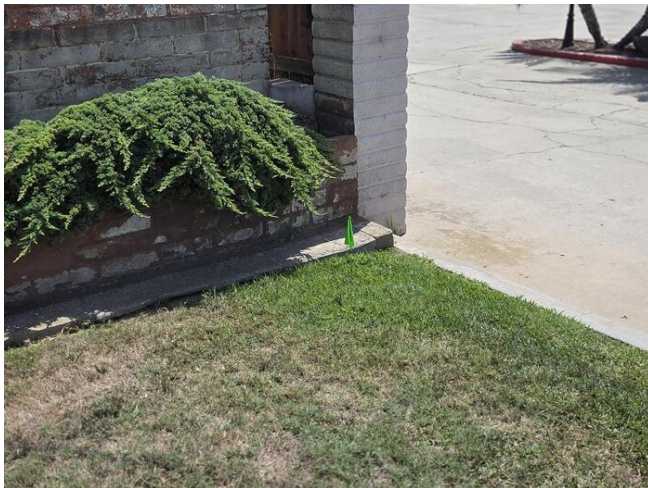
No title  
Flag marking an area of the damaged ABS (about 4' deep)
