# DeBerry / HomeSite Inspections

5702 Baltimore Drive, #255  
La Mesa, CA 91942  
File #: 201006-S1  
October 6th, 2020

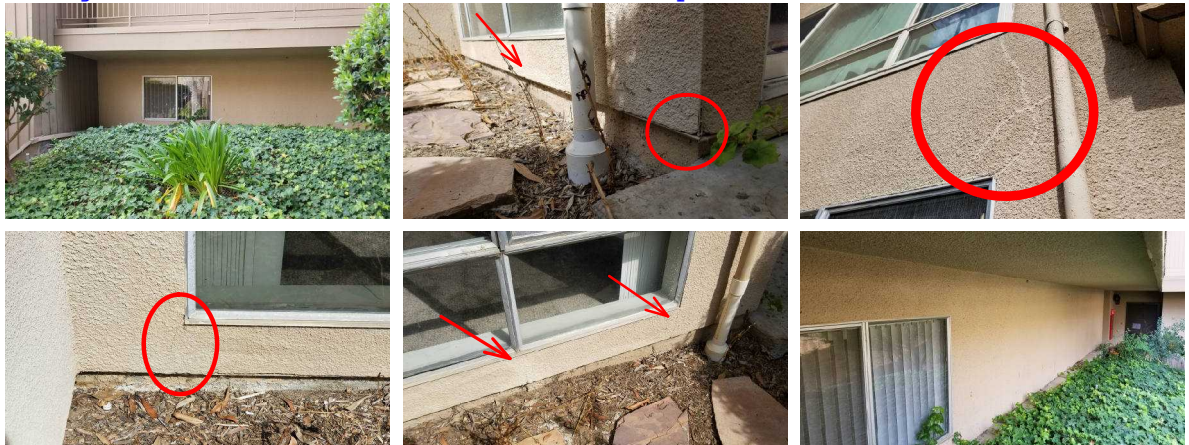
Minor damage to the stucco weep screed in areas. Ensure that grading is positively sloped away from the foundation / siding. Ensure water doesn't pool or pond against the foundation or siding. Keep moisture / water from hitting against the exterior siding.

Hairline settlement cracking noted - patched and repaired cracks visible. Seal cracks and voids to prevent moisture intrusion and damage. Items warrant attention and repair.

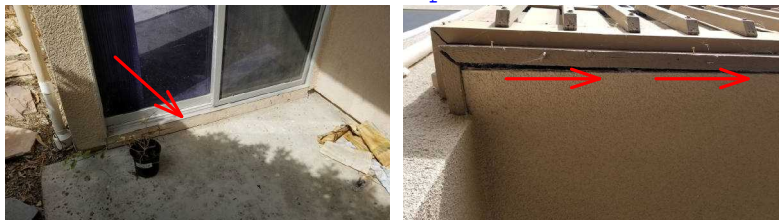
Trim(Eaves,Soffits,Fascia): Wood- Please Note: The exterior trim is part of the Home Owners' Association. Due to height and angle restrictions, the trim was not able to be fully inspected at this time.

Weathered wood along the threshold of the sliding glass door. Seal voids between the trim and stucco beneath the balcony situated over the patio. Ensure all exterior wood kept well painted and sealed. Items warrant attention and repair.

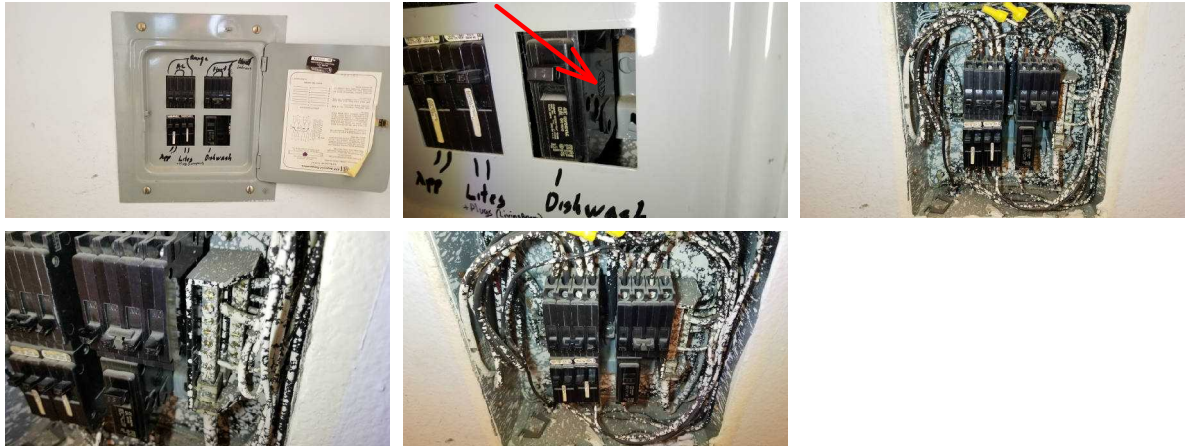
Defective Panel Notes: Sub-Panel- The following defects observed, include but are not limited to the following: Missing "twist-out" on the dead-front cover. This is a safety hazard. Cap should be placed over the opening.

Heavy paint over-spray noted inside panel. This condition can lead to overheating inside the panel. Recommend further review and repairs by a licensed electrical contractor.

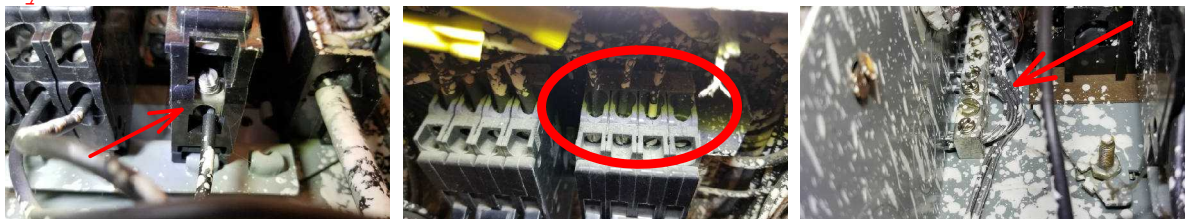
Defective Conductors - Branch Wiring: Aluminum. Aluminum wiring noted at the general 120 volt circuits, return neutral wires and ground wires. This is a safety hazard. Aluminum connections should be checked by a licensed electrician familiar with aluminum branch wiring.

See "Panel Notes" regarding the electrical panel and panel components. Further evaluation is recommended. Recommend further review and repairs by a licensed electrical contractor.

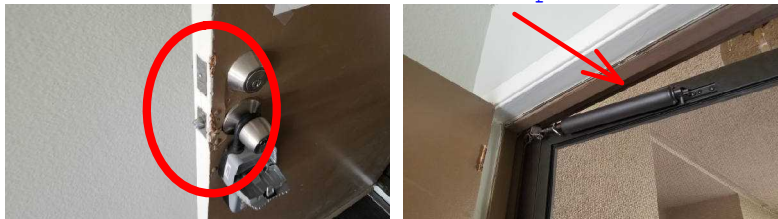
Marginal Doors (Entry:) Damage to the front door around the latching and locking hardware. Self closing mechanism on the screen door needs adjustment. Items warrant attention and repair.

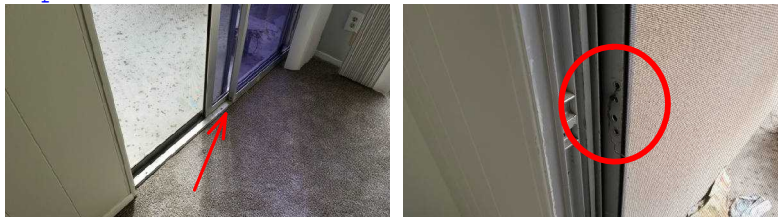
Marginal Doors (Exterior) Sliding Glass- The sliding glass door has been installed backwards. The fixed section of the door is situated on the inner track, leaving the sliding door on the exterior track. These doors should be reversed.

Damage to the screen door frame - handle missing. Corrosion / damage to the frame of the sliding glass door. Items warrant attention and repair.

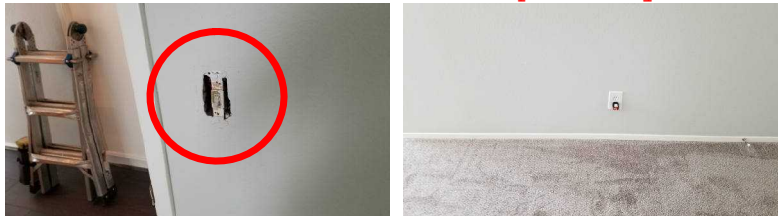
Electrical: 120 VAC outlets and lighting circuits- Missing cover plate over the light switch junction box at the entry to the Southeast bedroom.

Reverse polarity noted at outlets. Correction needed: West side of the Southeast bedroom.

Worn outlets, creating intermittent contact should be replaced: South side of the Southeast bedroom. East side of the living room. At the front entry.

Missing protective cover over light fixture: Southeast bedroom closet.

Recommend further review & repairs by a licensed electrical contractor.

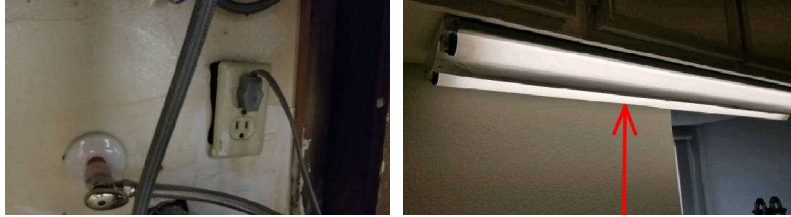
Electrical: 120 VAC- Kitchen - Non-GFCI receptacles noted. This is a safety hazard. Local codes require all outlets that serve kitchen counters to be GFCI protected. This is inclusive of kitchens that have been remodeled.

Receptacle located beneath the sink is loosely secured. This is a safety hazard.

Light fixture over the sink loosely secured. Recommend further review & repairs by a licensed electrical contractor.

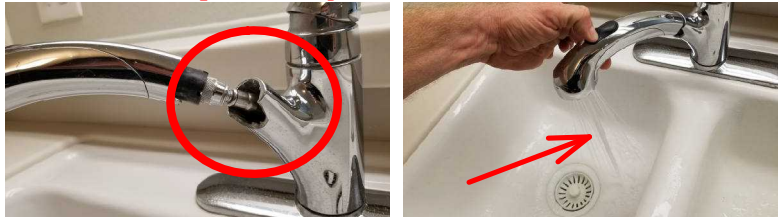
Faucet(s): Faucet housing is cracked at the base of the neck. Spray wand diverter is not functioning properly. Water coming out of both the faucet and the sprayer at the same time. Audible squealing sound noted during operation of the fixture. Recommend further review & repairs by a licensed plumbing contractor.

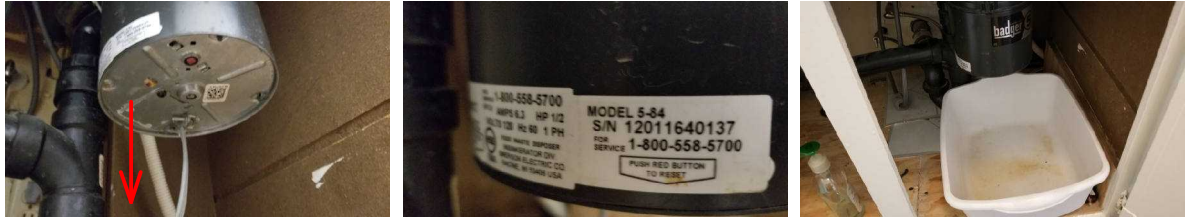
**Disposal(s):** Bucket situated beneath the disposal at the time of inspection. Interior of the disposal is corroded / rusted. Blades frozen. Water leaked from the underside of the unit when testing. Disposal is at the end of its life-span. Recommend replacement. Recommend further review & repairs by a licensed plumbing contractor.

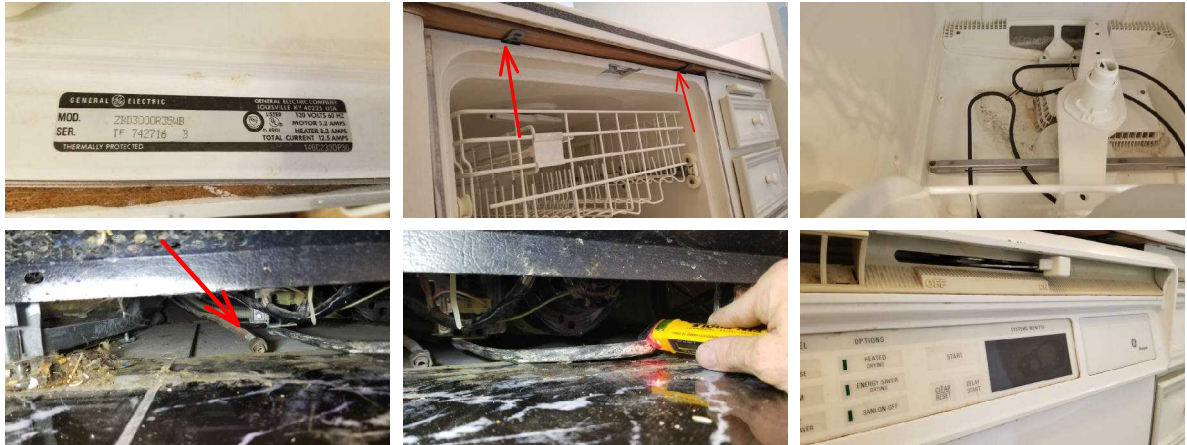
**Dishwasher:** Inoperative at time of inspection. Unable to test. No power to the display at the dishwasher controls. Base panel beneath the unit was removed. Power detected at the electrical cord to the unit however the hot water supply line was found to be disconnected.

Corrosive build-up at the interior of the unit. Dishwasher not adequately secured to the cabinetry / countertop. Dishwasher may at the end of its useful life. Replacement may be necessary. Recommend further review & repairs by a licensed contractor.

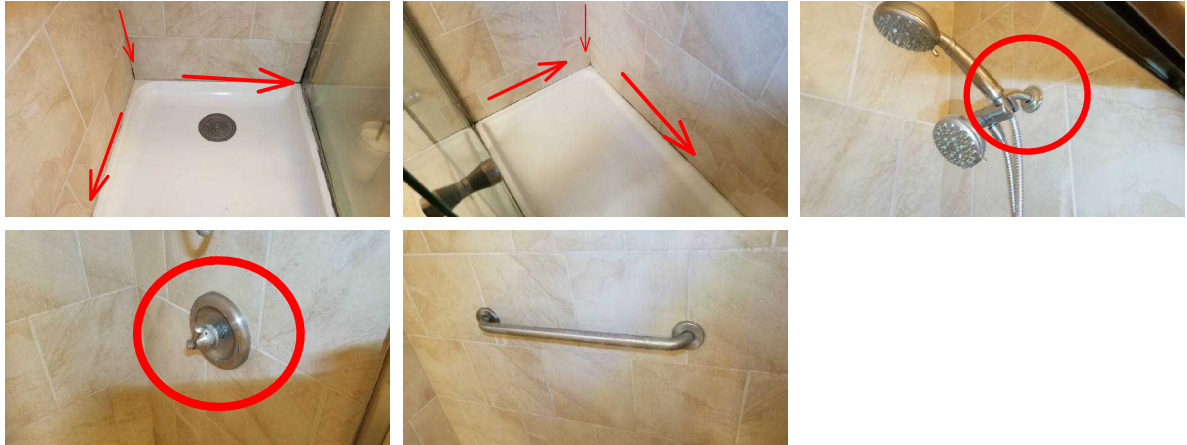
Seal around all fixture connections to the enclosure walls. Corrosion noted on the shower fixtures. Ensure all tiles & fixtures inside the shower are kept well sealed. Notice: Shower pan not leak tested. Item(s) warrant attention & repair.

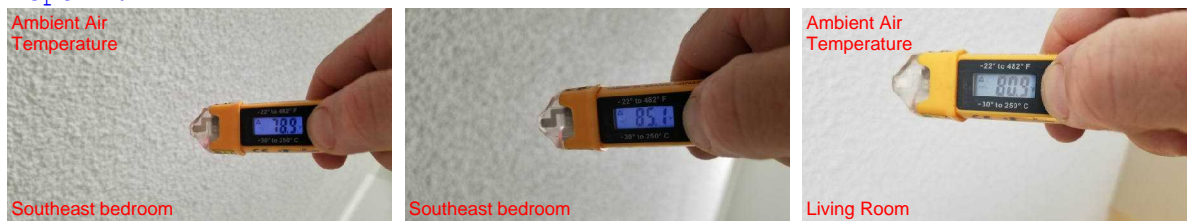
Southeast bedroom / Living room : Although functional at this time, the units may be at or nearing the end of their life spans based on the average expected useful life of such units. Item(s) warrant attention & repair.

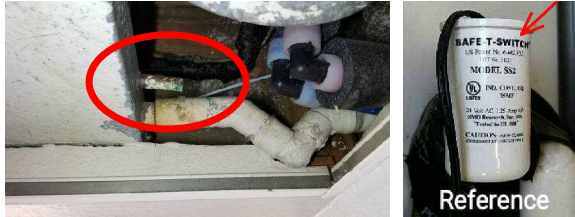
Condensate Lines: Not fully visible- No secondary condensate line installed. Should the primary condensate line become obstructed, this could result in moisture damage. Recommend the installation of a secondary "Safe-T" switch emergency cut-off. Recommend complete system evaluation by a licensed HVAC contractor.

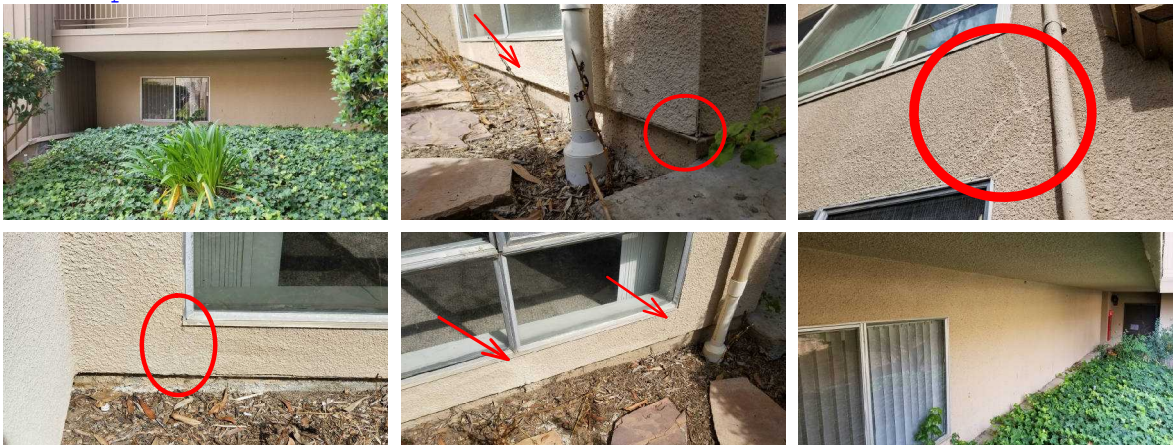
Hairline settlement cracking noted - patched and repaired cracks visible. Seal cracks and voids to prevent moisture intrusion and damage. Items warrant attention and repair.

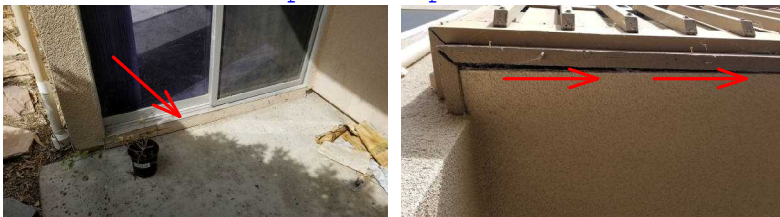
2. Trim(Eaves,Soffits,Fascia): Wood- Please Note: The exterior trim is part of the Home Owners' Association. Due to height and angle restrictions, the trim was not able to be fully inspected at this time.

Weathered wood along the threshold of the sliding glass door. Seal voids between the trim and stucco beneath the balcony situated over the patio. Ensure all exterior wood kept well painted and sealed. Items warrant attention and repair.

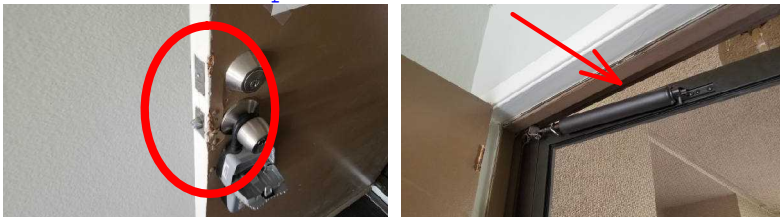
11. Doors (Entry:) Damage to the front door around the latching and locking hardware. Self closing mechanism on the screen door needs adjustment. Items warrant attention and repair.

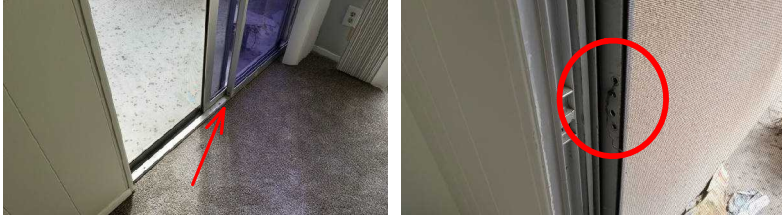
12. Doors (Exterior) Sliding Glass- The sliding glass door has been installed backwards. The fixed section of the door is situated on the inner track, leaving the sliding door on the exterior track. These doors should be reversed.

Damage to the screen door frame - handle missing. Corrosion / damage to the frame of the sliding glass door. Items warrant attention and repair.

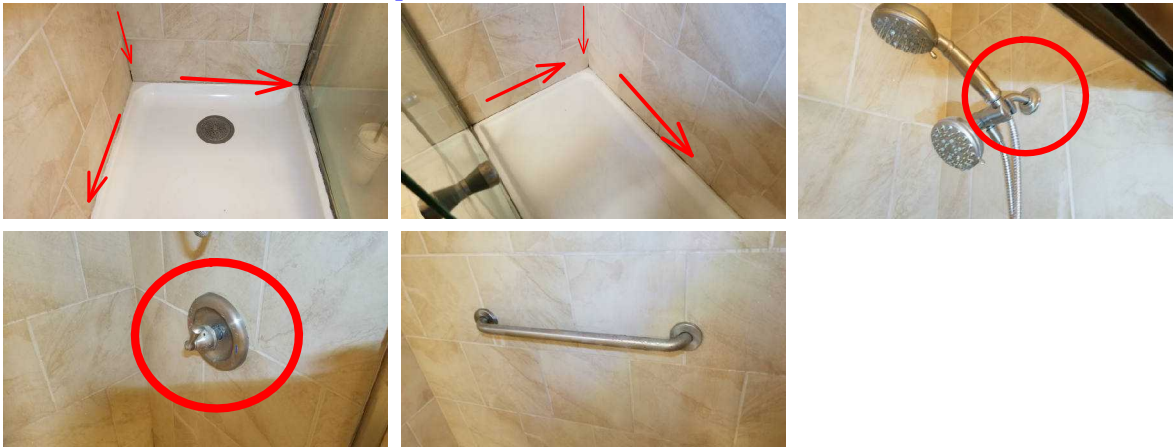
Seal around all fixture connections to the enclosure walls. Corrosion noted on the shower fixtures. Ensure all tiles & fixtures inside the shower are kept well sealed. Notice: Shower pan not leak tested. Item(s) warrant attention & repair.

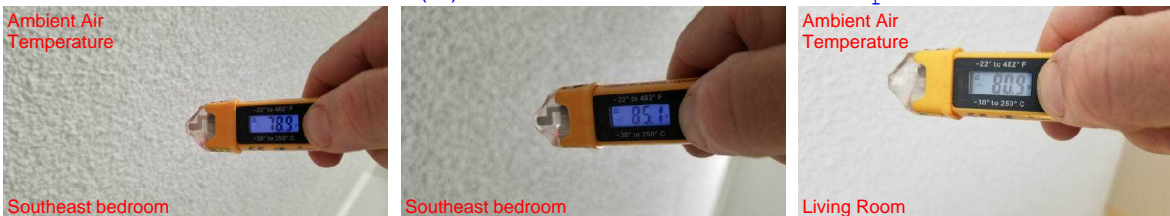
Southeast bedroom / Living room : Although functional at this time, the units may be at or nearing the end of their life spans based on the average expected useful life of such units. Item(s) warrant attention & repair.

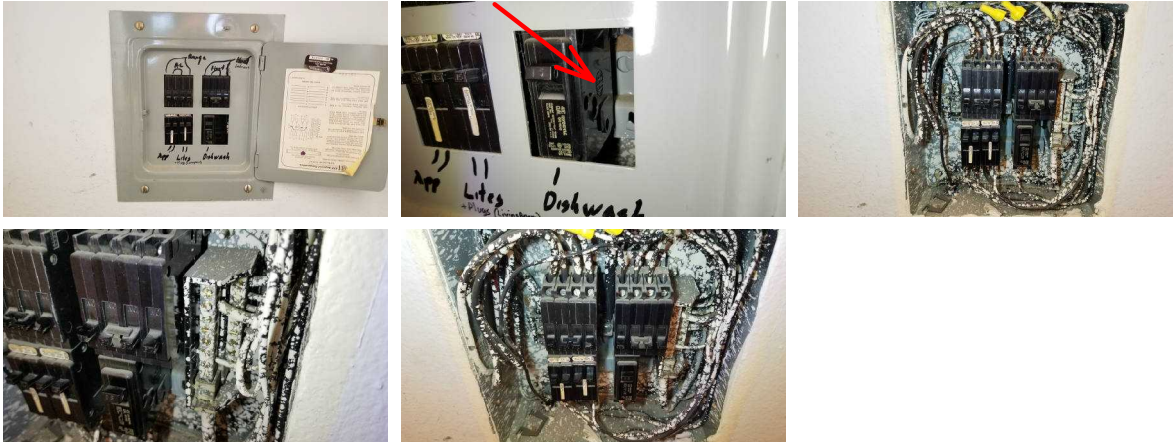
Heavy paint over-spray noted inside panel. This condition can lead to overheating inside the panel. Recommend further review and repairs by a licensed electrical contractor.

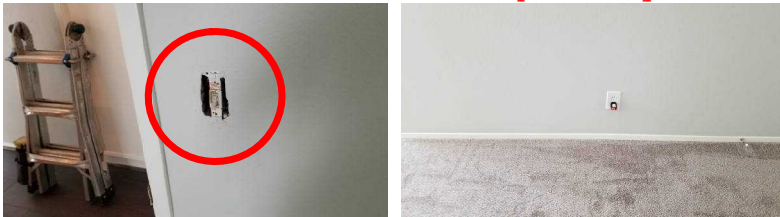
5. Electrical: 120 VAC outlets and lighting circuits- Missing cover plate over the light switch junction box at the entry to the Southeast bedroom.

Recommend further review & repairs by a licensed electrical contractor.

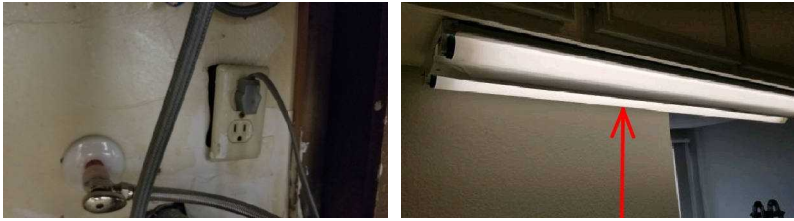
6. Main floor Kitchen Electrical: 120 VAC- Kitchen - Non-GFCI receptacles noted. This is a safety hazard. Local codes require all outlets that serve kitchen counters to be GFCI protected. This is inclusive of kitchens that have been remodeled.

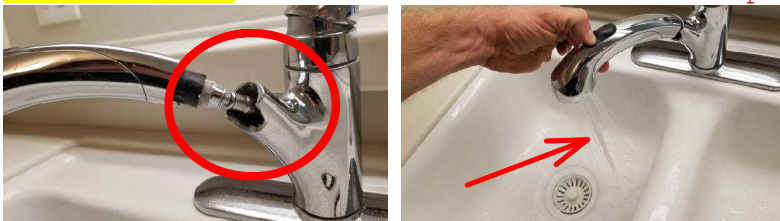
7. Main floor Kitchen Faucet(s): Faucet housing is cracked at the base of the neck. Spray wand diverter is not functioning properly. Water coming out of both the faucet and the sprayer at the same time. Audible squealing sound noted during operation of the fixture. Recommend further review & repairs by a licensed plumbing contractor.

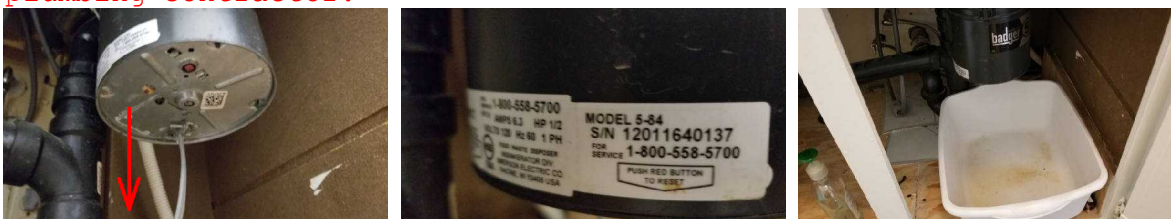
9. Main floor Kitchen Disposal(s): Bucket situated beneath the disposal at the time of inspection. Interior of the disposal is corroded / rusted. Blades frozen. Water leaked from the underside of the unit when testing. Disposal is at the end of its life-span. Recommend replacement. Recommend further review & repairs by a licensed plumbing contractor.

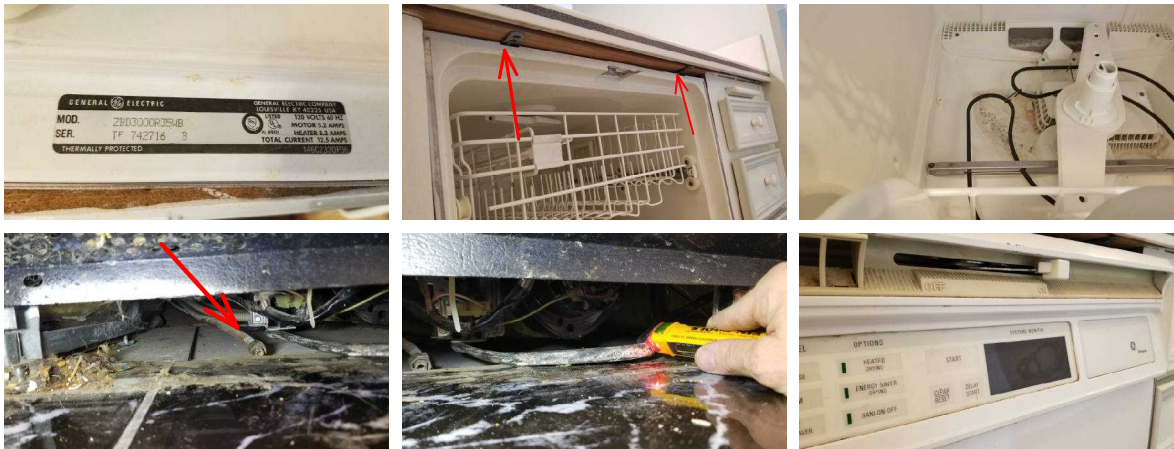
10. Main floor Kitchen Dishwasher: **Inoperative at time of inspection. Unable to test. No power to the display at the dishwasher controls. Base panel beneath the unit was removed. Power detected at the electrical cord to the unit however the hot water supply line was found to be disconnected.**

Corrosive build-up at the interior of the unit. Dishwasher not adequately secured to the cabinetry / countertop. Dishwasher may at the end of its useful life. Replacement may be necessary. Recommend further review & repairs by a licensed contractor.

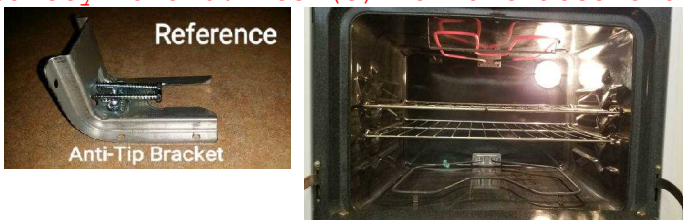
11. Main floor Kitchen Oven: Electric- Oven is missing an anti-tip bracket. This is a safety hazard. Item(s) warrant attention & repair.

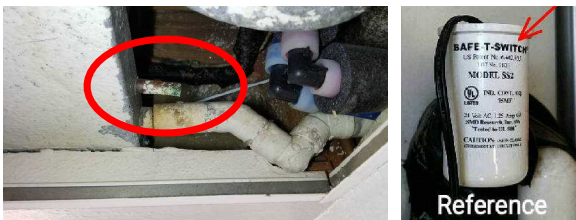
14. Recessed ceiling compartment. Heating System Condensate Lines: Not fully visible- No secondary condensate line installed. Should the primary condensate line become obstructed, this could result in moisture damage. Recommend the installation of a secondary "Safe-T" switch emergency cut-off. Recommend complete system evaluation by a licensed HVAC contractor.
