**COAST TO CACTUS**  
PROPERTY INSPECTIONS

# HOME INSPECTION REPORT

**7351 Purdue Ave, La Mesa, CA 91942**

| <b>Report Number:</b> | 2026010904 |

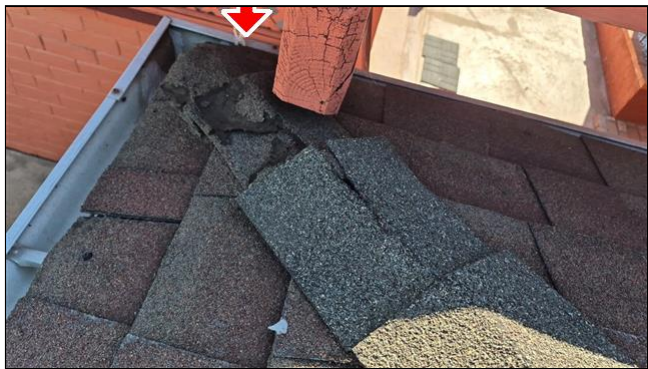
1.0 Item 1 (Picture)

(2) Damaged/temporarily repaired ridge cap observed at rear left. Recommend replacement.

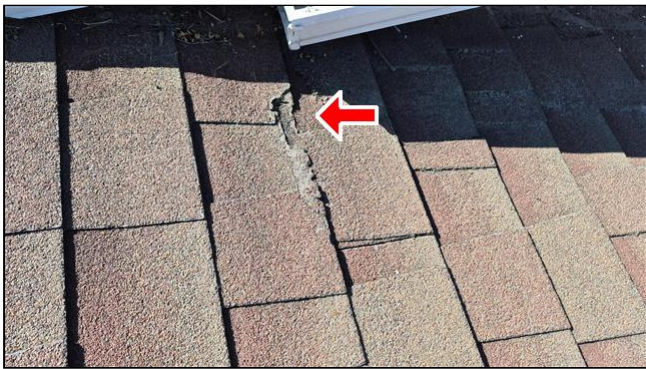
1.0 Item 3 (Picture)

(3) Damaged shingle observed at front left. Recommend replacement.

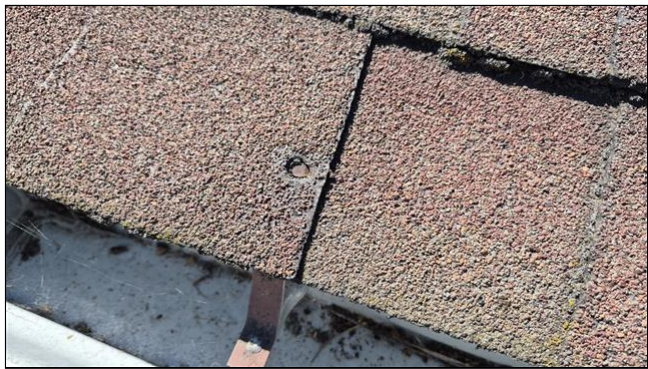
1.0 Item 4 (Picture)

(4) Exposed nails observed at the gutters. Recommend repair/correcting.

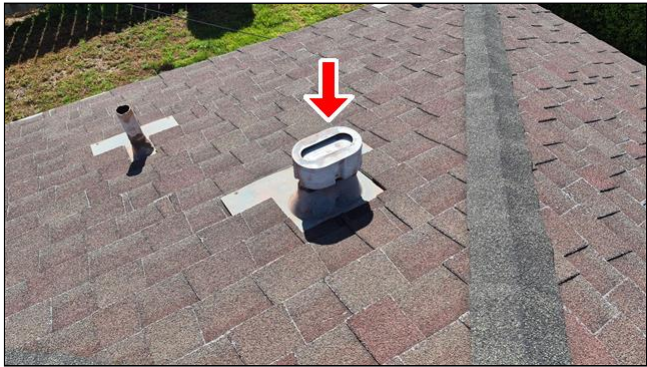
1.1 Item 2 (Picture)

(2) Loose rain cap observed at abandoned heating vent. Suggest securing.

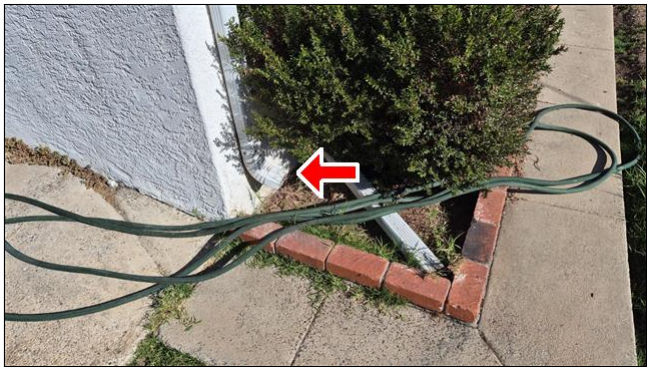
1.3 Item 1 (Picture)

🏠 (1) Downspout does not kick outward at rear right side. Recommend correcting and installing splash blocks at the base of the downspouts to divert water away from the foundation.

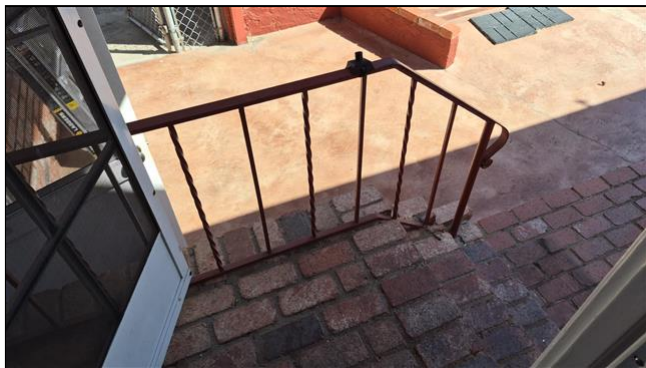
3.1 Item 1 (Picture)

(1) Barrier railings are not installed to meet current height standards (42") and baluster spacing is wider than current standards recommend (4") at the front and rear porch. Suggest correcting as a safety enhancement

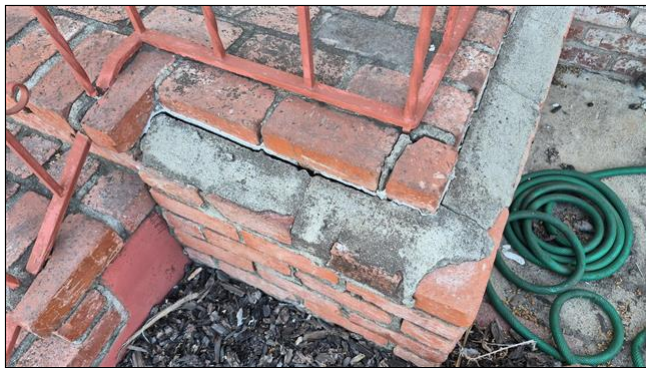
3.1 Item 3 (Picture)

(2) Cracking and loose bricks observed at porch/patios. Suggest repair.

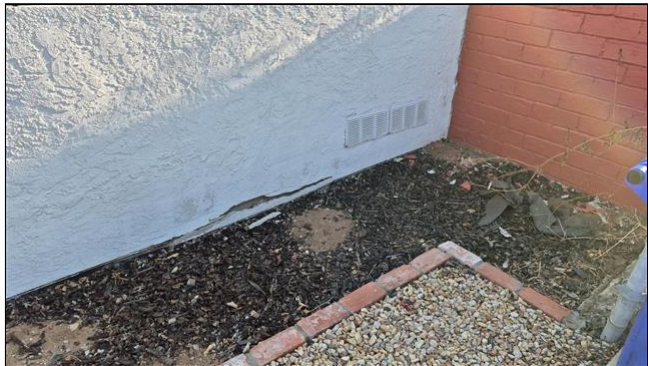
3.2 Item 1 (Picture)

🏠 (1) Rusted weep screed, excessive deterioration and inadequate clearance from grade/soil observed at front right side wall cladding. Recommend repair.

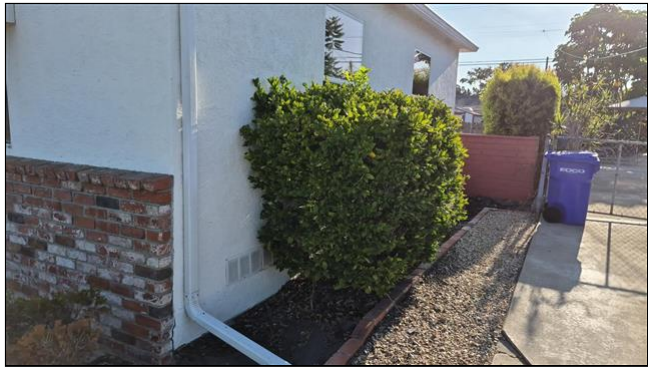
3.2 Item 5 (Picture)

🏠 (2) Vegetation is in direct contact with the wall cladding. Recommend trimming or removal.

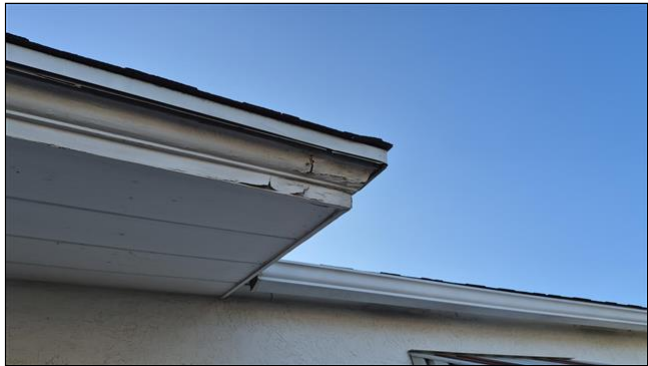
3.3 Item 1 (Picture)

🏠 Deterioration observed in areas of the eaves/fascia/exterior wood. Recommend further evaluation by a licensed branch 3 pest inspector, prior to the end of the contingency period.

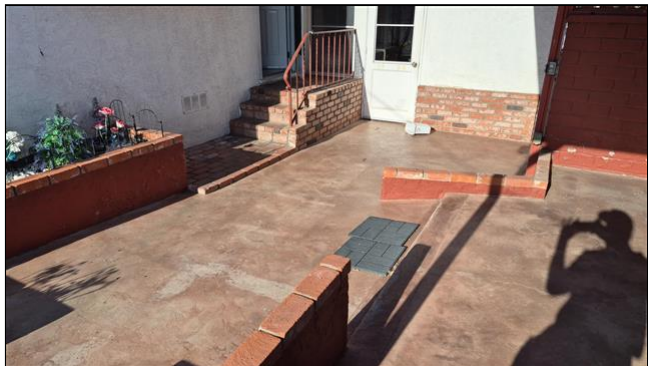
3.4 Item 1 (Picture)

(1) Inadequate grade drainage observed at rear. Regrading, filling low lying areas and/or adding alternative means of drainage is recommended to ensure all water drains away from the foundation and exterior walls.

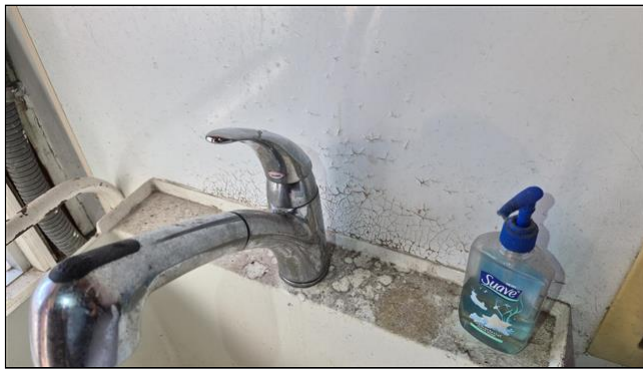
4.1 Item 2 (Picture)

(2) Peeling paint observed at garage walls. Suggest repair.

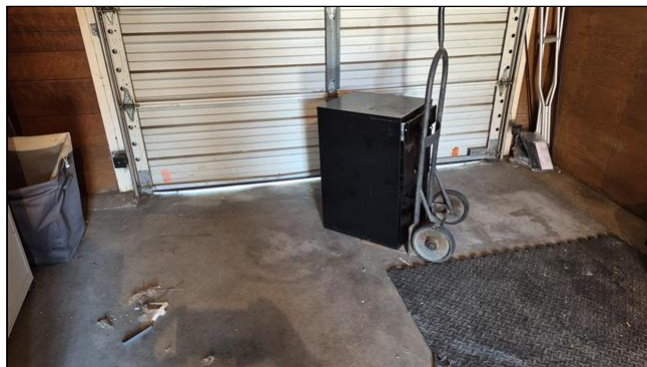
4.4 Item 1 (Picture)

📌 The garage door does not completely close or seal shut - gap observed. Recommend correcting.

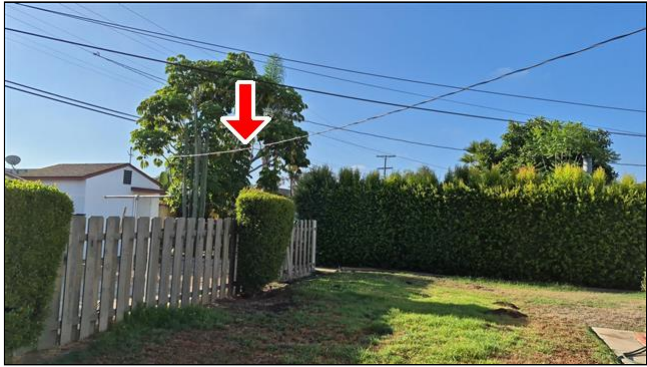
5.0 Item 1 (Picture)

🏠 The rear shed electrical service conductors clearance from the ground is lower than 10 feet. Recommend correcting.

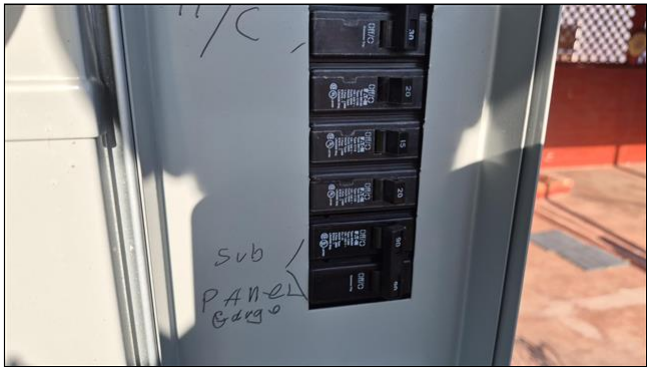
5.2 Item 1 (Picture)

🏠 (1) Circuits are not correctly labeled. Recommend labeling.

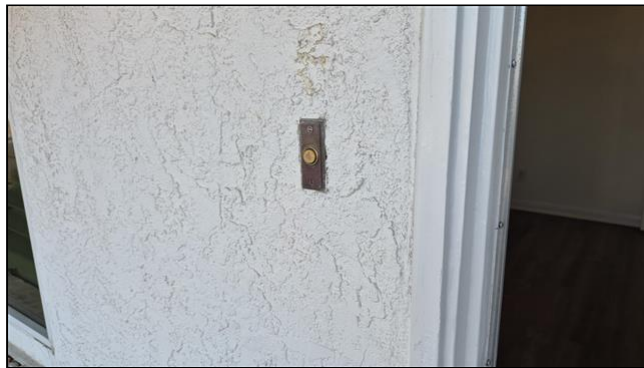
5.5 Item 3 (Picture)

(2) Door bell did not respond or is inoperable. Suggest repair.

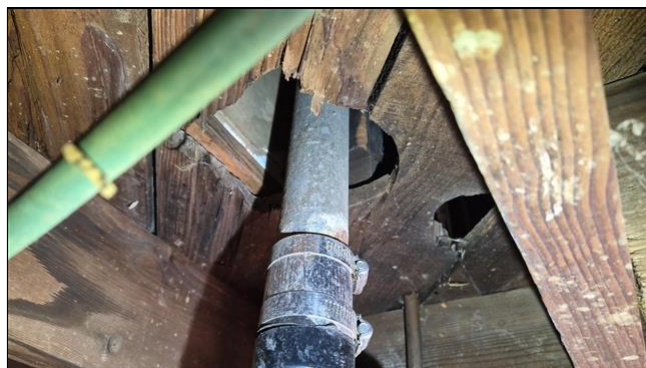
6.2 Item 1 (Picture)

📍 (1) Remaining cast iron/galvanized DWV piping in the crawlspace is beyond its intended service life. Recommend verifying overall condition and remaining service life with a qualified plumber, prior to the end of the contingency period.

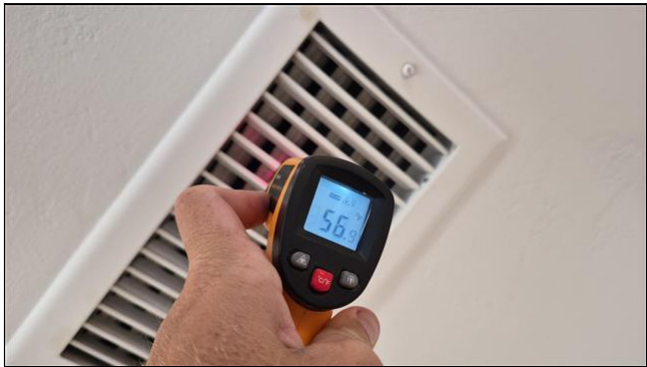
8.2 Item 1 (Picture)

(1) The air conditioning system was operated using normal operation controls (thermostat). The difference between the return air vent and the service registers was between the recommended range of 15 to 20 degrees Fahrenheit. Changing the air filters, servicing and regular maintenance of the components is necessary to prolong the service life of the system.

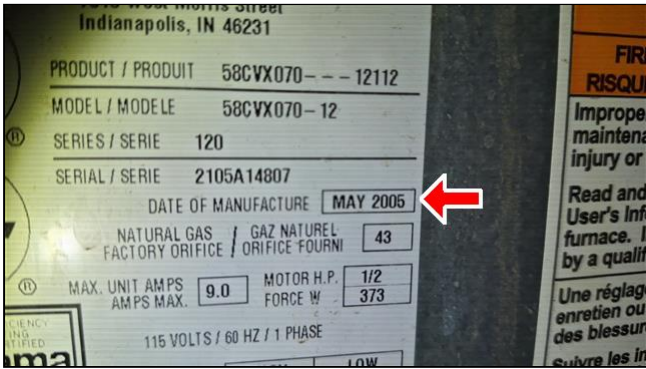
8.8 Item 1 (Picture)

(2) HVAC system is nearing the end of its estimated service life. The buyer is advised to verify the overall condition of the system with a qualified HVAC contractor, prior to the end of the contingency period.

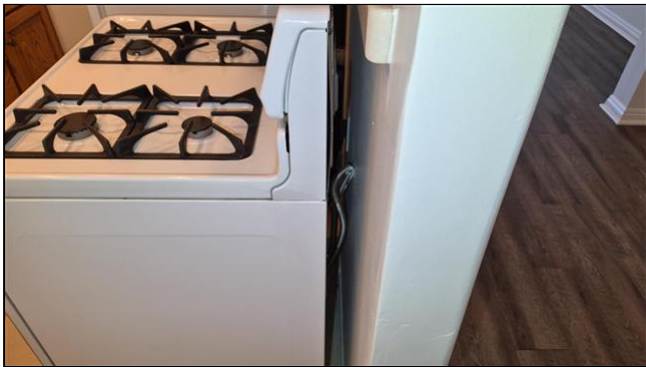
9.1 Item 1 (Picture)

Anti-tip bracket is not installed.  
Recommend installing.

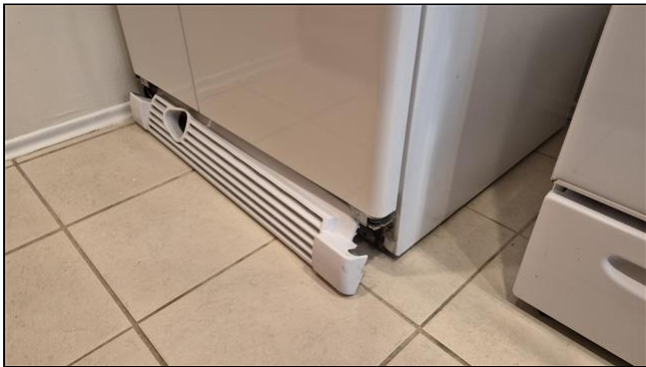
9.4 Item 1 (Picture)

Loose trim observed at  
refrigerator. Suggest repair.

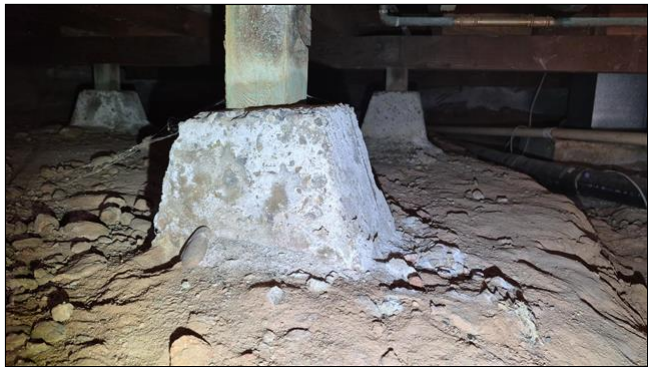
11.2 Item 1 (Picture)

Efflorescence/spalling observed on foundation walls and piers. This is an indication of excessive moisture intrusion into the crawlspace. See grading/drainage comments in the exterior category.

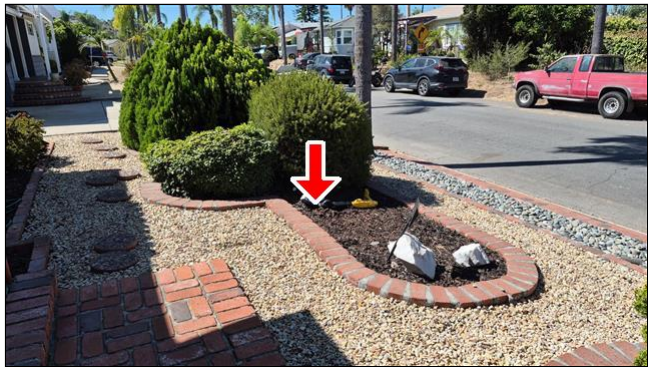
12.1 Item 1 (Picture)

The sewer line from the roof vent access to the stoppage point, measured at a length of 51 feet. Stoppage point is not due to any material defects within the line. Stoppage is due to bends within the sewer line and unavailable additional clean-out access points. (Main line clean-out is not installed/buried at front) - Recommend verifying the condition of the remaining line, prior to the end of contingency period.
