# **Inspection Report**

**Property Address:**  
12136 St Andrews Dr  
Rancho Mirage CA 92270

**Livingston Home Inspections, Inc.**

<b>Date:</b> 4/27/2022	<b>Time:</b> 09:00 AM	<b>Report ID:</b> 20220427-12136-St-Andrews-Dr
<b>Property:</b> 12136 St Andrews Dr Rancho Mirage CA 92270	<b>Customer:</b> Garrett Saikley	<b>Real Estate Professional:</b> Jonathan Olow Big Block Realty

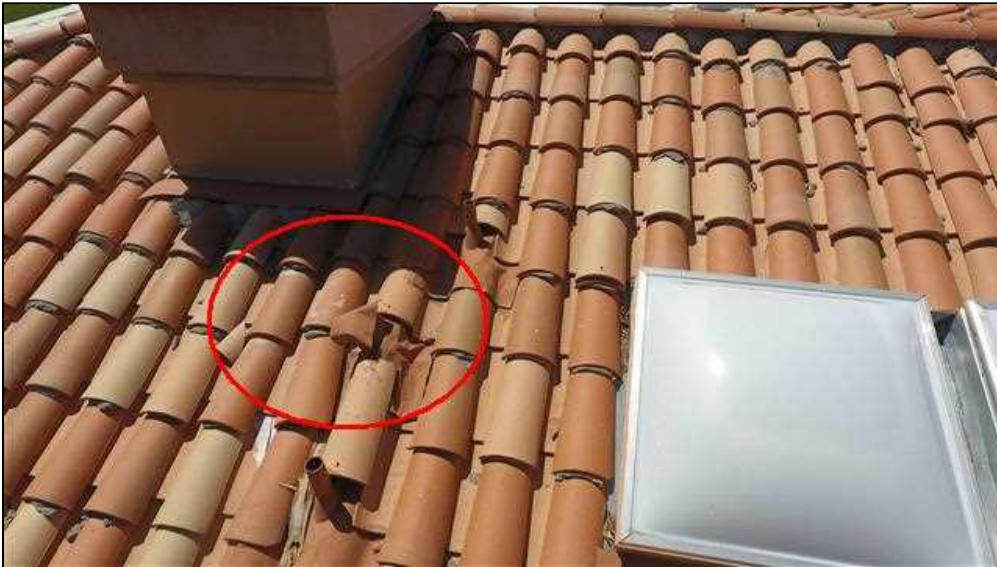
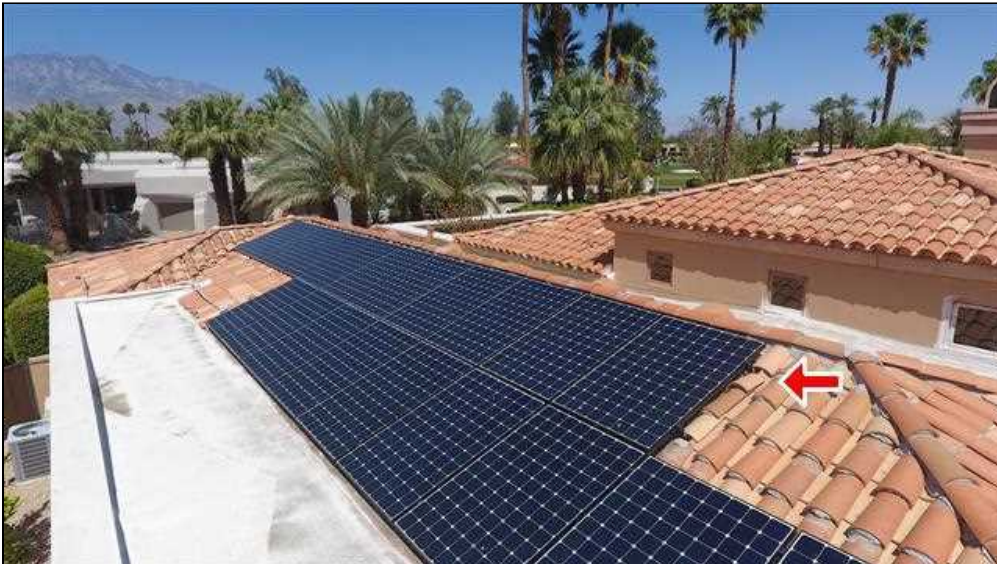
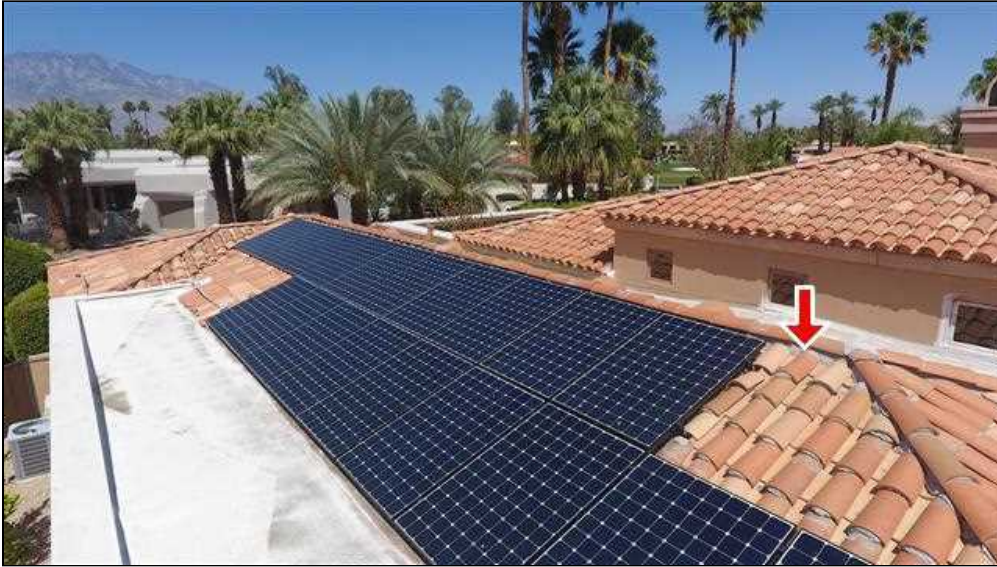
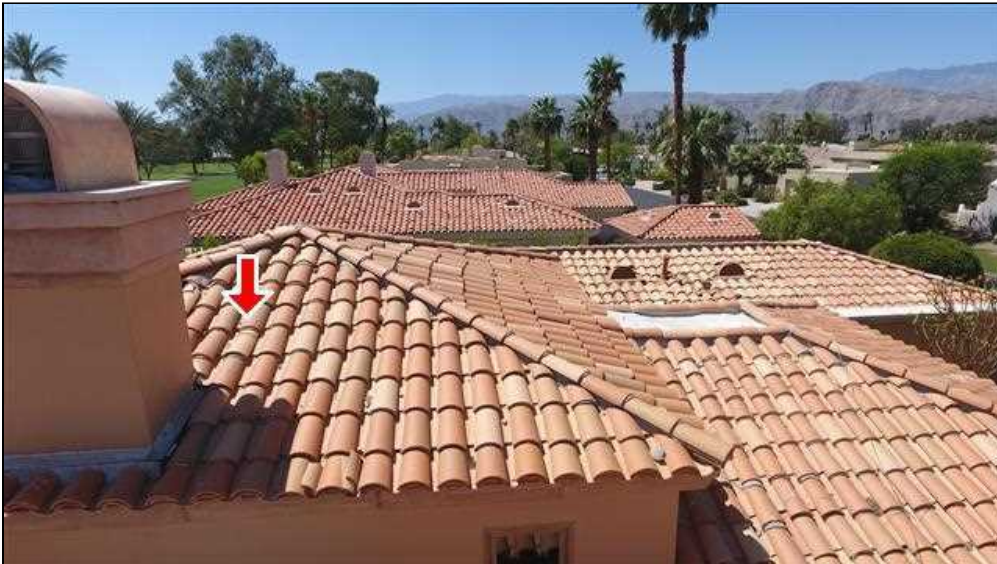
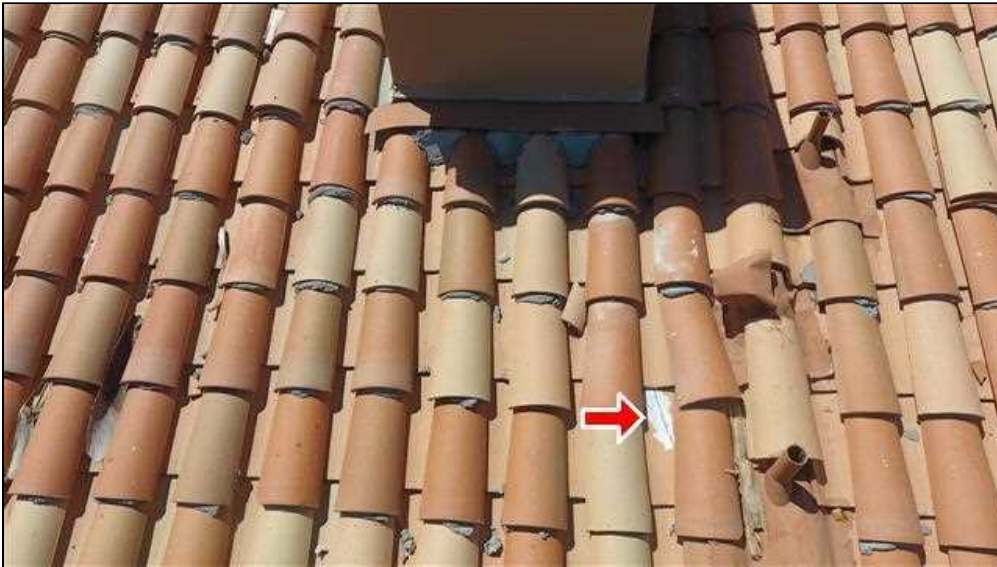
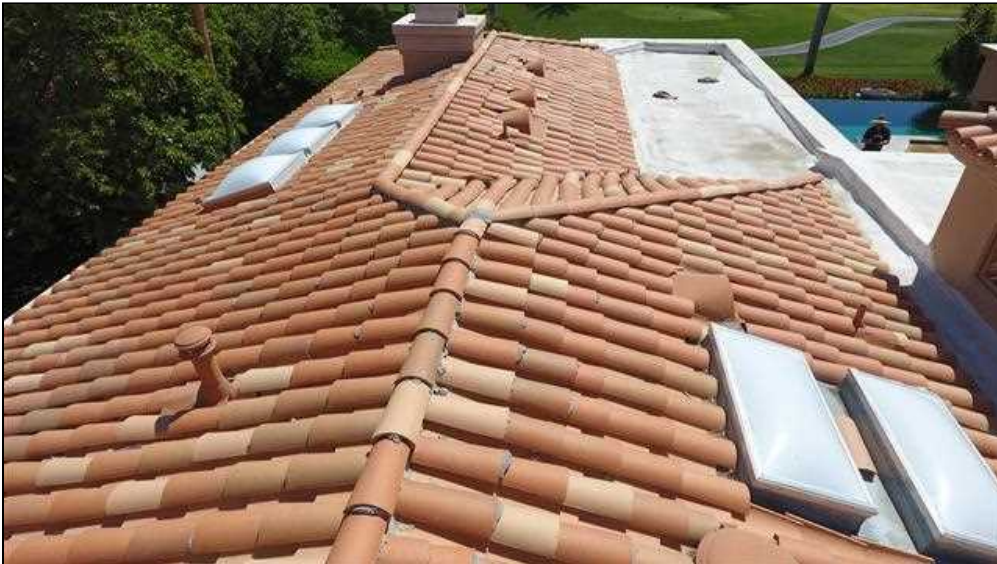
**1.0** (1) We noted several damaged and slipped tiles on the gable portion of this roof at time of inspection. Damaged roofing materials can lead to roof leaks. Recommend evaluation and replacement of all damaged tiles by a licensed roofing contractor.

1.0 Item 1(Picture) Damaged Tile

1.0 Item 2(Picture) Damaged Tile

1.0 Item 3(Picture) Slipped Tile

1.0 Item 4(Picture) Damaged Tile

1.0 Item 5(Picture) Damaged Tile

1.0 Item 6(Picture) Damaged Tile

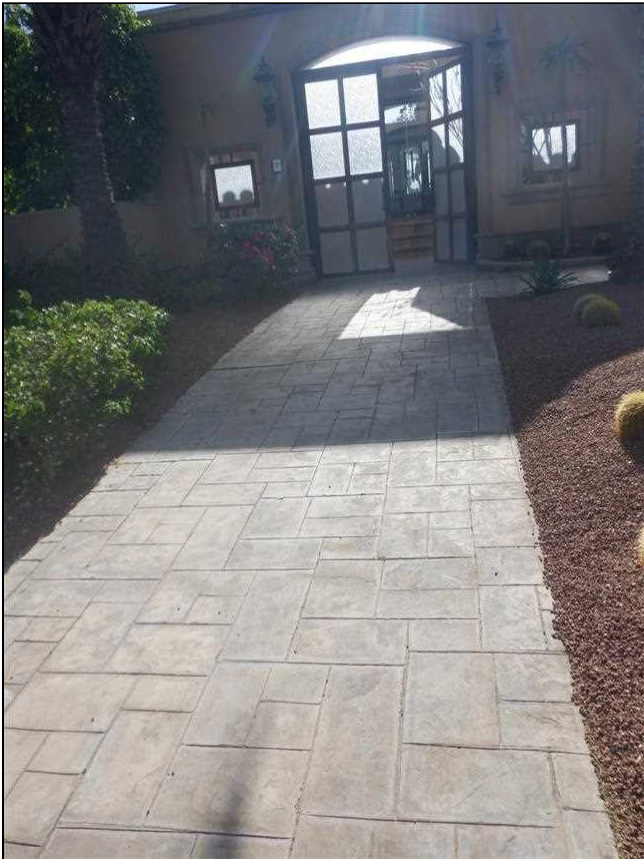
**2.4** (1) Settlement cracks were noted in the concrete driveway and walkway. These slab cracks are normal settlement cracks for a home this age, no uplift or trip hazards were noted. Recommend evaluation and repair as needed.

2.4 Item 4(Picture) Driveway Settlement Cracks

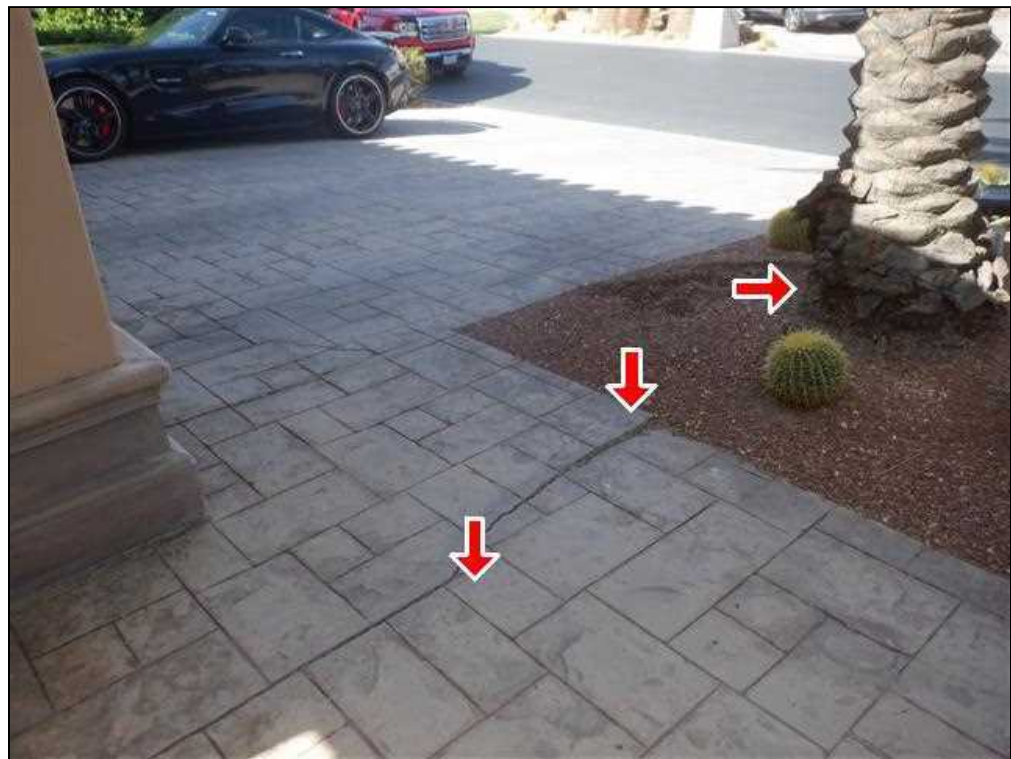
2.4 (2) We noted cracks in the walkway at the front of the home We believe that the palm tree next to this walkway are having a negative effect on it. Recommend evaluation by a licensed contractor for there opinion repair as needed.

2.4 Item 8(Picture) Walkway Uplift/Tree

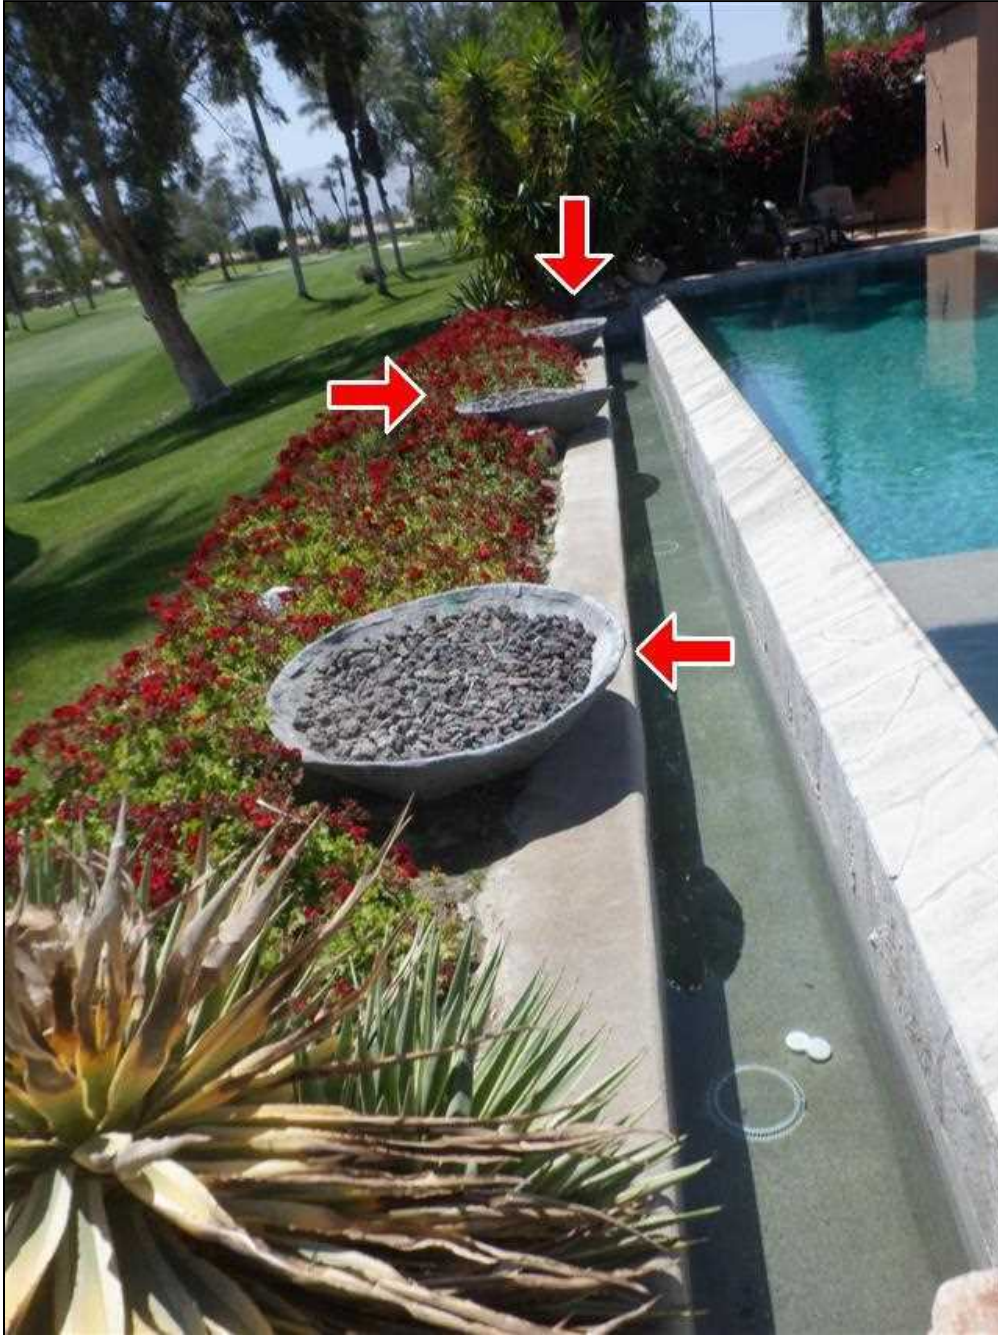
**2.10** This home is equipped with 3 fire pits (rings) by the pool. There fire pits are equipped with electronic igniters that we were unable to activate. Recommend evaluation and repair by a licensed contractor as needed.

2.10 Item 1(Picture) Fire Pits

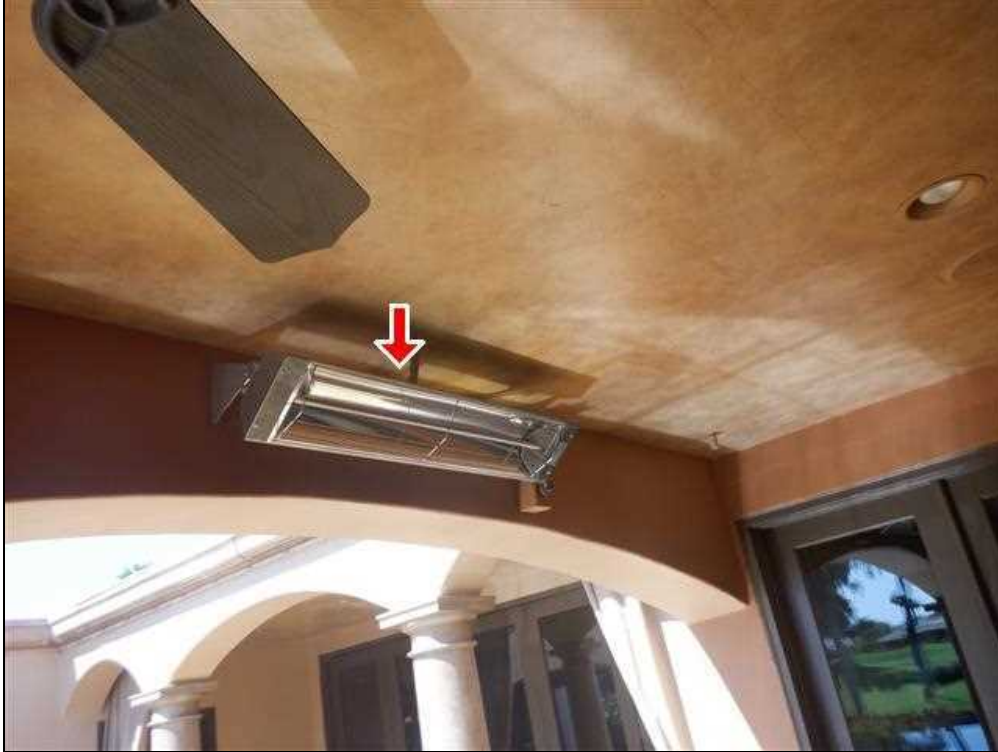
**2.16** All exterior electric patio heaters (7 total) appeared to be functioning properly except one. Recommend evaluation and repair by a licensed contractor.

2.16 Item 1(Picture) Patio Heater Not Functioning

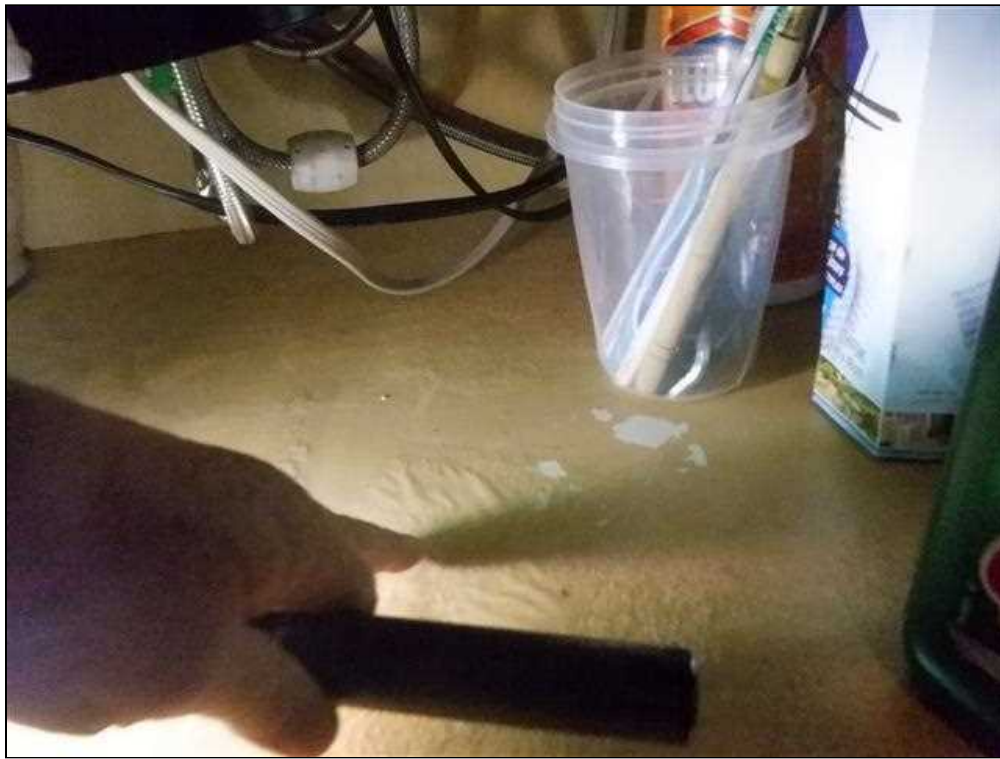
**4.5** We noted that the main sink and small (bar) base cabinet appeared to have past water damage at the bottom. No active leaks or moisture noted at time of inspection. Recommend repair replace as needed by a licensed contractor.

4.5 Item 1(Picture) Main Sink Base Moisture Damage

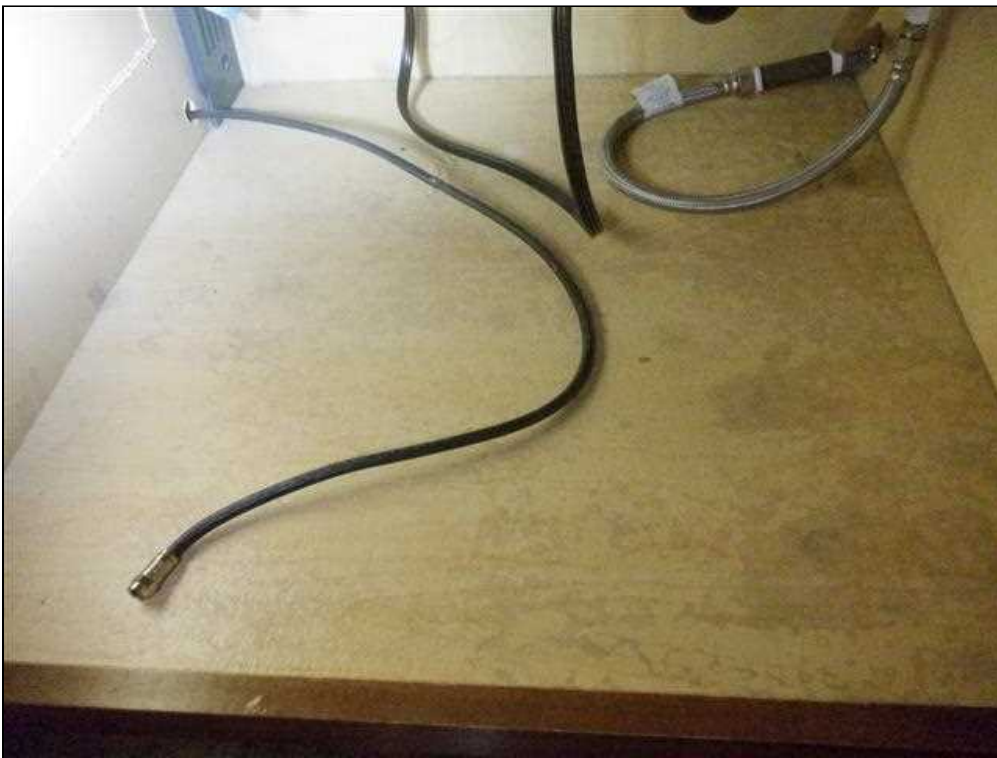
4.5 Item 3(Picture) Small Sink Base Moisture Damage

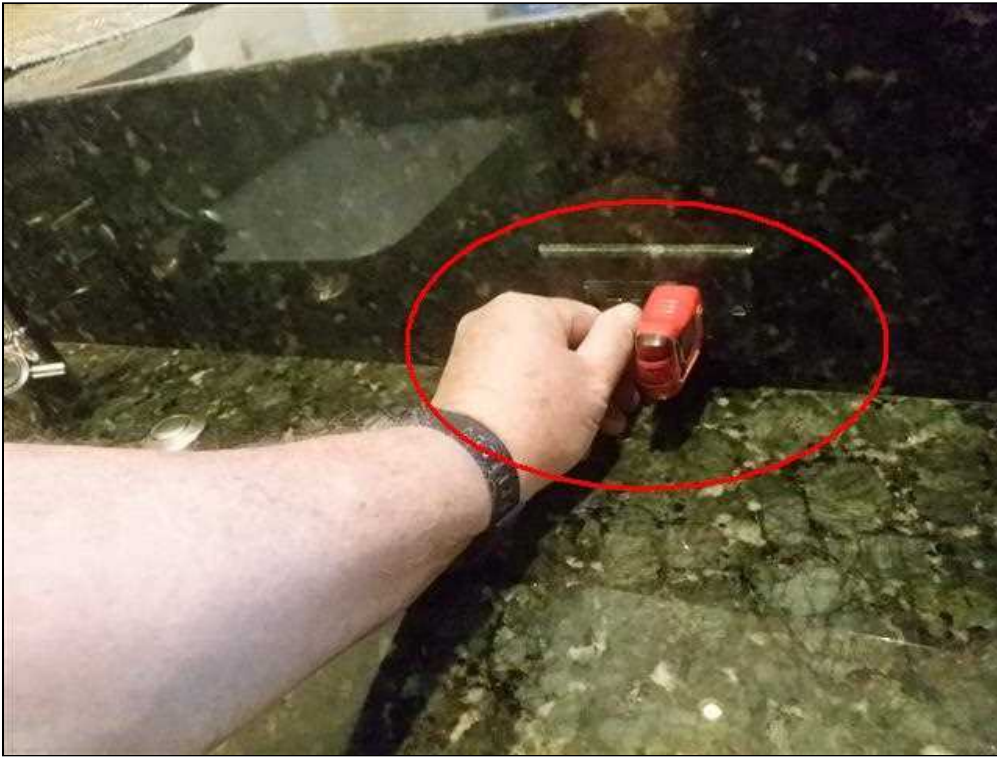
**4.8** Although all countertop outlets in this kitchen are GFCI protected we noted that they all have been painted over. We also noted that the GFCI outlet next to the small bar sink failed to reset after testing, we believe that the test buttons are damaged (stuck) due to this paint. Recommend replacement of this damaged GFCI outlet by a licensed electrical contractor. FYI electrical outlets should never be painted for obvious reasons. All the outlets for this countertop are not functioning due to this bad GFCI.

4.8 Item 1(Picture) Bad GFCI Outlet

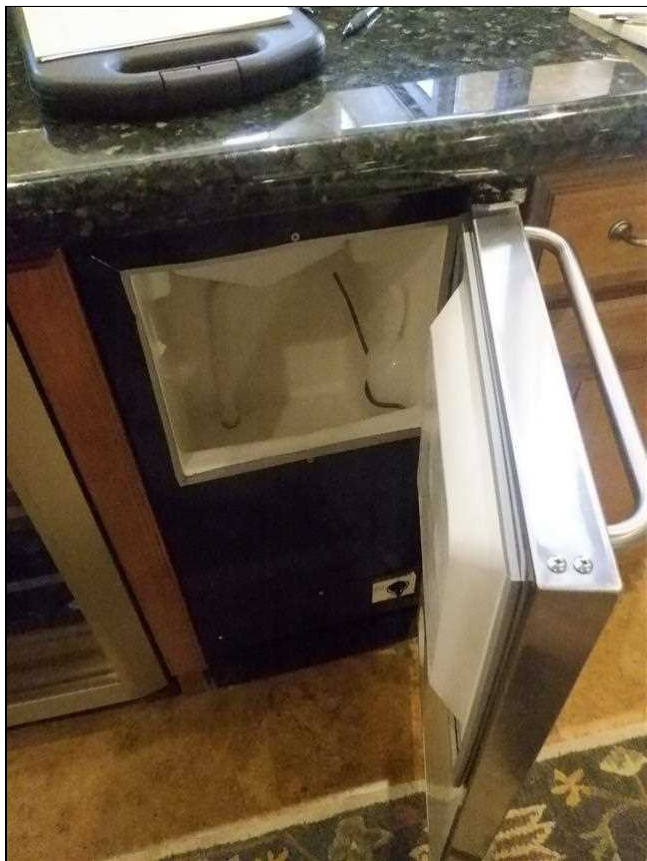
**4.16 (1)** We noted that the bar ice maker was off at time of inspection. Recommend activating unit and confirming proper operation before close of escrow.

4.16 Item 1(Picture) Ice Maker Off

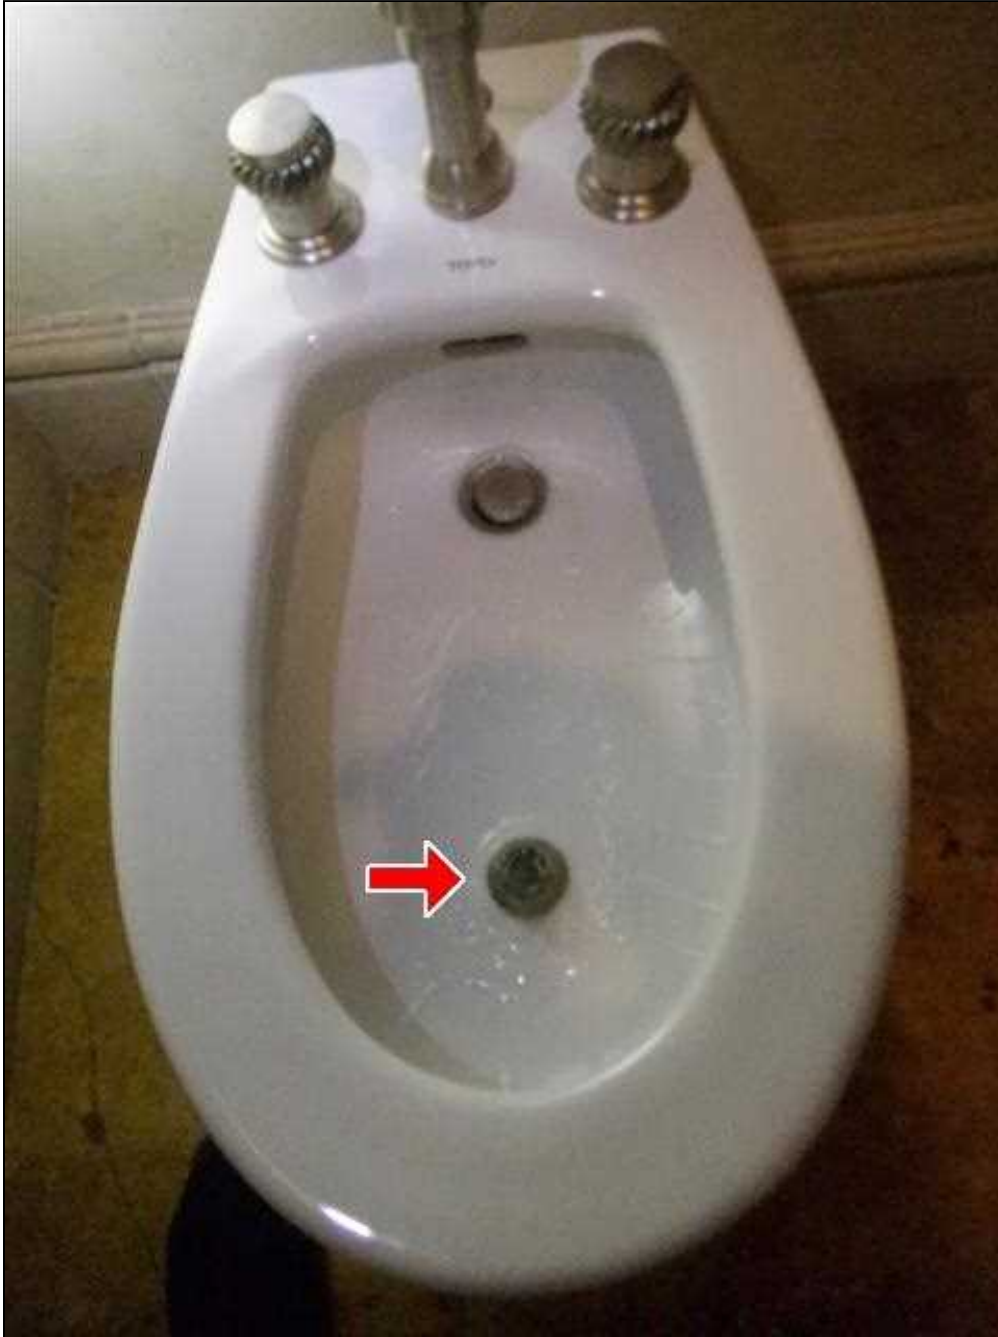
**6.8.B** We noted that the water supply to this bidet appeared low. This issue is isolated to this fixture. Recommend evaluation and repair as needed by a plumbing contractor

6.8.B Item 1(Picture) Bidet Low Flow

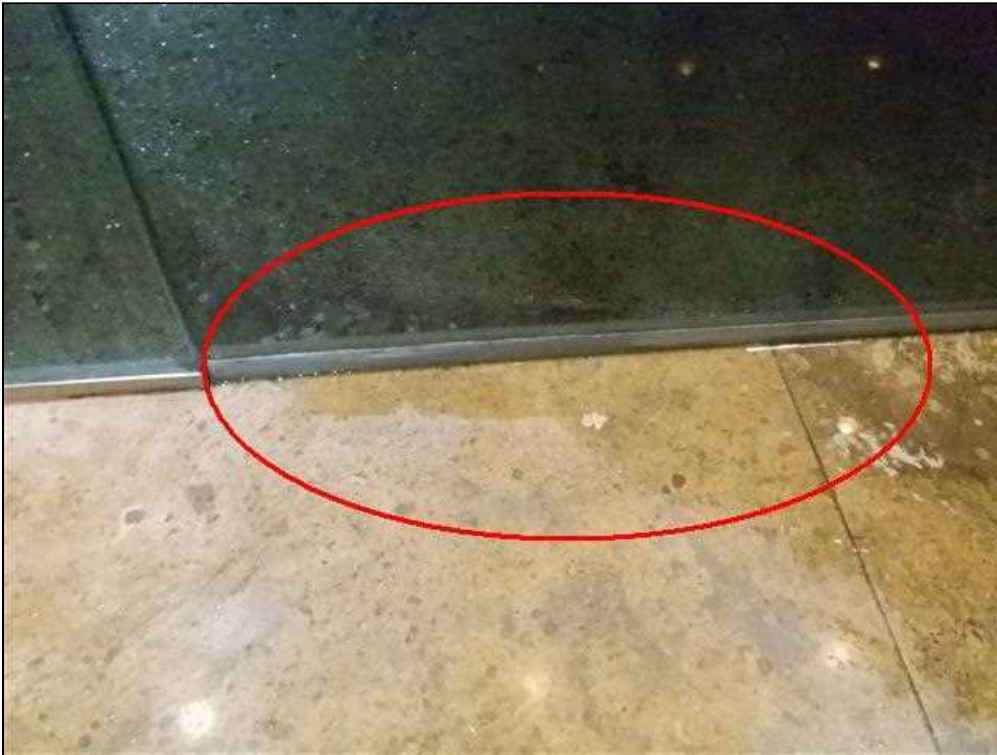
**6.12.B (1)** We noted upon activation of the shower that the water would creep out the shower opening onto the bathroom floor. We believe that this is caused by not enough pitch at the bottom of the shower towards the drain and shower head type/excessive pressure. Recommend evaluation by a licensed contractor to come up with a solution to this issue.

6.12.B Item 3(Picture) Shower Door Water Outside Of Shower

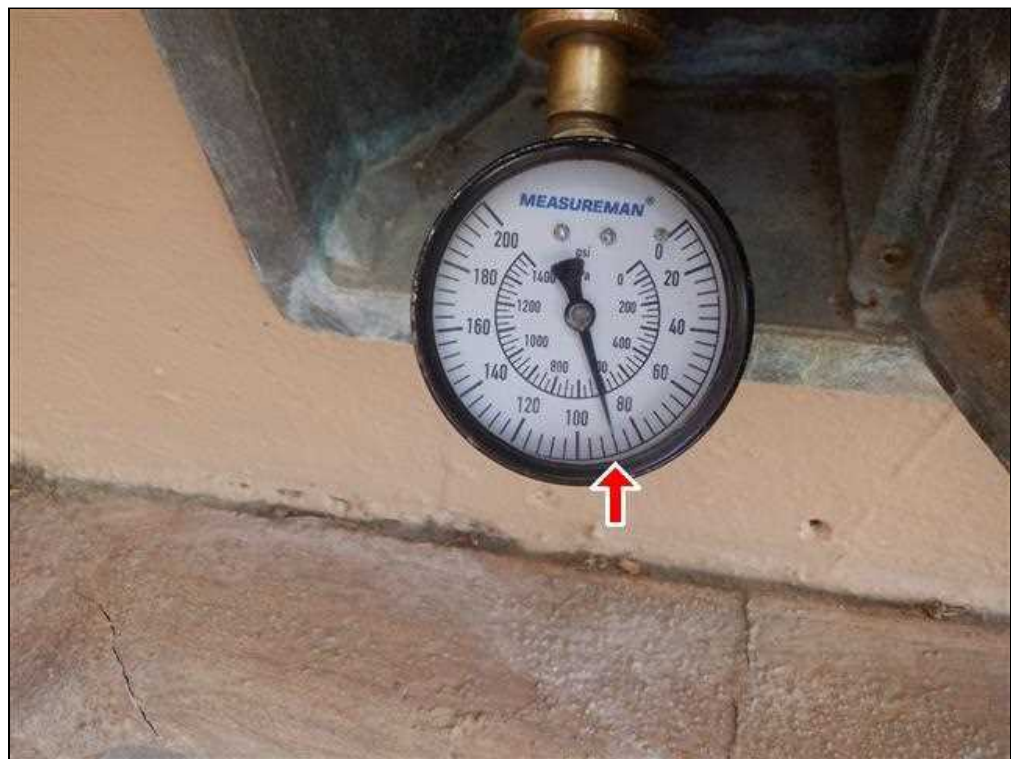
8.4 (1) At the time of Inspection water pressure tested beyond normal limits of 40-80 psi. At the time of inspection water pressure was 90 psi. We recommend installation of a regulator by a licensed plumbing contractor to reduce pressure to within the normal range. Excesses water pressure above 80 psi can cause water supply lines to fail.

8.4 Item 1(Picture) Water Pressure 90 psi

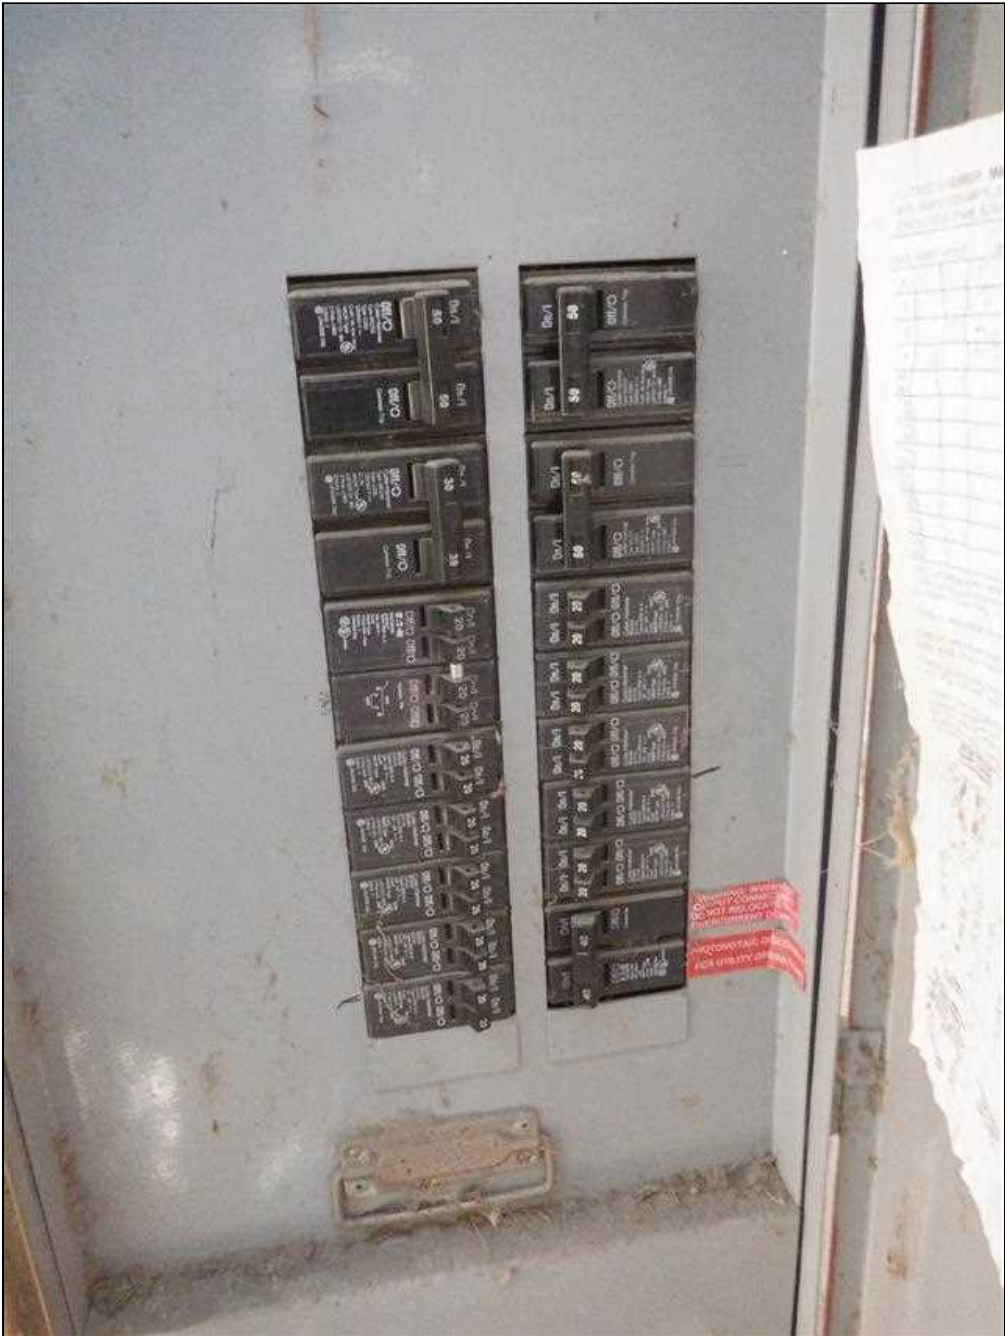
9.1 Item 3(Picture) Main Electrical Panel Distribution Missing Labels

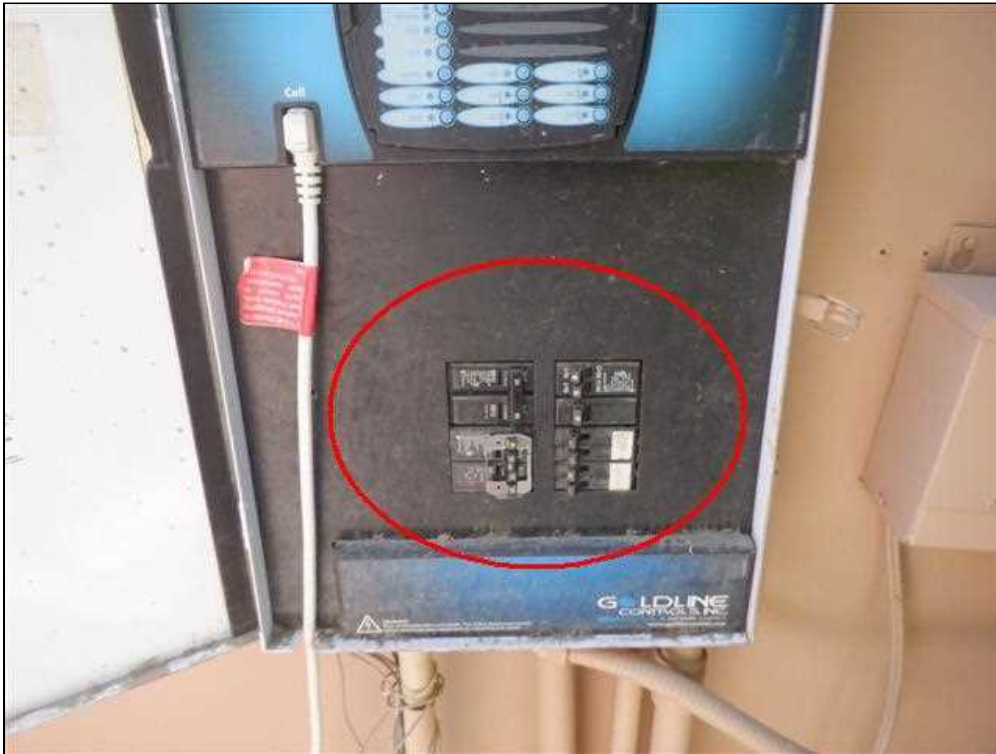
**9.1 (2)** The pool electrical sub panel is located on the north side of house by the pool equipment. Although we did not find any irregularities in this panel we noted that the circuit breakers were not labeled. Recommend evaluation and labeling of all circuits for proper identification and ease of use by a licensed electrician.

9.1 Item 5(Picture) Pool/Spa Sub Panel Circuits Not Labeled

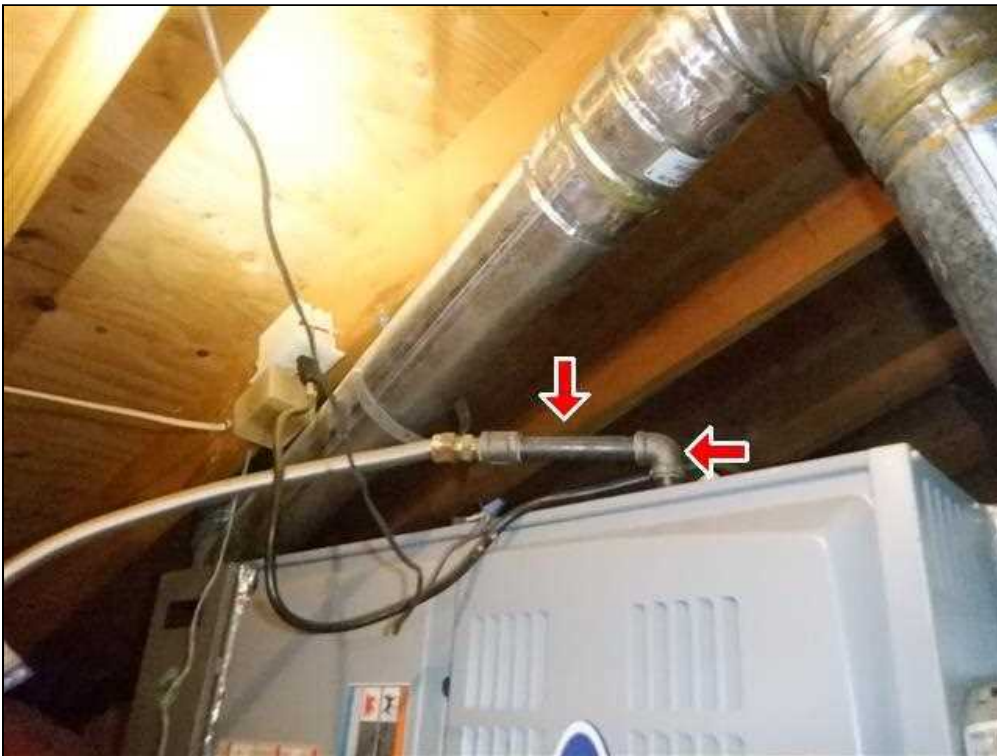
appliance. Recommend evaluation and installation of a sediment trap by a licensed plumbing contractor. This unit is 5 years old.

10.0.A Item 2(Picture) Heating Unit South Fuel Line Missing Sediment Trap

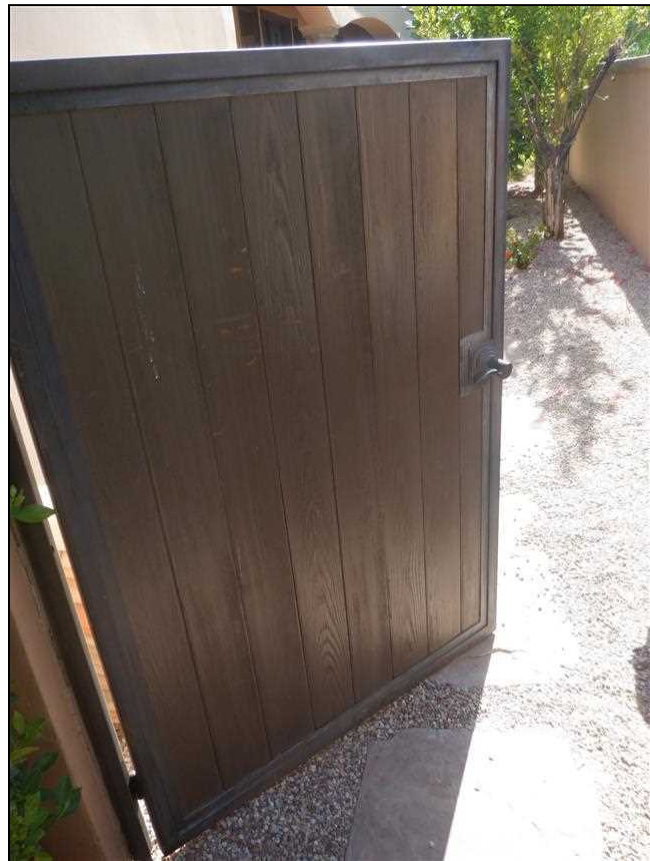
11.8 The gates to the backyard from the street do not have the required self closing hardware, we also noted that these gates open inward which by code is incorrect and although these gates have the required self latching hardware they appeared a little low, the self latching hardware must not be lower than 54 inches from grade. These are safety issues that should be corrected. Recommend evaluation by a licensed contractor repair replace as needed to bring these gates up to current code. FYI the rules for gates that will allow access to the pool from the street are as follows, all gates must have self closing self latching hardware, all gates must open outwards towards the street and all self latching hardware must not be lower that 54 inches.

11.8 Item 1(Picture) Gate 1 South

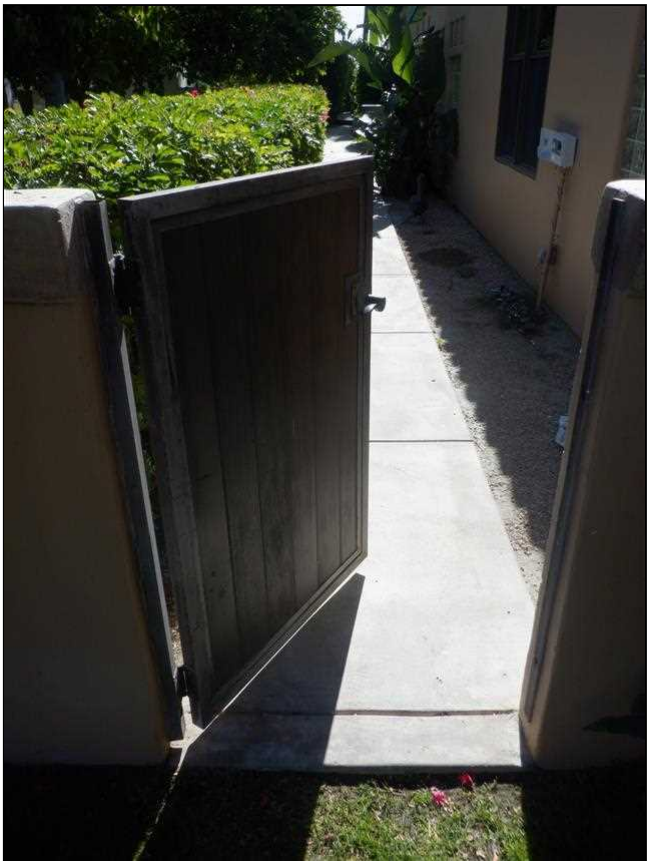
11.8 Item 2(Picture) Gate 2 North

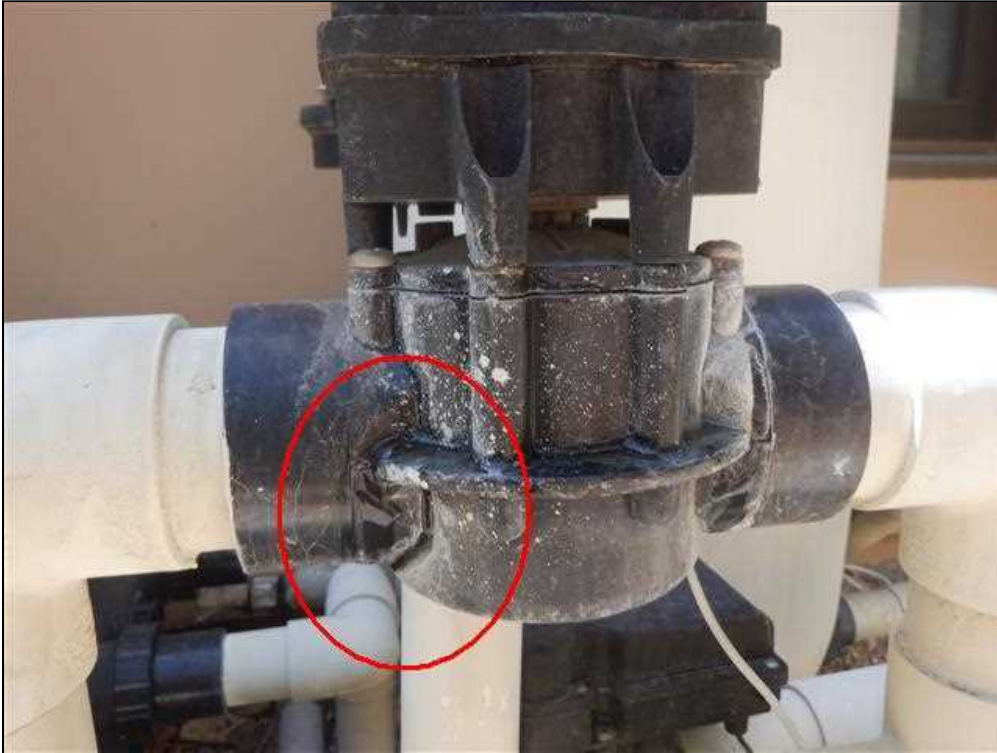
11.9 Item 2(Picture) Actuator Valve Leak

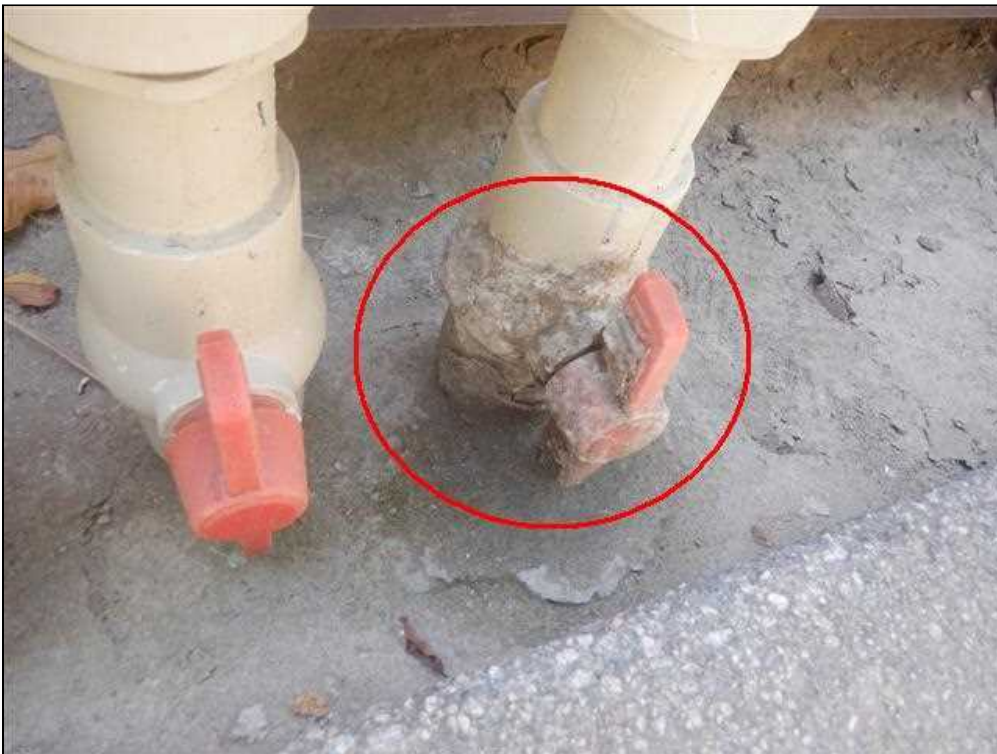
11.9 Item 3(Picture) Plumbing Valve Seepage Noted

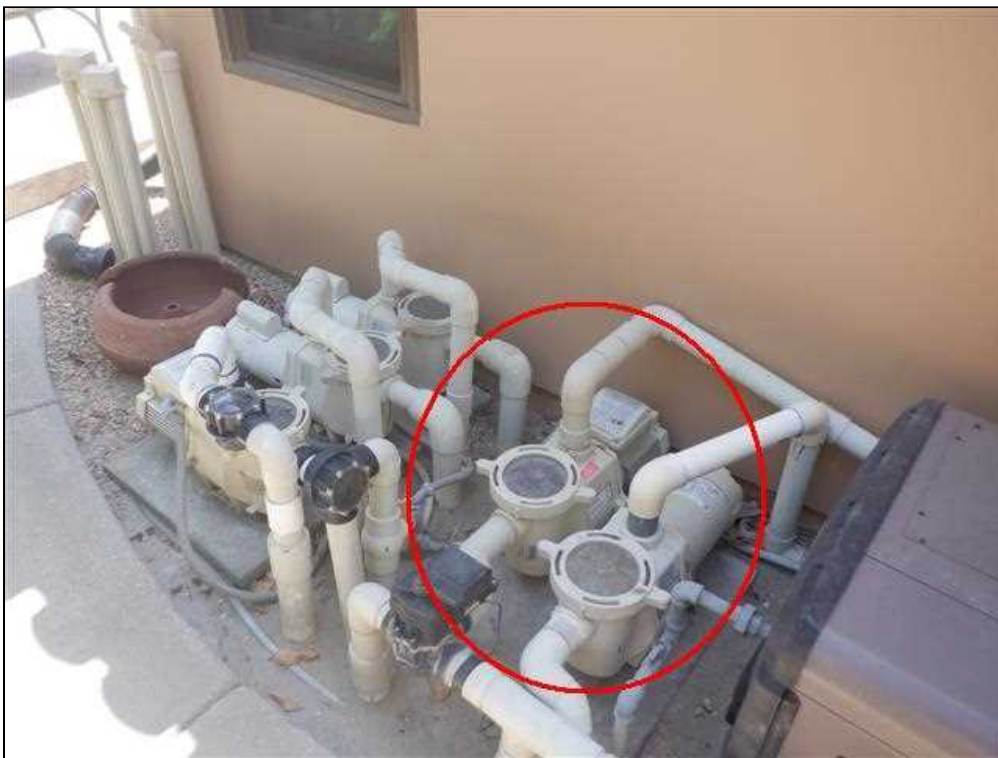
**11.26 (1)** Although we noted a bond wire present it was not connected to at least 2 of the pumps or the exterior controller/electrical sub panel box. This is a possible shock hazard that should be corrected. All metal parts of pool/spa pumps, motors, heaters, pool sub panels, junction boxes, timer clocks and control panels of any kind should be bonded together and bonded to the pools bonding grid. Recommend evaluation/repair/replace as needed by a licensed pool contractor.

11.26 Item 1(Picture) Pumps Not Bonded

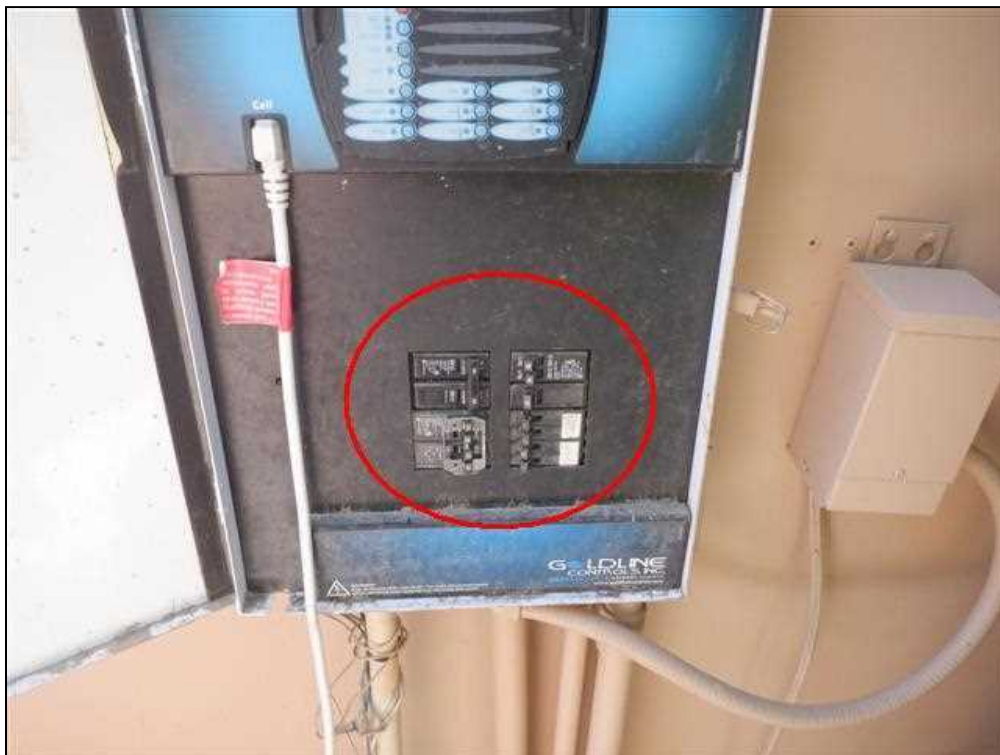
Recommend evaluation by a licensed pool contractor to determine if this pool equipment requires any additional GFCI protection and install as needed. FYI this additional GFCI protection may be required in certain jurisdictions for a vacation rental permits. FYI follow all local codes on this issue.

11.26 Item 4(Picture) Pool/Spa Equipment Not GFCI Protected
