# **Inspection Report**

**Property Address:**  
12136 St Andrews Dr  
Rancho Mirage CA 92270

**Livingston Home Inspections, Inc.**

<b>Date:</b> 4/27/2022	<b>Time:</b> 09:00 AM	<b>Report ID:</b> 20220427-12136-St-Andrews-Dr
<b>Property:</b> 12136 St Andrews Dr Rancho Mirage CA 92270	<b>Customer:</b> Garrett Saikley	<b>Real Estate Professional:</b> Jonathan Olow Big Block Realty

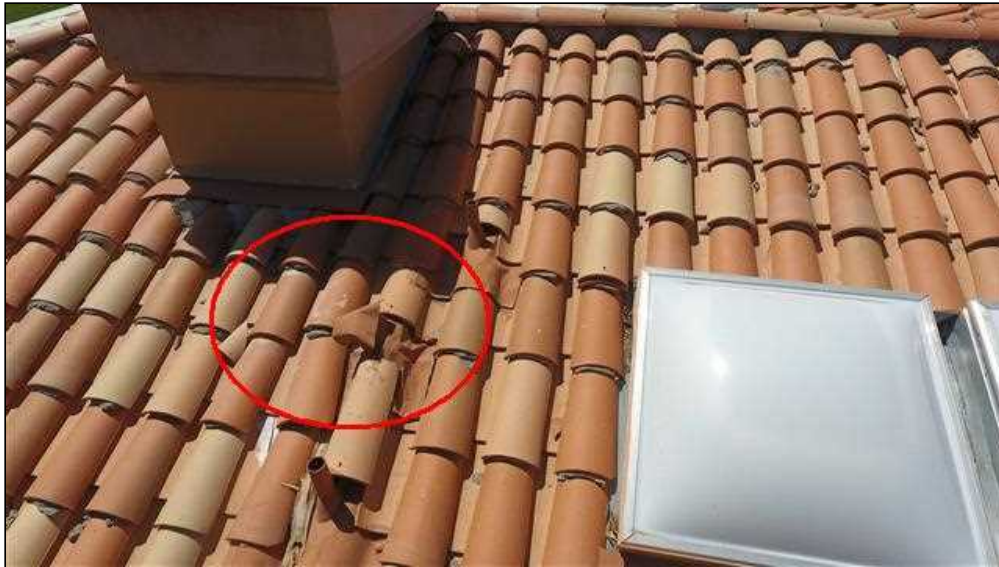
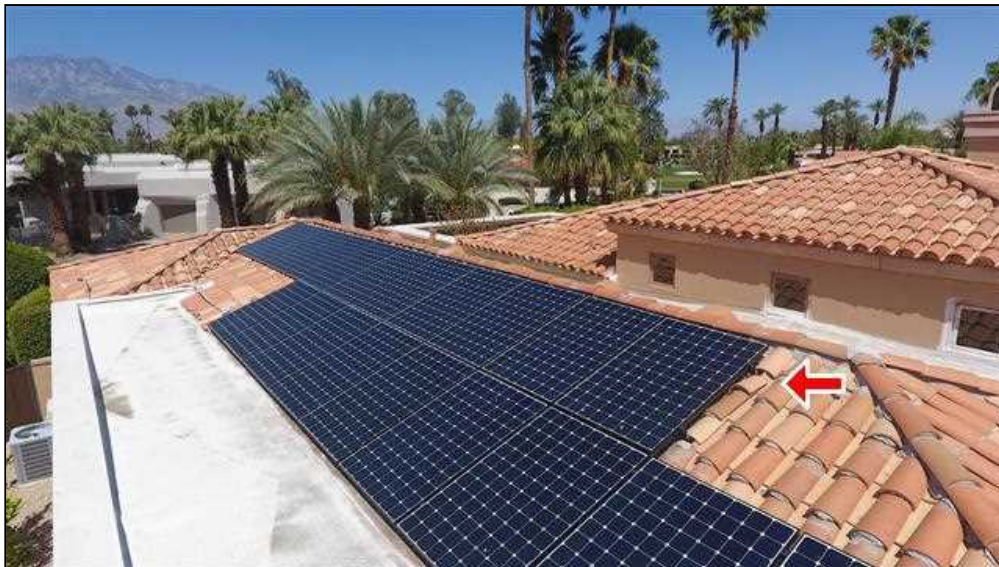
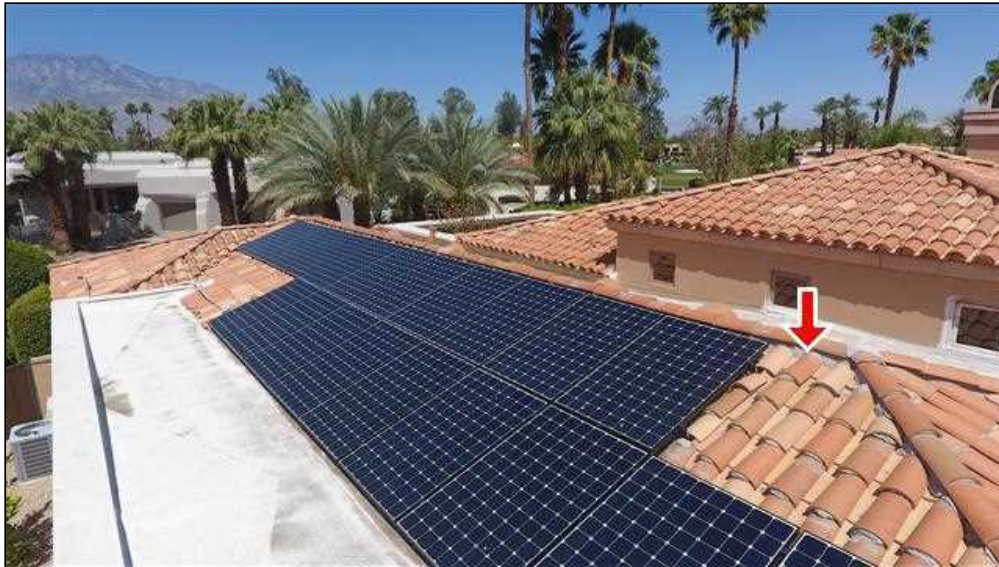
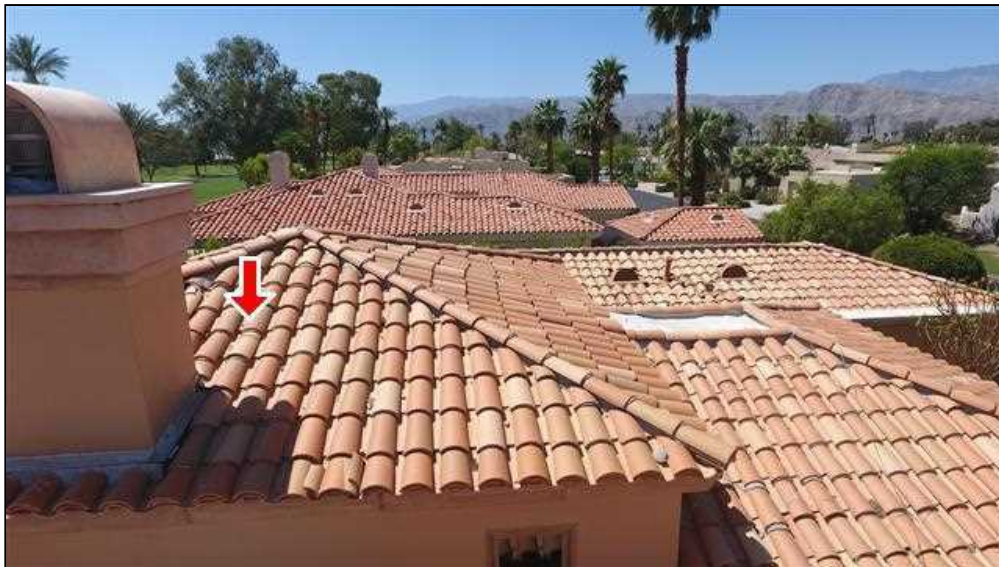
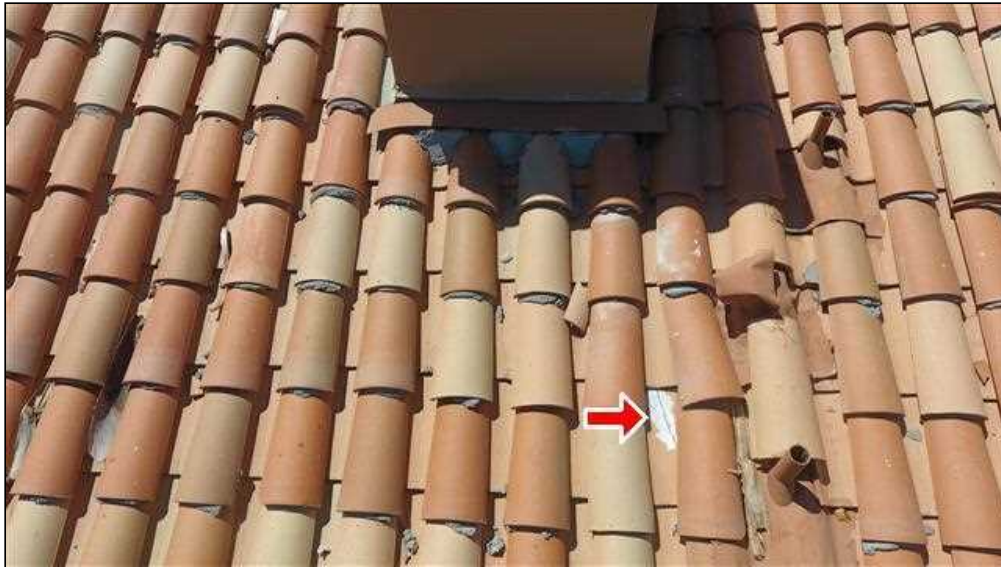
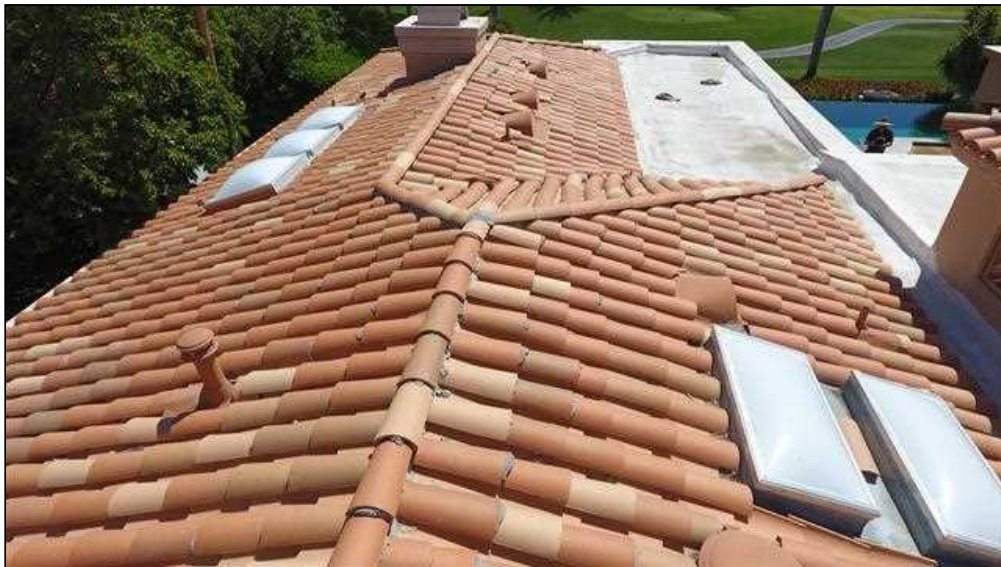
1.0 Item 1(Picture) Damaged Tile

1.0 Item 2(Picture) Damaged Tile

1.0 Item 3(Picture) Slipped Tile

1.0 Item 4(Picture) Damaged Tile

1.0 Item 5(Picture) Damaged Tile

1.0 Item 6(Picture) Damaged Tile

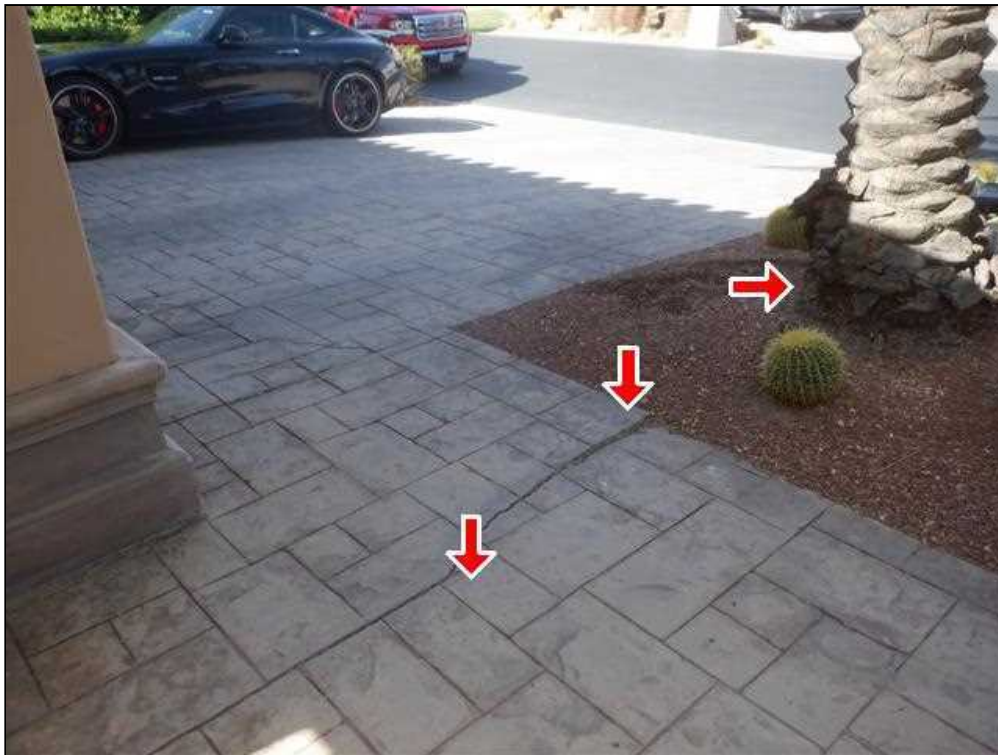
(2) We noted cracks in the walkway at the front of the home. We believe that the palm tree next to this walkway is having a negative effect on it. Recommend evaluation by a licensed contractor for their opinion and repair as needed.

2.4 Item 8(Picture) Walkway Uplift/Tree

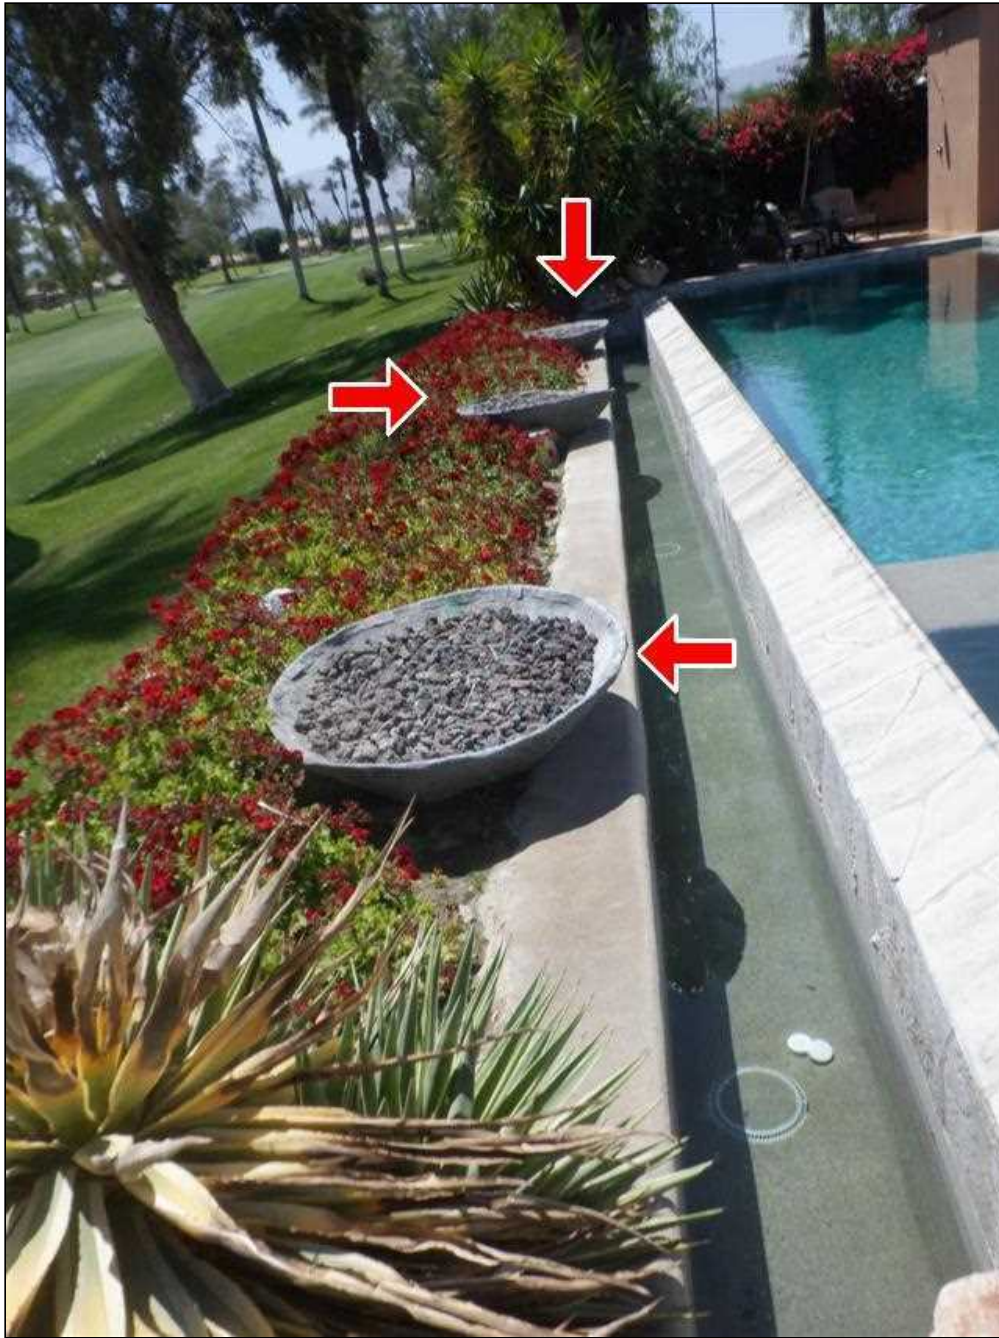
This home is equipped with 3 fire pits (rings) by the pool. There fire pits are equipped with electronic igniters that we were unable to activate. Recommend evaluation and repair by a licensed contractor as needed.

2.10 Item 1(Picture) Fire Pits

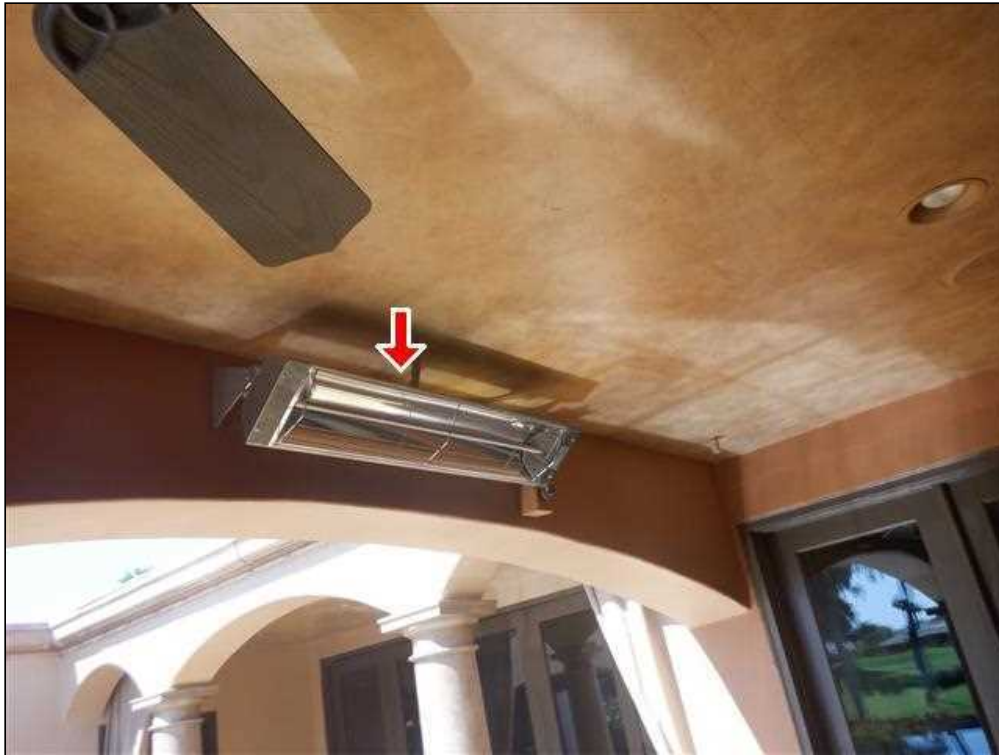
All exterior electric patio heaters (7 total) appeared to be functioning properly except one. Recommend evaluation and repair by a licensed contractor.

2.16 Item 1(Picture) Patio Heater Not Functioning

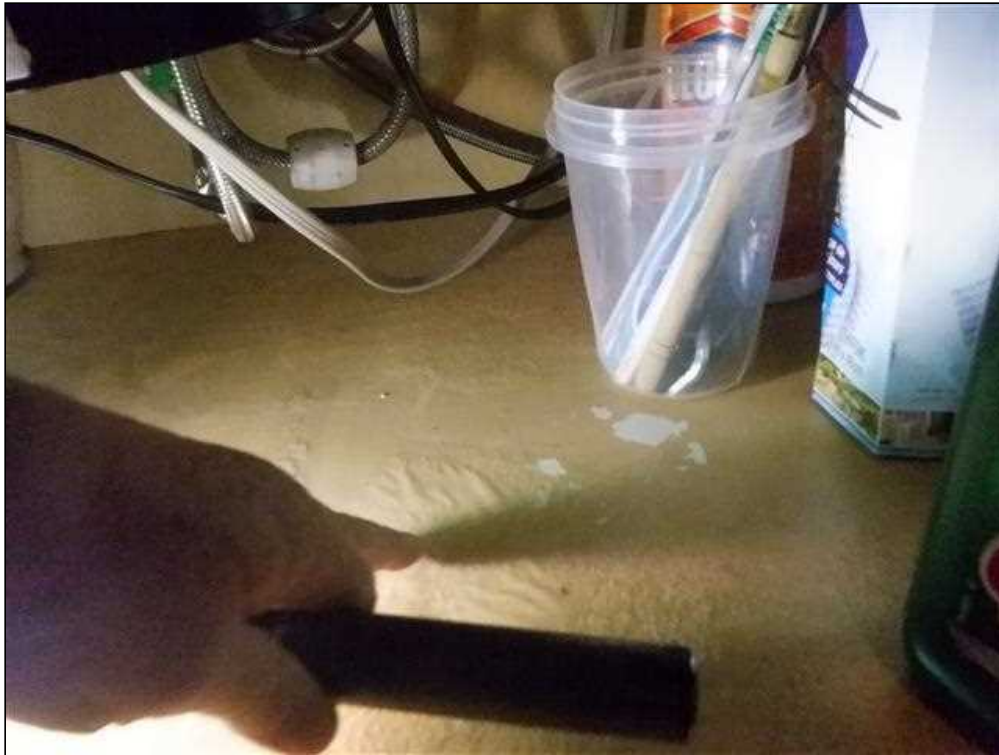
We noted that the main sink and small (bar) base cabinet appeared to have past water damage at the bottom. No active leaks or moisture noted at time of inspection. Recommend repair replace as needed by a licensed contractor.

4.5 Item 1(Picture) Main Sink Base Moisture Damage

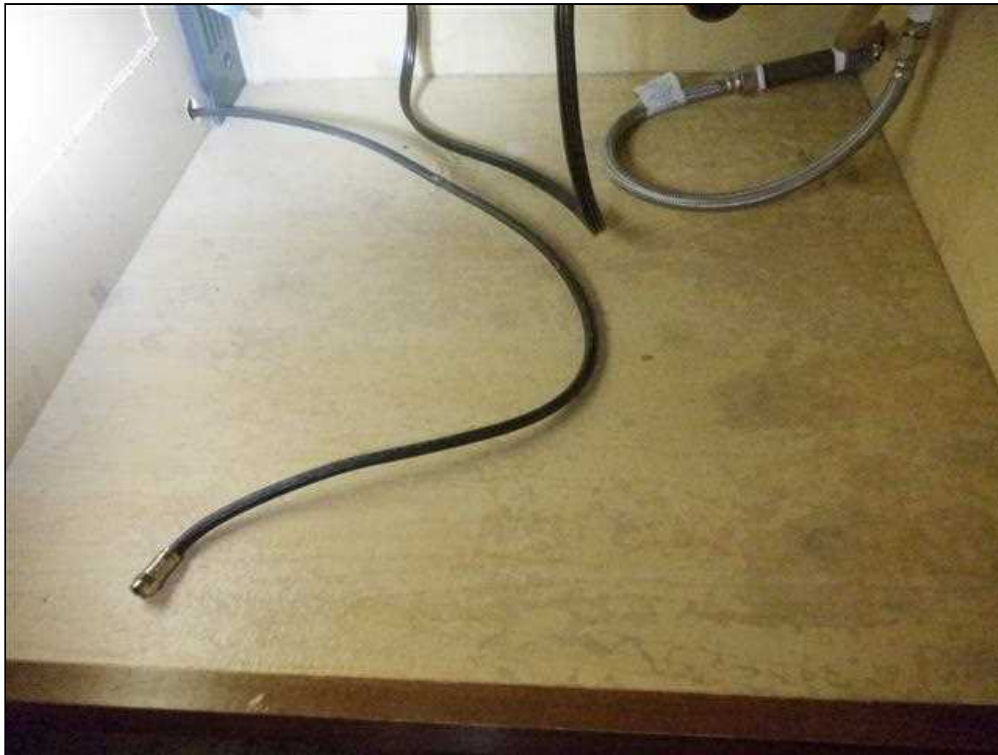
4.5 Item 3(Picture) Small Sink Base Moisture Damage

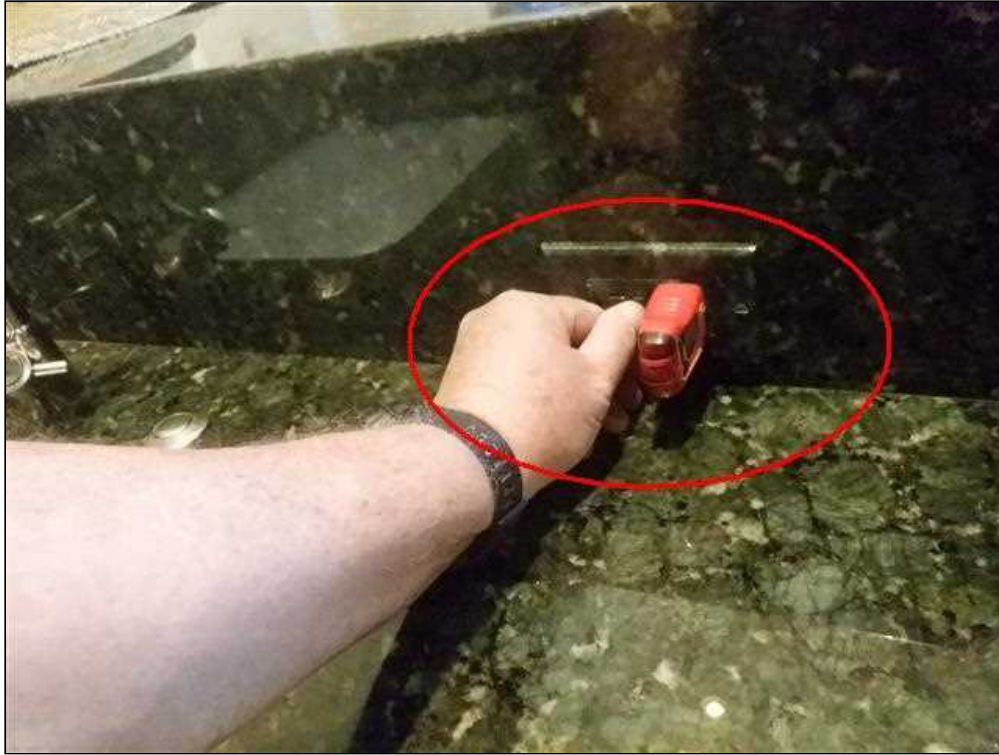
Although all countertop outlets in this kitchen are GFCI protected we noted that they all have been painted over. We also noted that the GFCI outlet next to the small bar sink failed to reset after testing, we believe that the test buttons are damaged (stuck) due to this paint. Recommend replacement of this damaged GFCI outlet by a licensed electrical contractor. FYI electrical outlets should never be painted for obvious reasons. All the outlets for this countertop are not functioning due to this bad GFCI.

4.8 Item 1(Picture) Bad GFCI Outlet

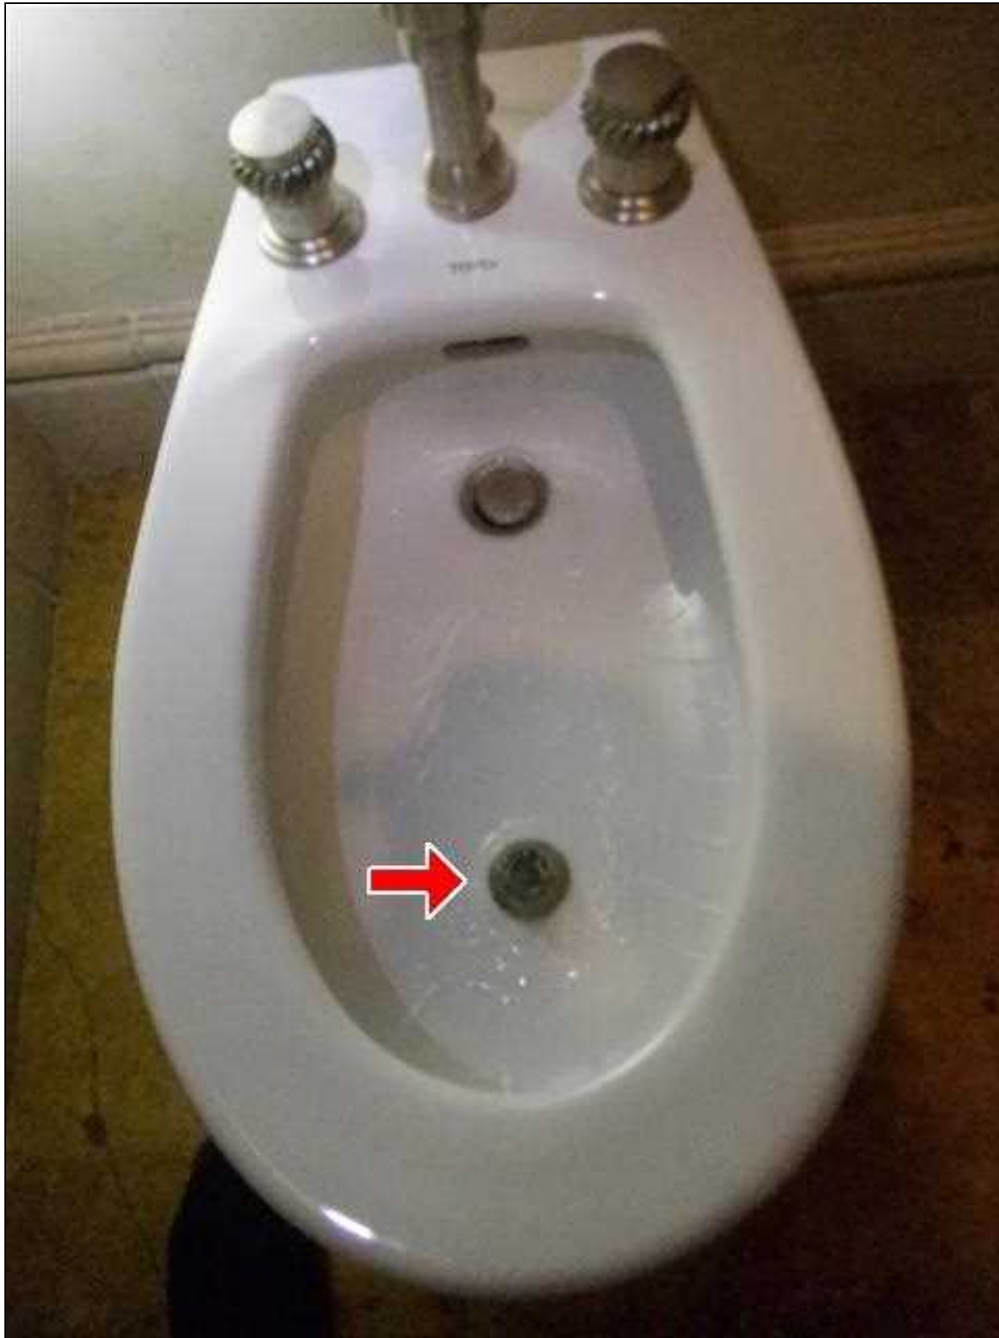
We noted that the water supply to this bidet appeared low. This issue is isolated to this fixture. Recommend evaluation and repair as needed by a plumbing contractor

6.8.B Item 1(Picture) Bidet Low Flow

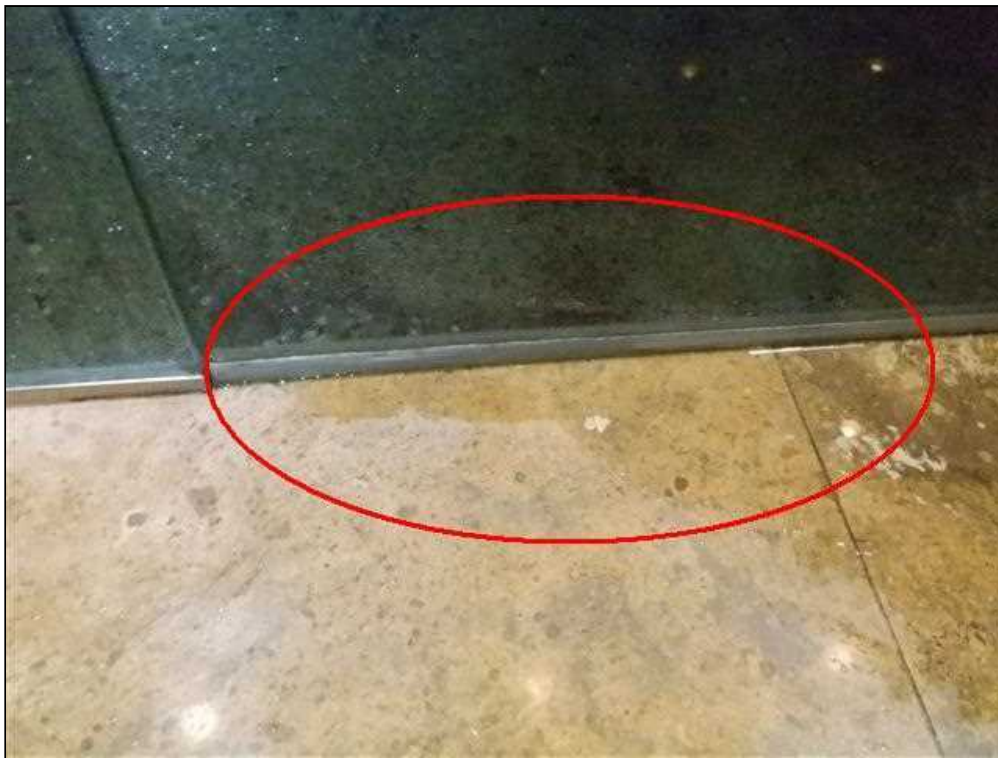
6.12.B Item 3(Picture) Shower Door Water Outside Of Shower

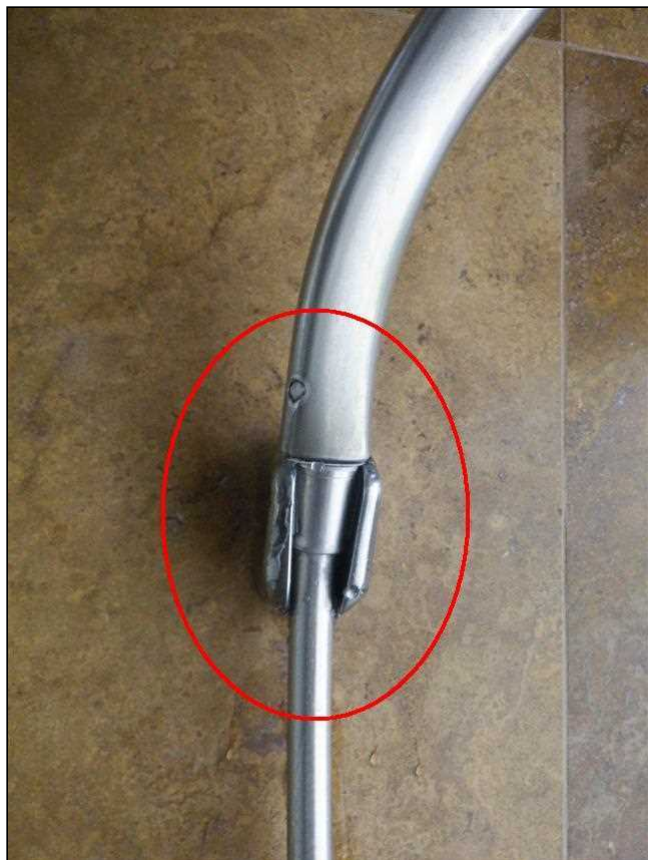
We noted a leak at the top of the shower head fitting at the time of inspection. Recommend repair/replace as needed by a licensed plumbing contractor.

6.4.D Item 1(Picture) Shower Head Fitting Leak

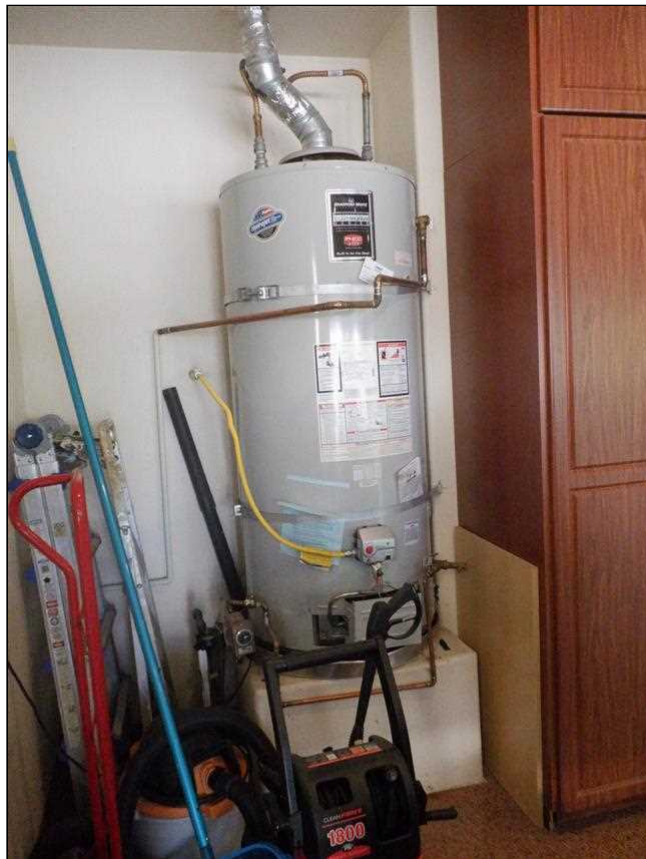
Although this water heater was functioning properly at time of inspection we noted that there was no sediment trap (Drip Leg) installed on the fuel line. The installation of fuel line sediment traps have been required for many years. We highly recommend installation of sediment traps (Drip Legs) on all gas fired tankless and tank type water heaters they are installed per manufactures requirements to help prevent sediment in the gas piping from getting into the gas valve or burner area of an appliance and causing safety issues with combustion. The installation of sediment traps may extend the life of an appliance. Recommend evaluation and installation of sediment trap by a licensed plumbing contractor. This unit has a 100 gallon tank it is 8 years old.

8.2 Item 1(Picture) Water Heater

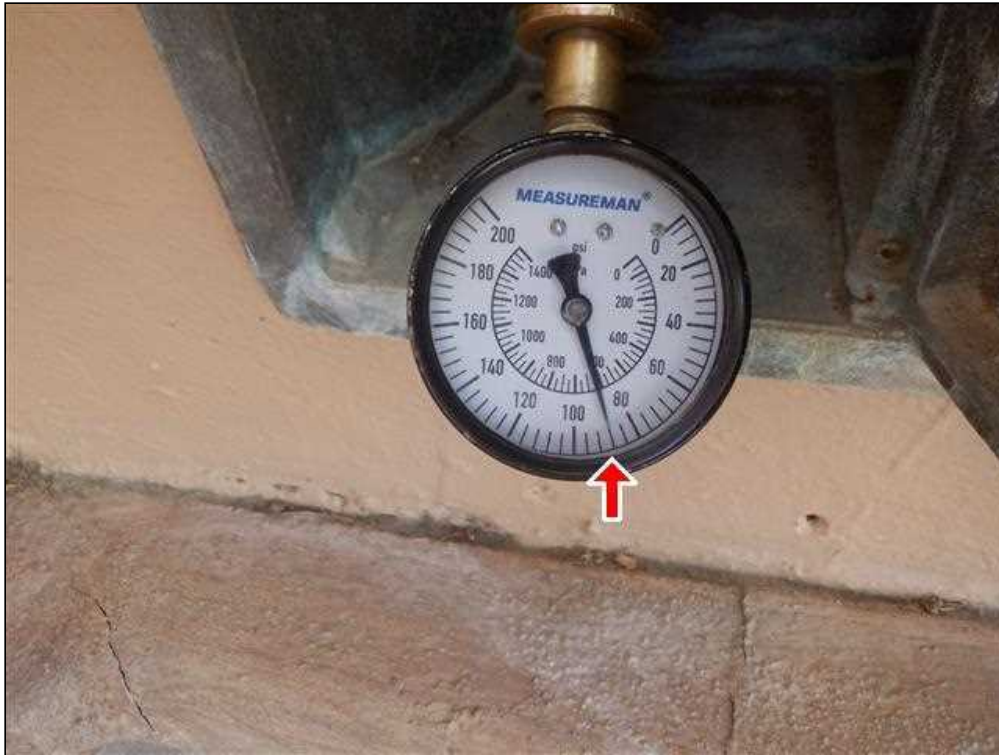
(1) At the time of Inspection water pressure tested beyond normal limits of 40-80 psi. At the time of inspection water pressure was 90 psi. We recommend installation of a regulator by a licensed plumbing contractor to reduce pressure to within the normal range. Excesses water pressure above 80 psi can cause water supply lines to fail.

8.4 Item 1(Picture) Water Pressure 90 psi

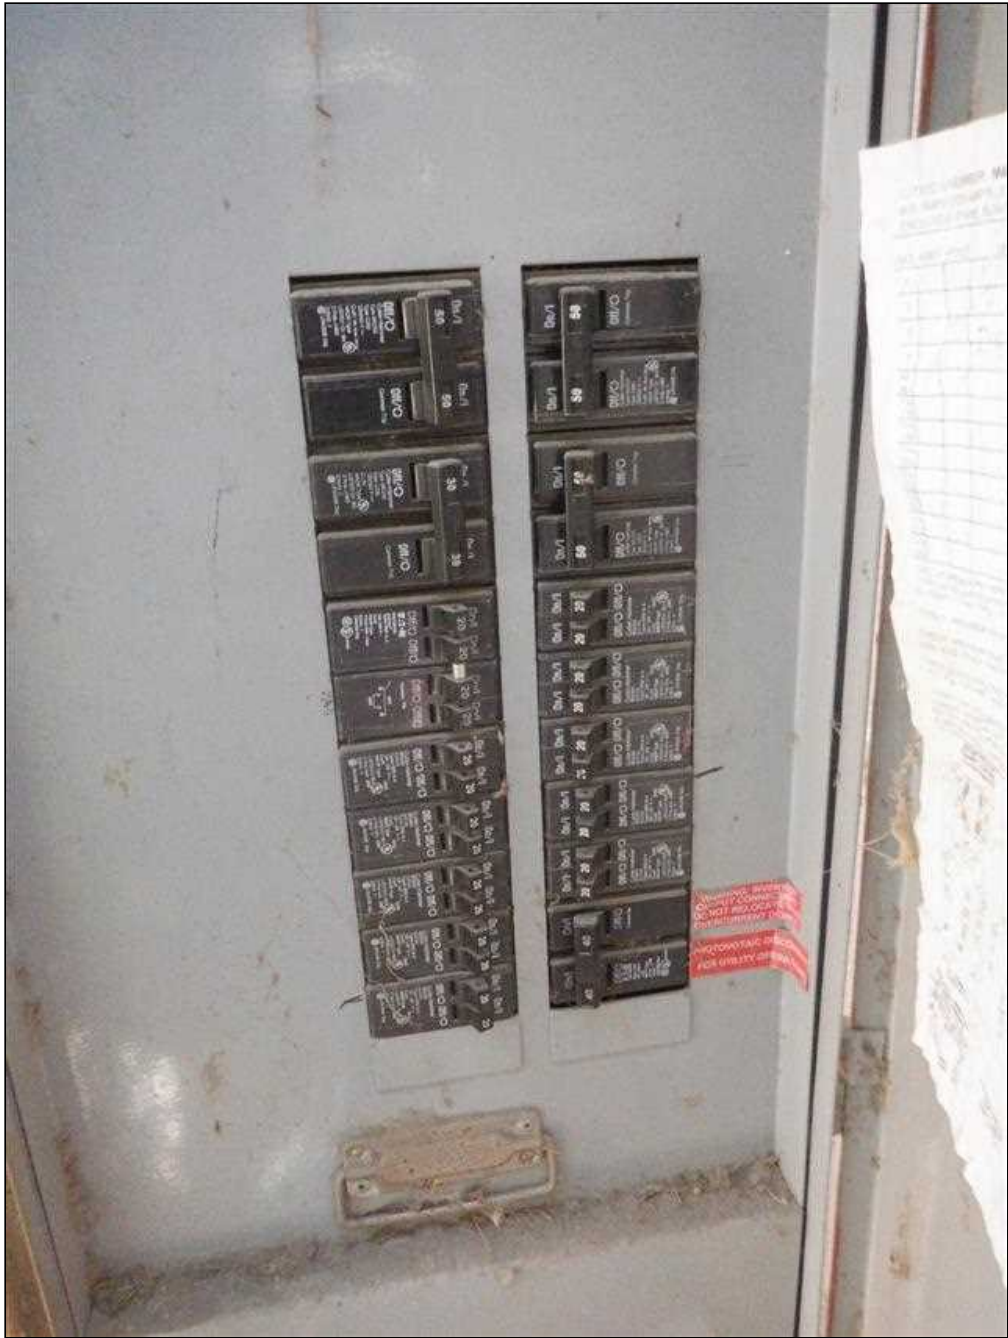
(1) The electrical panel is located on the south side of the garage. This panel has 2 200 amp disconnects and although we did not find any irregularities in this panel we noted that not all of the circuit breakers were labeled. Recommend evaluation and labeling of all circuits for proper identification and ease of use by a licensed electrician. FYI we also could not determine the size of the breaker for the pool/spa sub panel due to this panels circuits not being labeled.

9.1 Item 3(Picture) Main Electrical Panel Distribution Missing Labels

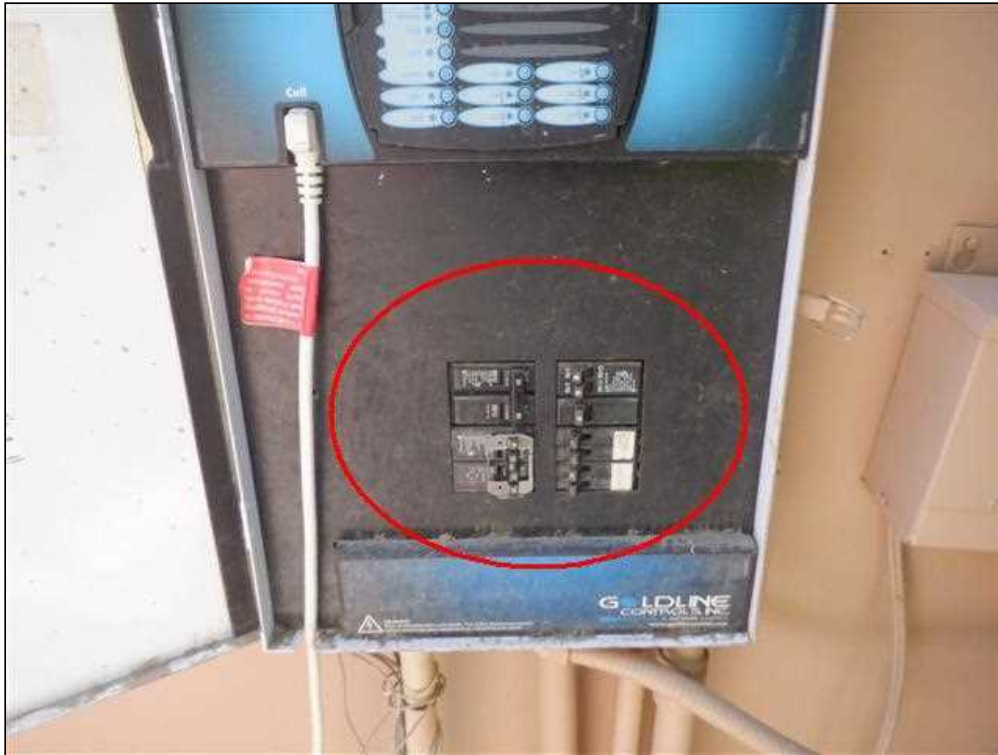
(2) The pool electrical sub panel is located on the north side of house by the pool equipment. Although we did not find any irregularities in this panel we noted that the circuit breakers were not labeled. Recommend evaluation and labeling of all circuits for proper identification and ease of use by a licensed electrician.

9.1 Item 5(Picture) Pool/Spa Sub Panel Circuits Not Labeled

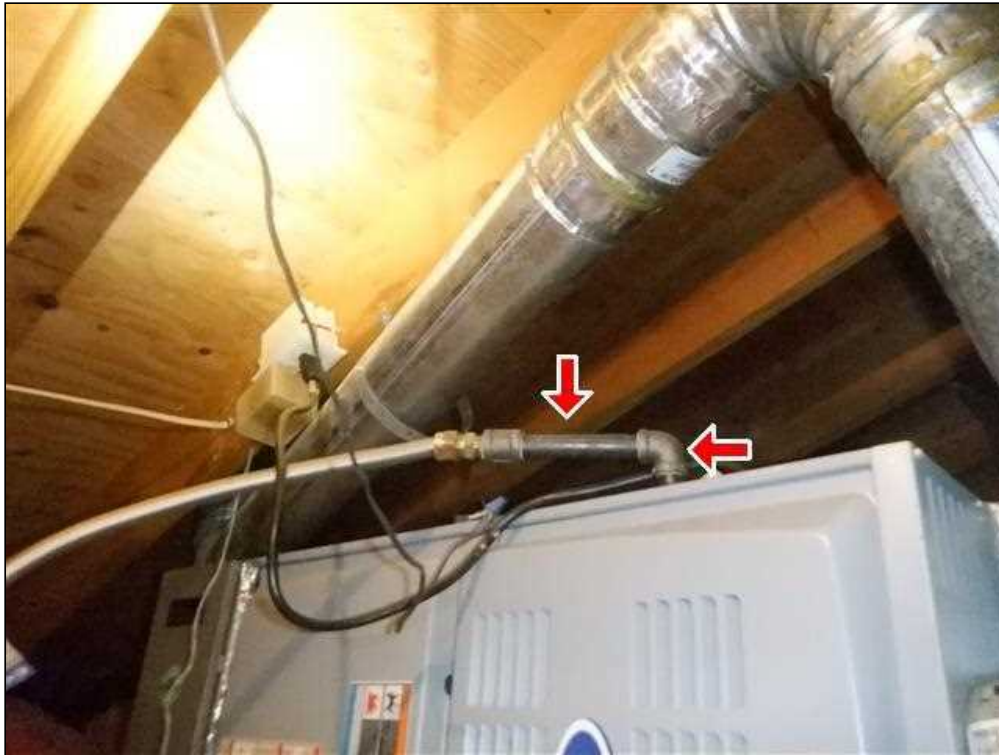
Although this heater was functioning properly at the time of inspection we noted that there was no sediment trap (Drip leg) installed on the fuel line. We highly recommend the installation of sediment traps (Drip legs) on all gas fired furnaces as they are installed, per manufactures requirements, to help prevent sediment in the gas piping from getting into the gas valve or burner area of an appliance and causing safety issues with combustion. Sediment trap (Drip legs) are now required on all gas fired heaters. The installation of sediment traps will extend the life of an appliance. Recommend evaluation and installation of a sediment trap by a licensed plumbing contractor. This unit is 5 years old.

10.0.A Item 2(Picture) Heating Unit South Fuel Line Missing Sediment Trap

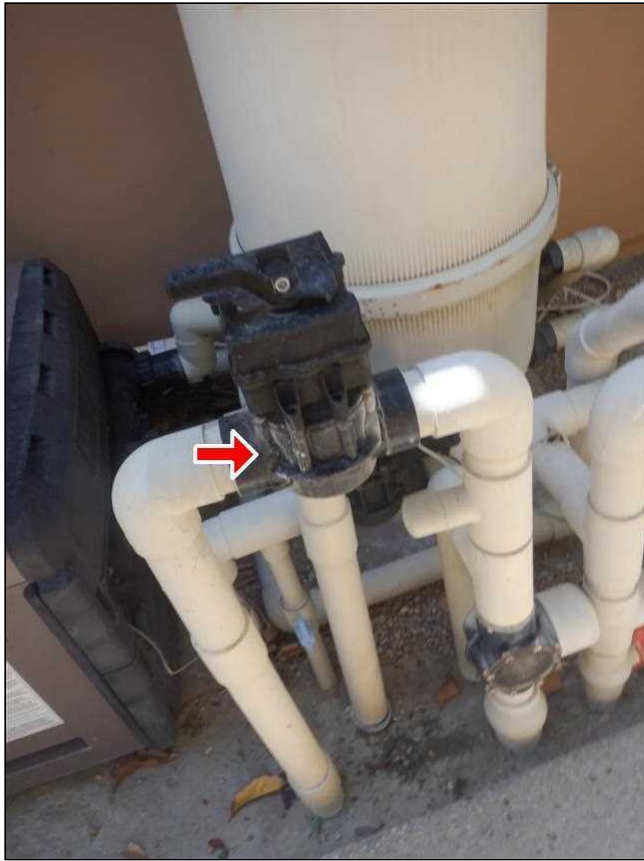
Our company does not inspect pool for leaks or seepage, only components readily accessible are inspected. We noted leaks in the plumbing at one of the fittings and valves. Recommend evaluation repair replace as needed by a pool contractor.

11.9 Item 1(Picture) Actuator Valve Leak

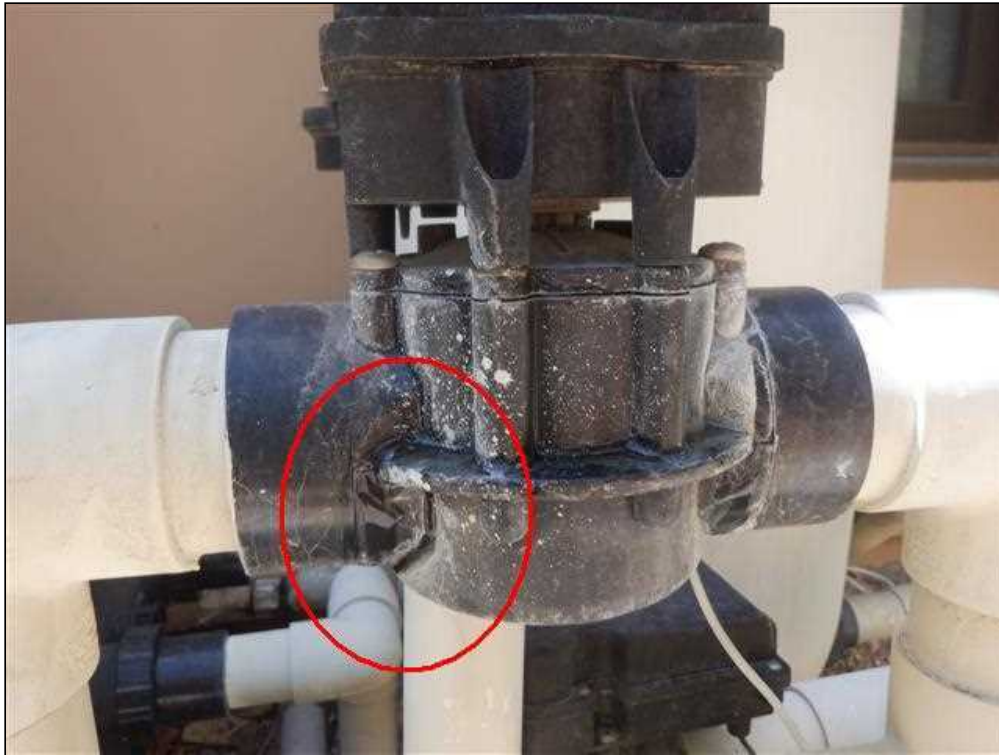
11.9 Item 2(Picture) Actuator Valve Leak

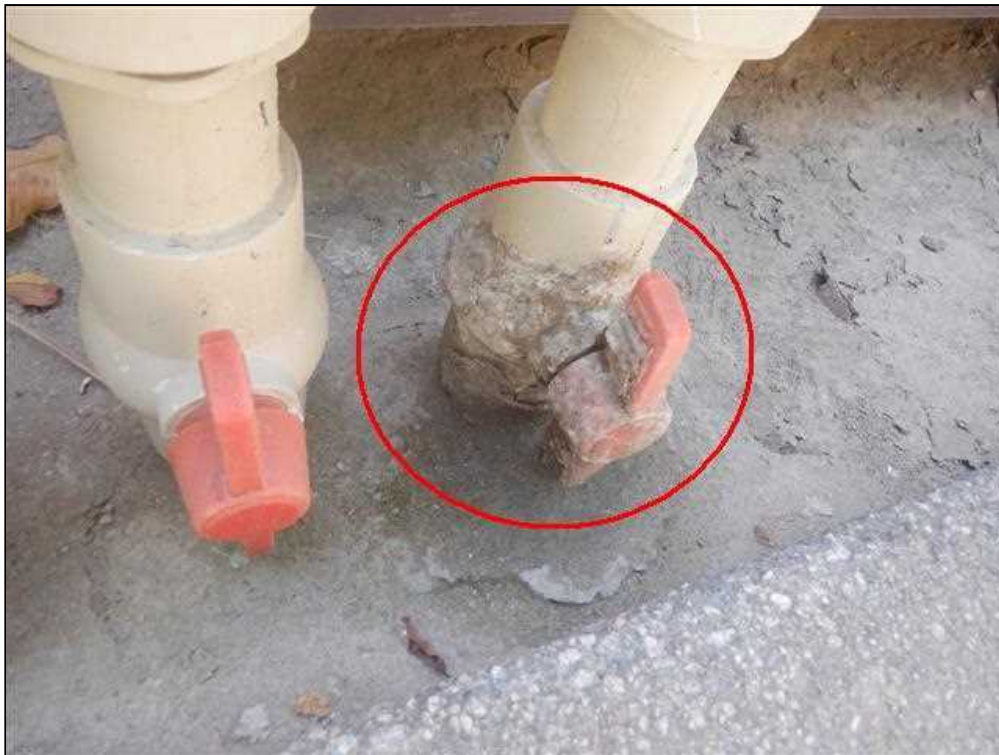
11.9 Item 3(Picture) Plumbing Valve Seepage Noted

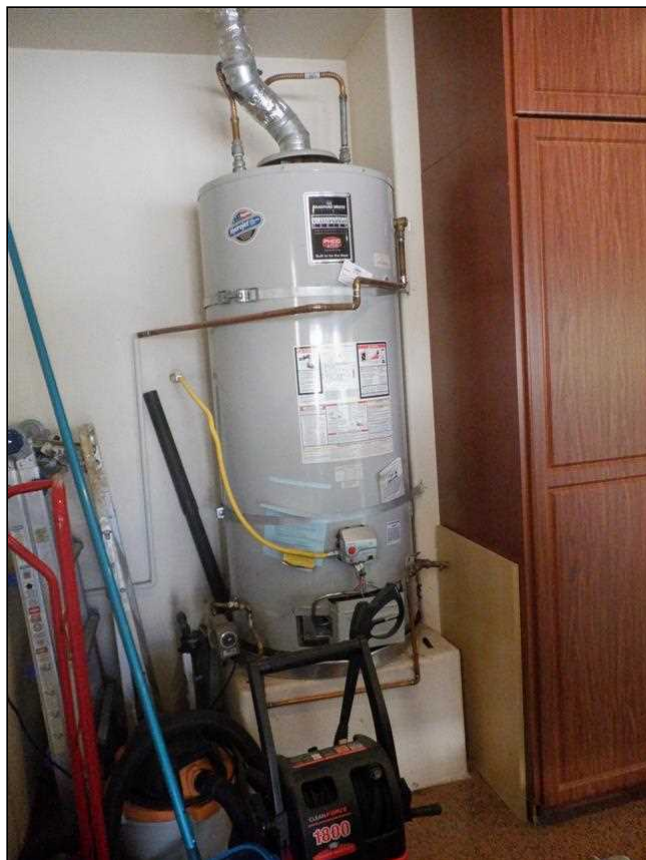
8.3 Item 1(Picture) Water Heater 2 Seismic Straps Only

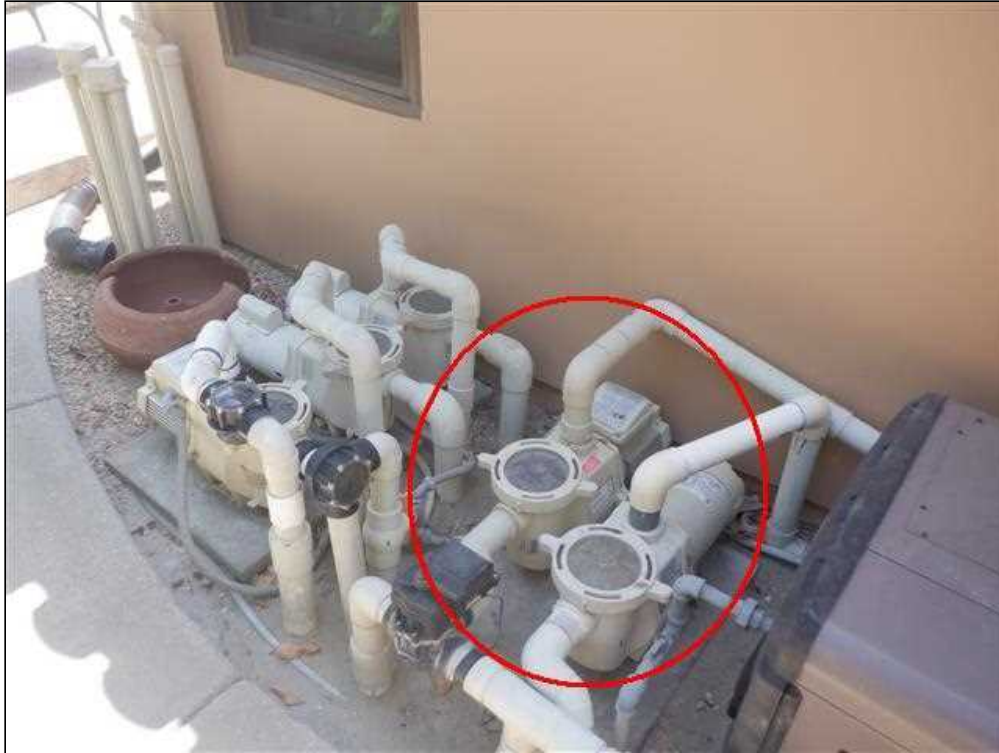
11.26 Item 1(Picture) Pumps Not Bonded

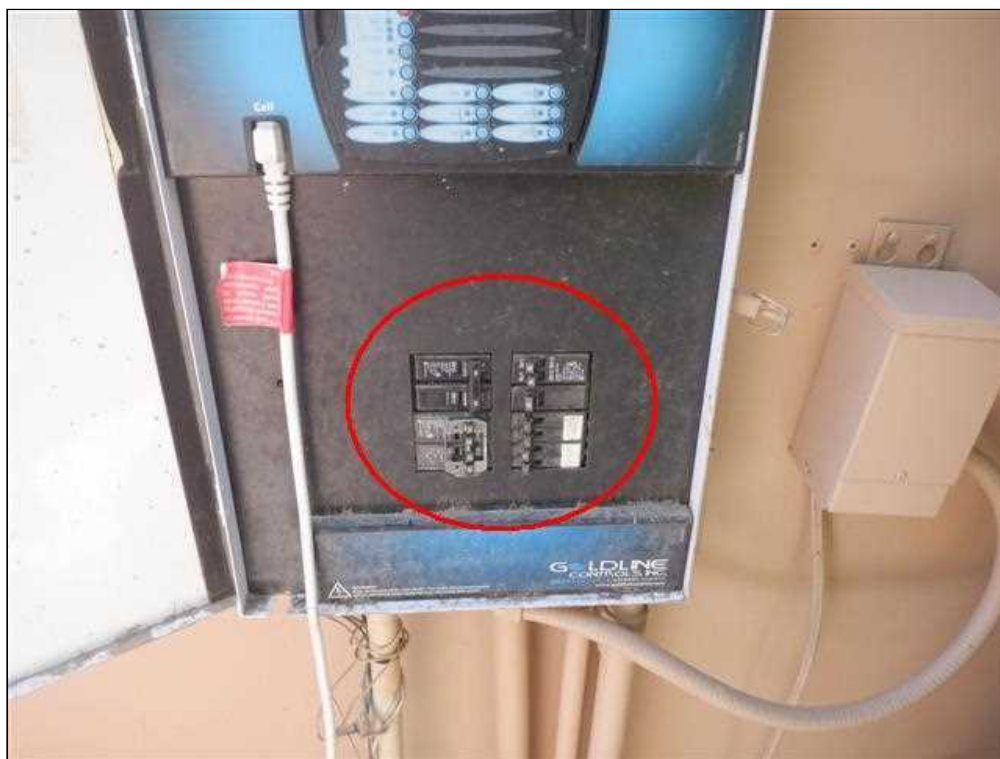
11.26 Item 4(Picture) Pool/Spa Equipment Not GFCI Protected
