## MOISTURE & MOLD ASSESSMENT REPORT

7023 San Bartolo  
Carlsbad, CA 92011

August 13, 2026

Report #26198-01

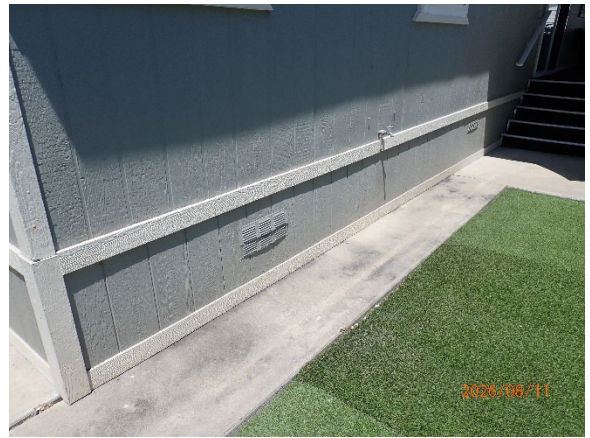
The full extent of mold growth on the substructure could not be determined due to the vapor barrier that is in place on the underside of the structure. While the underlying cause of mold growth and elevated moisture in these areas could not be determined, it was noted that there is no perimeter ventilation for the crawl space other than at the west side of the structure around the primary suite. The perimeter vents at the west side below the primary suite have very narrow openings and will not allow much airflow. Inadequate crawl space ventilation can contribute to moisture retention and mold growth in the crawl space.

*Perimeter vents at south side of home below primary bedroom*

It is important that conditions contributing to moisture intrusion and mold growth in the home be addressed to prevent further damage from occurring. This should include evaluation of all plumbing systems, the roof, and any sources of moisture penetration around the exterior envelope. Increased perimeter ventilation is needed for the crawl space. Perimeter vents should be installed on all sides of the home to allow for adequate air flow. Installing fans at some of the perimeter vents is also advisable to increase air flow; however, care should be taken to ensure these vents exhaust to the exterior of the structure. Use of a vapor barrier that covers the soil is not recommended since this can contribute to further moisture retention and fungal growth in the soil below the home.

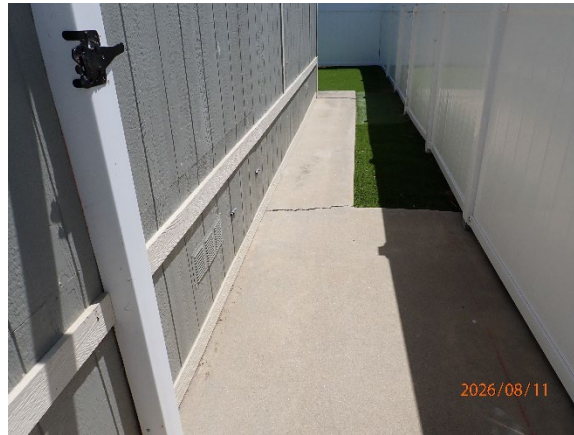
*Perimeter vents at west side of home below primary bedroom*

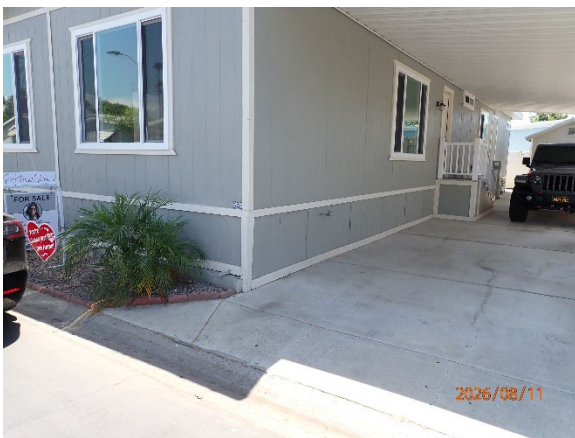
*No perimeter vents at east or north side of home below living room, laundry, guest bathroom, and guest bedroom*

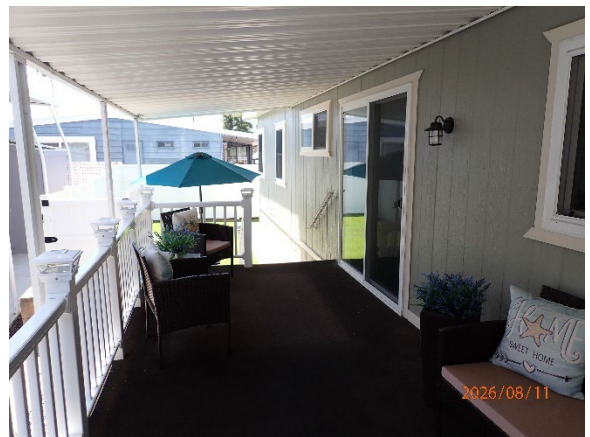
*No perimeter vents at south side of home outside of living room, kitchen, and family room*

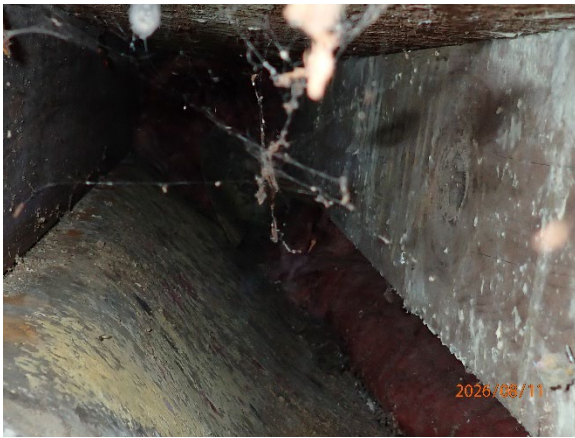
A strong mold odor was noted in the home. This was particularly evident at the east side of the home. Sagging flooring was noted in the living room, kitchen, and guest bedroom. There are floor registers throughout the home that used to be connected to the HVAC system before the supply ducts were moved to the ceiling. These registers were removed to inspect the space below the subfloor. Mold growth was noted on the floor joists and underside of the subfloor in the living room, and the metal that used to the base lining of the ducts was rusted. The view of the floor joists and subfloor was limited to the stud bay at each register, though it was noted that the heaviest growth was at the east side of the living room. Mold growth was also noted in the flex ducting at the return that runs from the family room to the HVAC unit. This duct is still an active part of the HVAC system. Elevated moisture readings (up to 85%) were noted on the floor in the living room, kitchen, family room, and guest bedroom.

*Mold growth below flooring at east side of living room*

In order to determine the extent of mold growth on the subfloor and floor joists, it is recommended that all flooring and baseboards be removed throughout the home along with all of the vapor barrier, insulation, and abandoned metal ducting from the underside of the structure. The return flex ducting that runs below the home should be removed. Any debris should be removed from within the crawl space so that the soil is left uncovered. All of the subfloor and floor joists should be inspected. Any subfloor with visible damage or mold growth should be removed. Floor joists that are structurally sound but have visible mold growth can be left in place but should be treated.

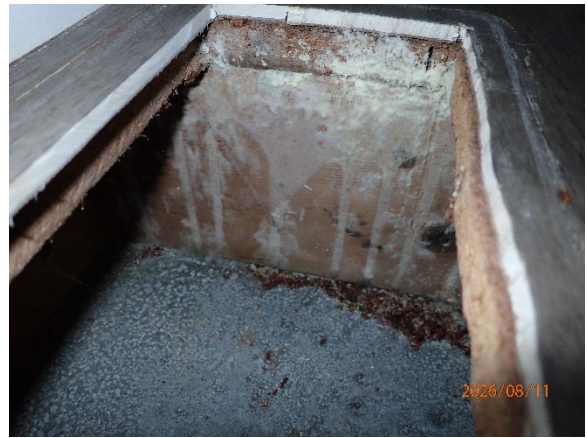
*Mold growth on subfloor and floor joist*

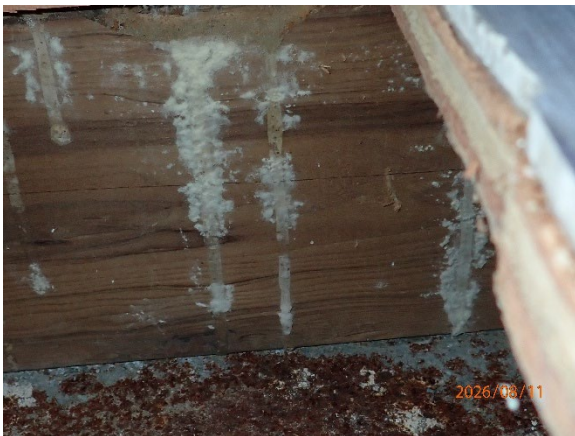
*Mold growth on floor joist*

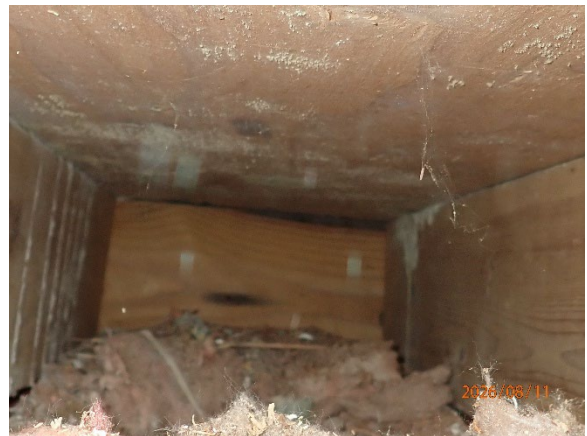
*Mold growth on underside of subfloor*

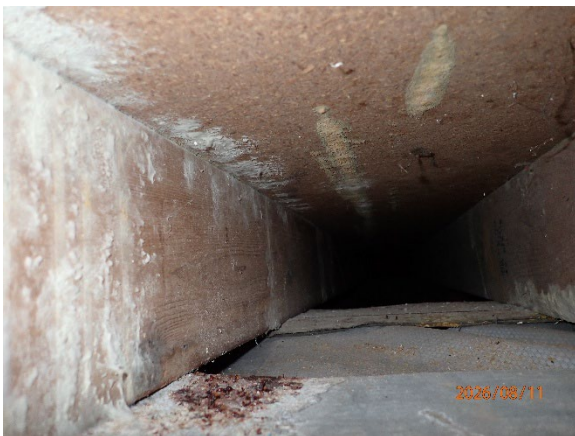
*Mold growth on underside of subfloor and floor joist*

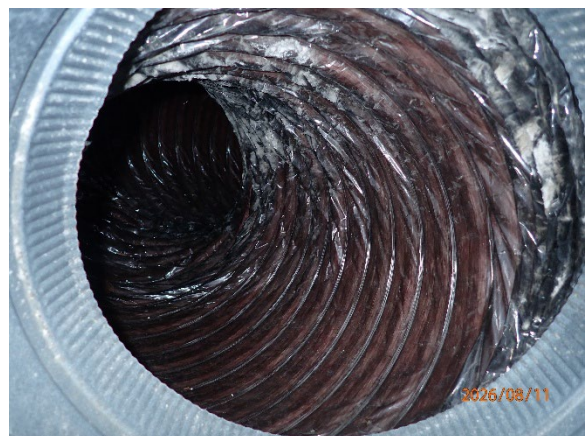
*Mold growth in return duct*

The HVAC unit should be evaluated by an HVAC contractor. The unit should be cleaned along with all of the supply ducts. New return flex ducting can be installed in the crawl space at this stage as well. Because duct cleaning can introduce particulates into the indoor environment, it is recommended that this be done prior to final interior cleaning. Once the system has been cleaned and the new return duct installed, all registers or openings to the ducts should be covered to prevent cross-contamination during final cleaning.

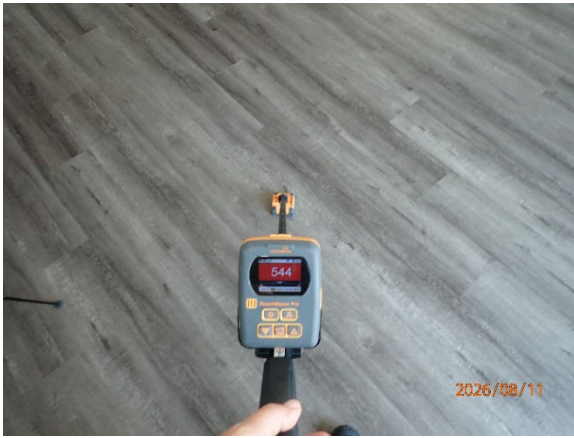
*Elevated moisture readings on floor in living room*

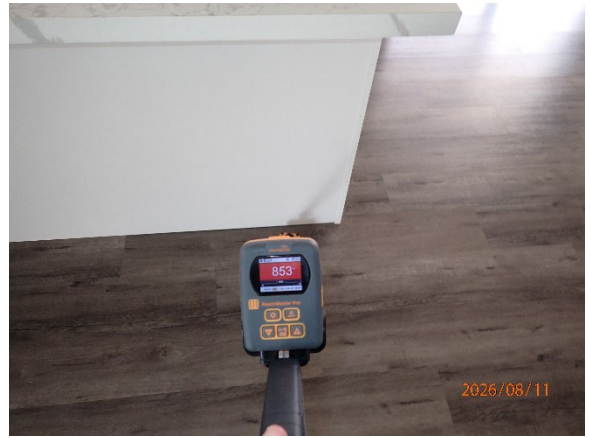
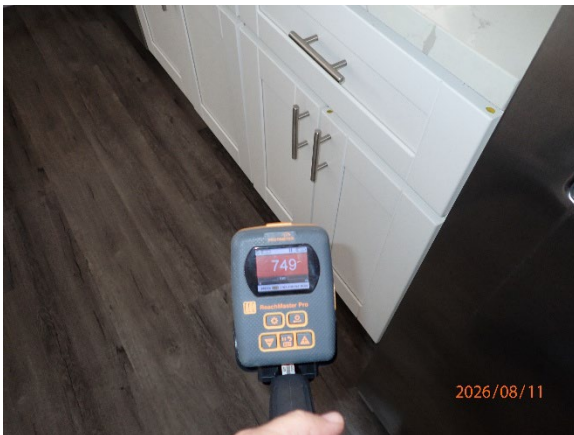
*Elevated moisture readings on floor in kitchen*

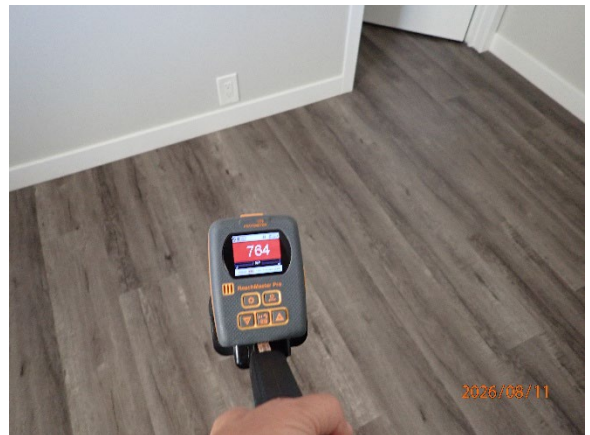
*Elevated moisture readings on floor in guest bedroom*

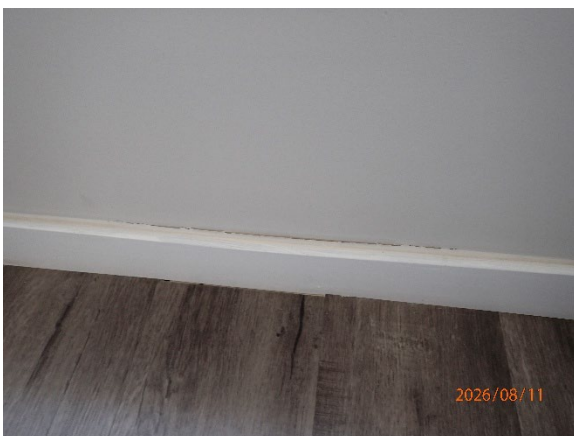
The baseboard at the east wall of the living room was separating from the wall. This was noted below the window closest to the northeast corner. This can be an indication of previous moisture exposure.

*Baseboard separating from east wall of living room*

Once the baseboards have been removed, the extent of drywall removal should be determined. Drywall and insulation should be removed from the lower two feet (minimum) of the walls in any areas where moisture stains, mold growth, or elevated moisture readings are noted. This should include the areas of concern described in the "Findings" section of this report, as well as any additional areas of damage or mold revealed by the removal of baseboards.

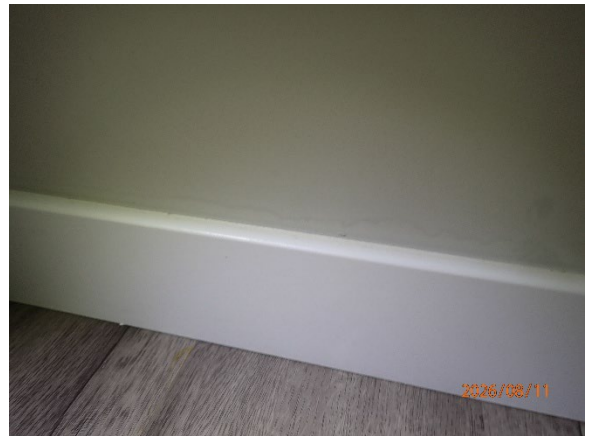
A faint stain was noted at the base of the west wall in the family room. It is unclear what caused staining in this area. This is not a plumbing wall, but the area could have been impacted by a roof leak or surface moisture (such as a dog bowl or nearby plant).

*Stain at base of west wall in family room*

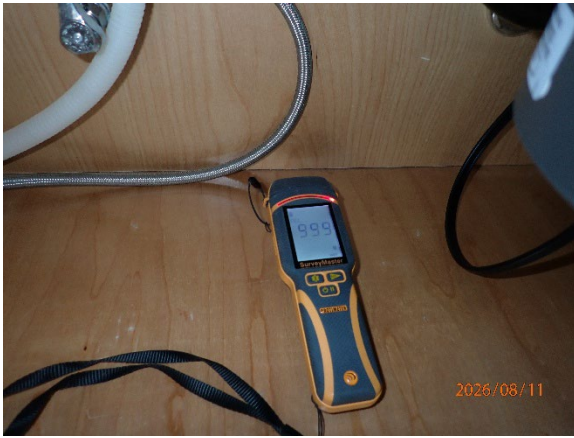
High moisture readings (up to 100%) were detected on the base shelf of the cabinet below the kitchen sink as well as the corner cabinet left of the sink. Moderate moisture readings (up to 25%) were detected on the toe kicks below the sink, at the island across from the sink, and on the peninsula that separates the kitchen and living room. There was a recent leak at the disposal below the sink which may have contributed to moisture in these areas.

*Elevated moisture readings on base shelf below kitchen sink*

Toe kicks should be removed from the cabinets in the kitchen and both bathrooms to allow inspection of the spaces below. If there is moisture damage or mold growth noted in any of these areas, the affected cabinets should be removed along with any affected drywall and insulation on the walls behind the cabinets.

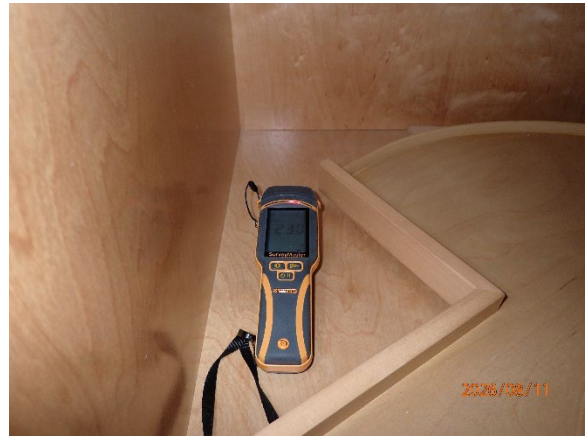
*Elevated moisture readings on base shelf of corner cabinet in kitchen*

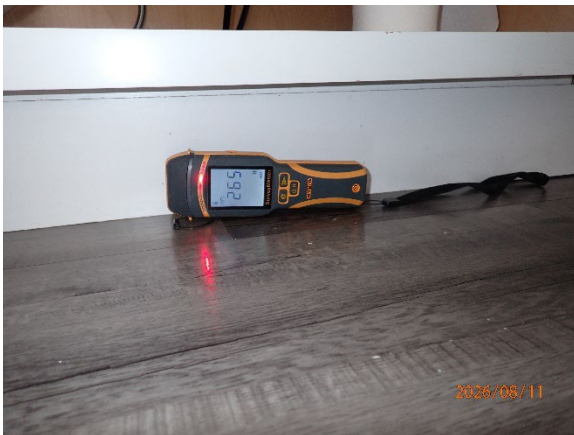
*Elevated moisture readings on toe kick below kitchen sink*

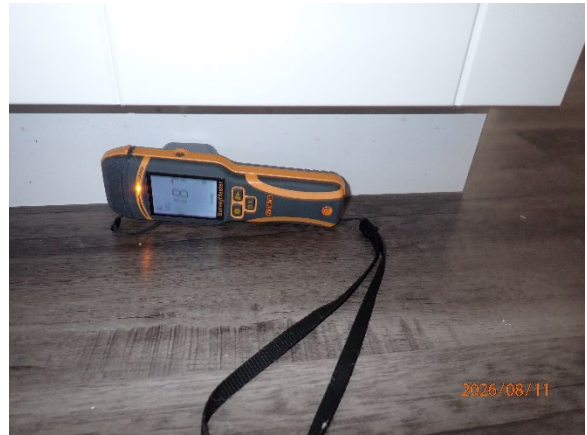
*Elevated moisture readings on toe kick of kitchen island*

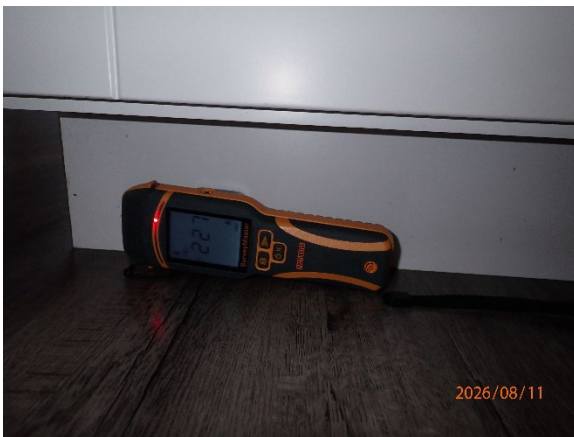
*Elevated moisture readings on toe kick of peninsula in kitchen*

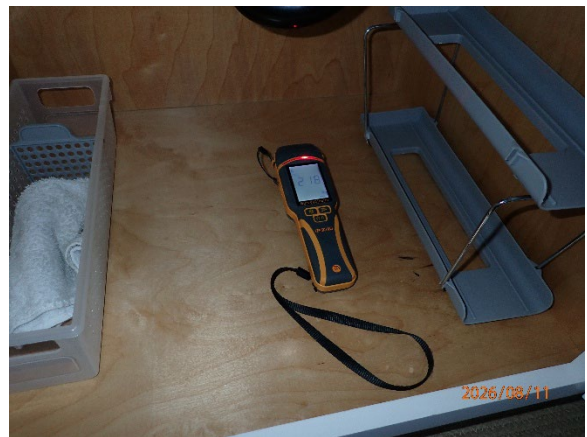
In the primary en-suite bathroom, elevated moisture readings (up to 25%) were detected on the base shelf below the sink.

*Elevated moisture readings on base shelf of cabinet below primary bathroom sink*

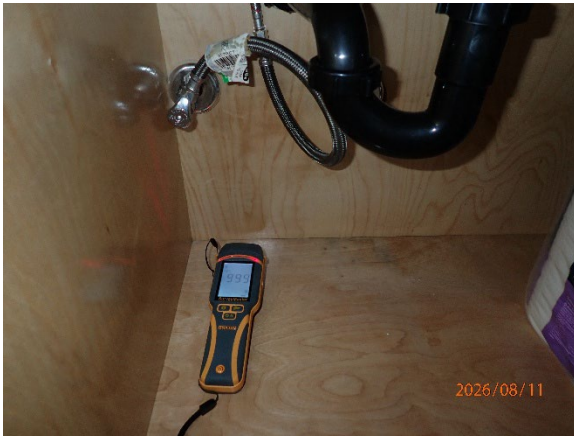
In the guest bathroom, elevated moisture readings (up to 100%) were detected on the base shelf of the cabinet below the sink. Moderate moisture readings (up to 25%) were detected at the base of the east wall behind the toilet, south wall between the vanity cabinet and door, and west wall next to the bedroom door. Elevated moisture readings (up to 28%) were detected on the adjacent wall in the linen closet. There appears to be visible mold growth on the floor below vanity cabinet (visible through a small gap at the base of the toe kick).

*Elevated moisture readings on base shelf of cabinet below guest bathroom sink*

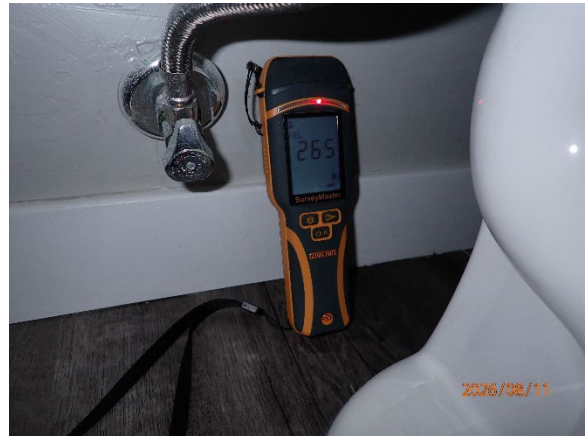
*Elevated moisture readings on east wall behind toilet in guest bathroom*

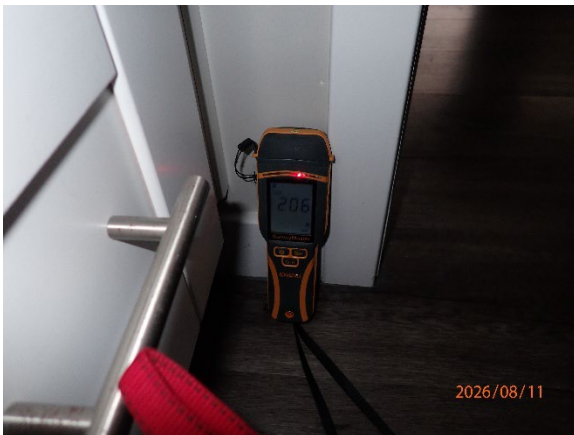
*Elevated moisture readings on south wall right of vanity cabinet in guest bathroom*

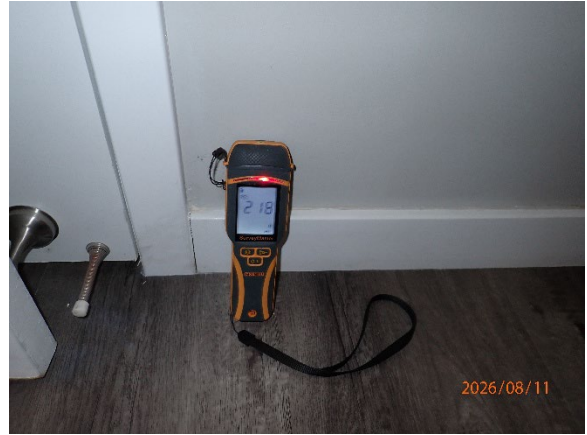
*Elevated moisture readings on west wall of guest bathroom next to bedroom door*

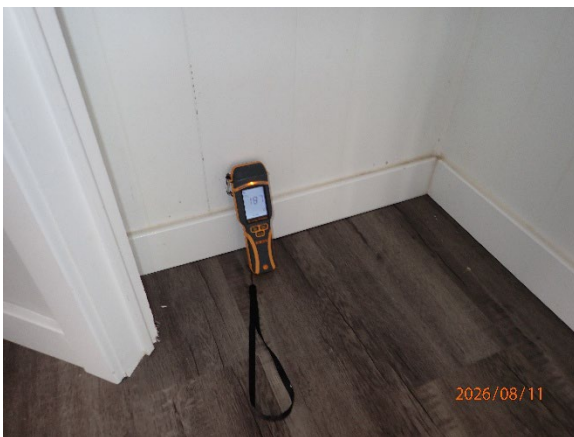
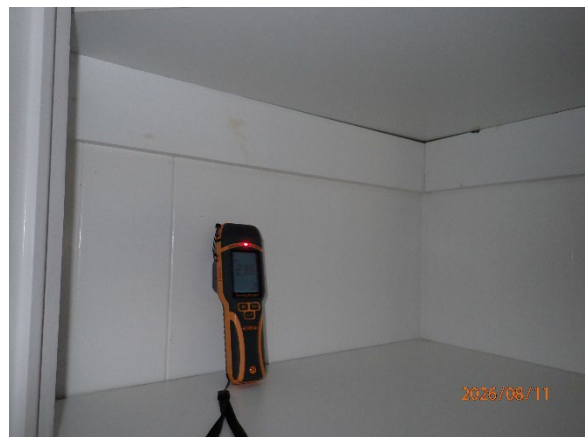
*Elevated moisture readings in linen closet adjacent to guest bathroom*
