HOME INSPECTION REPORT

1065 Brewley Ln, Vista, CA 92081

Inspection Date: 9/18/2025

Report Number: 2025020918KM Real Estate Agent: Steve Matsumoto Home Inspector: Kevin Mckinney

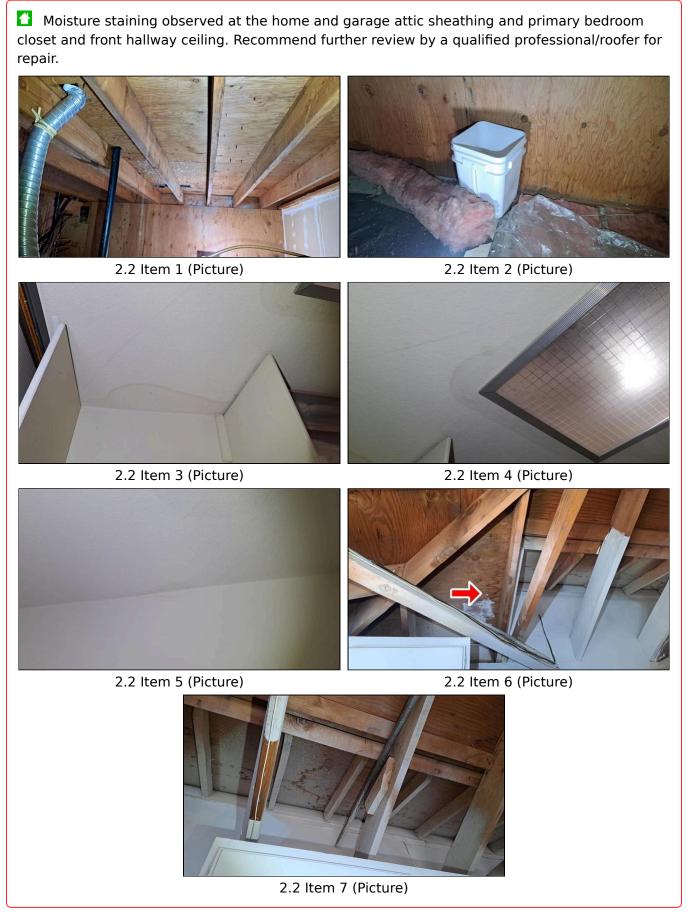
Moisture staining observed at the home and garage attic sheathing and primary bedroom closet and front hallway ceiling. Recommend further review by a qualified professional/roofer for repair.

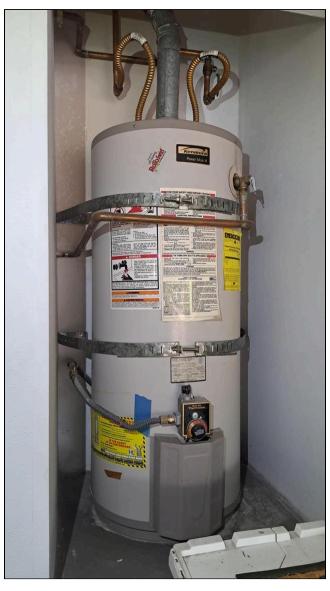
(1) Excessive corrosion and damaged vent piping observed at the water heater - safety concern Recommend replacement by a qualified professional.
